**Supermarket and Hotel Site, Aylesbury Waterside,  
Exchange Street, Aylesbury, Buckinghamshire**

**An archaeological evaluation**

**Site Code AWB10/15**

**Report 10/15b**

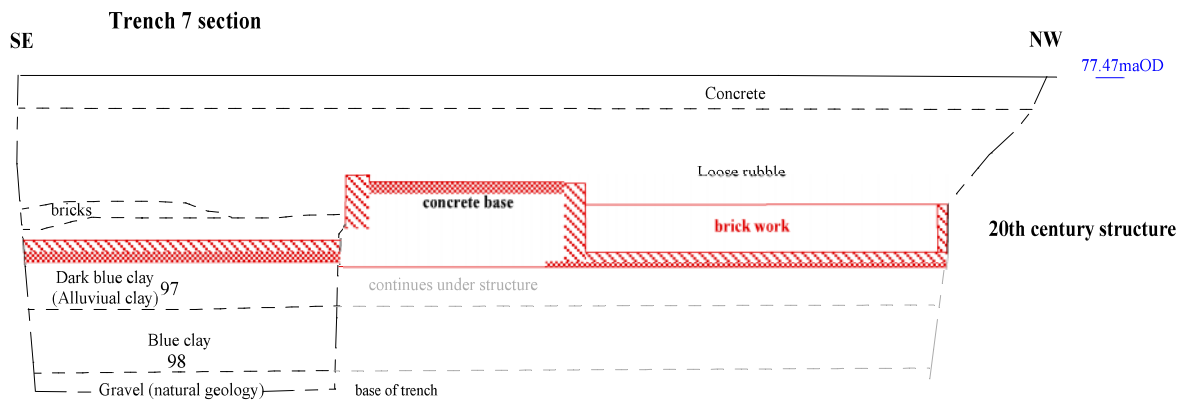
Figure 4. Section of Trench 7.

Trench 7 was 15.4m long and aligned SE–NW. The stratigraphy within Trench 7 comprised concrete reinforced with telegraph pole tensioning wire up to 0.12m thick above 0.7m of brick and concrete rubble, beneath which was a brick-built structure that formed the south and eastern edge of the trench and was 10.1m long with a centre division of a brick wall 0.40m wide, a concrete base 1.30m wide and a second brick wall 0.40m thick. The north wall to the structure was also 0.4m thick. The walls survived to a depth of 0.6m and consisted of five courses of modern frogged bricks in a stretcher pattern with a yellow sandy mortar. Between the walls was a brick floor heavily stained with oil. The southern part of the structure was broken out. The floor was found to consist of only one course of brick 0.11m thick. Beneath the floor was a concrete foundation up to 0.2m thick. Beneath the concrete was up to 0.6m thick of dark blue clay (97) with metal, modern frogged brick and hydrocarbon contamination. Beneath this was up to 0.4m depth of grey blue alluvial clay (98) similar to 156 in Trench 3, which contained no artefacts. Beneath 98 was clean gravel natural.

The northern 5.1m of the trench consisted of a modern service trench and a further brick wall which was left in place. No pre-modern artefacts or features were encountered within Trench 7.

These layers of made ground have been overlaid or cut through by foundations and concrete bases associated with the buildings that appear on the 20th-century Ordnance Survey maps of the site. The brick-built structure in Trench 7 is in a similar position and orientation to a building shown on the Second Edition Ordnance Survey map of 1899, the cellared building in Trench 5 is in the same position as a series of buildings shown on the Ordnance Survey maps from 1925 to 1996.

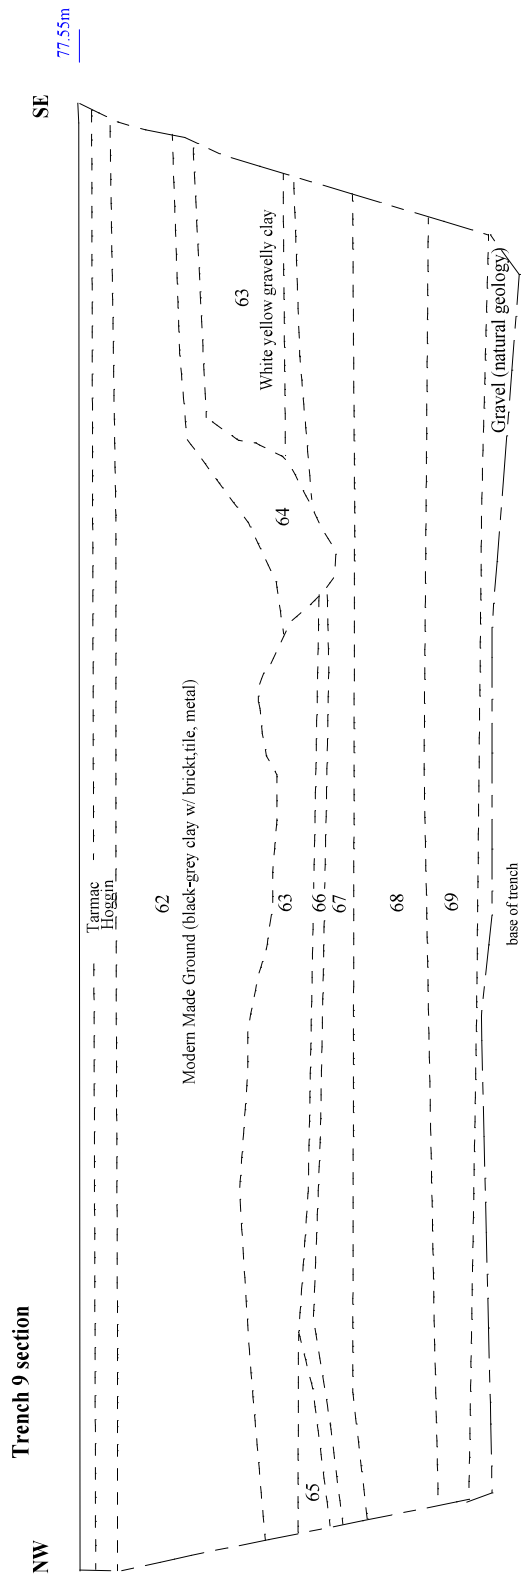
Figure 5. Section of Trench 9.

Trench 9 was 20m long and aligned SE–NW. The stratigraphy within Trench 9 comprised 0.02m of Tarmac, above 0.25m of hoggin, over up to 0.10m depth of blackish grey clay (62) with modern brick, tile and metal. Beneath 64 for the northern 17m of the trench lay up to 0.6m thick of brown red silty gravel (63) similar to (55) in Trench 8. Beneath (63) in the southern 3m of the trench was up to 0.55m thick of white yellow gravelly clay (64). Beneath 63 in the southern 3m of the trench was a thin band up to 0.05m thick of soft black silty sand (65)

with coal waste similar to (56) in Trench 8. Beneath (65) in the northern 5m of the trench was a large truncation that was filled with a dark brown grey clay that contained a dump of peg tile and telegraph poles. Beneath the truncation was a thin band (0.02m) of black grey clay (66), that contained modern brick and was similar to (58) in Trench 8. Beneath (66) was up to 0.4m thick greenish grey clay (67) that contained metal cable and modern brick. This overlay up to 0.5m thick of grey alluvial clay (68) with no artefacts which was similar to 156 in Trench 3. Beneath (68) was 0.4m thick of yellow brown alluvial clay (69) with no artefacts which was similar to 157 in Trench 3. Beneath 69 were natural gravel geology and the water table. No pre-modern artefacts or features were encountered within Trench 9.

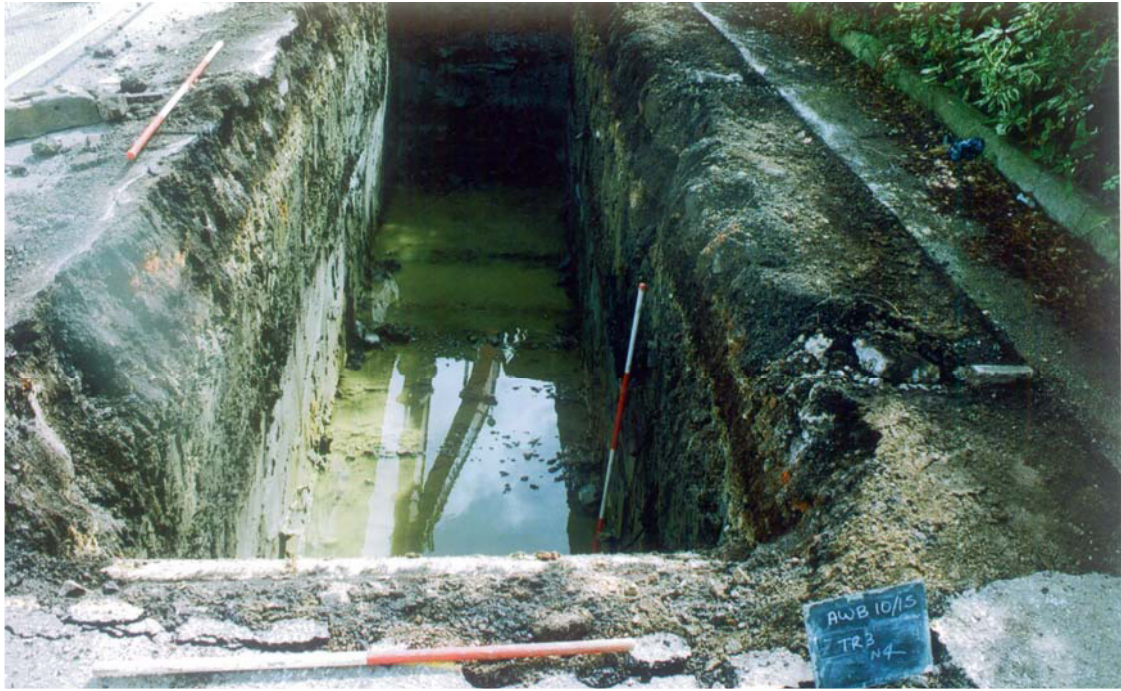
Trench 3 was 20.1m long and aligned SE–NW, although a central 4m section was occupied by a large reinforced concrete base. The stratigraphy within Trench 3 comprised 0.2m Tarmac, beneath which was 0.35m of hoggin. Beneath the hoggin was 0.15m of made ground (152), a mid brown red silty sand with gravel which included modern brick. Beneath 152 was 0.1m of light white yellow gravelly sand (153) with no artefacts. Beneath 153 was 0.55m of mixed blue green clay (154) with ash, coal and brick stamped LBC. Beneath this was dark black blue clay (155) with metal, modern frogged brick, peg tile, and hydrocarbon contamination. Beneath was 156, 0.6m depth of clean blue grey alluvial clay with no artefacts. Blue clay 156 overlay 0.3m of yellow brown alluvial clay (157) with no artefacts. Beneath (157) were clean gravel natural geology and the water table. No pre-modern artefacts were recovered from Trench 3.

Plate 1. Trench 3, looking east, near horizontal scale 1m, further 2m, vertical 2m.

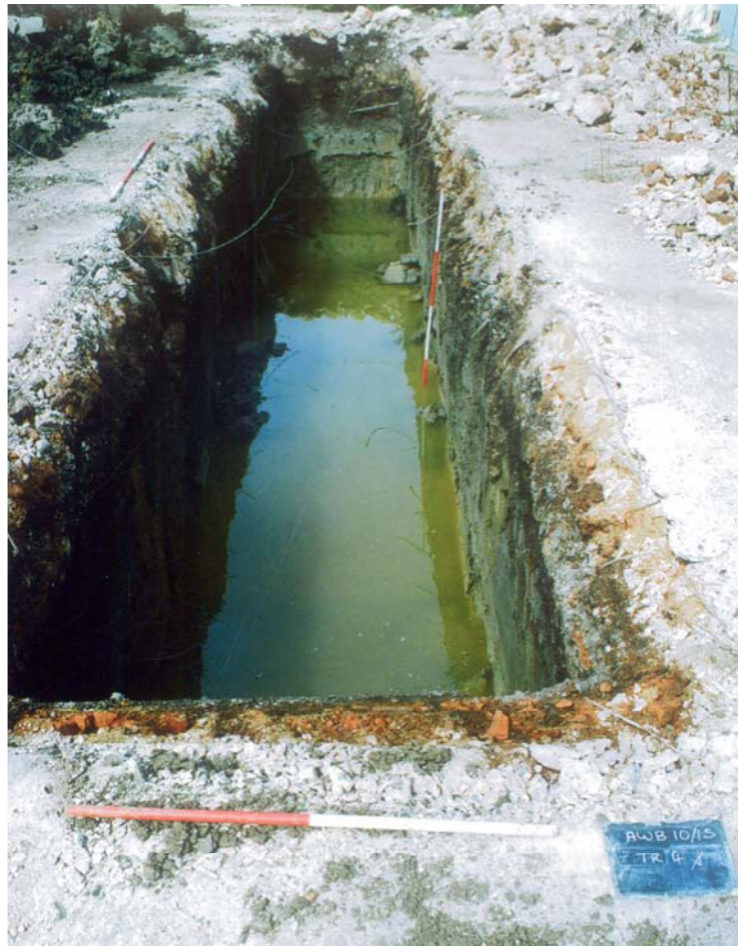
Trench 4 was 15m long and aligned SE–NW. The stratigraphy within Trench 4 comprised 0.20m of reinforced concrete beneath which was 0.3m of brick rubble made ground, above 0.33m thick of blackish grey clay (74) with bricks marked LBC, unmarked square sectioned frogged bricks, nails and ceramic insulators. Beneath 74

was a layer 0.19m thick of black silty sand (75) which contained telegraph pole tensioning wire. Beneath (75) was layer 76, which was 0.56m thick of greenish grey clay with modern glass bottle, metal, modern brick and sections of telegraph poles. This overlay 0.7m of grey blue alluvial clay (77), similar to 156 in Trench 3, and which contained no artefacts. Beneath 77 was 0.3m thick yellow brown alluvial clay (78) which was similar to 157 in Trench 3. Trench 4 contained no pre-modern artefacts or features.

Plate 2. Trench 4, looking north-west, near horizontal scale 1m, further 2m, vertical 2m.

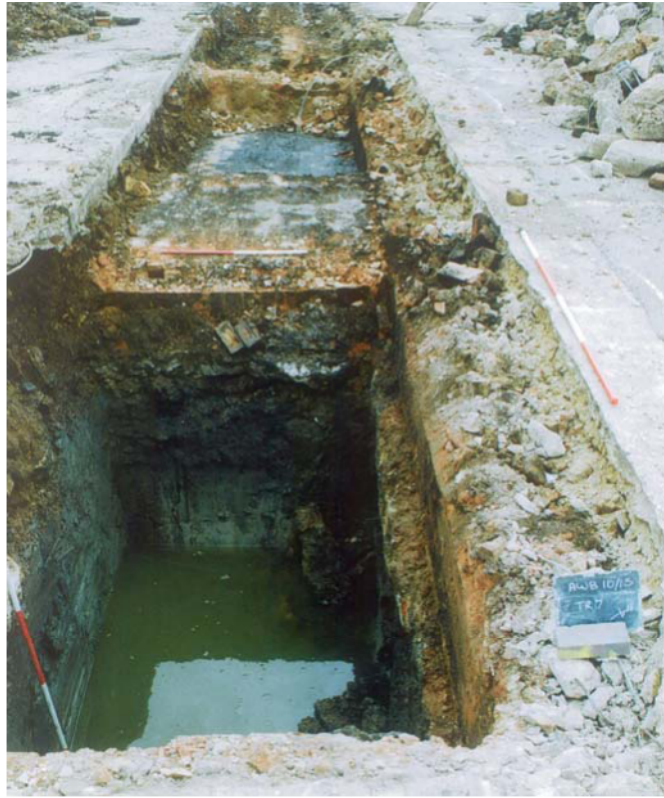
Plate 3. Trench 7, looking north-west, vertical and horizontal right scales 2m, horizontal central scale 1m.

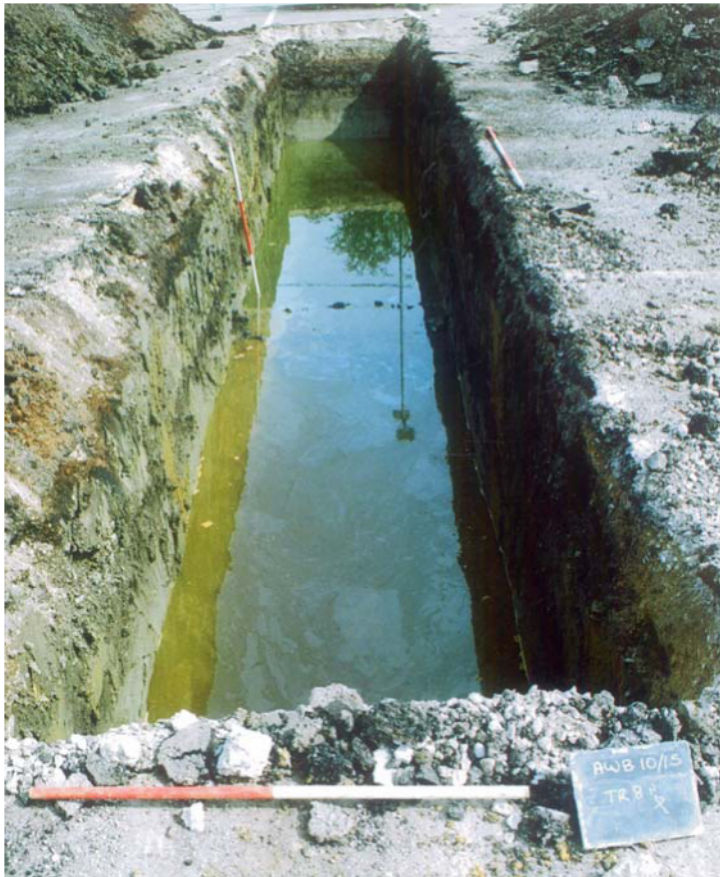
Trench 8 was 15.4m long and aligned SW–NE. The stratigraphy within Trench 8 comprised 0.02m of Tarmac beneath which was 0.25m of hoggin, above up to 0.35m thick of blackish grey clay (54) with modern brick, tile and metal. Beneath (54) was up to 0.11m thick of brown red silty gravel (55). Beneath this was deposit 56, up to 0.1m thick of soft black silty sand with coal waste. Beneath 56 was 0.27m of greenish grey clay (57) that contained metal cable, modern brick, and a screw-topped modern brown glass bottle. This overlay up to 0.2m thick of black grey clay (58) that contained modern transfer-printed pottery. Beneath layer 58 was 0.5m blue grey alluvial clay (59) with no artefacts, again similar to 156 in Trench 3, and again this overlay yellow brown alluvial clay (60), which was 0.6m thick with no artefacts, as 157 in Trench 3. Beneath 60 was natural gravel geology and the water table. No pre-modern artefacts or features were encountered within Trench 9.

Plate 4. Trench 8 looking north-east, near horizontal scale 1m, further 2m, vertical 2m.
