Westhill Farm, Chick's Lane, Collingbourne Ducis, Wiltshire

Archaeological watching brief

Site Code: WCD 11/13

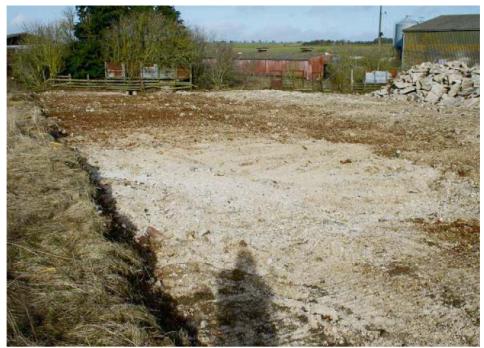
Plate 1. Levelled area of barn, looking north.

The concrete slab for the former barn had been removed and most of this area was available to be inspected (Pl. 1). This showed that the higher ground to the west had been cut into to form a level terrace, exposing chalk to the west. An area of brown silty clay was visible to the north-west, presumably less truncated, but no finds of archaeological interest were gathered during a walk-over survey of this ground.

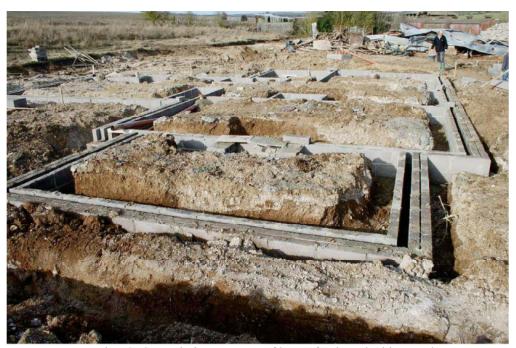
Plate 2. General view over top of house footings, looking north.

Most footing trenches for the new house were 0.7m wide, and were dug to a depth of at least 0.51m (Fig. 4, Pl. 2). The maximum depth of section could not be ascertained as the bases had been filled but these were well into the chalk. In the eastern end of the new house footing, in places, a brown silty clay, probably a natural deposit reached a depth of 0.3m before chalk was exposed. No archaeological finds or features were noted in the section.
