## **1EW03 – Enabling Works Central**

# **AWH Fieldwork Report for Trial Trench Evaluation at Piper's Wood Cottage, Little Missenden Vent Shaft and ATS, Buckinghamshire (AC100/11)**

**Site Code: 1C18PIPTT**

Document no.: 1EW03-FUS\_IFA-EV-REP-CS02\_CL04-000003

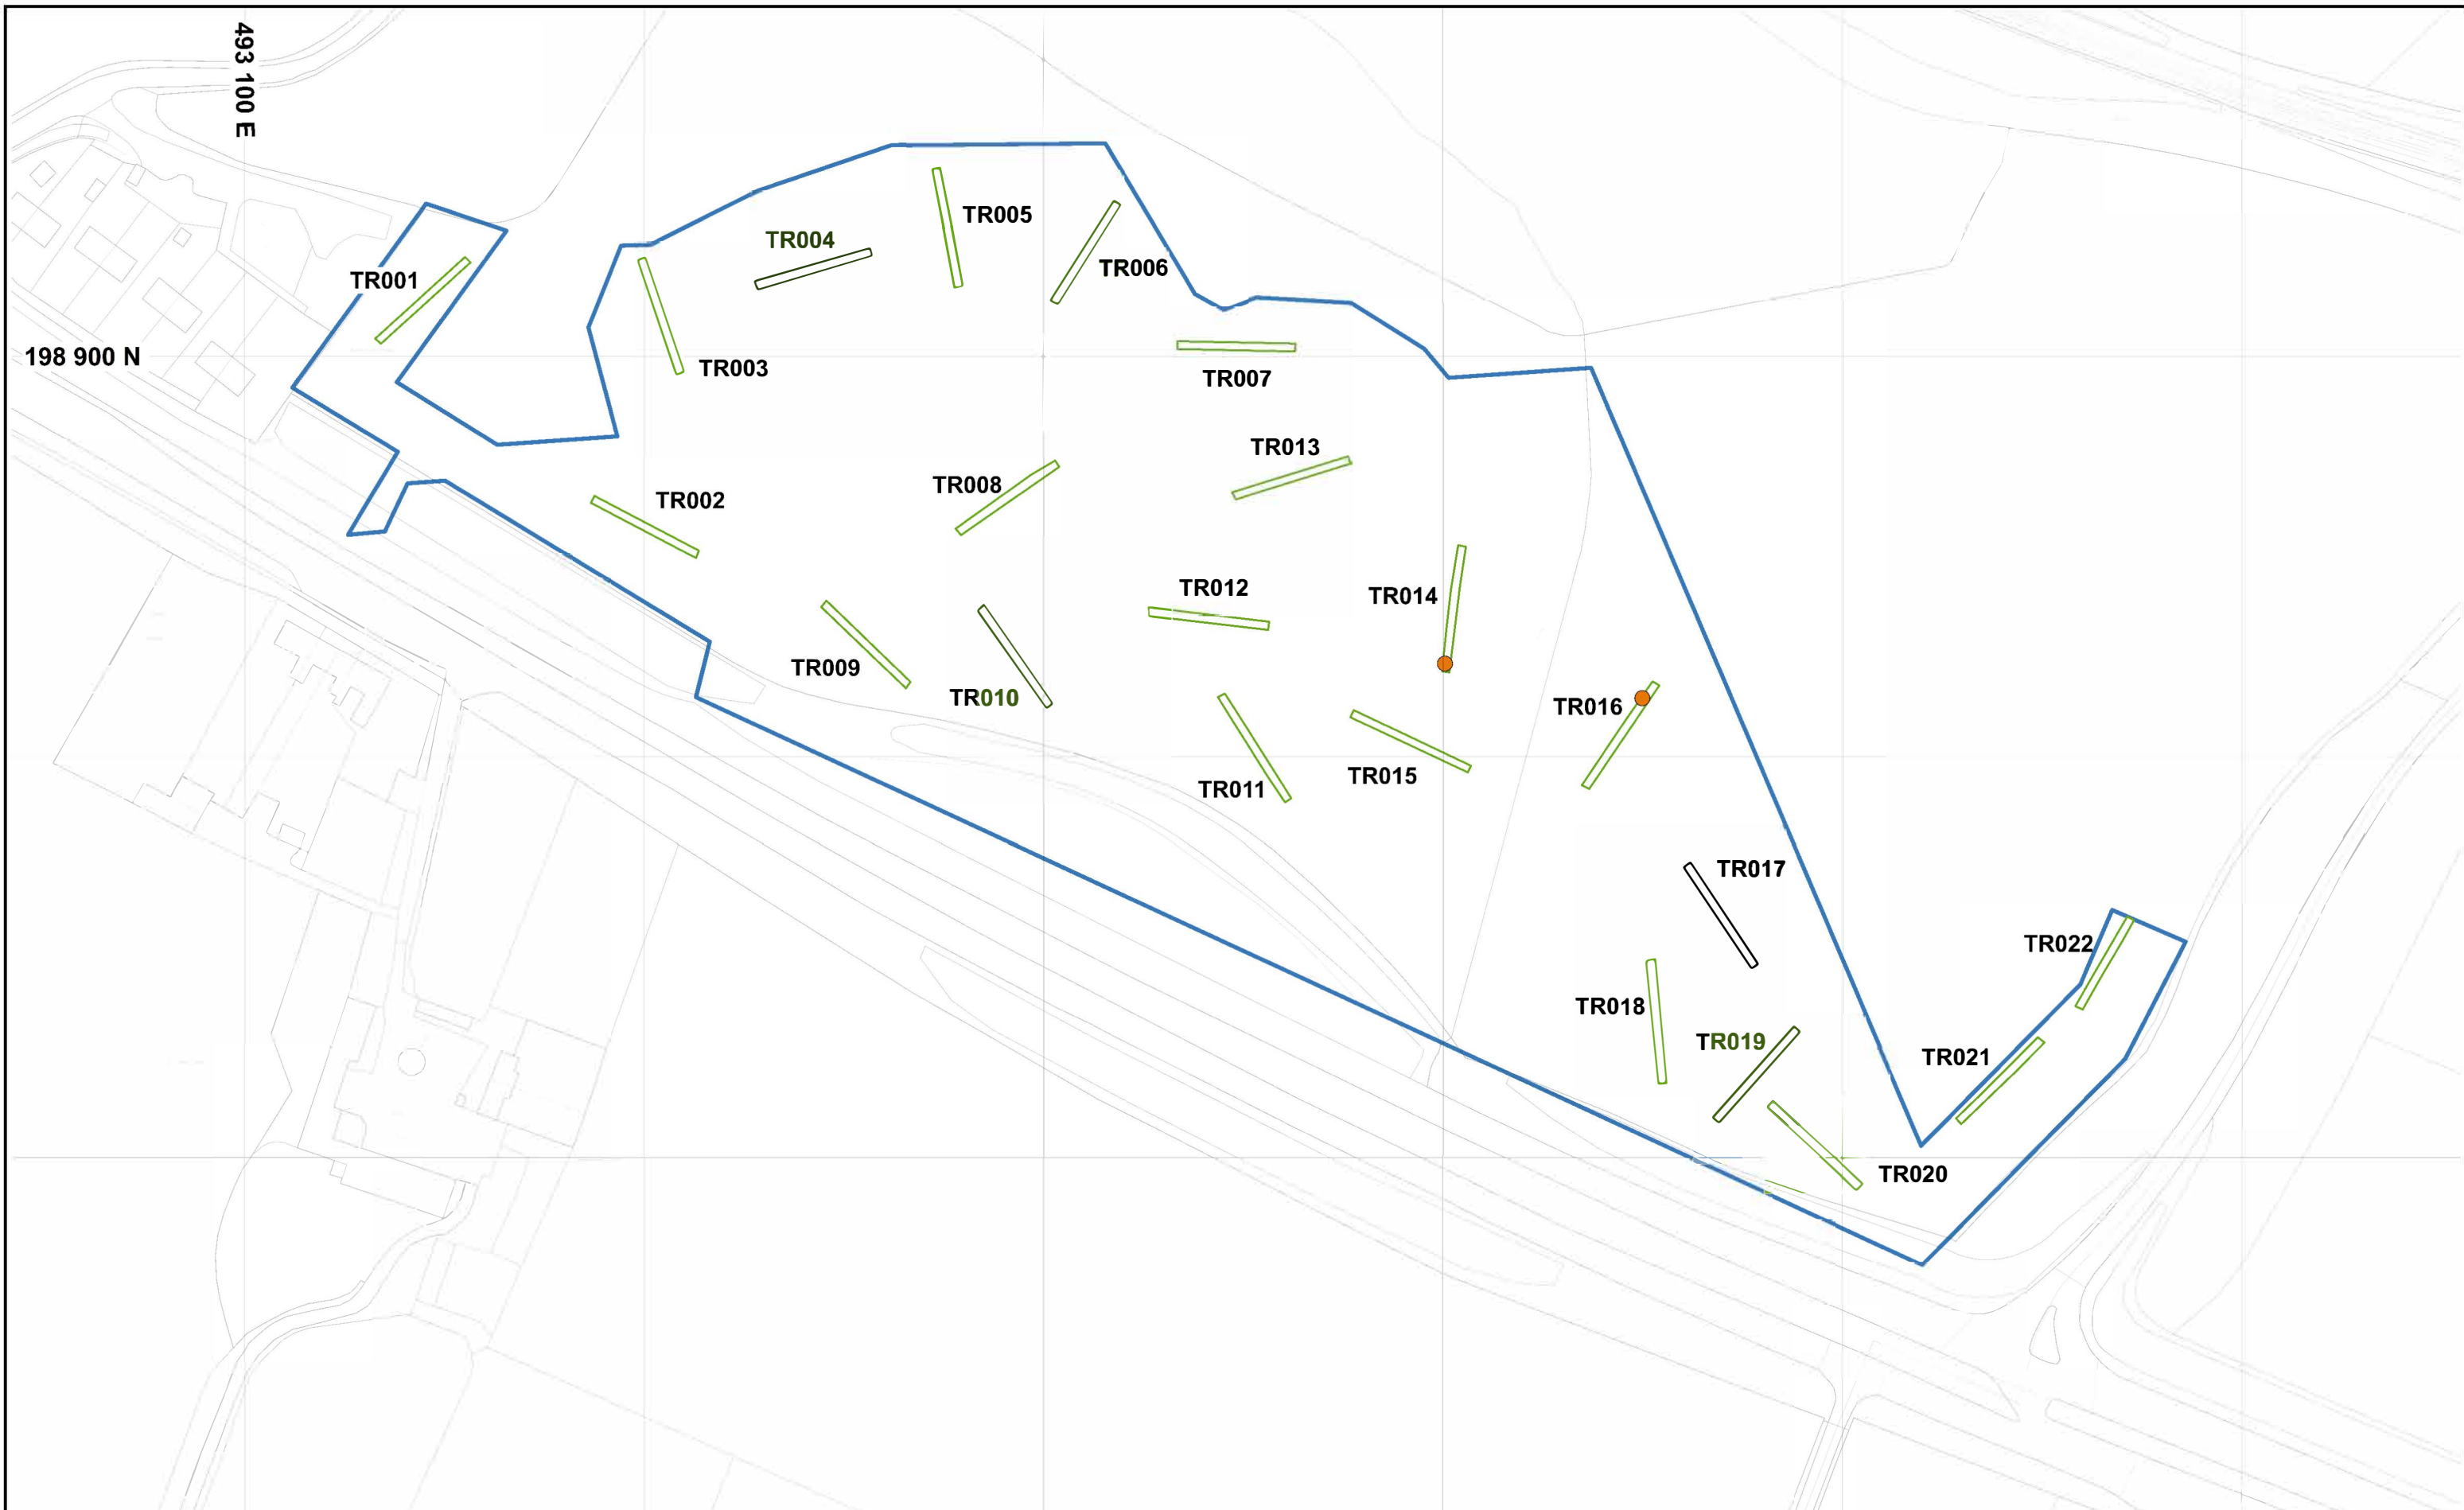
High Speed Two,  
Piper's Wood Cottages  
Figure 2. Location of natural features

- Site extent
- Excavated evaluation trench
- Location of natural feature

7.3.1 The movement of trenches from their original locations, descoping or amendment to methodology was implemented through change control (Figure 2). These were limited to the shortest distance to clear constraints and maintain orientation where possible.

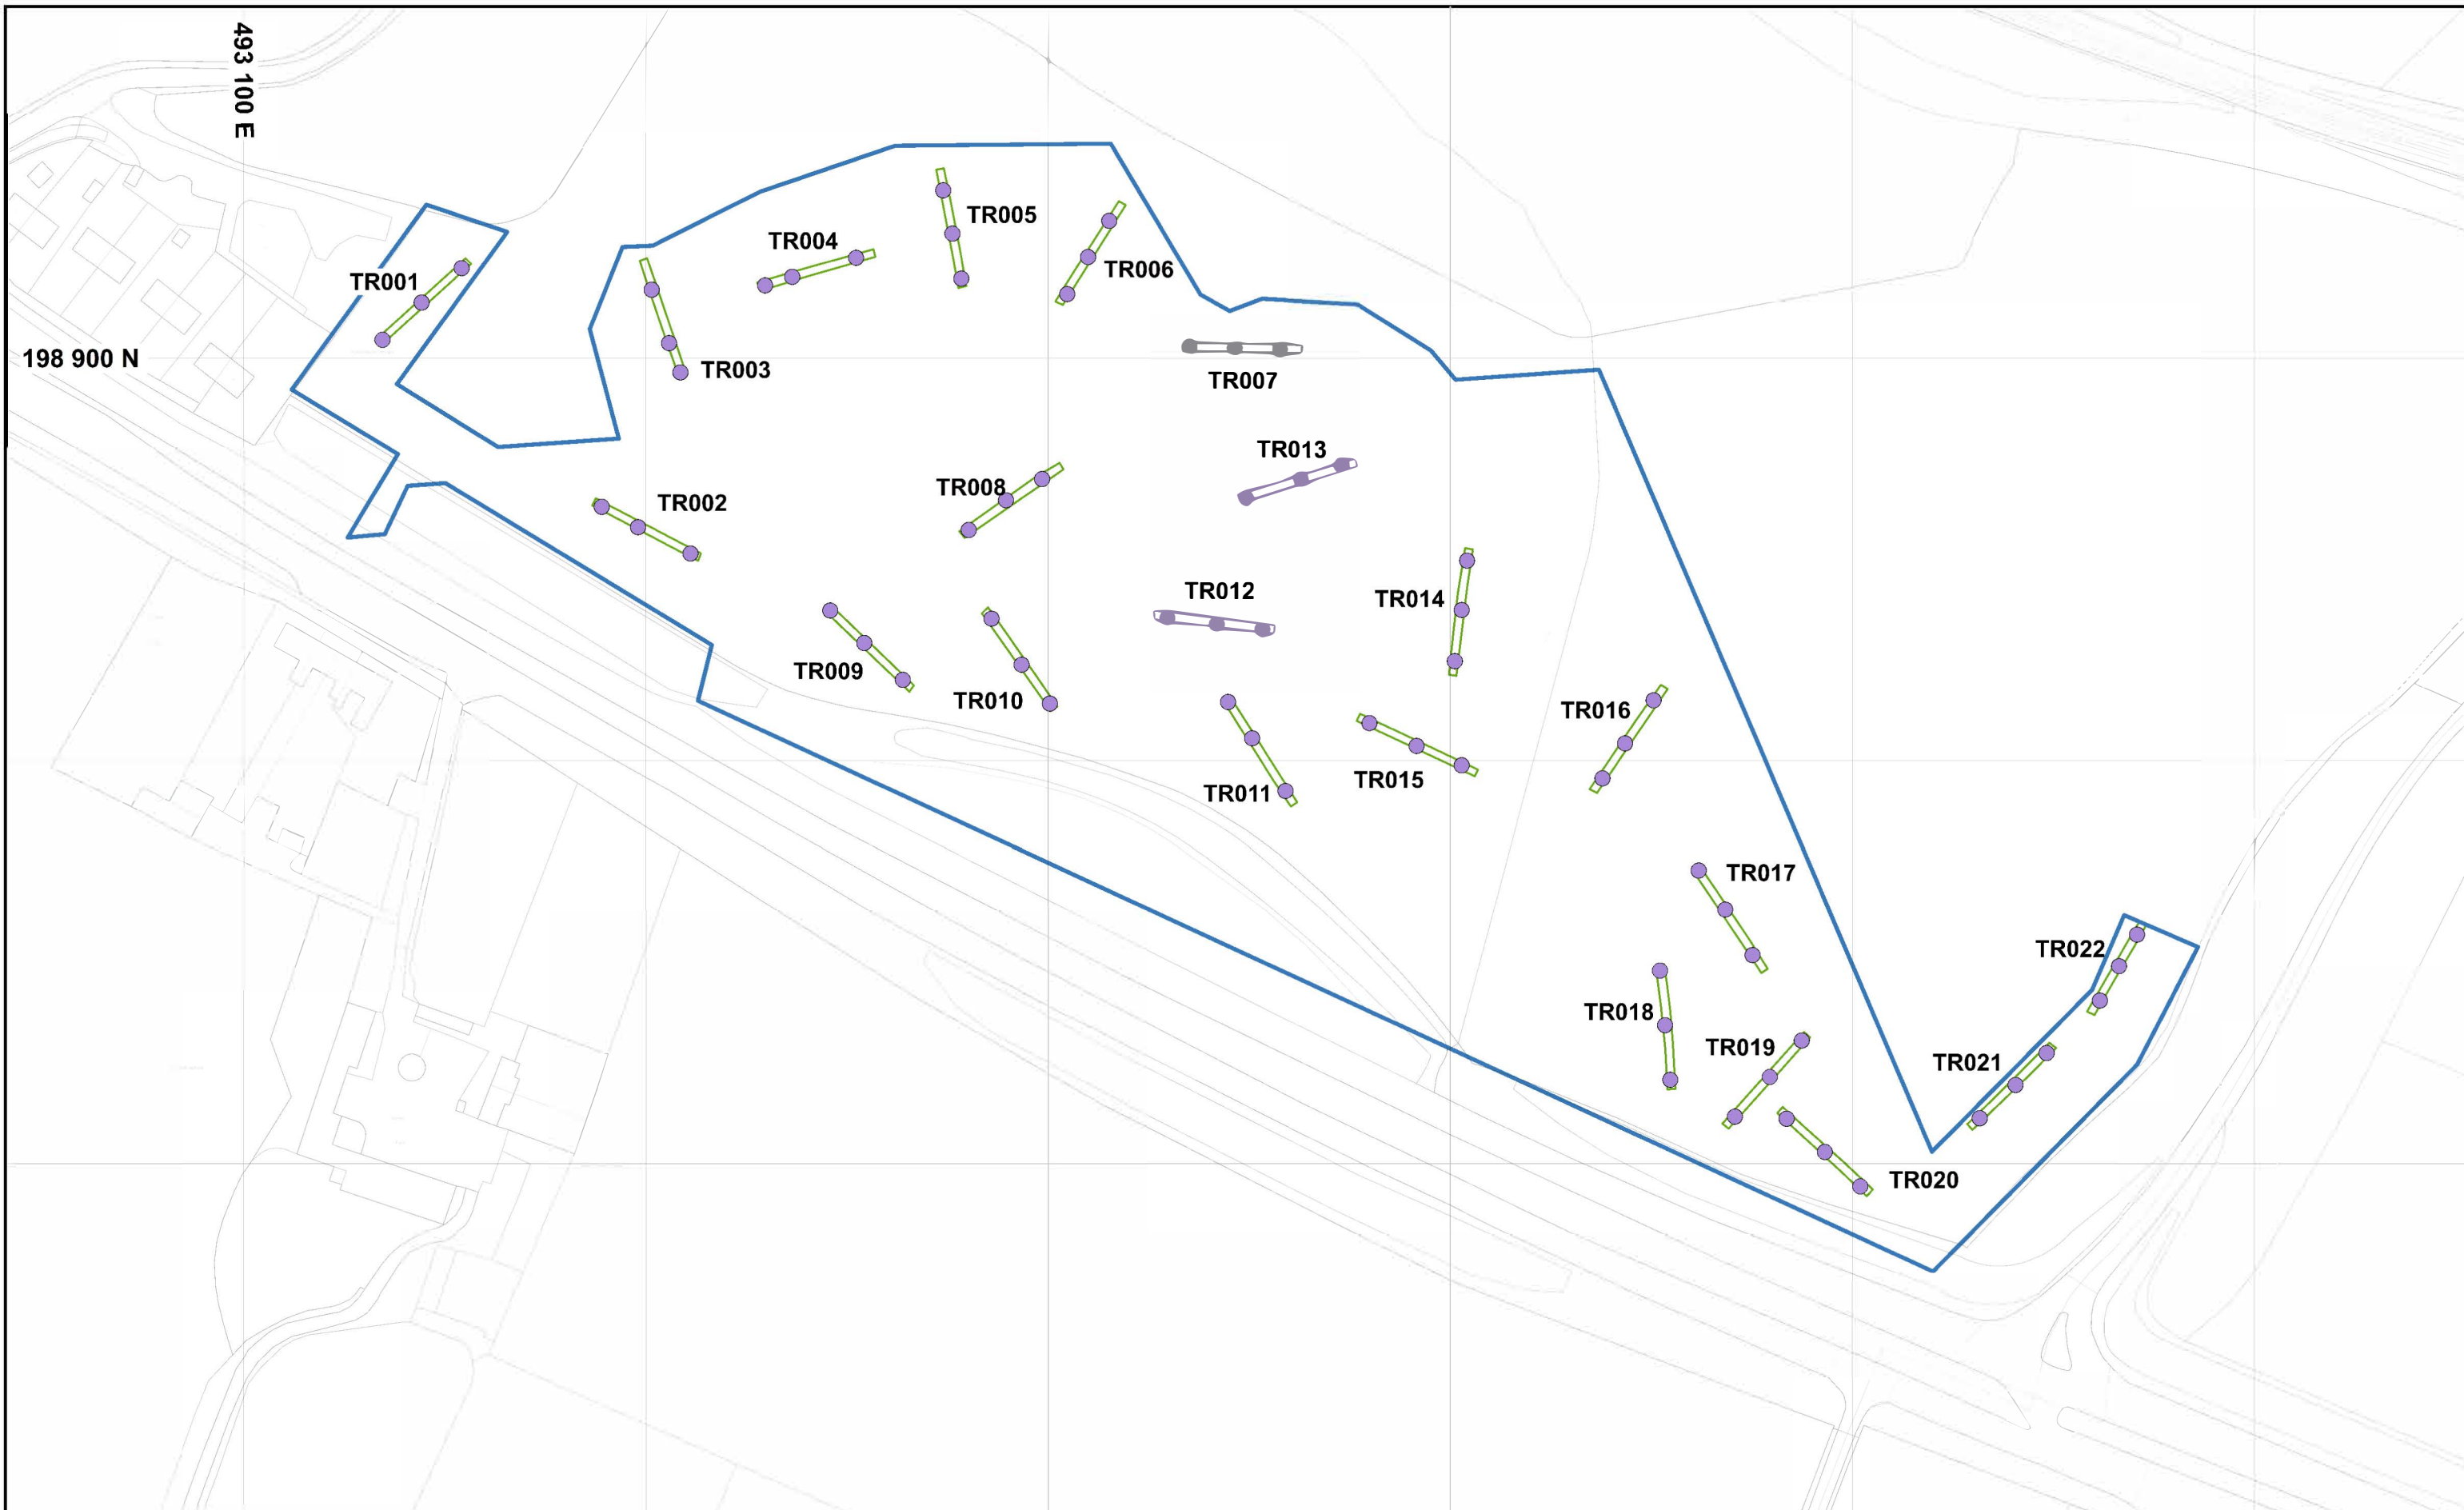
High Speed Two,  
Piper's Wood Cottages  
Figure 3. Overview of test pits

- Site extent
- Excavated evaluation trench
- Test pit

- 7.2.3 During the trenching process, approximately 0.5m<sup>3</sup> of topsoil samples were sieved from test pits at either end of the trench and centrally for the recovery of finds. A total of 66 test pits were sampled across the site the results of which are fully reported in 8.3.1.

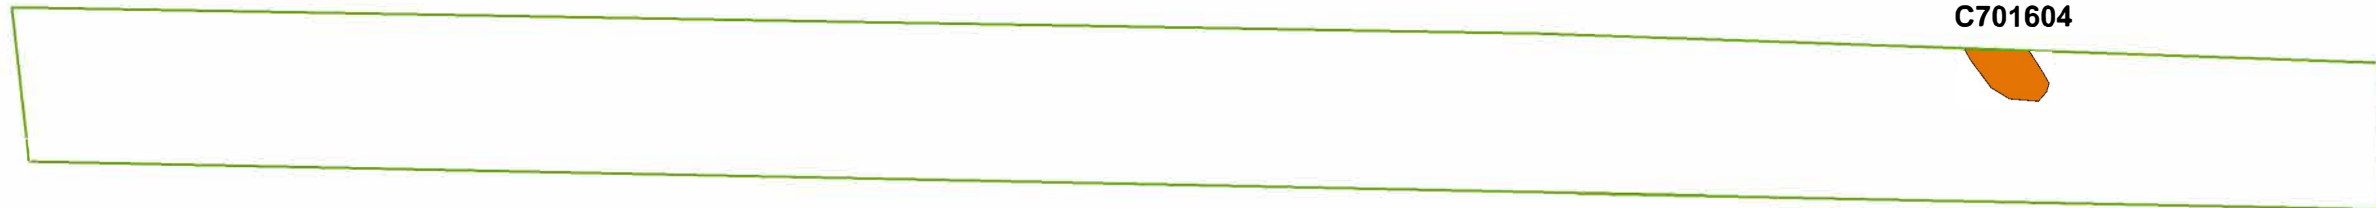
High Speed Two,  
Piper's Wood Cottages  
Figure 5. Details of trenches 14 and 16

8.2.5 A circular root bole [701403]. with concave sides to an irregular base, which measured 0.3m diameter and 0.09m deep was located at the south end of the trench. The fill was a firm brown silt-clay (701404) with rare small to medium sub-rounded and sub-angular flint inclusions, and very rare charcoal flecks. The fill was heavily bioturbated and no finds were recovered.

8.2.6 A sub-circular tree-throw [701603], which measured over 1m long by over 0.8m wide to the limit of excavation, and 0.44m deep, was located at the north-east end of the trench. It had steep concave sides to an irregular base with a tap-root hole present and was undercut to the east and north. The fill was a firm dark grey-brown silt-clay with rare clay patches, and contained small to medium sub-rounded, sub-angular and angular flints in patches. No finds were recovered.
