CPAT Report No. 1375

**Cavalier Centre, Bradley Farm, Much Wenlock,
Shropshire**

ARCHAEOLOGICAL ASSESSMENT

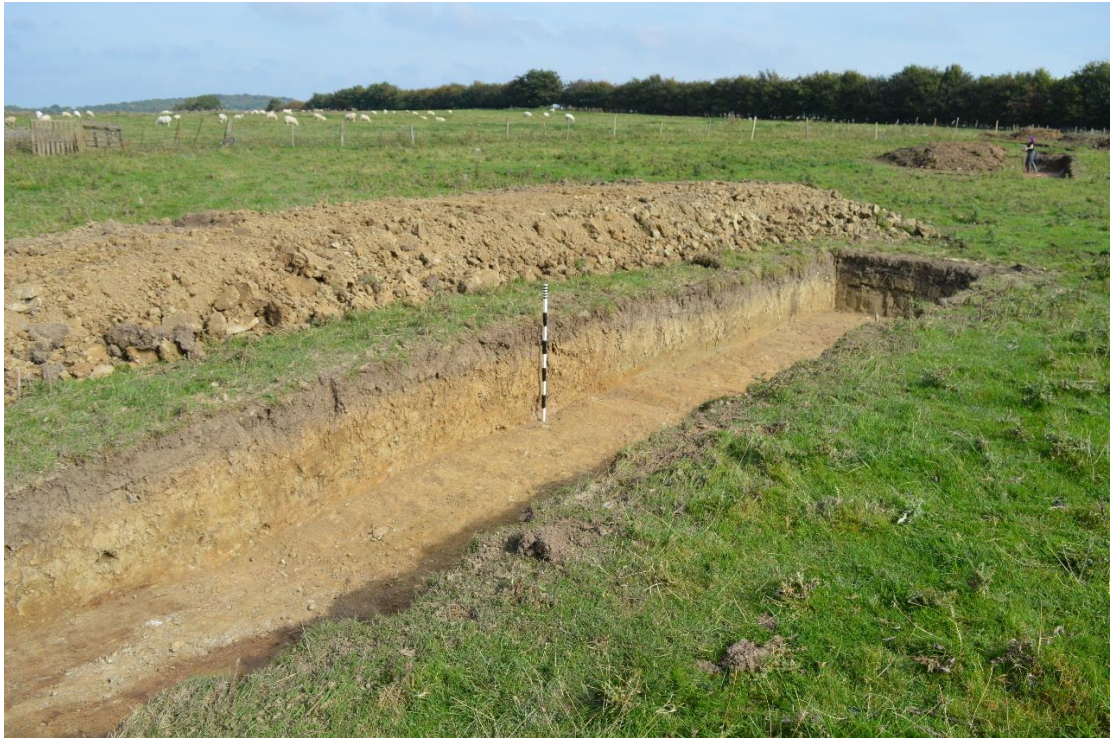
Fig. 5: CPAT 4081-0011 View from south-west of upcast bank (211)

- 4.6. At the east end of Trench 2, underlying the subsoil, an upcast soil bank (211) was discernible. This was constructed from a yellowish stony silt, probably redeposited subsoil and was oriented on a similar north-northwest south-southeast alignment to ditch [204]. Overlying the soil bank to the east was a thin black organic layer (210) overlying a compact very pale yellow silt layer (212).

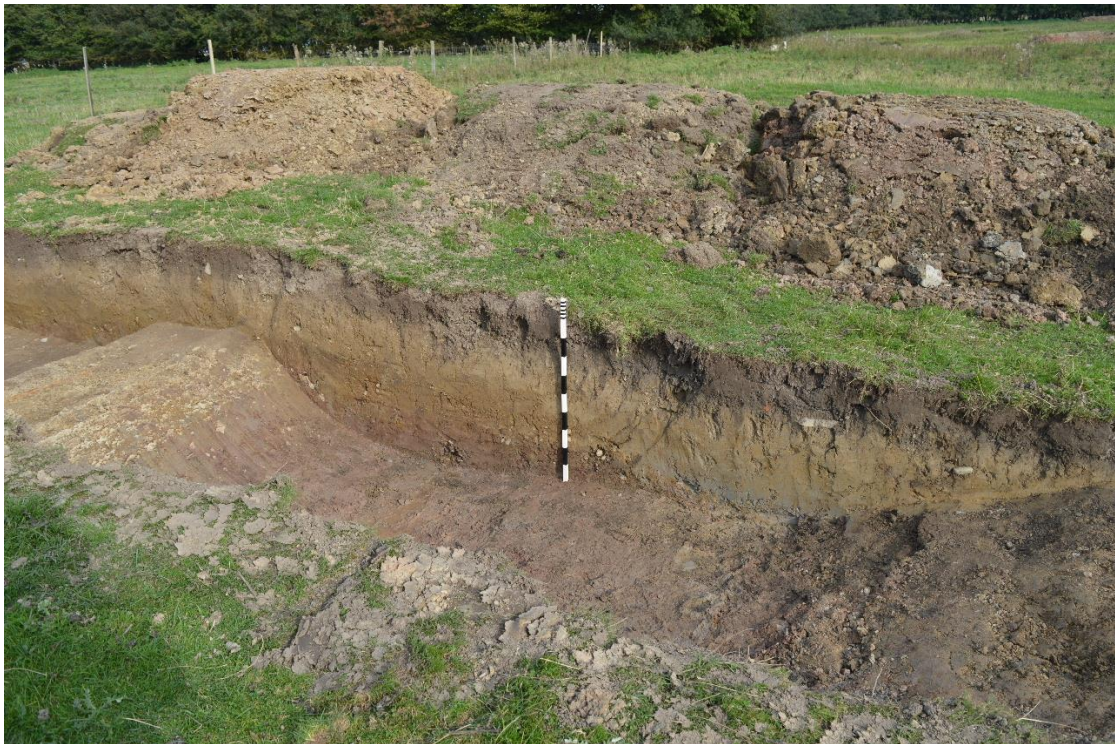
Fig. 6: CPAT 4081-0018 West facing section of Trench 4

- 4.10. The uppermost deposit comprised an uneven topsoil, overlying (402) a thick subsoil deposit. This was cut by two modern service pipes, oriented east west. Underlying (402) a silting deposition (404) was revealed, within a natural channel oriented east west in the south extent of the trench.

- 5.6. Deposits in Trench 4 were truncated by two modern service pipes. A single very heavily abraded sherd of late medieval dark green glazed pottery was recovered from the subsoil (402). The natural deposits in Trench 4 (403) trended away sharply to the south to form a silted up gully, possibly part of the same feature identified in Trench 5.

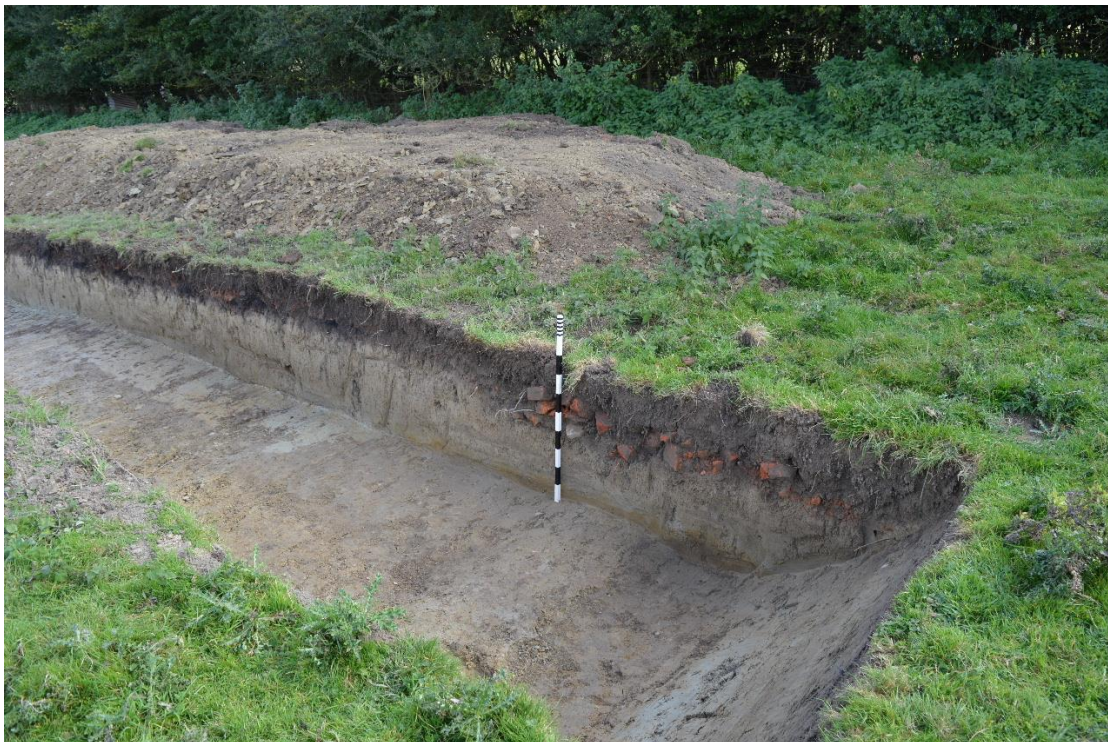
Fig. 7: CPAT 4081-0032 Deposit (702) in west facing section of Trench 7

- 4.16. Underlying the topsoil (701) a deposit (702) comprising burnt fuel waste, charcoal and handmade brick fragments was revealed, extending >12m by >1.4m and 0.25m in thickness. Underlying (702) was the subsoil (703). Cutting (703) at the northeast end of the trench was a large stone drain or culvert (706) oriented north-northeast south-southwest.

- 5.9. Excavations in Trench 7 revealed a layer of fuel waste and handmade brick wasters (702). The brick was similar in size and fabric to that used in the construction of the late 18th and early 19th century buildings at Bradley Farm. The brickwork used in the construction of the large main threshing barn built in 1783 compared very closely with samples of brick recovered from Trench 7. The farmhouse was partially rebuilt in brick during this period, probably using the same type of materials.

- 5.10. The presence of brick wasters and fuel dumped within a single deposit would very strongly suggest that brickmaking for this phase of the farm construction was carried out in this part of the study area, although no evidence for a kiln or kilns was found during the assessment.
