CPAT Report 1617

Moated site at Hartpury Court, Gloucestershire

Archaeological Evaluation

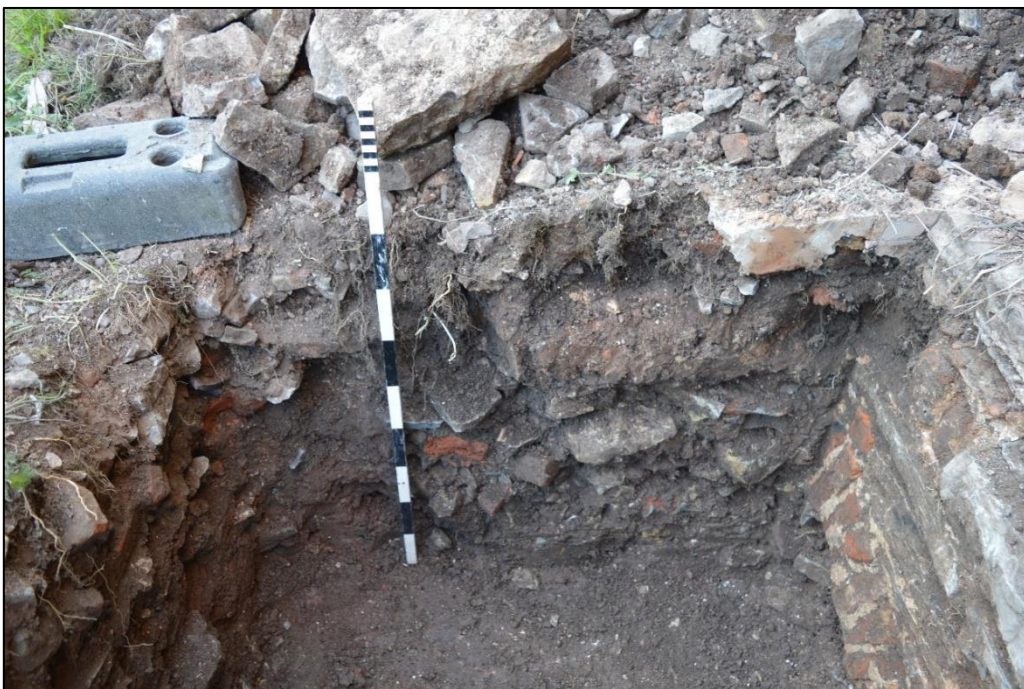
Fig. 5 East-facing section of Trench 1, showing cut [107] and layer (108), to the left of the scale. Photo CPAT 4539-0047

- 3.5. In front of the arch the excavations revealed a cut feature [107] filled by a loosely compacted, cohesive, gritty clay silt (106), containing brick and large, flat, angular sandstone rubble, which also extended beneath the arch, indicating that the arched structure had fallen out of use and been backfilled. The feature had been cut through a deposit of loose, reddish clay silt (105), perhaps representing the upper fill of the moat ditch, while augering demonstrated that the base of the feature was around 0.8m below the underside of the arch.

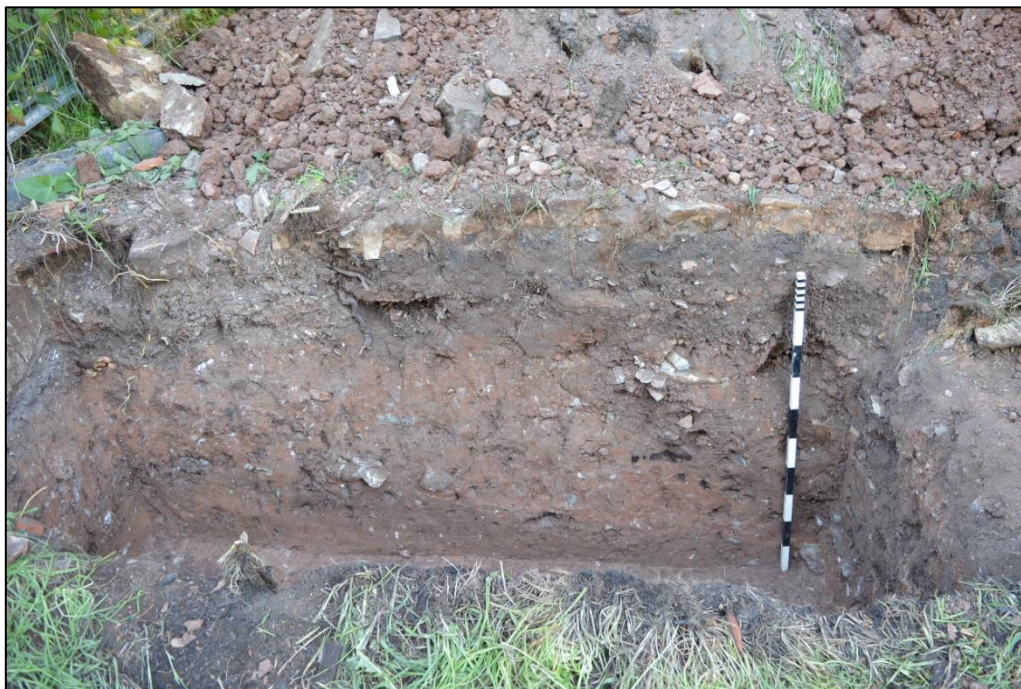
Fig. 7 South facing section of Trench 3. Photo CPAT 4539-0025

- 3.7. Abutting the stone floor (307) of the former lean-to was a stone threshold (302), 0.22m thick, for a doorway on the west elevation of the building. The floor and the threshold were laid on a friable, dark sandy silt and angular stone deposit (301), 0.33m in thickness. Underlying this was a firm, light-mid reddish clayey silt (305), which was 0.57m in thickness, and contained plaster or mortar flecks. A single piece of yellow-green glazed tile was recovered from deposit (305), which might represent the upper fill of the moat ditch. Cutting (305) was a pit [304] filled by a firm, reddish clay and angular stone (303), extending >0.98m by >1m by 0.69m. The basal deposit comprised a firm, dark reddish sandy clay silt (306), >0.35m thick, containing large angular stones and charcoal flecking. Natural deposition was not attained in this trench.

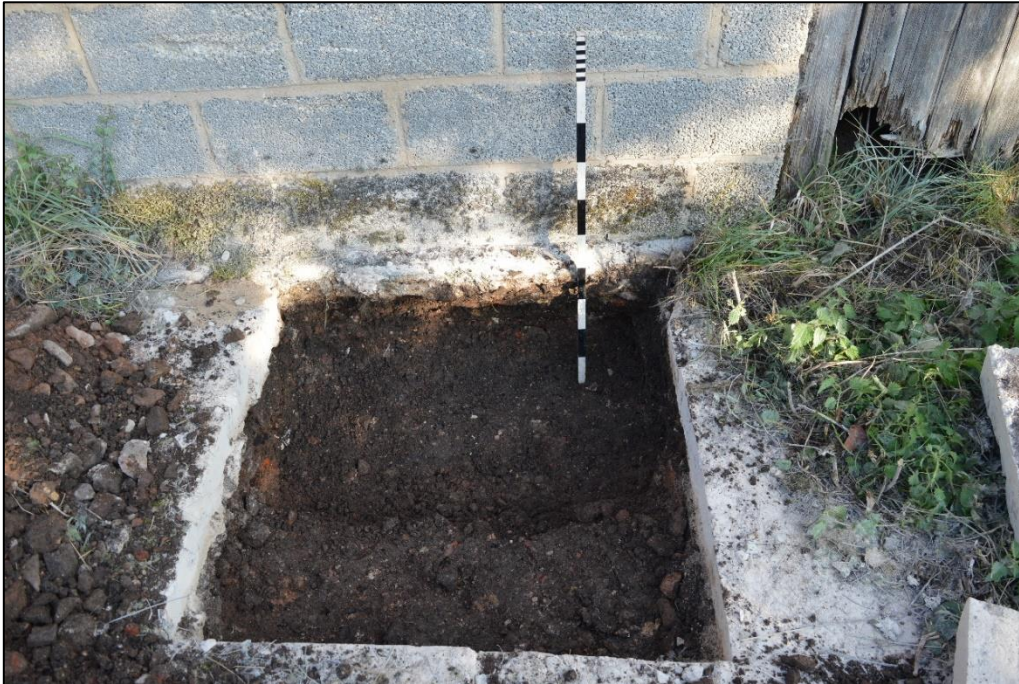
Fig. 11 View from the south of Trench 5. Photo CPAT 4539-0018

- 3.11. Trench 5 was located against the south elevation of the modern blockwork range (Fig. 2) in order to determine the depth of the foundations for this building. It measured approximately 1m by 1.2m.
- 3.12. Removal of the 0.15m-thick concrete hardstanding (501) revealed a cohesive dark reddish gritty clay, stone rubble and crushed brick deposit (502), >0.27m thick. At this level it was possible to probe underneath the concrete. This determined that the building was built directly off the concrete and had no other foundations.

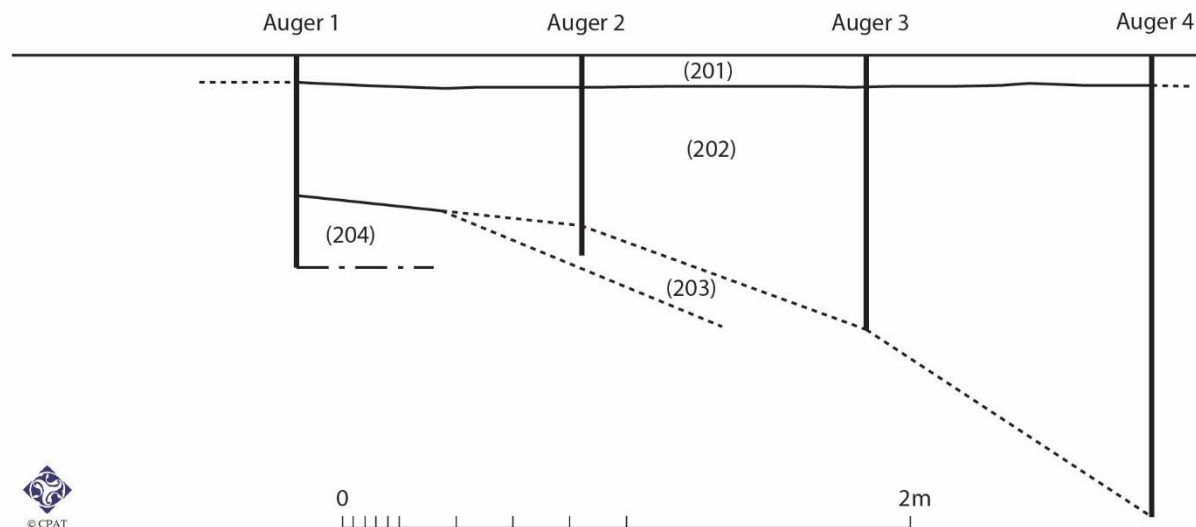
Fig. 12 Section view showing results of auger transect

- 3.13. The auger transect was located to the east of the modern blockwork range in order to determine the location and extent of the northern arm of the moat. Four auger samples were taken. Auger samples 1 and 2 not exceed a metre in depth owing to the large quantity of stone in the dump of material underlying the topsoil. The presence of the concrete roadway running south of the precluded the taking of additional auger samples further to the south. The results are depicted in Fig. 12.

- 3.14. The uppermost deposit was a loose, grey sandy silt (201), 0.1m thick, containing a heavy concentration of root matter. Underlying this was a compact dark greyish silt clay (202), varying in thickness between 0.4m and 1.5m, which contained angular sandstone fragments. Underlying this in auger sample 2 was a hard, compacted, light reddish clay silt (203), >0.1m thick, containing fragments of ceramics and charcoal flecking. Natural soils, consisting of a compact light reddish silt (204), were attained in auger sample 1 at a depth of 0.5m below ground level.

- 4.2. The results of an auger transect located immediately to the east of the blockwork range, east of The Old Forge, suggest that the outer edge of the north arm of the moat is located approximately 1.5m south of the churchyard wall. Natural soils were attained at a depth of 0.45m below the current ground level at this point, while the base of the ditch is in excess of 1.6m. Allowing for the depth of the overlying deposition this would suggest that the moat was at least 1.1m deep.
