CPAT Report No. 1648

Kenilworth Castle, Warwickshire

Archaeological Watching Brief

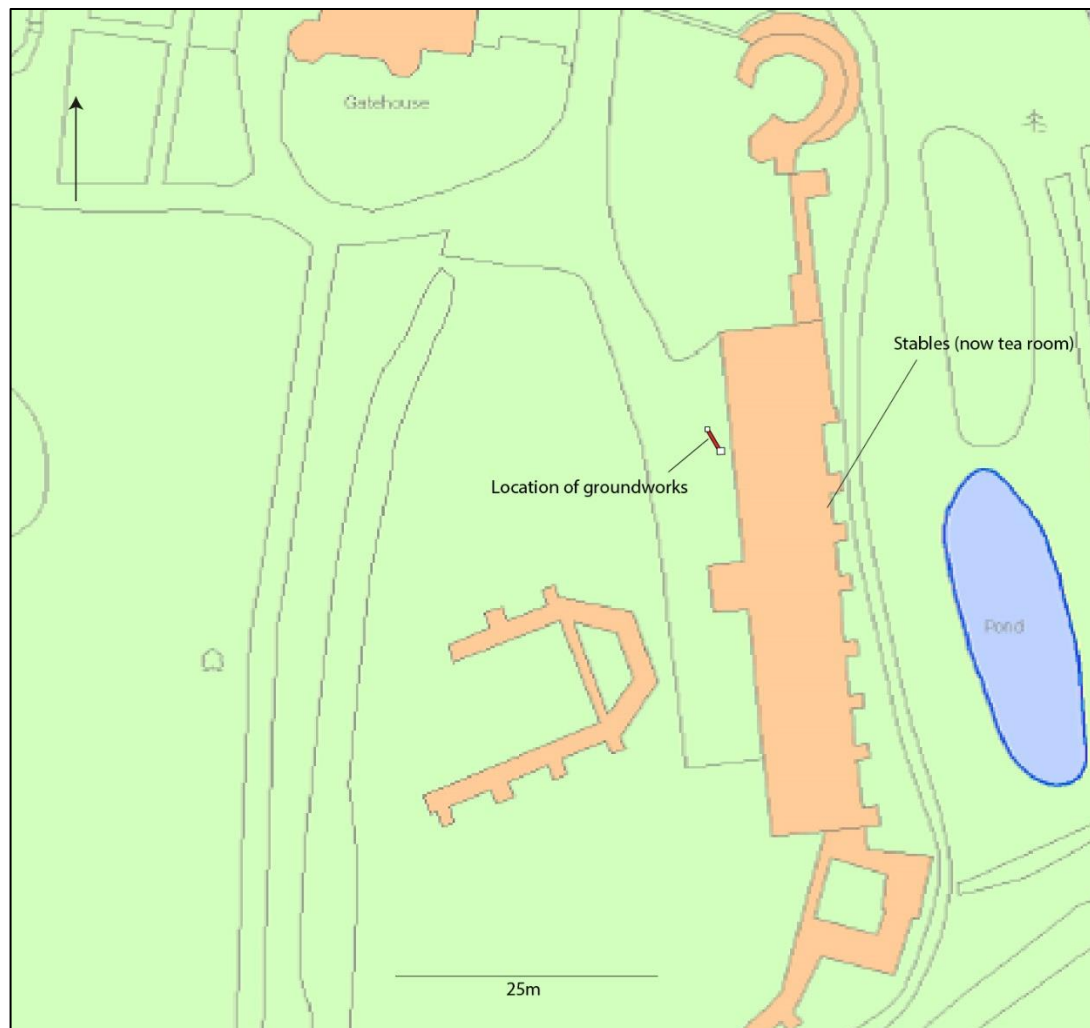
Fig. 1 Location of groundworks (marked in red). Reproduced from English Heritage plan.

- 1.1. The Clwyd-Powys Archaeological Trust (CPAT) was invited by English Heritage to undertake a watching brief during the groundworks for a drain adjacent to the tearooms at Kenilworth Castle, Warwickshire (SP 27965 72287). The castle is designated as a Grade I listed building (1035327) and as a Scheduled Monument (1014041), lying within a grade II* registered park and garden (100496).

- 7.2. Two rainwater gullies (Figs 1-3) outside the main entrance to Leicester's Stables (used as a tearoom) are frequently slow-draining and cause a large amount of silt to build up in the area, causing a significant slip hazard. The gullies are connected A through B, to soakaway 1 which, owing to its size and age, has insufficient capacity for the area of run off.

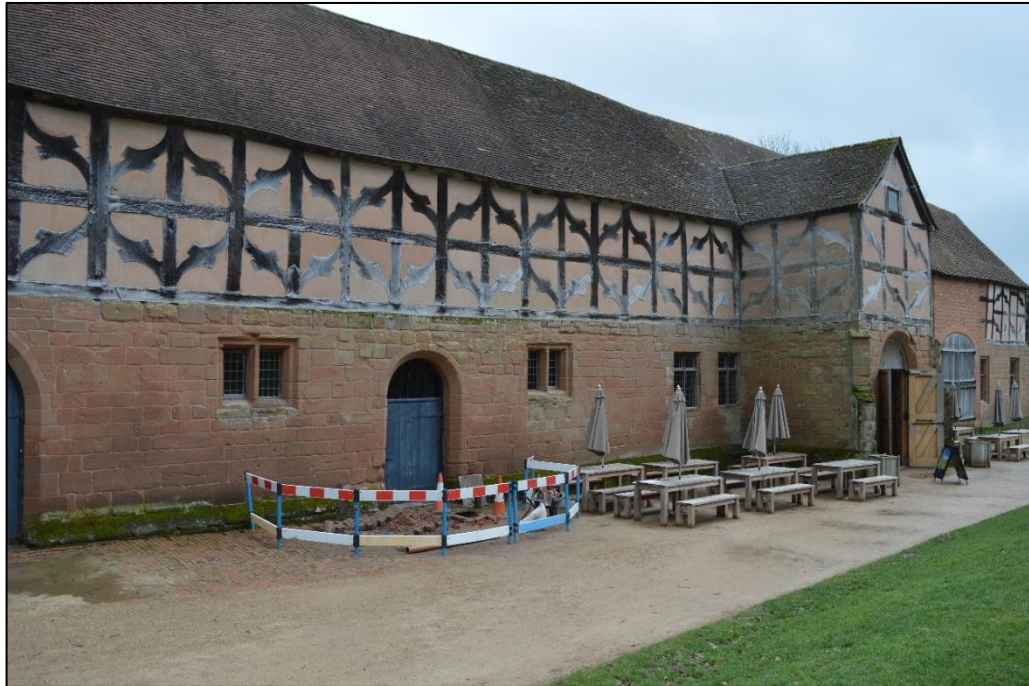
Fig. 2 View of the stables from the north-east, showing the location of the groundworks. Photo CPAT 4607-0006

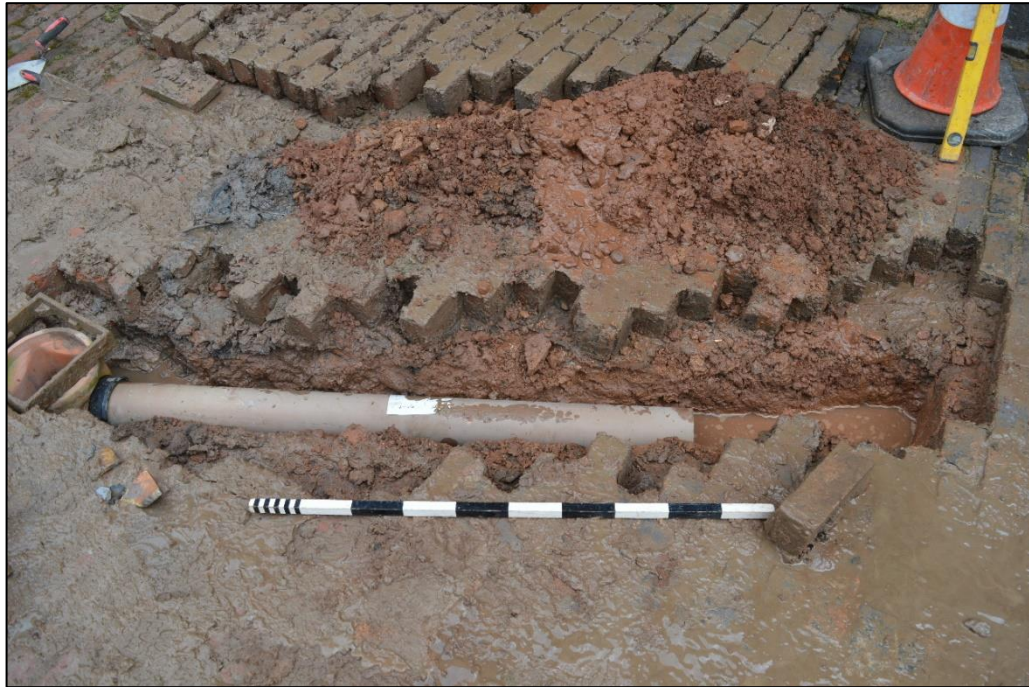
- 3.3. The uppermost context was a surface (001) constructed from frogged bricks (size: 100mm by 80mm by 220mm), laid on edge and bonded with mortar. Removal of this surface revealed a rather soft, cohesive, reddish sand and gravel layer (002), >0.22m thick, containing frequent charcoal or possibly coal inclusions, but no artefactual material to indicate a date. Red sandstone (003) was encountered underlying this at the southern extent of the trenching. This did not appear to comprise part of a structure, and is likely to be bedrock, although it was difficult to confirm this within the rather confined limits of the excavated area.

Fig. 3 View of the trenching from the south-west. Photo CPAT 4607-0001

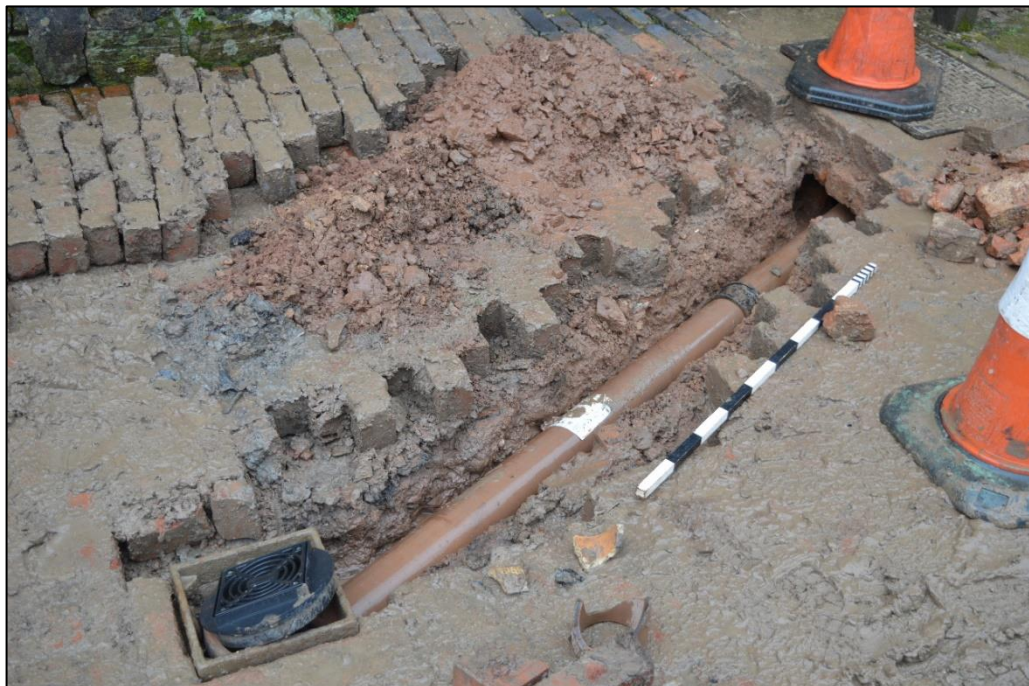
Fig. 4 View of the groundworks from the west following installation of the pipework. Photo CPAT 4607-0007

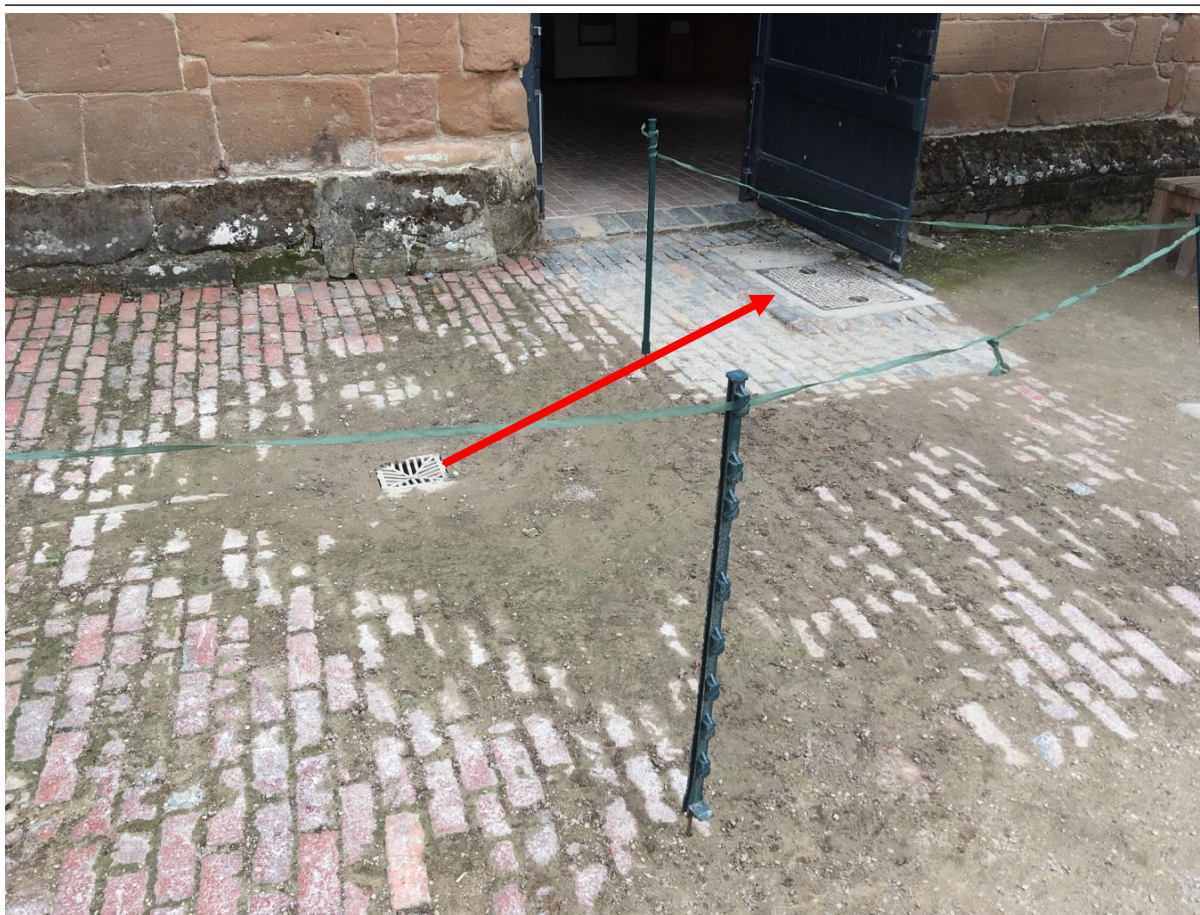
- 7.4. Gully hole A will need to be excavated to approximately 1000mm by 1000mm wide and 450mm deep to allow for a silt bucket and concrete surround, and to link the gully to inlet level in inspection chamber C. The existing surface brickwork will be re-laid on top. A watching brief will be maintained during these works.

Fig. 3 Location of Gully A connection to be subject to the watching brief
