CPAT Report No. 1667

Kenilworth Castle, Warwickshire

Archaeological Watching Brief

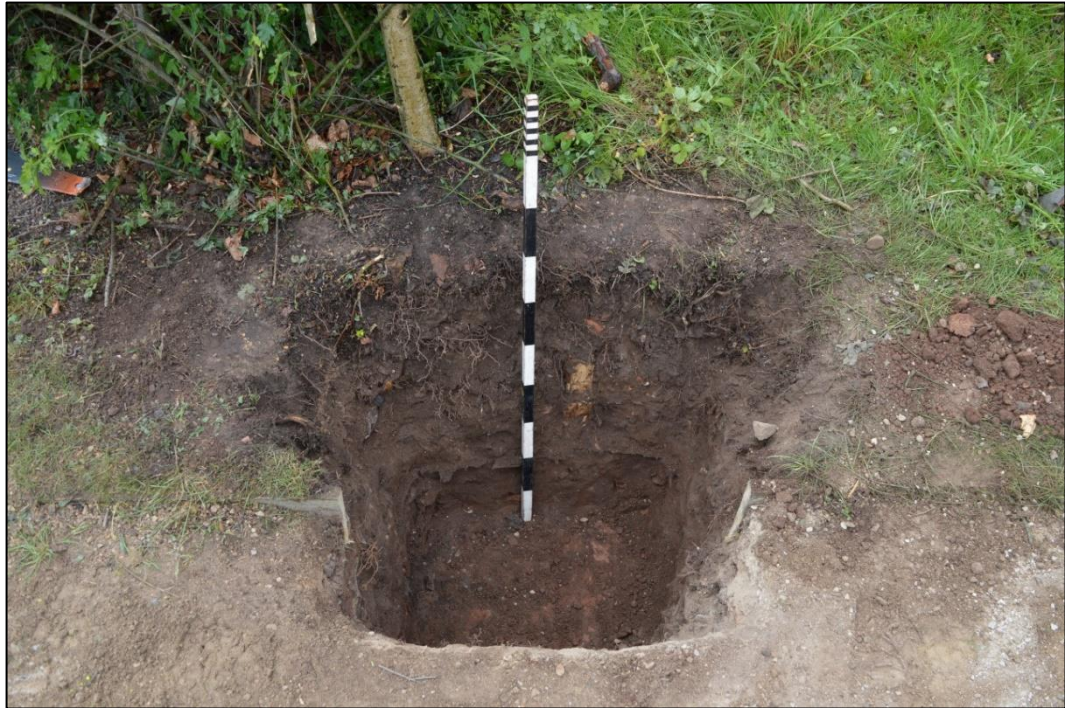
- 3.1. The watching brief was conducted on 28 May 2019 in accordance with the Chartered Institute for Archaeologists' (CIfA) (2014) *Standard and Guidance for an Archaeological Watching Brief*.
- 3.2. The new gateway was located at the entrance to the garden located in the south-eastern corner. The groundworks comprised two large pits (SP 27871 72325 and SP 27870 72329) located on either side of the existing pathway.
- 3.3. Deposition in both pits was similar and consisted of a grit path surface (101/201) 0.1m thick overlying deposit (102/202) composed of a moderately compacted silty sand 0.2m thick. Underlying this was deposit (103/203) comprising a layer of greyish red clay silt and stone laid on a terram sheet. Underlying the terram was a compact reddish sand deposit (104/204), 0.2m thick, overlying a compact red clay (105/205) >0.05m thick.

Fig. 2 Post pit 1 viewed from the north. Photo CPAT 4649-001

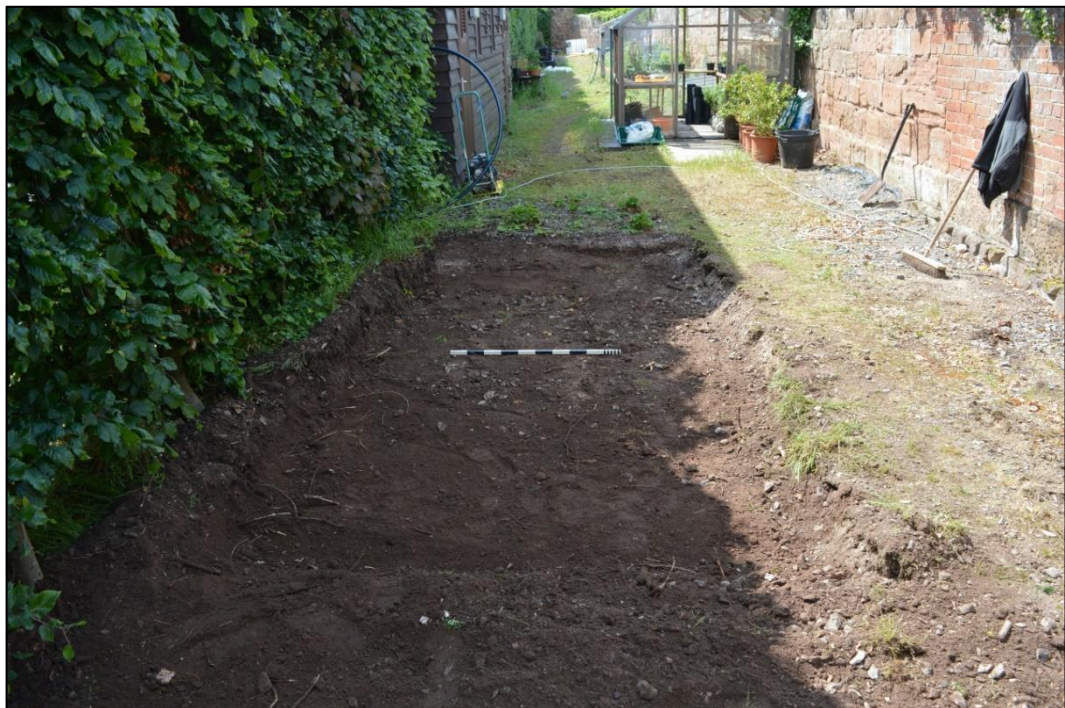
- 3.4. The groundworks for the water tank were located immediately to the north-east of the aviary which was located centrally at the north end of the garden (SP 27845 72367). It comprised a single trench measuring 4m by 2.2m.

Fig. 3 Water tank trench viewed from the east. Photo CPAT 4649-009

- 3.5. Removal of the upper deposit (301), which consisted of a soft dark brown clayey sand, 0.2m thick, revealed a soft mid-brown silt sand deposit (304) which was not

excavated into. Cutting deposit (304) was a line of six circular pits 0.5m in diameter and oriented east-west. Overlying deposit (304) at the north extent of the trench was a gravel surface (303), 0.1m in thickness.

- 4.1. The excavation for the water tank in the northern extent of the garden revealed the edge of the gravel surface running east-west along the perimeter of the garden and a series of closely spaced tree planting pits, presumably associated with an earlier phase of the garden layout, probably during the 20th century.
- 4.2. The excavation of two pits for the gateway located in the south-eastern corner of the garden identified approximately 0.4m of soil build up overlying a layer of terram, which suggests it was probably contemporary with the construction of the modern garden which opened in 2009. Underlying the terram was a layer of sand overlying a layer of clay which appear to represent the upper level of archaeological deposition. No archaeological finds or features were apparent at this level however.
