CPAT Report No. 1553

# Dudmaston Hall, Shropshire

ARCHAEOLOGICAL WATCHING BRIEF

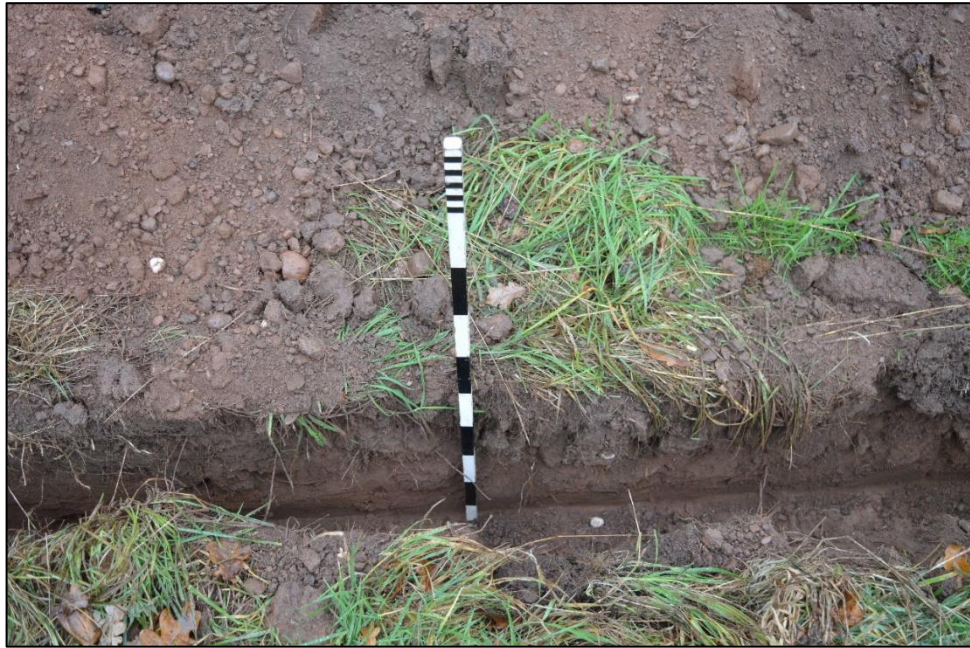
Fig. 3 South-facing section of the trench in parkland. Photo CPAT 4448-0003

- 3.1. The cable trench ran approximately 400m, between an access point on the west side of the A442, to an access point into the Hall, located in the courtyard. Trenching was carried out with a 0.3m-wide toothless bucket to a depth of 0.45m. Similar topsoil deposits consisting of a soft sandy silt (001) up to 0.3m in thickness extended across the entire parkland section of the trenching, overlying orange slightly clayey sand (004) >0.4m thick. Isolated finds of 19<sup>th</sup>-century pottery were recovered from trenching in the parkland (Fig. 1, 3 and 4).

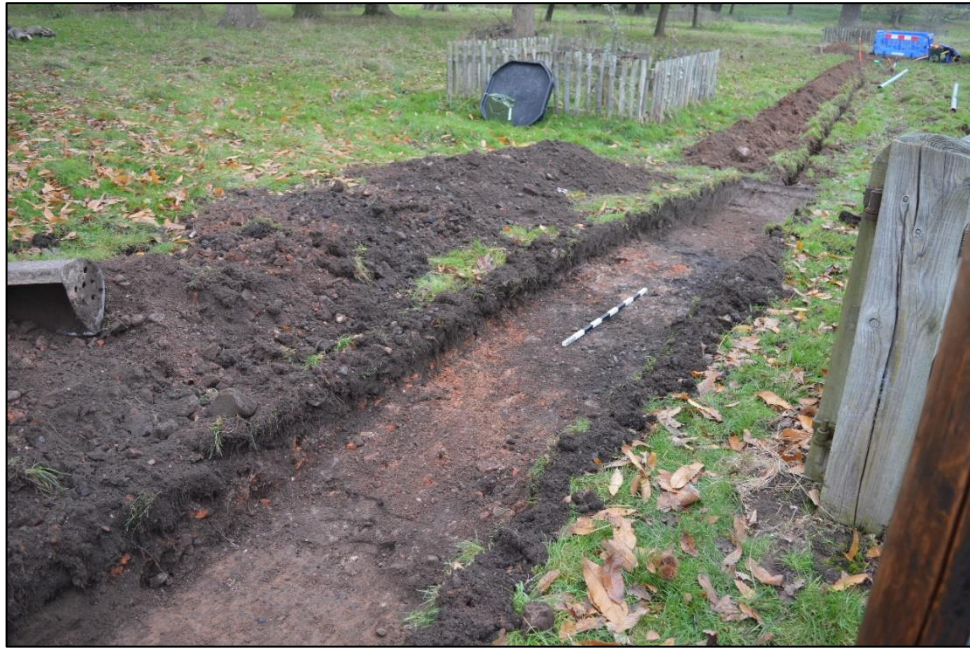
Fig. 4 View of the trackway (003) from the south-east. Photo CPAT 4448-0015

- 3.2. Close to the eastern end point of the cable trench, the route passed across a trackway (Fig. 1, 1). A section of the trackway measuring 0.9m in width was exposed, and cleaned and excavated by hand (Fig. 1, 2; Fig. 7). Underlying the topsoil (001) a road formed from packed river gravel (003) was revealed. This measured approximately 4m in width and 0.38m thick. Either side of the road were two ditches [007] and [008], both approximately 1.4m in width and >0.2m deep. The ditch fills (005) and (006) comprised similar greyish sandy silts containing late post medieval or modern pottery and ceramic building material. The natural subsoil (004) had evidently been cut [009] to form a level surface for the trackway. The upper track surface had been repaired on the south-east extent (002), there was evidence of minor repairs across the entire surface. There was no evidence of cart tracks or ruts in the exposed section of trackway.

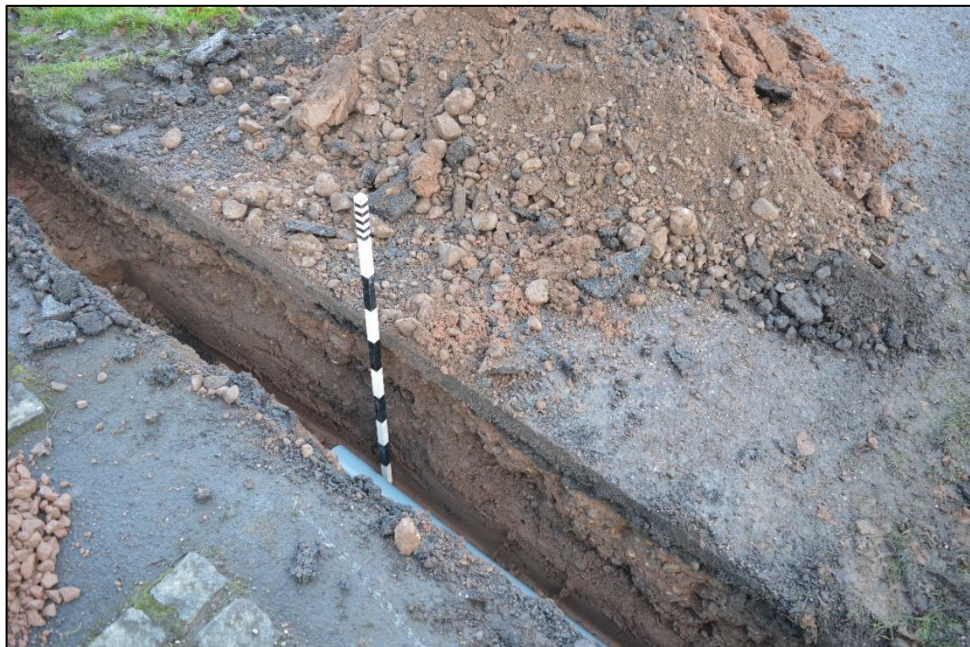
Fig. 5 Section view of the driveway to the Hall. Photo CPAT 4448-0009

- 3.3. Towards the south-west end of the cable route, the trenching crossed the main driveway to the Hall (Fig. 1, 5). Underlying the modern tarmac road surface (010) a hard compacted gravel sub-base (011) 0.2m thick was revealed. No trace of the earlier driveway depicted on early Ordnance Survey mapping was visible.

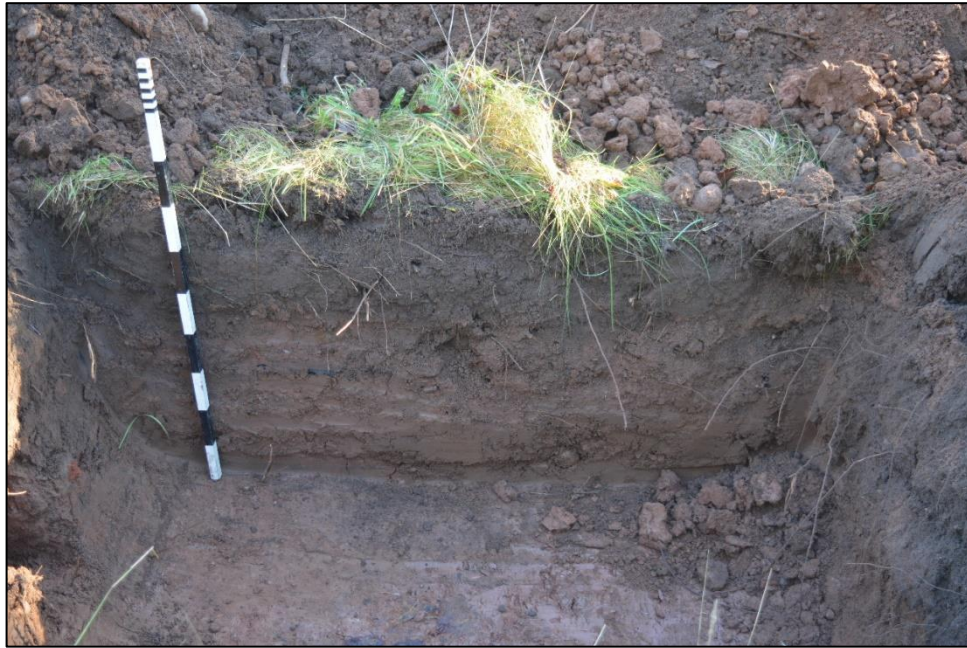
Fig. 6 North-west-facing section of the excavation for the junction box. Photo CPAT 4448-0005

- 3.4. Immediately to the south-west of the driveway, a pit was excavated to accommodate a junction box. Pottery, brick and bottle glass was recovered, which was 18<sup>th</sup>- or 19<sup>th</sup>-century in date.
