CPAT Report No. 1658

Longtown Castle, Herefordshire

Archaeological Watching Brief

Client name: English Heritage
 CPAT Project No: 2367
 Project Name: Longtown Castle, Herefordshire
 Grid Reference: SO 31890 29265
 County/LPA: Herefordshire
 CPAT Report No: 1658
 Report status: Final
 Confidential until: N/A

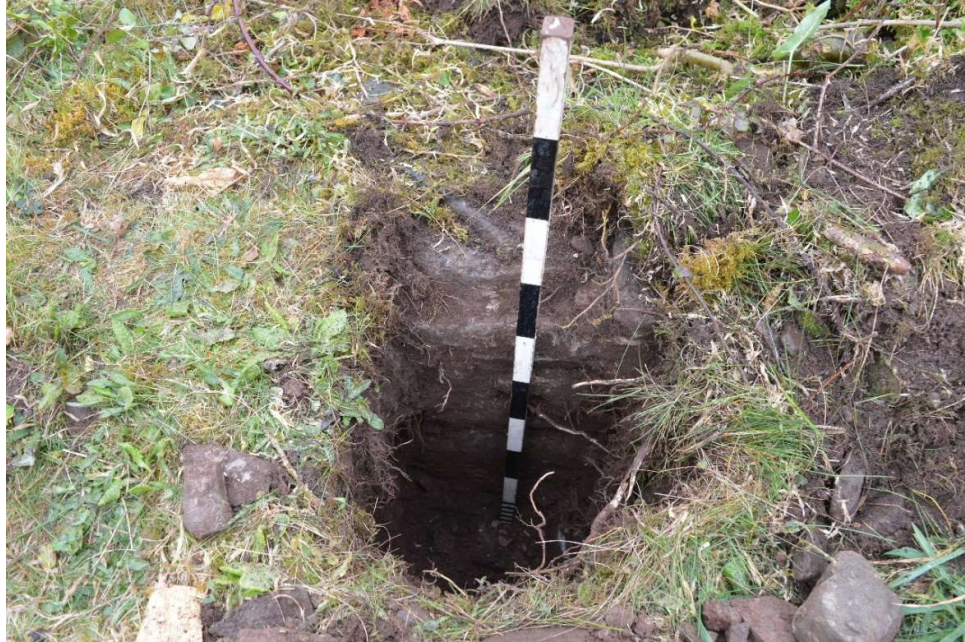
- 3.3. Three contexts were identified during the groundworks on the eastern side of the bailey. The uppermost context comprised a soft mid-reddish brown loam (001), 0.2m thick, extending across the entire excavated area. Underlying this was a soft mid-reddish brown silt sand (002), containing frequent building rubble, angular sandstone and occasional lime mortar flecking, >0.4m thick and also extending across the entire excavated area. A buried section of wall (003) was partially revealed in one of the postholes (Fig. 5, 1) comprising six courses of worked grey sandstone >0.6m thick (Fig. 2).

Fig. 2 Wall (003) viewed from the west. Photo CPAT 4639-0004

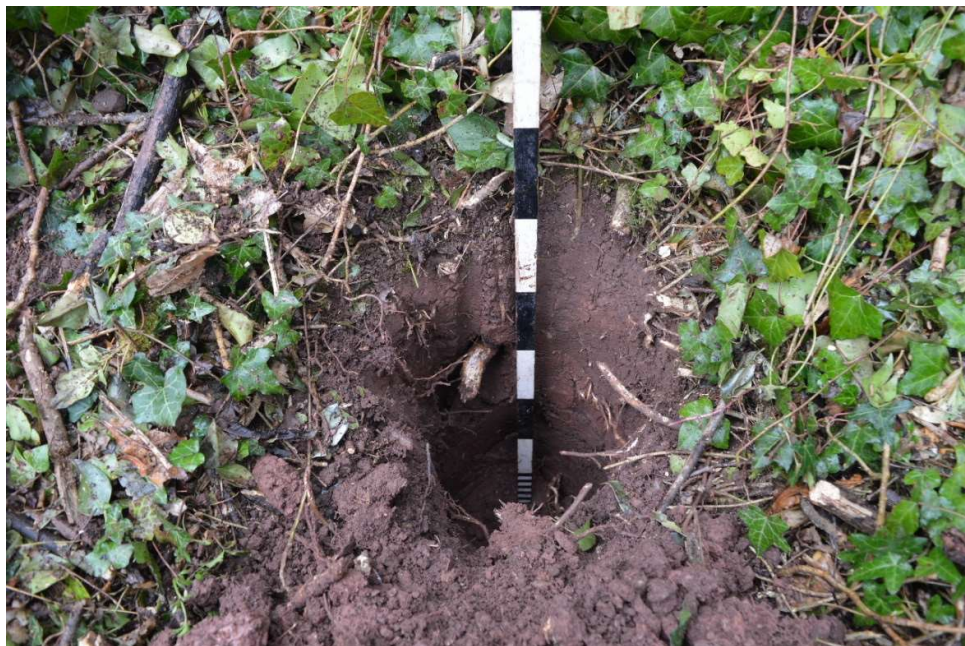
- 3.4. Groundworks on the west side of the bailey revealed homogeneous deposition across most of the area, comprising a soft mid-reddish clay silt (004) and occasional small angular stones, extending to >0.6m in thickness (Fig. 3). A change in deposition was revealed towards the north end of this area (Fig. 5, 2) comprising a soft dark reddish brown sandy silt and large flat sandstones (005) extending 12m by >0.6m.

Fig. 3 Posthole on the west side of the bailey showing deposit (004) Photo CPAT 4639-0012

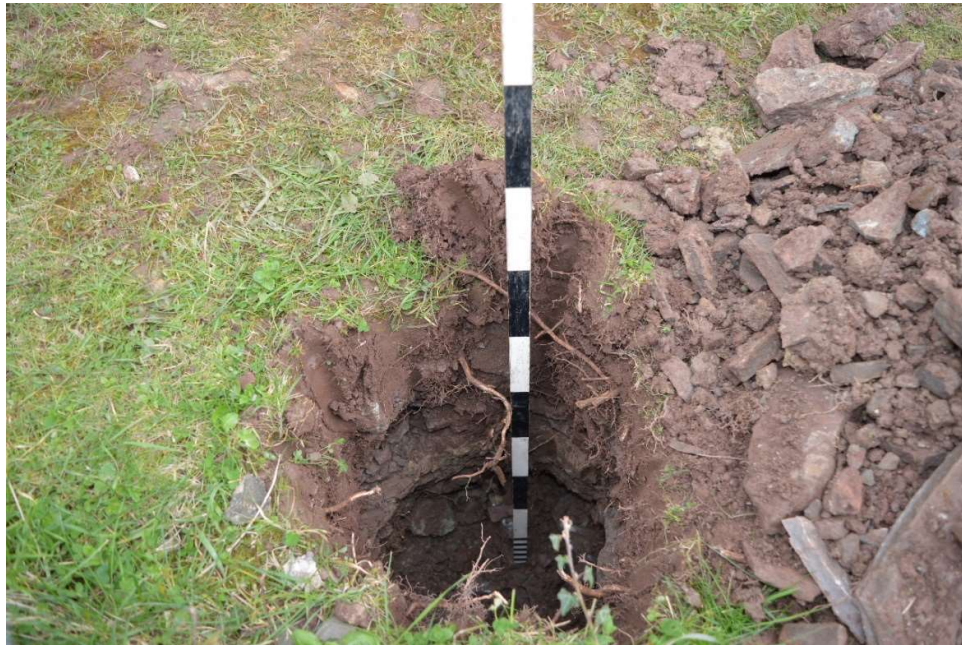
- 3.5. Groundworks around the motte revealed three contexts. The upper deposit comprised a soft dark brown loam (101), 0.3m thick. Underlying this was a firm light yellowish clay (102), 0.15m thick, sealing a firm reddish silt and sandstone deposit (103), >0.3m thick.

Fig. 4 Posthole on the north side of the motte Photo CPAT 4639-0024

- 4.3. Nothing of archaeological significance was revealed during the groundworks upon the motte. It is possible that a clay layer visible in several places was used to help retain the looser material forming the main body of the motte.
