Archaeological Observation

Staplecross to Iden: Field 12 Mains Renewal scheme Playden East Sussex

March 2019

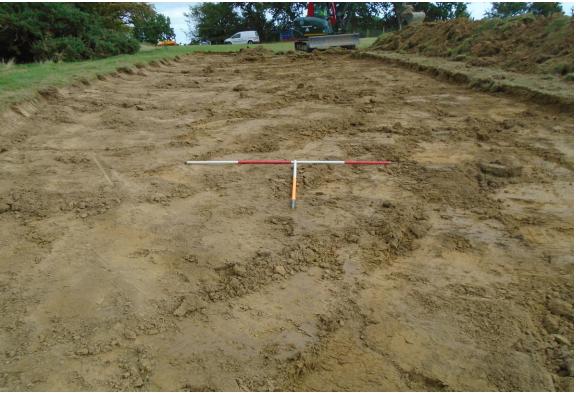
Plate 1: Overview of the topsoil strip in Trench 001, looking ESE (1m & 2m scales)

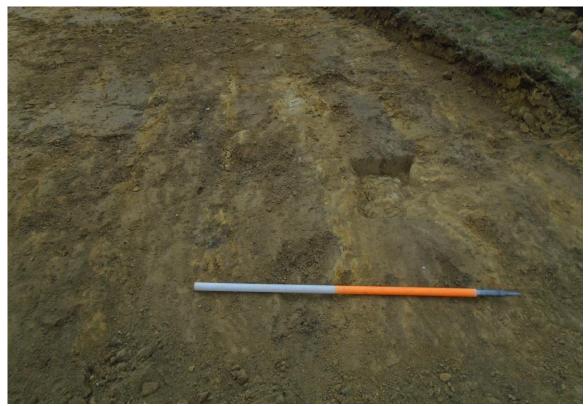
A small area of disturbance, attributable to rooting, was identified within the easement and determined to be nonarchaeological. A group of small linear features, orientated WNW-ESE, were also seen cutting the natural strata (001003). Investigation of one of these features, [001004], found it to have a fairly shallow, u-shaped profile, measuring 0.34m wide with a depth of 0.10m. No finds were recovered from the singular fill (001005) formed of a firmly compacted mid grey-brown silty clay. The fact that these linear features run in the same direction and are of similar form, suggests they are plough scars, the surviving remnants of ploughing activity (*Plate 2*).

Plate 2: Plough Scars (darker soil) running ESE in Trench 001, showing investigative slot in [001004] (1m scale)

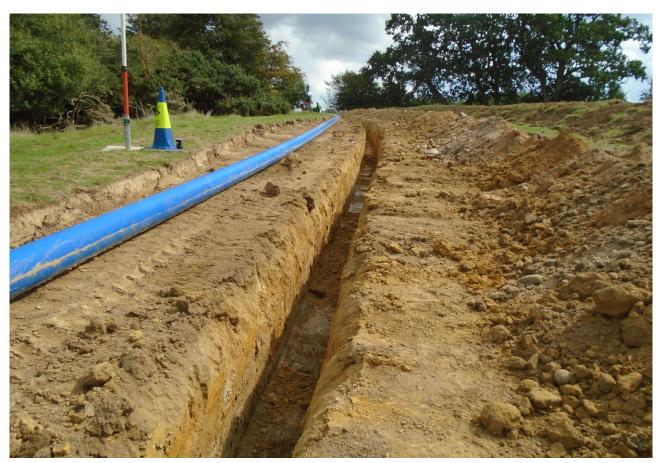
Approximately 0.18m of topsoil (001001), a mid to dark brown-grey silty clay of a moderate to friable compaction, was removed during the easement strip. (001001) was seen to overlay a mid orange-brown silty clay subsoil (001002) (*Plate 1*). The natural substratum (001003) was encountered at a depth between 0.18m and *c*. 0.33m bmgl, varying due to the absence of subsoil at the eastern end of the trench, where the natural substrate was significantly higher (*Plate 3*).

Plate 3: Pipe-trenching in Trench 001, looking ESE

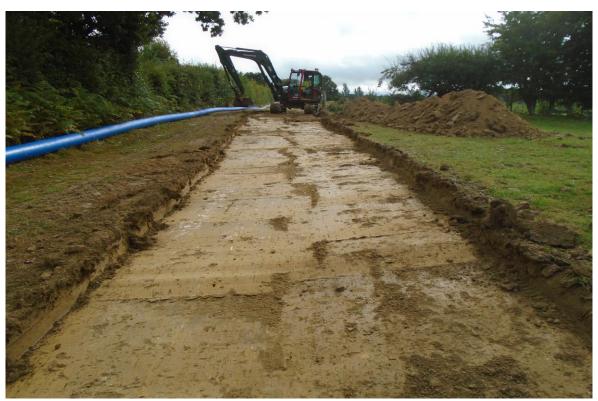
Plate 4: General view of topsoil strip in Trench 002 showing subsoil (002002), looking ESE

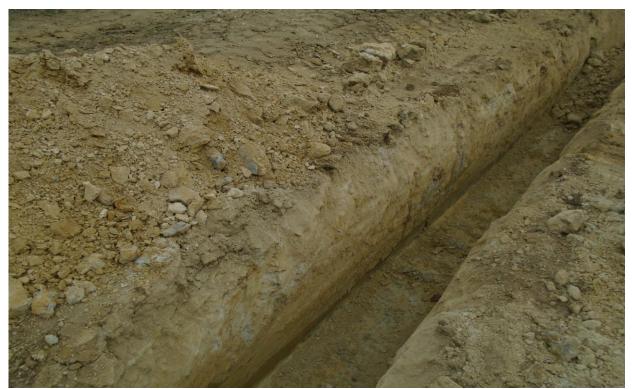
A graveled access track was located at the WNW end of the field, thus an easement strip measuring 40m long × 3m wide was excavated from the edge of this track along the N field boundary towards Field 003. This revealed a moderately compacted, friable topsoil (002001) of *c*. 0.15m depth overlying a mid grey-brown silty clay subsoil (002002), *c*. 0.20m thick (*Plate 4*). Natural substrate (002003), a light grey-orange sandy clay, was observed during the pipe-trenching at a depth of *c*. 0.35m bmgl (*Plate 5*).

Plate 5: S-facing section showing natural substrate (002003) within the pipe-trench in Trench 002, looking ENE

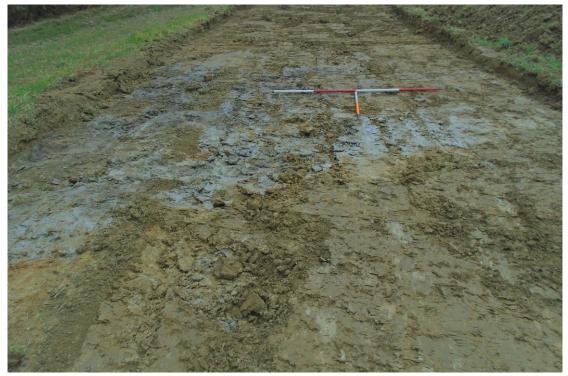
Located approximately 190m from the W end of the field, in an area of low-lying ground, a firmly compacted light blue-grey clay (003008) was observed, roughly covering an area c. 4m (w) × 3.4m (l) in plan, interleaved within the natural substrate to the base of the pipe-trench at a depth of c. 1.10m bmgl (*Plate 6*). This was sampled to confirm the interpretation of this clay as a naturally occurring band or seam, or if it perhaps represented colluvial wash. The latter was confirmed through the paleoenvironmental analysis. Six flecks of charcoal were identified within the sample; likely the subject of wind-blown inclusion, and of little interpretative value.

Plate 6: Trench 003 easement showing deposit (003008) in plan, looking E (2m scale)

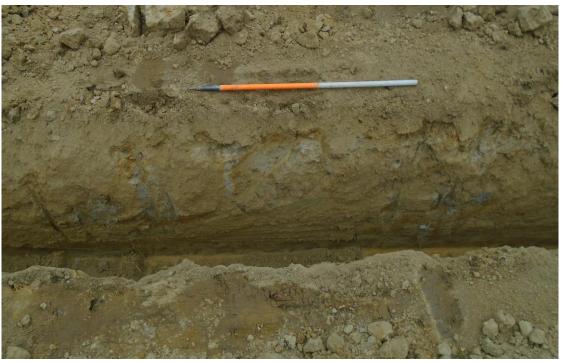
Plate 7: Trench 003, pipe-trench showing south-facing section, looking N (1m scale)

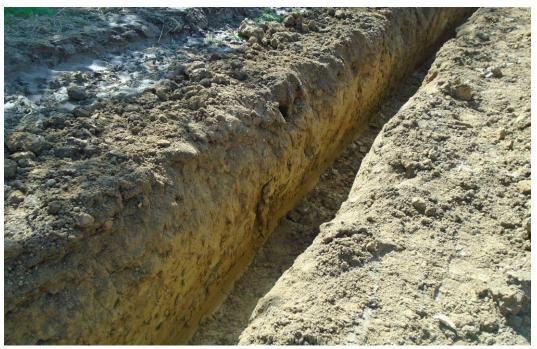
The groundworks revealed a moderate to friable mid-dark brown-grey topsoil (004001), approximately 0.25m in depth, overlying subsoil (004002), which comprised a mid grey-brown silty clay. Natural substrata (004003), a light orange-grey sandy clay, was encountered at a depth of c. 0.45 – c. 0.75m bmgl.

Plate 8: Trench 004 pipe-trench showing subsoil (004002) and natural substrate (004003), looking SSE

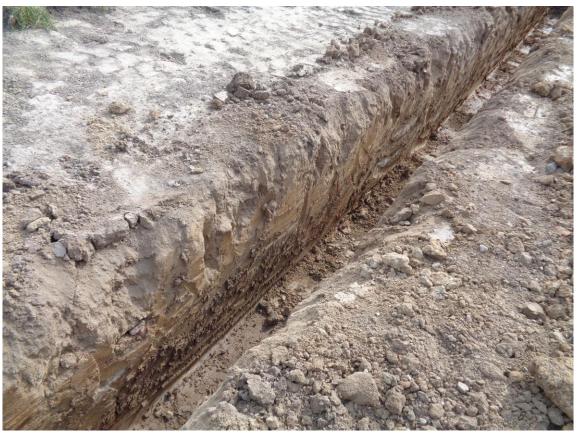
The pipe-trench was excavated within a 6m wide easement orientated SE – NW for 65m through agricultural land. The topsoil strip revealed a moderate to friable mid to dark brown-grey silty clay (005001), approximately 0.15m in depth, overlying subsoil (005002), which comprised a mid grey-brown silty clay with modern inclusions of ceramic building material (hereafter referred to as CBM), ceramic, and iron (Fe), possibly incorporated into the subsoil via agricultural activities. The natural substrata (005003) (*Plate* 9) was encountered at a depth of 0.30m bmgl.

Plate 9: Trench 005 showing natural substrate (005003) in E-facing section of pipe-trench

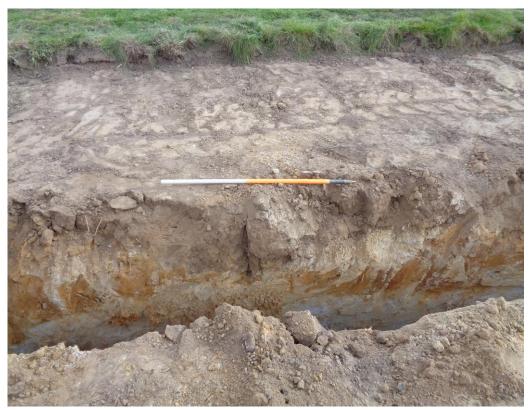
Three linear cut features were identified in the pipe-trench, approximately 25m from the E end of the trench. Features [006004], [006006], and [006008] (*Fig. 4*) measured *c*. 1.45m (w) x 0.25m (d); *c*. 1.27m (w) x 0.28m (d); and *c*. 3.00m (w) x 0.45m (d) respectively. All three features had similar profiles- gradual to moderately sloping sides and concave bases and their respective fills (006005), (006007), and (006009) were similar in appearance and composition to subsoil (006002). It was primarily considered that these might represent NE-SW aligned ridge and furrow or drainage ditches. The fairly equal spacing between the features suggests some form of agricultural field system. However, the lack of any inclusions visible within the fills, and their similarity to the subsoil (006002) coupled with the fact that they were not visible in plan, could suggest that what was encountered here were natural undulations/shallow depressions in the underlying substrate.

Plate 10: SW-facing section of Trench 006 showing [006004], looking NNW (1m scale)

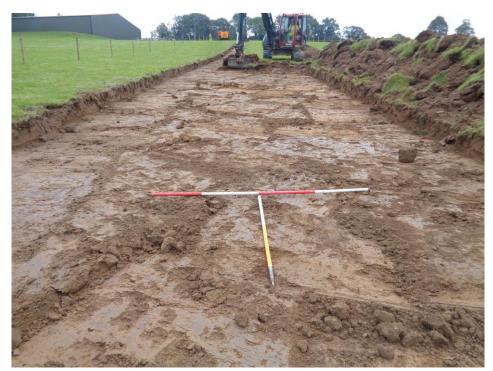
Plate 11: General overview of easement in Trench 008, looking NNW (1m & 2m scale)
