ARCHAEOLOGICAL EXCAVATION

FORMER CONGREGATIONAL CHAPEL
FORBURY CHASE
SHERFORD STREET
BROMYARD
HEREFORDSHIRE
HR7 4DL

PROJECT TITLE: FORMER CONGREGATIONAL CHAPEL BROMYARD

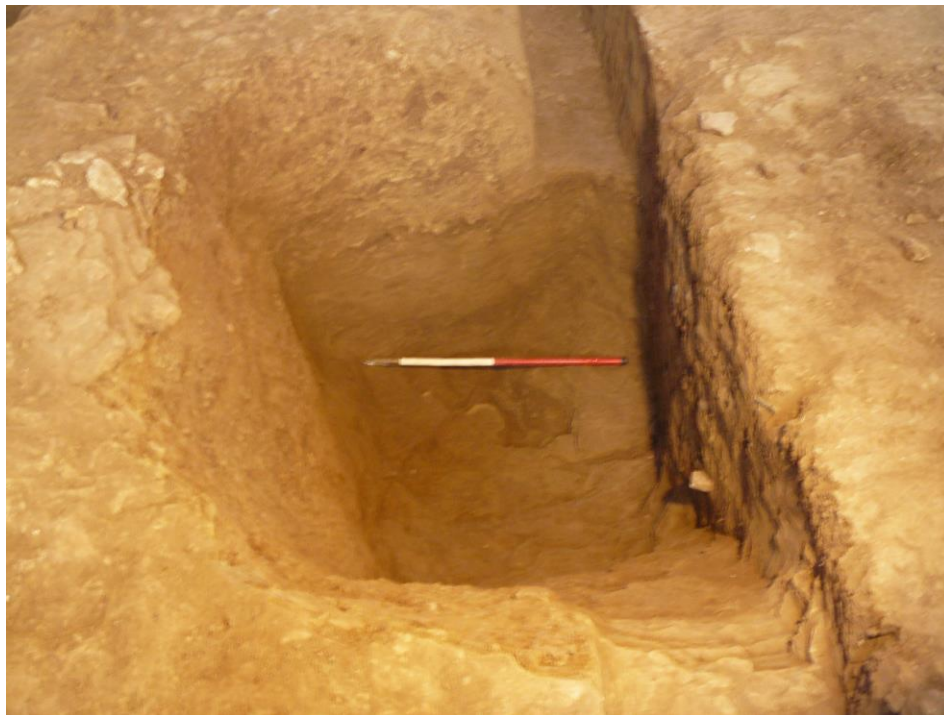
A deep irregular oval pit [141] appears to be the only feature associated with this early phase of activity (*Plate 1*). The pit (111.12m OD) was 1.18m deep and revealed sharp sides and a flat base (110.64m OD). Three distinct fills were identified, the earliest of which (140) contained early post-medieval pottery, with a piece of probable Herefordshire glazed fine micaceous ware (A7b) being recovered from the middle fill (139), suggesting the feature may well predate the chapel and could potentially be a rubbish pit associated with an earlier structure, possibly even the original meeting house of 1672 owned by John Bond. This identification can be corroborated with reference to the orientation of the pit, which does not conform to or respect the layout of the subsequent chapel building of 1701.

Plate 1: View of possible rubbish pit [141]

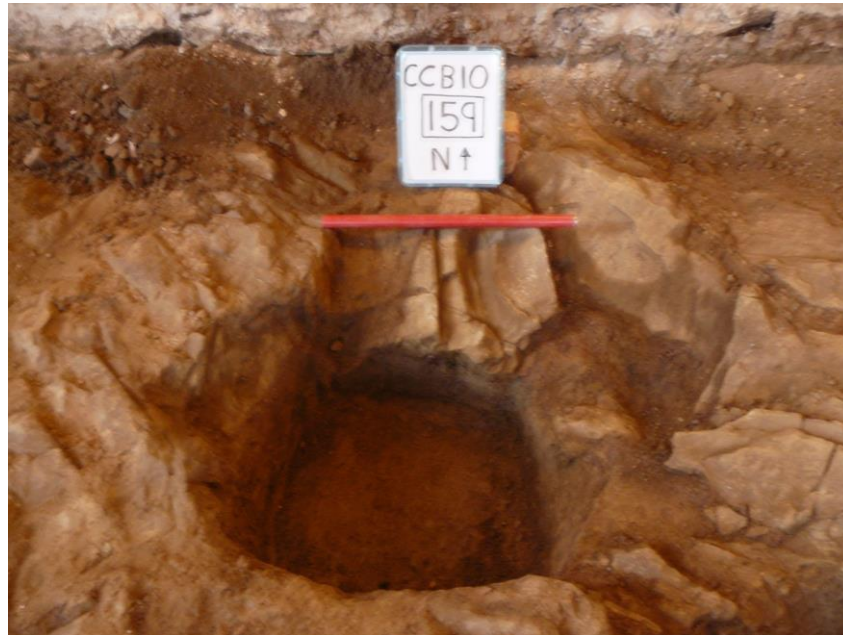
The interior of the chapel contained 20 rectangular pits [104 116 143–173 183 & 223] (*Plate 2*), which appear to have been dug to support scaffolding during construction of the chapel in 1701-2. The pits averaged 0.5m × 0.5m × 0.4m and were arranged in five rows cut into the natural soil (184) and bedrock (103) below (*Fig 4*). Traditional masons' scaffolds comprise upright standards, cross-braces or ledgers and putlogs, connected with rope. The standards were usually spaced approximately 2m apart and set about 0.6m into the ground, close the walls. The portions of scaffold were bound with cross-braces which enabled the

structure to support a greater weight. These pits did not follow the regular pattern of spacing prescribed by tradition (*Fig 4*); this could be because the same scaffolding was used to erect the roof or it could simply be the result of personal preference.

Plate 2: A possible 'scaffold pit'

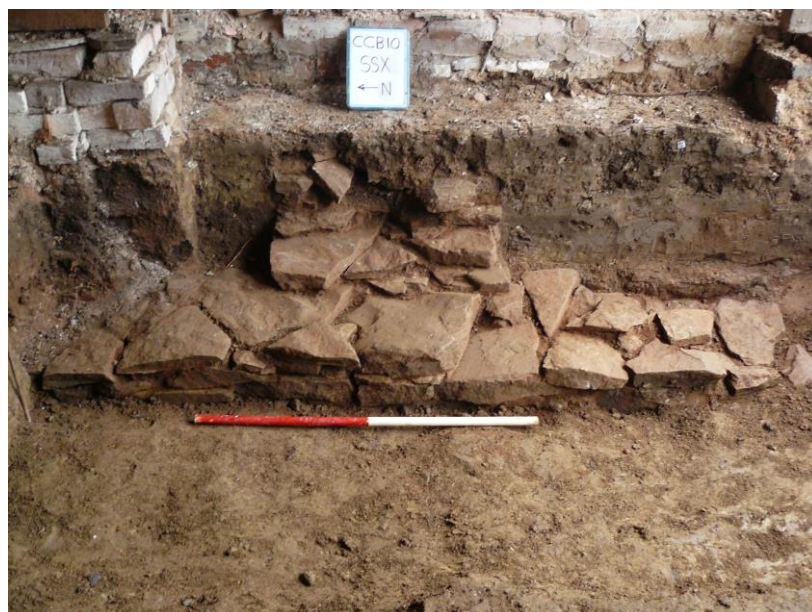
Wall [236] was revealed beneath the floor of the redbrick schoolhouse extension on the east side of the chapel and has been interpreted as the exterior wall of the original schoolroom and vestry building, built 1701-2, which was demolished in 1868 and replaced with the redbrick schoolroom standing today (*Plate 3*) (Stevens 1930, 4).

Plate 3: View E showing wall [236]

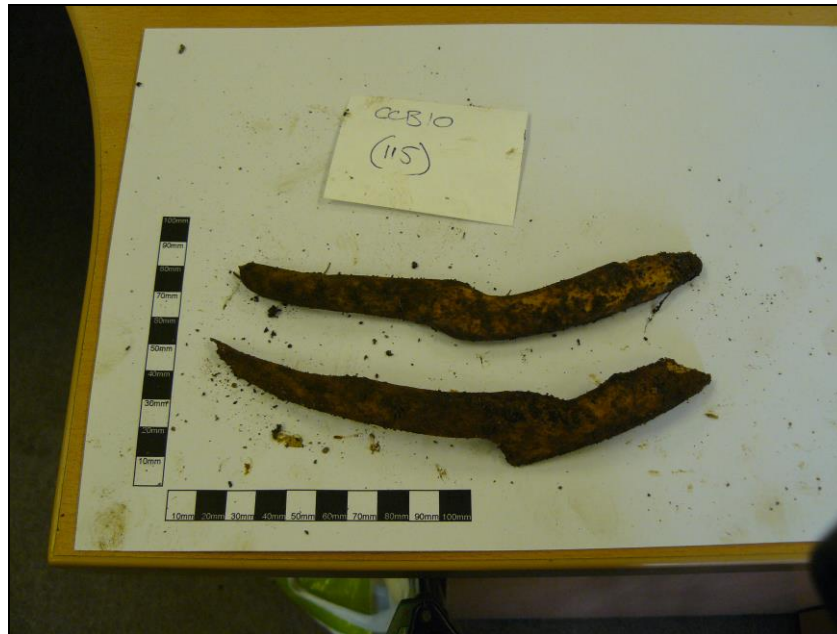
Plate 4: Healed and malaligned ribs from (115)

During the assessment it was noted that female (197) had two fused thoracic vertebrae, and evidence of DISH in the spine (Plate 5). Male (186) had evidence of the joint disorder osteoarthritis on the surface of his femurs, and males (127) and (221) had full ante-mortem tooth loss. Male (115) presented healed trauma to the ribs, the ribs having suffered fractures that had healed but were malaligned, the broken ends having failed to unite properly (Plate 4). No evidence of metabolic diseases, such as rickets or scurvy was observed.

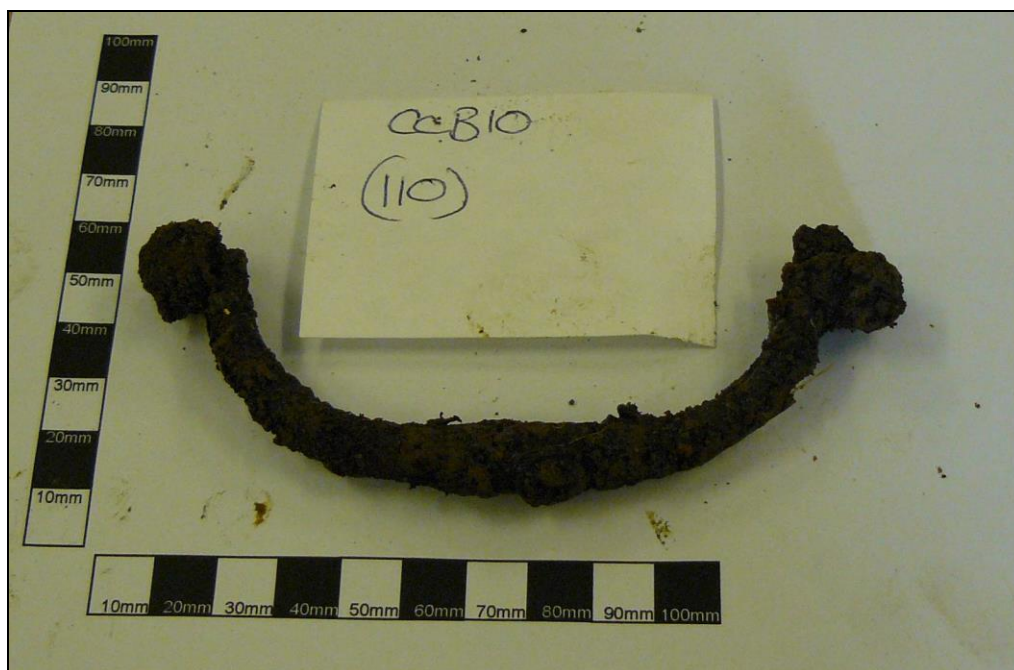
Of the 21 burials, 17 had coffin furniture, the majority of which consisted of London Types 1 and 2 grips (**Plate 6**), with two possible Type 5s from contexts [187] and [194] (**Plate 7**). Five of the contexts had breast plates, those associated with [110] and [217] are both YKW Type 14 (London typology) and have a date range of 1779-1851 (**Plate 8**). The breast plate on [187] is of an unknown type, heavily decorated with angels and the words "The Dead Shall Rise" embossed on the front. It can be loosely dated to the 19th century from the associated coffin handles. Those from [132] and [198] were unidentifiable due to their level of corrosion.

Plate 6: Type 2 group from coffin [110]

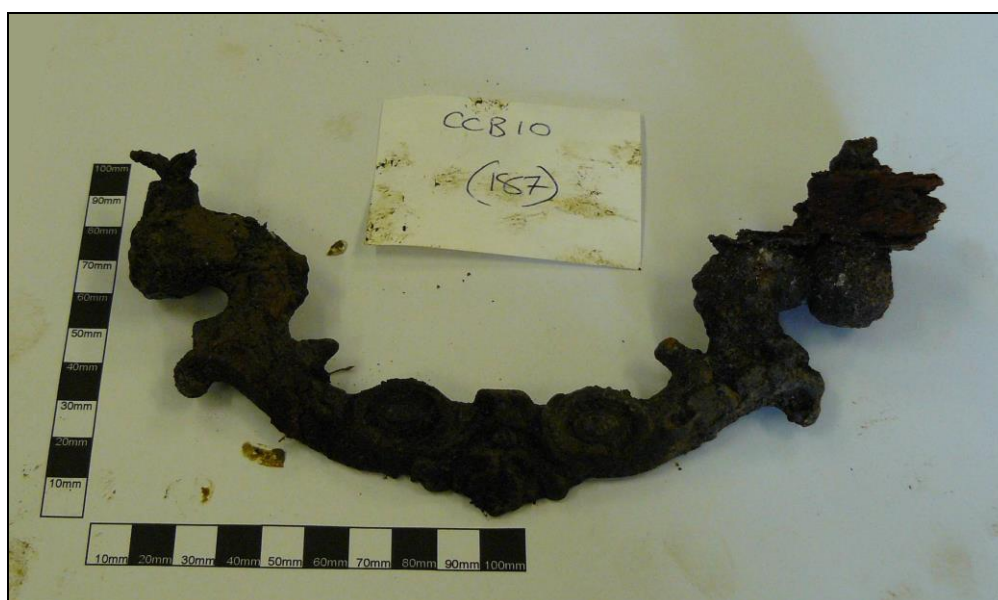
Although the vast majority of coffin handles, properly known as grips, cannot be precisely dated, there is a typology sequence for London, and even allowing for regional stylistic variations, a number of things can be stated with reasonable certainty: right-angled handles (London Type 3) are the earliest dated form, and have been found in contexts dated 1687-1739 in sites in London (Wroe-Brown, 2001; Cowie, Bekvalac & Kausmally, 2007). Rounded types (London Types 1 and 2) proliferate through the latter part of the 18th and the first half of the 19th century (**Plate 6**), while decorated London Type 5 have only been found in 19th century burials (**Plate 7**) (Miles, A, pers com).

Plate 7: Type 5 grip from coffin [187]

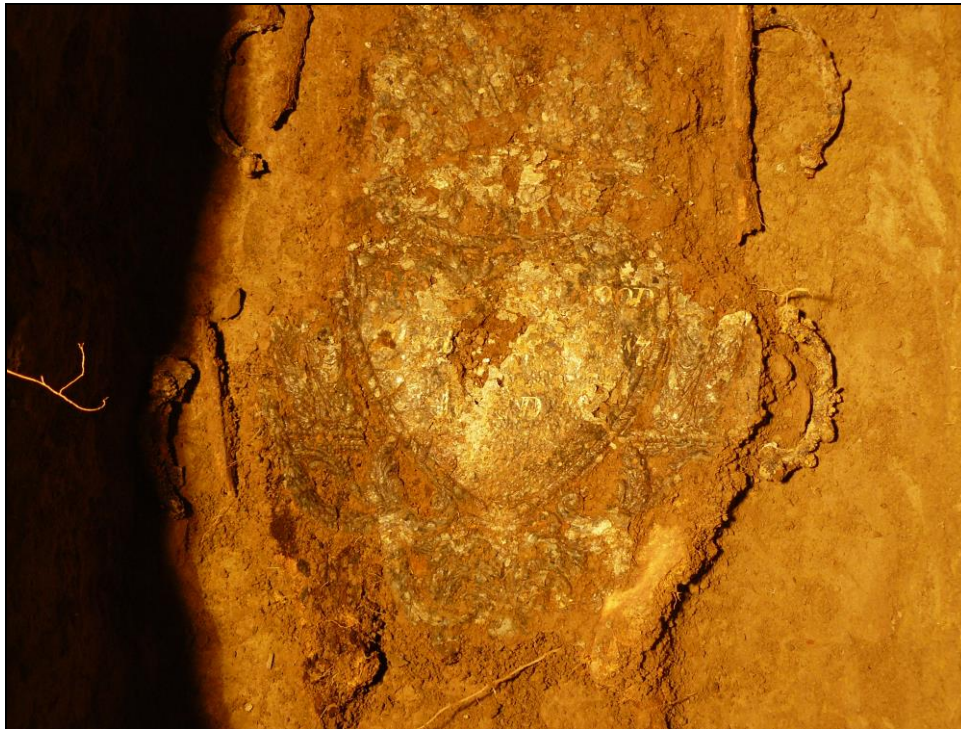
Plate 8: Close up of breast plate [110]

The coffin plates from the congregational chapel were very fragile, and were often only represented by a spread of corrosion across the ribs, or did not survive the lifting process. These were therefore examined and photographed in situ. Those that survived lifting were allowed to dry, however little information could be gleaned from them as the inscriptions had been painted on, rather than etched. The use of paint over etching suggests it is likely that there was no one skilled enough at engraving in Bromyard to carry out the work at that time. Comparative material for the congregational chapel assemblage is limited, as, to the authors' knowledge, no typologies for this area of Britain have been compiled, we can, however, make some comparisons with the London typologies.

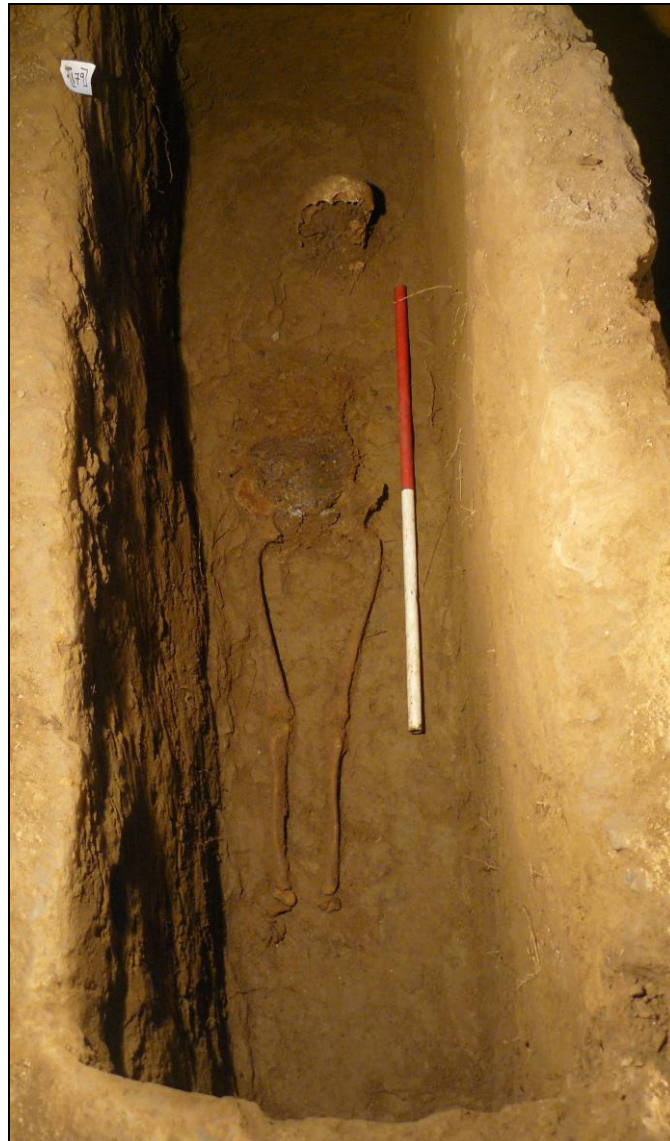
Plate 9: Heather Benbow (216)

Although the information left on the breast plate was not complete, we know from the burial register that this was the grave of Heather Benbow, died August 25th 1791, buried on the 27th August 1791, within the chapel (**Fig 4**, grave [179]). Little else is known about Heather Benbow, and not unusually she did not leave a will, more information could potentially be learnt from the congregational chapels' birth and marriage registers.

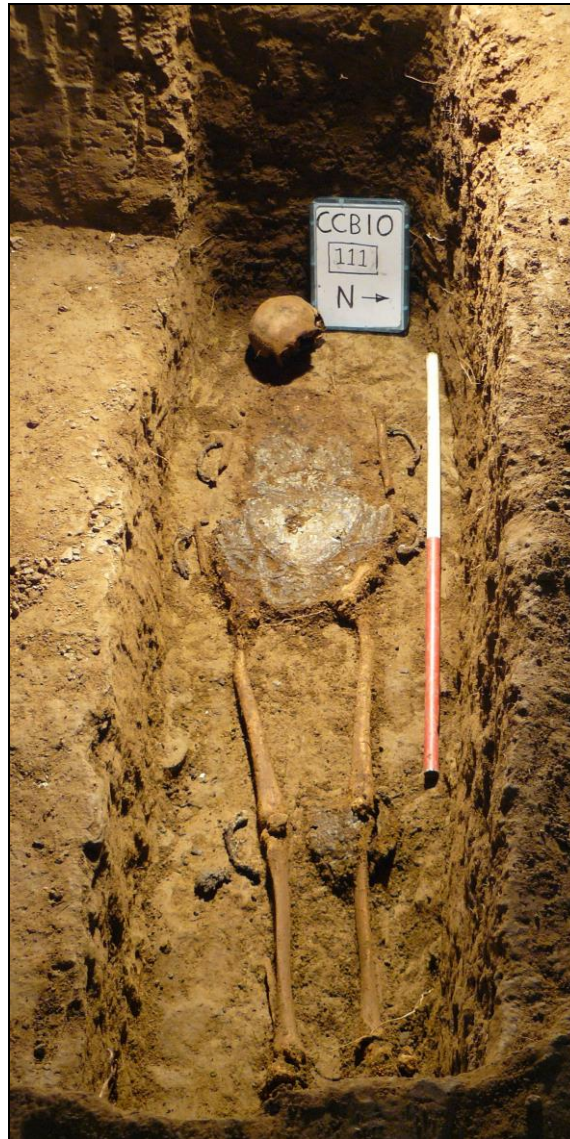
Plate 10: Mrs Mary Haywood (111)

The burial register tells us that Mrs Mary Haywood died on August 1st 1817 and was interred in the Bromyard meeting house on the 8th August (**Fig 4**, grave cut [108]).

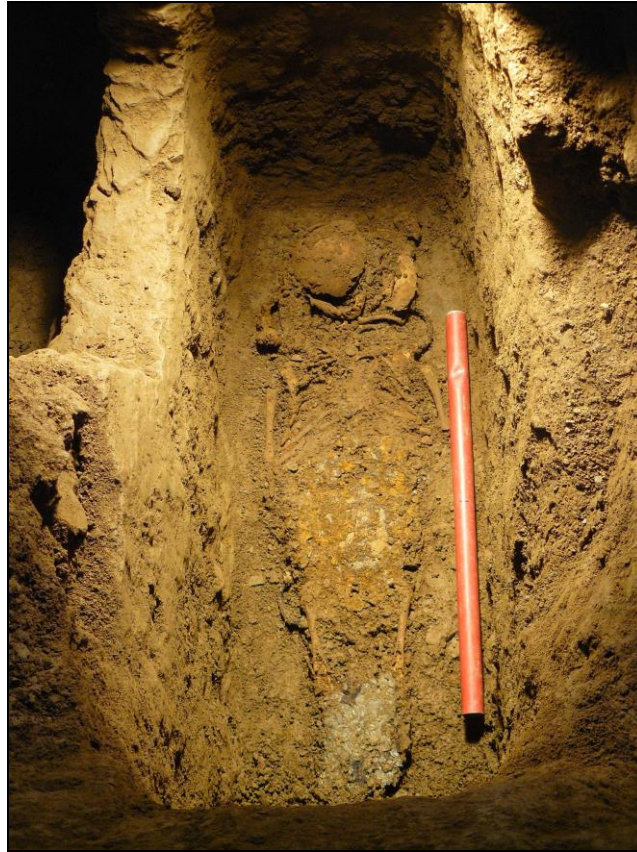
Plate 11: Context (197), probably Martin Chapman

Martin Chapman, according to the burial register, was the son of the Rev. Josephus Chapman, pastor of the chapel. He died aged 6 on the 28th January 1830 and was buried on the 5th February 1830 “...in the chapel before the pulpit by Rev George Redford.” It is highly likely that Martin Chapman corresponds to context (197) (Fig 4, grave cut [175]), as he was the only juvenile recorded as being buried within the chapel, and only one juvenile of this age was recovered during excavation.

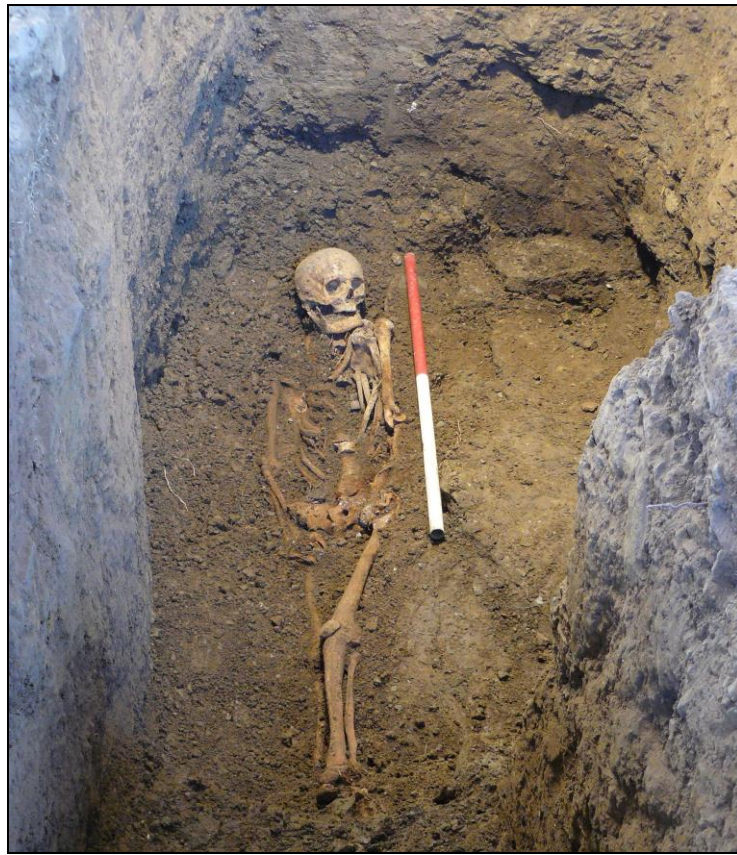
Plate 12: Context (127), probably Rev Joel Banfield

The Reverend Joel Banfield was pastor at the chapel from 1793-1820. A plaque on the wall of the chapel commemorates the death of Rev Banfield on the 6th May 1820, his wife Effe in 1808 and his second wife Harriet on the 8th September 1815. A grave containing three bodies, two females and one male, was excavated from within the chapel (**Fig 4**, grave cuts [124] and [230]), and it is highly likely that these three are the Banfields.
