# ARCHAEOLOGICAL PROGRAMME OF WORK

**ON SELECTED AREAS WITHIN THE BRISTOL WATER RESILIENCE SCHEME**  
(Harry Stoke to Clifton)  
**BRISTOL**

NGR ST 62001 78618 to NGR ST 57624 73711  
JOB N<sup>o</sup>: BA1130BWDD

APRIL 2013

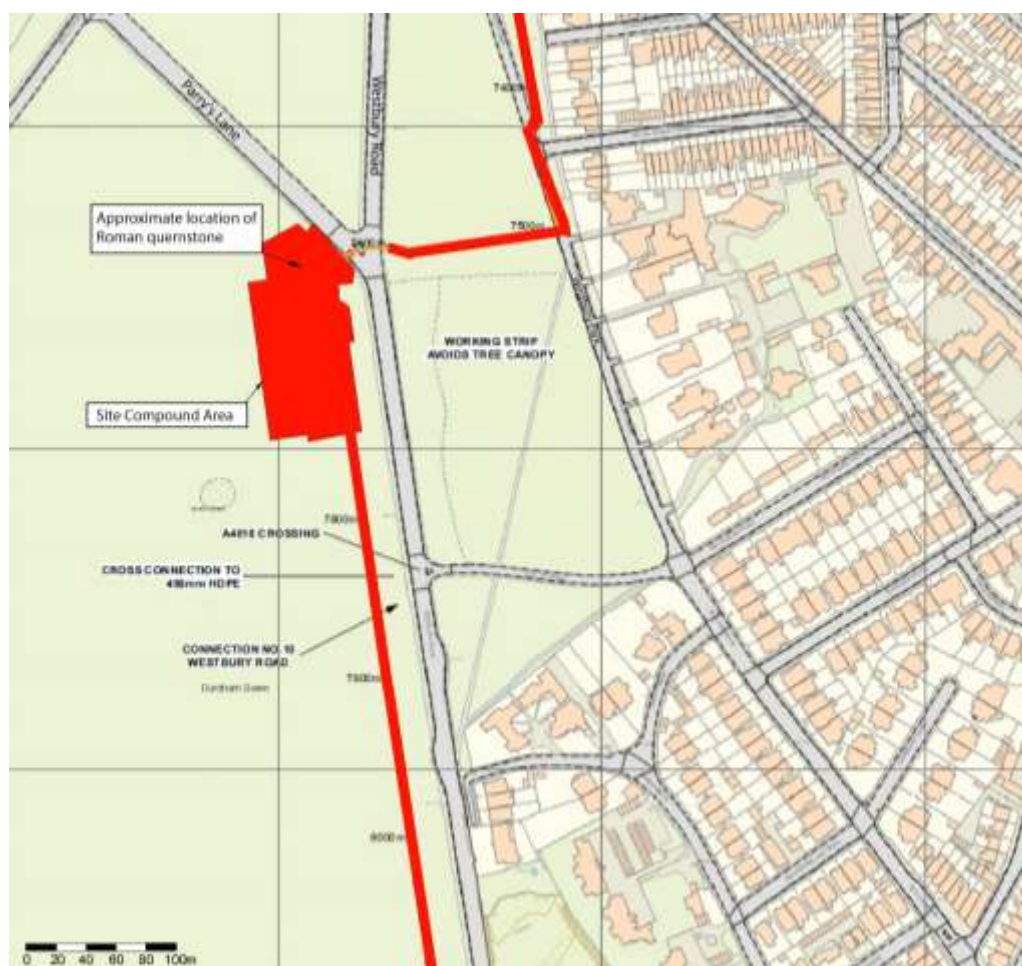
Fig. 1: Location plan showing Site Compound at the junction of Parry's Lane and Westbury Road

A site located at the junction of Parry's Lane and Westbury Road (centred on ST 57236 75505) was prepared for use as a fenced Compound for car-parking, storage, offices, access roads and paths; a piped water supply was installed from Westbury Road to the office area at the northern end of the Compound. Ground works comprised initial machine stripping of the Compound area and a short section of trenching for the installation of services (**Fig. 1**). All ground works were observed and all finds and features recorded.

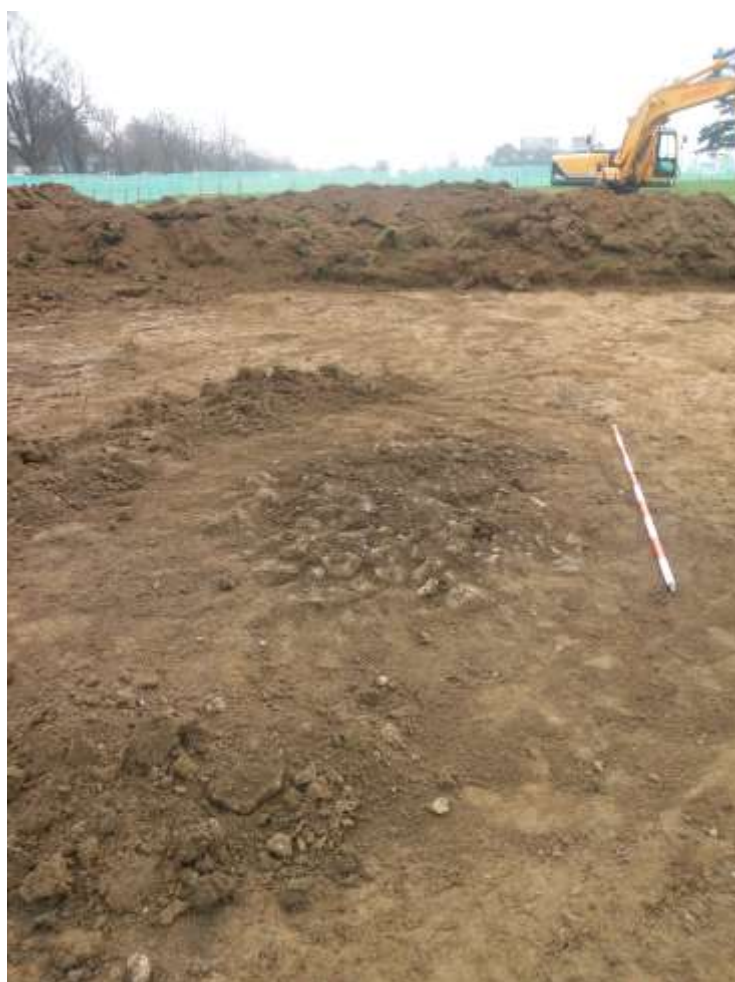
*Plate 1: View S showing compacted stony deposit (489)*

Further investigation, however, revealed no evidence of a cut and (489) was found to comprise a concentration of stones bedded within subsoil (487), possibly to create a post-pad or other structural support. A second feature (490) was located at NGR ST 57239 75480 within the second bay and comprised a poorly defined, roughly ovoid stony spread containing post-medieval pottery and charcoal (**Plate 3**). The deposit consisted of mid to dark greyish-brown clayey silt with small-medium sub-angular stones, incorporating chalk inclusions and measuring approximately 2.9m (N-S) × 2.5m (E-W).

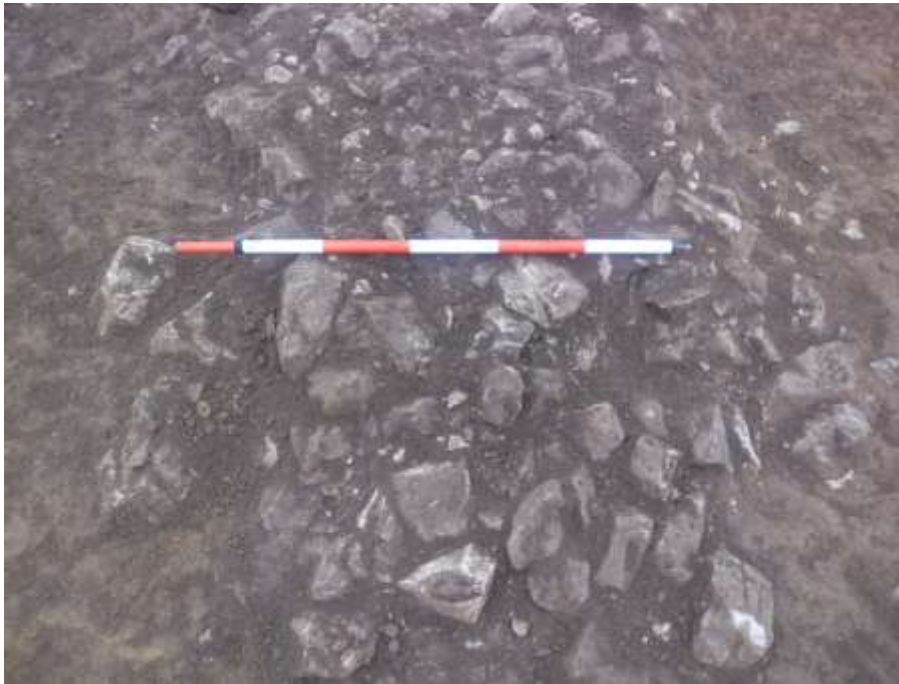
*Plate 2: Detail of compacted stony deposit (489)*

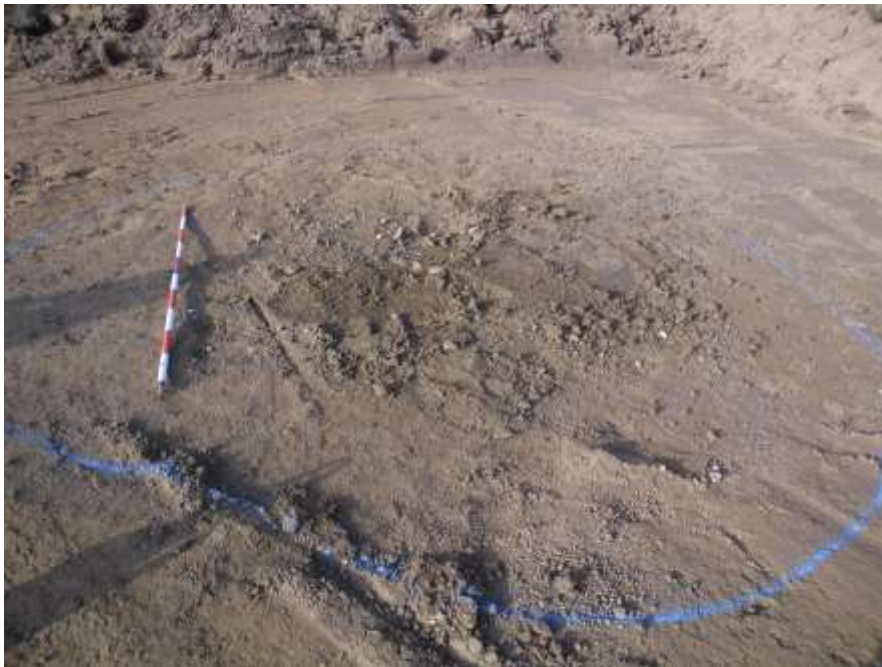
*Plate 3: View N showing disturbed stone/pottery spread (490)*

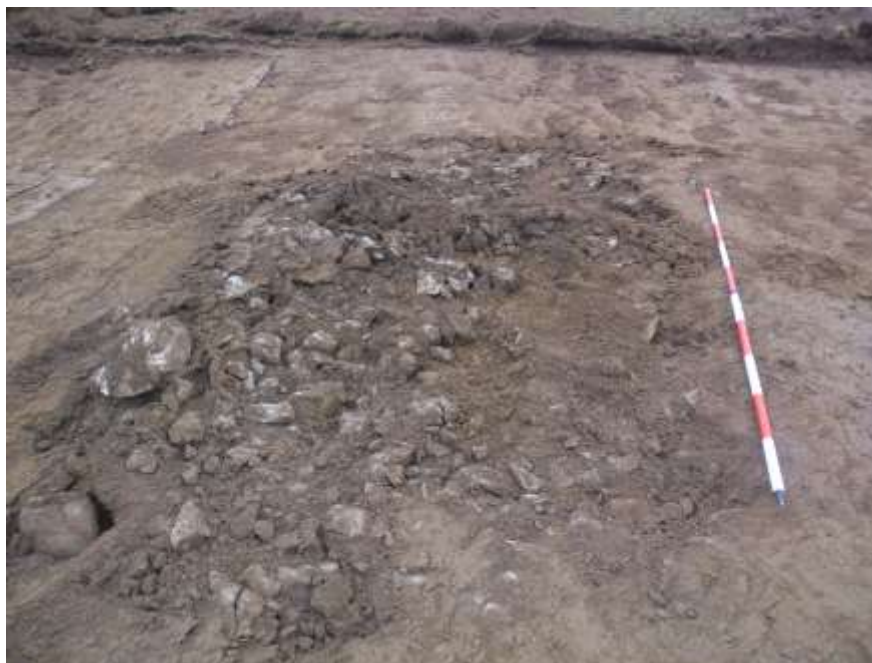
*Plate 4: View W showing heavily disturbed stone spread/capping deposit (491)*

A third feature (491) was located at NGR ST 57236 75471, SW of (490), and was also within the second bay. This consisted of a roughly ovoid spread of medium to large angular and sub-angular limestone fragments within a friable mid-greyish-brown clayey-silt matrix containing occasional post-medieval pottery and CBM (**Plate 4**). The feature extended over an area of some 3.20m (N-S) × 1.70m (E-W).

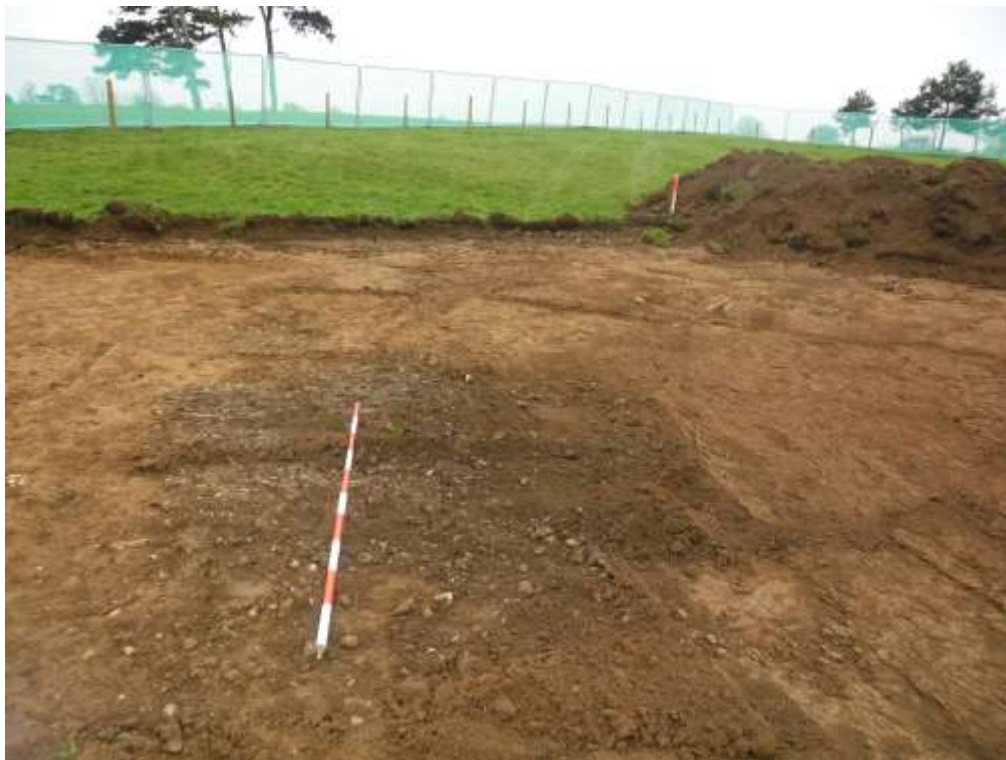
*Plate 6: Feature (492) looking SW*

Feature (492) (**Plate 6**) was revealed at the southern extent of the Compound to the W of the storage bay area (NGR ST 57210 75458) and consisted of moderately compact to firm dark greyish-brown clayey silt containing frequent charcoal inclusions, small to medium sized angular and sub-angular stones, post-medieval pottery, CBM & oyster shell, together with occasional clay pipe fragments. This again would appear to represent a dump of post-medieval domestic refuse.

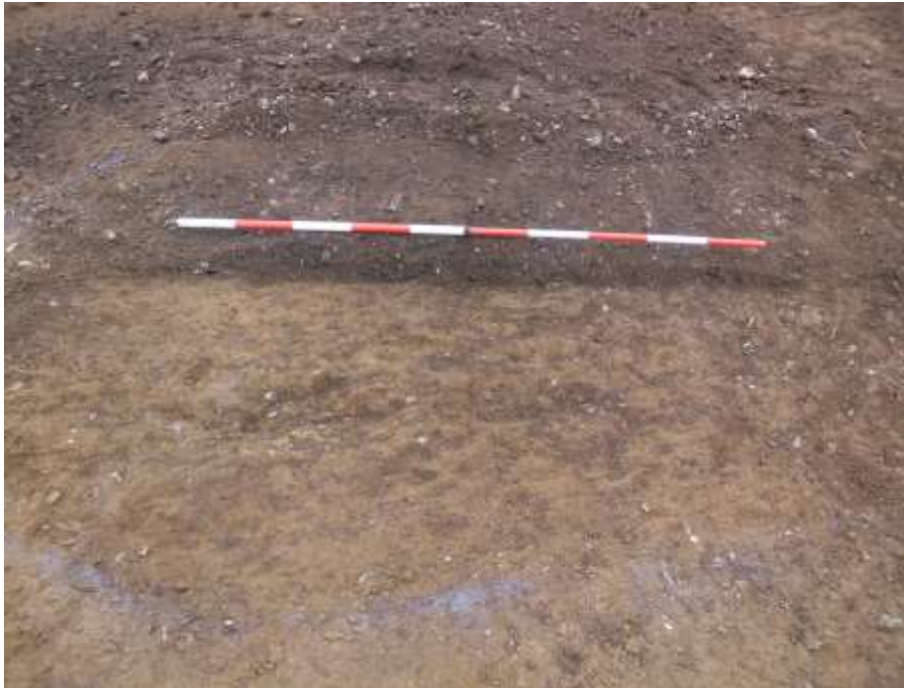
*Plate 7: View SW of compacted pottery spread (493) showing NE-facing section*

Feature (493) (**Plate 7**) was identified at NGR ST 57215 75478 consisting of moderately compact to firm dark greyish-brown clayey silt containing frequent charcoal, post-medieval glazed pottery, willow pattern porcelain and CBM, moderate oyster shell and occasional animal bone. This measured approximately 3.50m (NNE-SSW) × 2.80m (WNW-ESE) × 0.10-0.15m

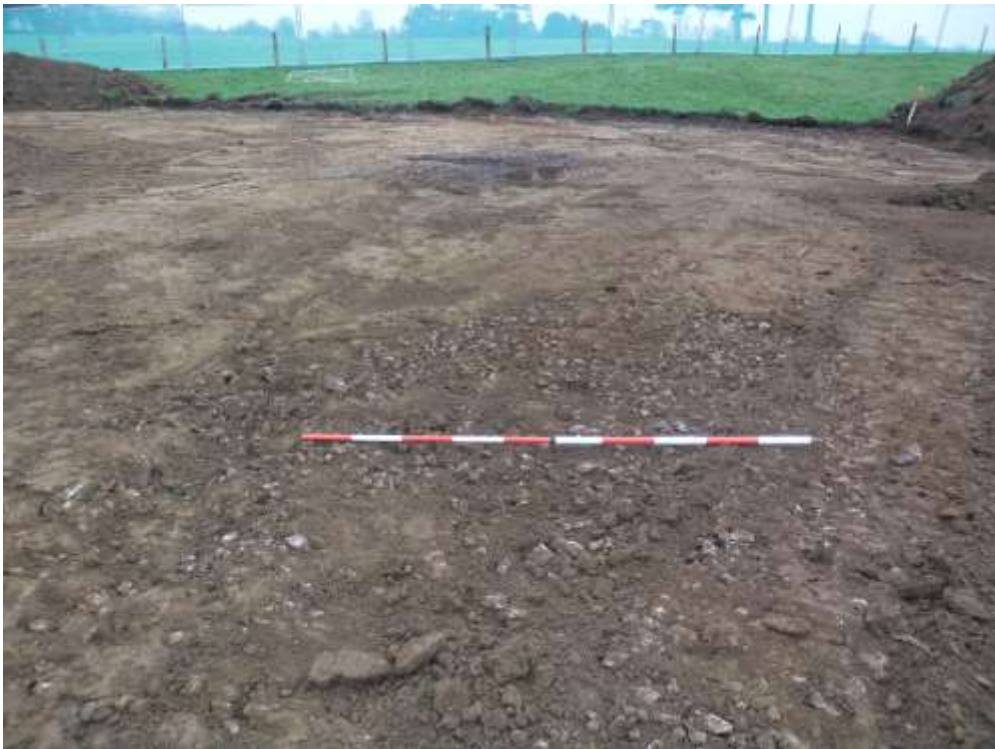
*Plate 8: View S showing limestone rubble spread (499)*

A seventh feature (499) (**Plate 8**) occurred at NGR ST 57254 75489 and was a limestone rubble spread within a moderate to firm dark reddish-brown clayey silt with occasional CBM & rare post-medieval pottery. The feature extended over an area of approximately 4.50m (NNE-SSW) × 3.20m × (WNW-ESE) × 0.15m and may be interpreted as part of a metallated path or track or possibly as an area of modern hard-standing.

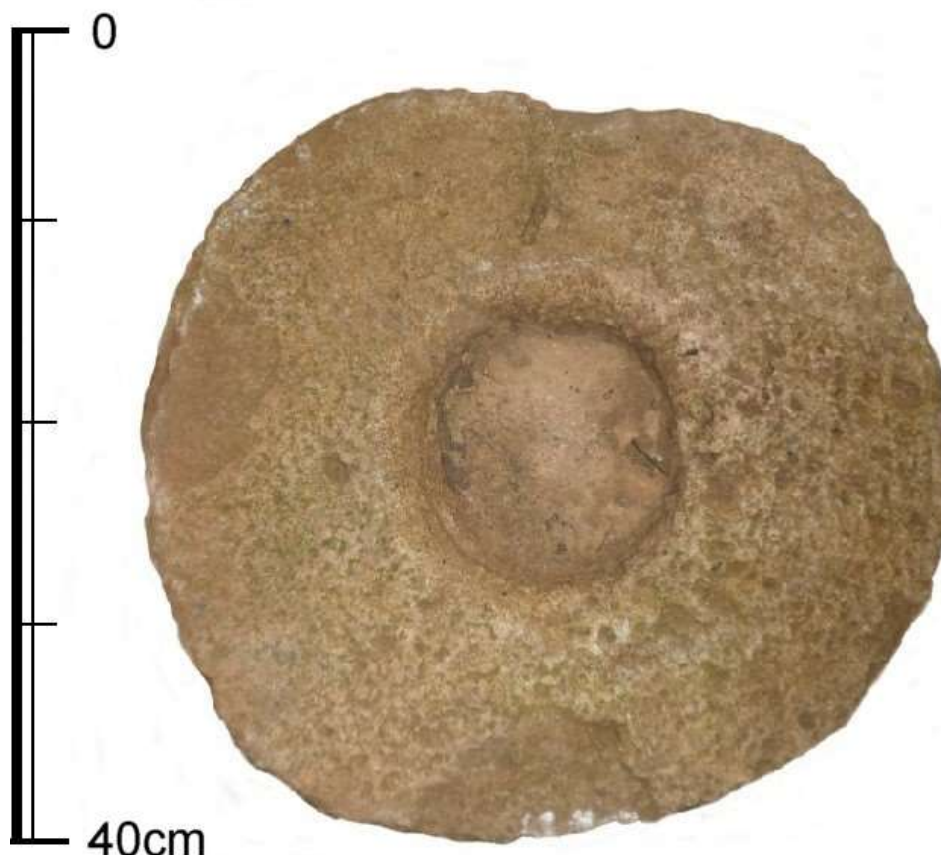
*Plate 9: Near complete early Roman lower rotary quern recovered from within limestone rubble in the car-park area*

Of considerable interest was a near complete early Roman lower rotary quern recovered from within limestone rubble in the car-park area (**Plate 9**). The piece was exceptionally thick (110mm), with a very slightly convex base and splayed edges. It was partially perforated with dimensions 120mm × 120mm × 25mm and its form appeared comparable to the type 1b beehive quern (Shaffrey 2006; Fig. 4.19), which occurs most frequently in early Roman contexts and is not found later than the 2<sup>nd</sup>-3<sup>rd</sup> century (Shaffrey, 2006, 42). The geological character of the piece compares with a type of quartz conglomerate from the Devonian of the Bristol/Forest of Dean Area and was evidently imported from outcrops at least 5km away to the W at Lydiard Trigorze or Wootton Bassett.

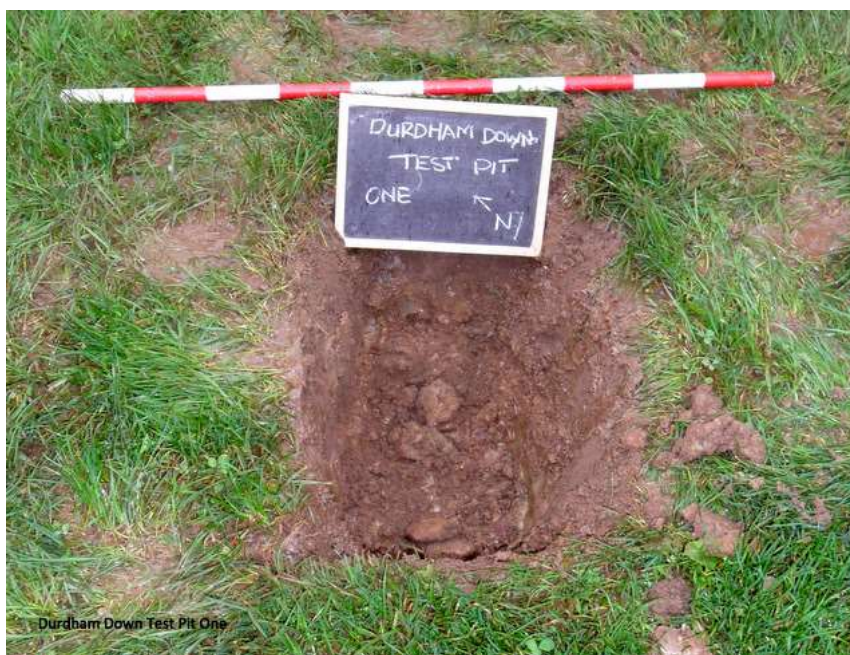
Plate 10: View SW showing deposits in Inspection Pit 1

Measuring 0.60m × 0.40m × 0.88m, the pit revealed a friable dark brown sandy loam with occasional small angular stones to a depth of 0.10m (100) (**Plate 10**). Beneath this was a subsoil deposit (501) composed of firm/moderately compact brown sandy clay some 0.09m in thickness, underlying which was a sterile natural deposit of plastic reddish-brown clay / alluvium (502) above a bedrock horizon occurring at a depth of approximately 0.88m. No archaeological features or deposits were observed.

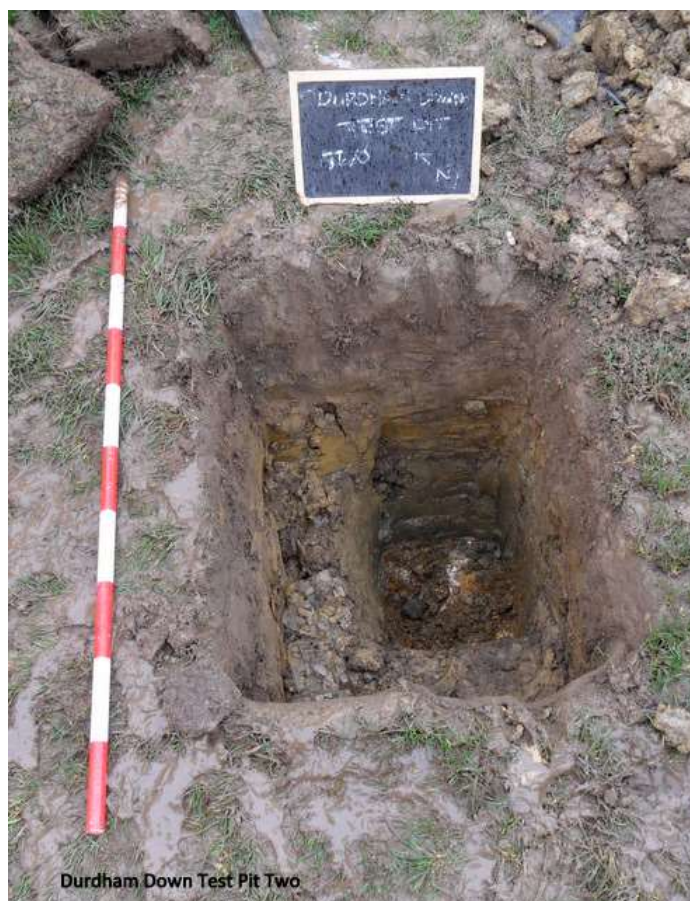
Plate 11: View SW of Inspection Pit 2 showing deposits (501)-(504)

Pit2 measured 0.65m × 0.45m × 0.88m (**Plate 11**). The topsoil consisted of 0.10m of friable dark brown sandy loam (503) with occasional small rounded / angular stones and charcoal flecking present throughout. Subsoil (501) consisted of mid brown moderately compact sandy clay with no inclusions, which this was found to overlie plastic reddish-brown natural clays (502) above bedrock (504), which was exposed at a depth of 0.88m. No archaeological features or deposits were observed.

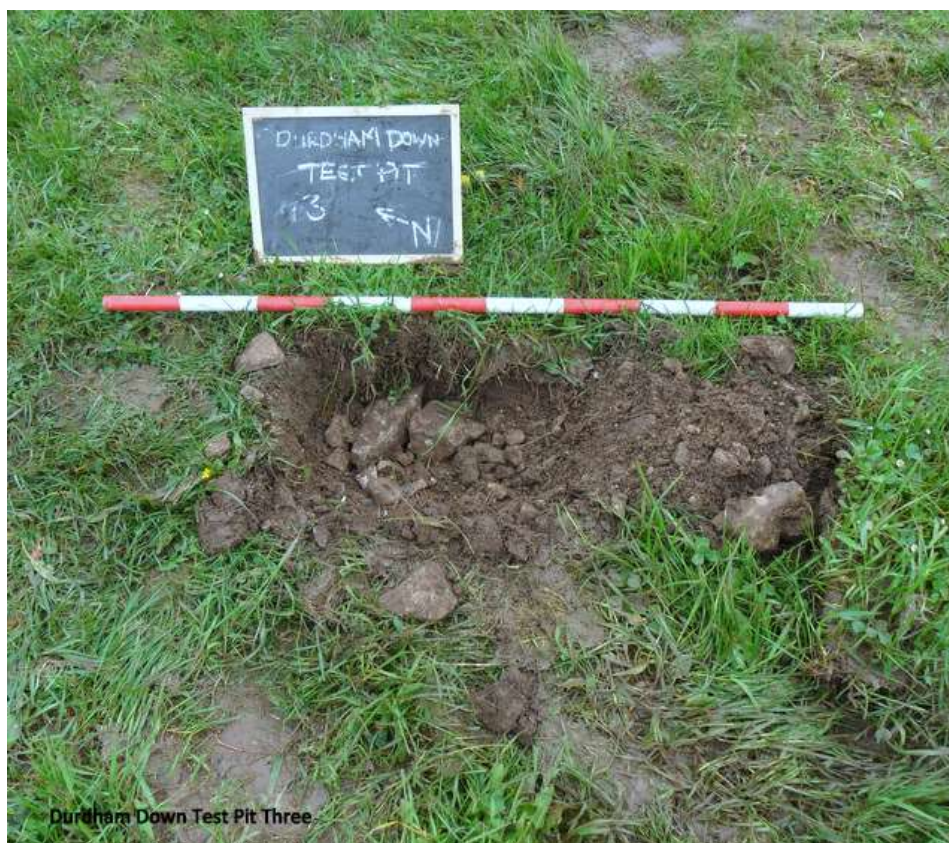
Plate 12: View SE showing Inspection Pit 3

Pit 3 (dimensions 0.40m × 0.20m × 0.10m) was located approximately 60m E of the Water Tower adjacent to the Bristol Water covered reservoir at Stoke Road (**Plate 12**). Excavation was halted at a depth of 0.10m due to the presence of a loose deposit of small to medium angular limestone fragments (+/- 6-10cm) (505=082), at least two of which were set deeply within a friable sandy clay, beneath the topsoil (506).

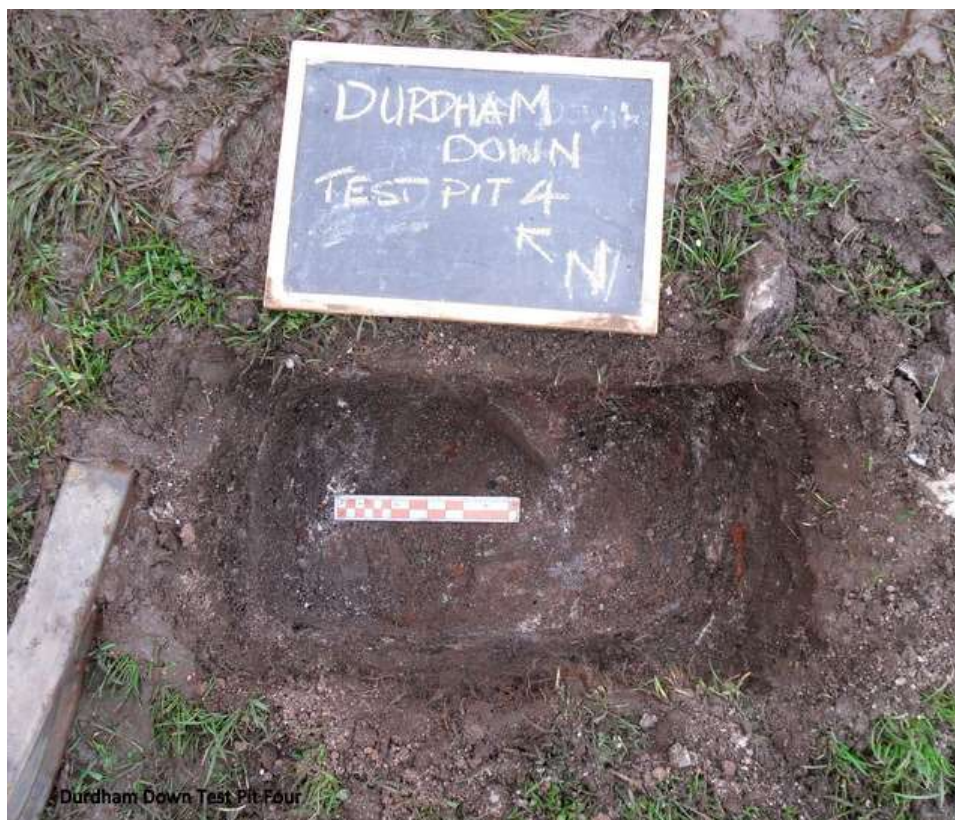
Plate 13: Inspection Pit 4

Pit 4 (dimensions 0.50m × 0.26m × 0.42m) was located approximately 60m SW of the Water Tower and 15m S of Stoke Road (**Plate 13**).

A total of three contexts were identified, the uppermost topsoil deposit (507) comprising a friable very dark grey sandy loam exhibiting occasional CBM, mortar and charcoal flecking and extending to a depth of 0.10m. Underlying this was (508), a semi-compact dark grey coarse / granular deposit with a substantial component of crushed red CBM, buff mortar, charcoal and occasional medium (+/- 10cm) angular stones. This came down onto apparently *in-situ* structural remains (509), possibly representing a masonry wall of coursed angular limestone construction, oriented NE-SW and extending for a distance of about 15m, with a coarse lime mortar cement containing frequent very small inclusions of a black unidentified material.

Although exposed only within the confines of a small *sondage*, it is probable that this stratigraphic sequence represented a building and associated demolition debris. The date and function of limestone wall (509) is uncertain; the coarse nature of the lime mortar bonding might suggest an early post-medieval date although it is difficult to be more precise due to the lack of datable material from the deposit overlying (509).

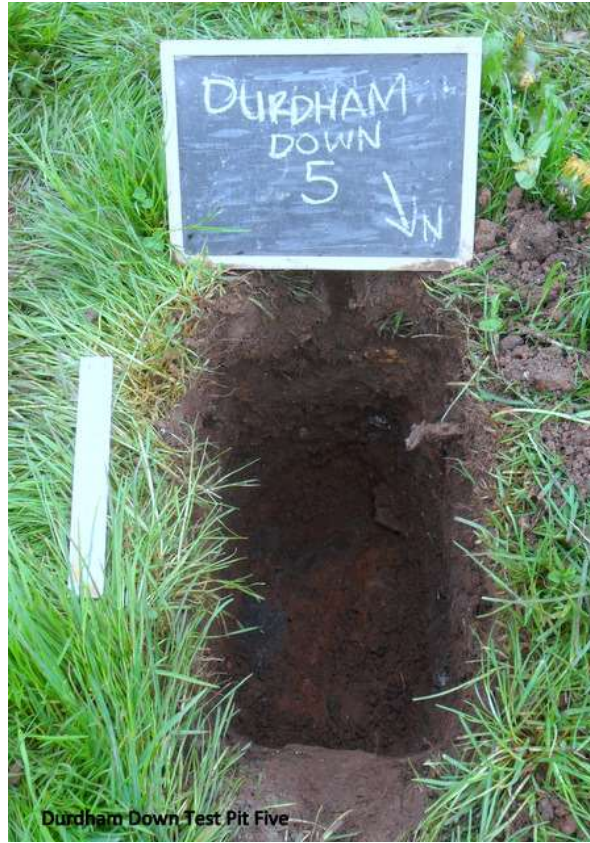
*Plate 14: Inspection Pit 5*

The final Inspection Pit (dimensions 0.50m × 0.26m × 0.58m) was located approximately 10m W of Upper Belgrave Road within an area of visible earthworks and former lead-workings on Clifton Down (**Plate 14**). The uppermost deposit consisted of friable dark grey sandy loam and occasional charcoal flecking (510) to a depth of some 0.17m. This overlay (511), a 0.20m thick deposit consisting of moderately compact made ground formed from rounded and angular stone fragments with occasional flecks of charcoal and buff mortar, which, in turn, overlay compacted dark grey coarse sandy silt with frequent very small fragments of buff mortar, charcoal and rare burnt stone (512).

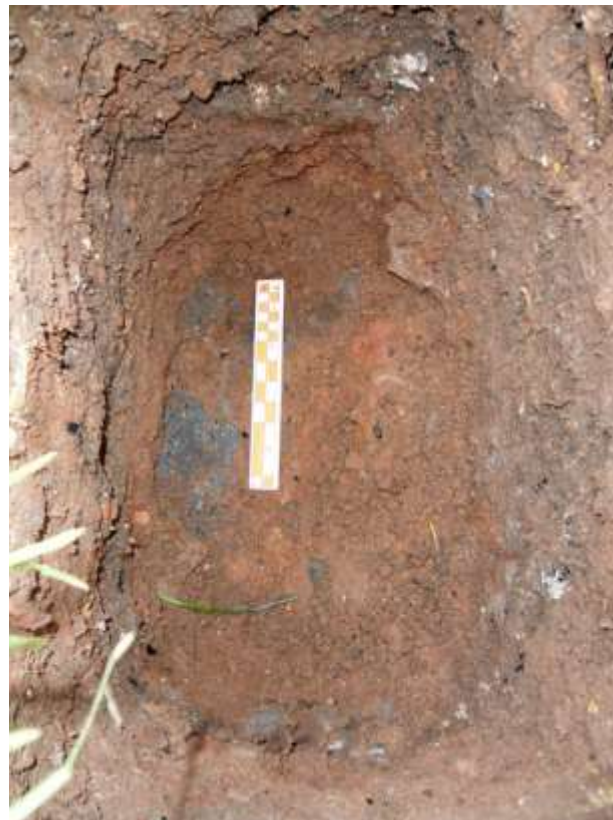
*Plate 15: Base of Inspection Pit 5 showing deposit (514)*

Beneath (512) was a reddish-brown sandy silt with frequent small to medium burnt natural stone inclusions and rare mortar flecking (513), which measured 0.12m in thickness. A horizontal mid grey compacted coarse cemented sandy deposit (514) was then revealed (**Plate 15**), which contained frequent charcoal and (buff) mortar flecking to create an impression of burning. The required engineering depth having been reached at this point, no further excavation took place; consequently it was not possible to determine the full depth and extent of (514).

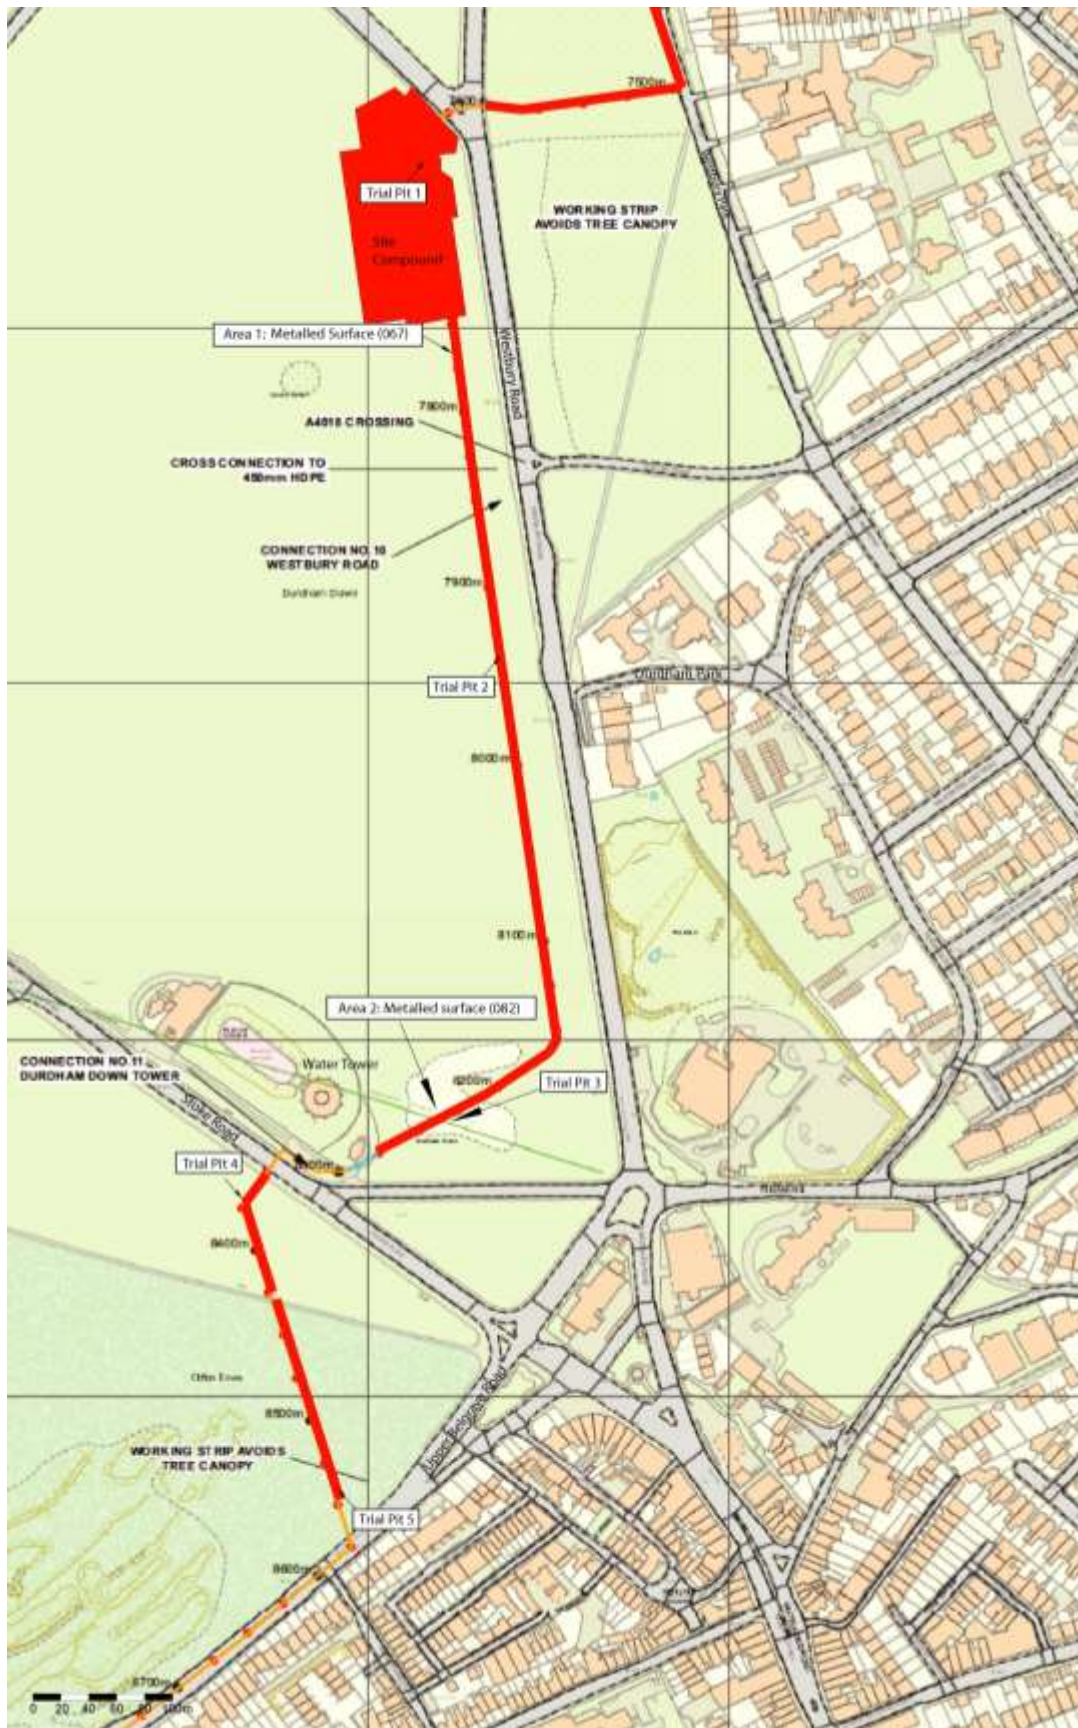
Fig. 3: Scheme plan showing easement route and location of areas of further investigation & recording in the NE corner of Durdham Down (Area 1) and to the E of the Water Tower on Stoke Road (Area 2)

Following the excavation of the inspection pits, a topsoil strip was undertaken along the easement of the proposed pipeline route to a pre-determined engineering depth of approximately 0.20m (**Fig. 3**). The pipeline easement extended approximately 450m from the Bristol Water Site Compound in a SSE direction turning SW at roughly ST 57303 75063 and continuing for a further 200m to its termination at the Water Tower on Stoke Road. An access way was also excavated from the eastern side of the Compound onto the easement. This revealed no archaeological deposits (**Plate 16**).

Area 1 (NGR ST 57230 75395) consisted of a metalled surface (067) running NNW/SSE across the easement at its northern end, immediately S of the Site Compound,

Area 2 (NGR ST 57230 74955) comprised a roughly metalled surface (082) oriented WNW-ESE, as revealed initially in Inspection Pit 3, which lay in the immediate vicinity of the known course of the Roman road, to the E of the concrete Water Tower constructed in 1954.

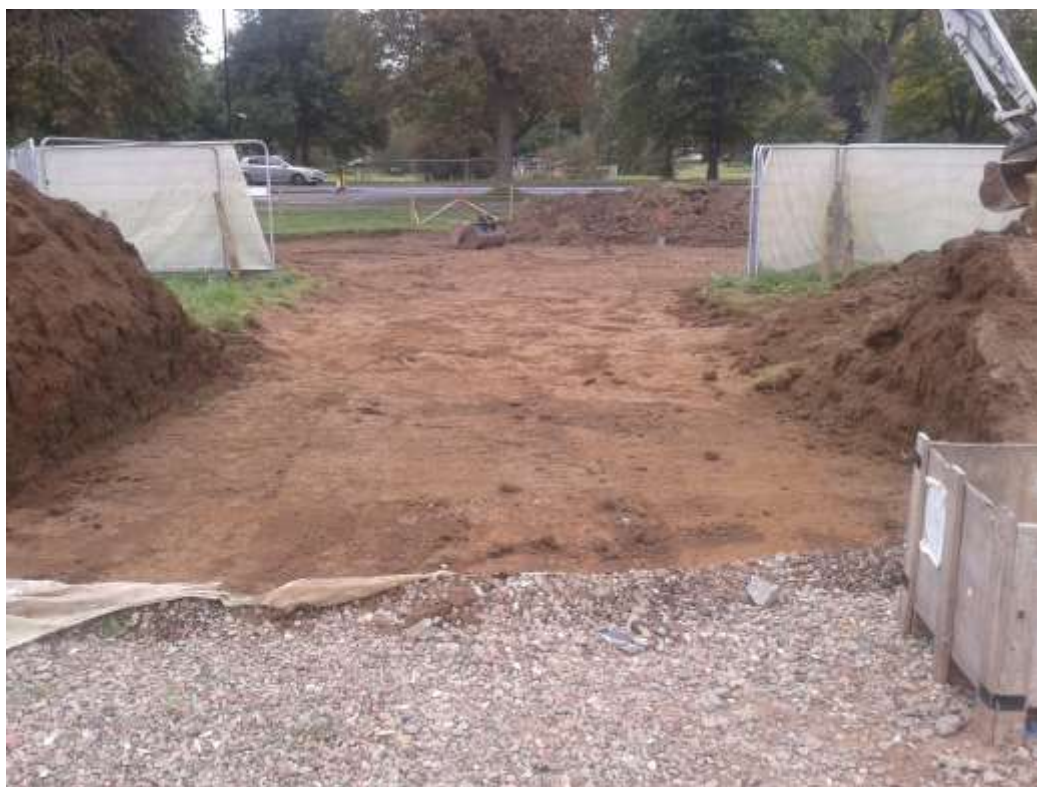
*Plate 16: View E showing access way from the Compound onto the easement*

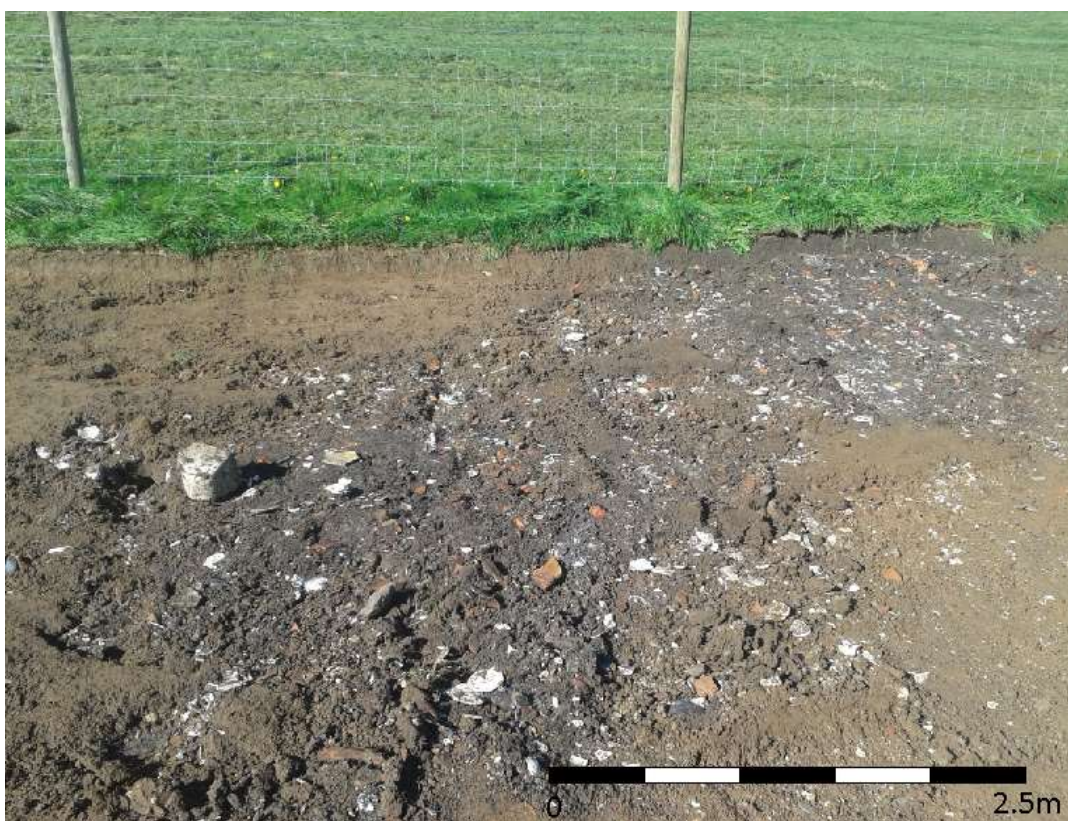
The first of these was a loose spread of dark brownish-black clayey silt (005) (**Plate 19**) measuring approximately 5m x 3.5m containing frequent angular stones together with a mixed deposit of glass, oyster shell and late post-medieval glazed ceramics and china, the material being very similar to the spreads of domestic refuse revealed during topsoil removal in the Compound area.

*Plate 19: View W showing spread of domestic refuse (005)*

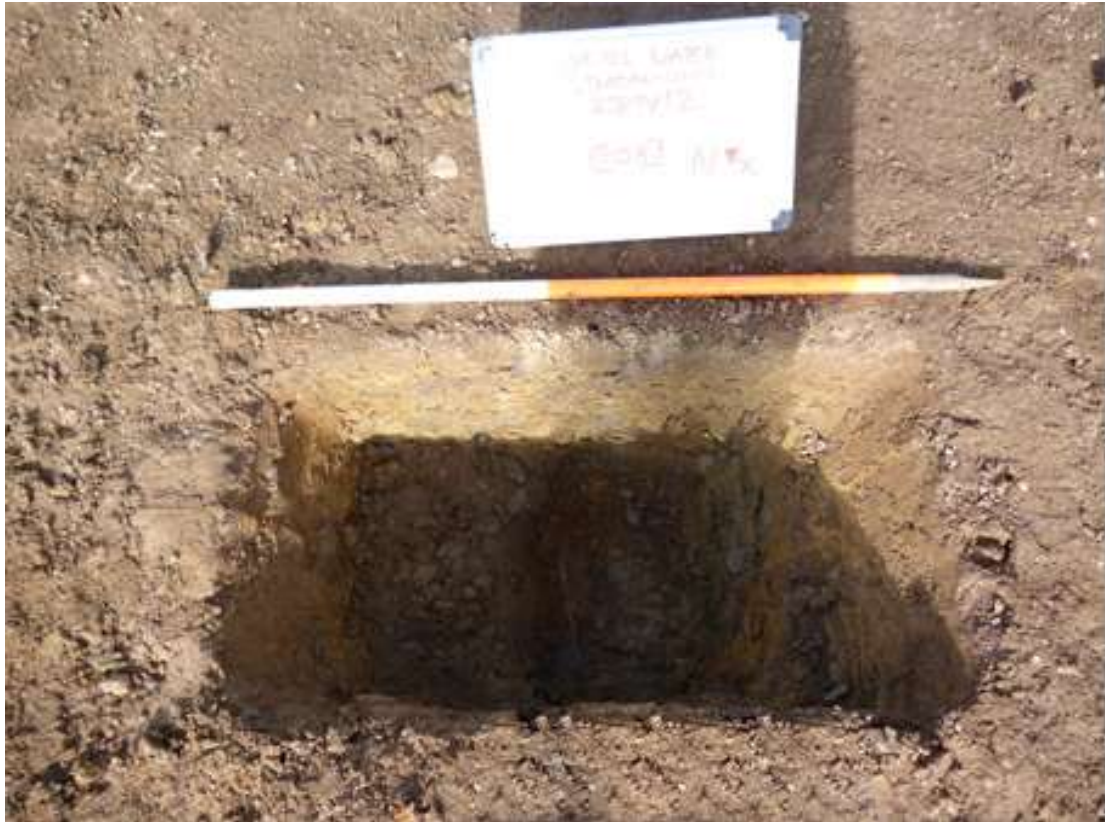
*Plate 20: Service trench [008]*

Service trench [008] (**Plate 20**) was orientated NE/SW across the NE end of Durdham Down and parallel to drainage trench [011]. The lower fill (007) was of re-deposited natural while the upper fill (006) was a dipping of the topsoil into the hollow in the top of [008]. Drainage trench [011] (**Plate 21**) was orientated NE/SW across the NE end of Durdham Down and parallel to service trench [008]. It measured some 0.5m wide. The lower fill (064) was re-deposited natural while the upper fill (010) was again a dipping of the topsoil into the hollow in the top of [011].

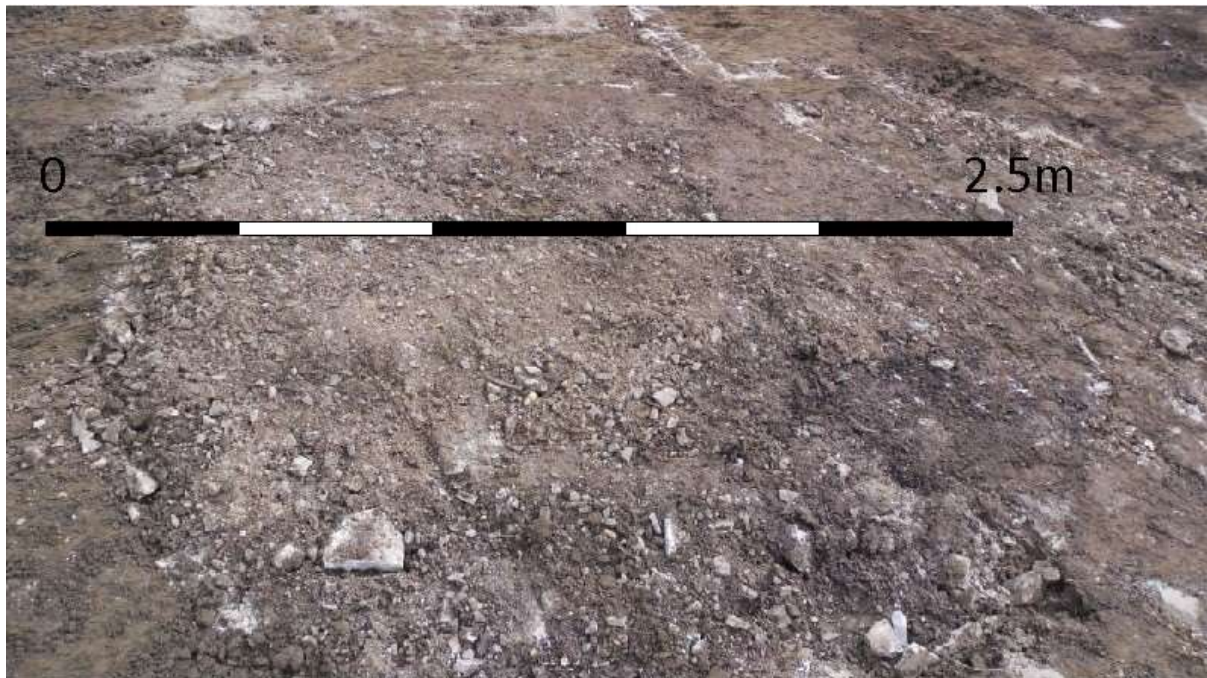
A feature interpreted as a modern flower bed or garden display fixture (012, [013]), was identified towards the centre of Durdham Down, near to an alignment of brick (**Plates 22 & 23**). This consisted of a circular, stone-lined vertical cut [013] of 2.5m diameter apparently associated with the remains a semi-circular brick construction immediately to the S and an alignment of modern brick to the E. Cut [013] was filled by loose, very humic dark brownish-black clayey silt leavened with bark mulch and containing occasional stones (012). A plastic label identifying a shrub and bearing a price was found within (012) and suggests a very recent date, probably within the last decade. Another such feature consisted of a circular cut of roughly 1.0m in diameter and 0.28m depth with a moderate break of slope at the top and concave sides breaking to a flat base [066]. Pit [066] was located towards the central section of the easement and was close enough to the presumed garden feature [013] to suggest that the modern fill (065), consisting of a moderately compact mid yellow silty clay with brown/red mottling and containing occasional polystyrene fragments and frequent charcoal (**Plate 24**), related to a similar event(s).

Plate 23: View E showing circular feature [013]

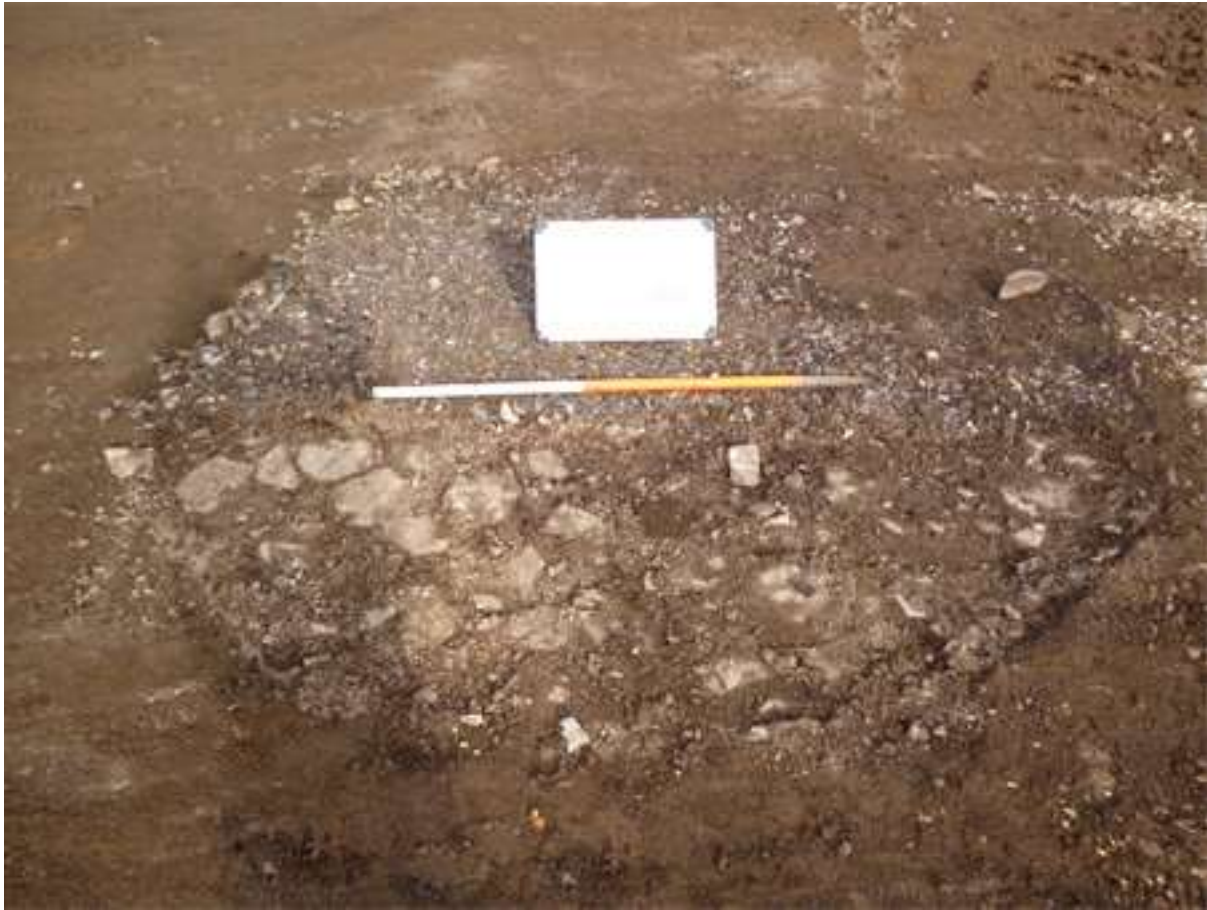
*Plate 24: View E of feature [013] partially excavated to reveal stone base*

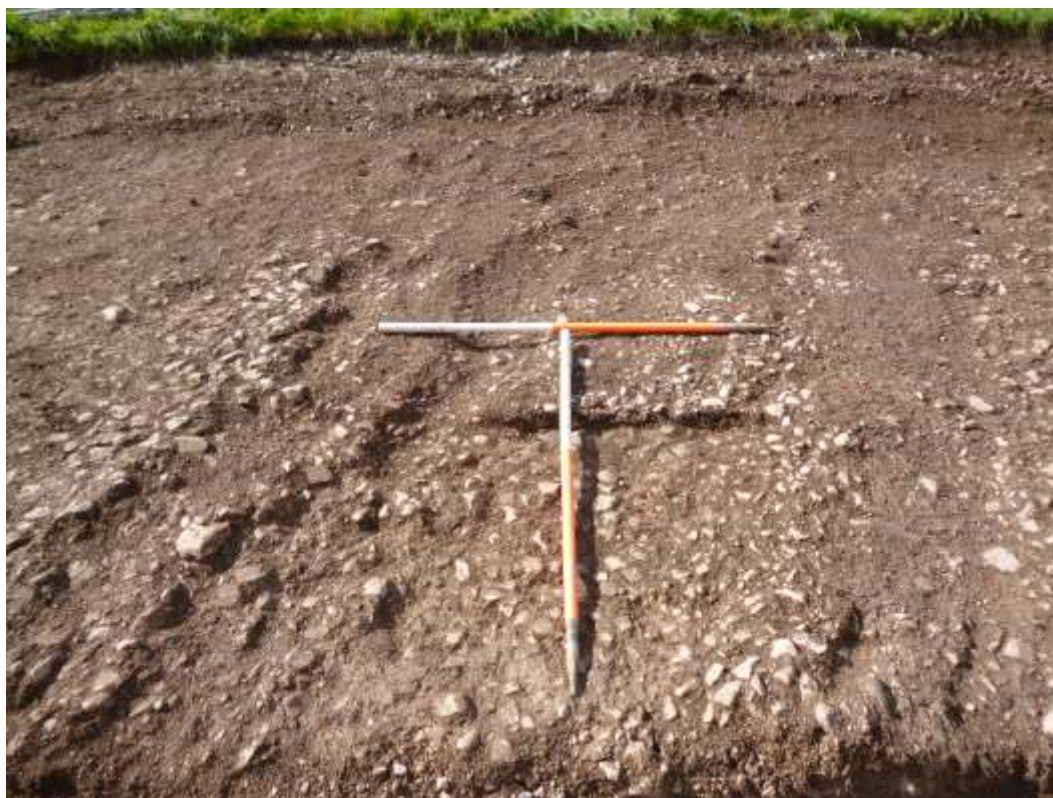
*Plate 25: View NW of metalled surface (067) showing linear features [070] & [075]*

An earlier feature comprising a metalled surface (067) located at the NE end of the easement was subject to further archaeological investigation and is interpreted as a track of probable mid-19<sup>th</sup> century date linking a former quarry site on Durdham Down with Westbury Road to the E. This interpretation is based both on the archaeological evidence and historic mapping, in particular the Westbury tithe map of 1844 and Ashmead's plans of 1855 and 1874. Surface (067) appears likely to have been re-laid multiple times and was clearly extended to the SW in the Victorian period and resurfaced with (081), a 6m x 3m area of compact dark grey silty sand containing very frequent small angular (though worn) stones, towards the end of its life (**Plate 25**).

Two contemporary linear features [070], [075] were clearly visible in the surface of (067) (**Plates 25 & 26**). The first of these [070] ran NW/SE and was 0.80m wide with a depth of 0.50m. The break of slope at the top of the feature was sharp and the sides near vertical at around 70° breaking gradually to a concave base. Four fills were identified, the basal fill (071) being roughly 0.20m thick and consisting of moderately compact dark yellowish-brown sandy silt with occasional small stones. Overlying this was (072), a 0.20m-thick consolidated mid yellowish-white gritty coarse sand with patches of dark grey and blue and moderate stone inclusions. Above this was (073), a moderately compact dark reddish-brown silty sand with moderate stone inclusions and again a thickness of around 0.20m. The upper fill (074) consisted of consolidated light brownish-grey silty sand with occasional stones.

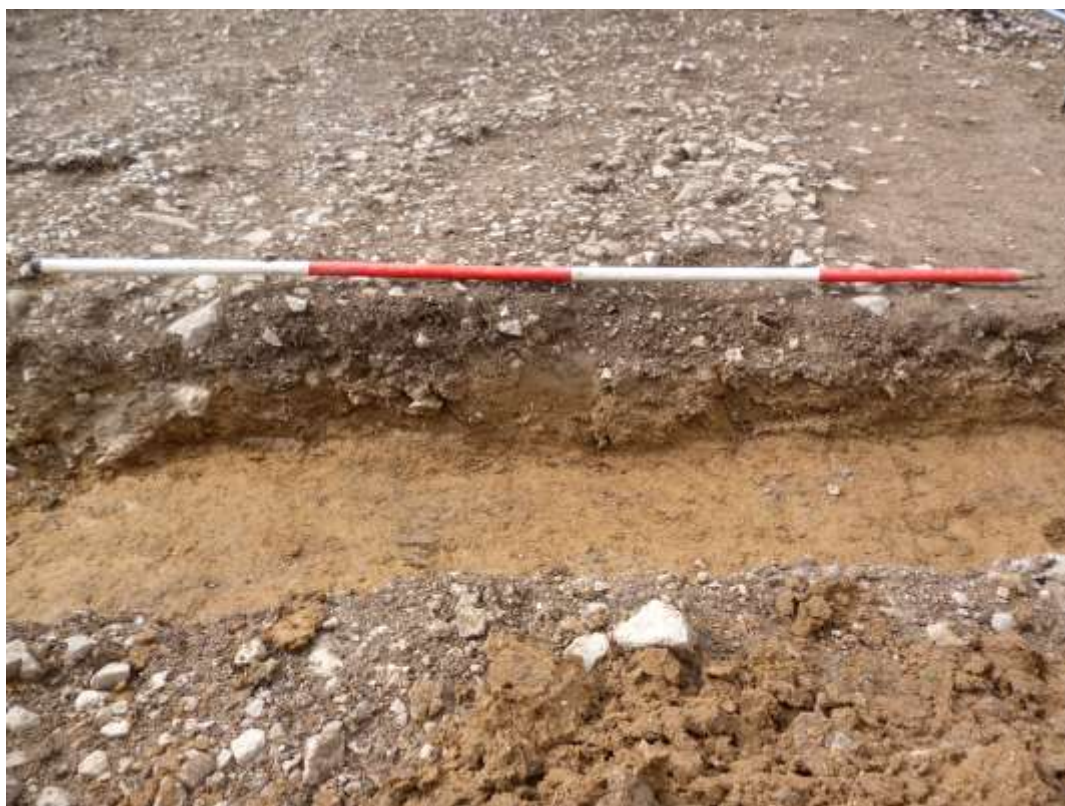
*Plate 26: View NW of slot through metalled surface (067)*
