# ARCHAEOLOGICAL PROGRAMME OF WORK

**ON SELECTED AREAS WITHIN THE BRISTOL WATER RESILIENCE SCHEME**  
(Harry Stoke to Clifton)  
**BRISTOL**

NGR ST 62001 78618 to NGR ST 57624 73711  
JOB N<sup>o</sup>: BA1130BWDD

APRIL 2013

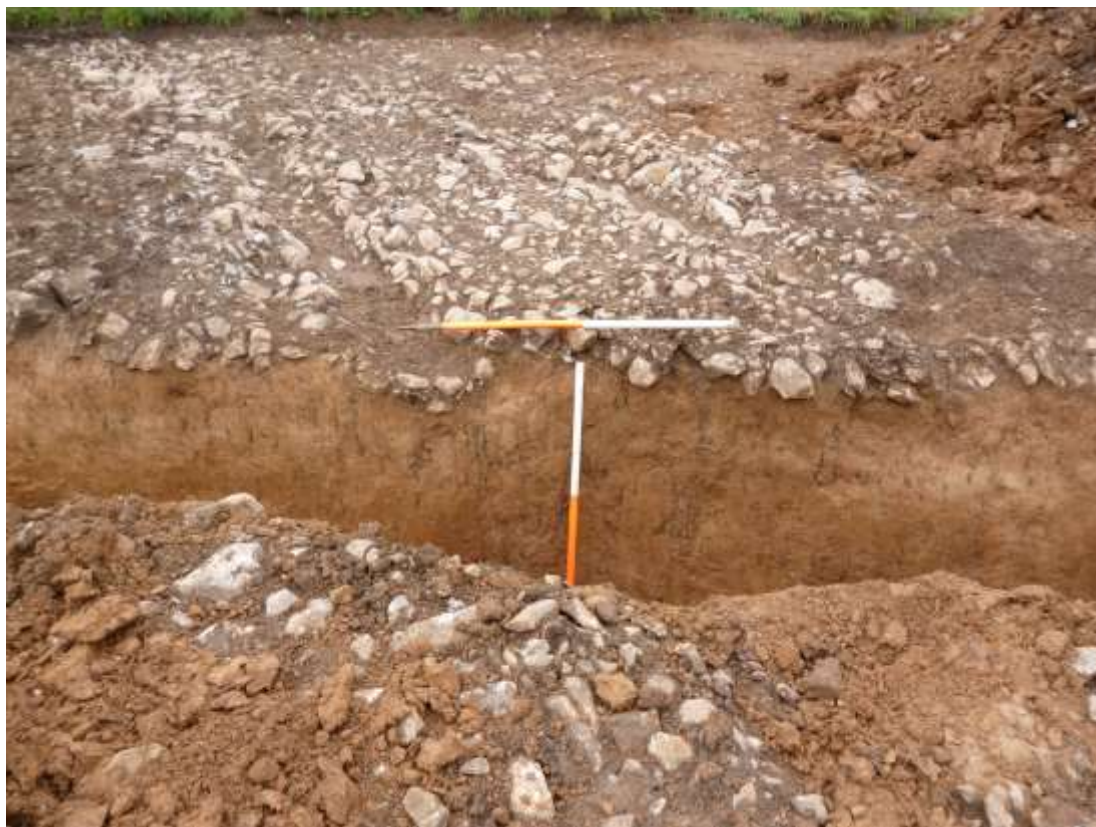
*Plate 28: View WNW showing section through surface (082)*

Subsequent investigation however initially cast some degree of doubt on the antiquity of the remains. The surface (082) was aligned approximately WNW/ESE and comprised moderately compact to loose grey limestone fragments ranging in size and form from large rounded stones of some 40cm diameter to small angular components around 2cm in size. The majority of the surfacing material however comprised sub-angular stones of approximately 8cm in size. The deposit was 20cm thick and 6-7m wide, being slightly wider at the NW end, and the exposed section extended for approximately 12m across the easement.

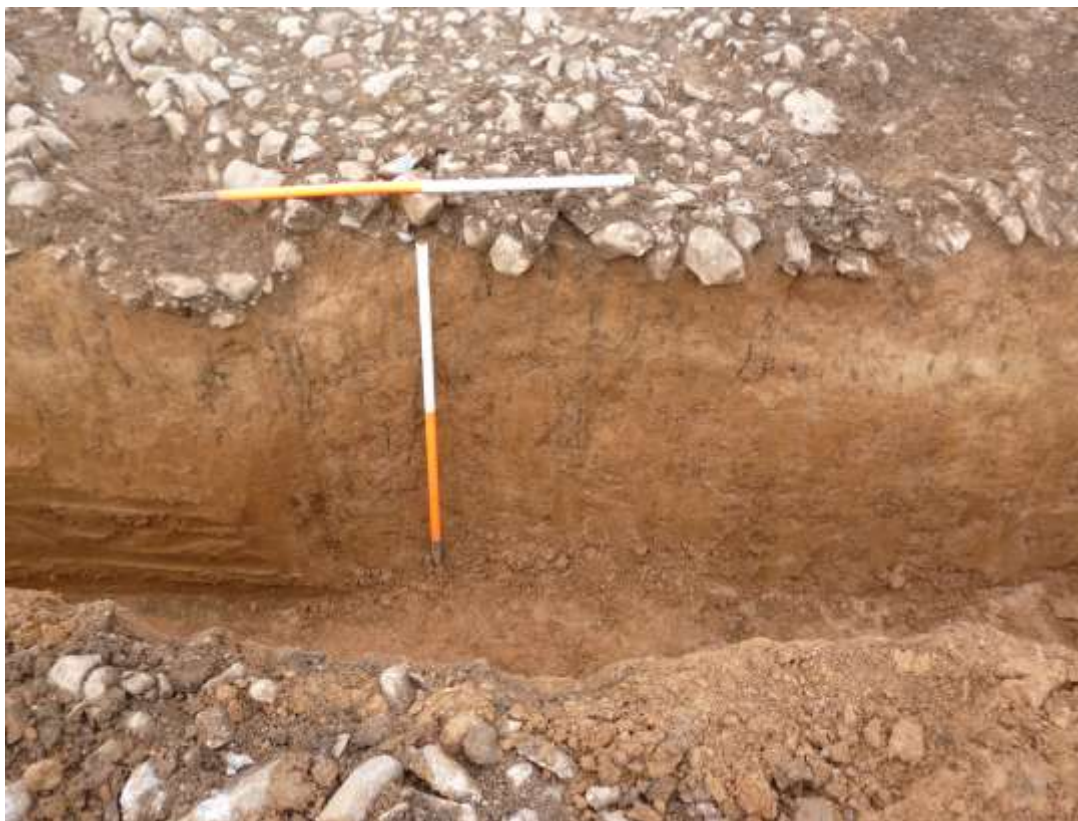
*Plate 29: View NW of section through (082) showing detail of construction*

Beneath (083) was a further deposit of construction material (084) consisting of moderately compact to loose stone-free light yellow clayey sand possibly exhibiting slight charcoal flecking although the flecks may well have been manganese rather than charcoal. The high sand content of (084) suggested this material had been deliberately laid for construction purposes and was not merely the result of water action reworking natural. The natural itself (085) consisted of compact orangey-red sandy clay containing no inclusions. Thus it would appear that (084) was laid above (085) and that re-deposited natural (083) was then placed over (084) and a single layer of stones (082) bedded-in to form a surface

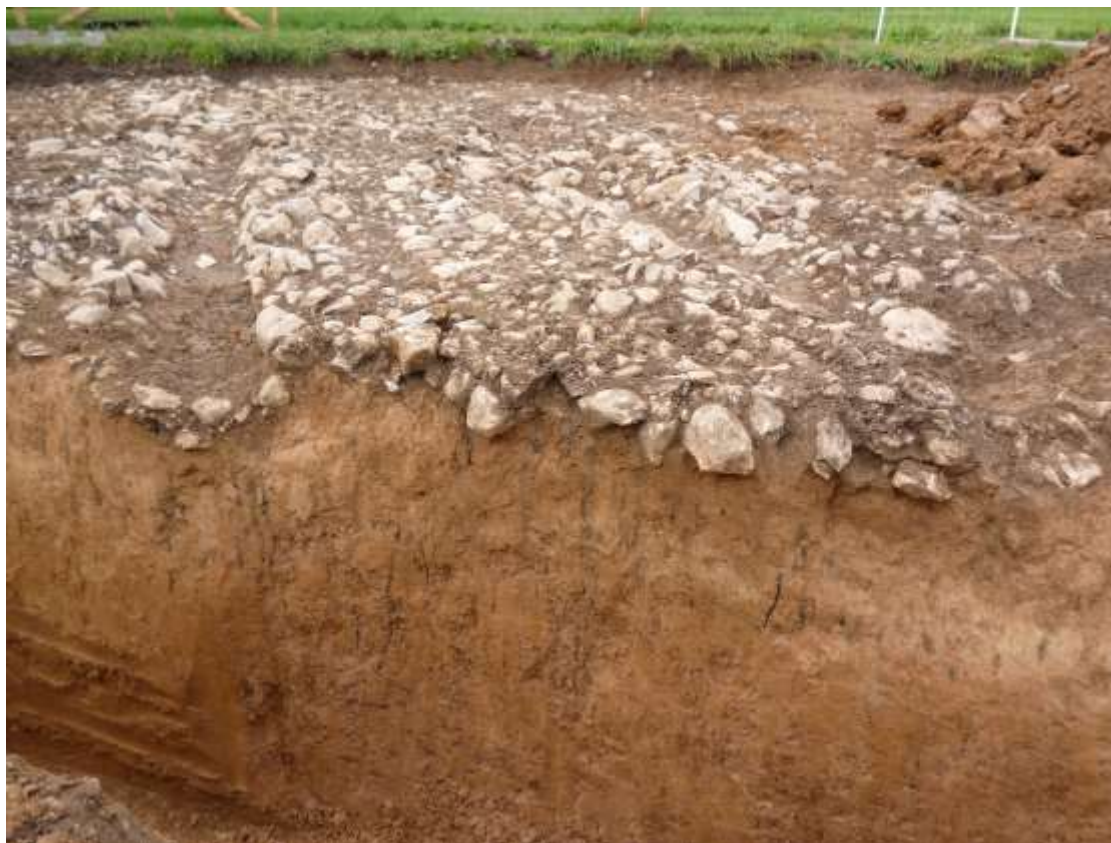
*Plate 30: View WNW showing composition of deposits underlying surface (082)*

The form and composition of the road and the absence of any trace of roadside ditches cast some doubt on (082) being of Roman date. Furthermore, the exclusively modern finds assemblage recovered from the surface material, which indicate the possibility of a mid-20<sup>th</sup> century construction date, are of concern and may be regarded as somewhat problematic. A possible hypothesis is that the metalled surface was laid down to accommodate site traffic during construction of the Water Tower in 1954, and the absence of repairs or infilling of the wheel ruts suggests a limited life consistent with it being a temporary metalled road or track.

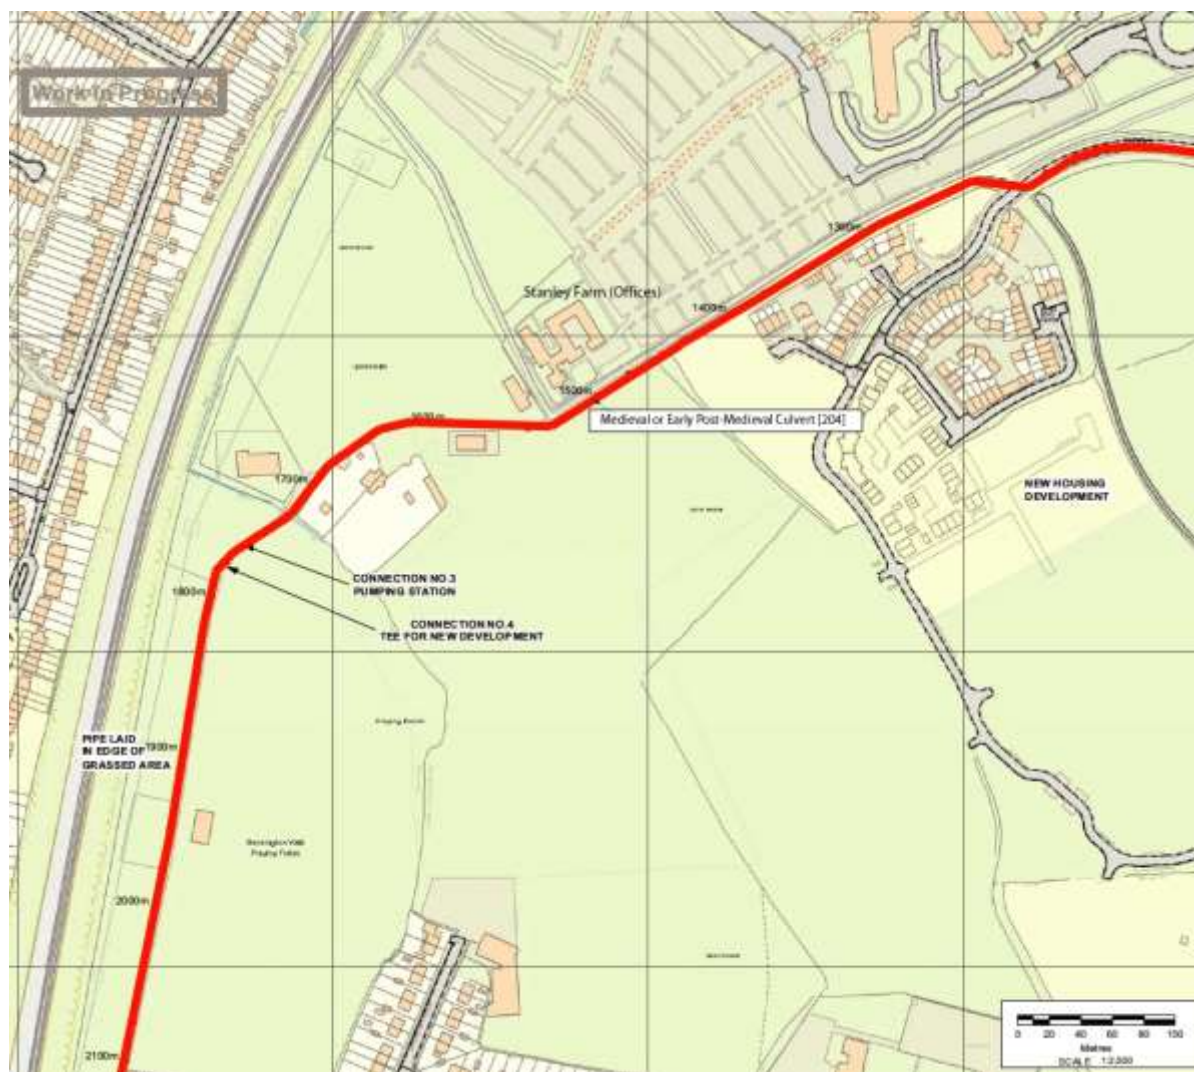
Fig. 10: Scheme location plan showing area of groundworks monitored at Stanley Farm/Bonnington Walk

Archaeological Observation was carried out in the Stanley Farm area from March 6<sup>th</sup> to March 8<sup>th</sup> 2012 (**Fig. 10**). Recorded in trenching adjacent to the Council Offices (NGR ST 60947 77960) were the remains of a well-constructed masonry water culvert [204] of dry-stone construction, aligned NNE-SSW across the NE-SW trench, with a decline to the NNE of  $\pm 5^\circ$  (**Plates 31 & 32, Fig. 11**).

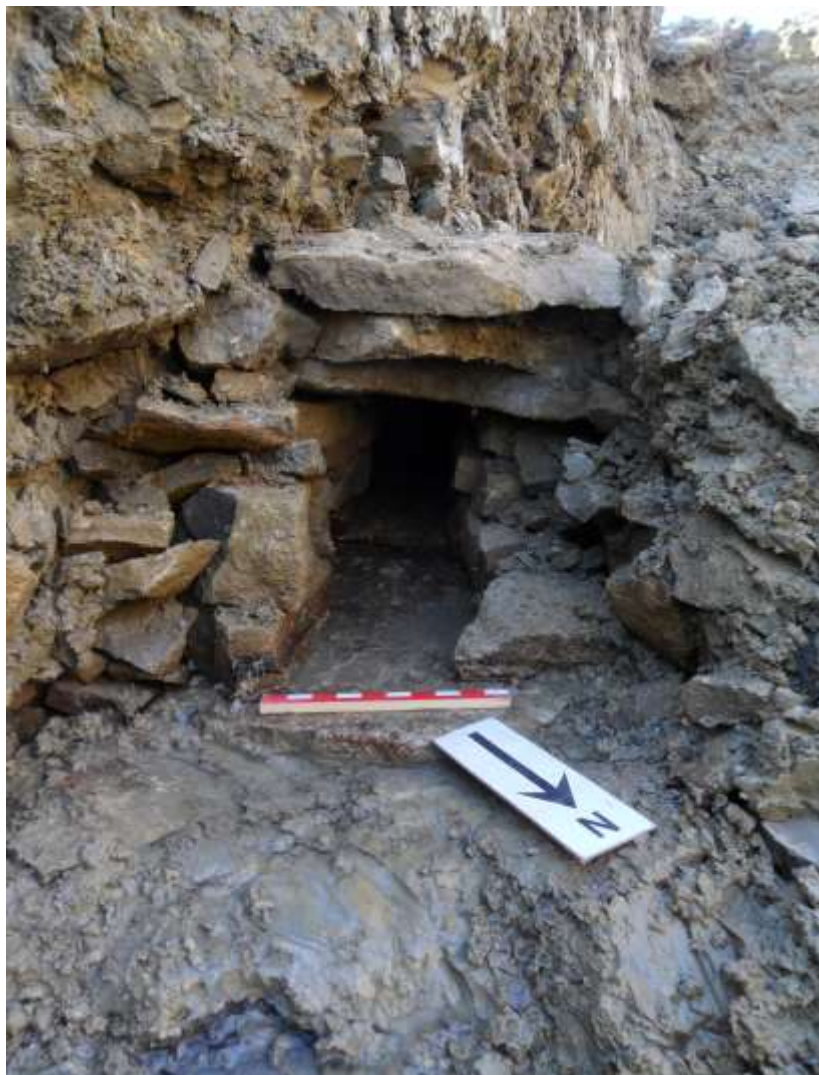
*Plate 31: View SW of masonry culvert [204] (20cm scale)*

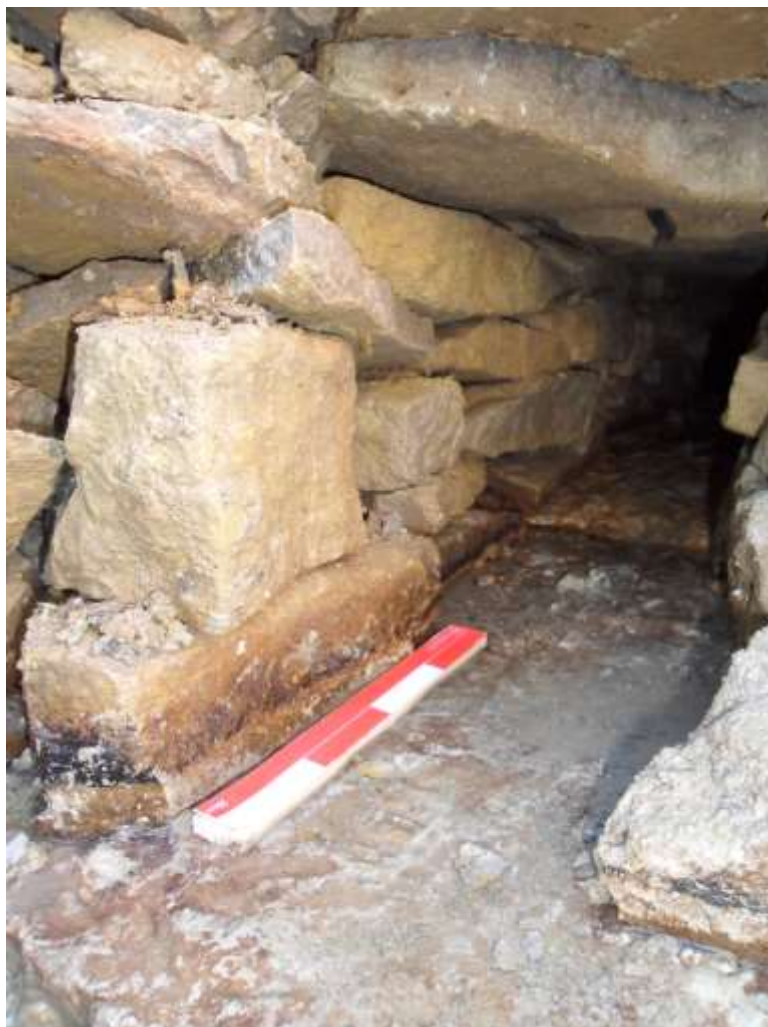
*Plate 32: View S showing internal E wall construction of masonry culvert (20cm scale)*

The interior of the culvert (**Plate 32**) was 0.24m high and 0.16m wide and showed evidence of a calcite build-up of +/- 5mm on the bedrock base (208), indicating that the feature had been active, with a low but steady flow rate probably extending over a period of several hundred years. No sediment was noted in the base or cracks between the stones, pointing towards [204] being a spring-fed feature. This suggests domestic rather than industrial usage.

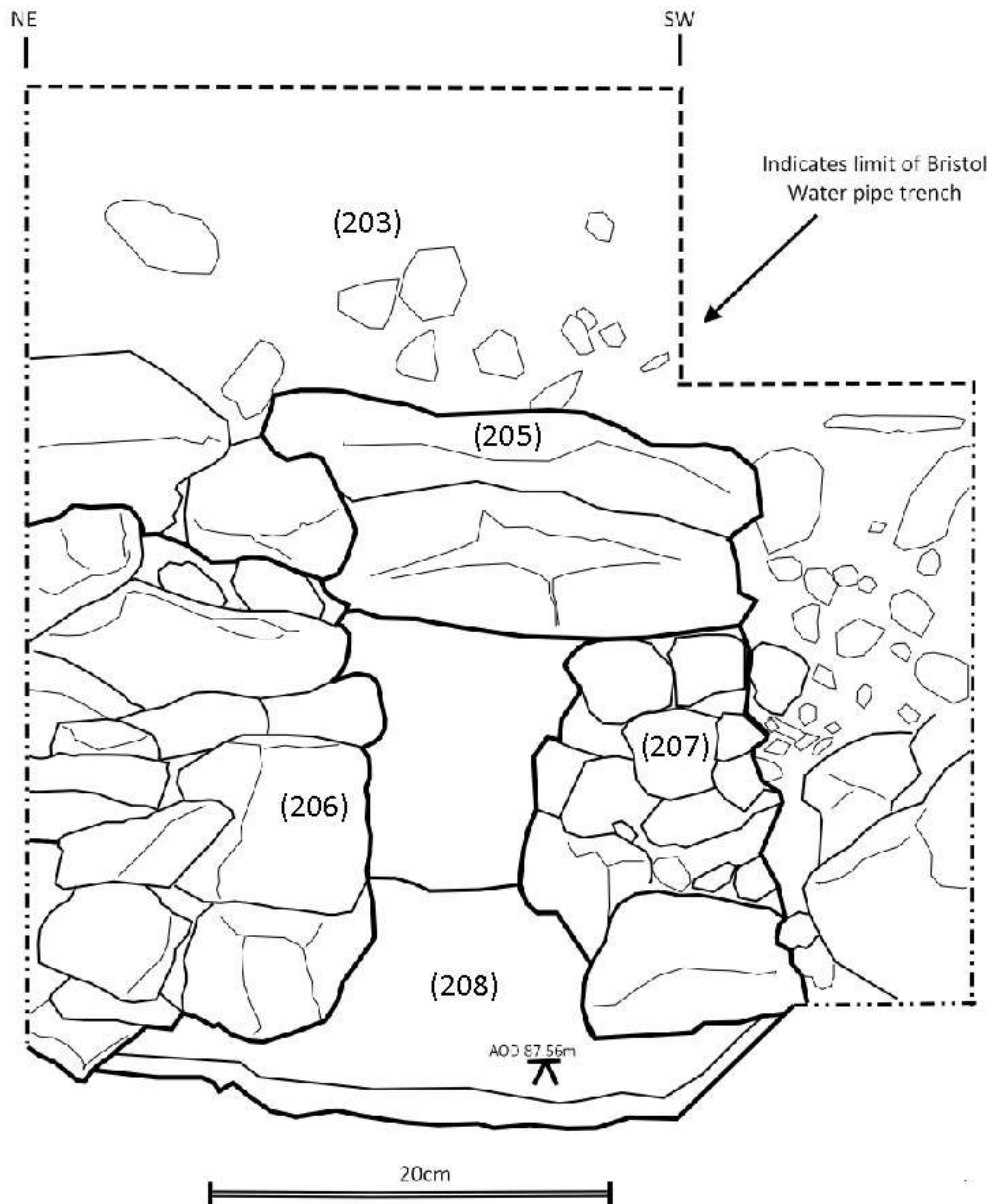
Fig. 11: Elevation of masonry culvert showing detail of construction

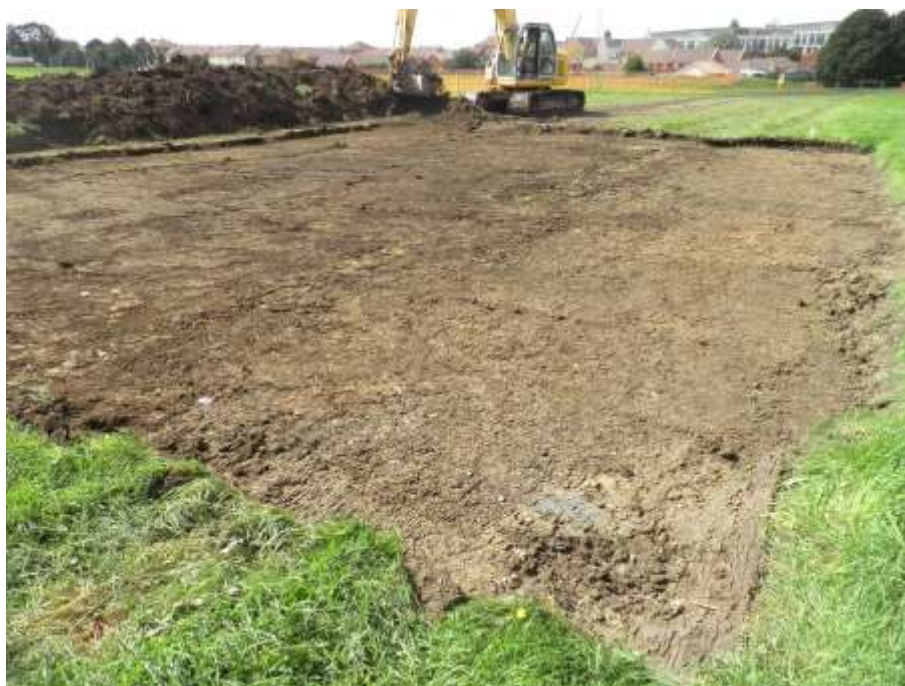
A wide strip of topsoil (up to 13m) was removed along the northern part of the route under archaeological supervision. Along the western/southern part of the route, the area stripped area was considerably narrower, up to a maximum of 6m wide (**Plate 33**). The cut of the pipe trench itself was generally >1.5m, with vertical sides, although, at the far NE end, the trench was cut wider with sloping sides to facilitate access to connections with the existing main.

*Plate 33: View SW showing initial topsoil strip in the NE corner of the playing fields. Clean turf and thin topsoil (101) removed to reveal layer (102) (old loam/subsoil & 19<sup>th</sup> century debris)*

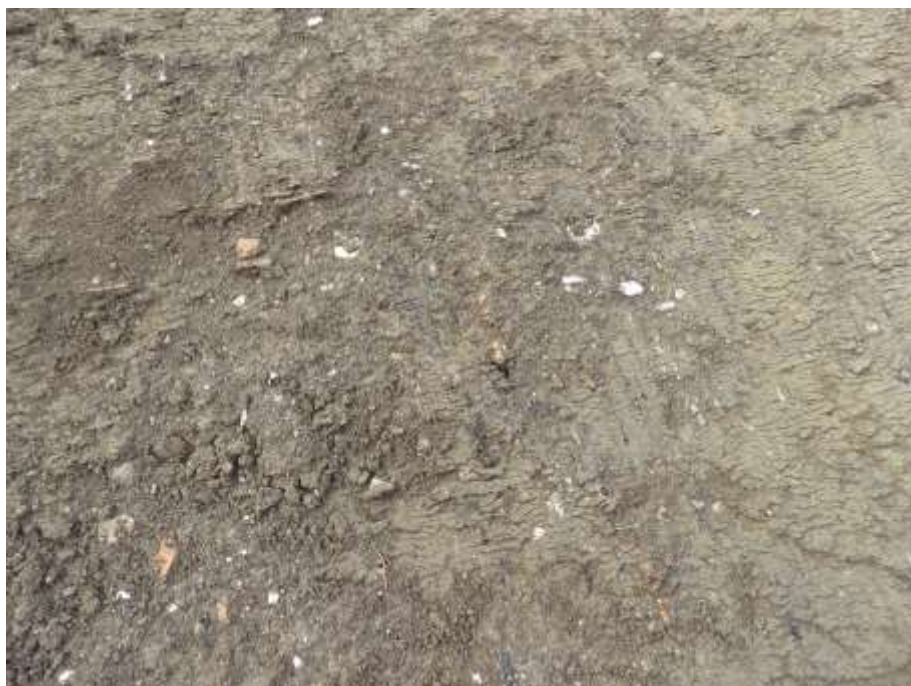
Layer (102) appeared to be the remains of the earlier topsoil after modification during 20<sup>th</sup>-century landscaping activity and had evidently not been introduced to create made ground (**Plate 34**). The debris within it was spread evenly and was very much of a character that would be expected as a result of manuring or the disposal of waste in agricultural fields (or comparable activities). Land drains were also present, consisting both of shallow 19<sup>th</sup> century terracotta pipe and c. post-1940s clay-filled deep drains dug by mechanical 'chain-trenchers'. This indicates that the immediate area had been in agricultural use or was otherwise a 'green-field' site during this period (*Plate 34*).

*Plate 34: View N showing detail of (102)*

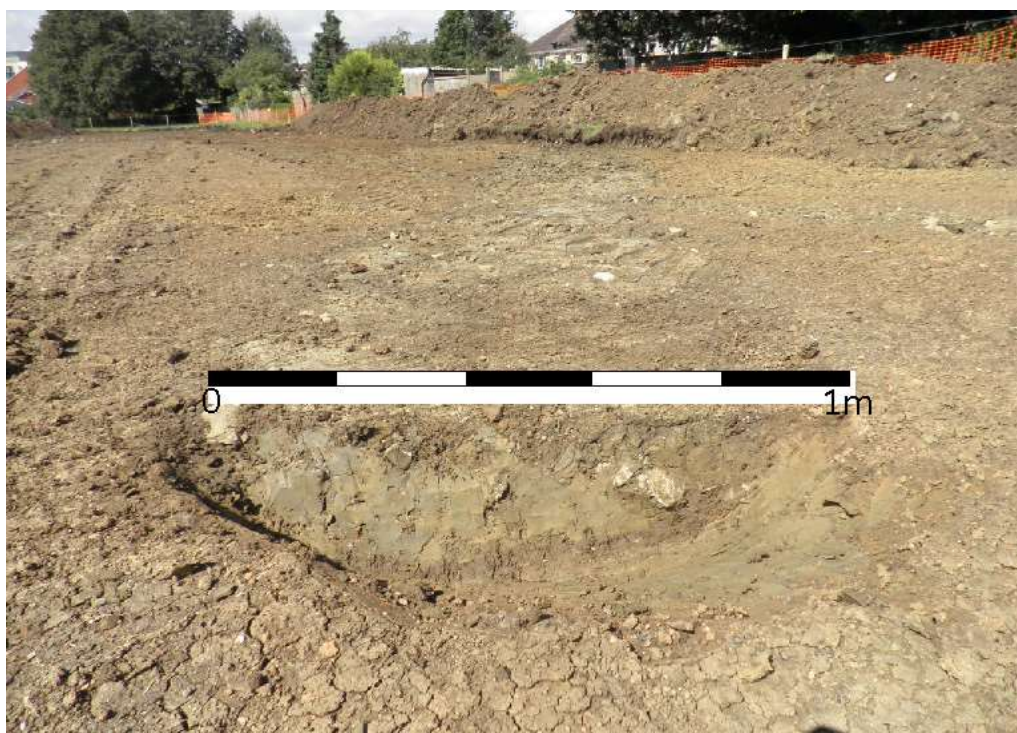
Feature [135], however, was possibly more noteworthy, comprising a NW-SE aligned boundary ditch, extending N beyond the stripped area and terminating near the centre of the pipe trench itself (**Plate 35**). The ditch was c. 1m wide and the terminus was test-excavated, showing a depth of only 0.15m. No finds were recovered but coal fragments were present, generally suggesting a post-medieval date. Additionally, a single fragment of possible pre-19<sup>th</sup> century brick (probably of 17<sup>th</sup> /18<sup>th</sup> century date) was recovered from the surface fills. Only its terminus was impacted by the actual pipe, with the majority of this linear feature being unaffected by the engineering ground works.

The reason for the termination of [135] at this point remained unclear. Although not marked on any historic maps of the area, the earliest consulted plan being the OS surveyors' drawing of 1826, the feature is clearly shown on an RAF vertical photograph of 1946 and appears to relate to a zig-zag pattern of linear features extending to the W, possibly representing military practice trenching associated with the Gloucestershire Regiment barracks immediately to the SE or, as would appear more likely, the result of ground disturbance and landscaping associated with the construction of housing along Grittleton Road in late 1930s.

*Plate 35: View NW of excavated terminus of late post-medieval boundary ditch [135]*

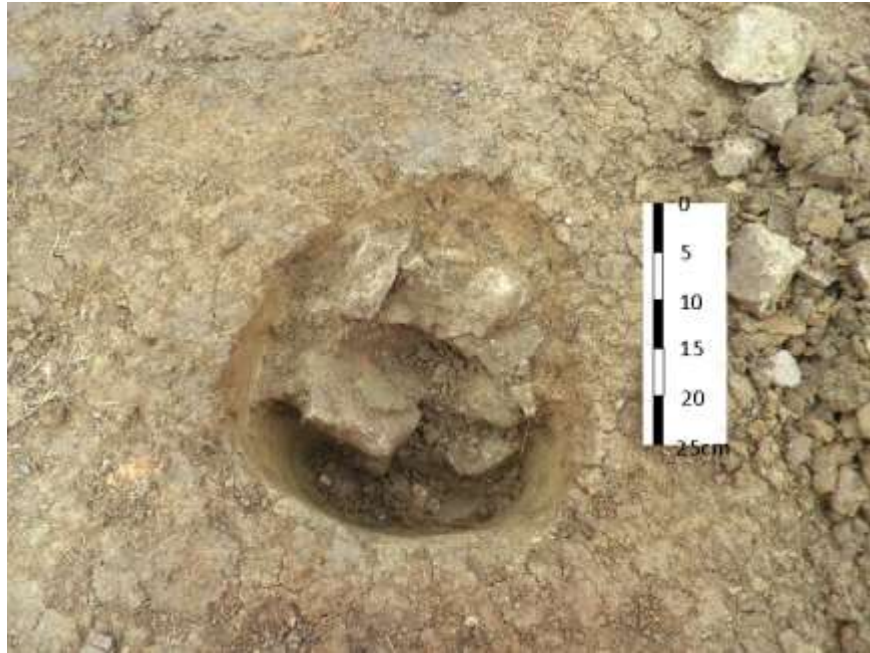
A range of other features, all associated with 19<sup>th</sup> century ceramics, were present and well-defined once layer (102) had been removed along the N edge of the playing fields; none, however, was of archaeological significance (*Figs. 11*). They included [104], a single posthole feature with a stone-packed fill, which was partially excavated to recover dating evidence, including a fragment of 19<sup>th</sup>-century brick and a lump of concrete (**Plate 36**). Also revealed were two postholes [106], [108] with post-pads formed from 19<sup>th</sup>-century brick, located approximately 6.80m apart. These appeared to have supported fence posts or similar simple structure, or possibly even to have been sports-related, perhaps containing goalposts.

*Plate 36: Single posthole feature with a stone-packed fill [104]*

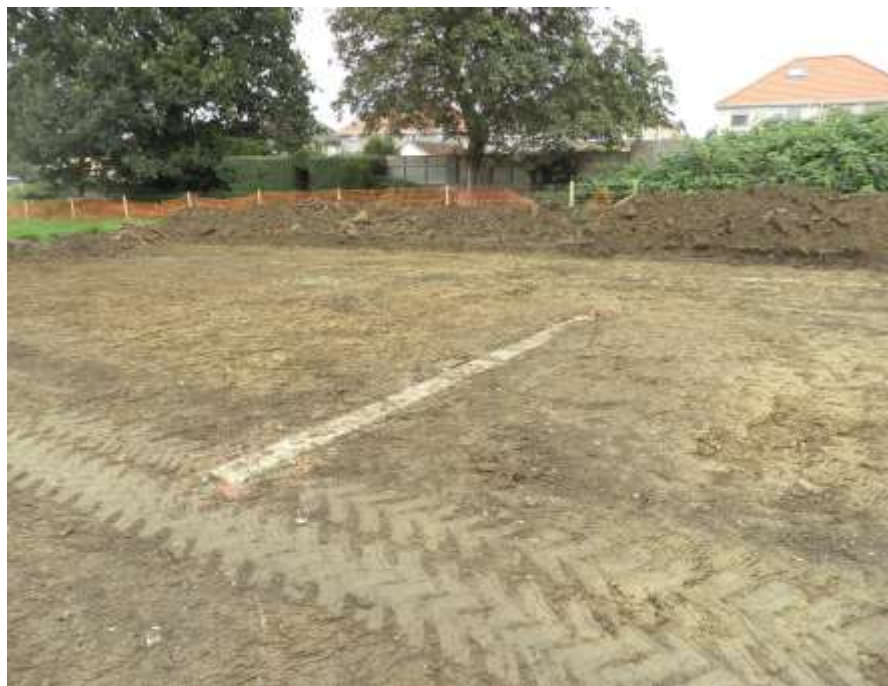
A 5m foundation for an isolated free-standing brick wall of 20<sup>th</sup>-century brick [114] was also identified, comprising a feature exhibiting the typical garden-wall construction characteristic of parks or other similar non-building function (**Plate 37**). A scorched area [122] associated with 19<sup>th</sup>-century ceramic material was interpreted as a shallow fire-pit for the disposal of non-woody 'green-waste', as it contained virtually no identifiable charcoal. A very small pit [129] postdating a mechanically excavated 20<sup>th</sup>-century land drain was revealed, which contained a part cemented/vitrified, very ashy fill (130). The origin of this material was unclear but it was clearly 20<sup>th</sup>-century in date.

*Plate 37: View NW showing brick wall footings of probable early 20<sup>th</sup> century date [114]*

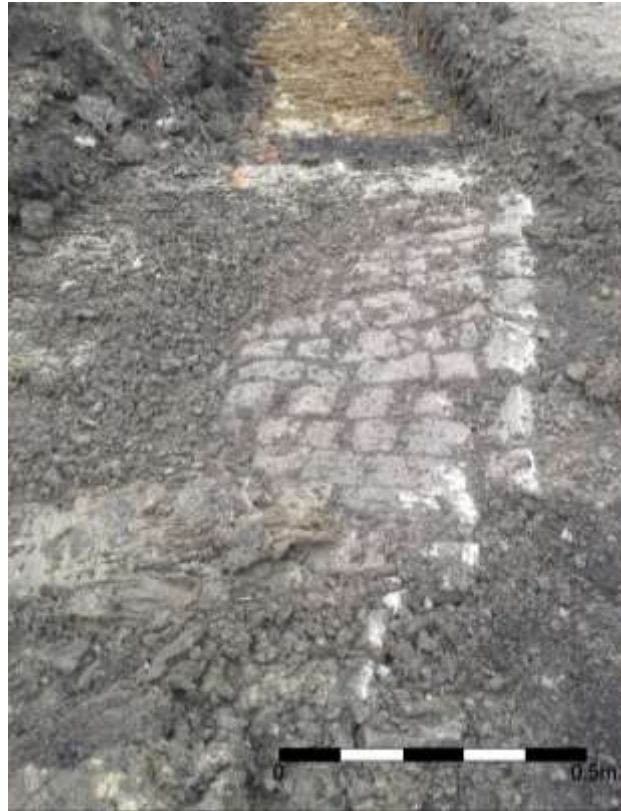
A section of cobbled surfacing (140) measuring some 1.60m x 0.5m (maximum), as revealed, was recorded towards the SW extent of the easement (**Plate 38**). Some 32m to the S of the cobbles, adjacent to the Leisure Centre car park, the cut for a dog inhumation [137] was revealed approximately 0.25m below the ground surface which contained a fully articulated skeleton (138) within backfill material (139) (**Plate 39**).

*Plate 38: Cobbled surface of late post-medieval date (140)*

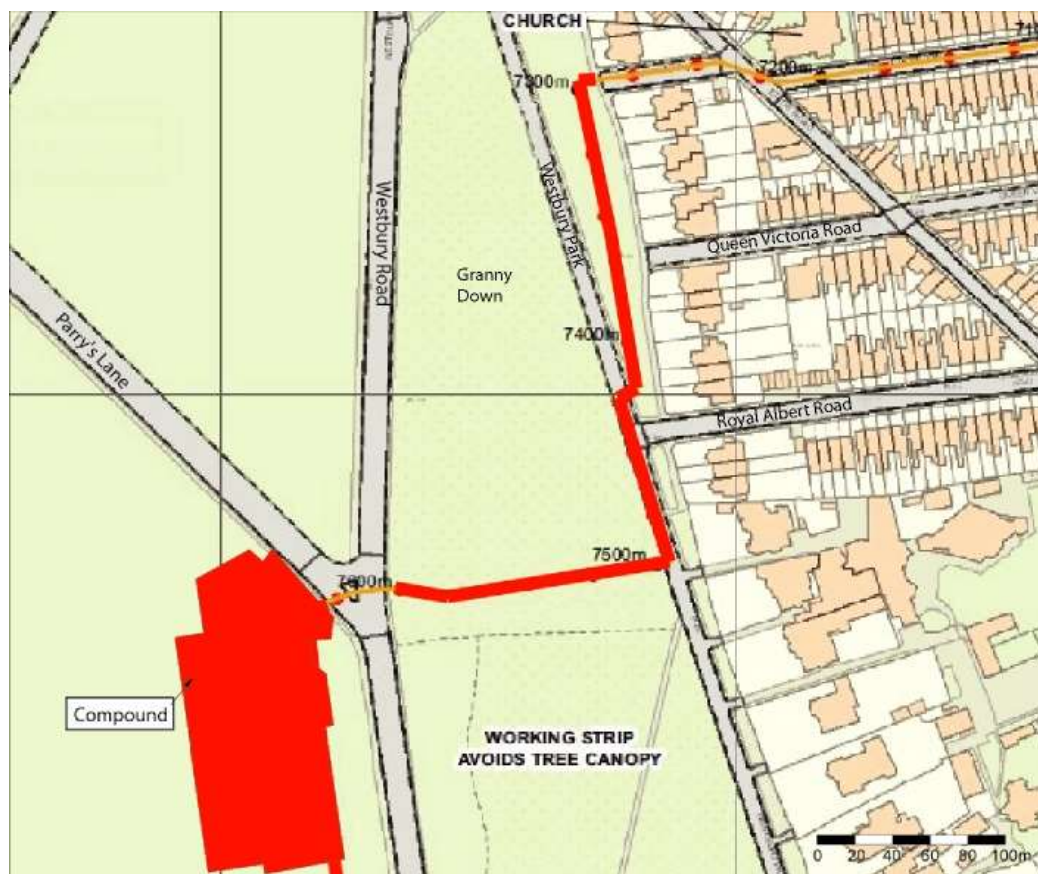
Fig. 16: Plan showing location of pipeline ground works on Granny Down (NGR ST 57344 75718- ST 57270 75548)

Topsoil was removed under archaeological observation within an easement extending NNW/SSE from ST 57344 75718 for approximately 120m, traversing Granny Down to its intersection with Westbury Park at ST 57354 75637, where it turned SW to cross Westbury Road at ST 57270 75548 (Fig. 13).

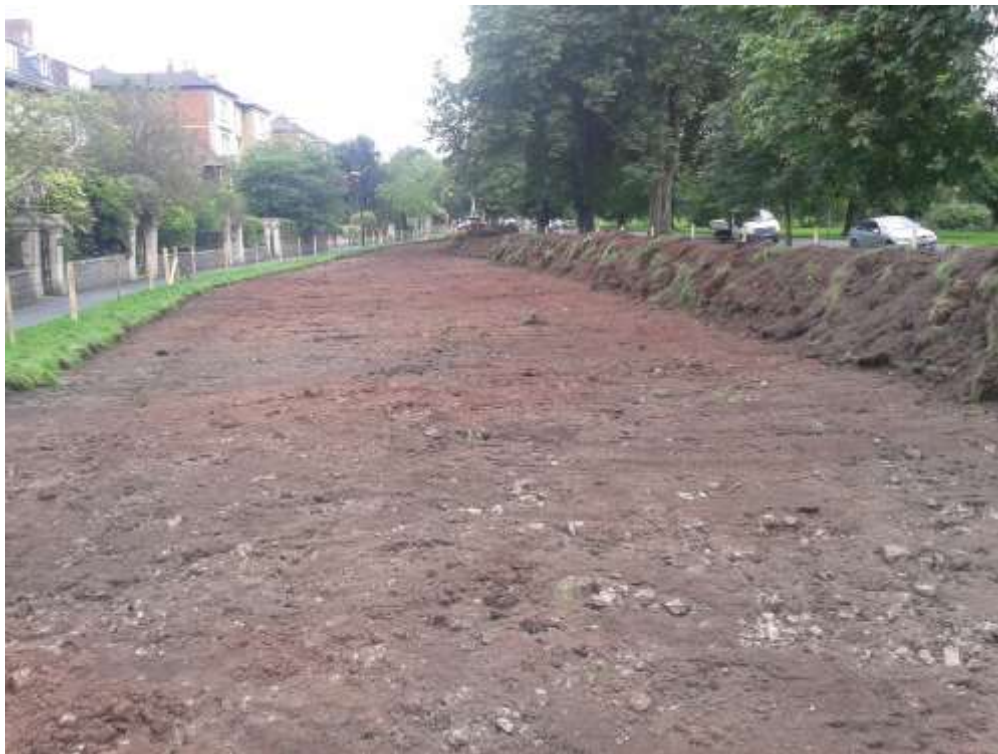
*Plate 40: View SSE along Granny Down showing area of topsoil removal*

The topsoil (0100) consisted of dark brown humic clay containing frequent small stones and roots extending to a maximum depth of 0.15m. This overlay a sterile light greenish-yellow silty clay (0101) (**Plate 40**). A spread of post-medieval domestic refuse (0102) was noted (**Plates 41 & 42**); this consisted of a loose spread of mid greyish-brown silty clayey silt containing frequent angular stones and measuring approximately 5.25m x 3.2m. The material comprised glass, oyster shell and late post-medieval glazed ceramics and china.

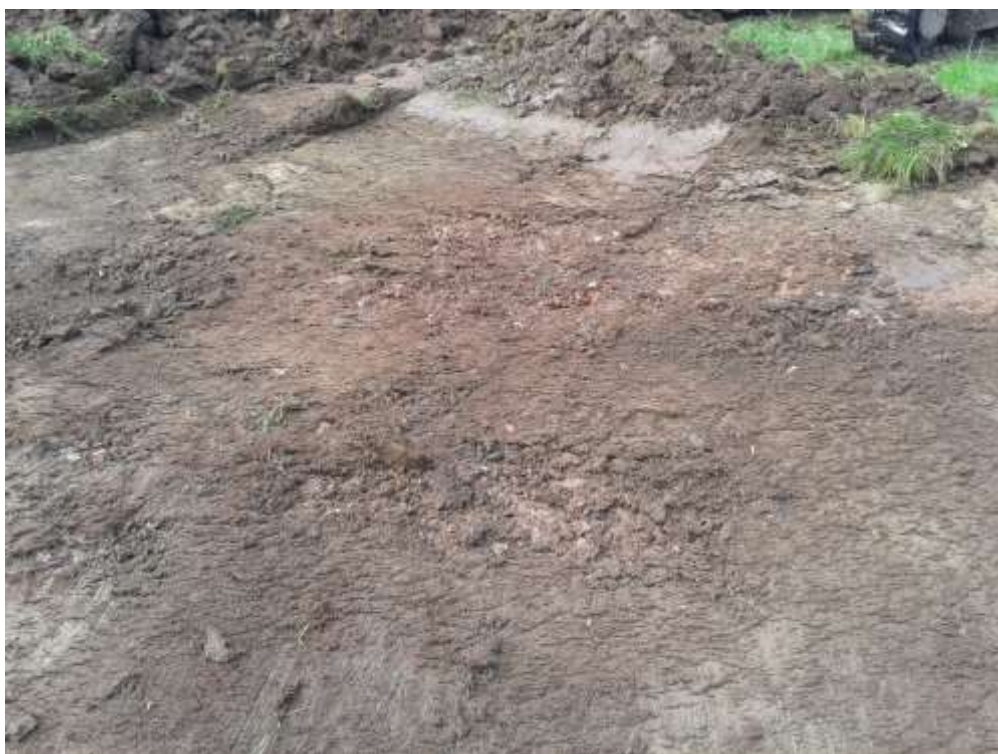
*Plate 41: Spread of post-medieval domestic refuse (0102) below topsoil on Granny Down*

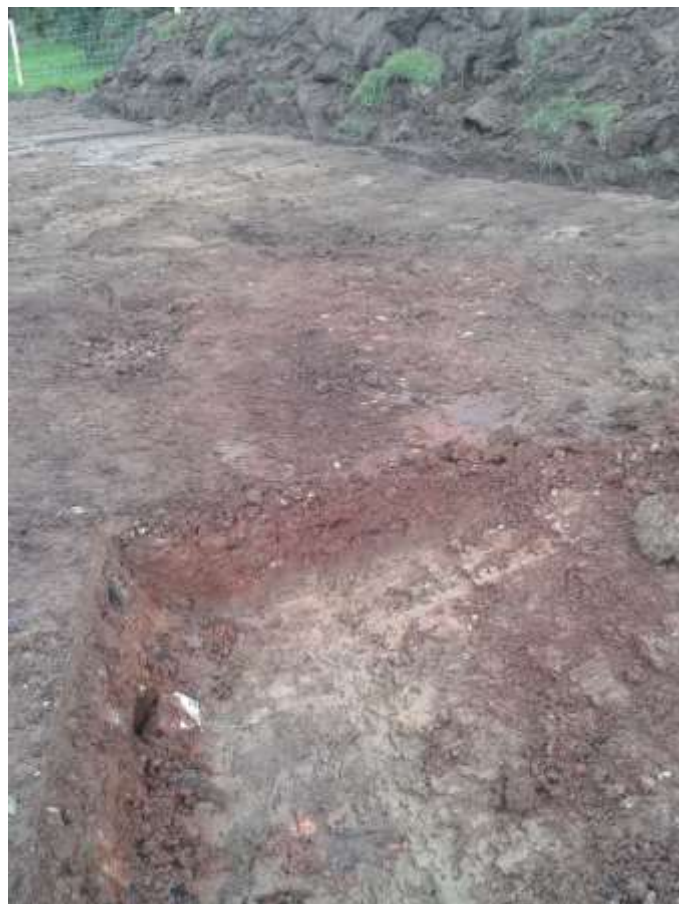
*Plate 42: Spread of domestic refuse (0102)*

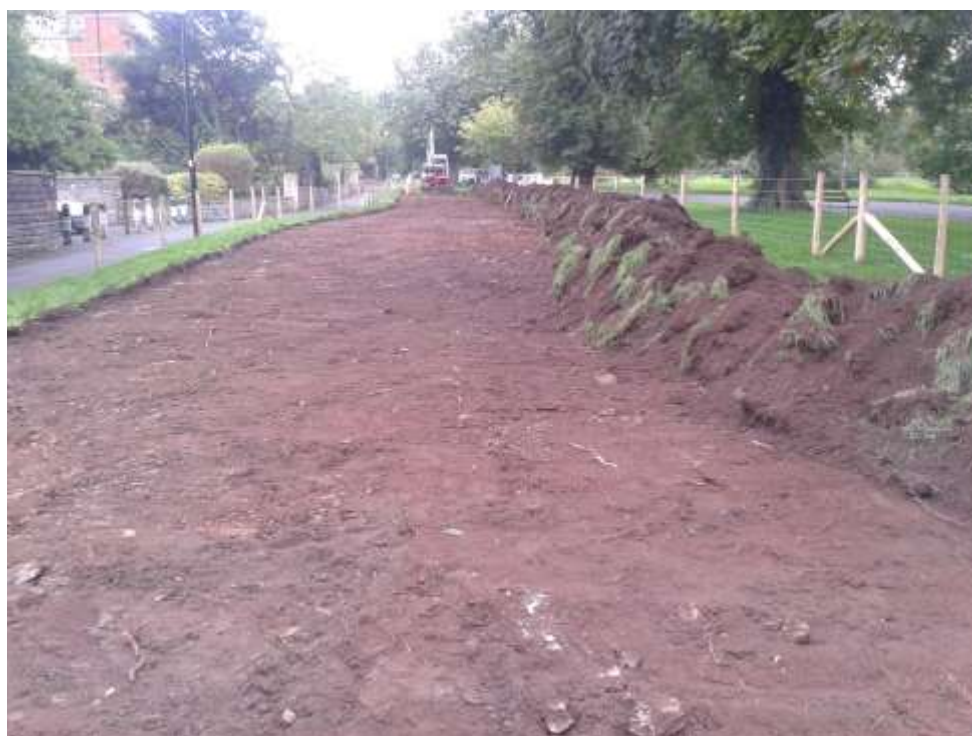
*Plate 43: View S of easement parallel to Westbury Walk*

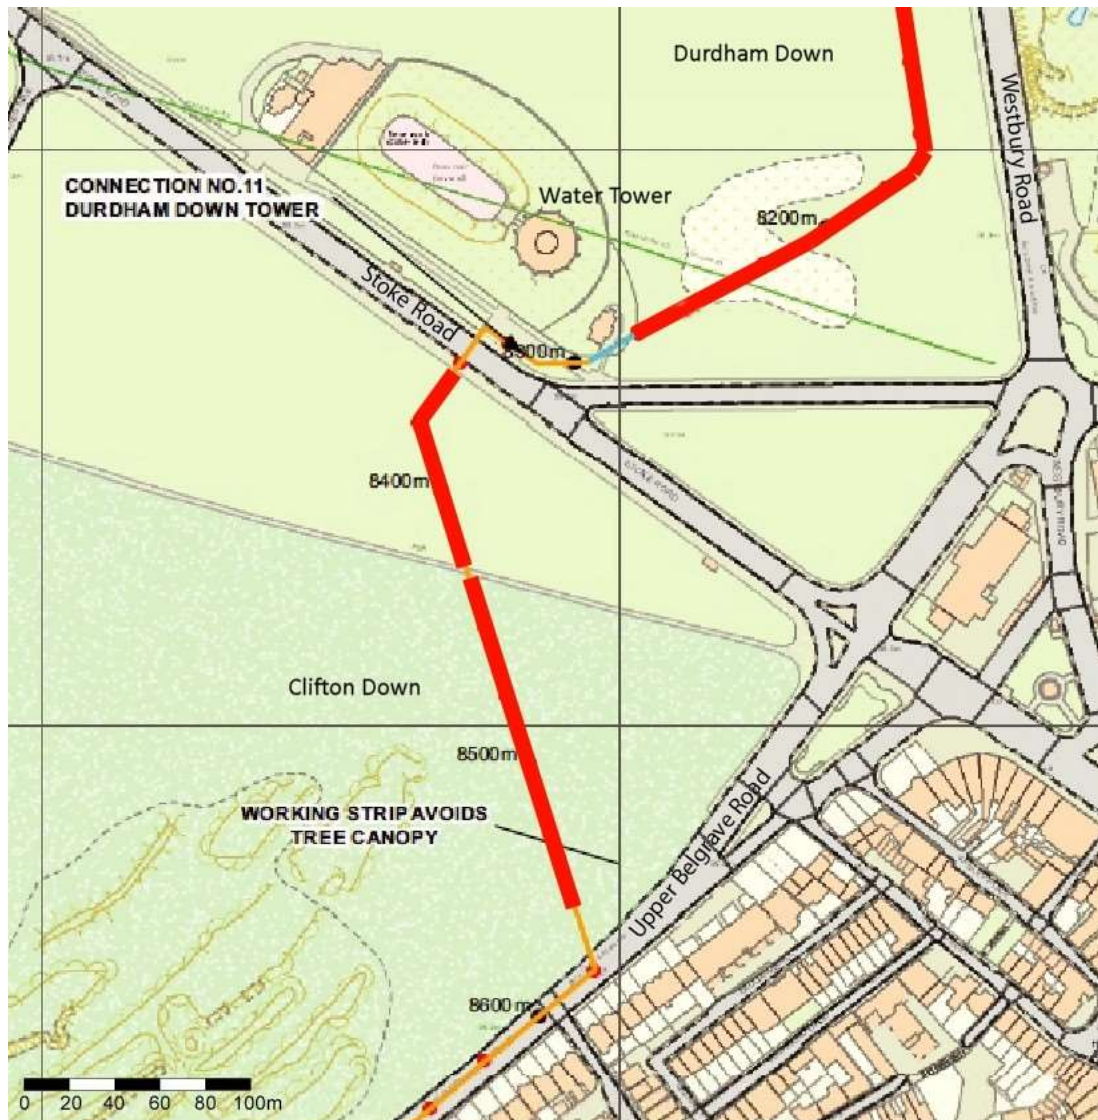
Fig. 17 Plan showing extent of pipeline ground works on Clifton Down from NGR ST 57147 74915 to ST 57186 74717

Topsoil removal and subsequent trenching operations were observed extending across the NE corner of Clifton Down between Stoke Road (ST 57147 74915), adjacent to the Water Tower, and Upper Belgrave Road (ST 57186 74717) (**Plates 44 & 45; Fig. 17**).

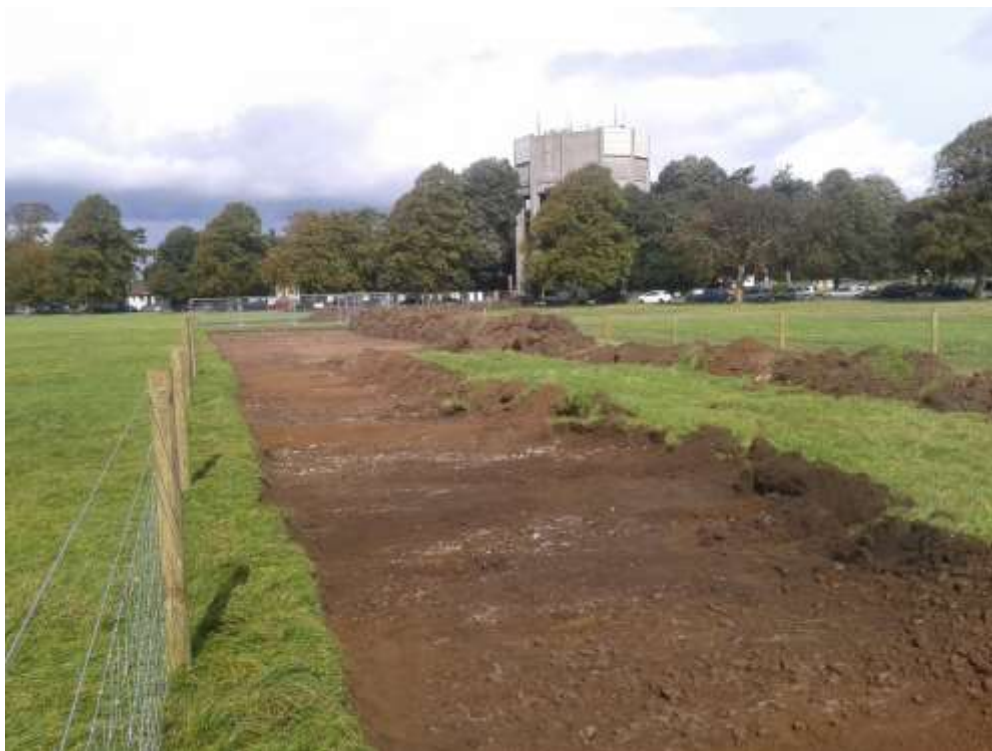
*Plate 44: View NW towards Stoke Road and the Water Tower showing topsoil strip on Clifton Down*

Approximately 0.30m of topsoil (301) was removed from the easement, exposing a moderately compact dark greyish-brown silty clay subsoil deposit containing frequent small angular limestone fragments with fragmentary post-medieval CBM noted in places (302). No significant archaeological features were revealed during stripping of the easement.

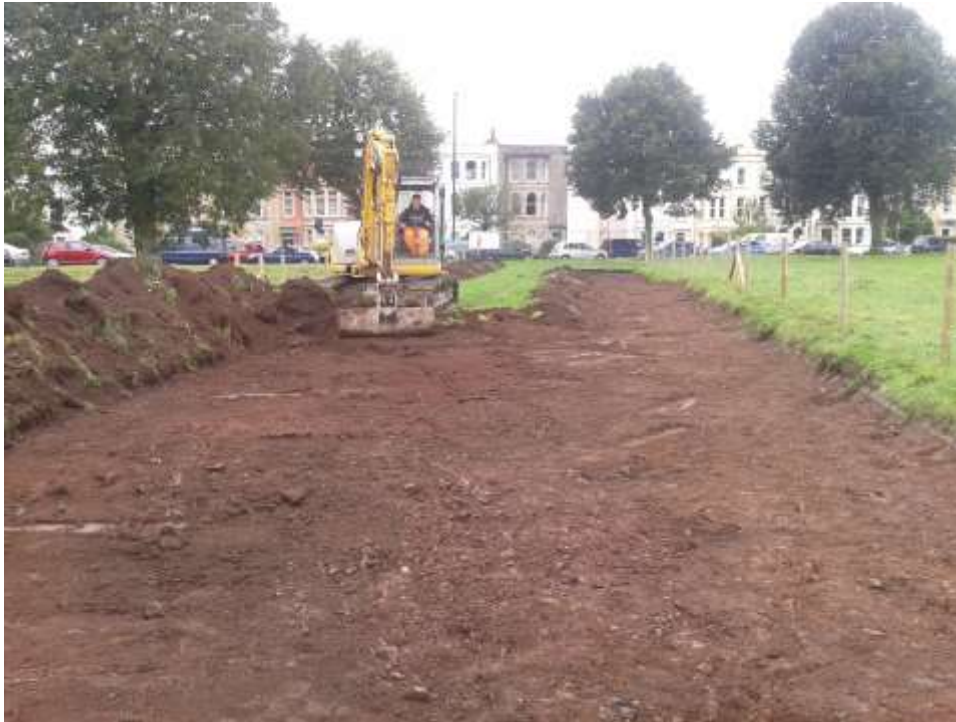
*Plate 45: View SW towards Upper Belgrave Road*

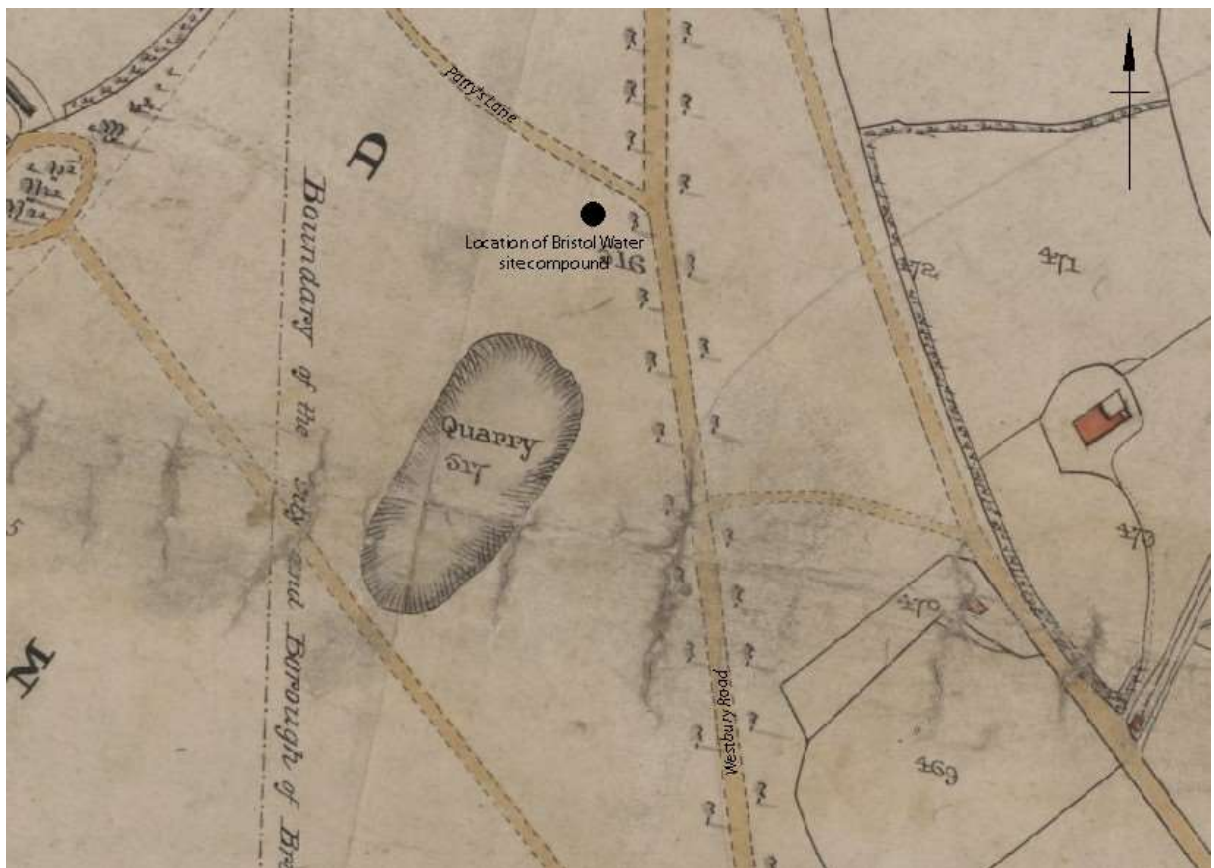
*Plate 47: Extract from the Westbury parish tithe map of 1844 showing the location of the quarry and Bristol Water's Site Compound  
(Reproduced courtesy of Bristol Record Office)*

The evidence for the renewal of (067) on several occasions suggests that it could possibly have represented part of a long-standing trackway extending across Durdham Down. However the cartographic evidence strongly indicates that the track was probably associated with a quarry site to the W of Westbury Road which was in use for a limited period during the middle decades of the 19<sup>th</sup> century. The Westbury tithe map of 1844 (**Plate 47**) marks the quarry site as a large, elongated sub-oval feature oriented roughly NNE-SSW, located W of Westbury Road and bordered to the S and SW by a linear avenue running NW-SE from Down House to Westbury Road, close to the junction with Redland Hill. No indication is given on the tithe map of a trackway linking the quarry site to Westbury Road, although the possibility that it may have not been recorded on the tithe map cannot be discounted.

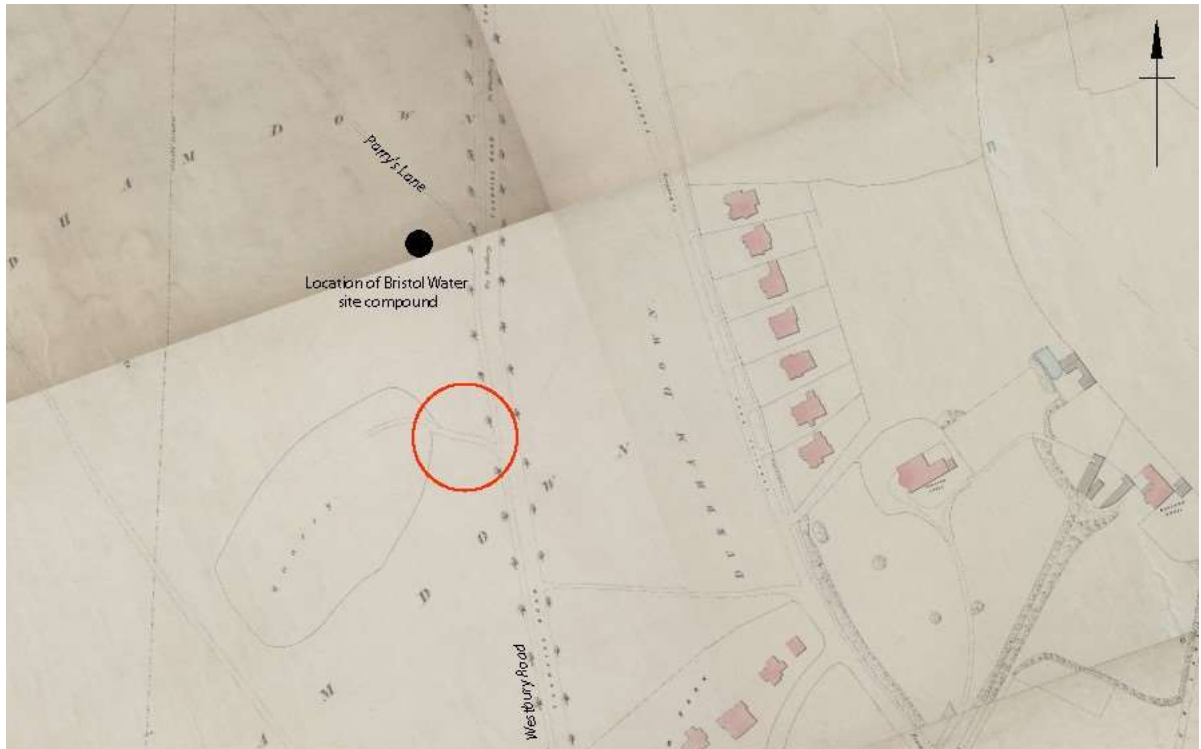
Plate 48: Extract from Ashmead's plan of 1855 showing location of track (067)  
(Reproduced courtesy of Bristol Record Office)

Ashmead's map of Bristol dated 1855 (**Plate 48**) clearly indicates the existence of a trackway on the alignment of (067), running approximately NNW-SSE from the NE corner of the quarry site to Westbury Road. Significantly, the subsequent edition of Ashmead's map dated 1874 shows neither the quarry nor the track, suggesting that the quarry had been in-filled at some point before 1874 and that the associated trackway had fallen out of use by that date (**Plate 49**).

earlier title map. However, its absence from Ashmead's later plan of 1874 provides a reasonably conclusive *terminus post quem* for the feature, which would appear to have passed out of use at some point between 1855 and 1874.
