# ARCHAEOLOGICAL PROGRAMME OF WORK

**ON SELECTED AREAS WITHIN THE BRISTOL WATER RESILIENCE SCHEME**  
(Harry Stoke to Clifton)  
**BRISTOL**

NGR ST 62001 78618 to NGR ST 57624 73711  
JOB N<sup>o</sup>: BA1130BWDD

APRIL 2013

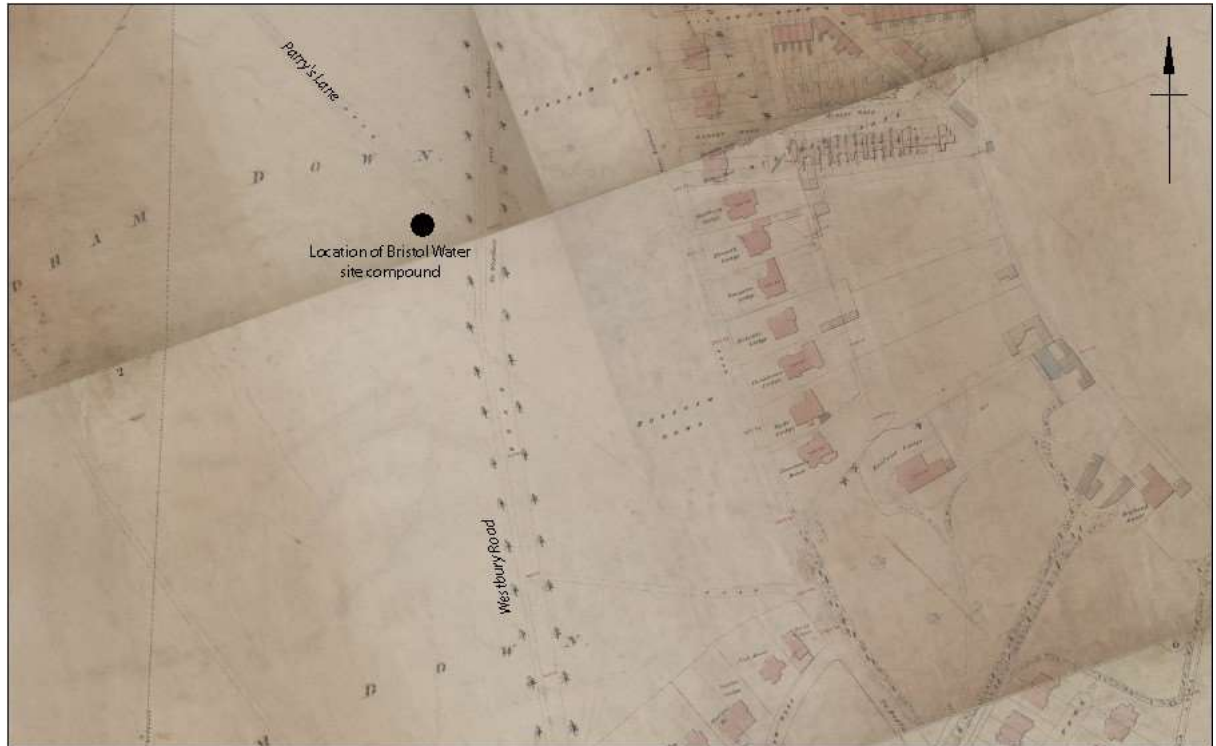
Plate 49: Extract from Ashmead's 1874 map showing neither the quarry nor the track  
(Reproduced courtesy of Bristol Record Office)

Ashmead's map of Bristol dated 1855 (**Plate 48**) clearly indicates the existence of a trackway on the alignment of (067), running approximately NNW-SSE from the NE corner of the quarry site to Westbury Road. Significantly, the subsequent edition of Ashmead's map dated 1874 shows neither the quarry nor the track, suggesting that the quarry had been in-filled at some point before 1874 and that the associated trackway had fallen out of use by that date (**Plate 49**).

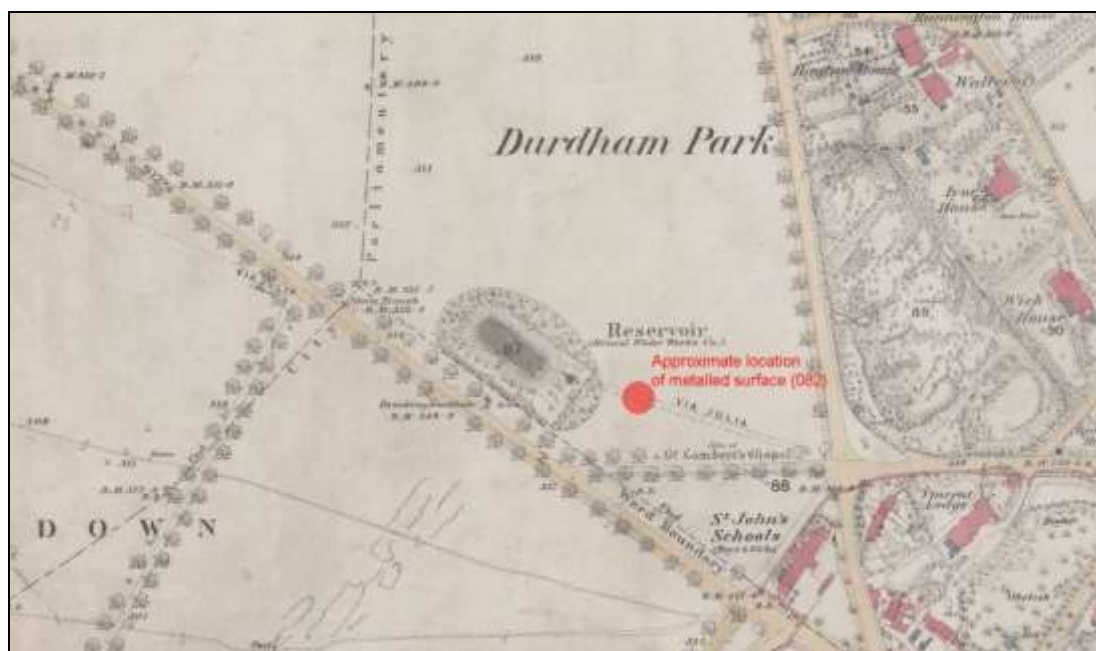
Plate 50: Extract from the OS 1<sup>st</sup> edition map of 1885 showing the line of the Roman road heading NW from Westbury Road towards the reservoir (indicated as a dotted line)  
(Reproduced courtesy of Bristol Record Office)

Post-medieval maps of the study area provide little or no evidence for the existence of a metalled road or trackway in this location corresponding to the alignment of (082). Jacob Wilstar's plan of the manor of Clifton (1746) which includes the southern fringes of Durdham Down, does not show a trackway in this location; neither is one depicted on the Westbury tithe map of 1844 (the trackway lies just NE of the boundary between the parishes of Westbury and Clifton), nor does it appear on Frederick Ashmead's plans of 1855 and 1874. The OS 1<sup>st</sup> edition map of 1885 is the earliest map to indicate the alignment of a feature denoted as a Roman road ('Via Julia') in this specific location, but it is not clear whether the

surveyor was recording an extant visible trackway or if he was in fact depicting the *presumed* alignment of the Roman road based on historical evidence or antiquarian observations.

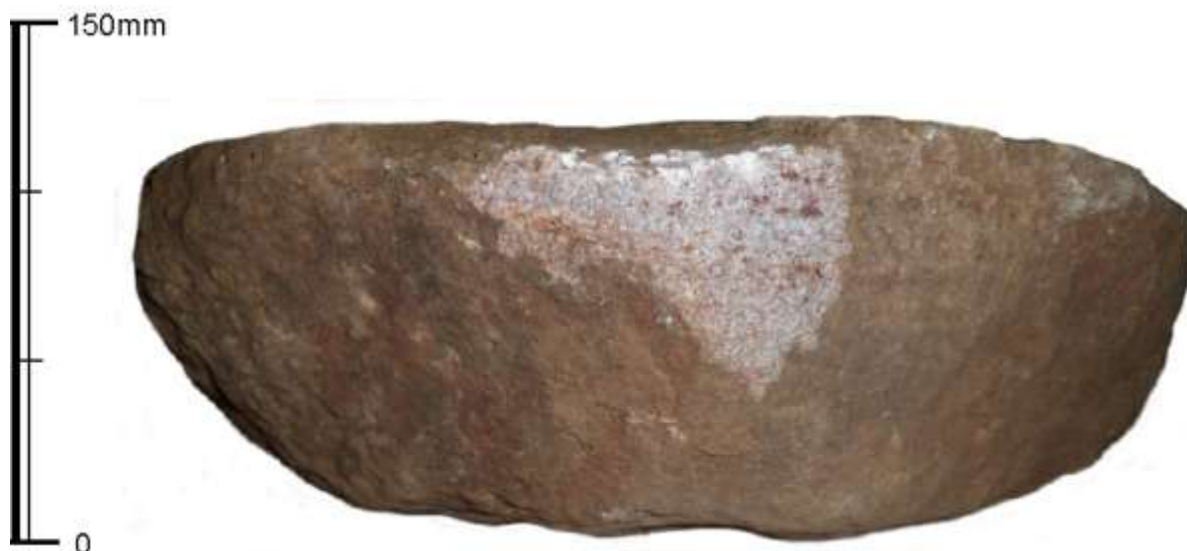
*Plate 51: Side view of quern stone*

(496)	Large angular blocks of some 0.20-0.70m diameter and a maximum width of maximum width 44m × 7m. A complete lower rotary quern was found at the southern end of (496)
<i>INTERPRETATION:</i>	<i>Roughly linear deposit of limestone rubble</i>
(497)	Plastic green silty clay some 400mm below ground level.
<i>INTERPRETATION:</i>	<i>Natural deposition at base of water pipe trench from Parry's Lane into Site Compound</i>
(498)	<i>VOID</i>
(499)	Limestone rubble within a moderate to firm dark reddish-brown clayey silt. Occasional CBM & rare post-medieval pottery. Extended approximately 4.50m (NNE-SSW) × 3.20m × (WNW-ESE) × 0.15m
<i>INTERPRETATION:</i>	<i>Part of a metalled path or track or possibly as an area of modern hard-standing.</i>

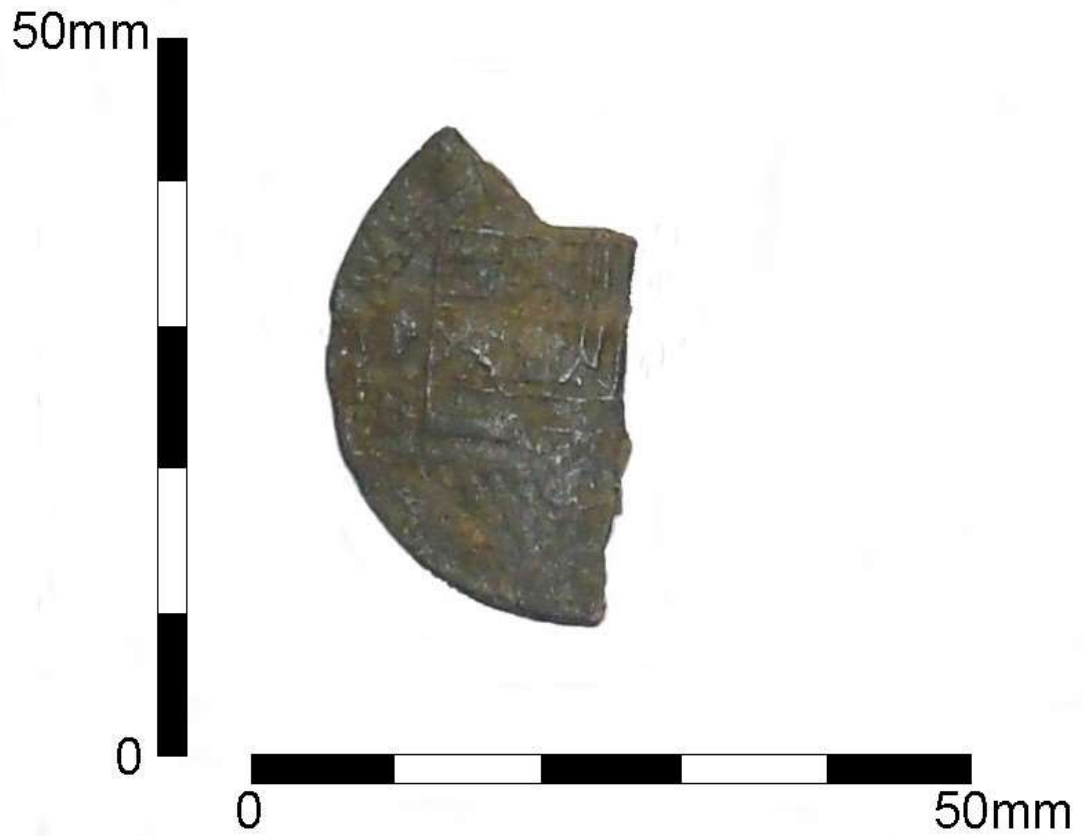
*Plate 52: Spanish colonial silver real coin (obverse depicting the royal arms of Philip II)*

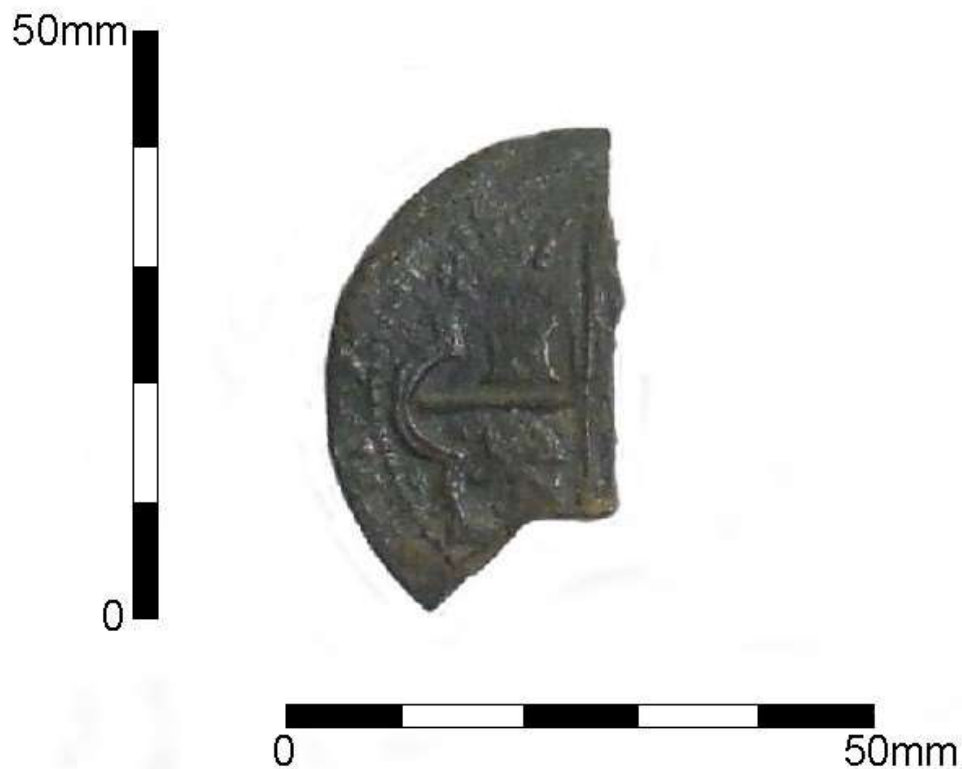
*Plate 53: Spanish colonial silver real coin (Reverse depicting the arms of Castille and Leon)*

Reverse: Greek cross set within an eight-lobed border, quartered with lions and castles (Arms of Castille and Leon). Date missing. Only partial legend intact – [INDIA]RUM REX

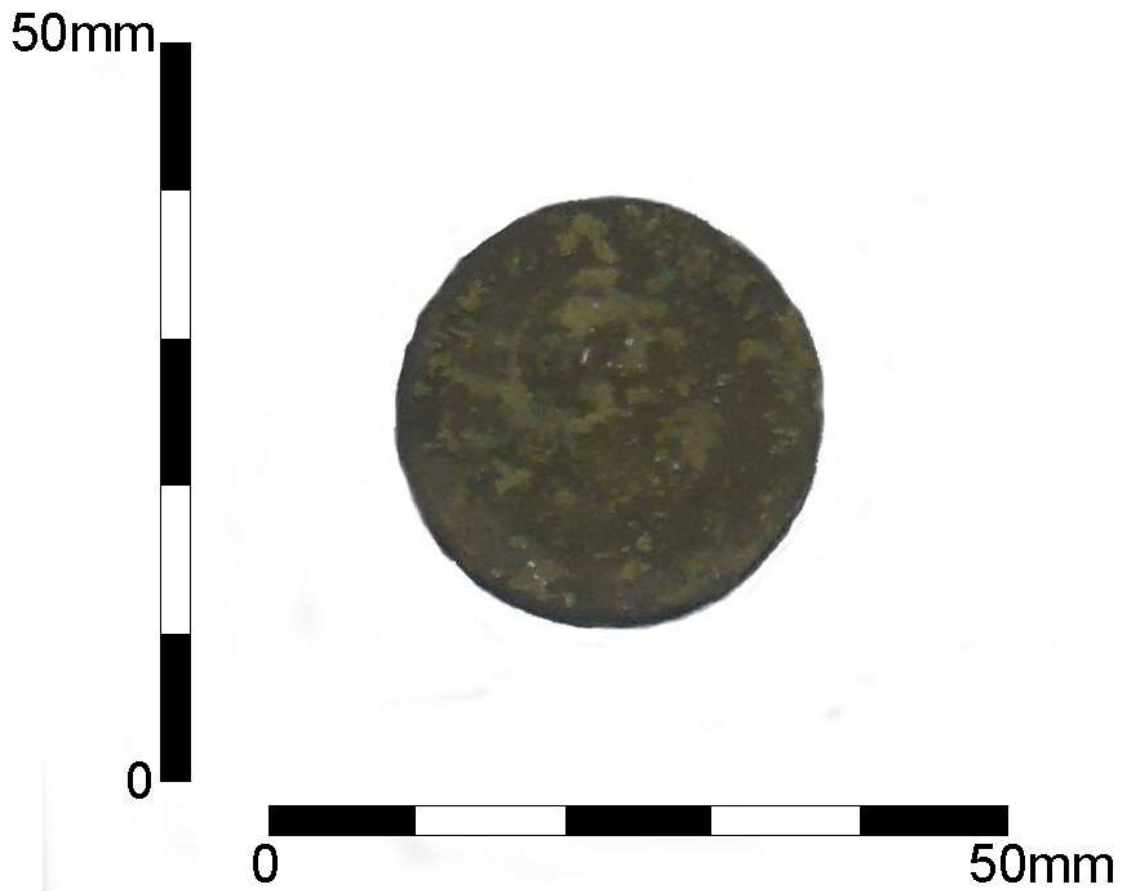
*Plate 54: Copper halfpenny of George III (obverse)*

2. Copper halfpenny George III probable date of issue 1798 or 1799 (very heavily worn, inscription only barely visible) Diameter 30mm

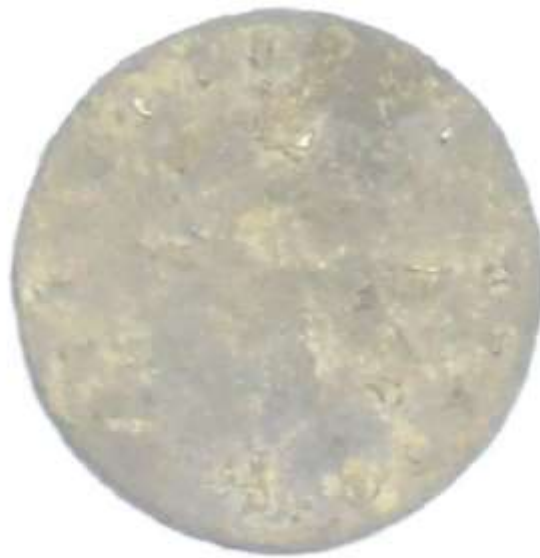
*Plate 56: Copper third farthing of Queen Victoria (obverse)*

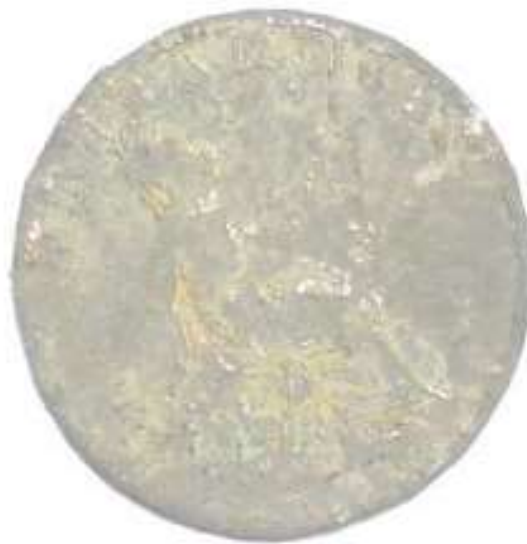
*Plate 57: Copper third farthing of Queen Victoria (reverse)*

Reverse: Inscription partially defaced BRITANNIAR [REG. FID. DEF.] Britannia depicted facing right
