# ARCHAEOLOGICAL OBSERVATION

## WESTON-SUPER-MARE WATER MAINS REPLACEMENT SCHEME WESTON-SUPER-MARE NORTH SOMERSET

NGR ST 3260 6140  
JOB N<sup>o</sup>: BA1231BWWSM

NOVEMBER 2013

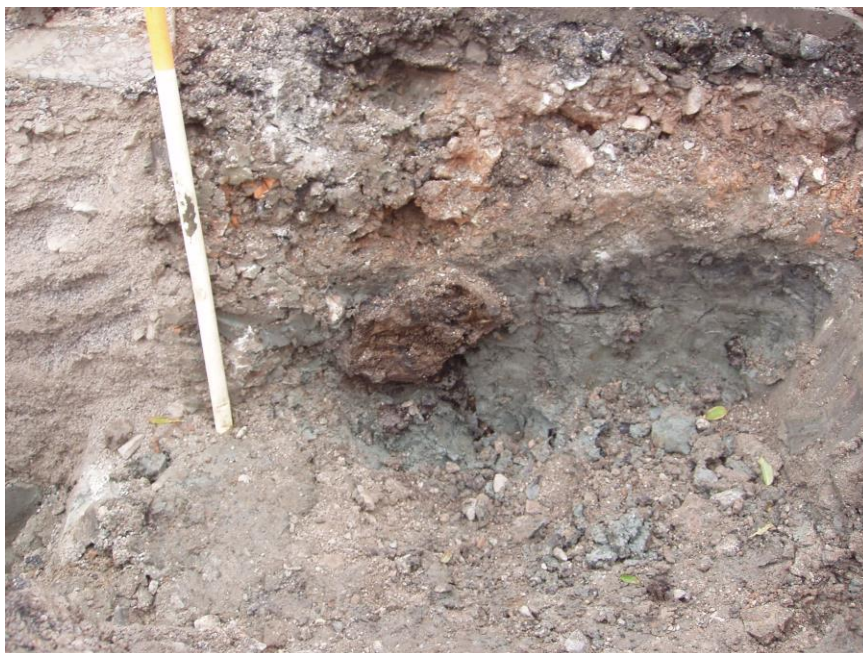
Immediately underlying the road foundation deposit (1001) was a >0.40m deep deposit of light bluish-grey tidal clays (1002) which contained a singular highly eroded small piece of wood (1003) (see *Plate 1* below). Although no dating evidence was recovered from either deposit (1002) or (1003) the deposition of the wood probably marked a late post-medieval flooding event and illustrated the extent of tidal incursion prior to development in this area.

*Plate 1: W-facing section showing wood (1003) within clay (1002)*

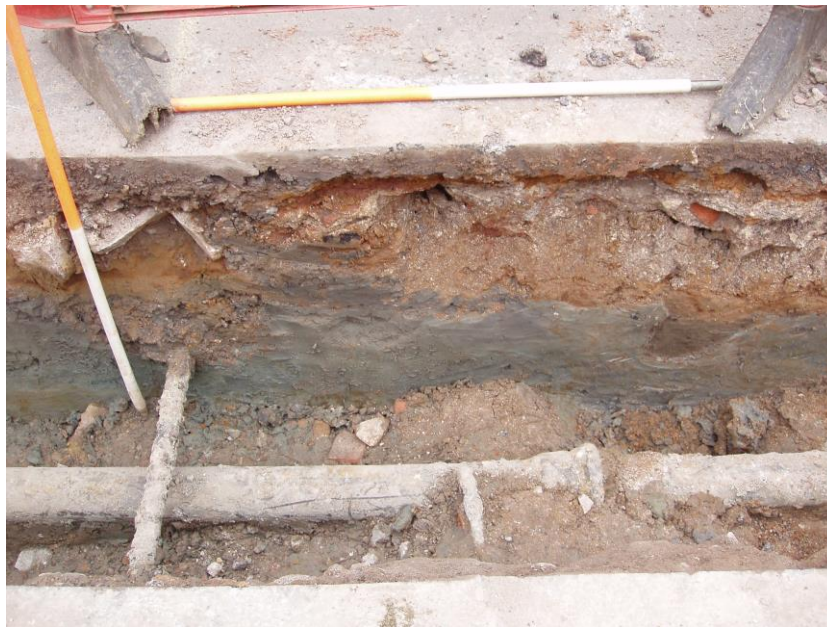
Outside No.37B Swiss Road a large access pit (Pit 17) 5.00m long x 1.00m wide provided an opportunity to investigate the archaeology of the inter-tidal deposits within this part of the study area in detail. Underlying the modern road (6000) and foundation layer (6001) was a re-deposited layer of coarse sand (6010) which overlay modern service trench cut [6005] and fill (6006). Deposit (6010) also overlay a funnel shaped feature filled with dark brown clayey-silt (6011) which probably represented root disturbance or an animal burrow; this feature in turn cut a light bluish clayey-silt (6007 & 6012) which probably formed the infilling of a shallow palaeochannel. Also cutting (6007) was the extant evidence for a possible post-pipe cut ([6008] measuring 0.30m deep x 0.16m wide, it was filled with loose dark brownish-grey coarse sand (6009). A sample taken from (6009) contained seeds of elder, bramble and fumitory; together with the shells of land snails (*Appendix 1*) suggesting the area had been dry for a period of time. Deposits (6007 & 6012) overlay a similarly constituted clayey-silt (6003) to the N which probably had been deposited by an earlier phase of silting of the inter-tidal margins, It is possible these deposits had infilled a narrow shallow sided flat bottom palaeochannel (see *Plate 2 & 3* below). Underlying (6003) was a >0.10m thick deposit of firm mid-brownish grey clayey-silt (6004), which would have accumulated in a similar manner to overlying silts as a result of inter-tidal deposition. In a similar manner to deposits identified further to the N in Swiss Road the archaeology suggests this area originally formed a W to E aligned inter-tidal landscape crossed by tributaries and geochannels which slowly infilled with silt. The intertidal zone, also known as the foreshore or seashore is occasionally referred to as the littoral zone and is the area that is above water at low tide and under water at high tide.

Plate 2: Runnel or cut [6008] and palaeochannel (6003 and (6007) in Swiss Road; facing W

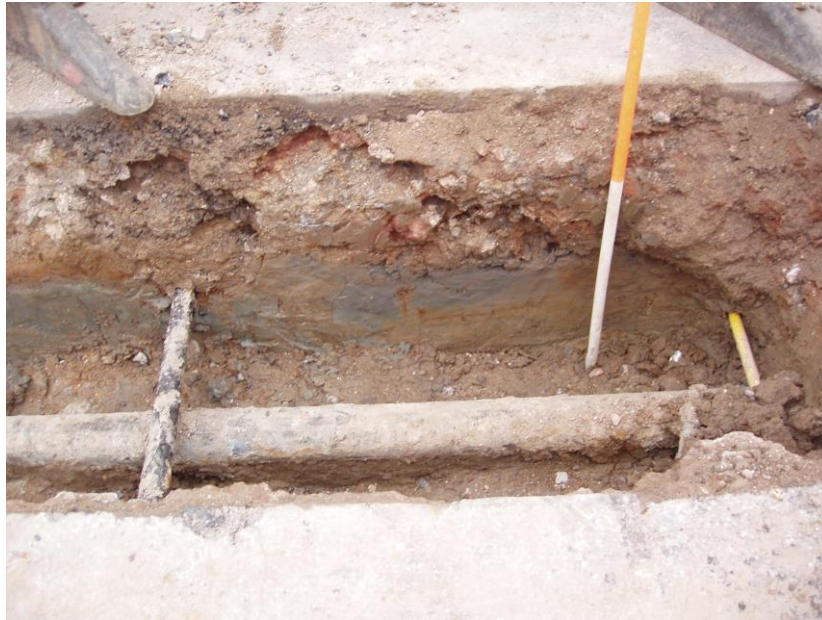
Plate 3: Bank of possible palaeochannel (6013); facing W

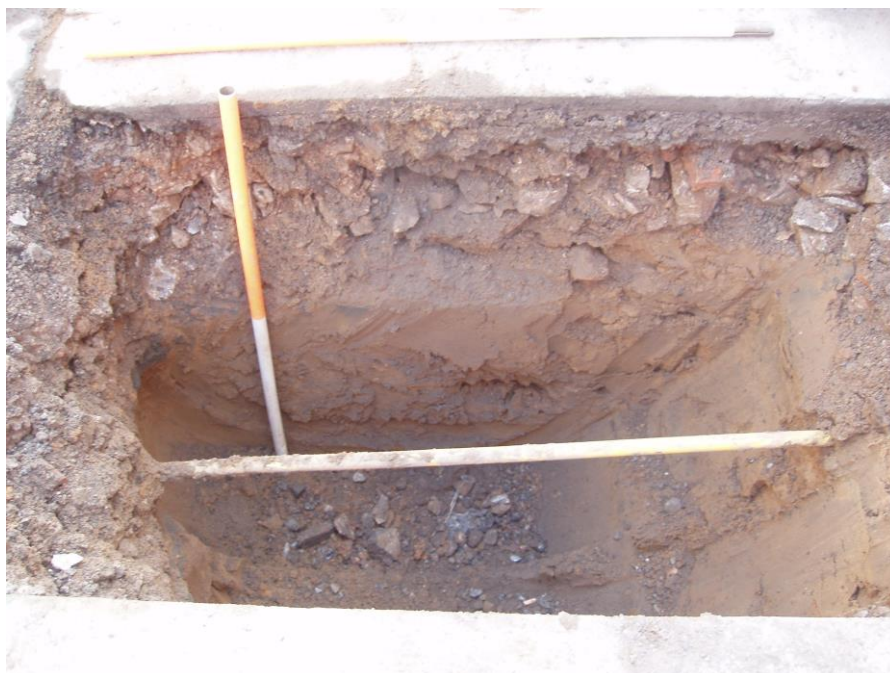
The archaeology revealed a similar stratigraphic sequence as identified in Camden Terrace of general disturbance relating to development of the area for residential purposes in the late 19<sup>th</sup> to early 20<sup>th</sup> century with further significant levels of intrusion relating to installation of services, road construction and subsequent later repair. Underlying the modern road (8000) surface and foundation (8001) was a 0.50m deep deposit of yellow-grey coarse sand (8002) which was probably a sand bank/beach which was levelled during construction of the terrace circa early 20<sup>th</sup> century. (see *plate 4* below)

*Plate 4: Levelled sand dune (8002) beneath road surfaces in Little George Street*
