Archaeological Observation

Bristol Water

Water Main Replacement
Knowle Reservoir to Victoria
Reservoir Bristol

January 2015

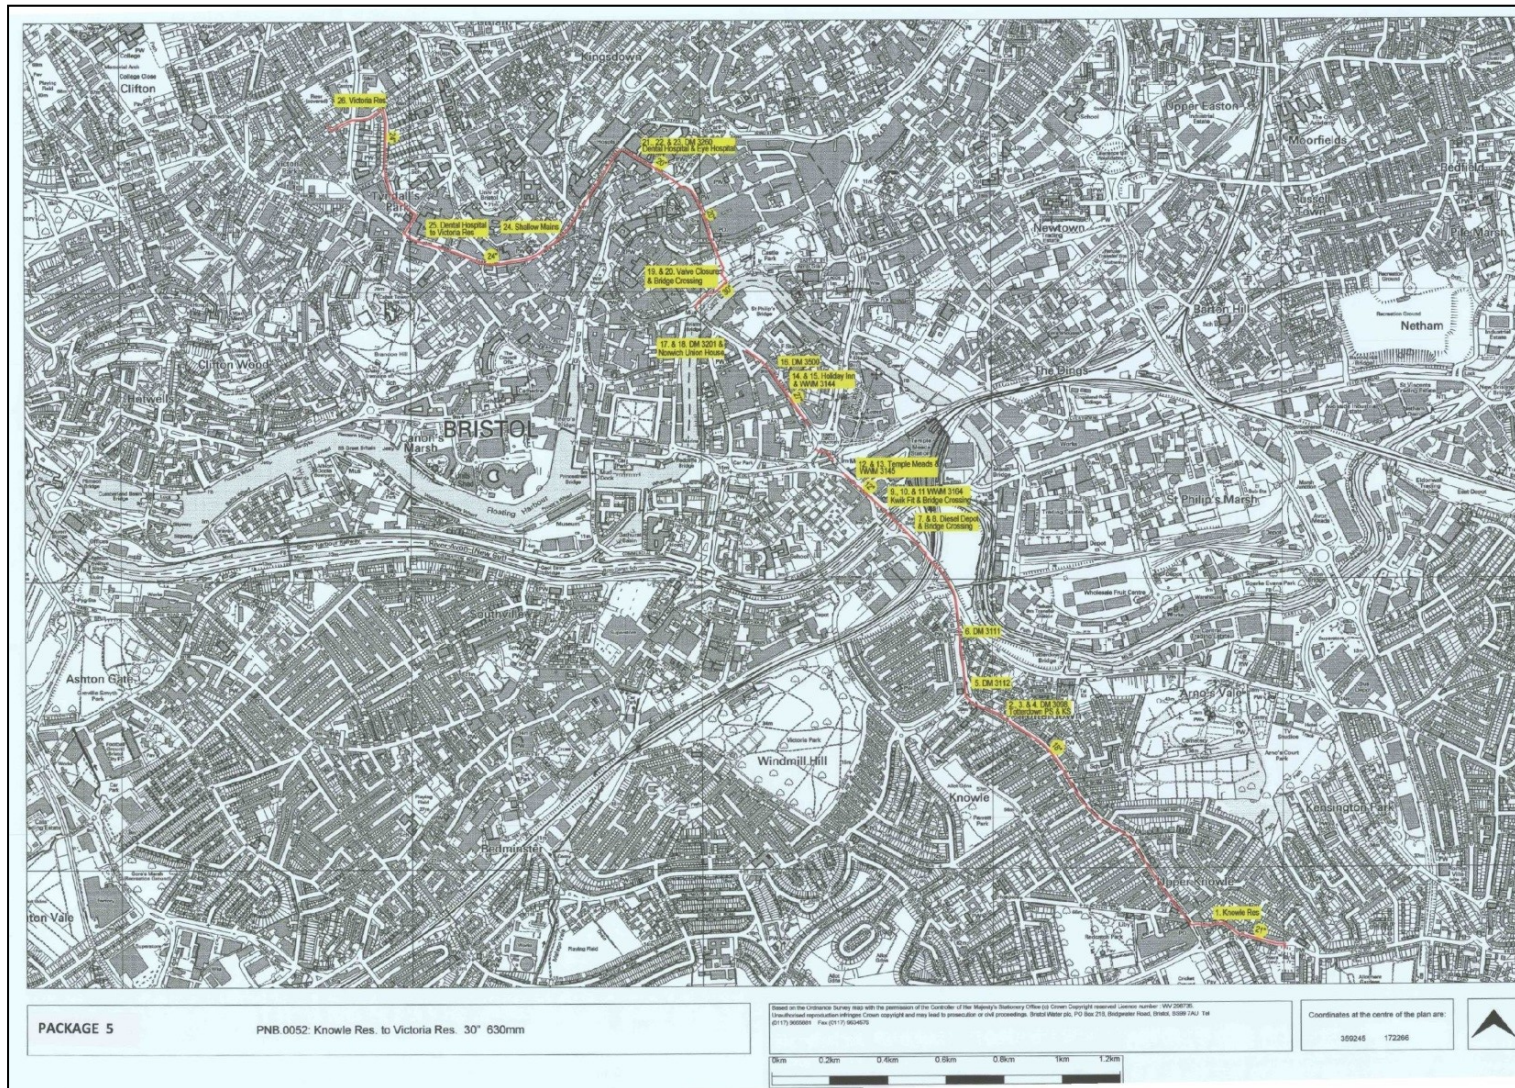
Fig 1: Bristol Water scheme map showing the route of the replacement water main marked in red

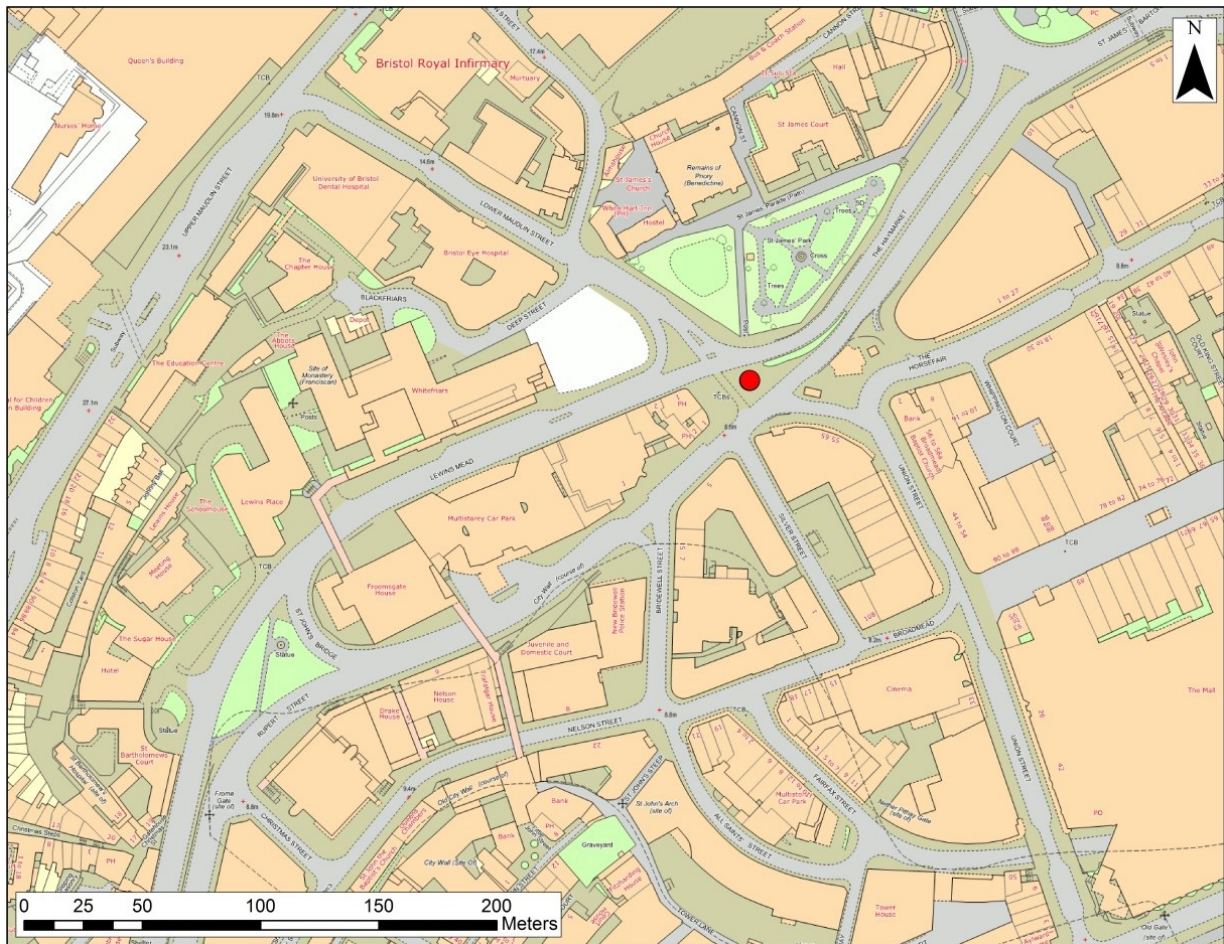
Fig. 2: Plan showing location of Pit 1 (enabling works) (Pit 1 marked in red)

Archaeological Observation of initial enabling works was carried out on April 26th 2013 following the discovery of human skeletal remains. A three-tonne mini digger and toothless bucket was used to open a single pit (Pit 1) on the pedestrian island to the NE of the Bay Horse PH in The Haymarket and S of the existing boundary of St. James' Park - formerly the Priory of St. James, a 12th-century foundation, and its associated churchyard (*fig. 2*).

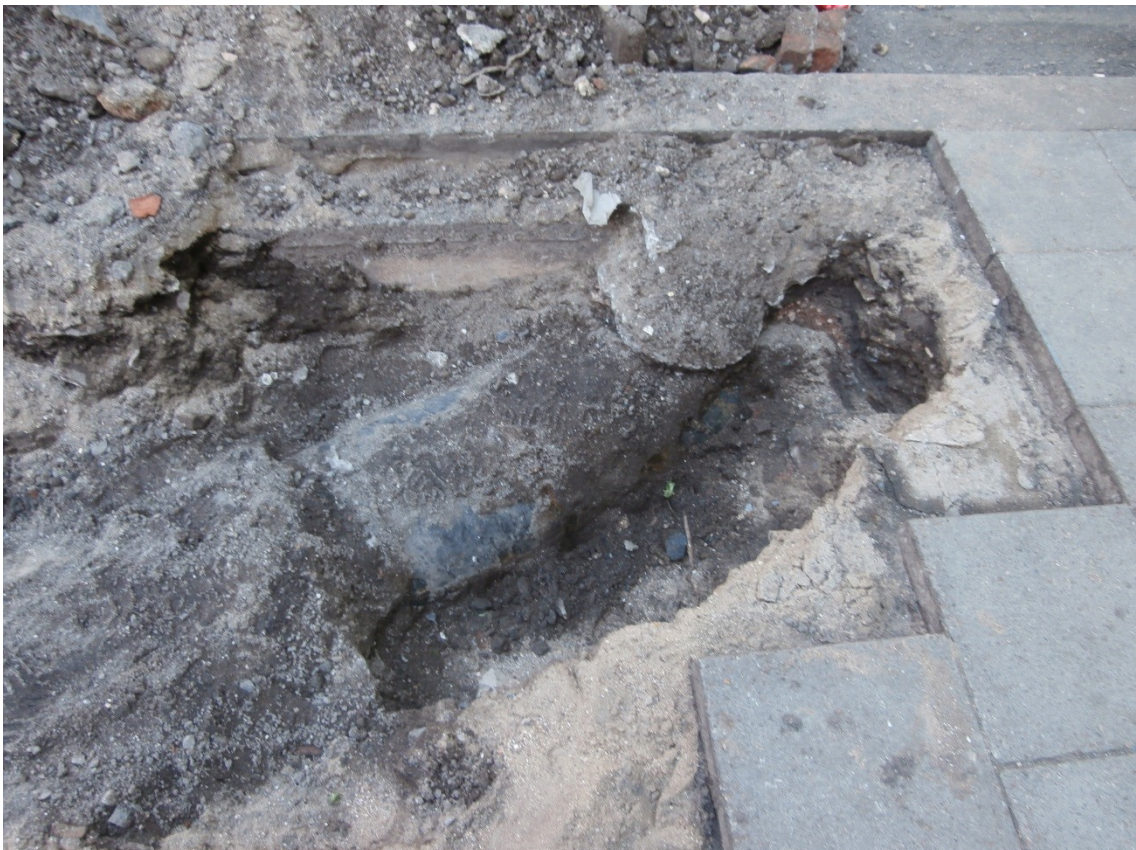
Plate 10: View N showing Trench 2 and exposed 19th -century main

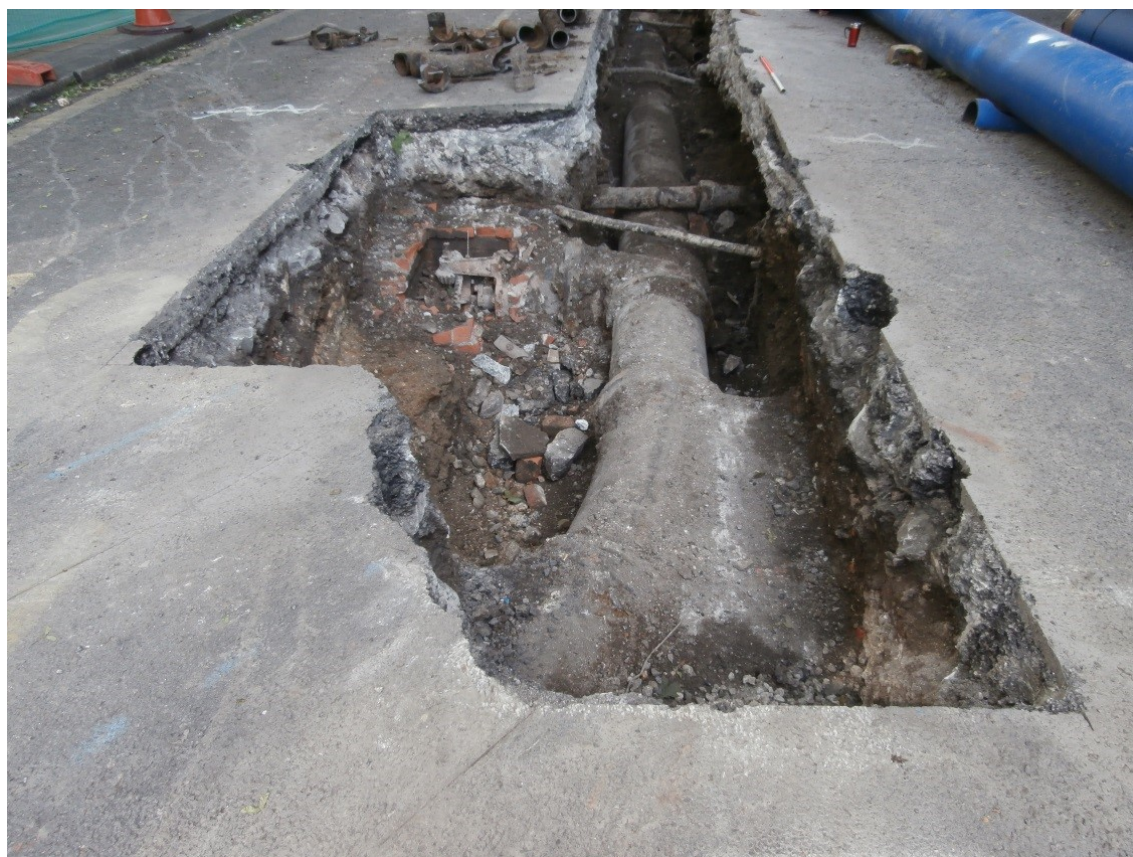
Plate 11: View N showing exposed 19th -century water main in Trench 3

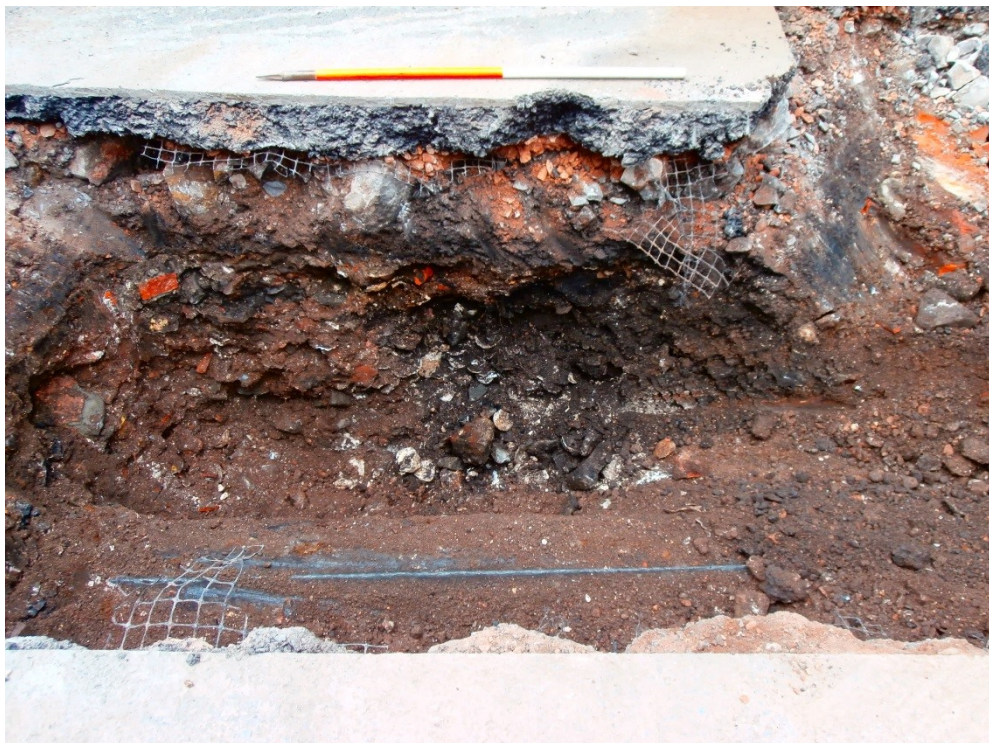
Plate 20: View to the W showing deposit (703) in the E-facing section, which would appear to represent a dump of probable domestic waste evidently predating the installation of the 19th-century water main

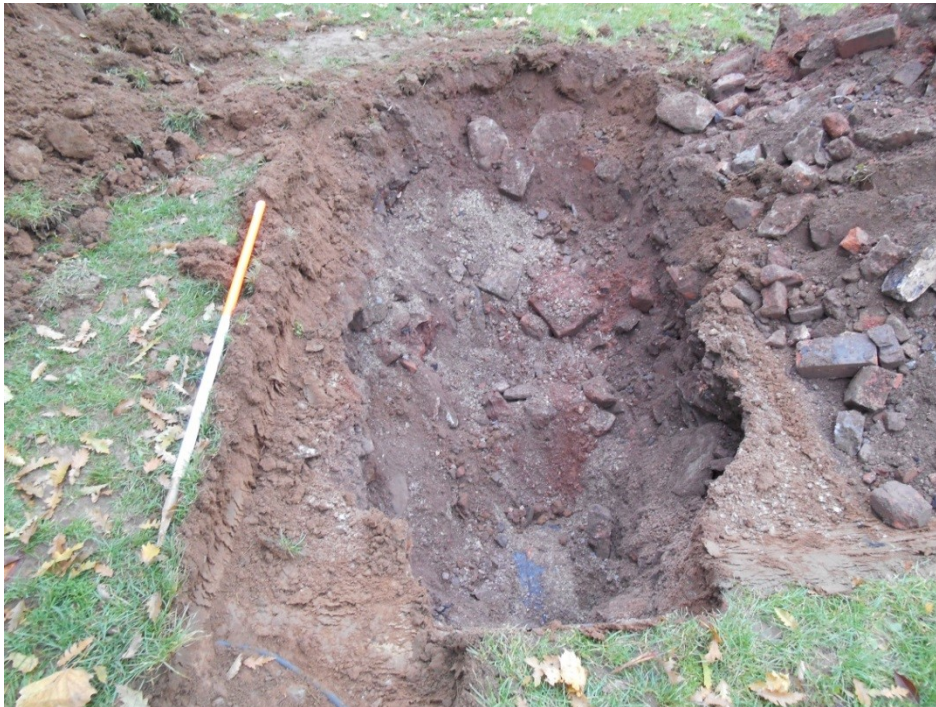
Plate 50: NE-facing view of Trench 24 showing quantity of demolition material

The demolition material (2402) was similar to that found in Trench 23, although the rubble fragments were much larger and intact sections of mortared brickwork were also present (*Plate 50*). This larger concentration of demolition material may suggest that Trench 24 was located within the footprint of one of the properties lining Bridge Street, possibly No. 44, whilst Trench 23 may have been within the former line of the street.

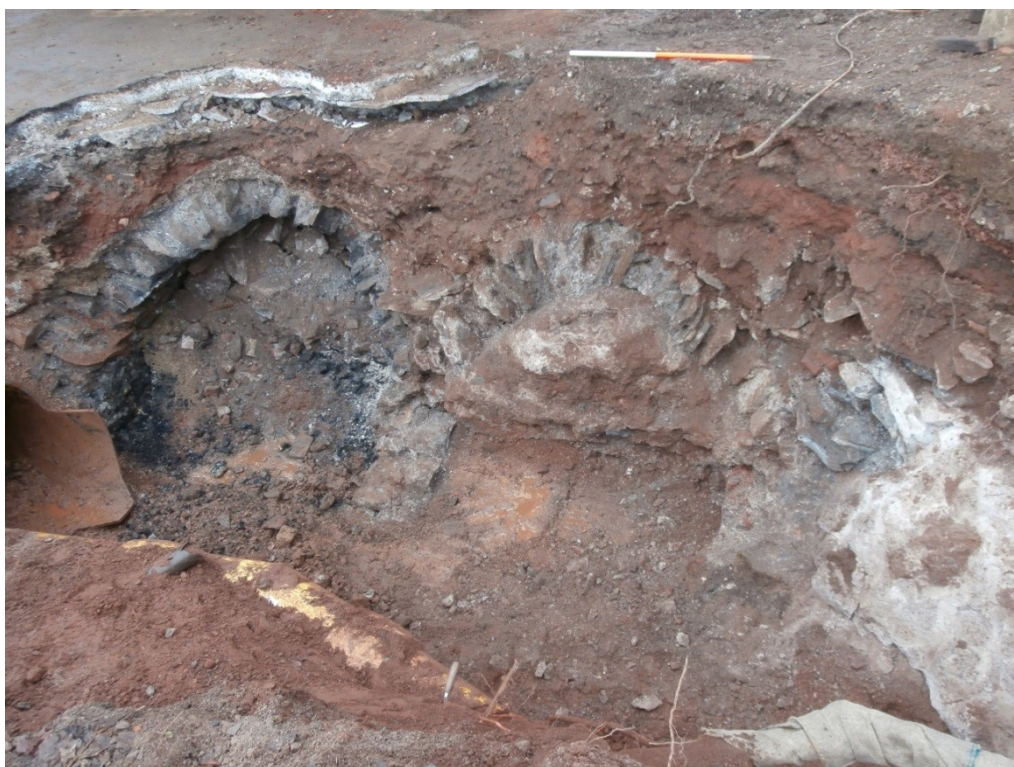
Plate 60: View to the NW of arched structure (2906) in Trench 29

The arched structures had been backfilled with rubble (2907) and concrete (2911) and (2912) precluding further investigation.

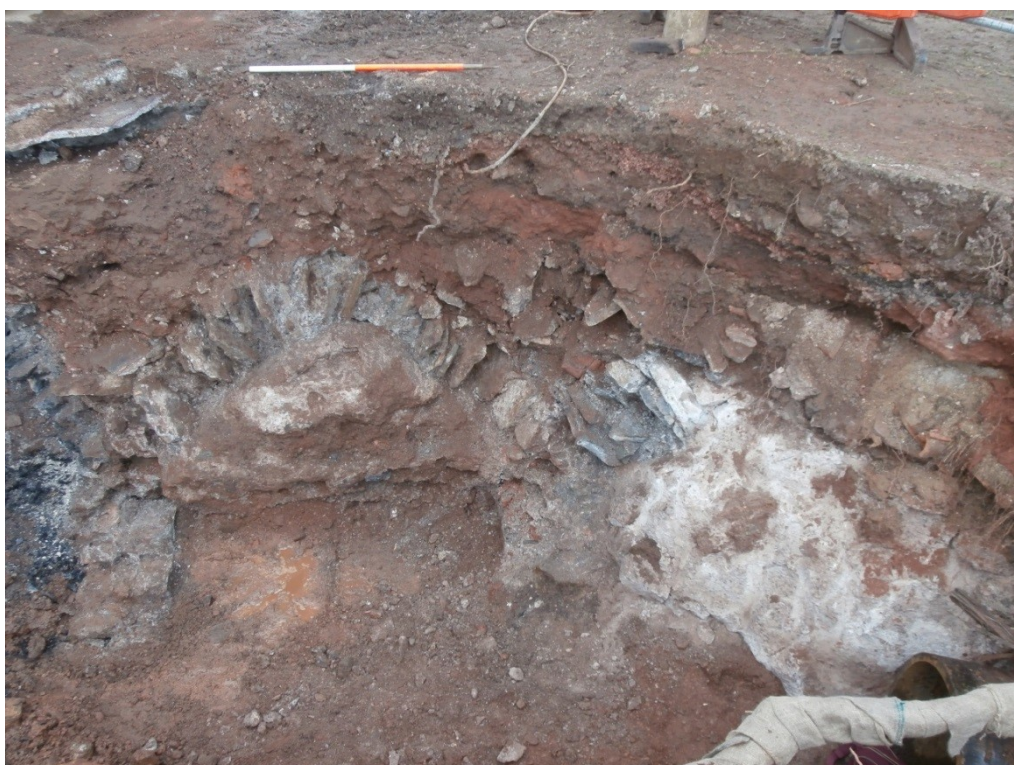
Plate 61: View to the N of arched structure (2906) in Trench 29

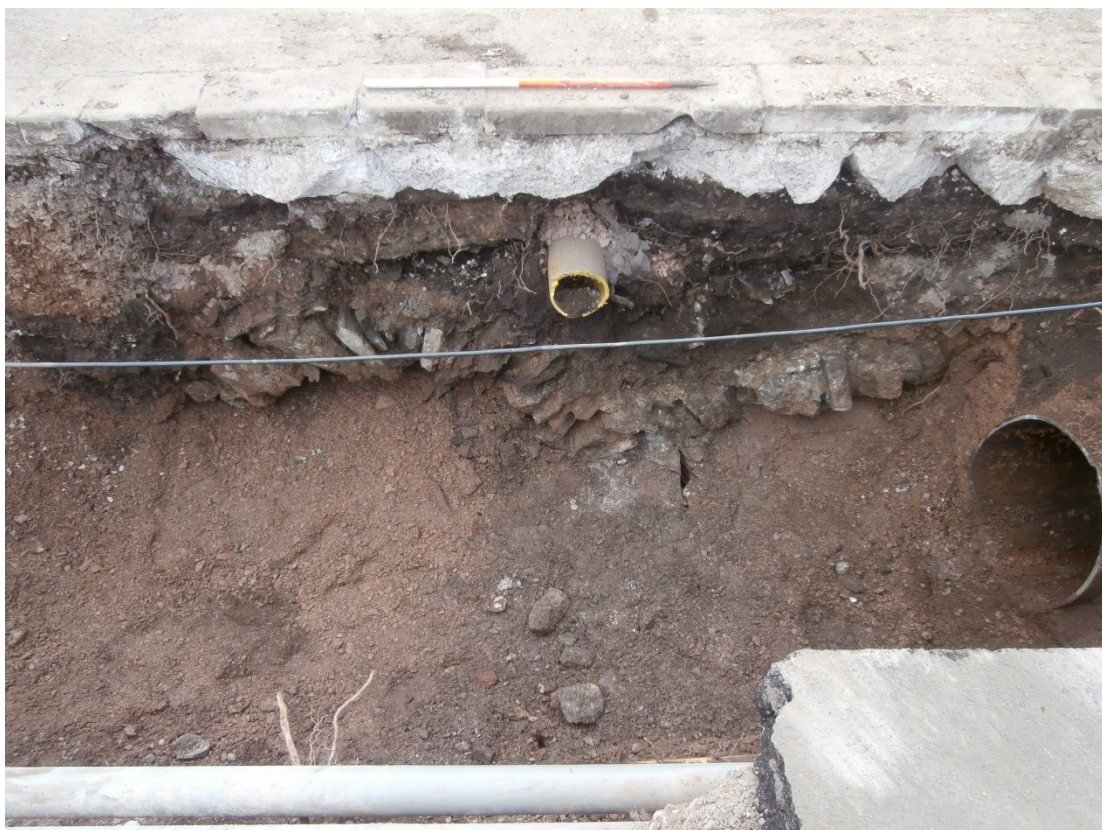
Plate 62: View to the NW of arched structure (3011) in Trench 30

Comparison of Ashmead's 1874 plan with the 2013 Ordnance Survey map would appear to suggest that the remains of the vaulted cellarage (3011) (*Plate 62; fig. 20*) probably relate to former property at No 23/24 on the southern extent of Bridge Street, which dates from c. 1760 (Leech 1998) and was demolished after the Second World War. Similarities in terms of construction methodology and building materials would suggest (3011) and (2906) were contemporary.

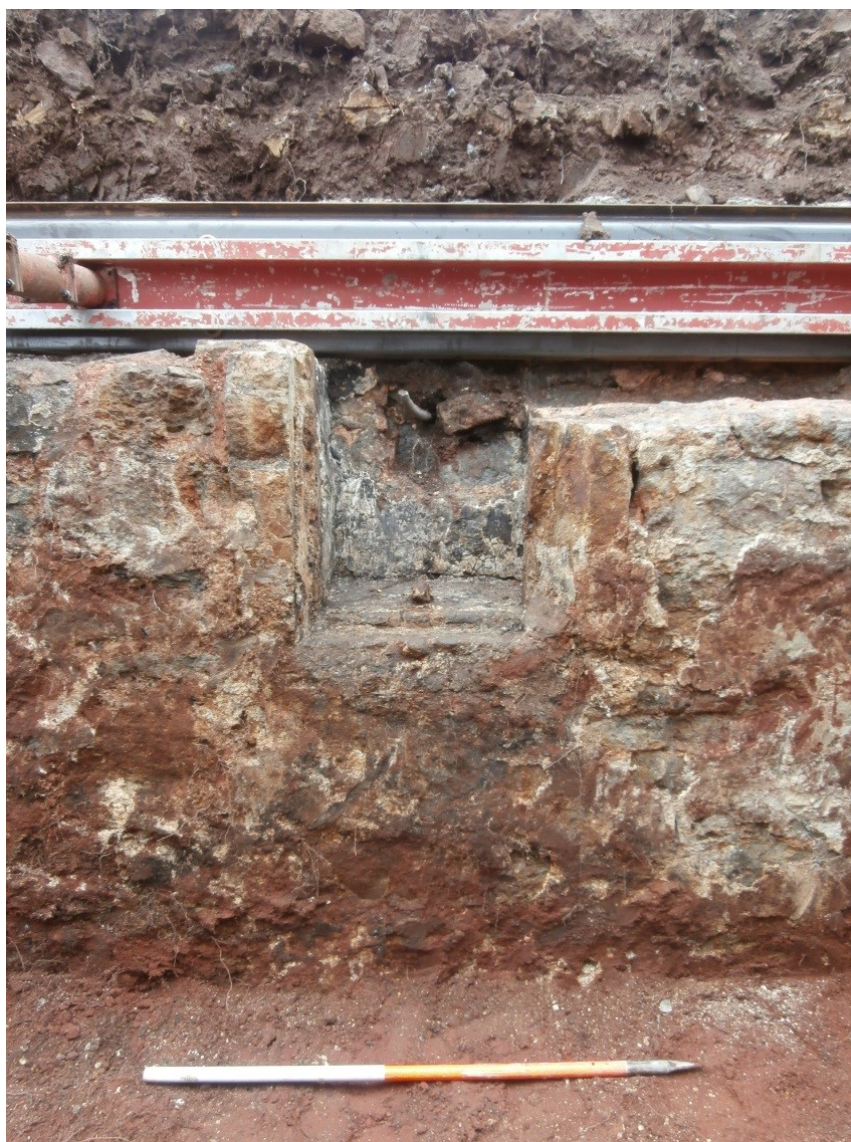
Plate 69: View to the S of possible coal chute within the NW/SE aligned wall of structure (3206)

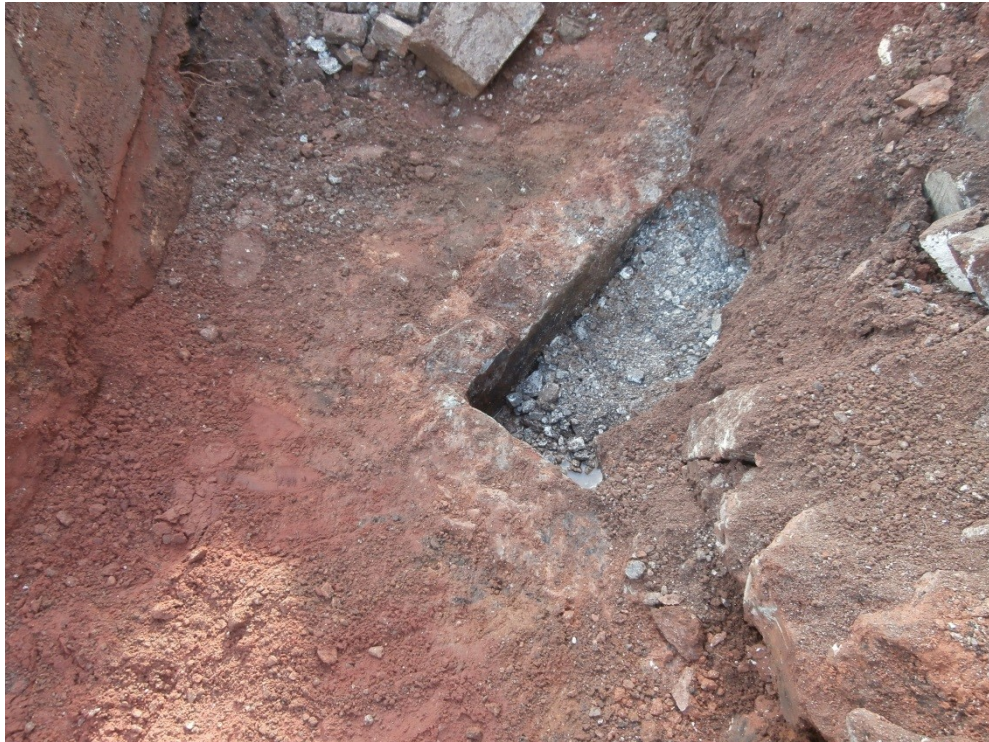
Plate 91: View SW showing wall foundation (2521) in Trench 25

The extension of Trench 25 revealed a corner of a wall foundation (2521) extending from the SE-facing section of the trench (*Plate 91*). Comparison with the OS 1st -edition 25-inch map of 1886 suggests this wall foundation relates to a property that formerly stood at the western extent of Dolphin Street; it may possibly represent an internal wall of a cellar beneath a property marked as 'hotel'. The area around Dolphin Street was heavily damaged in the air assault of November 1940 and previous excavation work has confirmed the extent to which archaeological remains have been truncated by landscaping activity in the Castle Park area during the 1970s; the extent to which the foundations may continue NW beyond the trench could not be established.

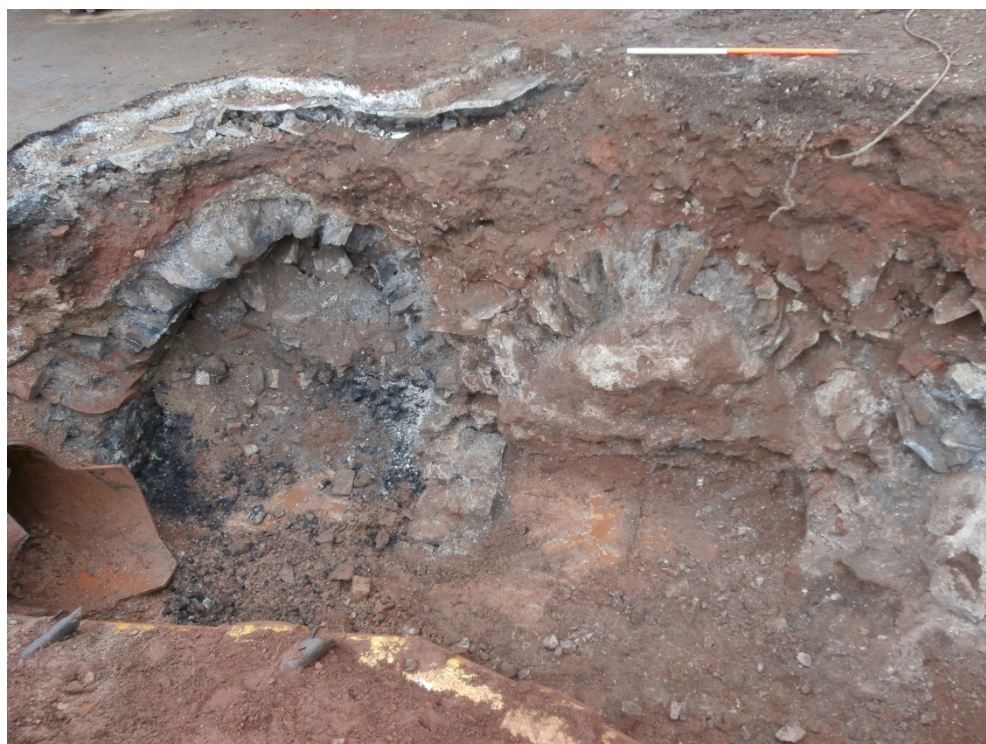
Plate 92: View to the N of arched structure (2906) in the S-facing section of Trench 29

Trenches 29 and 30 were opened in Bridge Street: Trench 29 was located at the NE end of the street whilst Trench 30 was located in the footpath along its southern extent, near the junction with High Street. Bridge Street was established in the 1760s, replacing the medieval curving alignment of Worshipful Street. Bridge Street contained four-storey dwellings on either side, each having a cellar extending below the street frontage into the middle of the carriageway (Leech 1998). Comparison of the trench locations with Ashmead's map of 1874 would suggest that the arched structures revealed in Trench 29 and Trench 30 represent cellars attached to properties occupying the southern extent of Bridge Street. Structure (3011) in Trench 30 would appear to relate either to No. 23 or 24 whilst structure (2906) in Trench 29 may relate to No. 16 Bridge Street (*Plates 92 & 93*).

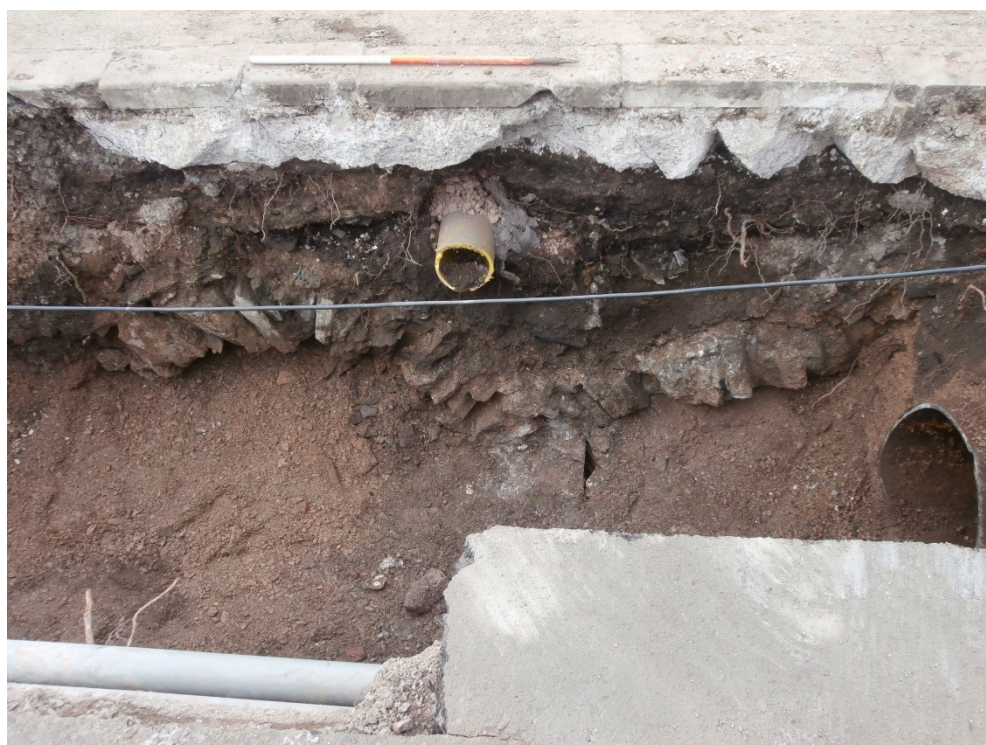
Plate 93: View to the NW of arched structure (3011) in the SE-facing section of Trench 30
