# ARCHAEOLOGICAL OBSERVATION

## WATER MAIN REPLACEMENT SCHEME SPRINGER'S HILL COLEFORD SOMERSET

NGR: ST 68320 49695 – ST 67790 48580  
REF: BA1238BWSHC

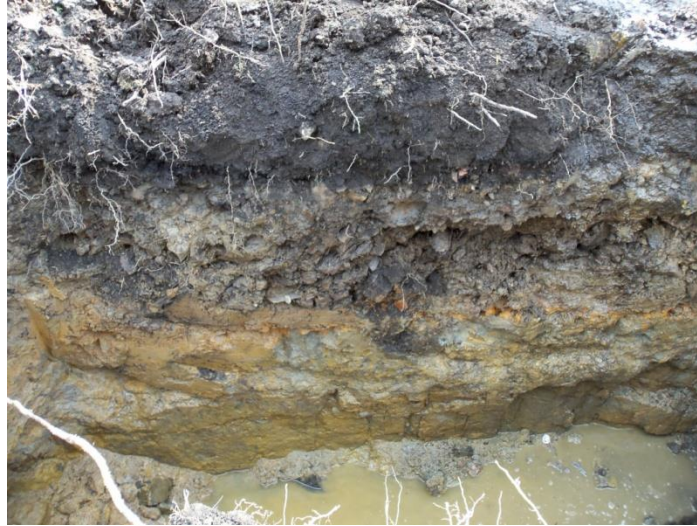
*Plate 1: Re-deposited clay (5001) and brick rubble (5002); view W*

Beneath a soft dark greyish-brown sandy silt topsoil (5000) containing occasional charcoal, CBM, modern pottery fragments and small stones, was a firm yellowish-brown clay deposit with moderate small stones (5001) (*Plate 1*). The precise function of this material, a re-deposited natural, is unclear; it is probable that, like the underlying (5002), it was associated with the demolition of the Coal Barton colliery and levelling of the surrounding area. Beneath (5001) was a friable, very dark grey gritty silt (5002) containing frequent charcoal and brick fragments and occasional fragments of coal and slag. A sample taken from (5002) contained clinker, cinder and coal. The alder and bramble seeds found in it were not charred and were thought to be recent intrusions (See *Appendix 1*).

Underlying (5002) was a layer of natural shale and mid-bluish-grey clay (5003) sealing a sterile compact yellowish-brown clay (5004), both of which layers were naturally formed and sealed the sandstone bedrock (5005).

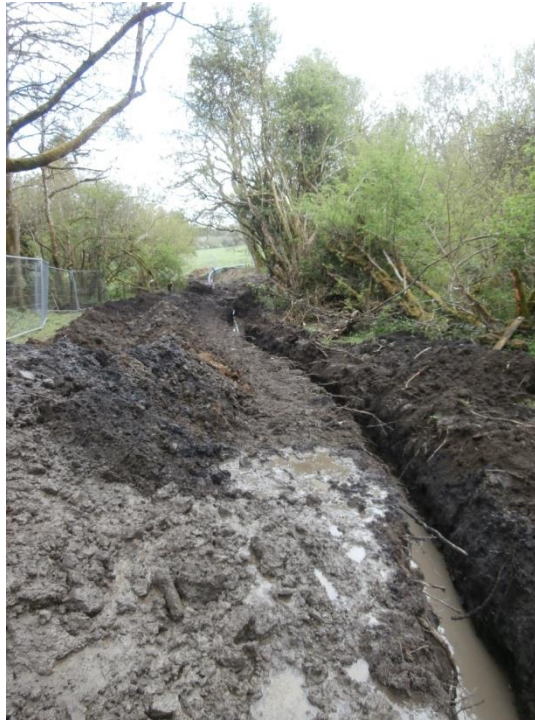
*Plate 2: Open-cut trenching in colliery area facing ESE*

There was no significant archaeology present and the stratigraphic profile seen in AP 4 and AP 5 was present in the trench. At the SE end of the cut, the profile of AP 4 extended for a further 10m, although at this point the subsoil thinned and was not present in the remainder of the trench. The deposits at either end of the trench were seen to slope downwards towards the centre, a result of the waterlogged ground conditions around the course of the stream.

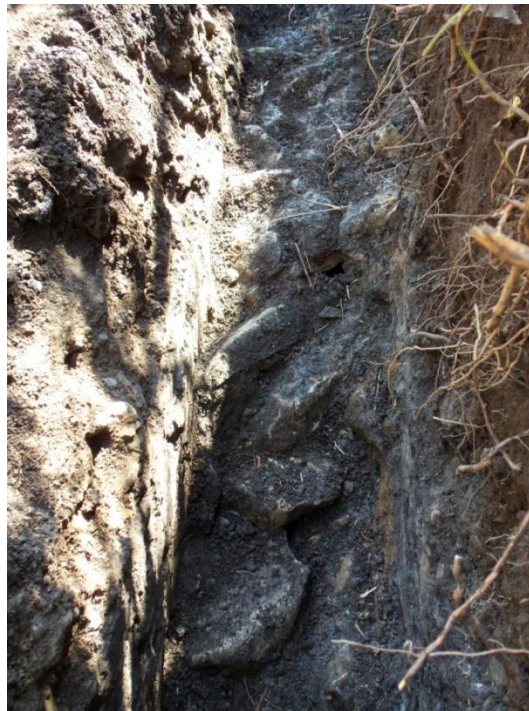
The millrace (9007) was constructed from rough-hewn stones bonded with a white mortar, had a maximum width of 0.7m and was approximately 1.7m deep. Due to the fact that the structure was still in use, it could only be revealed in plan and no further investigations could be made (*Plate 3*).

*Plate 3: Millrace (9007) in AP 9, view S*
