ARCHAEOLOGICAL OBSERVATION

**THE DOWER HOUSE
QUATT
NR BRIDGNORTH
SHROPSHIRE**

**NGR SO 75595 88251
JOB N^o: BA1240DHQ**

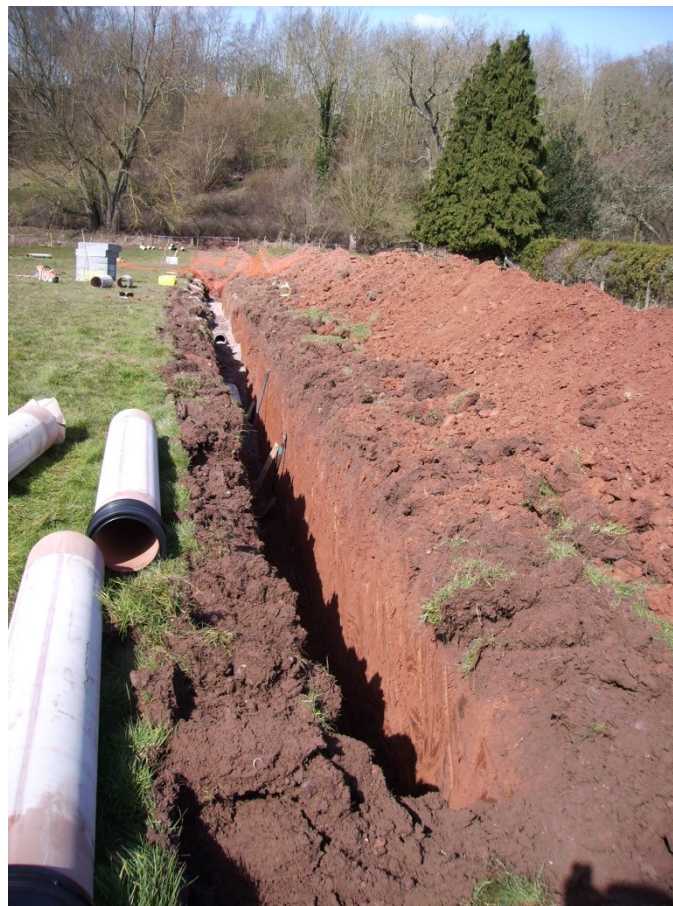
Plate 1: Field 1 facing N to commencement of drain-run

No deposits of archaeological significance were present in Field 1, which lay at the northern extent of the drainage run. No evidence for a worked subsoil was identified, with the topsoil lying above naturally derived deposits.

The possible field boundary had been backfilled with material indistinguishable from the topsoil suggesting that it was of recent date or had been recently backfilled.

Over most of the site the topsoil apparently lay immediately above geological deposits (*Plate 1*). It is possible - certainly within the area of the former playing fields - that levelling and landscaping to form a flat surface may have disturbed any archaeological deposits which may have been present.

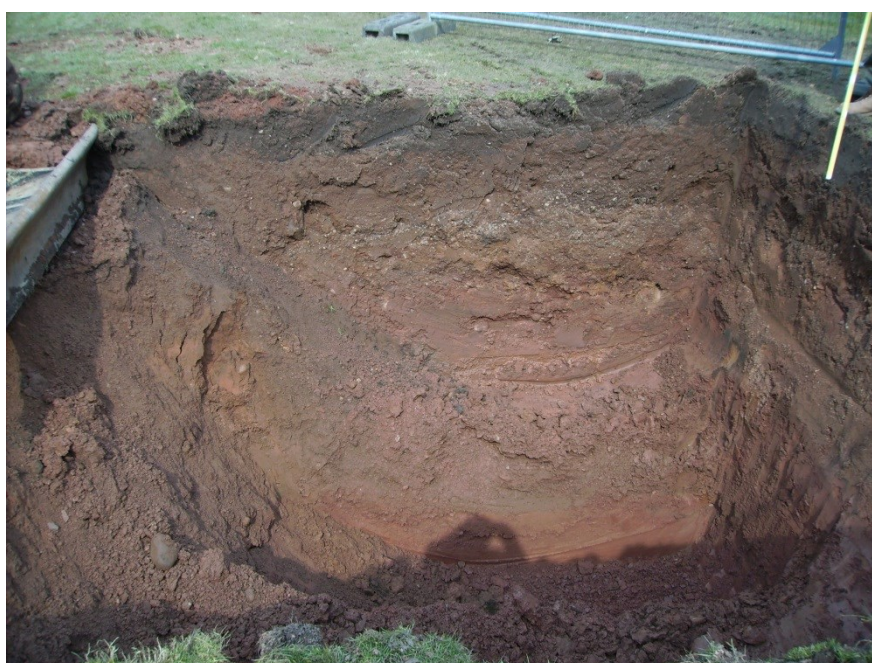
Plate 2: Deposits in the chamber excavation, view N

The excavation for the 'Klargester' chamber was rectangular in form and measured 8m E-W, 3.4m N-S and was excavated to a total depth of 4.2m. The topsoil (101) as seen on other parts of the site was present to a depth of some 0.35m and contained pottery of similar date (19th century and later). Its presence was noted but it was not retained. From the chamber southwards, the natural deposits were of a mixed nature with bands of clay, sand and gravel.

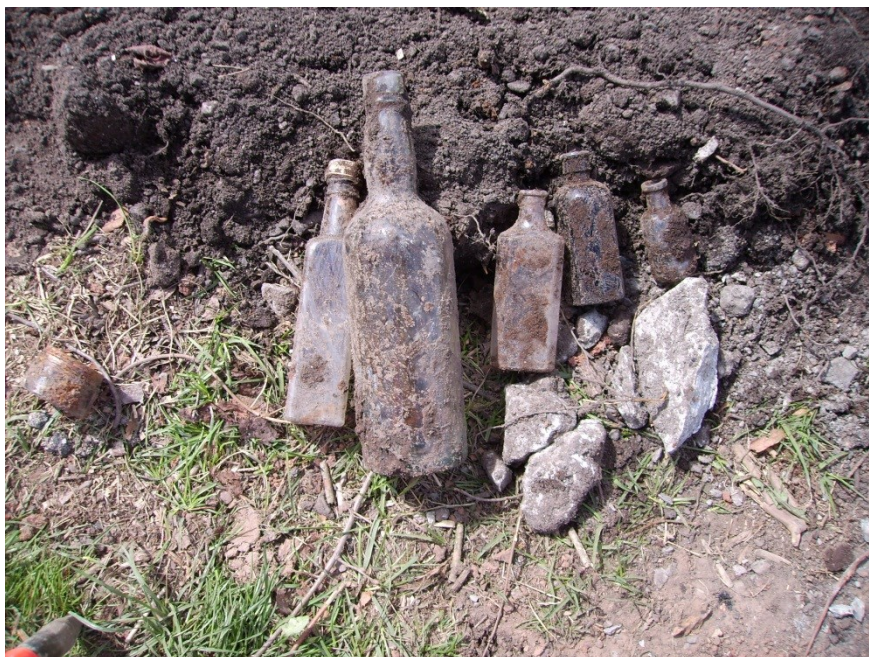
Plate 3: Sample of mid-20th century bottles and jars recovered from ash pits within the car park area

A number of layers of aggregate formed the surface of the car park with the topsoil not present. Beneath them lay the red clay natural subsoil. A large number of modern ash pits were present of which [118] was recorded as a representative sample. The finds (Plate 3) from these features were noted but they were not retained.

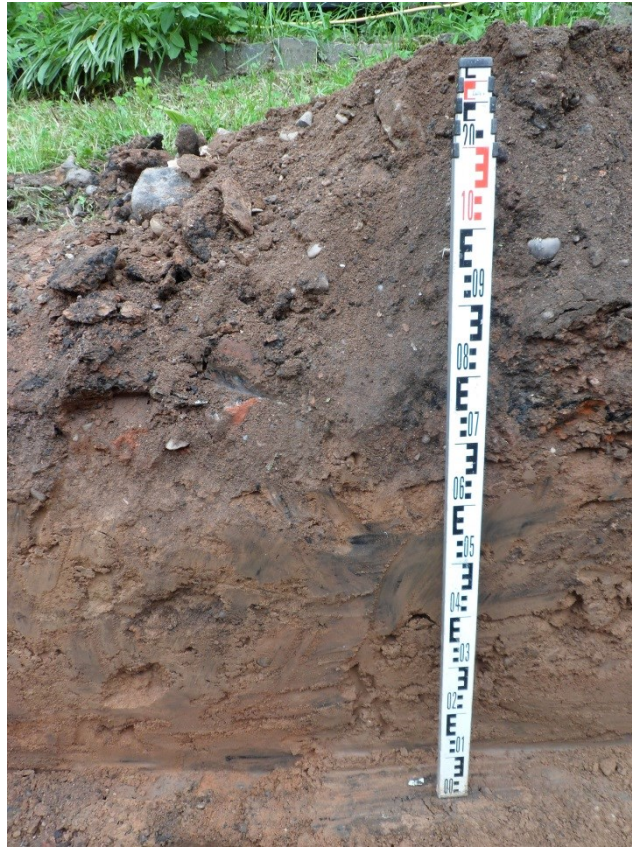
Plate 4: View E showing deposits revealed outside Unit 4 (fig. 3) on driveway

No deposits of archaeological significance were observed. Deposits in this area are described in Table 6

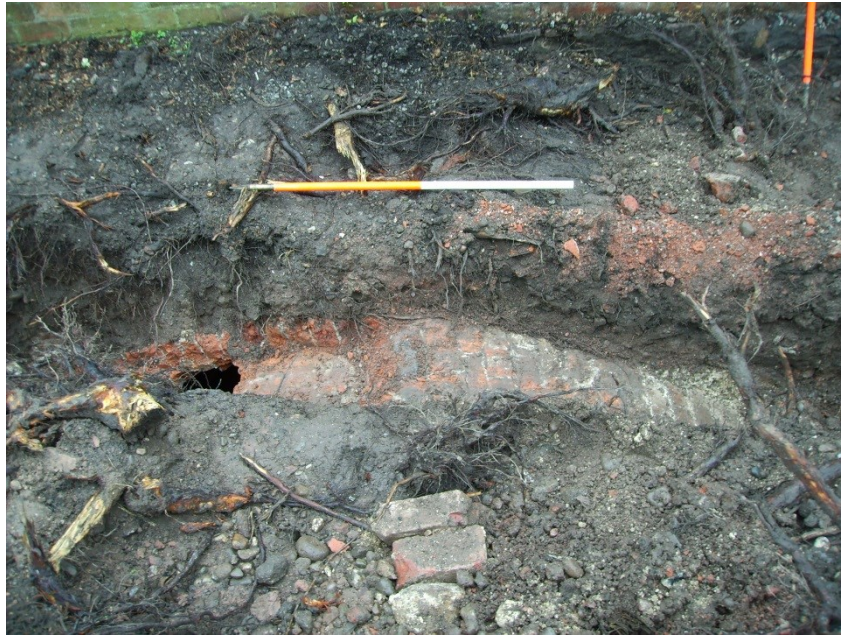
Plate 5: View S showing vaulted roof of the brick tank or cistern

A single structure was recorded on the site, to the S of the garden wall. The part seen was constructed entirely of brick and measured about 3.m in length and the same in width. Where measured it was 3m deep and contained 0.6m water in the base. ‘Tidemarks’ indicated that the water level was higher at some point (Plate 5). Pipes could be seen entering the structure from the direction of the Dower House indicating that the structure was associated with the house.

The vaulted brick roof [124] was of double thickness (Plate 4). The existing garden wall ran above it, demonstrating conclusively that the tank or cistern predated the construction of this wall.

Although damaged, the bricks used were fairly soft and red, with no frogs. They more closely resembled the brick of the Dower House than that used in the construction of later buildings on the site. The mortar in the part of the structure observed was soft and cream with black flecks.

The tank or cistern revealed to the S of the garden wall could have been roughly contemporary with the Dower House. The brickwork certainly suggested that of the older structure rather than the more recent ones and the presence of pipes heading towards the Dower House also imply that it was almost certainly an ancillary structure. It may have been used for gathering water from the guttering for use in the garden, although use as a cesspool is not out of the question.

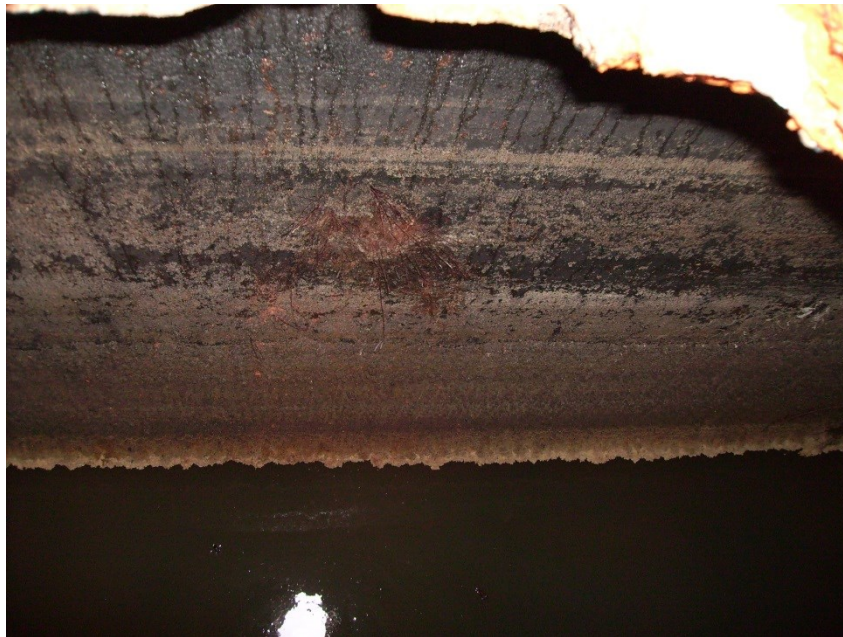
Plate 6: View inside tank or cistern

Use as a cistern is possible, perhaps collecting water from the gutters of the house, although no evidence for a pump or other means of extracting the water was seen.
