ARCHAEOLOGICAL OBSERVATION

PREYWATER ROAD WOOKEY SOMERSET

NGR: ST 51955 45815 – ST 51658 45490
REF: BA1244BWPRW

This report details the results of a programme of archaeological works undertaken by Border Archaeology during the ground-works associated with water mains renewal scheme located within the village of Wookey (Somerset).

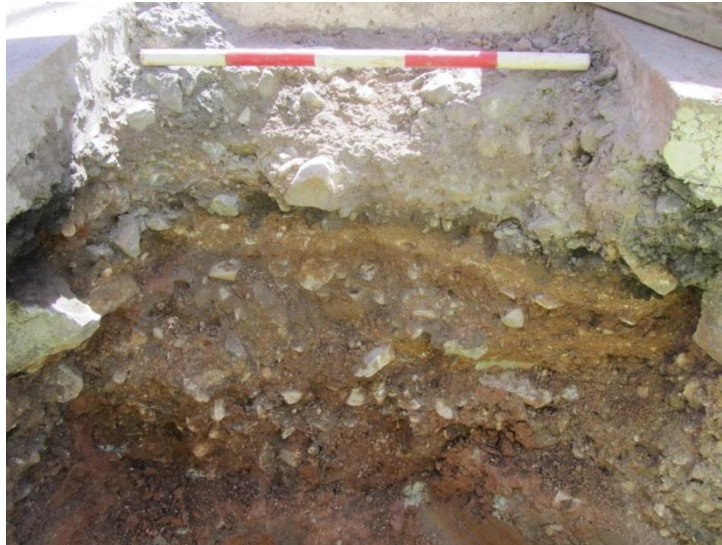
Underlying the modern tarmac road surface (100) and foundation (101) was a sequence of three earlier trackway or courtyard surfaces (102), (103) and (104). Although no dating evidence was recovered from any of these an estimate for the construction date of the surfaces suggested that (102) was probably late 19th – 20th century, (103) early to late 19th century and the earliest surface (104) was of late 18th to early 19th century date. All three surfaces were well constructed and probably had a reasonably long usage serving the church, which lies immediately to the south.

The latest surface in the sequence (102) was constructed from a 0.05m thick layer of very compacted coarse sandy gravel with frequent small fragments of limestone set in a clayey matrix with occasional charcoal flecks. Underlying it the second surface (103), was of compact dark khaki silty clay 0.05-0.07m thick, with occasional charcoal flecks and set with frequent small angular stones. Its silty nature suggested that it may have partly formed during usage. Underlying (103) was the third and earliest of the recorded surfaces (104); this was constructed from a 0.06m thick deposit of very compact brown-buff coarse sand with frequent small fragments of limestone and occasional charcoal flecking. One small non-diagnostic piece of post-medieval ceramic building material (CBM) was noted but was not collected.

Plate 1: Pit 8 view south - outside Lychgate showing surfaces (102), (103) & (104) with ditch [106].

Sealed by (104) was ditch fill (105) which consisted of silty clay with frequent small to medium angular to sub-angular fragments of limestone, occasional charcoal flecks and one very small (5cm) fragment of slate. The open 'V' shaped ditch cut [106] was 0.55m wide and 0.27m deep. Only seen in section, the ditch probably originally formed a continuation of the western boundary of the church.

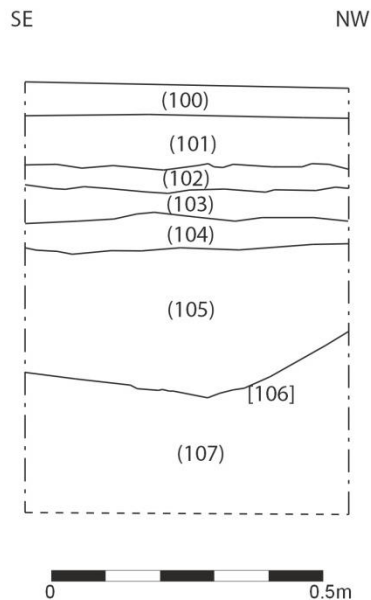
Access Pit 8 was located outside the lychgate in Church Road, it was approximately 'L' shaped with the sides generally of equal length, 2.70m by 0.75m wide and 0.80m deep. The road surface was recorded at a height of 24.40m OD.

Fig 2: Pit 8 - Section recorded outside the lychgate, Church Road, showing multiple surfaces (102-104)

The fact that the three track or courtyard surfaces were not seen in any of the access pits situated further east or west along Church Road suggests they may have only been

constructed in a very localised area surrounding the lychgate and may have been courtyards associated with the church rather than a trackway or lane.

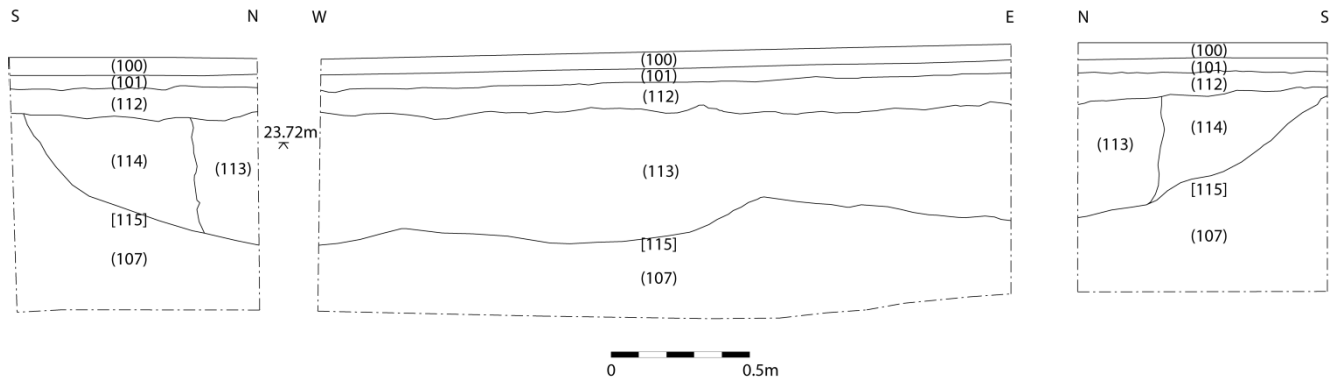
Underlying two modern tarmac road surfaces (100 & 101) was a 0.12m thick deposit of clay and limestone fragments (112) forming the road construction foundation layer. Beneath (112) was (113) the extant remains of the original street frontage curtilage wall of Church

House. Wall (113) was constructed from undressed local limestone blocks bonded with a coarse sandy lime mortar, the style of build suggesting it was random rubble brought to course. The surviving section of wall measured 2.50m long by 0.24m width by 0.50 depth. Underlying (112) and overlying wall (113) was the construction trench backfill (114) which consisted of clayey-silt with frequent small-medium fragments of limestone, charcoal and mortar flecks with rare crushed CBM. Although only the southerly extent of construction cut [115] was seen it appeared to have had a comparatively wide open 'U' shaped profile.

Fig 3: Sections outside Church House showing wall (113)

Documentary evidence suggests Church House was built around 1730, a date supported by a single rim sherd recovered from context (113) brown-glazed pancheon (earthenware mixing bowl) dated 18-19th century (see Appendix 1). It is probable the original boundary wall (113) of Church House was pulled down and moved approximately 1.0m northwards to its current position when High Street was widened during the 20th century and footpaths were instated.

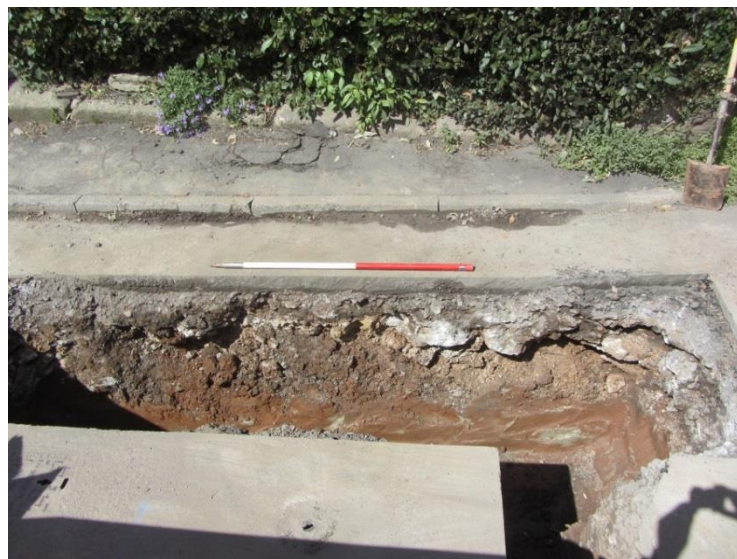
Plate 2: Pit 12 view north - Section outside Church House showing wall (113).

Outside Church House, High Street the surviving remains of the original street frontage curtilage wall (113) was revealed in access pit 12. Documentary evidence suggests Church House was built c.1730, pottery recovered from the wall backfill (114) suggested an earliest date of 18-19th century for construction of the wall which supports documentary sources. The current front wall of Church House is located approximately 1m further to the north, it is probable the original wall was demolished during the late 20th century when the road was widened and the footpath instated.

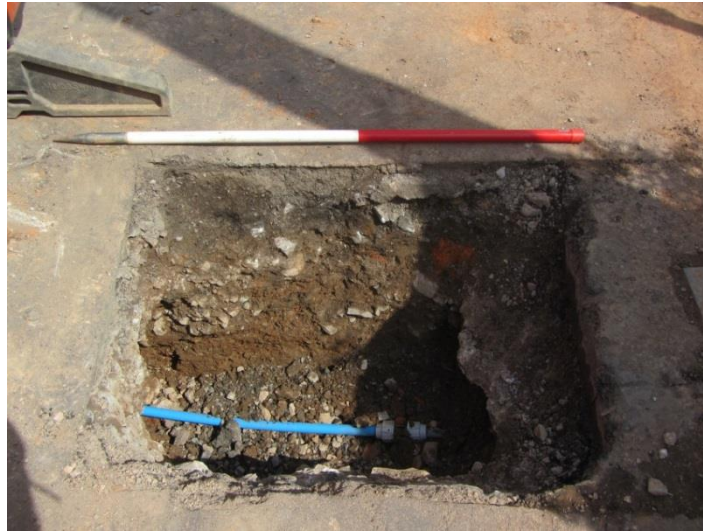
A small access pit (*Plate 3*) was excavated by contractors on the south side of High Street in a position aligned with the partition wall of numbers 1 & 2 High Street. The excavation of this pit was not scheduled; its position blocking access along High Street necessitated closure after approximately two hours highly restricting potential investigation.

The archaeology revealed the same simple upper stratigraphic sequence as was recorded elsewhere with modern road surface (109) and foundation layer (110) overlying the cut [118] for a deep modern water utilities service trench. Service trench cut [118] cut the fill of a post-medieval rubbish pit (119) a compact dark grey silty clay intermixed with small angular fragments of limestone. Pit [120] cut the upper fill (121) of an earlier rubbish pit, a compact dark brown silt clay with flecks of charcoal, occasional non-diagnostic fragments of post-medieval CBM, a single fragment of animal bone (not collected) and two sherds of pottery. Underlying (121) was (122) a dark brown silty clay, the earliest identified fill of the pit. Due the limited area seen it was not possible to elucidate any further about the character of this deposit or of the pit itself. The two sherds of pottery recovered from fill (121) were identified as being either Bristol or Staffordshire feathered slipware from the late 17-18th century providing a probable earliest date for the fill.

Plate 3: Pit 29 view east opposite No.1 & 2 High Street showing post-medieval pit fill (119) & cut [120] and earlier pit fills (121-122)

The only archaeological features and finds of any significance were identified to the north of the scheme in High Street and Church Road. In access pit 29 opposite Nos. 1 & 2 High Street was evidence for the remains of two intercutting rubbish pits. Unfortunately the access pit had to be backfilled the same day, substantially limiting its recording and interpretation; however pottery recovered from fill (121) suggested an earliest date of the late 17-18th century.
