# ARCHAEOLOGICAL OBSERVATION

## WATER MAINS REPLACEMENT SCHEME CASTLE PARK BRISTOL

NGR ST 58980 72940 - ST 59099 73040  
JOB N<sup>o</sup>: BA1314BWCPB

APRIL 2013

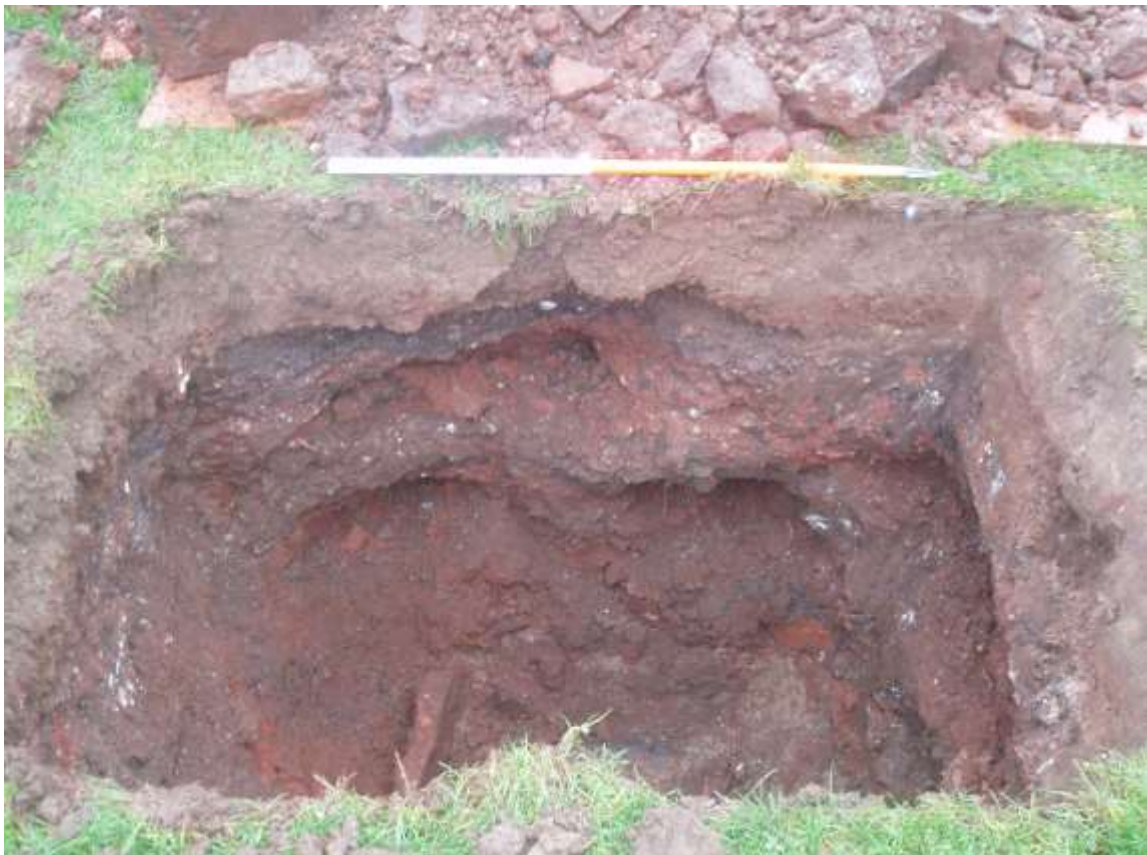
There was nothing of archaeological significance present, with the stratigraphic profile comprising of a soft dark greyish-brown sterile clayey silt topsoil (101) overlying a reddish-brown stony gravel levelling layer (102) encountered at a depth of 0.2m. Underlying this was a silty sand and rubble made ground deposit with inclusions of small to medium stones, brick fragments, oyster shells and charcoal and mortar flecks (103), encountered at a depth of 0.3m, that is associated with the 1970s landscaping of Castle Park and postdates the insertion of the main.

(103) sealed a deposit of demolition material at a depth of 0.7m, containing large worked stone blocks, concrete and sections of mortared brickwork in a loose dark brown and black sandy silt matrix (104) probably associated with the post-WWII levelling and clearance of the bomb damaged properties in this area.

*Plate 1: View looking SE showing NW-facing section of Pit 1*

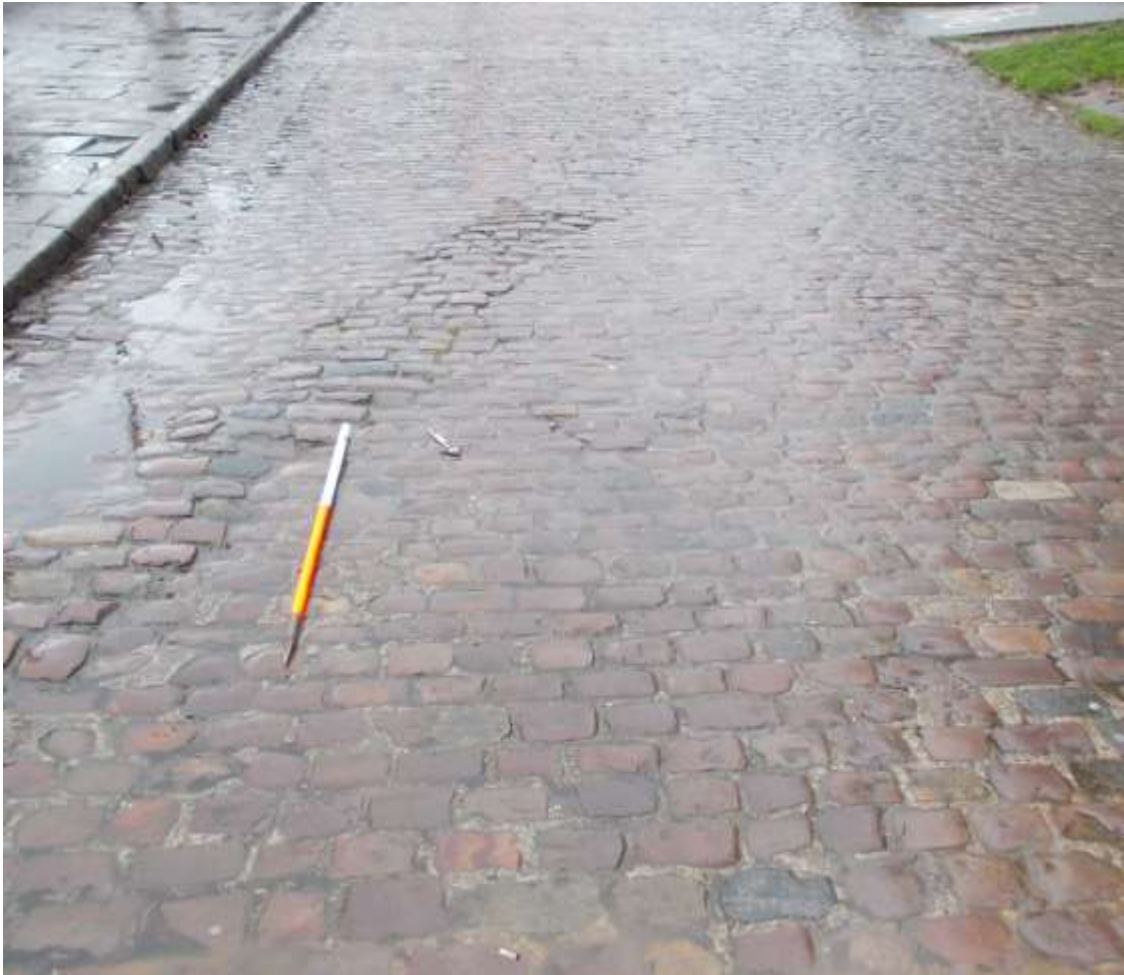
*Plate 2: View looking SW along Back Bridge Street towards the junction with High Street showing former cobbled road surface (201)*

The surface (201) was formed of regular/sub-rectangular cobbles with rounded corners and of varying sizes, approximately 500mm to 200mm in length and 100mm to 60mm in width, with an average depth of 250mm. Underlying the cobbles was a grey sandy bedding deposit (202) encountered at a depth of 0.25m which sealed three separate concrete deposits (203), (204) and (205), all backfills around various services (including the 1885 disused main).

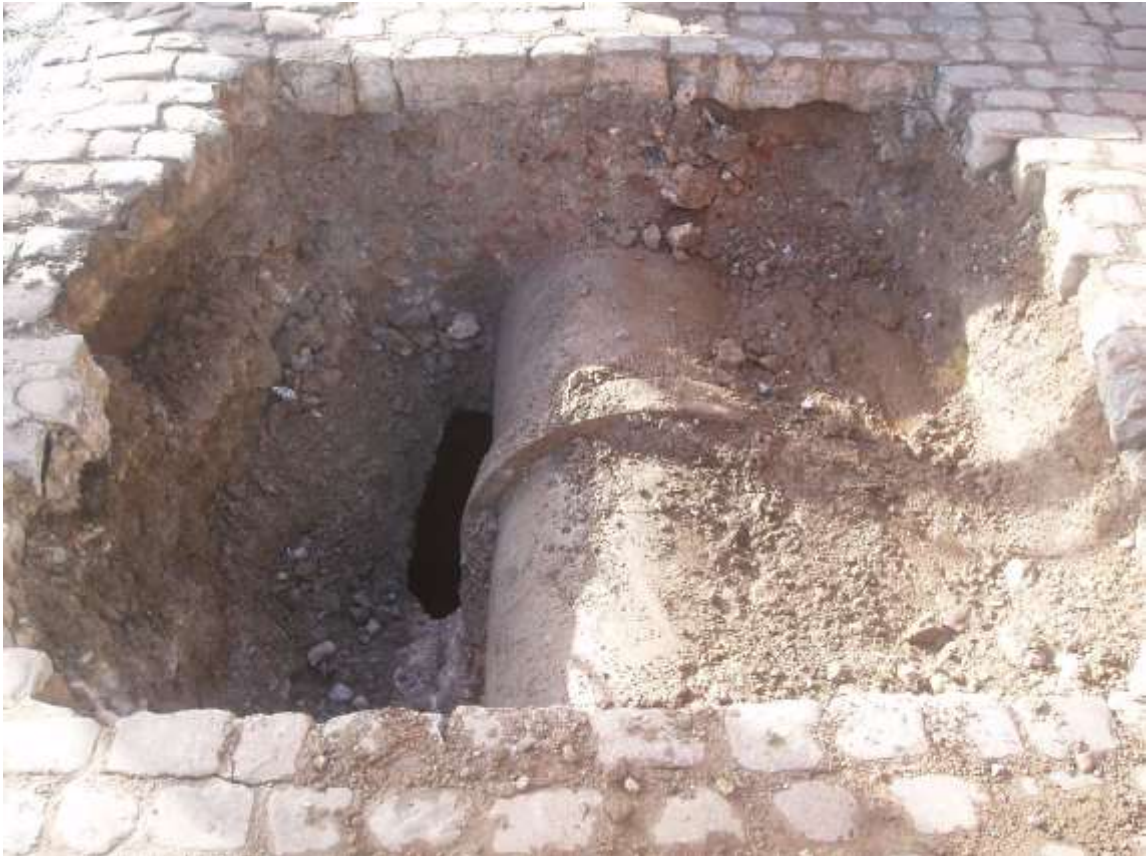
*Plate 3: View looking NE showing void in Pit 2 beneath 1885 water main*

In the course of removing (205) to gain access to the main, a void was encountered beneath the pipe and further excavation was halted (*Plate 3*). Unable to be continued, this trial-hole was abandoned and backfilled.

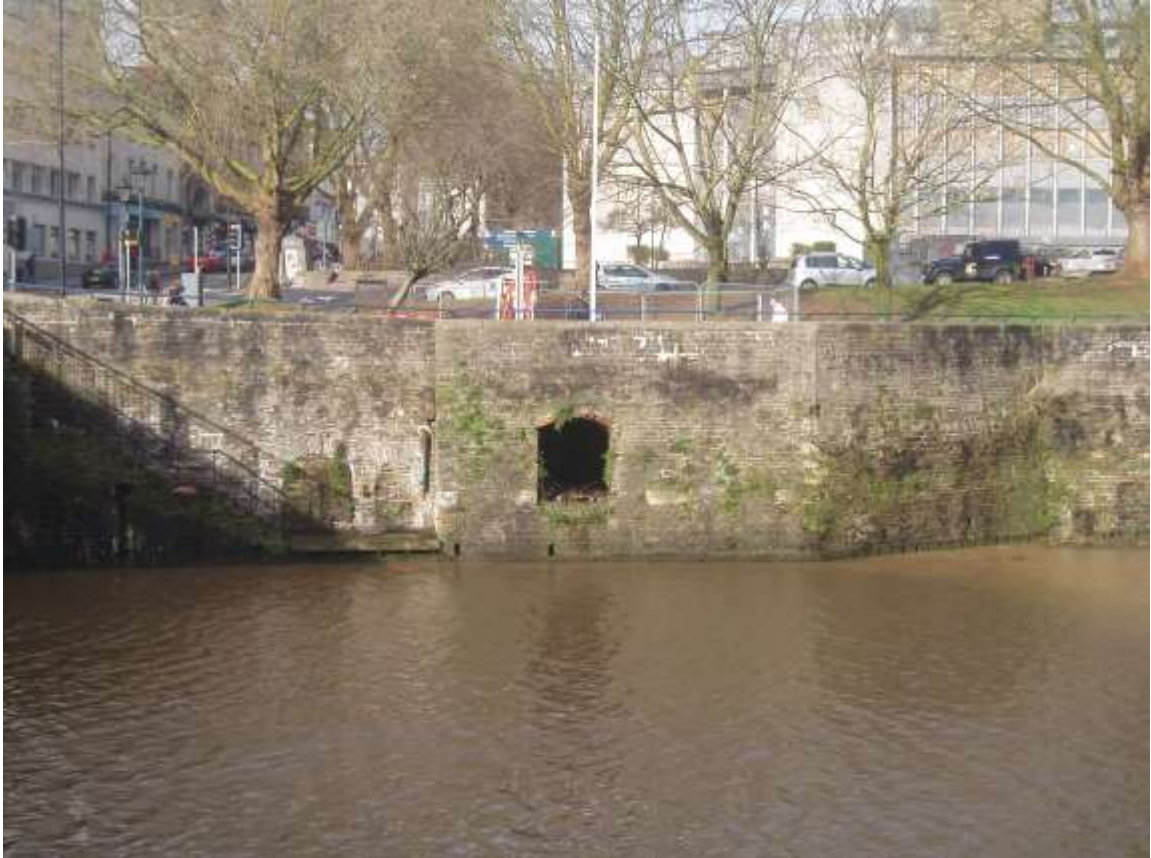
After subsequent study of the area from the opposite side of the river, it was established that the void led into a chamber or cellarge built underneath Back Bridge Street, which appears to have led to a landing stage on the waterfront, accessed via a segmental arched opening inserted in the walls of the floating harbour (*Plate 4*). The date of the chamber is uncertain; it could be associated with properties on the S side of Bridge Street (laid out in the 1770s), although it could be connected with a late 19<sup>th</sup> century urinal and horse shelter marked in this location on the OS 1<sup>st</sup> edition map of 1885. The archway and landing stage can be seen in a photograph of the waterfront taken from the S side of the river in the early 1920s (*Plate 13*).

*Plate 4: View looking N showing segmental-headed archway leading to chamber set into the thickness of the early 19<sup>th</sup> century harbour walls*

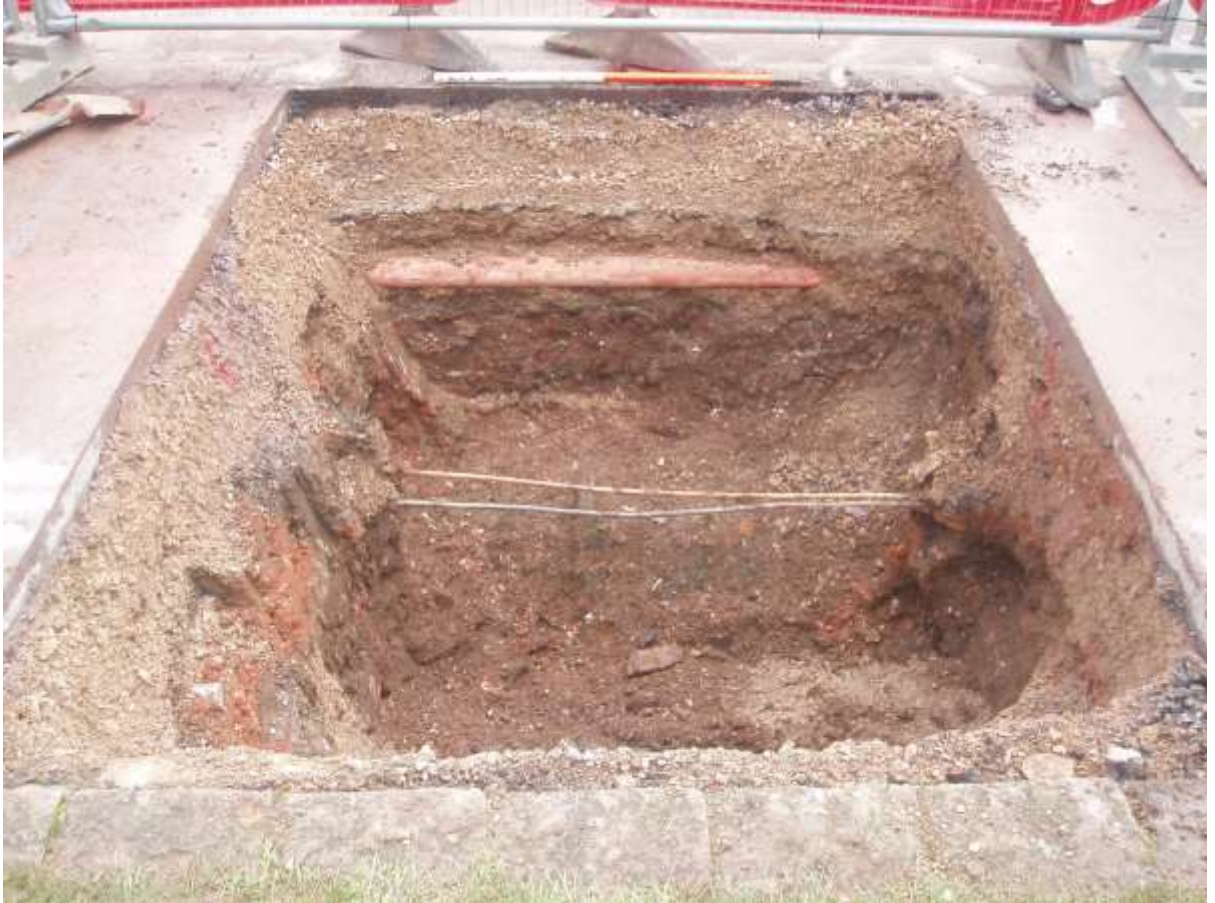
Pit 3 was located approximately 70m to the E of Pit 2 along the route of the 1885 main and was excavated as a replacement for Pit 2. It measured 2.54m (NE/SW) × 2.03m (SE/NW) reaching a depth of 1.2m (*Plate 5*).

Beneath the modern tarmac surface of the cycleway (301) and associated mid yellowish-brown small stone bedding layer (302) encountered at a depth of 0.1m, there was a demolition layer (303). This layer was similar to that in Pit 1 (104) and encountered at a depth of 0.38m. However, unlike (104) with a thickness of at least 1.1m this material was only 0.35m thick and contained much smaller stones and brick rubble. It seems likely that this difference in depth is due to Pit 1 being located in the footprint of a cellared building whilst this pit is located in the former road.

*Plate 5: View looking SE showing NW-facing section of Pit 3*

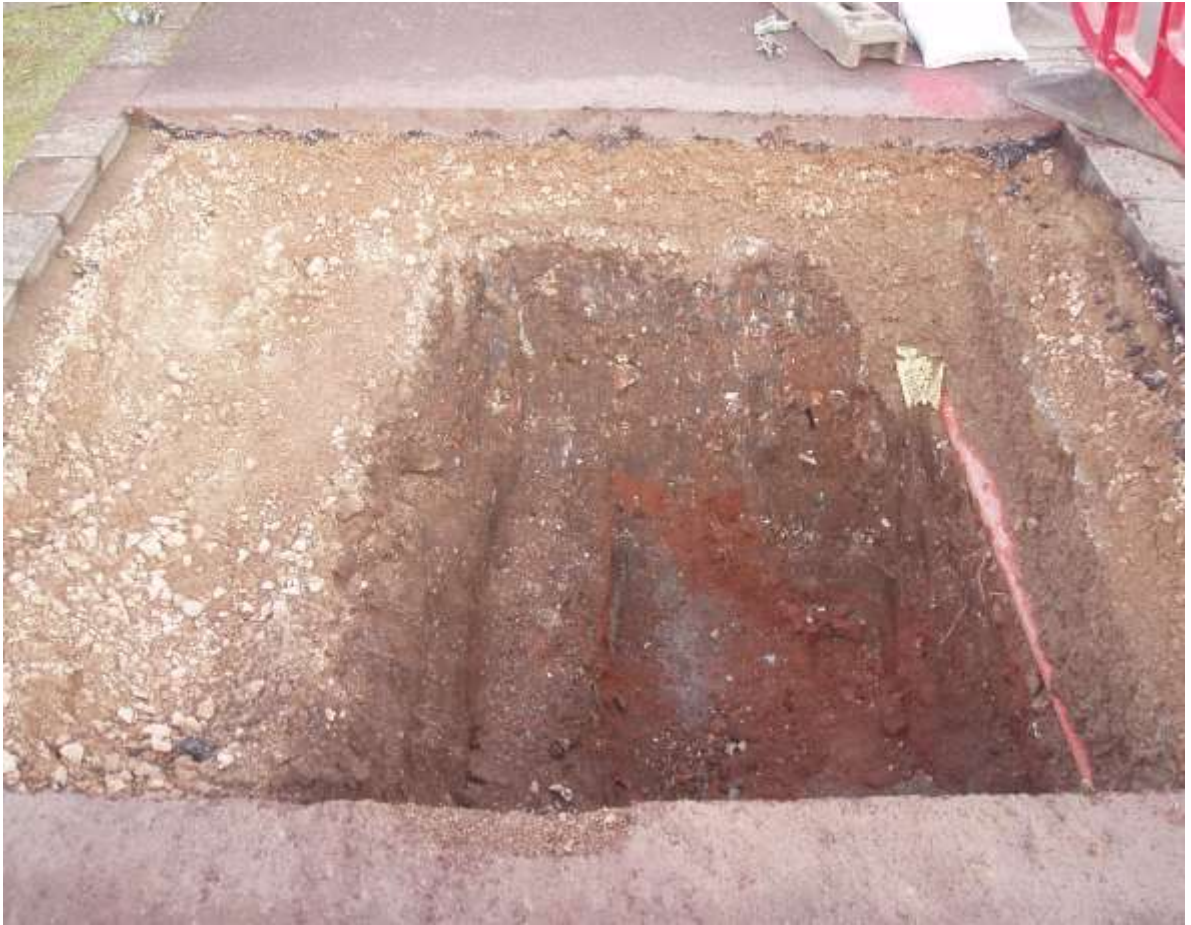
The uppermost deposits comprised the tarmac surface of the cycleway (401) and associated mid yellowish-brown small stone bedding layer (402) encountered at a depth of 0.1m. This overlay a soft dark reddish-brown and black mottled sandy silt with frequent small to medium sub-angular stones and occasional oyster shell (403), encountered at a depth of 0.67m, which sealed a fairly sterile soft mid reddish-brown sandy clay with moderate small to medium stones (404) encountered at a depth of 1.05m (*Plate 6*). As with (304), both (403) and (404) appeared to represent made-ground deposits associated with the construction of Bridge Street and Back Bridge Street in the 1770s, which were heavily disturbed by the insertion of the late Victorian water main and later by extensive demolition and landscaping activity following the bombing of the area during WWII.

Plate 6: View looking NE showing SW-facing section of Pit 4

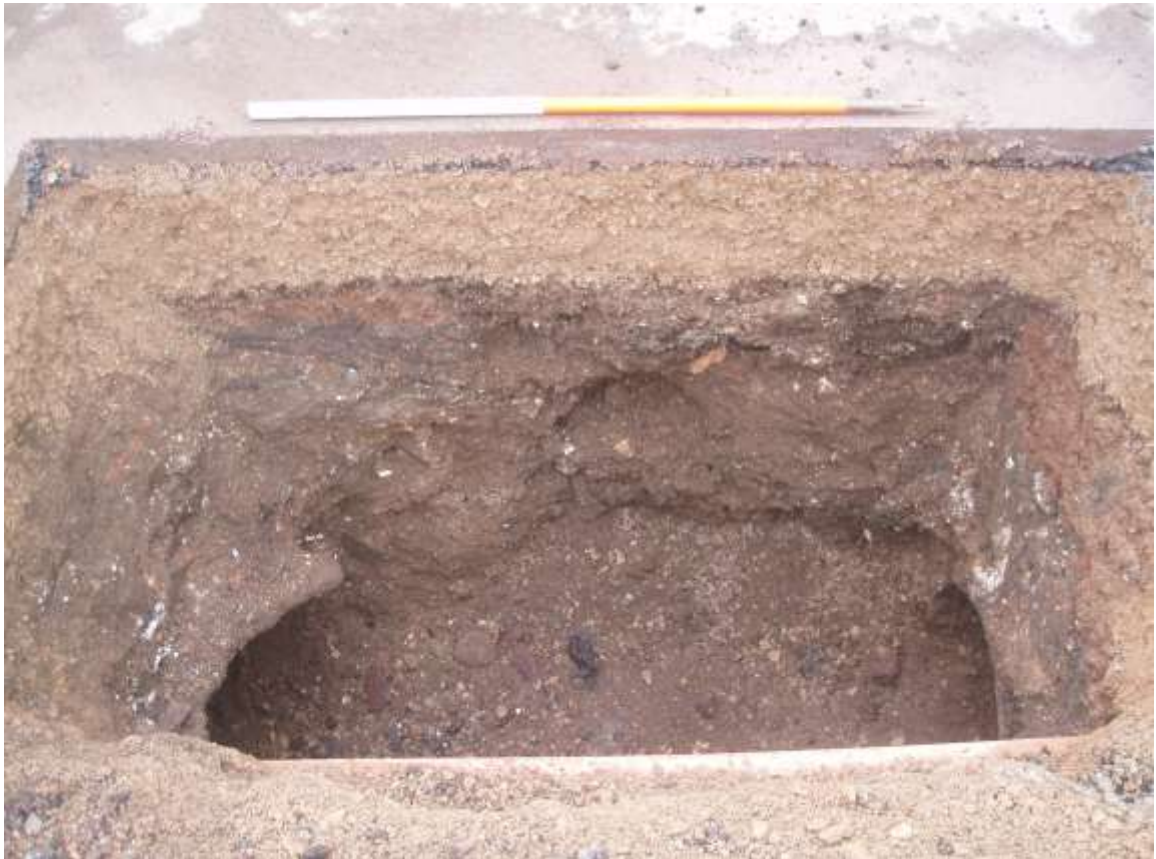
*Plate 7: View looking NW showing SE-facing section of Pit 6*

The stratigraphic profile comprised the tarmac cycleway surface (601) and associated mid yellowish-brown small stone bedding layer (602) encountered at a depth of 0.1m. Underlying this was a made ground deposit of soft mid reddish-brown and dark greyish-brown mottled clayey sand with inclusions of moderate small to medium stones and brick fragments (603) encountered at a depth of 0.45m. This material is again likely to relate to the mid-18<sup>th</sup> century road construction but later disturbed context (603) was truncated by [606] the linear 1m wide and greater than 1.35m deep cut for a storm drain that feeds into the river. This was backfilled with (604), disturbed and re-deposited (603) to a depth of 1.25m sealing (605) light grey small stones to a depth of greater than 1.6m.

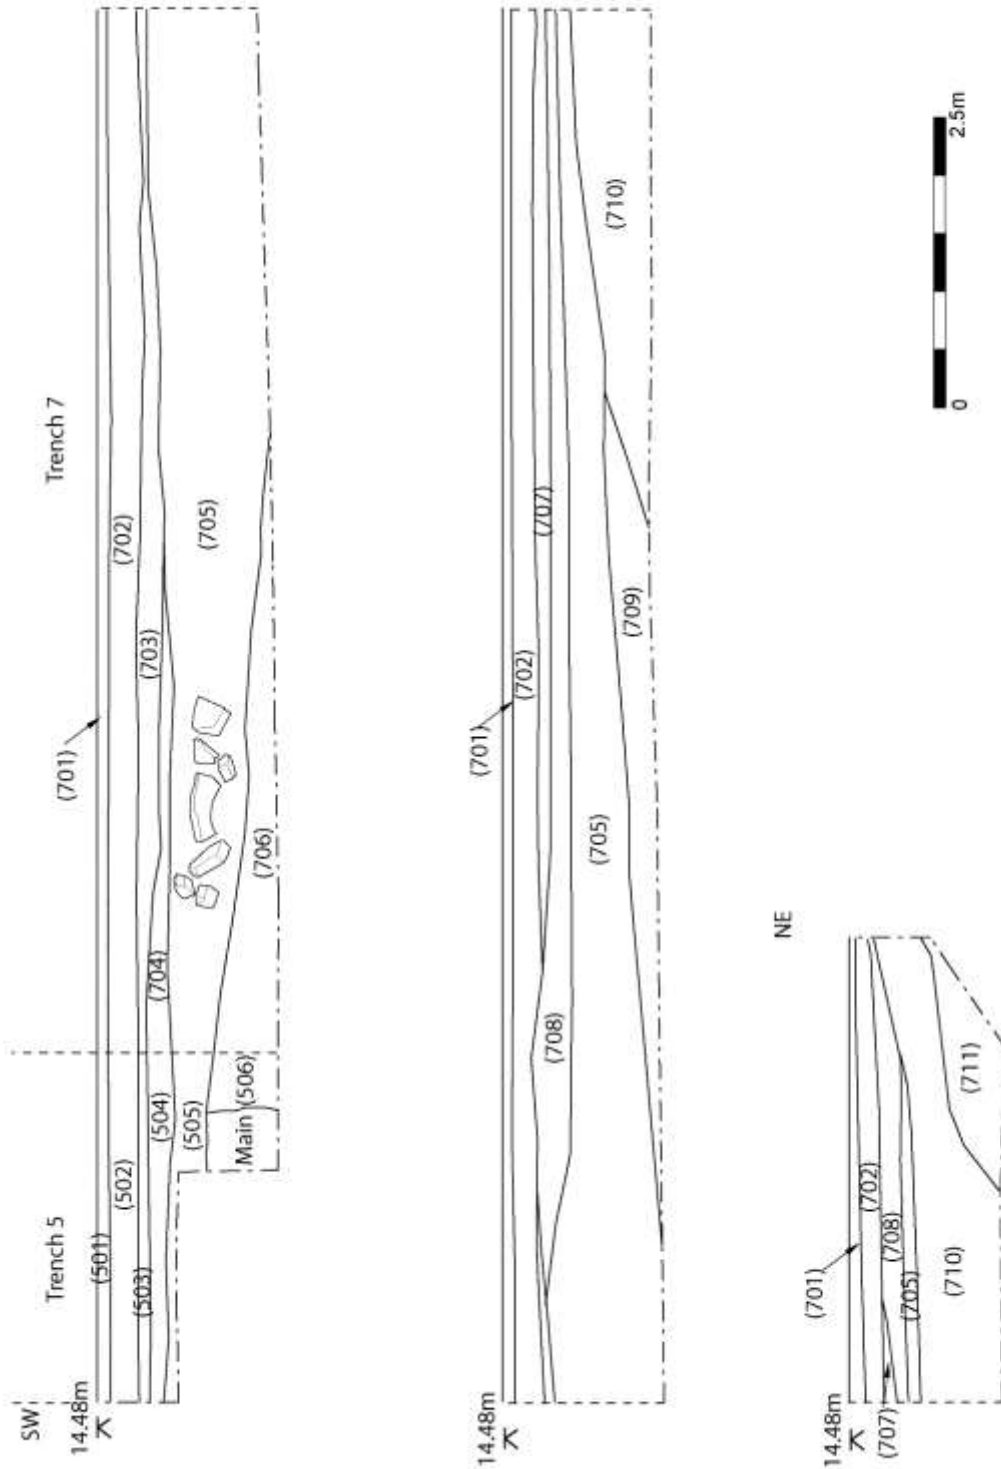
Although no significant archaeology was identified, the sequence of deposits within this pit differed slightly from those along the majority of the route, with several additional layers beneath the tarmac surface of the cycleway (501) and associated mid yellowish-brown small stone bedding layer (502) encountered at a depth of 0.1m. These were the fairly sterile dark blue clay (503) and underlying loose mid orangey-brown sand with medium to small stone inclusions (504) encountered at depths of 0.4m and 0.6m, respectively (*fig. 2*). These layers were also present in Trench 7 and are likely to represent additional levelling associated with an area of demolition material in this pit and the trench.

Underlying (504) was a demolition deposit (505), which contained large to medium sub-angular stone blocks including keystones, flagstones, small to medium stones and bricks in a loose dark reddish-grey and black gritty sand matrix and was encountered at a depth of 0.95m. Context (505) was interpreted as a demolition deposit probably associated with post-

Fig. 2: SE-facing section of Pit 5 and its continuation in Trench 7

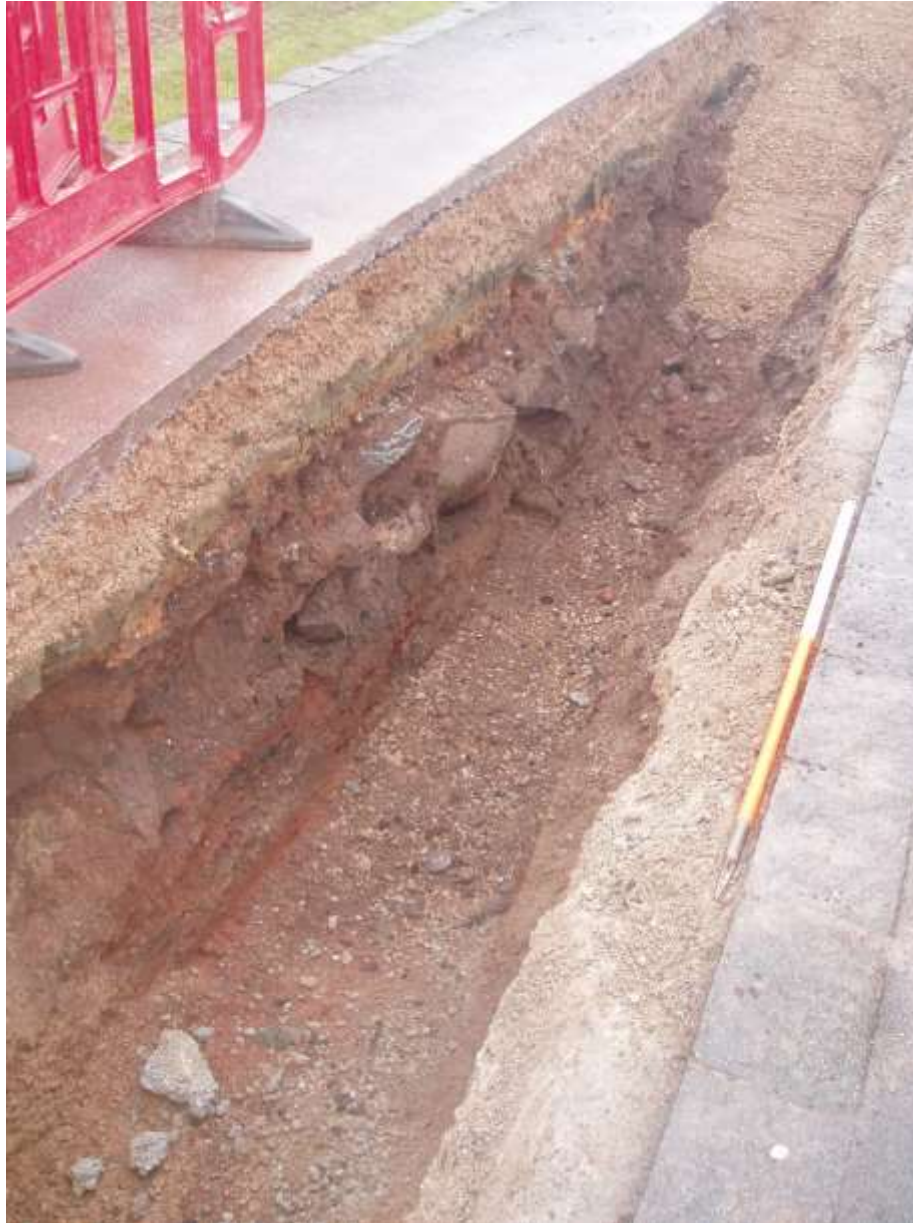
Trench 7 was a stretch of open-cut trenching between Pits 4 and 5 along the route of the 1885 main and was excavated to lay pipe where the main was missing. It measured 24m (NE/SW) × 1.6m (SE/NW) reaching a depth of 1.5m (*Plate 8; fig. 2*).

*Plate 8: View looking NNE along Trench 7 showing concentration of worked stone in demolition deposit (705) in SE-facing section of trench*

A sequence of made ground and demolition deposits was recorded, largely resembling those revealed in Pit 5, with several additional layers present at the E end of the trench. Underlying the tarmac and bedding deposits that are present in Pit 5, (701) and (702), respectively, was another sequence of similar deposits. Tarmac (707) was encountered at a depth of 0.3m and the associated mid brownish-red small stone bedding layer (708) was encountered at a depth of 0.45m. Both of these layers are only present over an area of

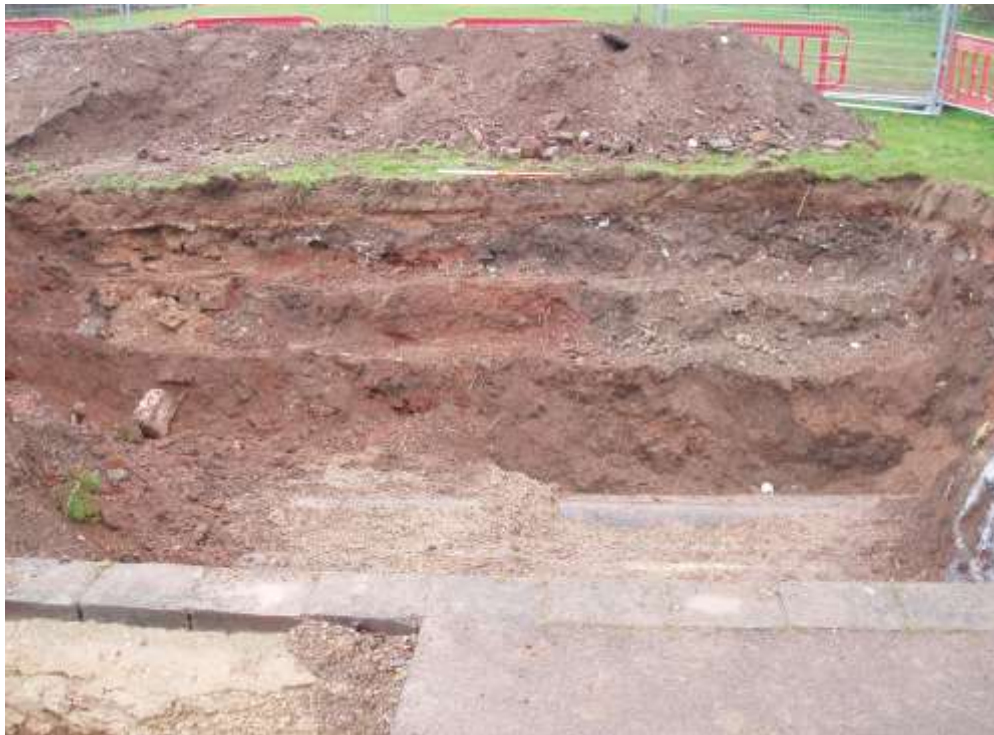
*Plate 9: View looking NW showing SE-facing section of Pit 8*

The pit contained no significant archaeology although extensive demolition deposits associated with post-WWII clearance and landscaping activity was noted. The stratigraphic profile comprised a soft sterile dark greyish-brown clayey silt topsoil (801) overlying a reddish-brown stony gravel levelling layer (802) encountered at a depth of 0.2m. Underlying this at the SE end of the pit was (807), similar to the modern made ground deposit present in Pit 1 (103) and at the NW end, (803) a light brownish-yellow stone levelling layer, encountered at a depth of 0.3m and extending 4.5m (SE/NW). This layer was 0.15m thick and sealed the demolition deposits (804) (805) and (806).

All of these deposits contained large sub-angular stone blocks, small to medium stones, bricks and brick fragments, with (804) also containing large sections of mortared brickwork. Context (804) was in a loose mid greyish-black sandy silt matrix (805), a loose mid reddish-orange sandy silt matrix, and (806), a loose light pinkish-grey silty sand matrix. Context (804) also contained a glazed tile fragment probably originating from the demolished properties. These deposits all sloped slightly towards the NE indicating that they were tipped from the W during the clearance and levelling of the area. Although this trench was not entirely located over the footprint of a former property, it is likely that the whole area was substantially reduced during the demolition of the properties and associated cellarge and these deposits are filling that lowered area.

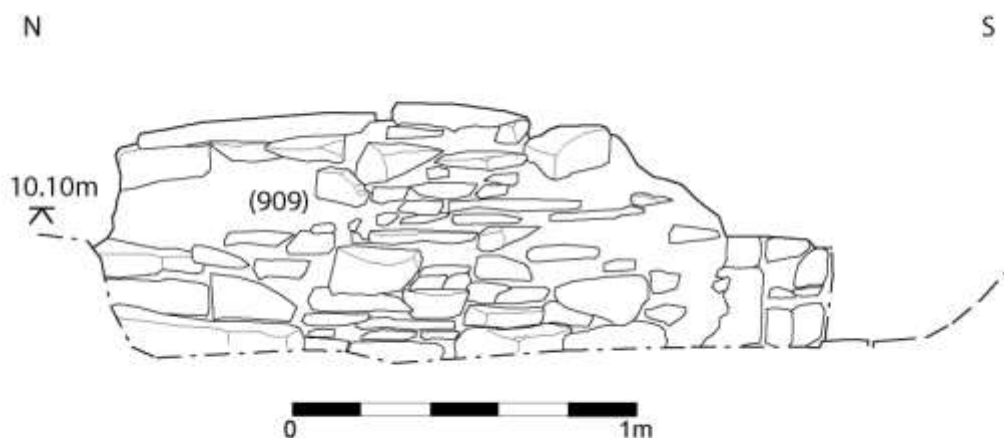
Fig. 3: W-facing profile of masonry wall (909) identified in Pit 9

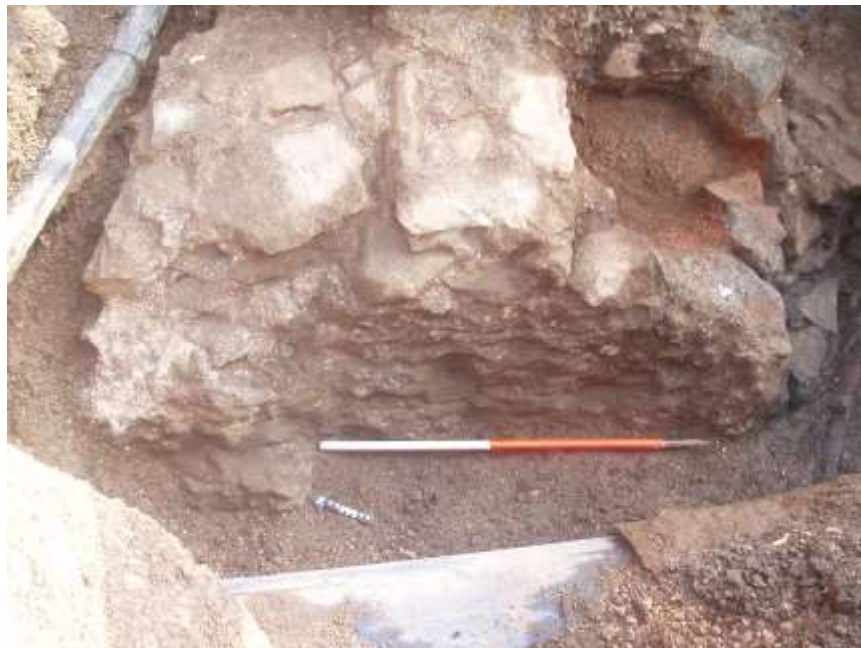
*Plate 10: View looking NE showing SW-facing elevation of wall (909) in Pit 9*

Underlying this made ground (and also truncated by all of the same service trenches) were the fragmentary remains of a Pennant sandstone masonry wall (909) (*Plates 10 & 11; fig. 3*). The wall was composed of irregular un-worked grey sandstone of varying size, approximately between 600mm to 180mm in length and 380mm to 60mm in width, with depths of between 140mm and 40mm. The masonry was chiefly bonded with a mid to light whitish-grey mortar with charcoal flecks and was of a random un-coursed construction.

Despite the truncations, the wall survived in plan to measurements of 2.1m (NE/SW) × 1.9m (SE/NW) and was exposed to a depth of 0.75m between 1.25m and 2.00m below existing ground level (11.96m AOD). An area at the S end of the wall had been disturbed by concrete (911), which was likely to be associated with service trench [914]. The bonding and construction of the stonework at the extreme SE end of the wall appeared differ slightly from the main part and there was a small area at the NE side where the stones were pitched instead of lying flat and this could possibly represent the insertion of a post-pad and packing (*Plate 12*). The presence of several services within the pit meant that these areas were

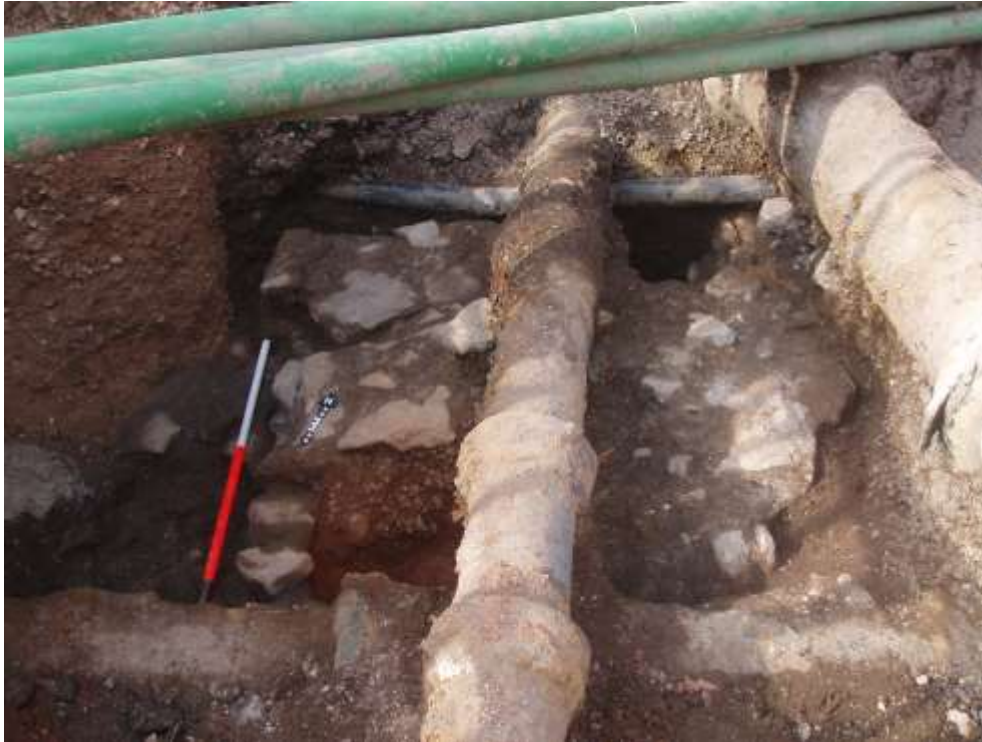
*Plate 11: View looking NW showing wall (909) overlaid and partially truncated by late 19<sup>th</sup>-20<sup>th</sup> century service pipes*

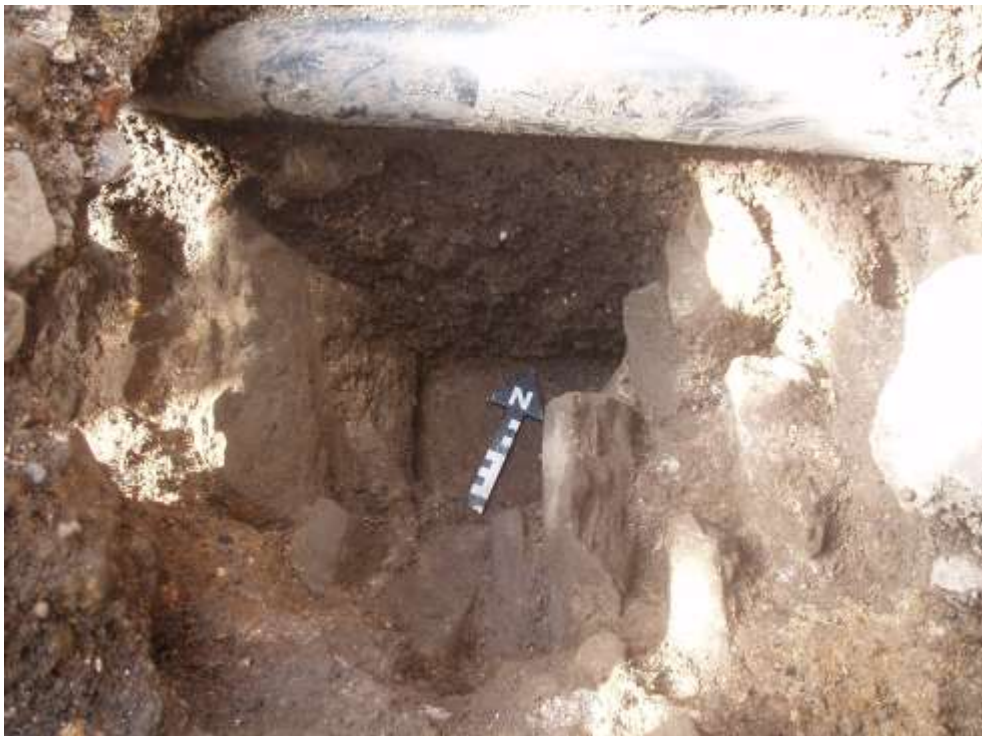
*Plate 12: View looking NNW showing area of pitched stone (possible post-pad and packing) in wall (909)*

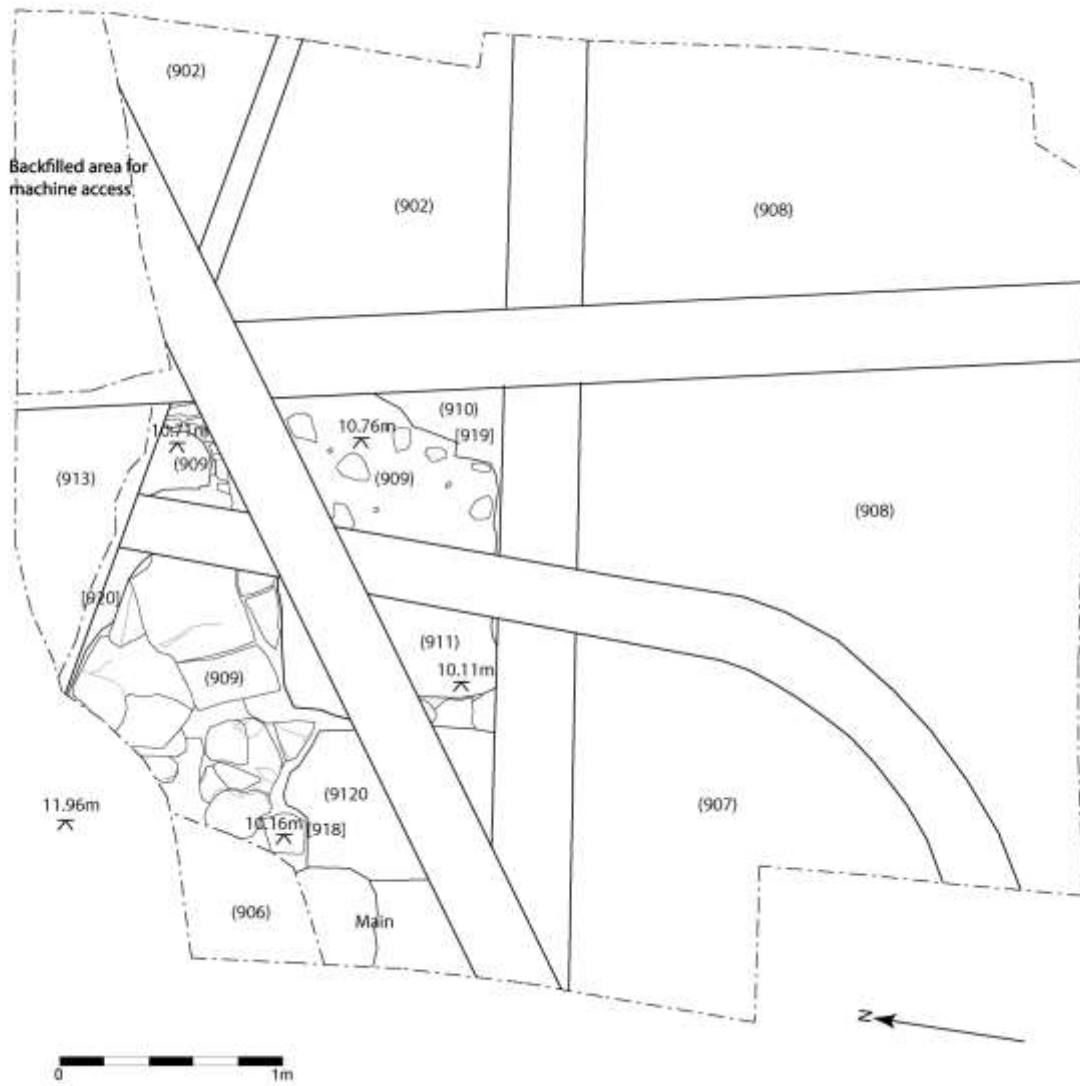
Fig. 4: Plan of Pit 9 showing masonry wall (909)

A heavily truncated section of masonry walling (909) was revealed in Pit 9 at a depth of between 1.25 and 2.00m below ground level, situated at the junction of Back Bridge Street and the High Street on the northern approach to Bristol Bridge. Only a small section of the wall was visible, due to the limited extent of the excavation and the presence of several services within the pit. Context (907), the deposit overlying (909) produced a small ceramic assemblage, chiefly comprising slipwares of late 17<sup>th</sup> -18<sup>th</sup> century date, with a small quantity of number of porcelain and blue painted wares of late 18<sup>th</sup> -early 19<sup>th</sup> century date and later 19<sup>th</sup> century stonewares and wall tile fragments; however, none of this material can be regarded as securely stratified as this deposit had clearly been heavily disturbed by the insertion of 19<sup>th</sup> -20<sup>th</sup> century services.

The date of the wall cannot be more definitely established by stratigraphic means; however analysis of three mortar samples recovered from (909) appears to indicate that there were two distinct phases of construction/repair. The predominant bonding material appeared to be a mid to light whitish-grey mortar while the area of pitched stones, possibly representing a post-pad on the NE side of the wall was bonded with a yellowish- brown-grey mortar. Significantly the lime in the two samples taken from the N and S parts of (909) had not carbonated, suggesting that the parts of the structure with which they were associated must have always been underground and/or in wet conditions, whereas the sample taken from the pitched stones had carbonated. The crude composition of both mortars, consisting of a coarse lime/ash mixture (the fuel ash probably being derived from the base of the kiln and not deliberately added coal ash), suggests a medieval or early post-medieval date, probably predating the 19<sup>th</sup> century.

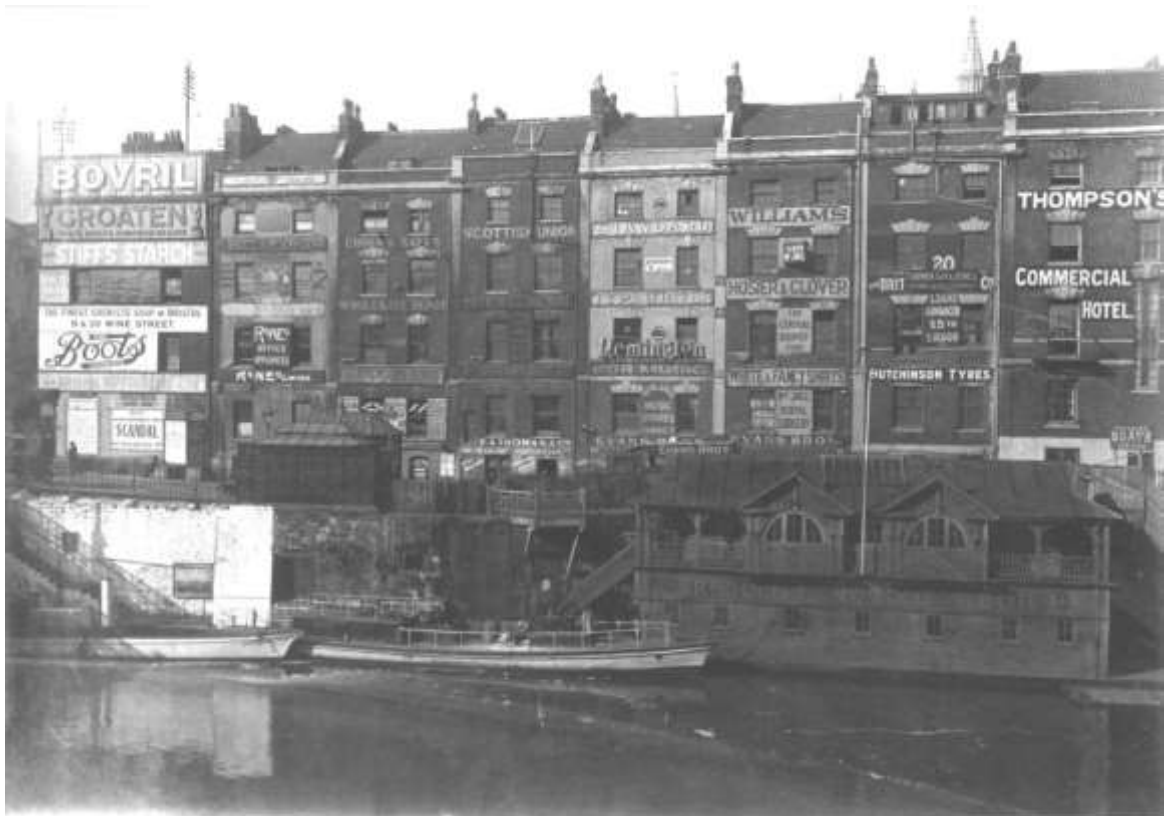
The excavation of Pit 2, located in the area of the former cobbled road surface (201) at the W end of Back Bridge Street, revealed evidence of a void leading to a subterranean chamber or cellar which it was not possible to investigate further (as excavation was halted in this location). The chamber/cellar appears to have been associated with a landing stage on the riverside, accessed via a segmental-headed archway set into the thickness of the floating harbour walls which project out slightly at this point.

The subterranean chamber may have provided access to the waterfront for premises situated on the S side of Bridge Street, although it is also possible that the chamber was associated with a late 19<sup>th</sup> century cast-iron urinal and horse shelter (first marked on the OS 1<sup>st</sup> edition map of 1885) located on Back Bridge Street immediately above the archway. The archway and the landing stage associated with it are visible on a photograph of Back Bridge Street from the river taken in the early 1920s, which also shows the cast-iron urinal and horse shelter (removed by 1946) located on the waterfront just above the archway.

*Plate 13: Photograph taken in the early 1920s looking NW across the river towards Back Bridge Street, showing the archway and landing stage in the bottom left-hand corner of picture  
(Reproduced by courtesy of Bristol Record Office)*

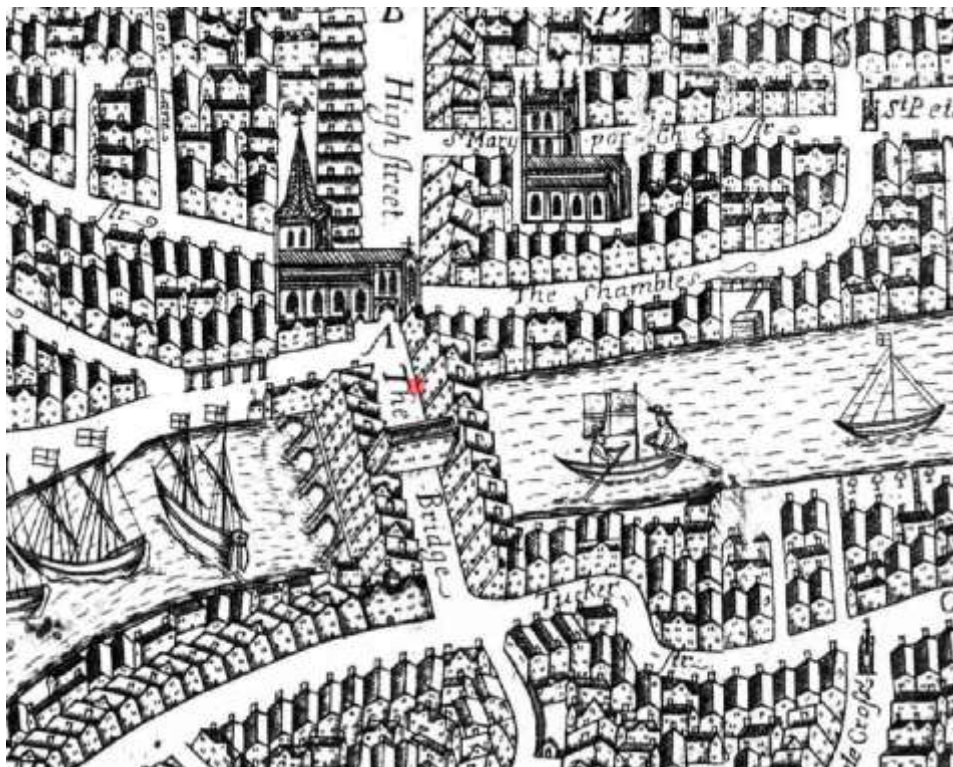
*Plate 14: Extract from Jacob Millerd's bird's eye view of Bristol dated 1673 showing Bristol Bridge, with approximate location of Pit 9 indicated by a red circle  
(Reproduced by courtesy of Gloucestershire Archives)*

Prior to its rebuilding in the mid-1760s, the medieval bridge (built between c.1240-50) is known to have been a four-arched masonry structure lined with approximately 45 houses and a chapel in the centre, as well as properties on the immediate northern and southern approaches, as depicted on Millerd's map of 1673 (*Plate 14*) and early to mid-18<sup>th</sup> century engravings of the bridge (Leech, 2000).
