Border Archaeology carried out Archaeological Observation of ground-works between November 14th and 22nd 2013 at 2 Gloucester Road Cheltenham prior to construction of an extra-care assisted-living facility comprising 54 apartments, two guest/staff bedsits & communal residents' facilities.

Report title: Archaeological Observation: 2 Gloucester Road Cheltenham Gloucestershire		Report Ref: BA1335GRC	
Report written by	William Logan BA PgDip		
Reported edited by	George Children MA MIfA		
Issue No.	Status	Date	Approved for issue
1	Final	April 2014	Neil Shurety Dip.M G M Inst M

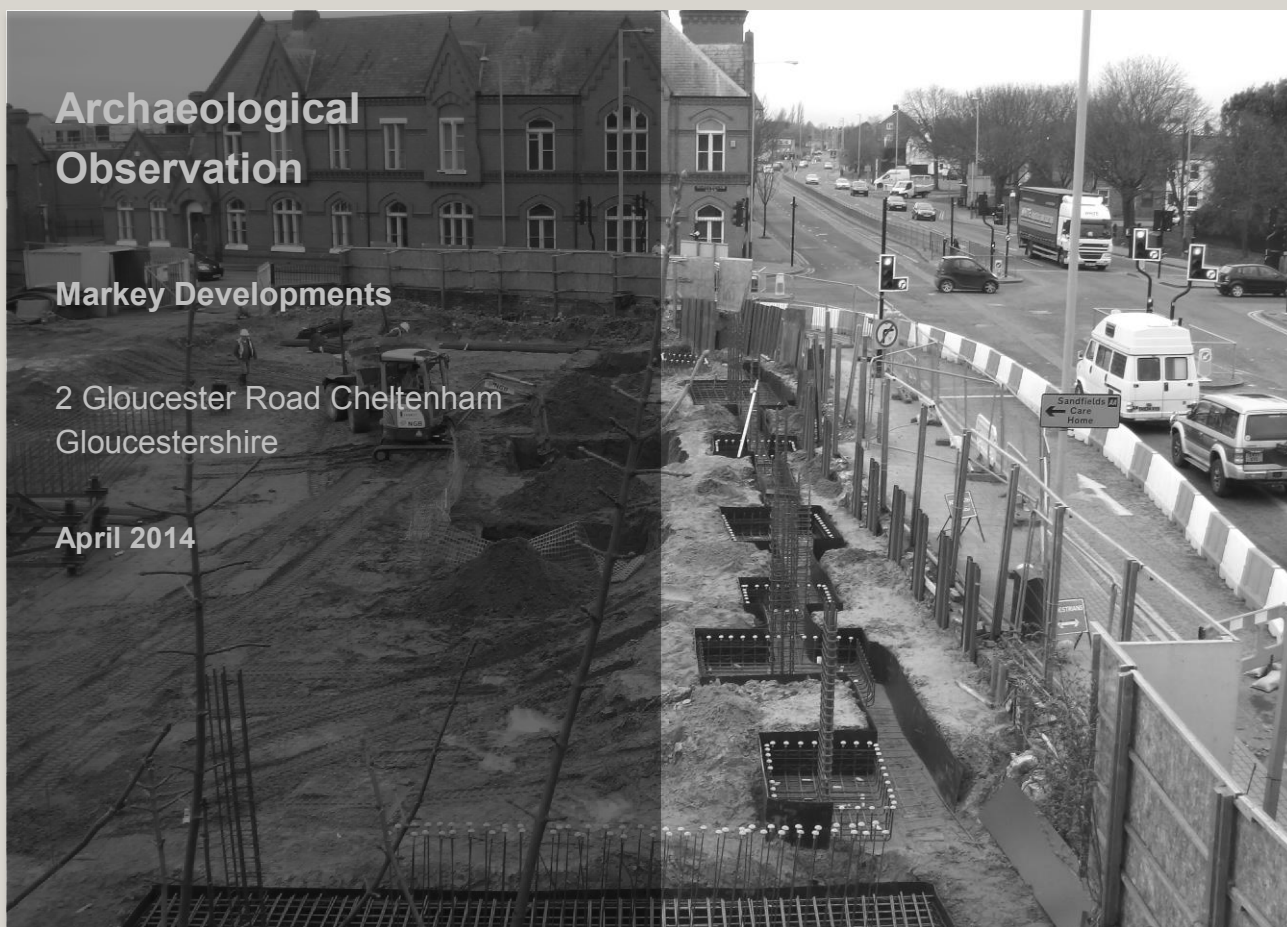
Cover: View of ground works with gasworks building to the south

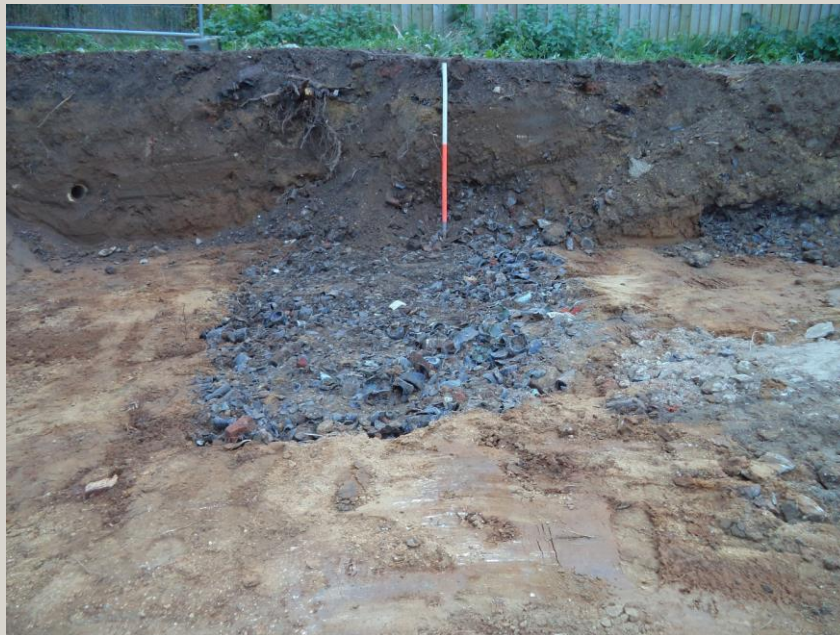
Plate 1: View W of post-Second World War bottle dump [103], filled by (104), in the southern extent of the site

Three further bottle dumps ([103], [107] & [127]) were identified at the southern extent of the site (*Plate 1; figs. 2 & 4*). The glass was of a similar type to that revealed within (118), suggesting that it was dumped as part of the same event. It is likely that it was dumped after the site was bombed during the Second World War. Several buildings on the Wine Vaults site were known to have been destroyed and it is likely that those adjoining Stoneville Street would have incurred substantial damage.

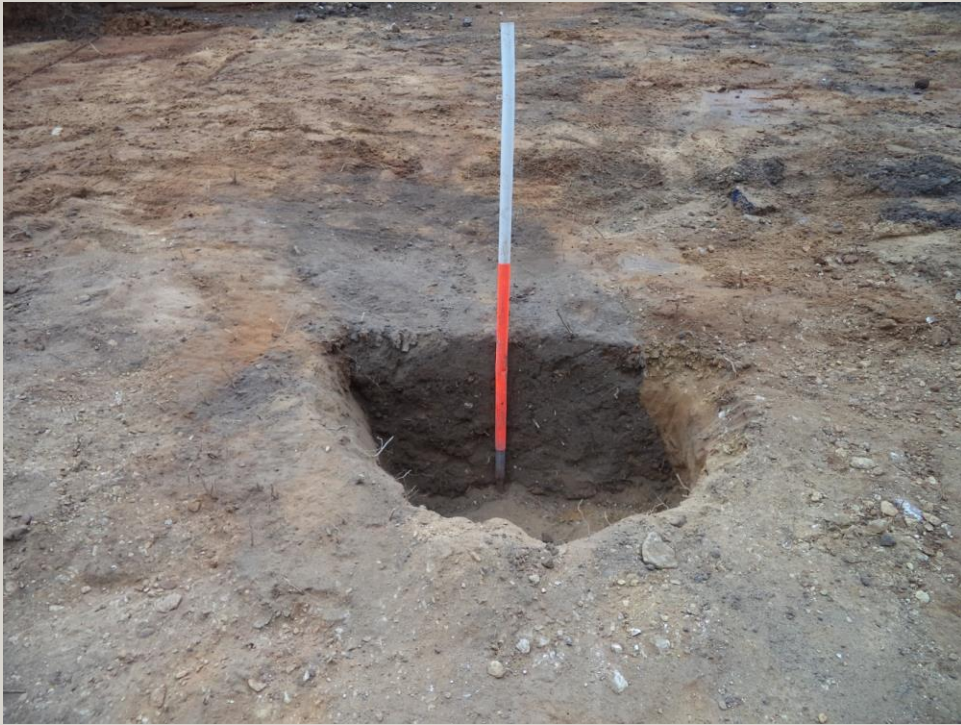
A single feature predating the development of the site was revealed during the initial reduction. This comprised a sub-rectangular pit [101] in the southern extent of the site filled by a greyish silty sand containing frequent clay pipe stems and fragments of coke (102) (*Plate 2; fig. 2*). This feature probably represented either a tree-planting hole or a sand-extraction pit, which had been backfilled during the mid-19th century

Plate 2: View N of post-medieval pit [101] in southern extent of site

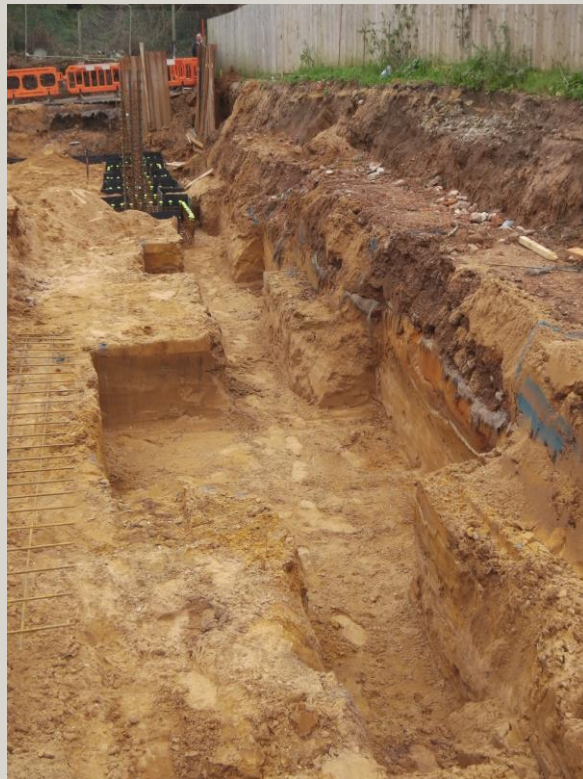
Plate 3: View SSE of pile-pit trenching along the SW extent of site, showing the depths attained during the second stage of ground works
