## Archaeological Excavation

### Border Oak

Land Adjacent to the Red Lion Inn

Bell Square Weobley Herefordshire

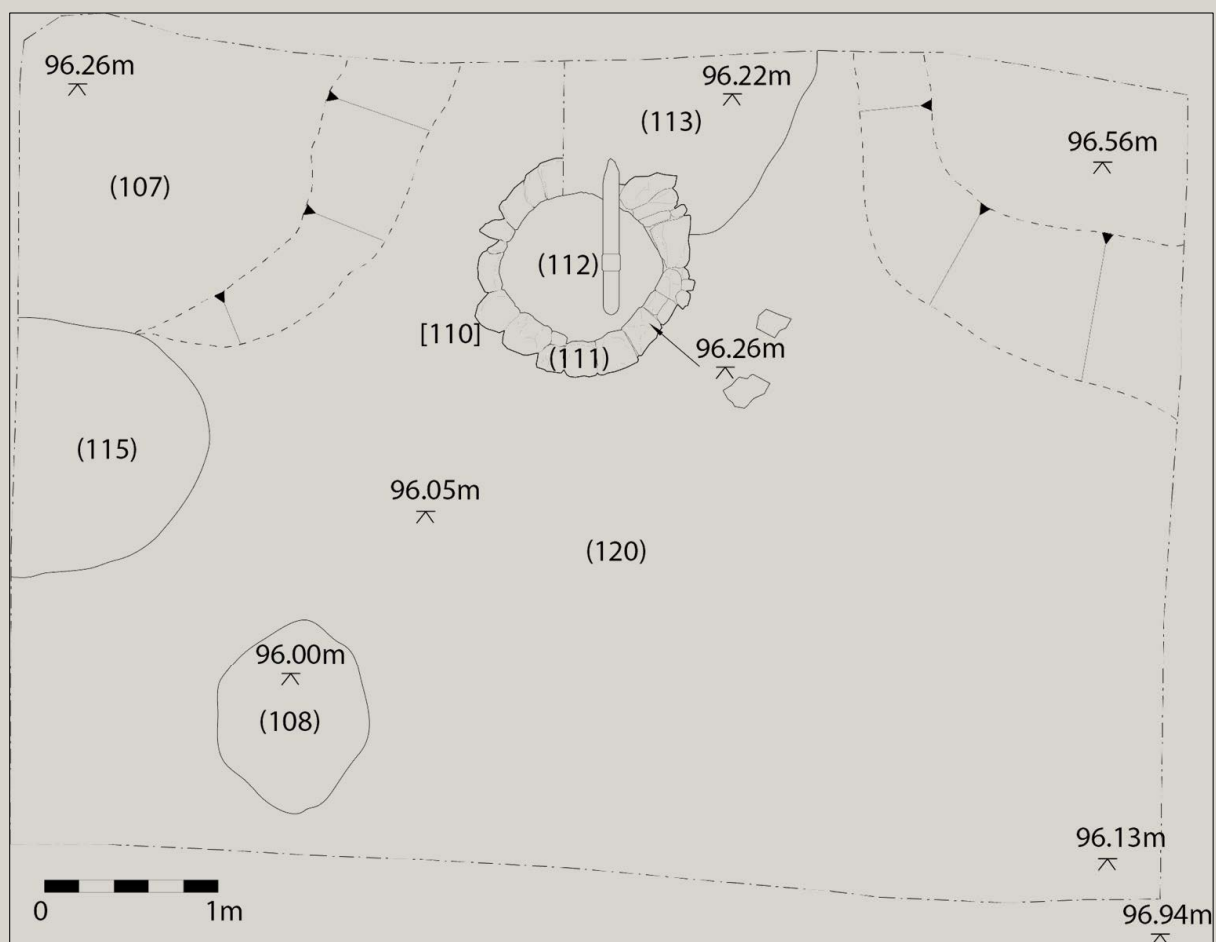
Fig. 2: Plan of excavation area

Underlying (102) was the latest surface of access or driveway [104], which consisted of a 0.10m-thick layer of limestone scalplings (103). This overlay the original surface (113) of laid, reused brick (including bricks from the Holmer Brickworks dating to the 1830s and later) on a shallow layer of rubble. At the N edge of the drive, a number of unworked and un-bonded fragments of sandstone (121) may have formed a rough retaining wall. The cut [104] for the access was about 5m wide and a maximum of 0.80m deep; it sloped up from the W (Church Road) towards the hotel car park.

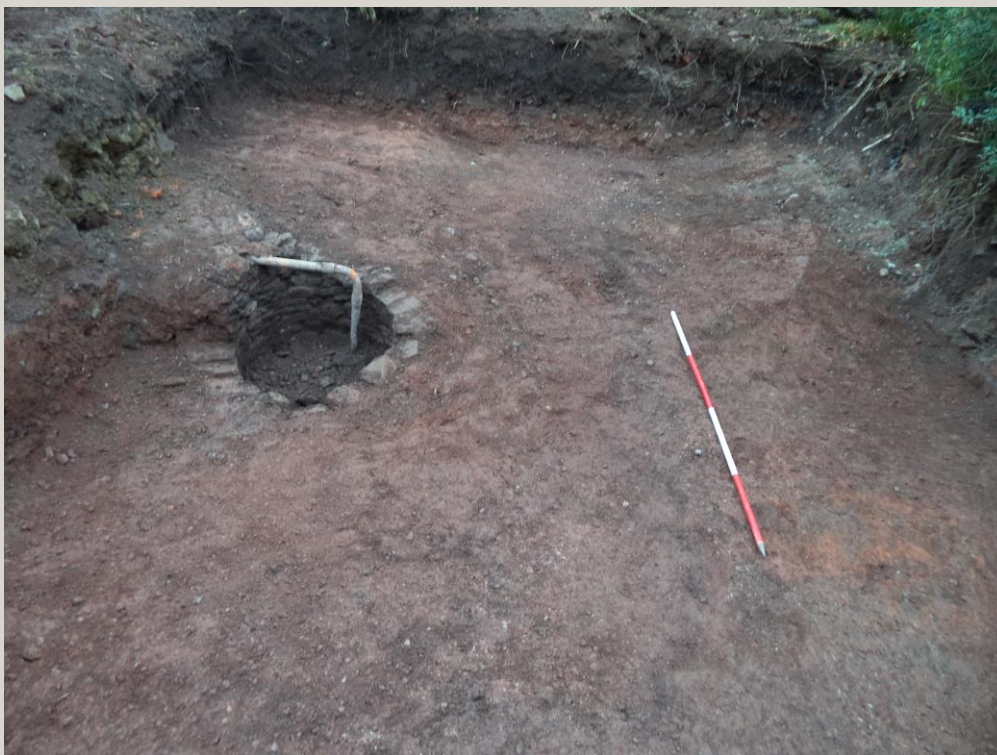
On the SW part of the site, a patch of burning (108) (*Plate 1*) of natural (120) measured 1m E/W × 0.80m N/S. It was bright orange-brown in colour and soft and silty. It contained numerous small flecks of charcoal. However, truncation by modern feature [104] and a lack of finds meant that it was not possible to date this feature.

*Plate 1: View of the site facing S, showing burnt area (108) [front right] & well (111)*

Pottery from this deposit dated to the later post-medieval period and included numerous sherds of transfer-printed wares and also local red-wares. A date in the middle part of the 19<sup>th</sup> century seems likely for this feature. Well (111) lay on the E part of the site (*Plate 1, fig. 4*). The cut [110] was 1.30m in diameter and the internal diameter of the well itself was 0.90m. The lining (111) was of sandstone, roughly shaped and earth-bonded. No brick was seen in the lining, suggesting that it may have been of some antiquity. However, it was also apparent that it had remained in use until comparatively recently, as a pump, still in place and sealed by the earliest surface of the driveway (113), was present. After it went out of use, the well was filled with a soft and cohesive very dark greyish-brown silt clay (112) with charcoal flecks. No dating evidence was recovered from it.
