STANDING BUILDING RECORDING SURVEY

11 Load Street
Bewdley
Worcestershire
DY12 2AF

NGR: SO 78654 75334
Job No: BA1206LSB
HER Ref. WSM 46445

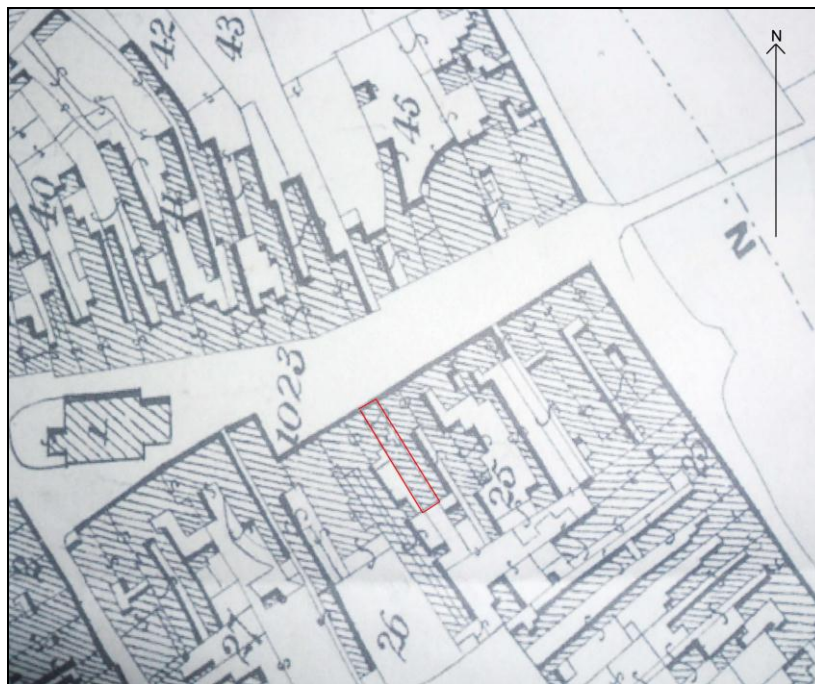
*Fig. 2: Extract from the Ribbesford tithe map of 1845 showing No. 11 Load Street (marked in red)
(Reproduced by courtesy of the National Archives)*

The map depicts a rectangular structure extending SE to the rear of the street frontage, which may be identified with the existing house at No. 11. The tithe map shows the rear wall of the house as staggered in plan with a small T-shaped yard immediately to the NE; this probably represents the projecting bay and bow window on the NE-facing elevation (which appear to be slightly later additions to the original building), both of which are still visible today. Attached to the rear of the house, an elongated rectangular structure is shown,

The earliest available map to show the properties along Load Street is the tithe map for Ribbesford parish (including Bewdley borough) dated 1845 (NA IR30/39/18). This map shows the plan of the property at No. 11 Load Street in a somewhat schematic form (no internal divisions are shown), although in many respects it resembles the existing layout. The narrow passageway separating No. 11 and the neighbouring property, No. 10, is not explicitly delineated, although the map does depict an axial boundary running NW-SE dividing the two properties, which may well represent the line of the passageway.

It would appear from the evidence of the tithe map that the division between Nos. 10 and 11 was already established by 1845 (although both premises appear to have been occupied as a single commercial premises until 1900), which suggests that either 1/Nos. 10 & 11 were built as a single townhouse which was substantially reorganized and rebuilt in the early to mid-19th century, or 2/Nos. 10 & 11 were constructed in a single building campaign but were always conceived as two separate properties. The latter explanation appears to be the more likely, although further documentary evidence would be required to confirm or disprove this hypothesis.

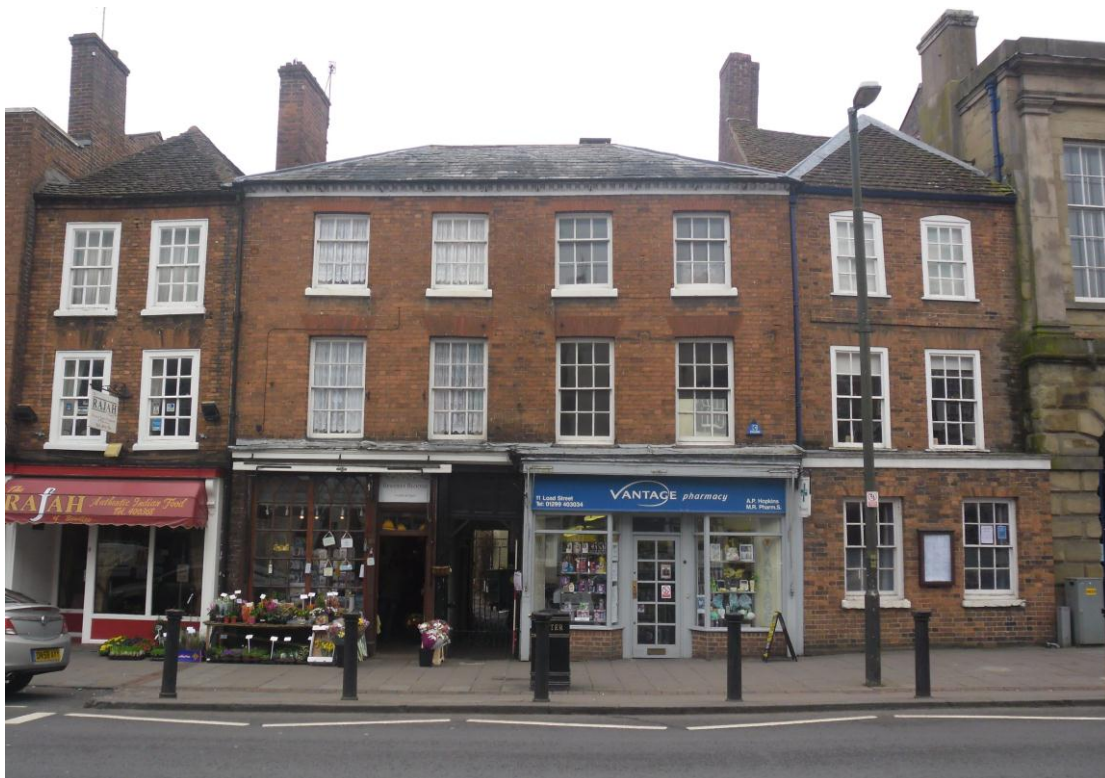
Plate 1: View SE showing principal (NW-facing) elevation of No 10 and No. 11 Load Street (to the left and right, respectively)

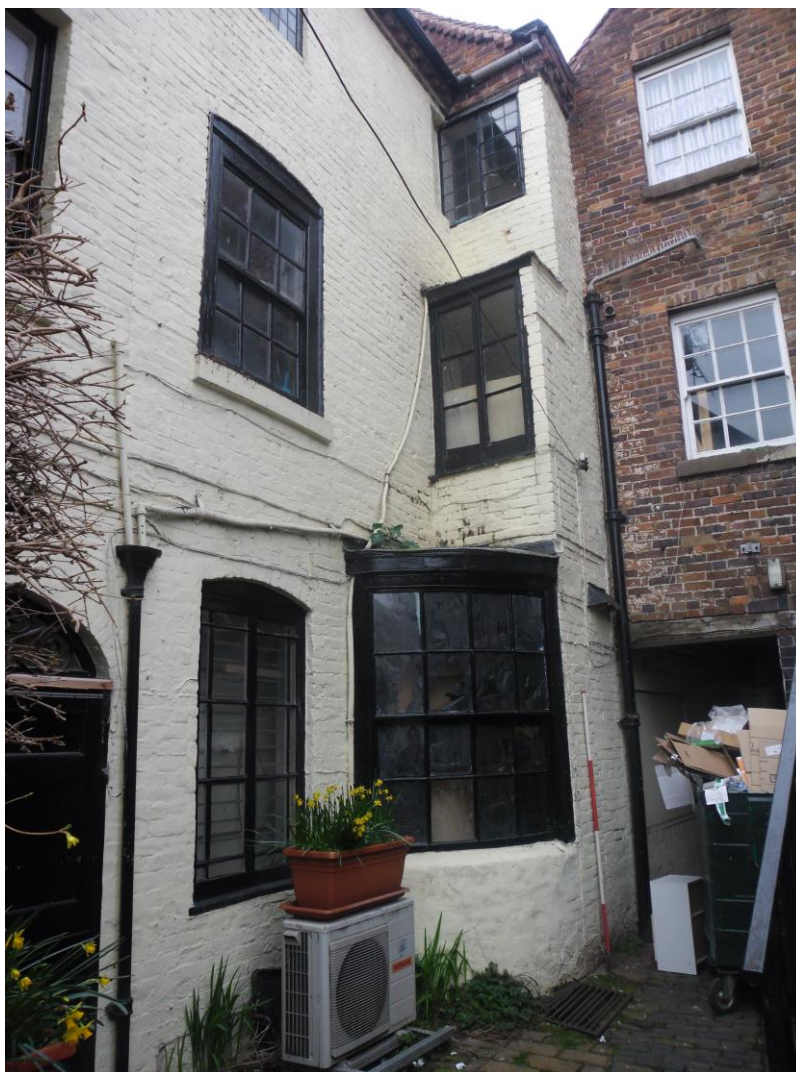
Plate 2: View NW showing NE-facing elevation to the rear of the house, with 16-pane bow window in foreground and casement window above, with cobbled passageway to right

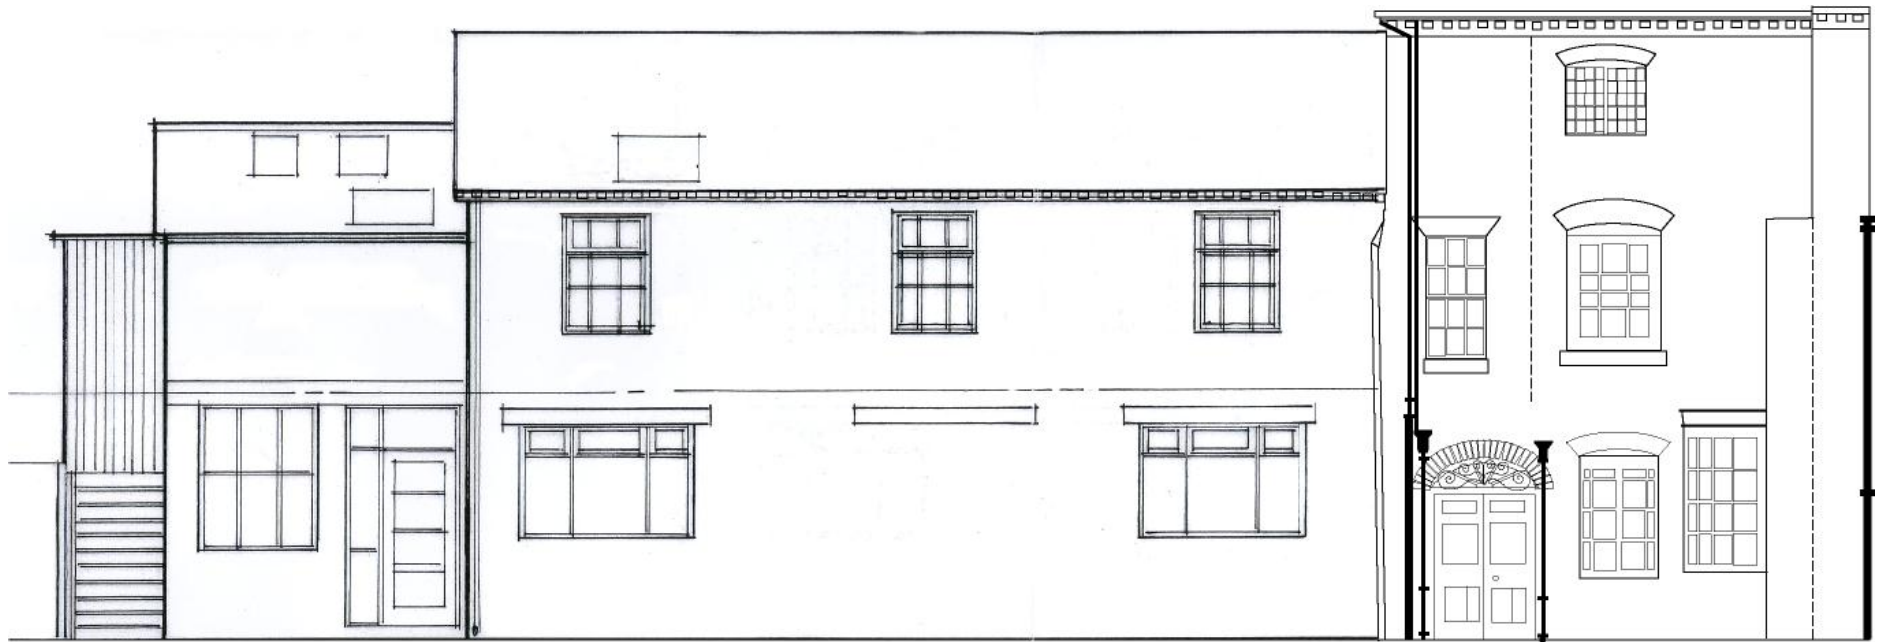
Fig. 6: NE-facing external elevation of main house and two-storey outbuilding at No. 11 Load Street

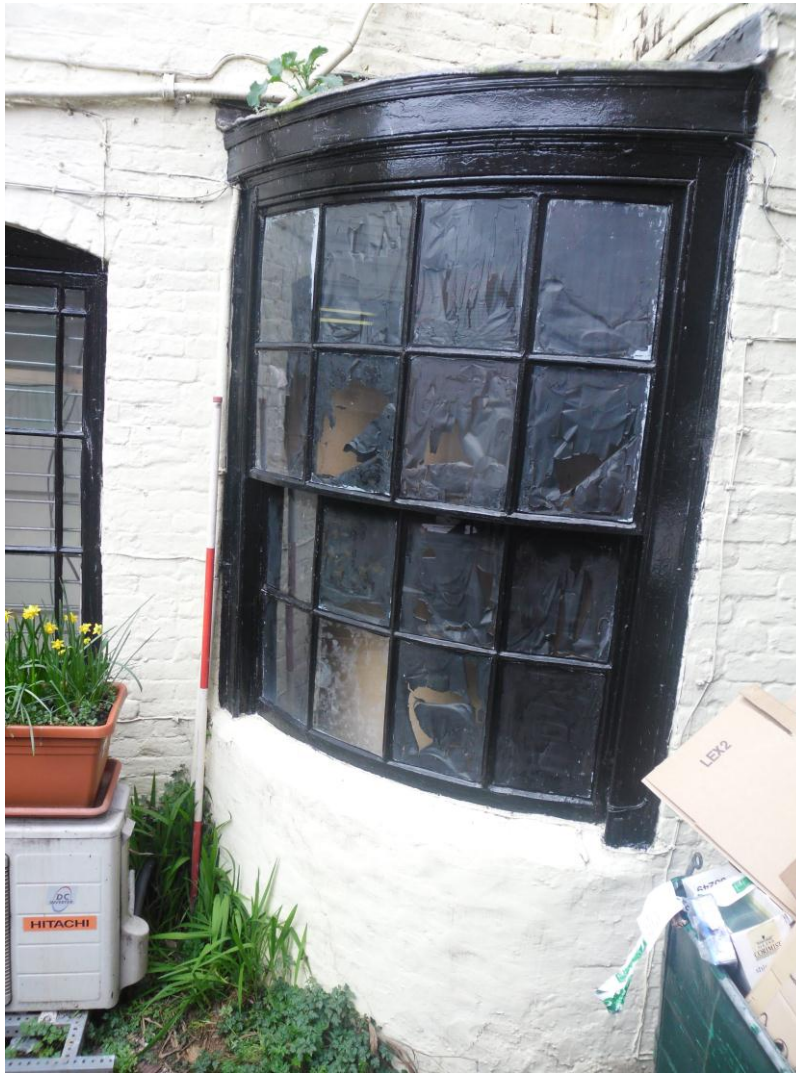
Plate 3: View looking SW showing detail of 16-pane bow window in NE-facing elevation

Immediately to the left of the bow window is a segmental-arched window with a moulded wooden surround and sill; the glazing (which appears to be recent in date) consists of a multi-pane fixed casement window. To the left of this window is a broad, round-arched doorway flanked by two drainpipes which appear to be of 19th century date. A vertical construction break is visible above the drainpipe to the right of the doorway, extending from first floor to eaves level, and a clear difference in brick bonding was also noted. However, this construction break did not appear to continue down to ground level.

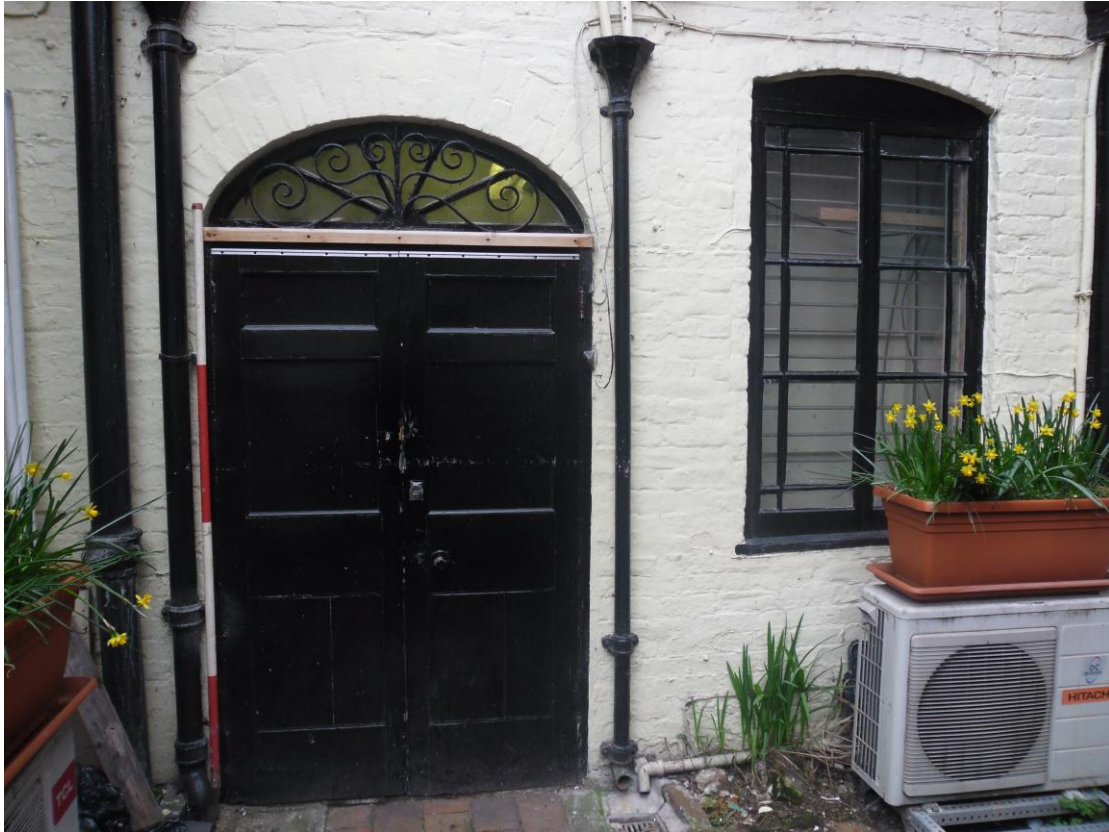
Plate 4: View looking SW showing NE-facing elevation with round-arched doorway and casement window to right

The round-headed doorway comprises a pair of 6-panelled doors with a well-preserved 5-pane radial fanlight above containing wrought-iron external scrollwork, suggestive of a late 18th or early 19th century date (*Plate 5*). The quality of the wrought-iron scrollwork is particularly noteworthy and may suggest that this was originally the principal entrance to the house (rather than the shopfront); this side-entrance arrangement is reflected in several other properties along the S side of Load Street, as in the case of the neighbouring property at No. 12 (of early 18th century date) the main entrance to which is located in the arcade under the Town Hall.

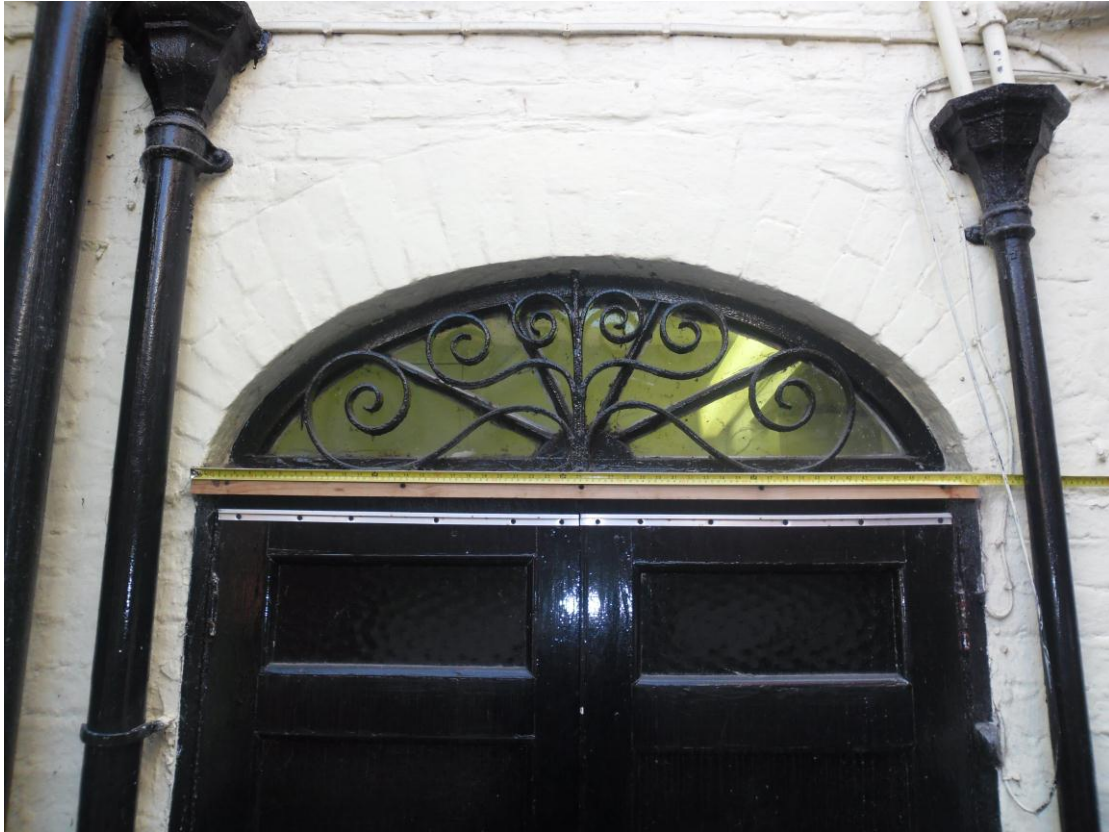
Plate 5: View SW showing detail of wrought-iron scrollwork in front of fanlight above doorway in NE-facing elevation

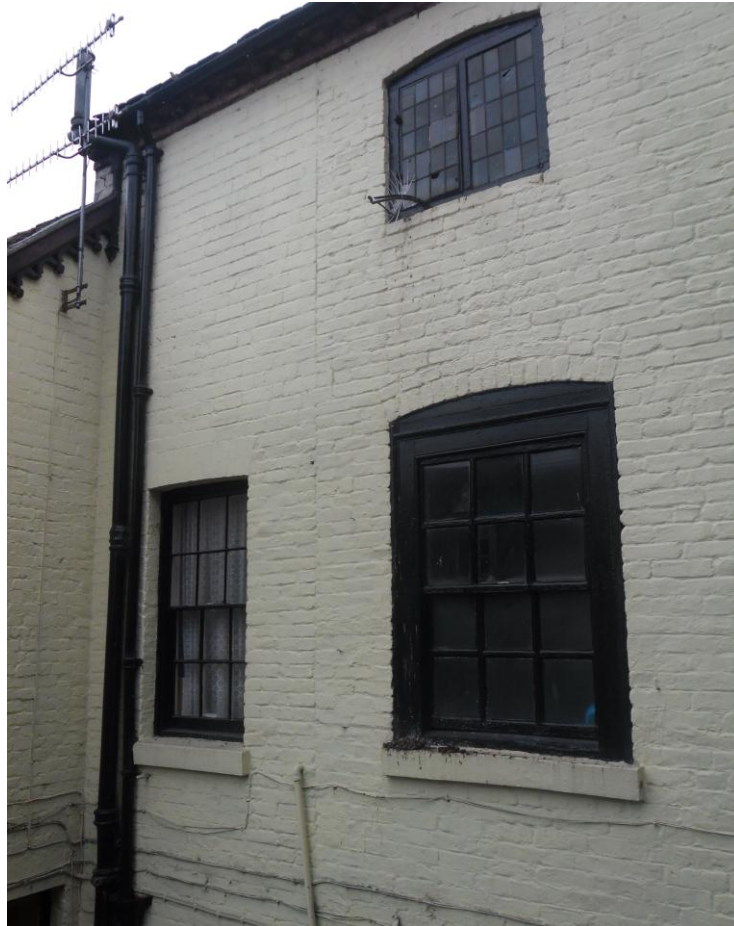
To the left of this splay is a small multi-pane casement window under a gauged brick segmental arch, inserted in the NE-facing elevation immediately below eaves level. The gauged-brick segmental arch is identical in form to that used for the box-framed sash immediately below this window at first-floor level, which suggests that these two windows may well be of the same date.

Plate 6: View looking S showing fenestration of NE-facing elevation at first- and second-floor level, with a segmental-arched box-framed sash window and segmental-arched casement window above, and a vertical construction break visible to the left of these windows at first- and second- floor level

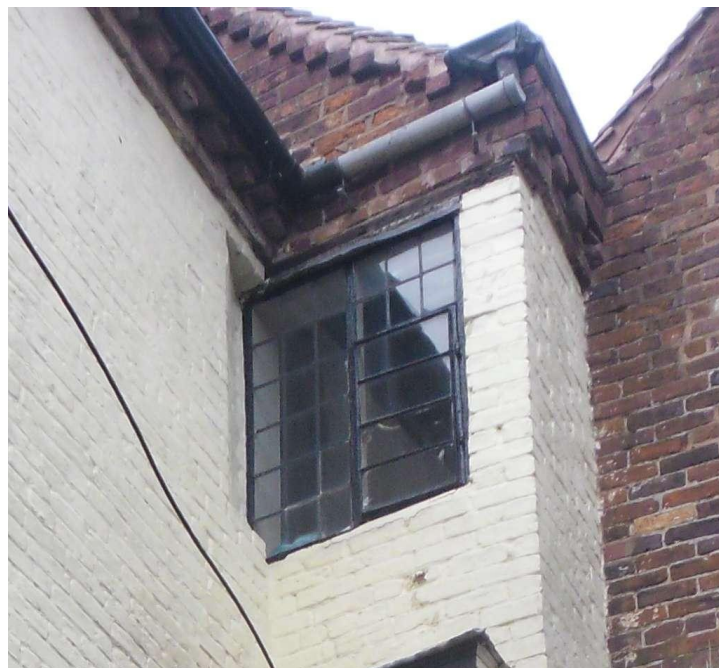
Plate 7: Detail showing second-floor casement window in SE-facing elevation with splay to left

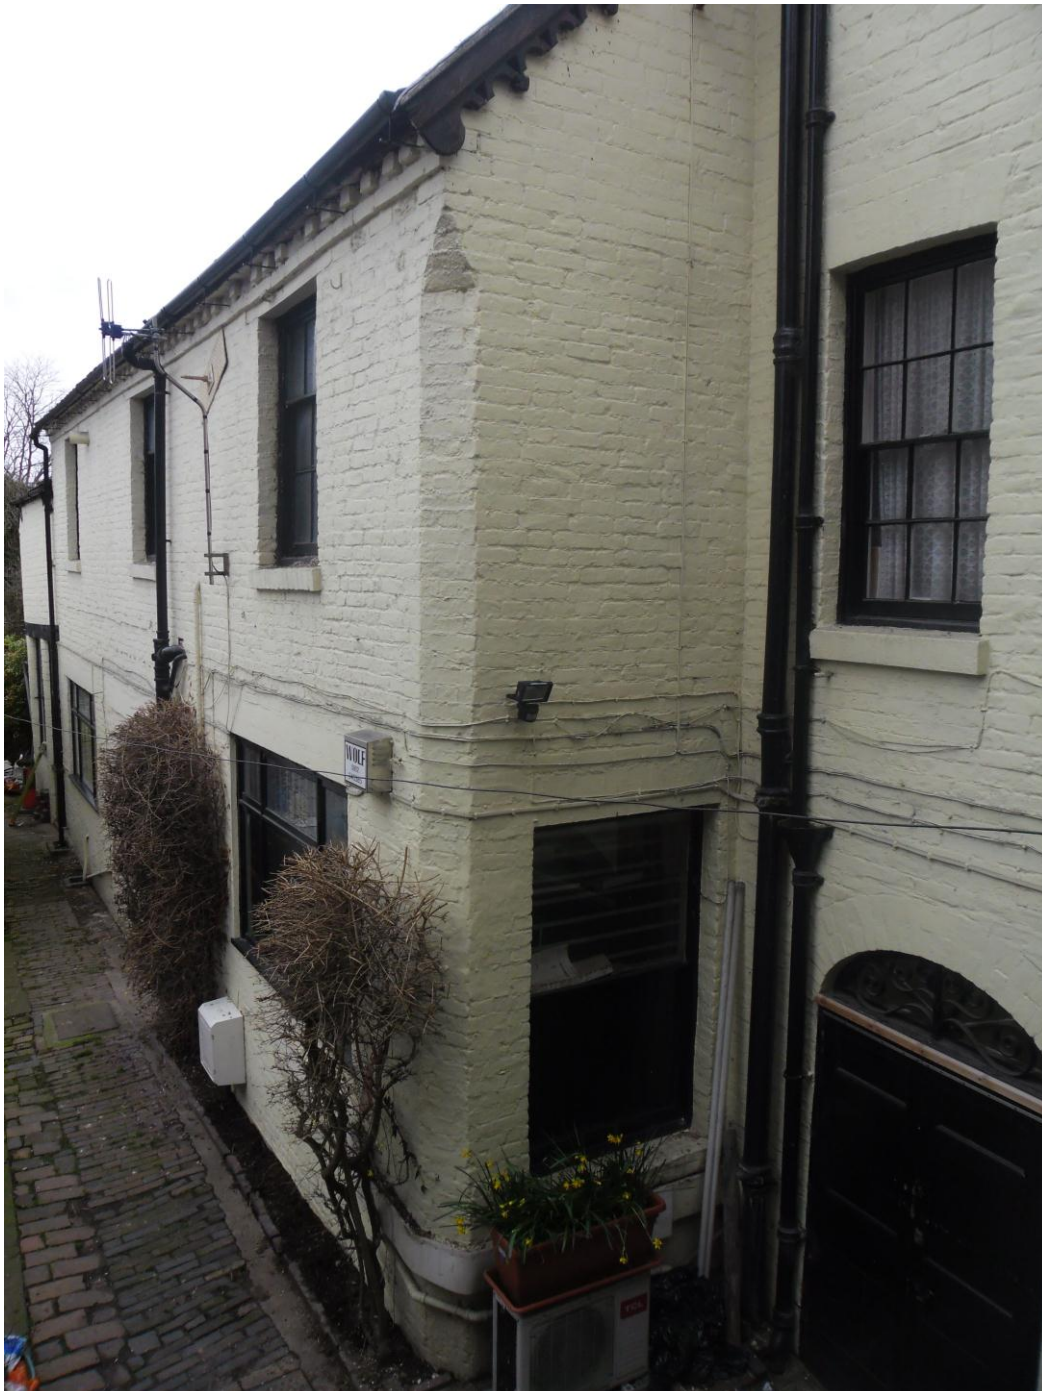
Attached to the SE end of the main, three-storey building is a two-storey block which appears to have housed the former printing works. This building is also of brick construction (laid in an irregular English garden bond with noticeably fewer rows of headers compared to the main house), four bays long (NW-SE) and two bays wide (NE-SW), with a gabled, tiled roof and a dentilled brick eaves cornice with string course similar in detail to that of the main house (*Plate 8*). The NW-facing gable elevation of the block has ornate wooden scrollwork decoration at eaves level, with a plain, flat-headed 2-light window at ground-floor level (*Plate 9*).

Plate 8: View looking SSE showing NE-facing elevation of printing works with dentilled eaves cornice and chamfer at the NW gable end of the building

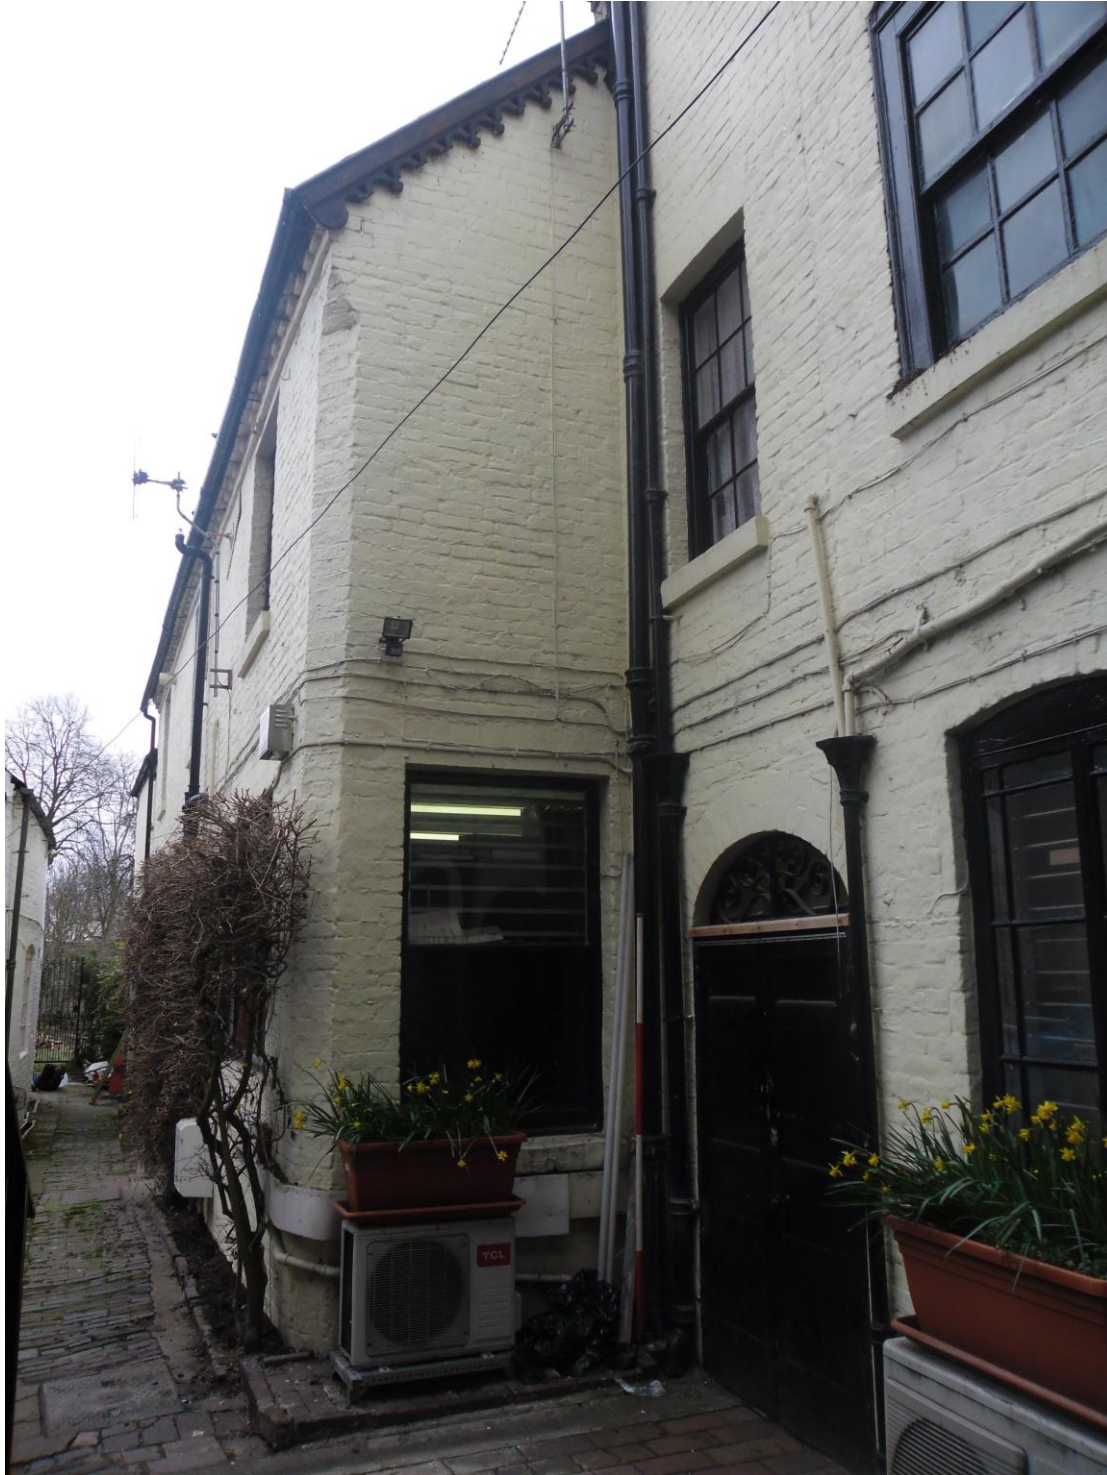
Plate 9: View SE showing NW-facing gable elevation of printing works with ornate scrollwork decoration at eaves level

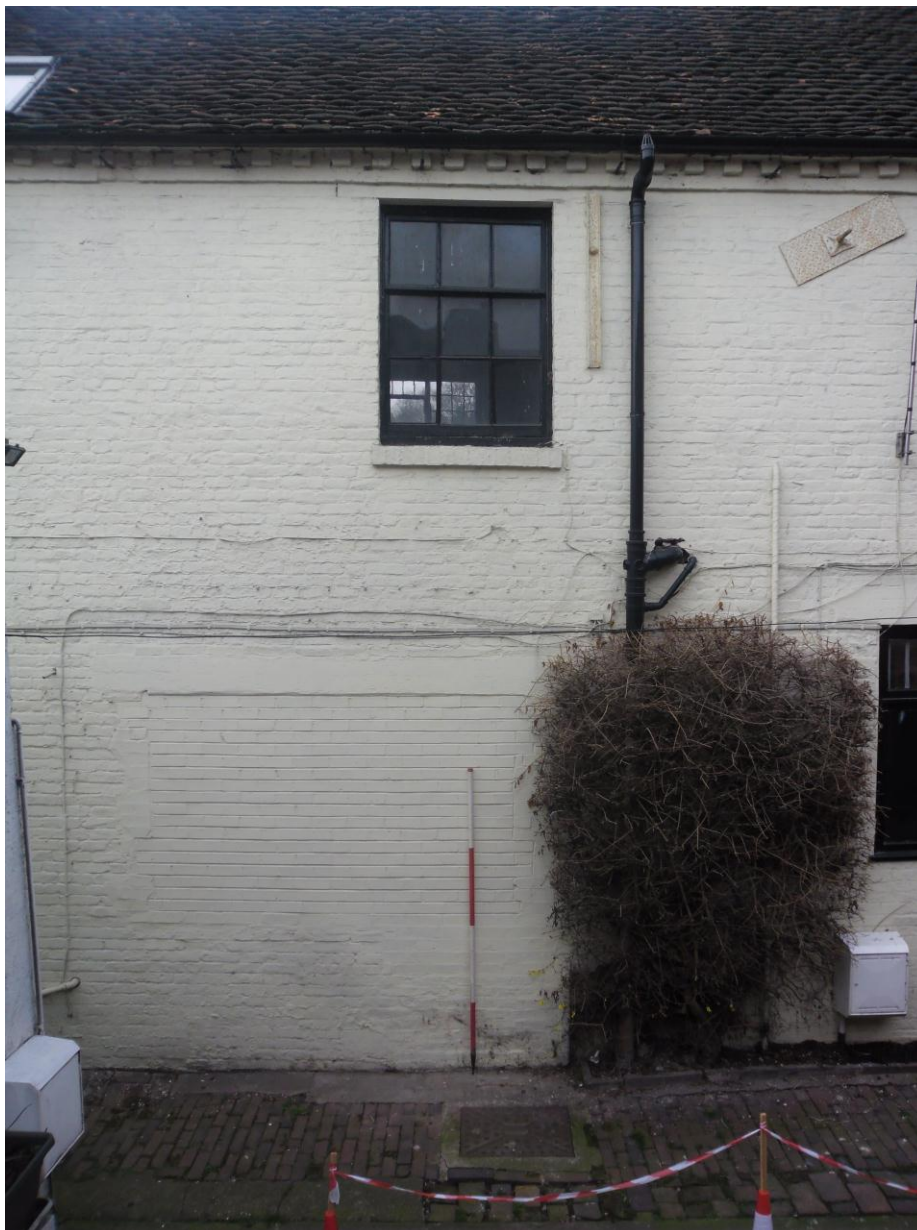
The NE-facing elevation of the two-storey block is chamfered at its NW end, tapering outwards just below eaves level. The fenestration at ground-floor level consists of three rectangular windows with large concrete lintels. The central window has evidently been blocked in recent years, indicated by the marked difference in brickwork where the window has been bricked up in contrast to the surrounding elevation (*Plate 10*).

Plate 10: View looking SW showing blocked window opening in centre of NE elevation of printing works, with 19th century sash window visible at first-floor level

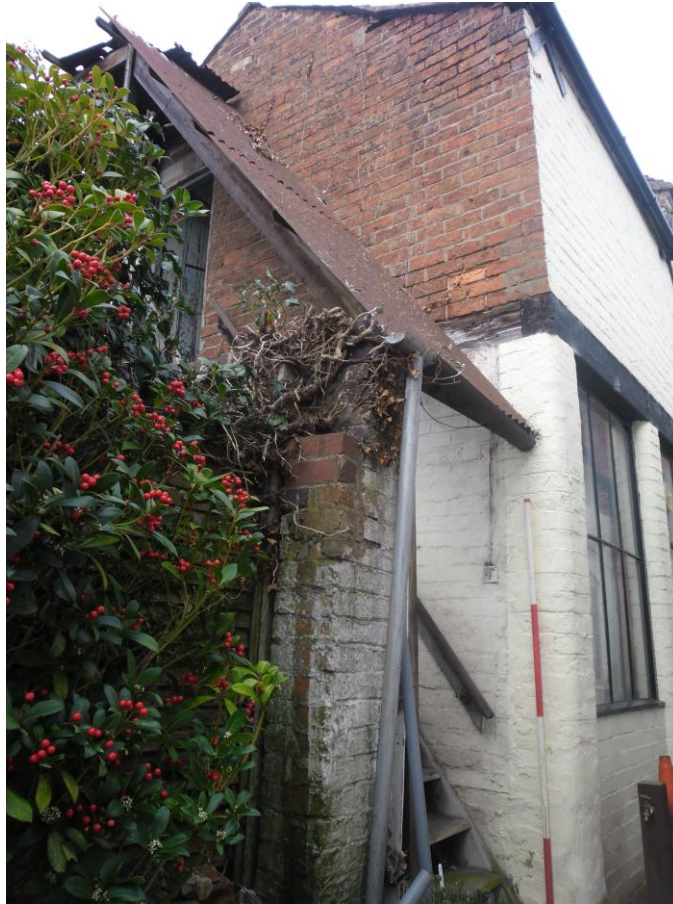
Two iron ties have been inserted into the thickness of the wall at first-floor level, presumably to provide additional support (it is noticeable that the wall tapers inwards slightly along the entire elevation, which may be a result of the somewhat weakly bonded brickwork, mostly consisting of rows of stretchers). Due to access restrictions, it was not possible to view the SW-facing external elevation: there is no indication of glazing on the ground floor, however, two casement windows appear to have been inserted in the middle and the NW end of the elevation at first-floor level.

Plate 11: View NNW showing gabled extension at SE end of printing works (with cross ties inserted in the NE-facing elevation at eaves level)

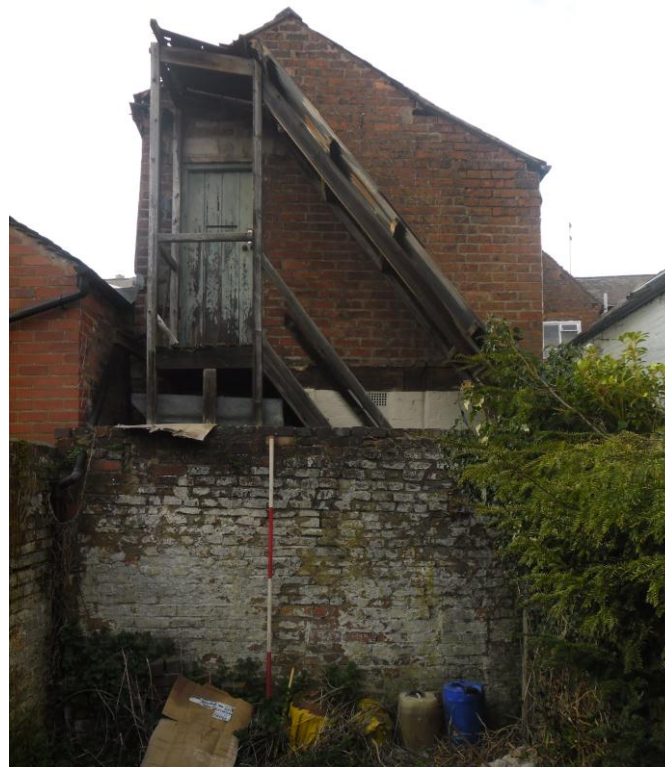
Plate 12: View looking NW showing SE-facing gable elevation of gabled extension to printing works, with wooden stair leading to entrance at first-floor level.

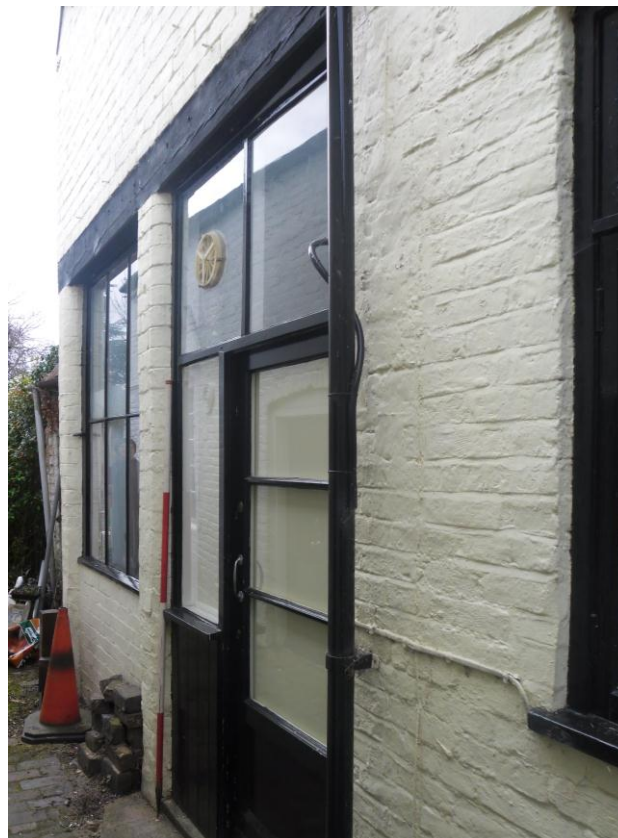
The exterior is again completely whitewashed, apart from the upper part of the SE gable elevation and an exposed horizontal timber wall-plate, which marks the division between the ground and upper floors (*Plate 12*). Two wrought-iron cross ties have been inserted in the NE-facing elevation at eaves level. Part of the wall-plate in the NE-facing elevation appears to have been replaced recently, contemporary with the remodelling of the ground-floor level. The fenestration at ground-floor level consists of a flat-headed, 3-pane glazed door with a 2-pane overlight (extending up to wall-plate level), immediately to the left of which is a flat-headed, 6-pane glazed window. Both the doorway and the window, in this present form, appear to be late 20th century additions (*Plate 13*).

Plate 13: View looking SSE showing modern glazed doorway and window in NE-facing elevation of gabled extension

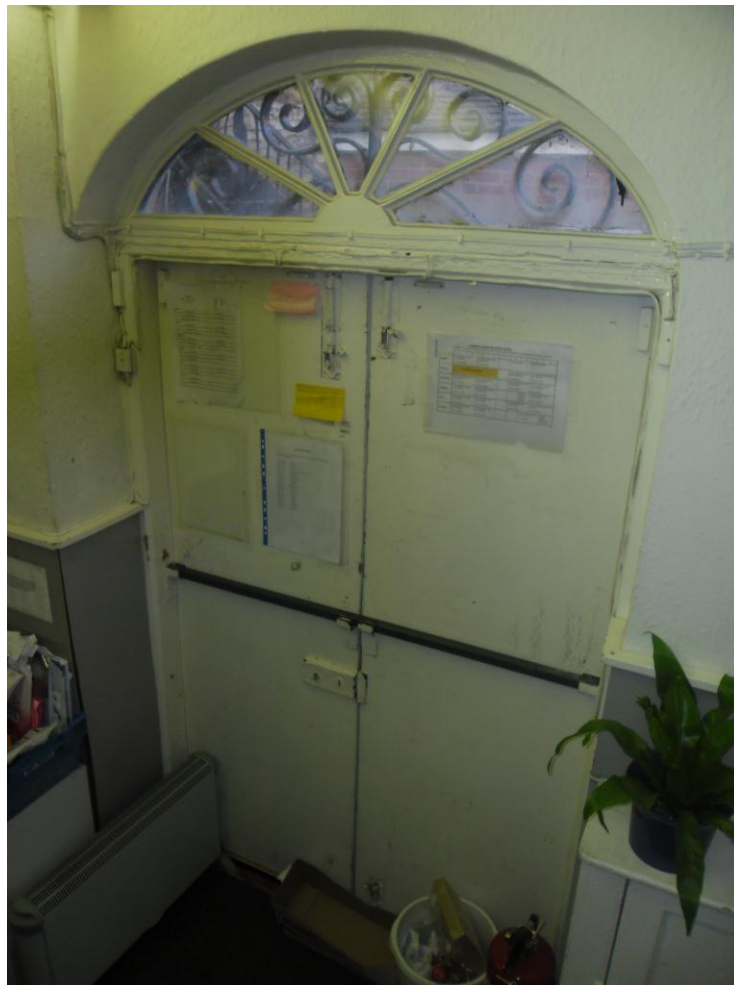
Plate 14: Internal view looking NE showing the round-headed door in the ground floor lobby with 5-pane fanlight and external wrought iron scrollwork

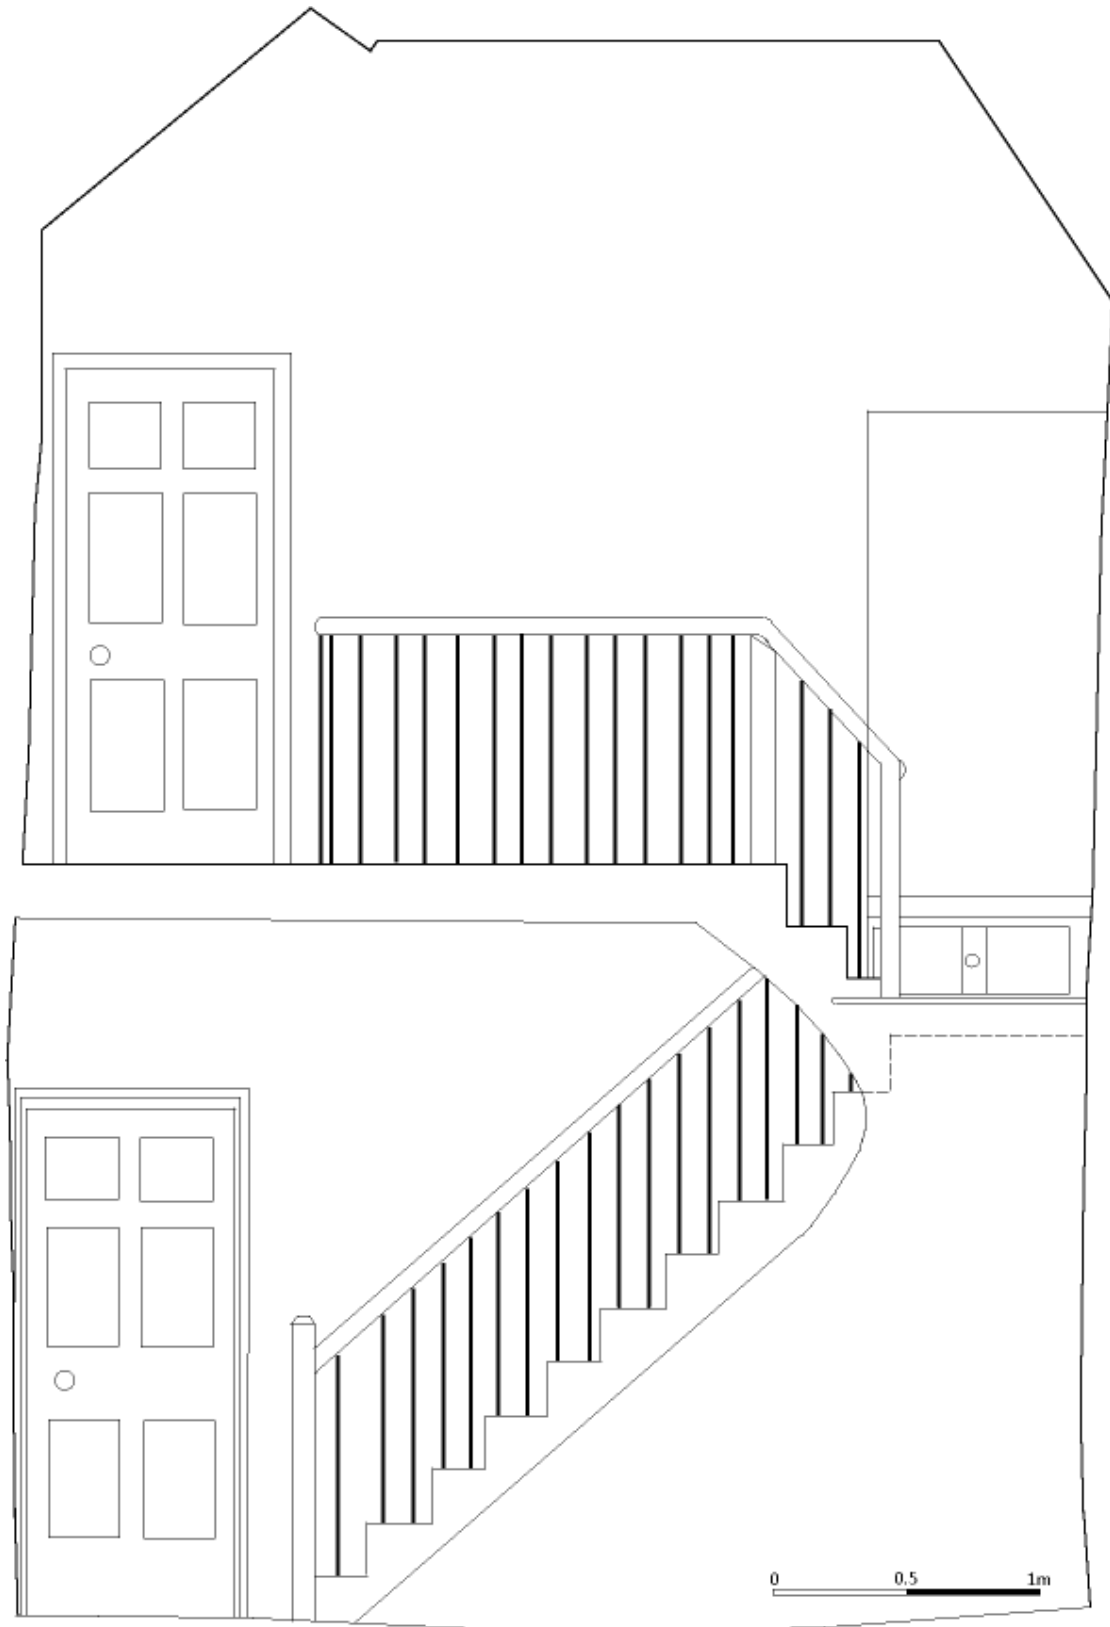
Fig. 7: Internal cross-section of first and second floors of main house looking NW showing dog-leg staircase and blocked doorway on half-landing

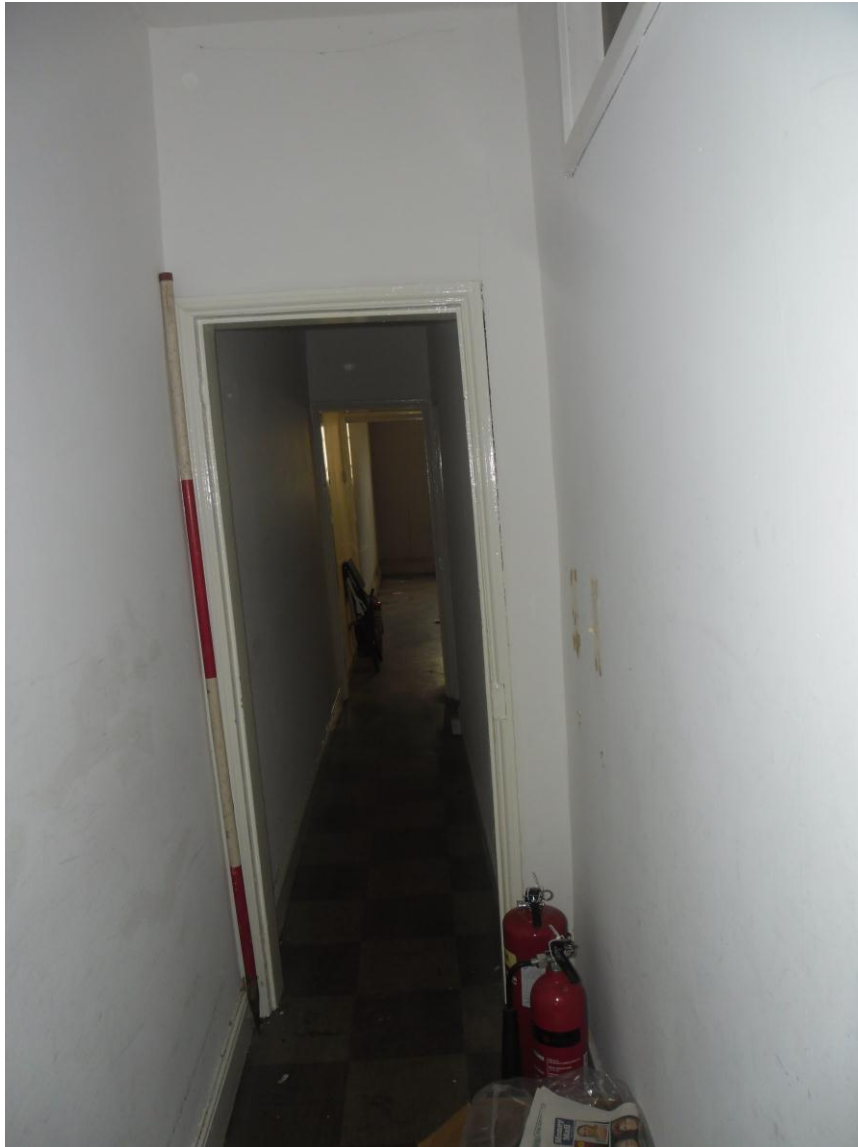
The first floor exhibits evidence of several phases of extensive reorganization and repair from the 19th century through to the late 20th century. The dog-leg staircase from the ground floor leads to a narrow, cross-axial corridor, entered through a flat-headed, plain-reeded architrave, which, in turn, runs NW to a landing with a dog-leg staircase leading up to the second floor. The alignment of the corridor and the floor at first-floor level is noticeably lop-sided (*Plate 15*).

Plate 15: Internal view looking NW along corridor at first-floor level towards staircase to second floor

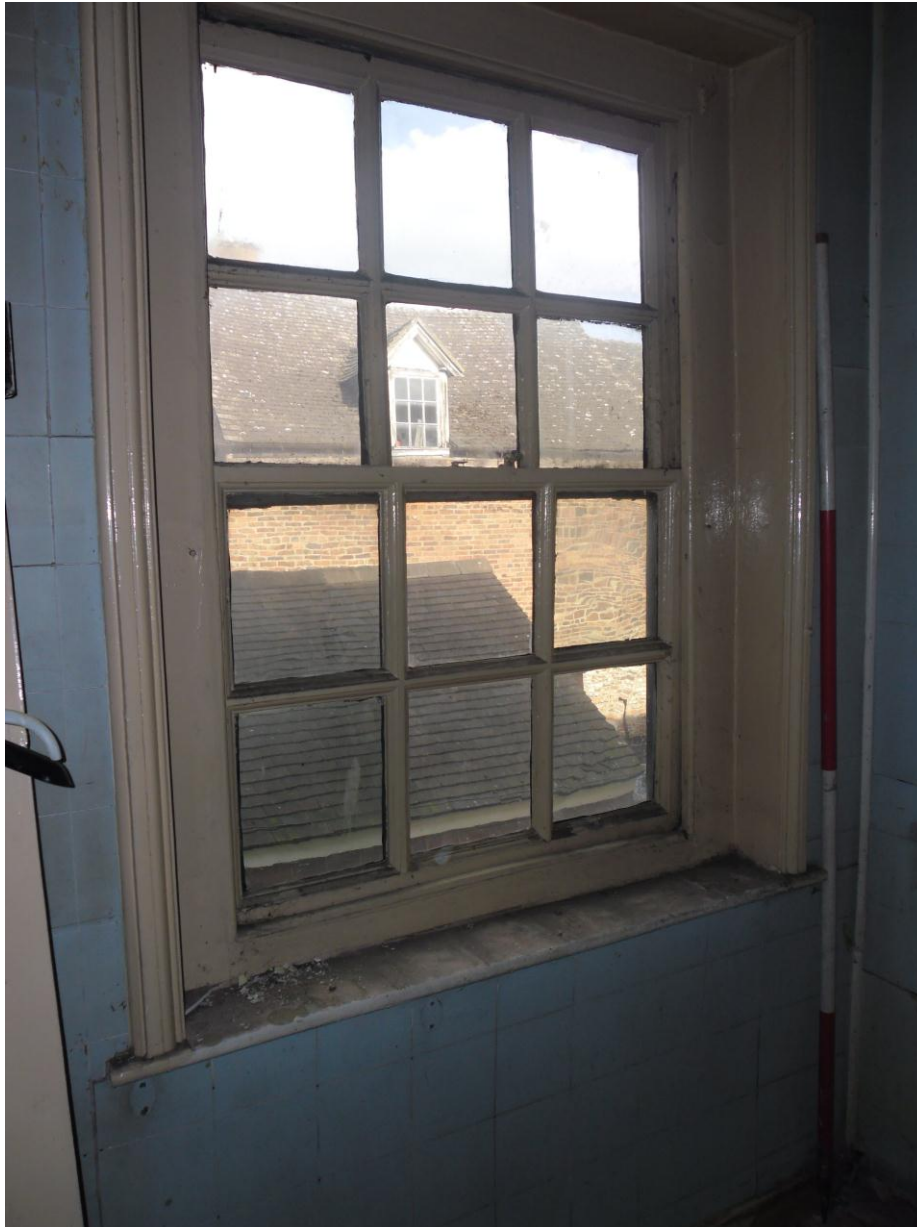
On the NE side of the corridor are three rooms, the layout of which exhibits evidence of extensive modern alteration and reorganization; consequently, it is difficult to reconstruct their original appearance and plan. The water closet immediately next to the landing is evidently of late 20th century date in its present form; the presence of a sash window of mid to late 19th century date appears to be the only diagnostic architectural feature. Similarly, the L-shaped bathroom/shower-room immediately adjacent to the water closet is largely devoid of architectural features, with the solitary exception of the 12-pane box-framed sash window (of probable late 18th-early 19th century date) in the NE elevation (**Plate 16**).

Plate 16: Internal view looking E showing box-framed sash window in bathroom/shower-room on first floor surrounded by modern ceramic panels

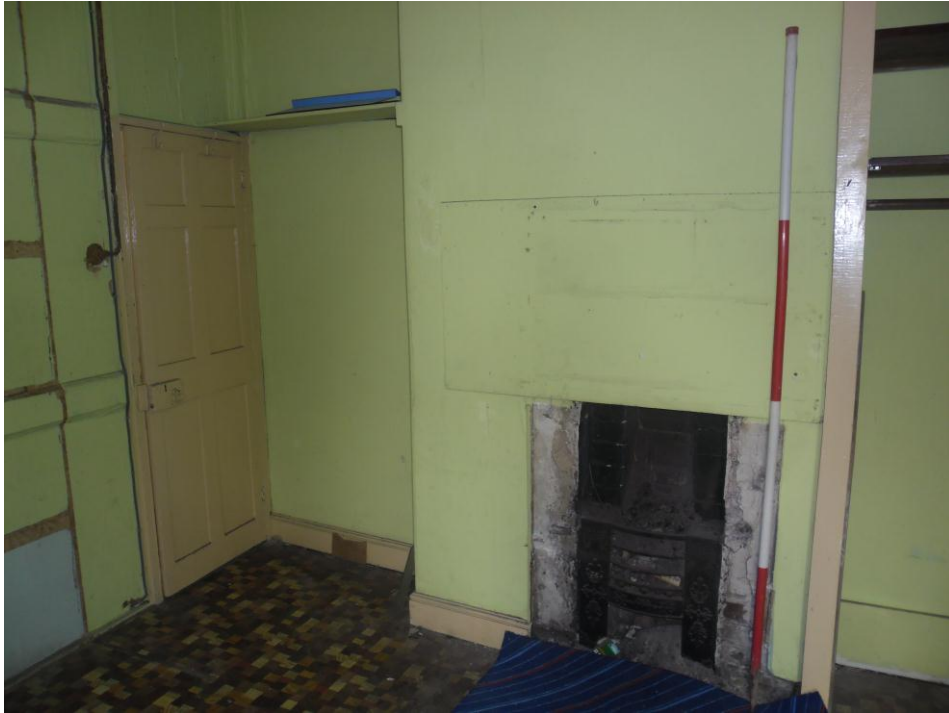
Plate 17: Internal view looking NW showing first-floor room with fireplace (with intact iron grate in the SE-facing wall) flanked by recesses

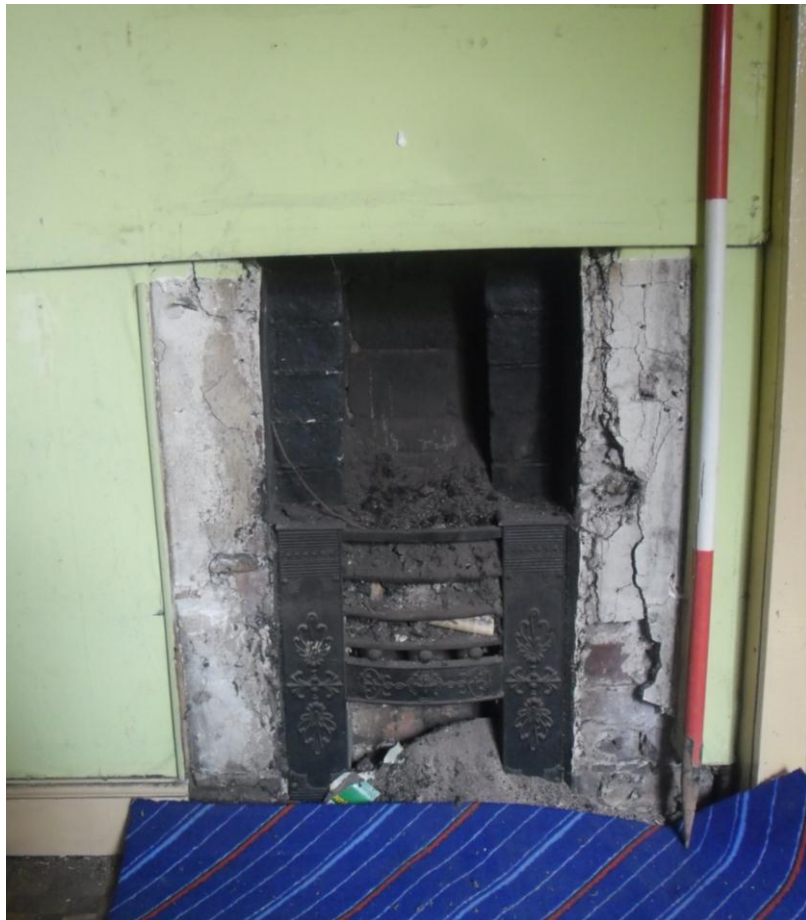
Plate 18: Detail of iron fireplace grate in first-floor room showing acanthus leaf detailing in panels and crosspiece

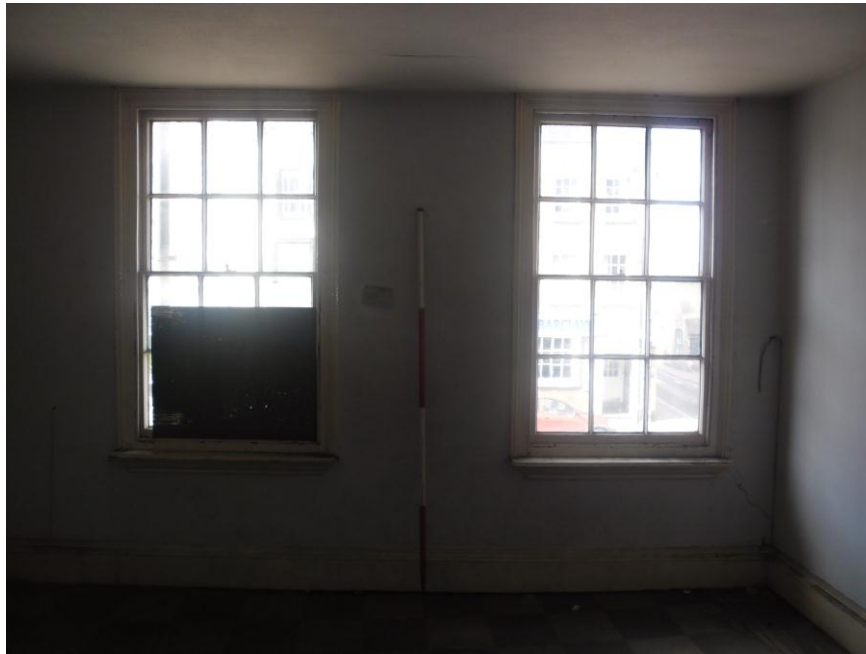
Plate 19: Internal view looking NW showing 12-pane sash windows in first-floor room overlooking Load Street
