STANDING BUILDING RECORDING SURVEY

11 Load Street
Bewdley
Worcestershire
DY12 2AF

NGR: SO 78654 75334
Job No: BA1206LSB
HER Ref. WSM 46445

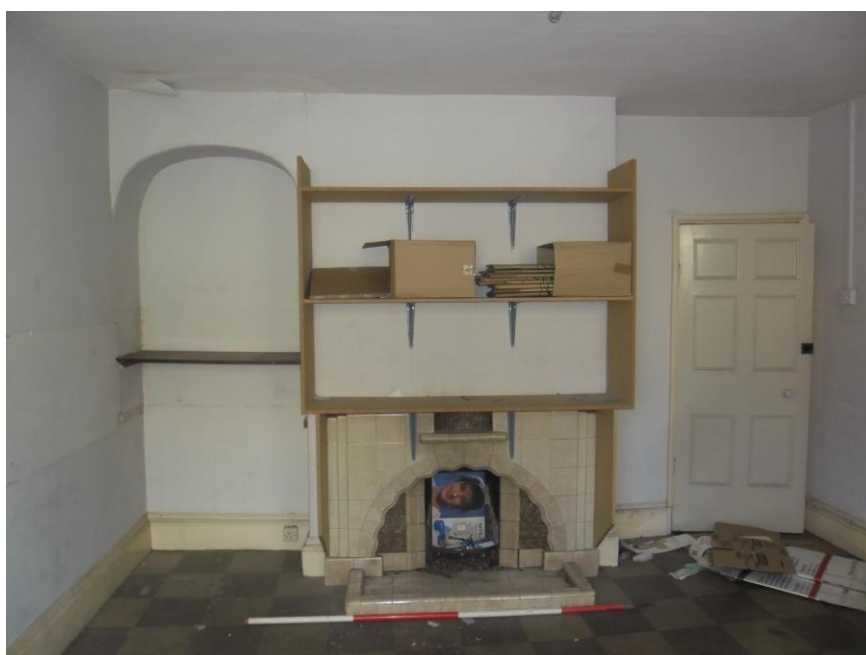
Plate 20: Internal view SE showing Art Deco fireplace in first-floor room and arched recess to left

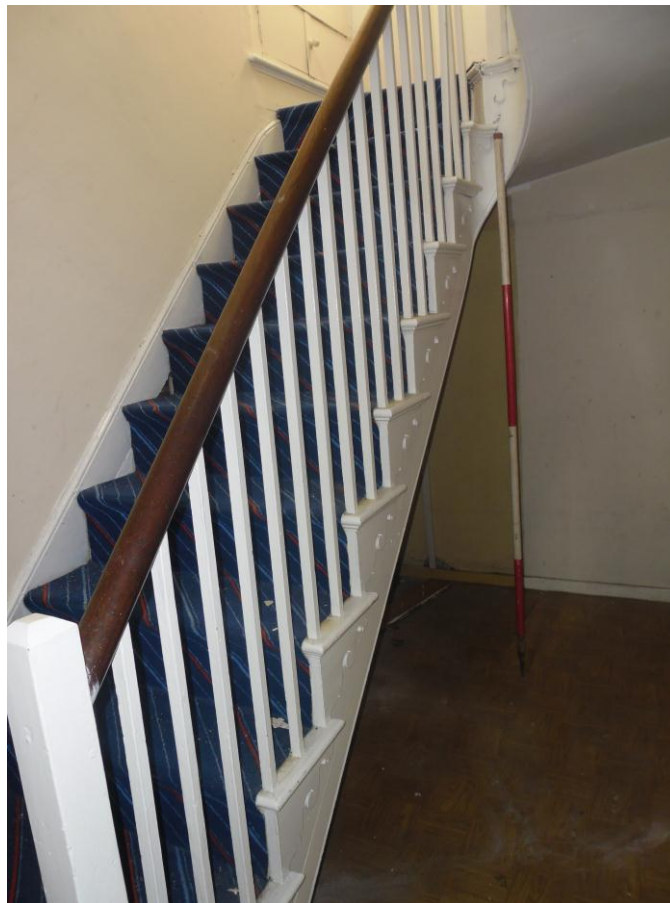
Plate 21: Internal view looking NE showing dog-leg staircase leading from first to second floor with 'Vitruvian Scroll' decoration on brackets to tread ends

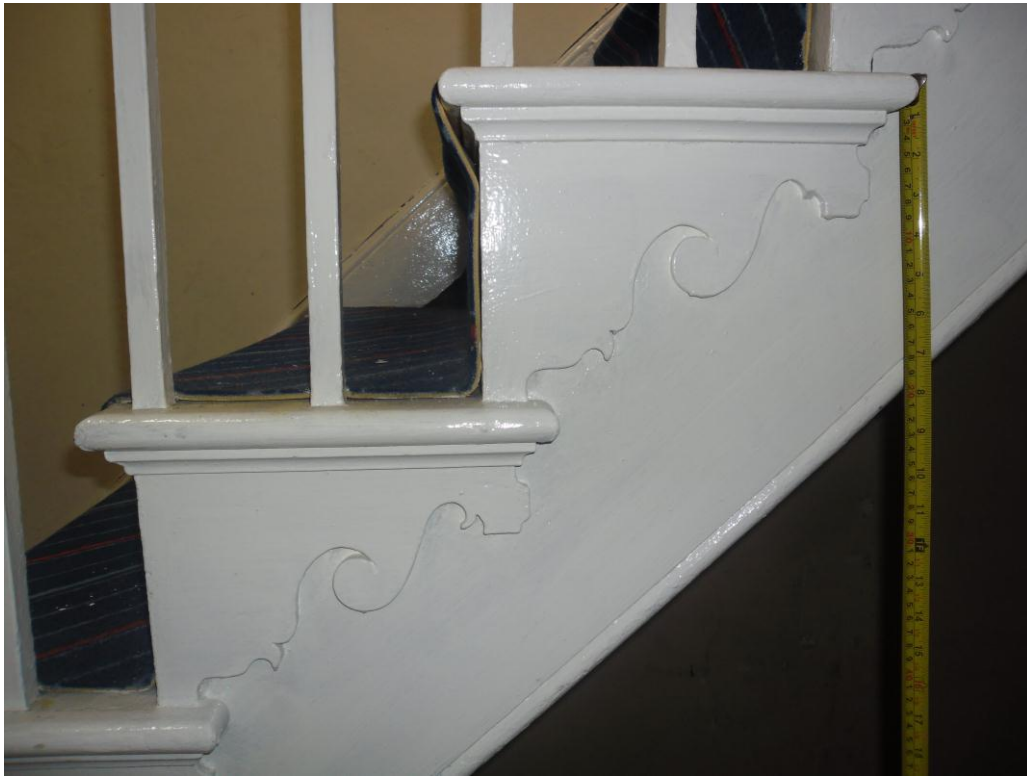
Plate 22: Detail showing plain 'Vitruvian Scroll' detailing of brackets to tread ends of dog-leg staircase to second floor

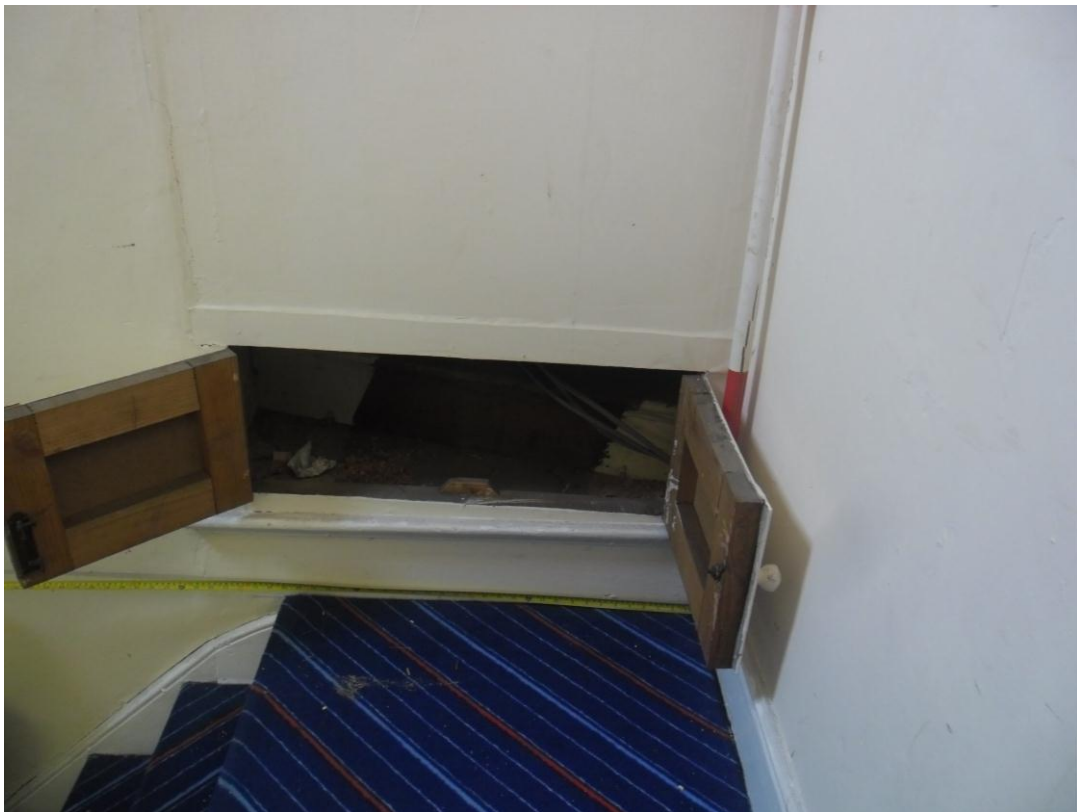
Plate 23: Internal view looking NW showing blocked doorway and stairs in SE-facing wall on half-landing between first and second floors

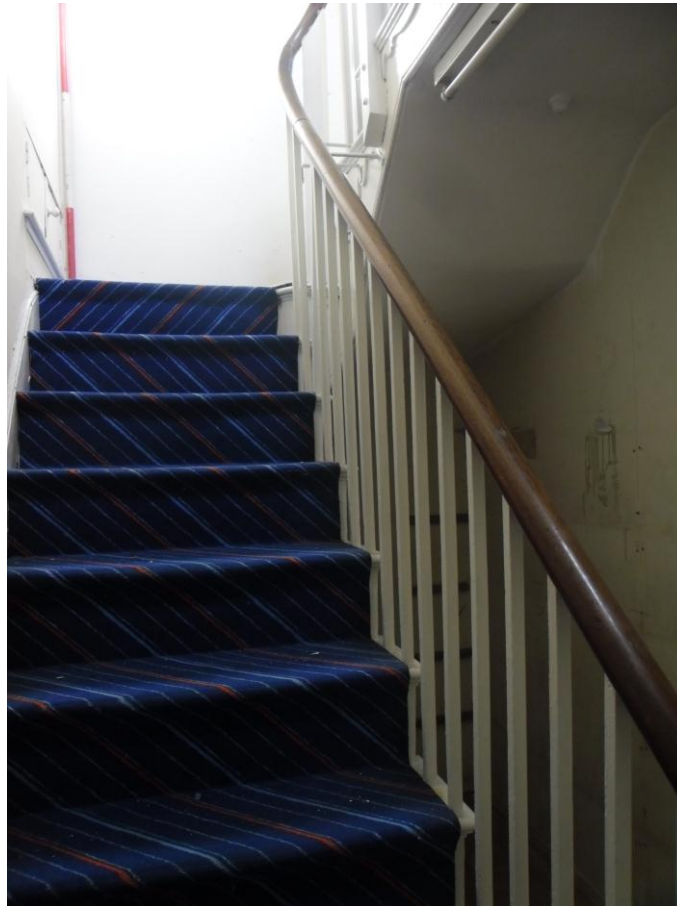
At the point where the staircase changes direction and ascends from the half-landing to the second floor, two newel posts have been inserted, below which are three iron rods linking the treads to the opposite balusters and hand rail (*Plate 24*). It is also noticeable the detailing of the landing tread on the second floor is a much simpler, wavy moulding compared to the scrollwork on the stair treads leading up to it (*Plate 25*).

Plate 24: Internal view looking up first-floor staircase to half-landing showing newel posts and iron rods connecting the treads to the opposite handrail and balusters

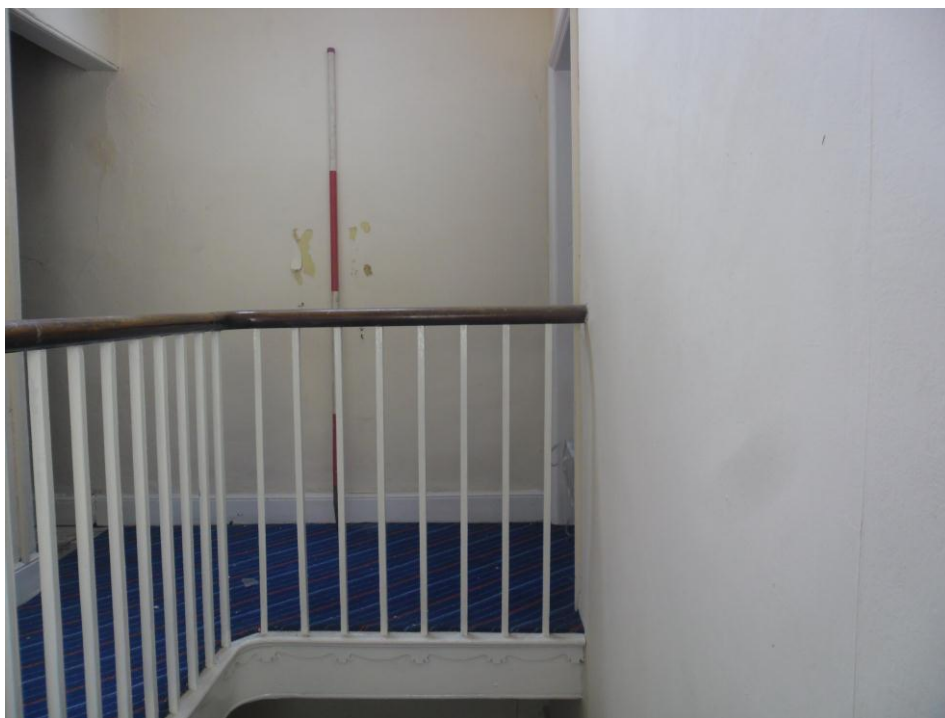
Plate 25: Internal view looking SW showing second-floor landing

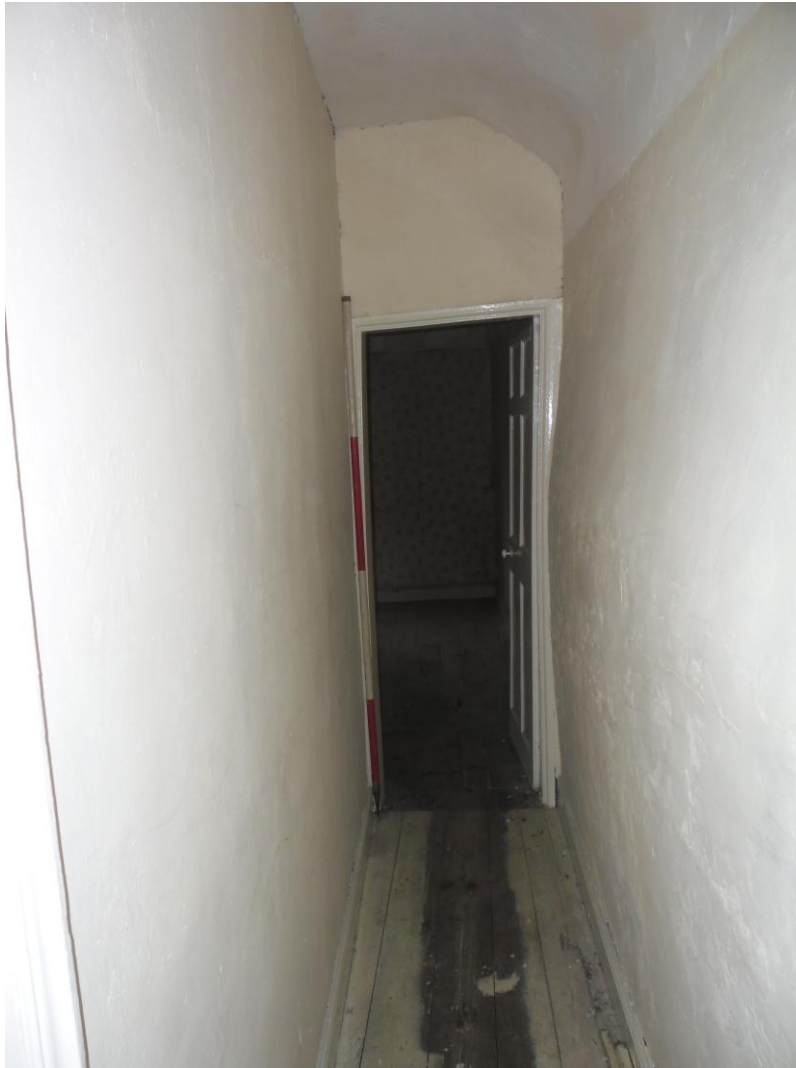
The second floor displays some evidence of modern alteration (in particular, the skylight inserted above the second-floor landing), although this appears to be much less extensive compared to the first floor. The plan of the second floor represents a much better preserved example of what the first-floor must originally have looked like (before extensive late 20th century remodelling), with a narrow cross-axial corridor leading SE from the landing to three rooms, one lying immediately NE of the corridor while the other two rooms are located at the SE end of the house. It is noticeable, however, that the ceiling above the second-floor corridor is distinctly coved, compared to its counterpart at first-floor level (*Plate 26*).

Plate 26: Internal view looking SE along second-floor corridor, showing coved ceiling

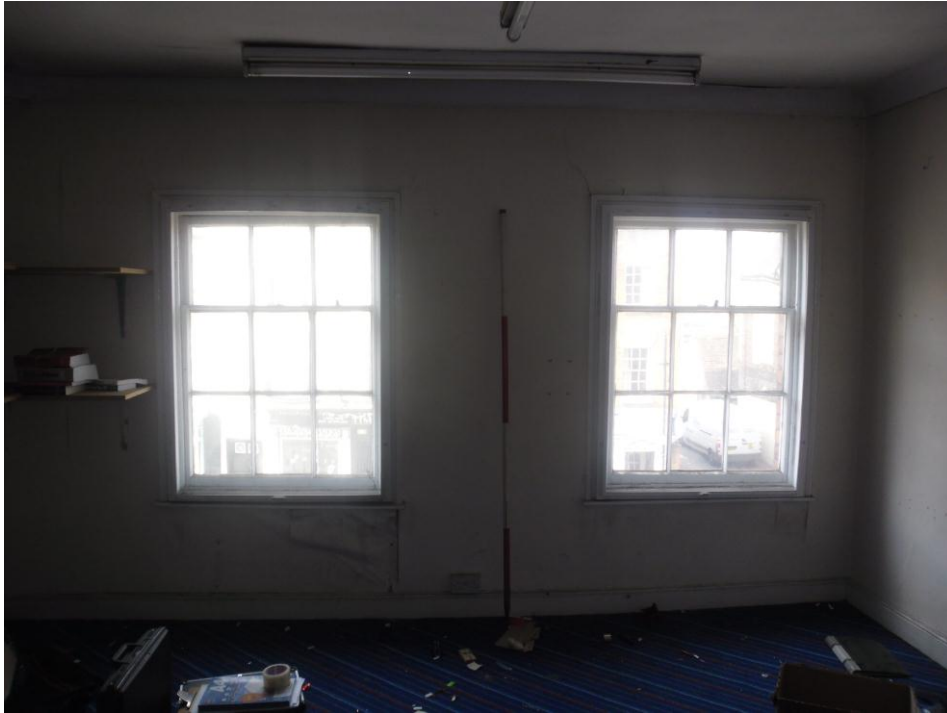
Plate 27: Internal view looking NW showing 9-pane sash windows with reeded architraves in second floor room overlooking Load Street

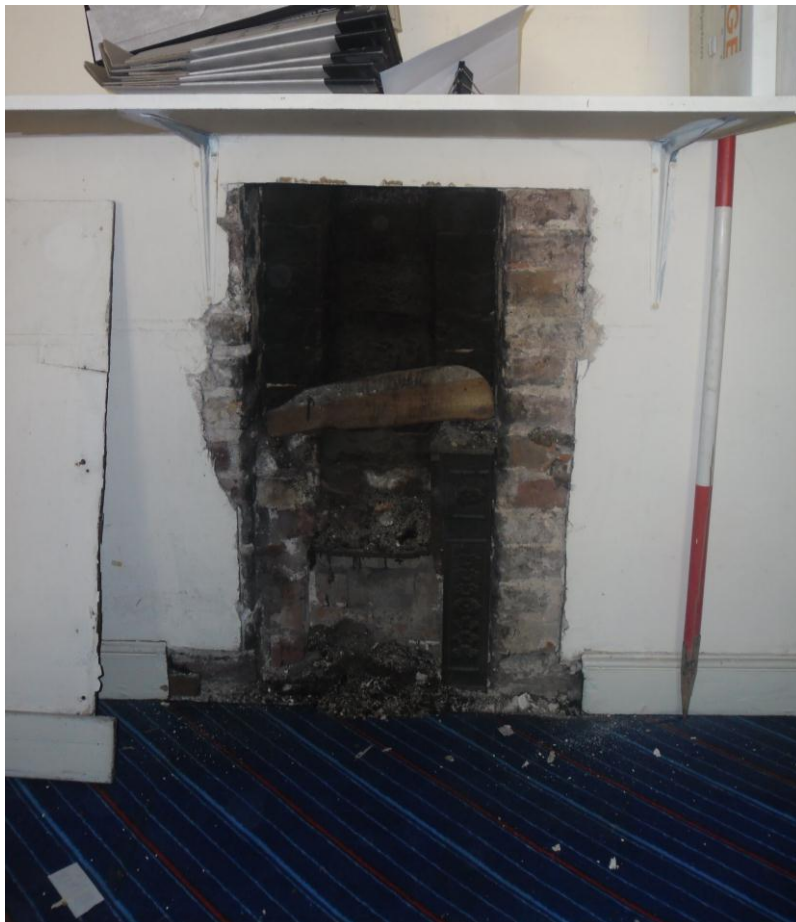
Plate 28: Internal view looking SE showing detail of fireplace grate with foliage decoration in second-floor room overlooking Load Street

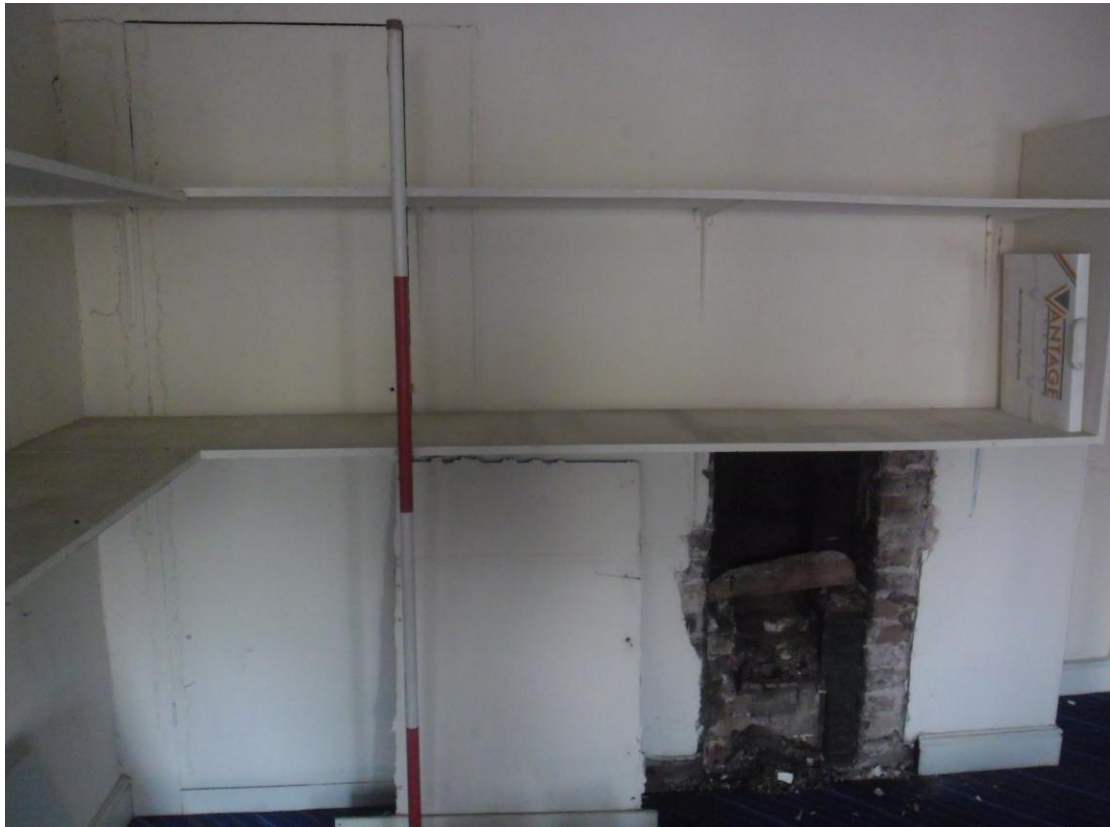
Plate 29: Internal view looking SE showing fireplace and blocked-up doorway in second-floor room overlooking Load Street

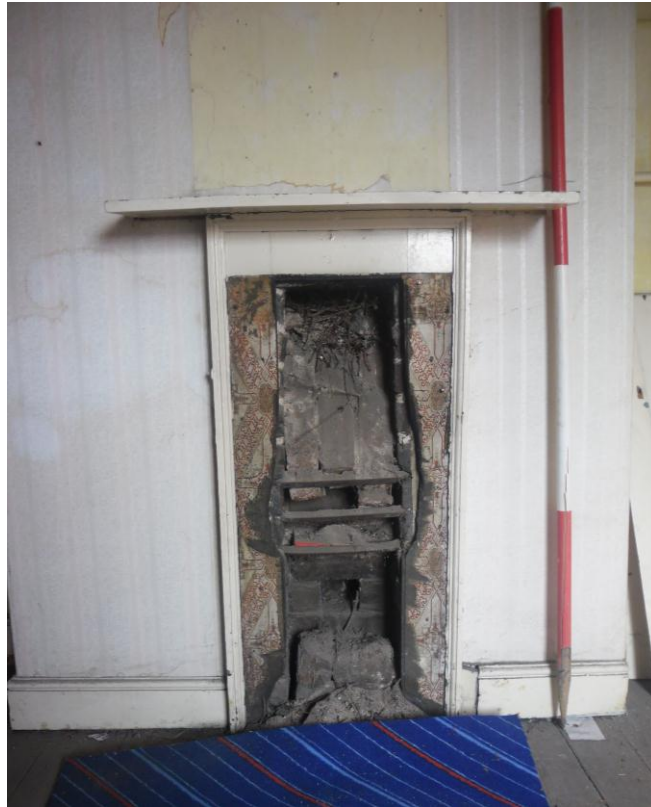
Plate 30: Internal view looking NW showing fireplace in SE-facing wall of second-floor bedroom

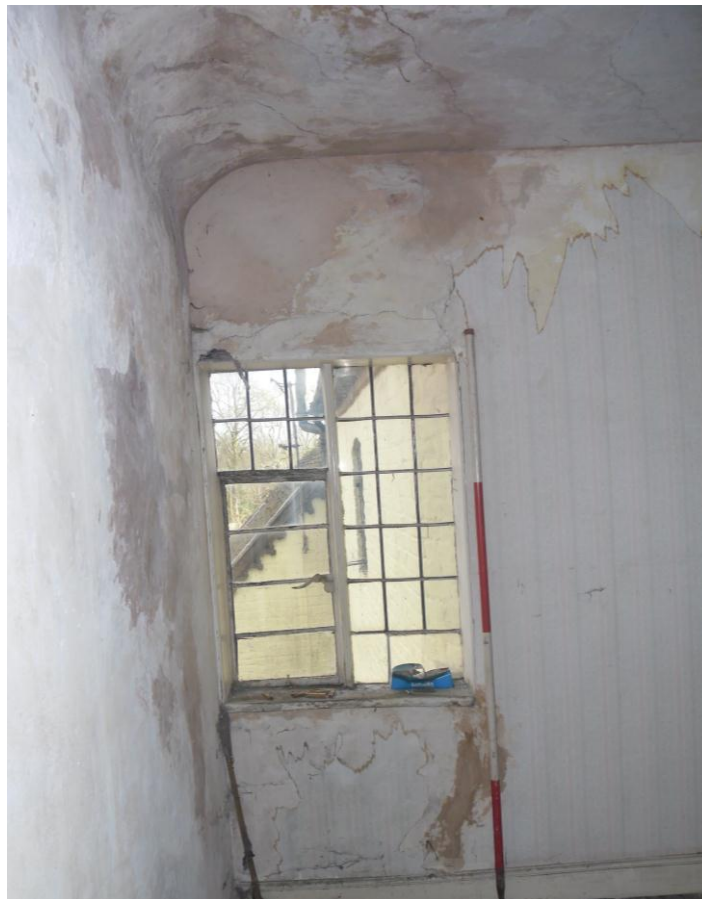
The room to the NE of the corridor is similar in plan to its counterpart at first-floor level, lit by a single casement window, with a fireplace projecting from the SE-facing wall with recesses for cupboards or shelving on either side. The fireplace (*Plate 30*) has survived in reasonably good condition; the wooden surround and mantelpiece have survived intact, as well as the iron grate with its painted surround, decorated with a simple geometric foliage motif. The ceiling, as with all the other rooms on the second floor, is noticeably coved (*Plate 31*).

Plate 31: Internal view looking SE showing coved ceiling & casement window in second-floor bedroom

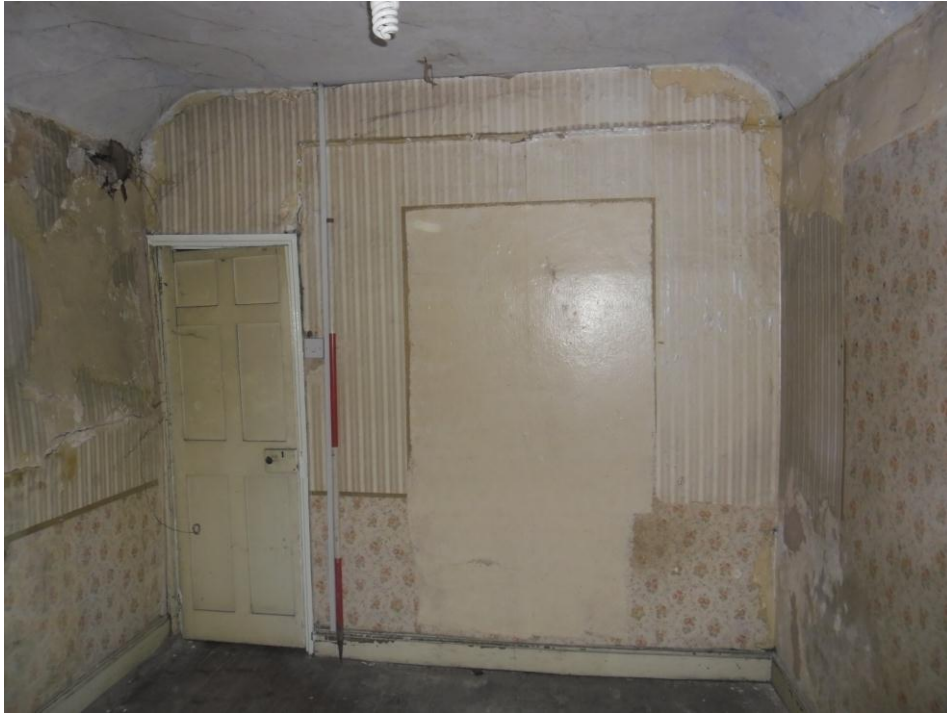
Plate 32: View looking NW showing interior of second-floor room at SE end of corridor

The large rectangular room at the SE end of the corridor appears probably to have been used as a bedroom, judging from the indentation for a large cupboard or wardrobe left in the SE-facing wall (*Plate 32*). No fixtures, fittings or architectural detailing were noted, apart from the casement window in the NE elevation, set within a rectangular moulded architrave (*Plate 33*). A door in the SE corner of the room leads to a small oblong storeroom lined with shelves (*Plate 34*). No other features of interest were noted.

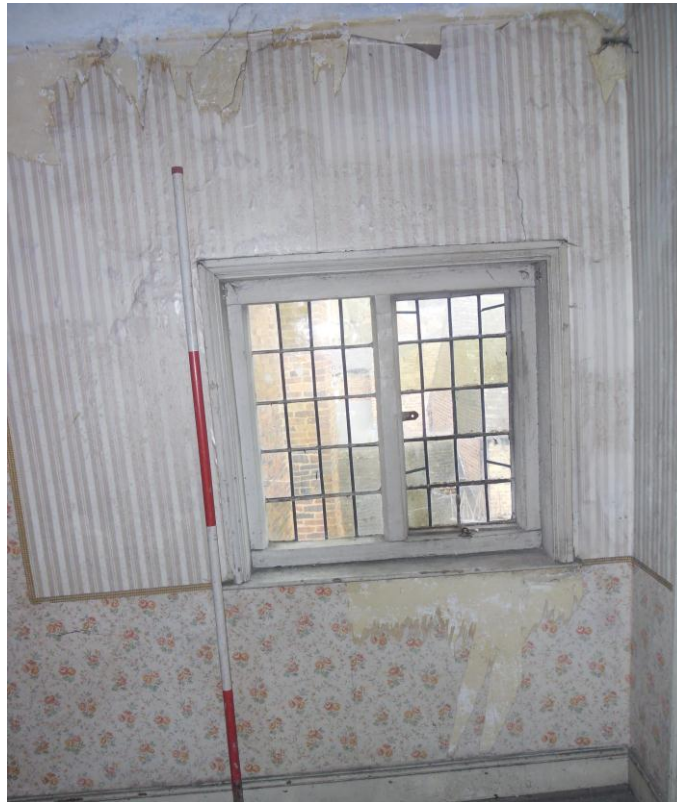
Plate 33: Internal view looking NE showing casement window in SW-facing wall of room to SE of corridor

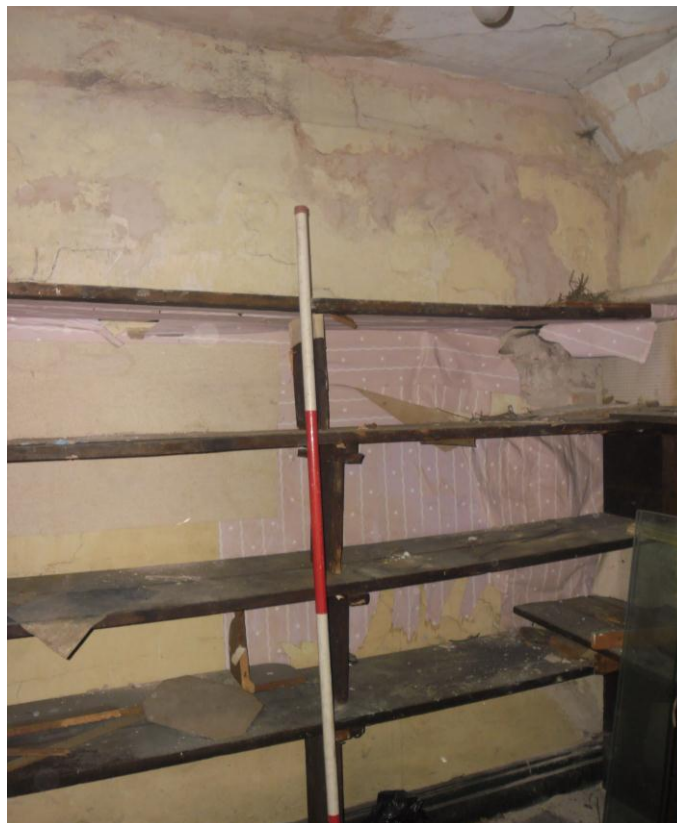
Plate 34: Internal view looking SE showing shelving in storeroom adjacent to second-floor room at SE end of corridor

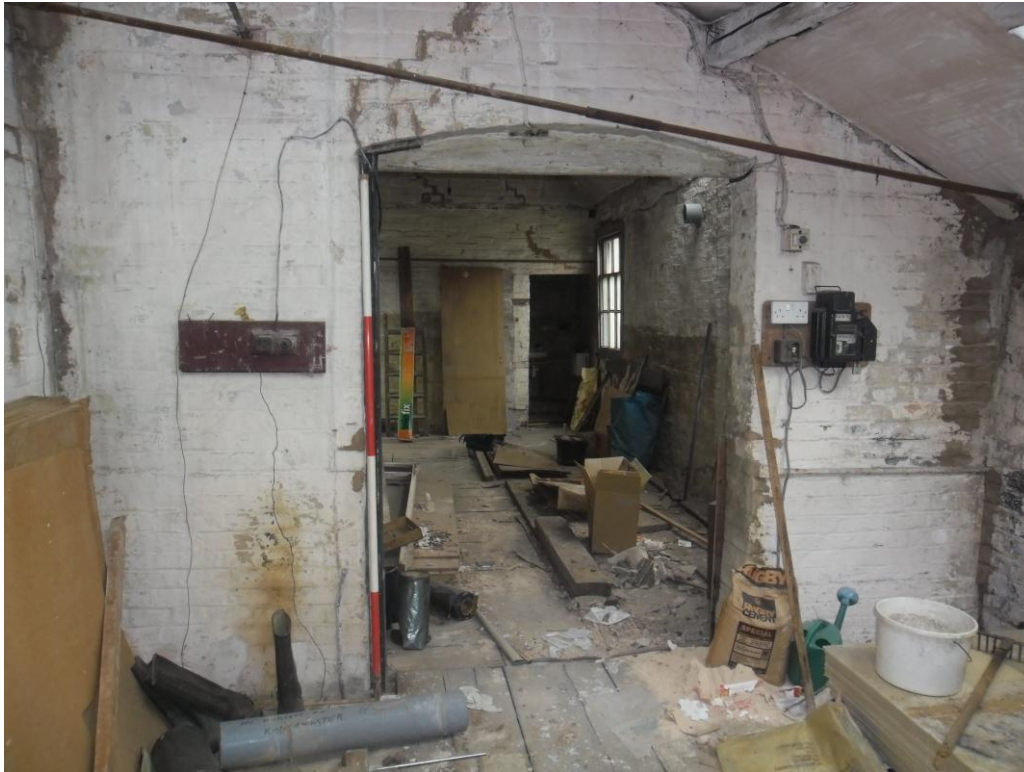
Plate 35: Internal view looking NW showing first floor of two-storey outbuilding (printing works) with segmental-arched door opening

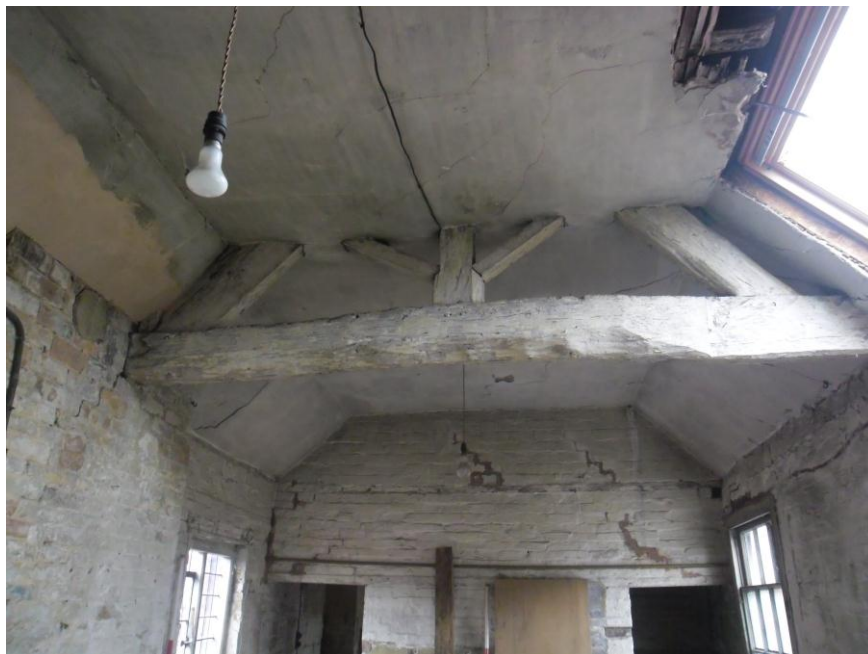
Plate 36: Internal view looking NW showing kingpost roof truss (partially concealed by a coved plaster ceiling) in central compartment of printing works/workshop

(the uppermost part of the truss is concealed by the plaster ceiling) (*Plate 36; fig. 8*). Two 9-pane sash windows with thick glazing bars, set within plain moulded architraves, are inserted into the SW-facing wall of the room (*Plate 37*), while on the opposite side of the room, to the right of the fireplace, a flat-headed, multi-pane casement window with a wooden lintel has been inserted (the original glazing of the casement appears partly to have been replaced).

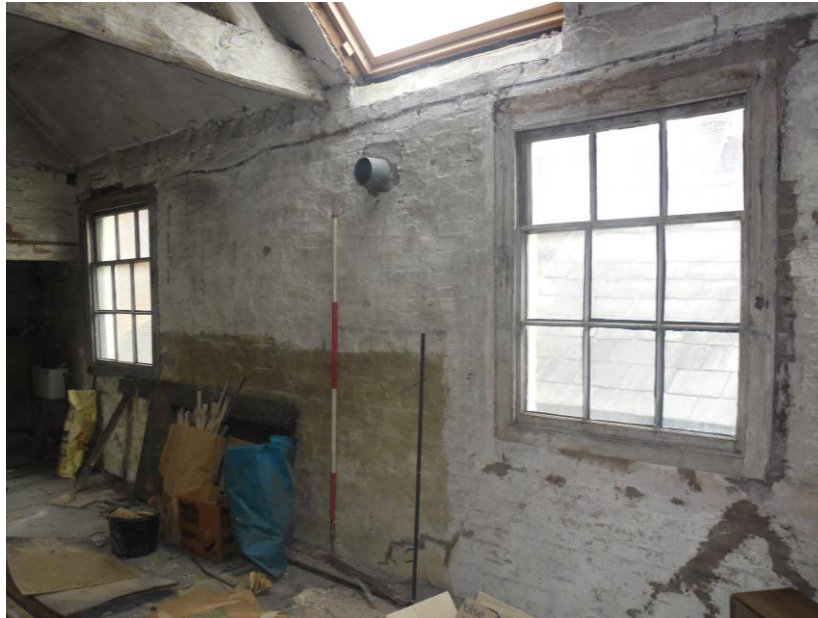
Plate 37: Internal view looking N showing 9-pane sash windows in SW-facing wall

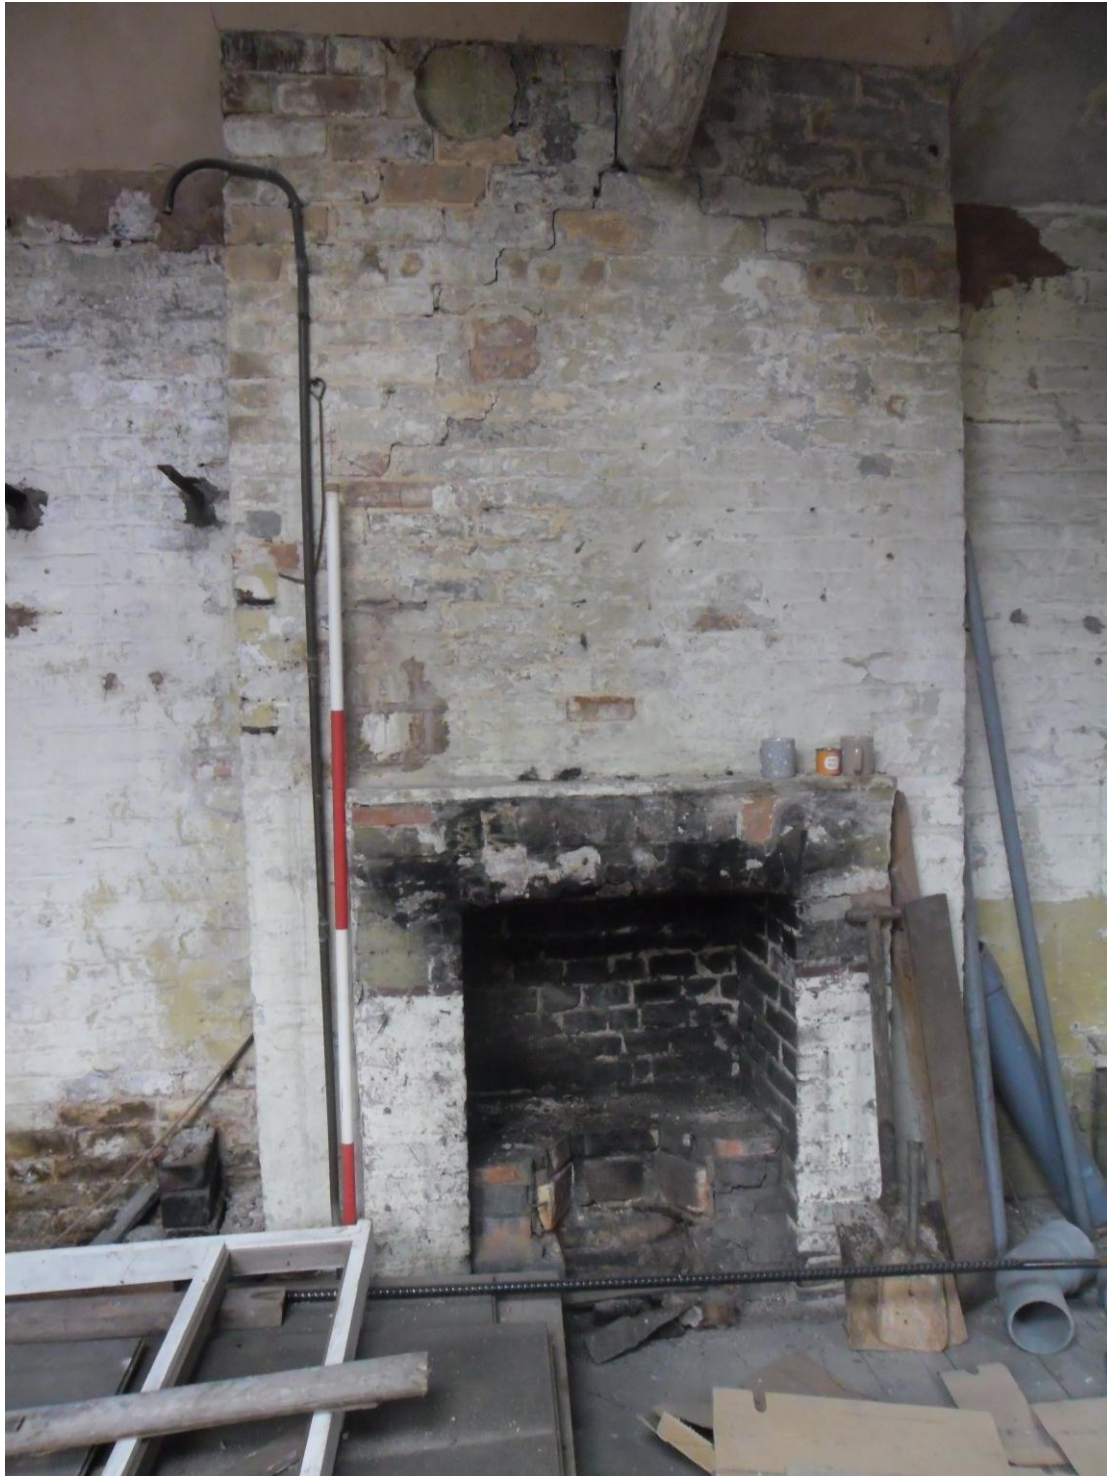
A plain, flat-headed brick fireplace (the iron grate having been removed) is set within a projection of the NE-facing wall, roughly in the centre of the elevation. At the NW end of the room is a thin, brick-built partition wall. Set into the thickness of this partition wall, just below eaves level, is a horizontal timber wall-plate. No evidence for fixtures, fittings or machinery associated with its usage as a printing works was noted.

Plate 38: Internal view looking SW showing fireplace in NE-facing wall

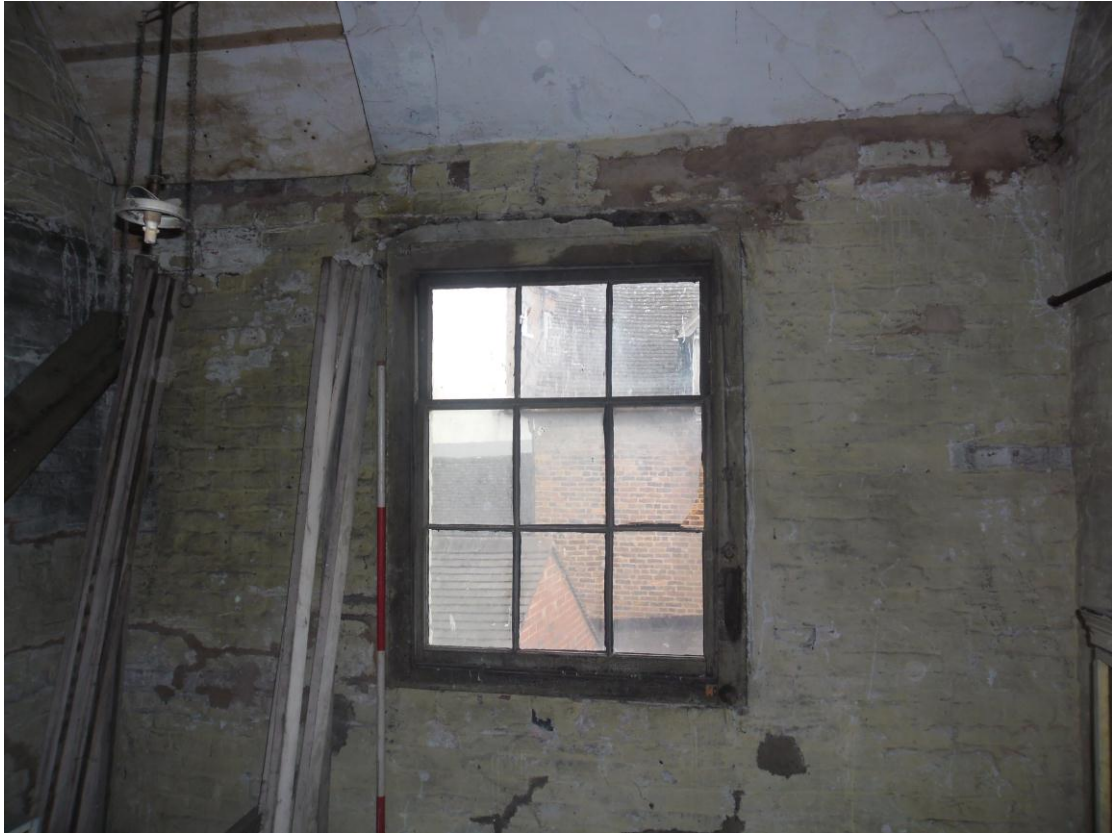
Plate 39: Internal view looking NE showing sash window in SW-facing wall of compartment at NW end of printing works/workshop

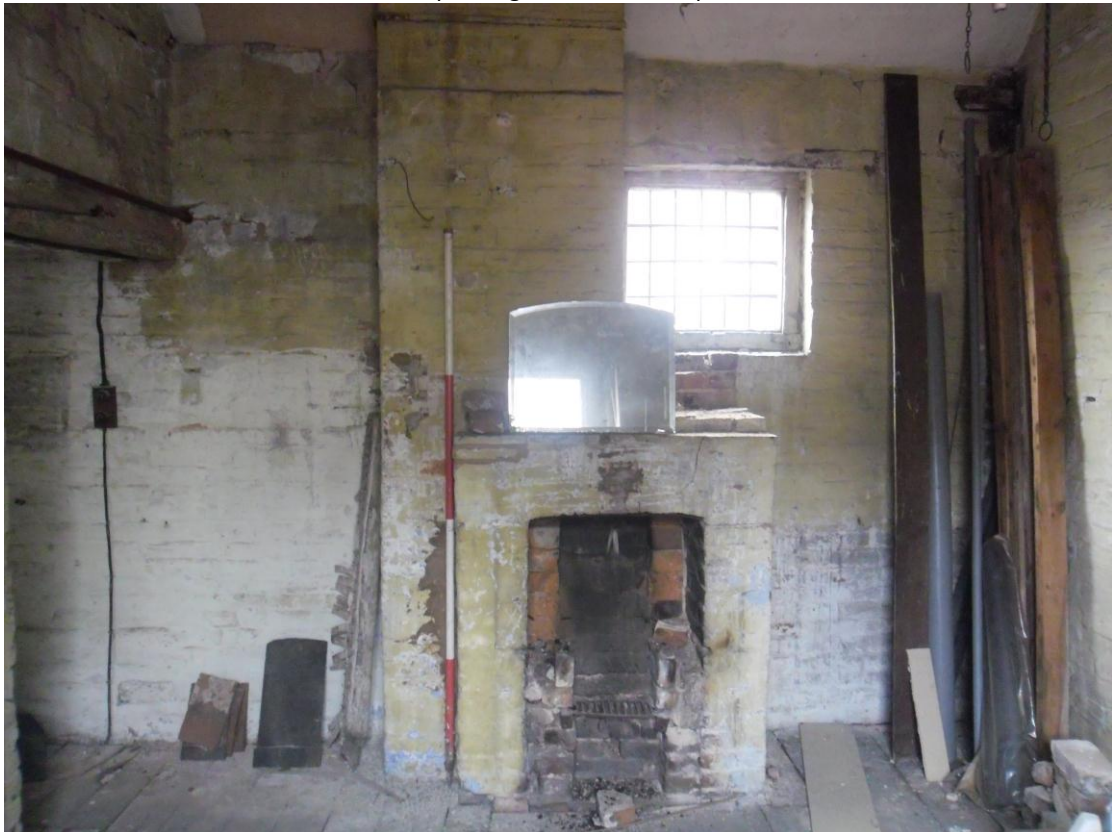
Plate 40: View looking SW showing brick fireplace and casement window in NE-facing wall of compartment at NW end of printing works/workshop
