# ARCHAEOLOGICAL EVALUATION

Carpenters Arms  
53 Whitburn Street  
Bridgnorth  
WV16 4QP

NGR: SO71430 93169  
JOB N<sup>o</sup>: BA1213CAB

October 2012

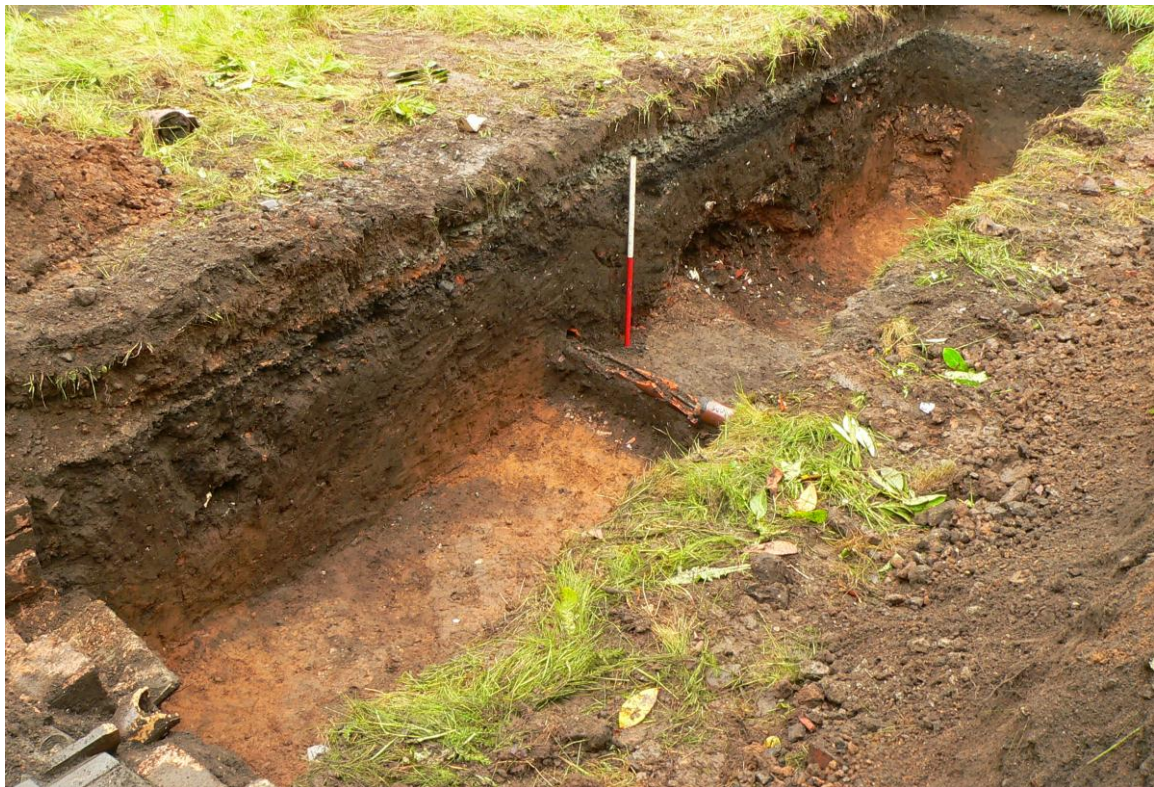
*Plate 1: General view WNW of Trench 1*

Trench 1 (*Plate 1*) revealed a total of 23 contexts. Underlying a deposit of modern imported topsoil (101) were contexts (102) and (103), comprising a 20<sup>th</sup> century gravel surface and sub-base, respectively. Underlying (103) was an imported garden soil (109) extending across the entire trench to an average depth of 0.46m. This overlay (109) a modern duct (111) filling [112] overlying a large pit [120] containing late post-medieval demolition rubble. The remains of a 19<sup>th</sup> century floor surface (104) and wall foundation (105) were revealed at the SE extent of the trench oriented NW-SE. A possible robbed wall foundation (122) was revealed in the NW corner on a similar orientation. Natural soils were encountered at a depth of 0.88m below existing ground level (66.49m AOD).

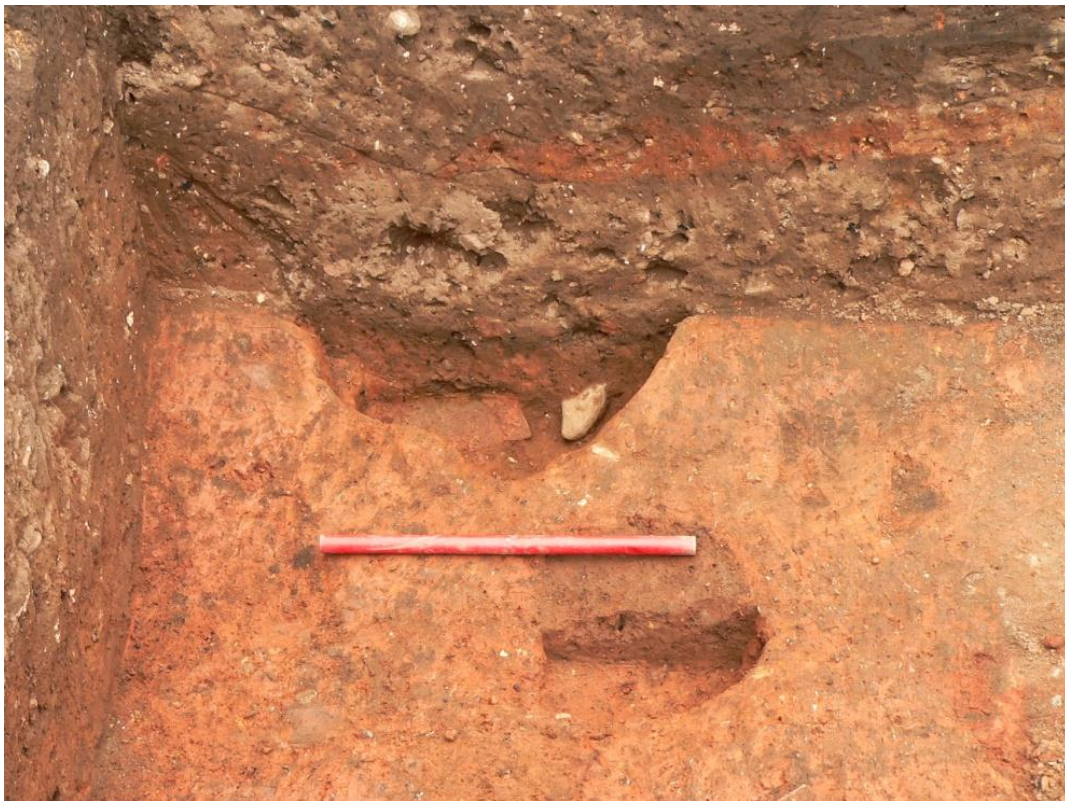
*Plate 2: View NW of medieval pits or postholes [218] (foreground) and [216] (section)*

Trench 2 (*Plate 2; fig. 2*) revealed 20 contexts. Underlying the modern tarmac surface and sub-base (201) and (205), respectively, was a post-medieval garden soil deposit (207), which, in the E extent of the trench, overlay a large rubble-filled pit [214].

Beneath this was a sandy clay layer revealed at 0.4m to 0.8m below current ground level (66.38m AOD to 66.69m AOD). Two small circular pits [216, 218] were revealed, which were cut from this deposit and which contained four sherds of 12<sup>th</sup> century Worcester ware cooking pot (Clarke pers. comm.).

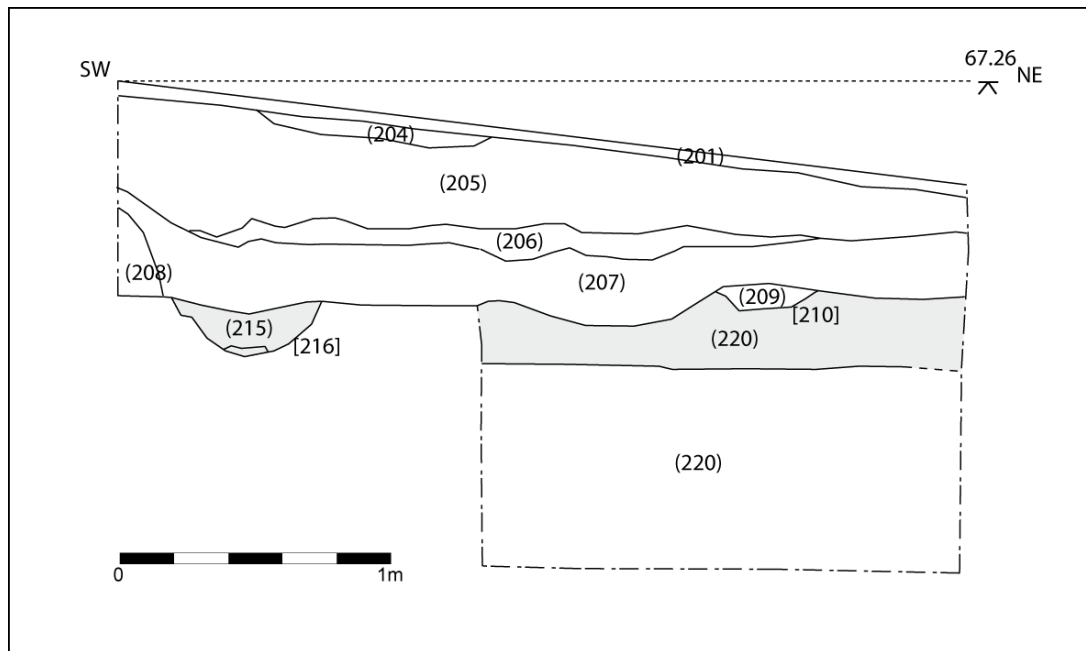
Fig. 2: SE-facing section of Trench 2 (medieval horizon highlighted in grey)

Trench 2 (*fig. 2*) was located close to the street frontage and once again revealed evidence of late 19<sup>th</sup> century/modern landscaping, as a trench-wide garden soil deposit was identified sealing a rubbish pit containing late post-medieval building rubble. A medieval occupation horizon was encountered, although this was truncated and only visible in the northern and western extent of the trench. Two small truncated pits or possibly large postholes were revealed at this level; both of these features contained sherds of 12<sup>th</sup> century Worcester ware.

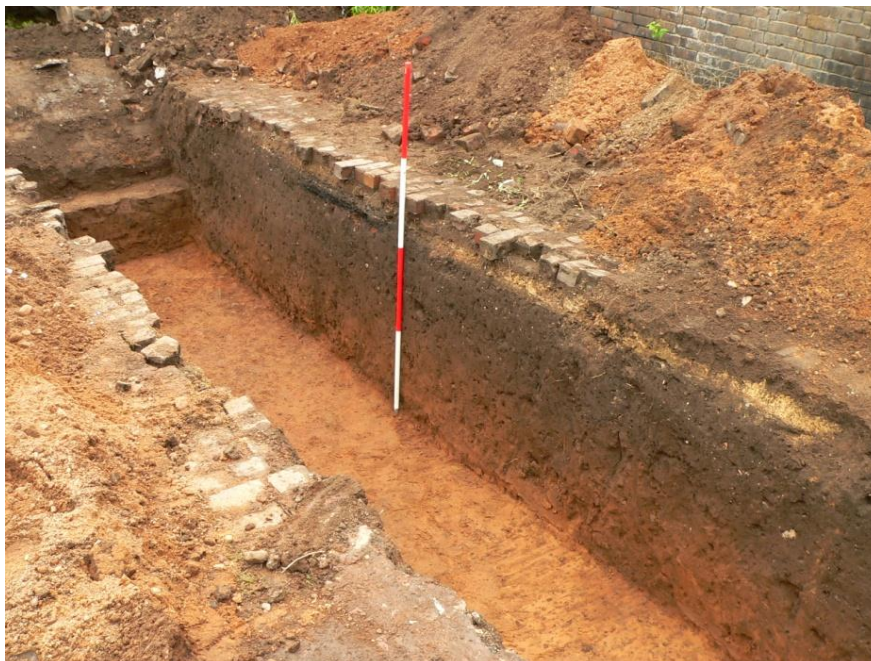
Plate 3: General view SW of Trench 3

Trench 3 (*Plate 3*) contained nine contexts, the uppermost of which, context (301), was a sand-bonded brick floor surface overlying a crude prepared surface/sub-base (302). Underlying this were a series of late post-medieval imported garden soil type deposits.
