ARCHAEOLOGICAL OBSERVATION

**QUAY COTTAGE
NO 12 QUAY STREET
HEREFORD
HR1 2NH**

*NGR: SO 51121 39601
Planning Ref: S113336/FH*

JOB No: BA1318QSH

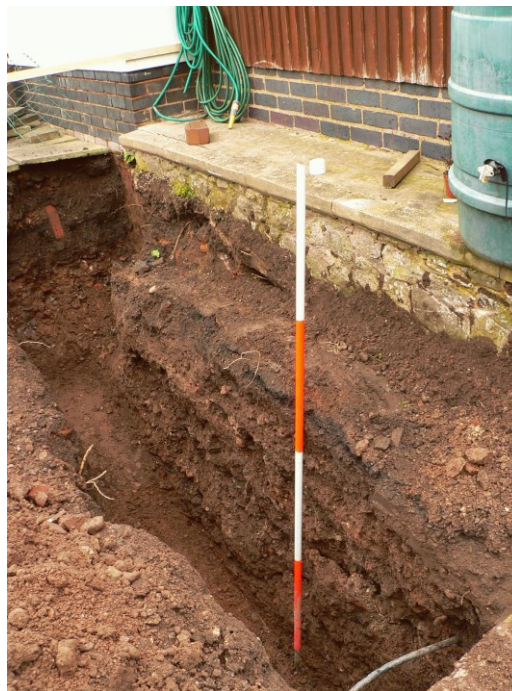
Plate 1: View NW of cut [103] in SSW facing section

Further excavation revealed that (102) formed a backfill deposit within a linear [103] measuring approximately 6.2m wide and >0.8m deep which appeared to run on a NNE-SSW alignment (*Plates 1 & 2; figs. 3 & 4*). The break of slope (top) was quite sharp on both sides, although the building foundations truncated it in the SW extent of the site. The ESE side of the cut was moderate to steeply sloping the WNW was stepped. The base of the feature was not revealed and this clearly lay well below construction depth
