ARCHAEOLOGICAL OBSERVATION

WALLED GARDEN

CROFT CASTLE

NGR: SO 4486 6554
JOB NO: BA1312WGC

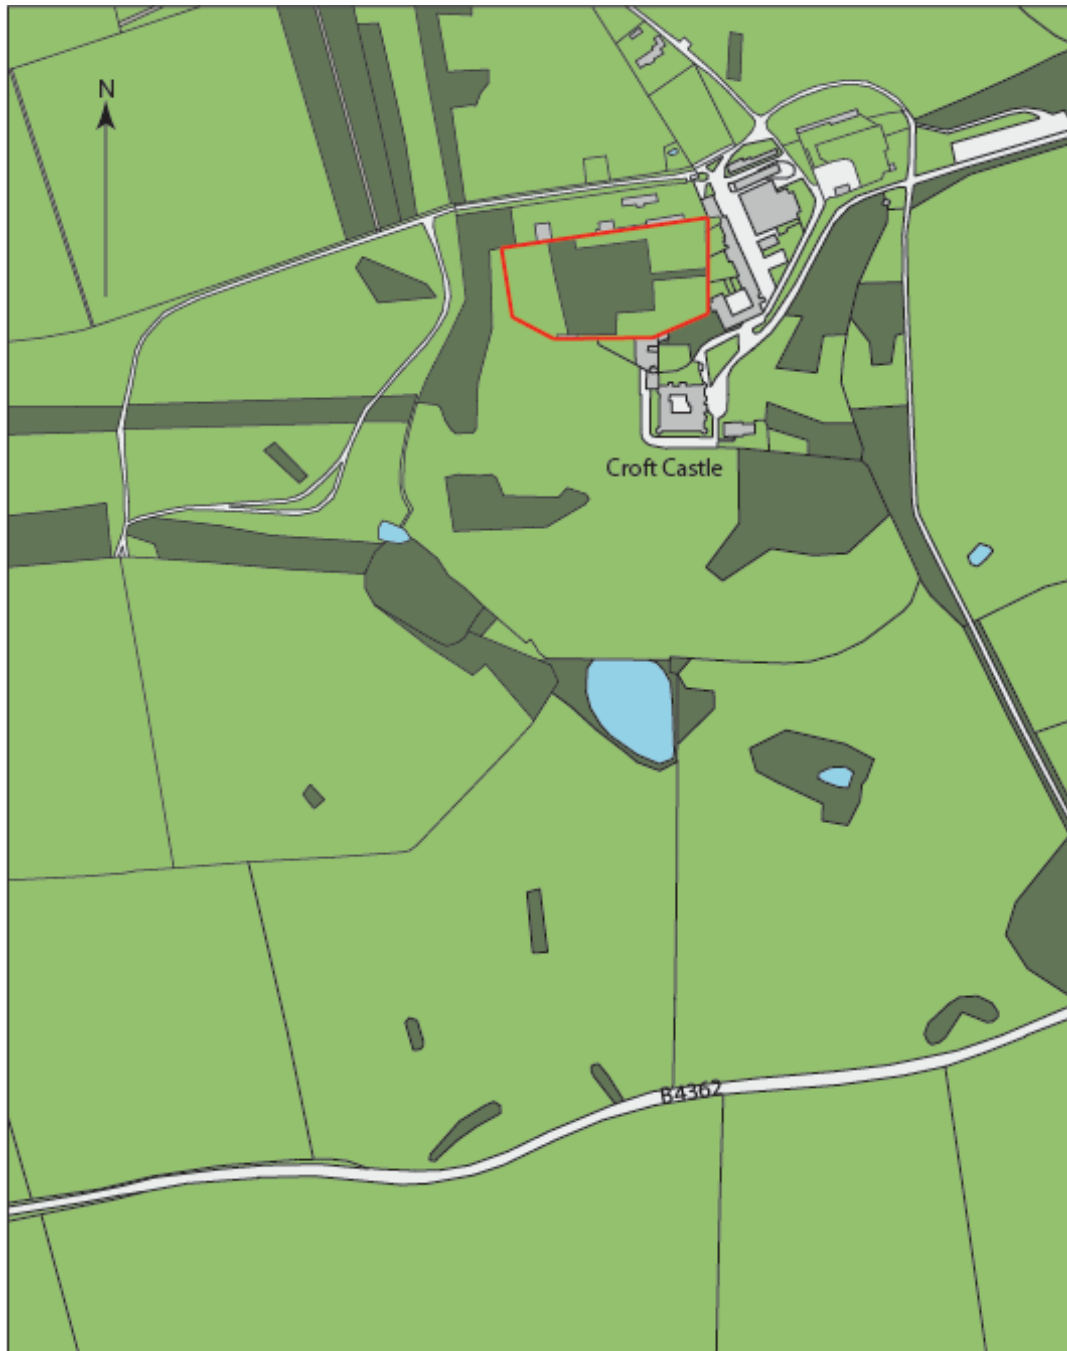
*Fig. 1: Plan showing location of ground-works (marked in red)
(Based on plan supplied to Border Archaeology by the National Trust)*

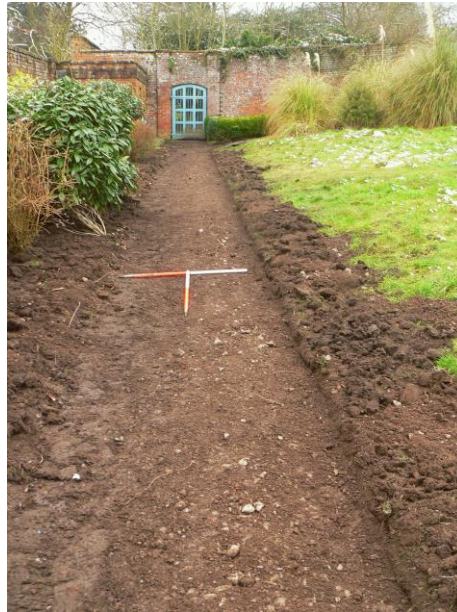
Underlying a site-wide topsoil (003) and garden soil (004) were a series of path surfaces. Path surface (001) ran E-W adjacent to the S wall (*fig.2: indicated in orange*) (Plate 1) and was composed of reddish gravel with occasional larger stones extending 58m × >2m. The eastern extent of this surface appeared to have been truncated by a modern planting bed adjacent to the SE wall. The W extent was truncated by an extant cobbled surface (002) measuring 5.4m × 1.6m (*fig.2: indicated in yellow*) located close to the shed occupying the SW corner of the garden.

Plate 1: View E of E-W pathway (001) adjacent to S elevation of wall

Trenching adjacent to the S elevation revealed an E-W reddish gravel pathway (001) dissimilar in terms of surfacing to that revealed elsewhere in the garden and probably representing a different phase of path construction. A cobbled surface (002) was revealed in the SW corner of the garden truncating (001) but no relationship to (005) was established.

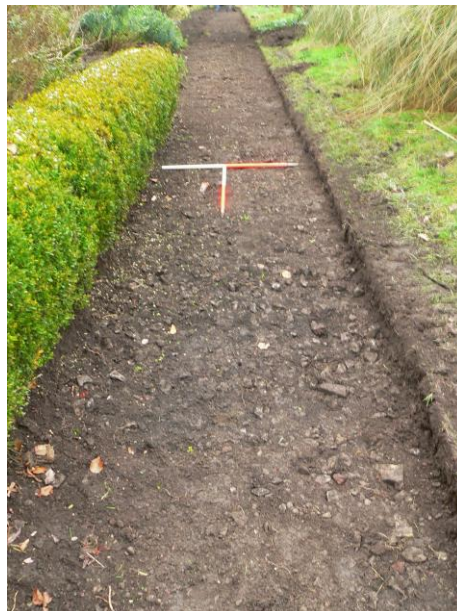
Trenching immediately to the N of (003) revealed a crude path surface (005) (*fig.2: indicated in green*) (*Plate 2*) composed of small angular stone chippings. The path ran roughly N-S on a parallel alignment to the W wall and extended 65m x >1.5m.

Plate 2: View N of N-S pathway (005) adjacent to W elevation of wall

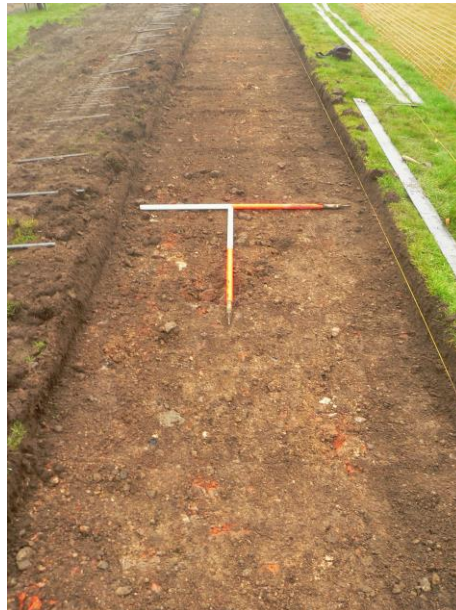
Underlying (007) was a compacted light brown siltstone deposit (008) (*fig. 2: indicated in red*) (*Plate 3*) containing frequent CBM, mortar flecking, slate and imported stone, extending >9.7m in the area immediately to the S of the cottage.

Plate 3: View E of levelling (008) adjacent to N elevation of wall and gardener's cottage

The area E of this (to the S of the cottage) revealed re-deposited natural siltstone (008), (009). This had been dumped to form a level surface in the vicinity of the glasshouses located on the N wall either side of the cottage as shown on the OS 1st Edition 1:10,560 map of 1891. No further evidence of the glasshouses was revealed, these probably being located further N than the northernmost extent of the ground-works. No evidence for cuts containing buried external heating or water pipework was revealed in this area.

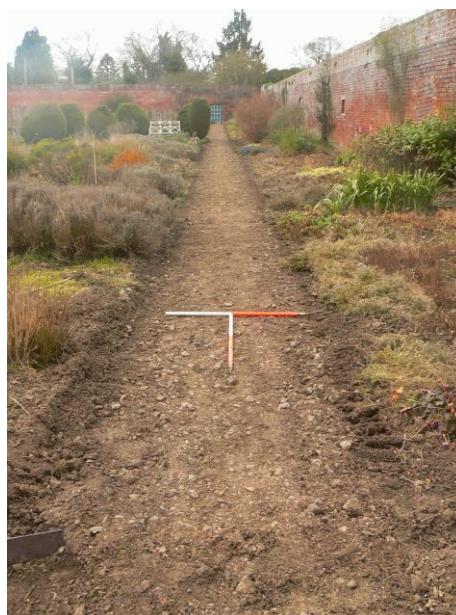
Plate 4: View N of N-S pathway (010) adjacent to E elevation of wall

Ground-works adjacent to the N wall E of the main entrance and adjacent to the E wall revealed a wide ranging surface deposit (010) composed of angular stones of a similar composition to (005) and (007) (*fig. 2: indicated in green*) (*Plate 4*).

Archaeological observation of ground-works revealed evidence of the perimeter pathway (005) and (010) running adjacent to the garden wall on the E, W and part of the N internal elevations. A remnant of the pathway (007) was also revealed where the trenching passed to the W of the cottage. This pathway was constructed from angular stone chippings and was >1.5m wide. It may have served as a rough track-way providing access for cultivation equipment. An oblique aerial photograph from 1946 (Williams 2011) showed that the perimeter path was extant at least until this date and also that the garden had been used for larger-scale vegetable production consistent with its use as a market garden and orchard. The 1891 Ordnance Survey map appears to indicate planned avenues separated by open planting beds.
