STANDING BUILDING RECORDING SURVEY

Upper House
Lyonsall
Herefordshire

NGR: SO 51186 39775
JOB No: BA1116UHL/01
SMR Event No. 1893

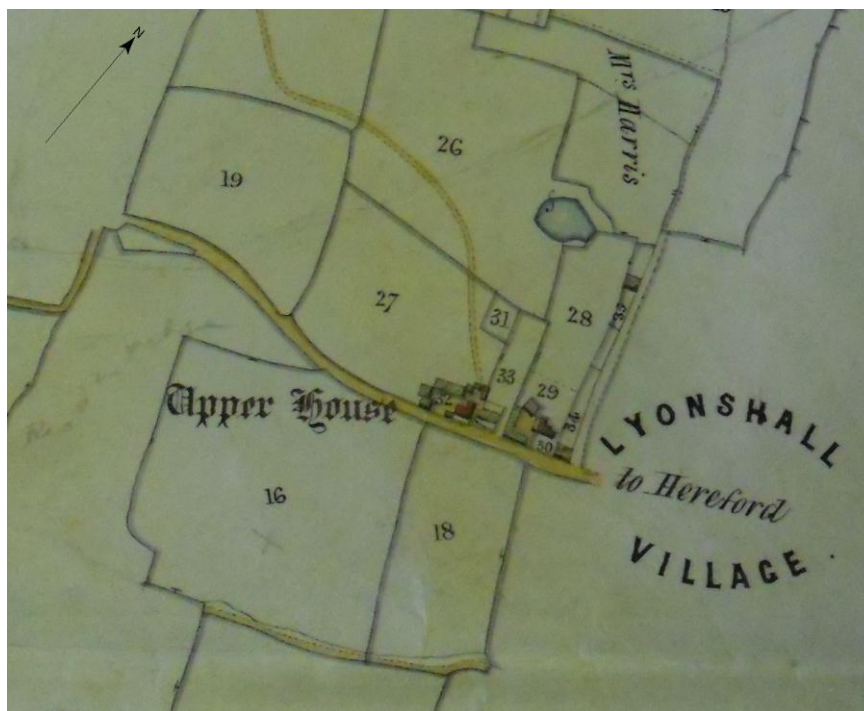
Fig.2 Extract from a plan of the estate at Upper House, Lyonshall, attached to a marriage settlement of 16 October 1860

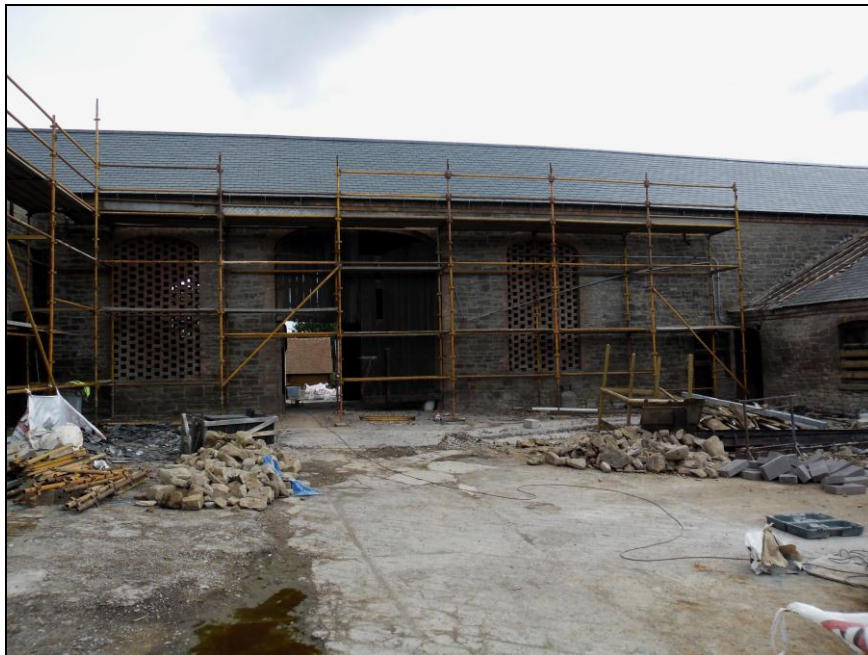
Plate 1: View looking NE showing the principal elevation of the threshing barn (Building 1) overlooking the central courtyard with flanking wings (Buildings 2 & 3) to the NW and SE

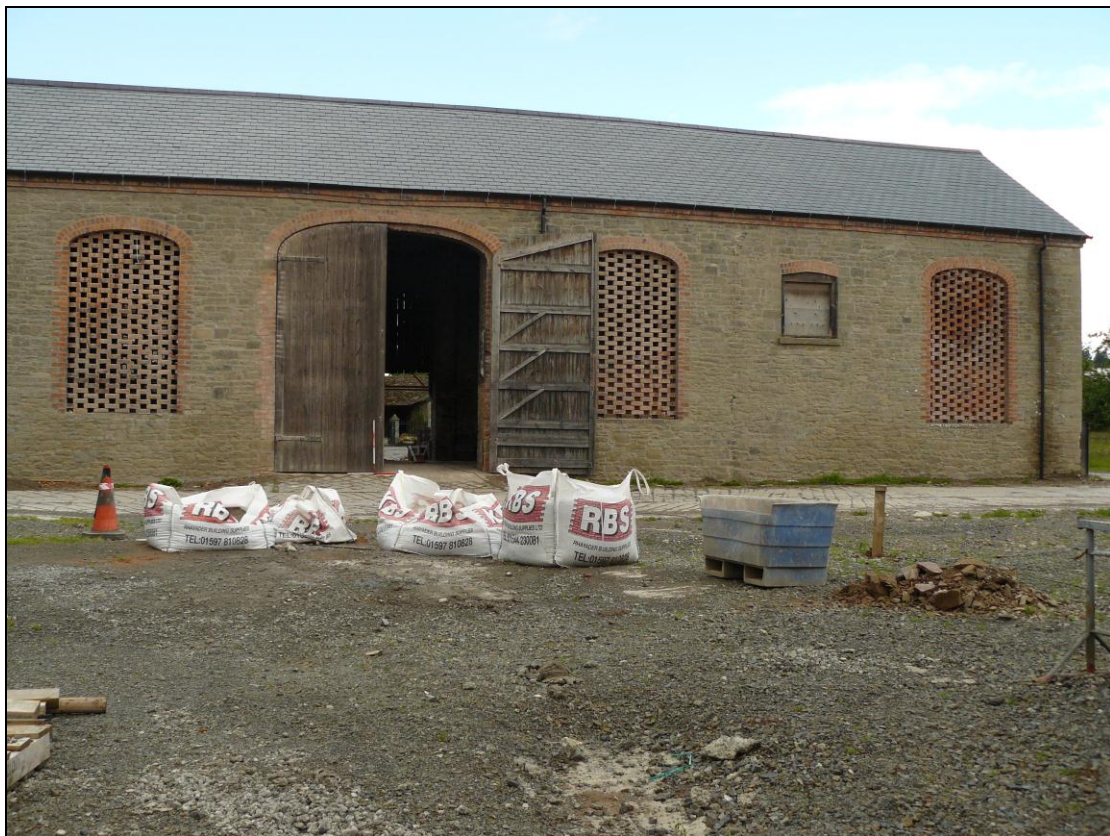
At the NE end of the courtyard is a substantial threshing barn, oriented NW-SE and 9 bays in length, built of roughly coursed sandstone with a stepped brick cornice at eaves level and stepped brick pediments at the NW and SE gable ends. The stonework has mostly been repointed in recent years however there is evidence of worked masonry blocks which could possibly have been incorporated from another, earlier structure on the site. The present slate roof is a modern addition. There is a broad central doorway, depressed-arched with brick dressings, in the front and rear elevations of the barn, which provided access to the central bay of the barn. Flanking the central doorway are two large, depressed-arched ventilation windows with a distinctive chequerboard infill of bricks with alternate holes.

Plate 2: View looking SW showing rear (NE facing) elevation of threshing barn (Building 1) with doorway flanked by chequerboard patterned ventilation windows

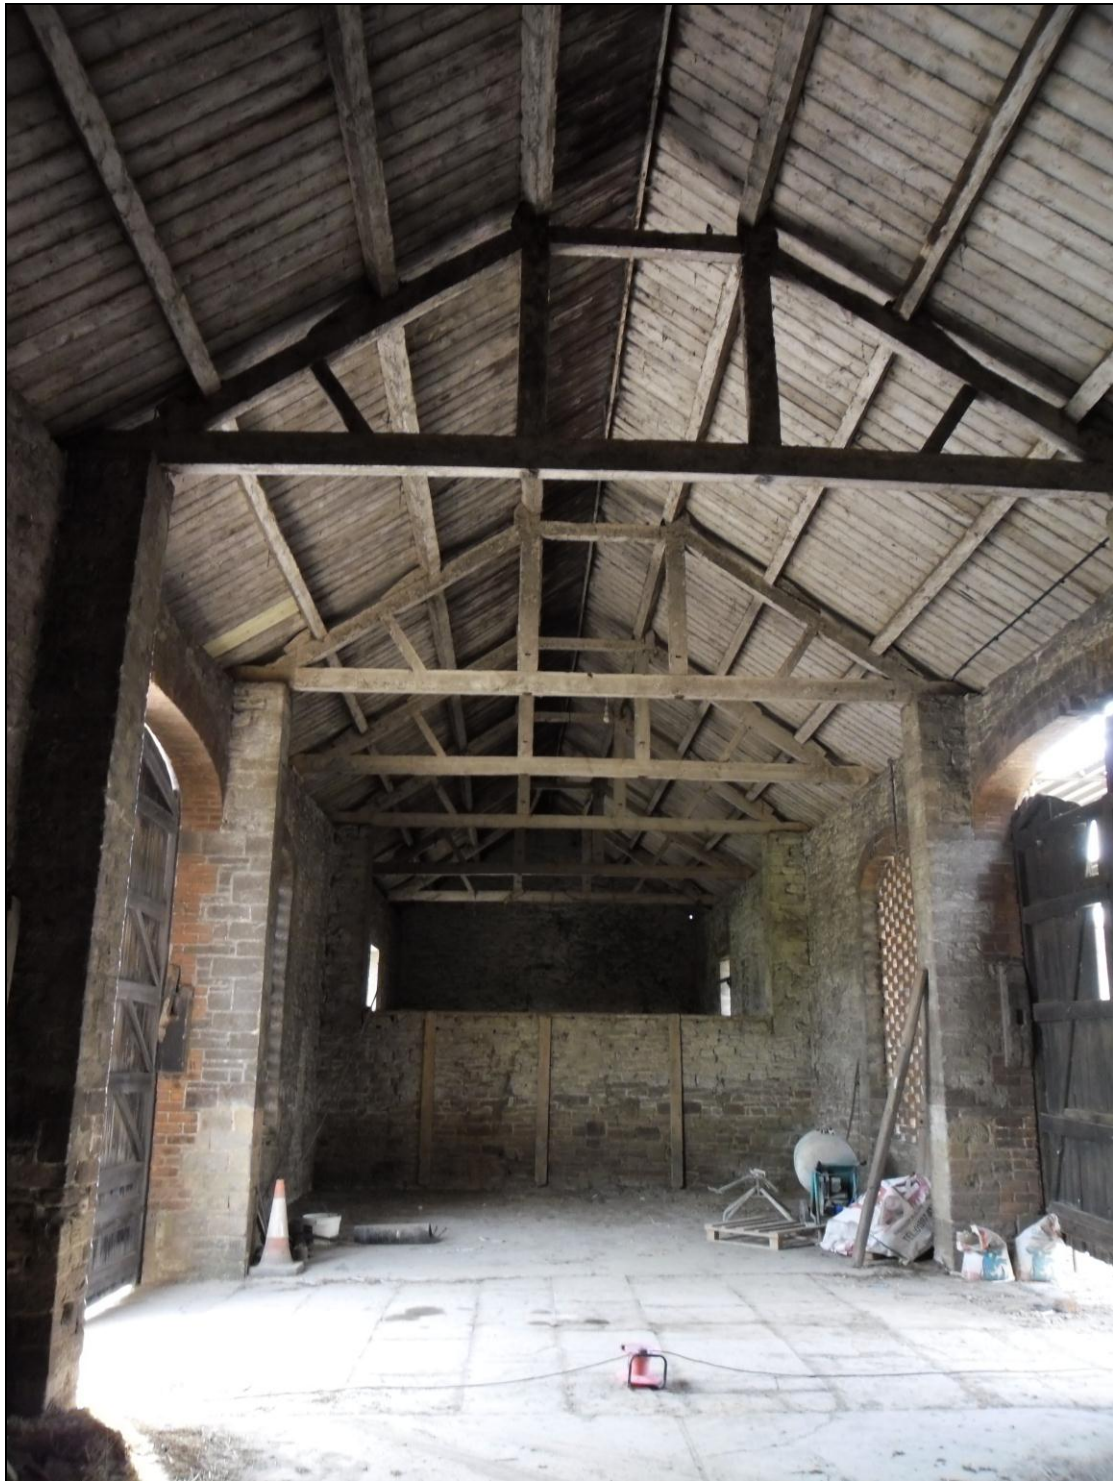
Another large ventilation window is visible at the NW end of the rear (NE-facing elevation), to the left of which is a small segmental arched opening with a stone lintel (presumably a loading bay window) set in the upper part of the elevation. Internally, the most noteworthy features are the well-preserved stone-flagged threshing floor in the central bay of the barn which has still survived largely intact and the queen-post roof with angled struts connecting the tie beam to the principal rafters and three sets of trenched purlins.

Plate 3: Internal view of threshing barn (Building 1) looking SE showing queen-post roof trusses and stone-flagged threshing floor in central bay, with stone partition wall in background

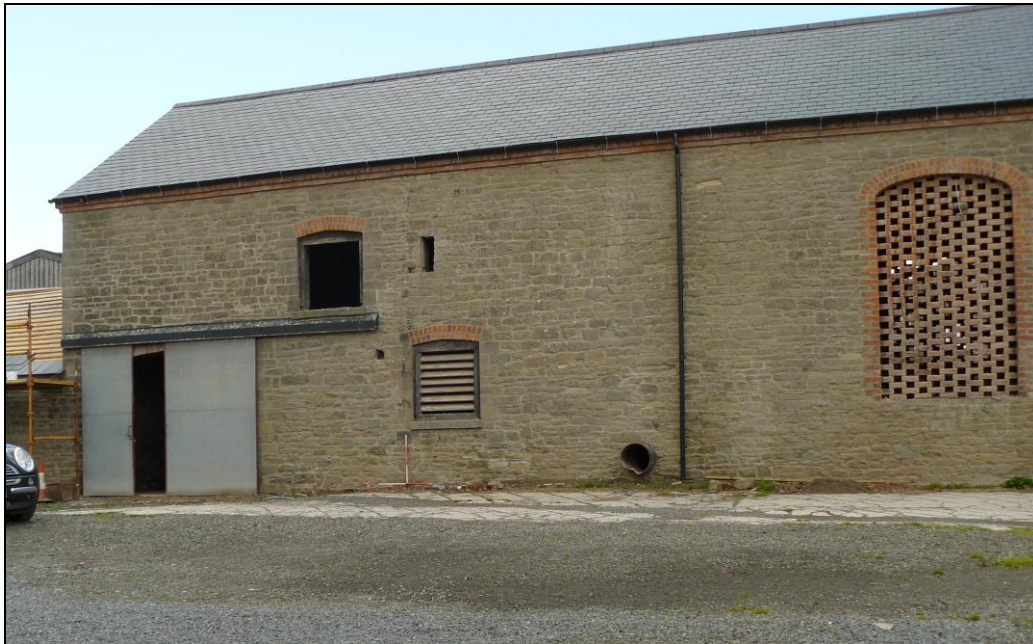
The three southeasternmost bays of the barn appear to have been separated from the rest of the barn and converted to use as a stable with hayloft above (probably at some time between 1887 and 1904). This is indicated internally by the stone partition wall with vertical timber braces and externally by the broad, segmental arched brick archway at the SE end of the rear elevation (partially concealed by modern sliding doors and fascia) with a segmental arched loading bay immediately above and to the right of the doorway. A narrow ventilation slot immediately to the right of the loading bay probably represents an earlier survival.

Plate 4: View looking SW showing SE end of rear (NE-facing) elevation of Building 1 with segmental arched doorway (concealed by modern sliding doors and fascia) with loading bay above

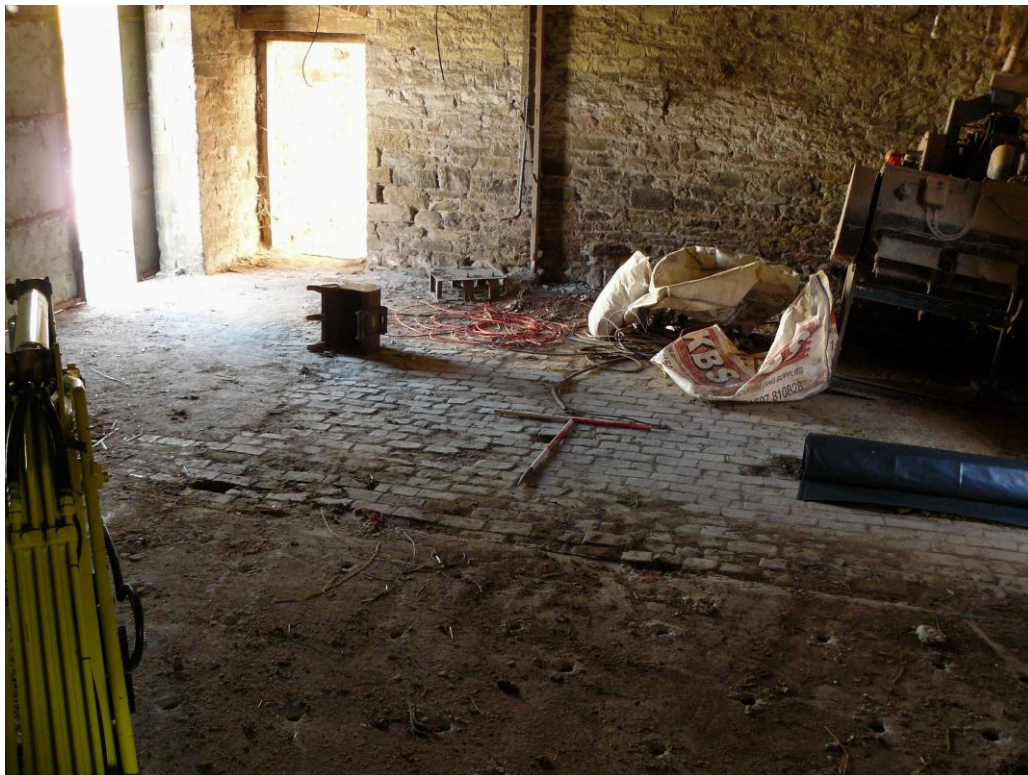
Internally, the most notable features within the stable block consist of the brick cobbled floor and the low ceiling with hatch leading to the loft above.

Plate 5: Internal view looking SE showing brick cobbled floor in stable at SE end of threshing barn (Building 1)

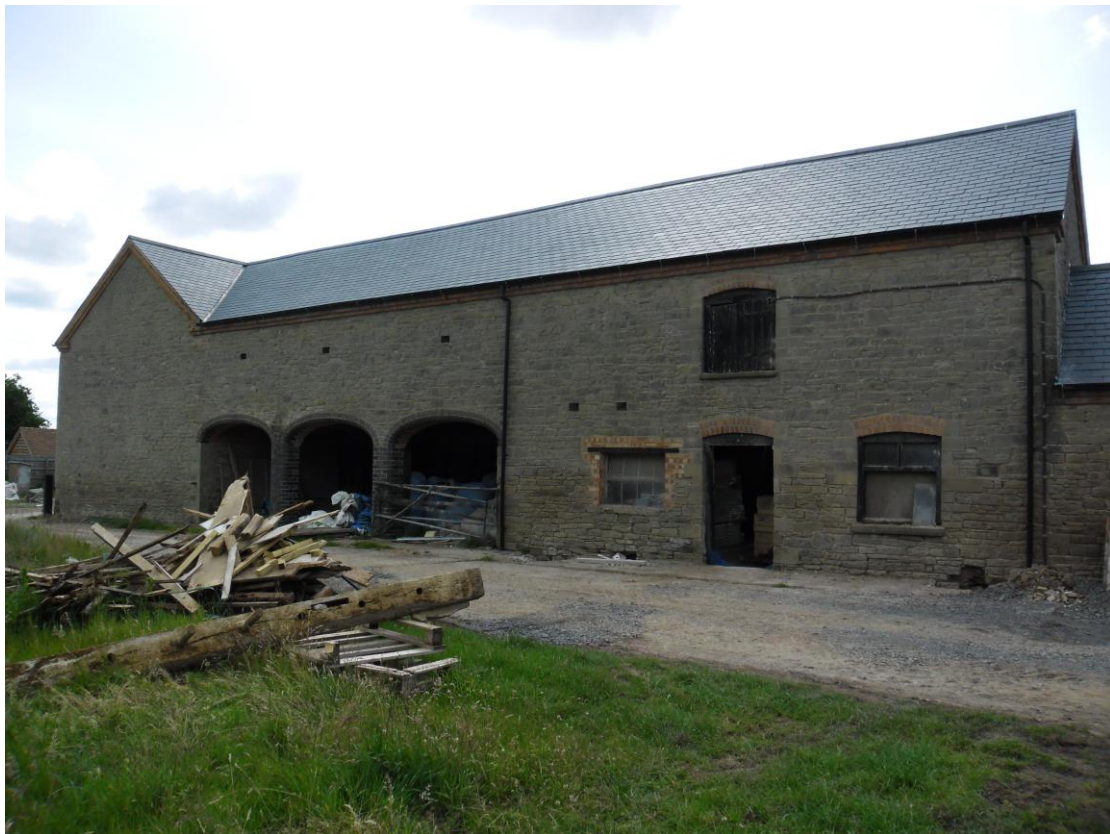
Plate 6: View looking E showing rear (NW facing) elevation of Building 2 with cartshed and granary to left and stable and hayloft (with loading bay window) to right

The two storeyed block appears to have had two distinct uses, the three northeasternmost bays being used as a cartshed with granary above (**Plate 6**). This usage is indicated by the three depressed-arched openings in the rear (NW facing) elevation, which are externally faced with Staffordshire blue bricks but with red brick dressings internally (**Plate 7**). Above the archways are three small ventilation slots with iron grilles, again characteristic of granary usage. A narrow segmental arched doorway in the NE corner of the front (SE-facing) elevation provided access to the granary at first floor level, which was lit by two segmental arched casement windows (**Plate 8**).

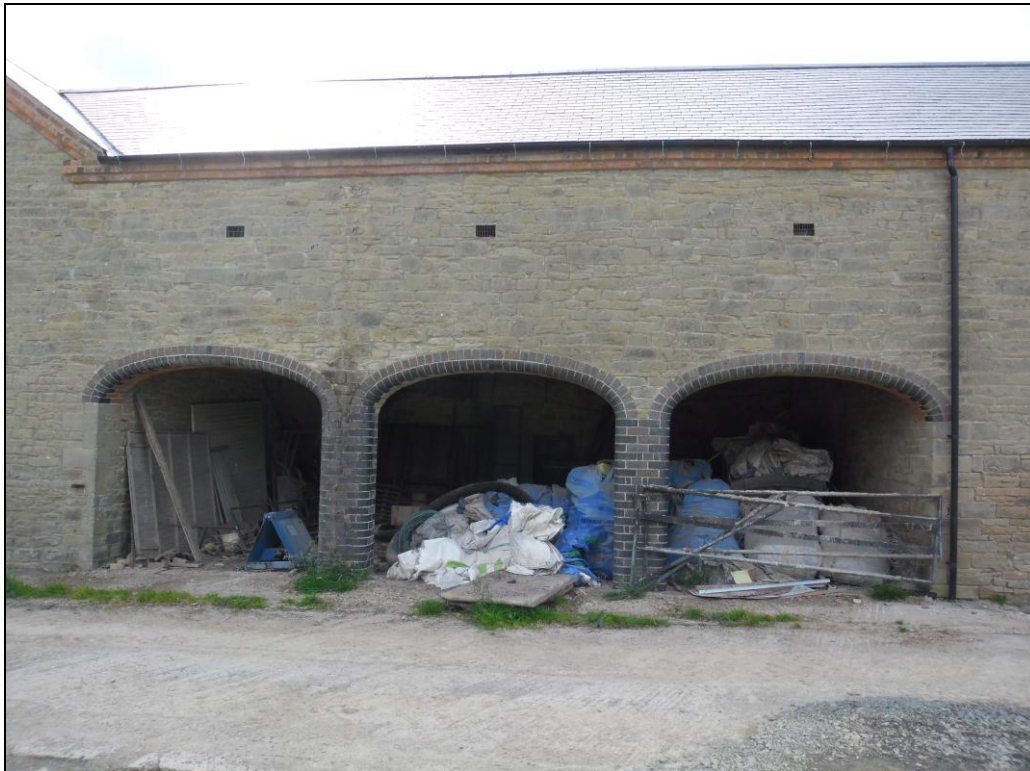
Plate 7: View looking SE showing rear (NW-facing) elevation of Building 2 showing broad arches for cartshed with ventilation grilles for granary at first floor level

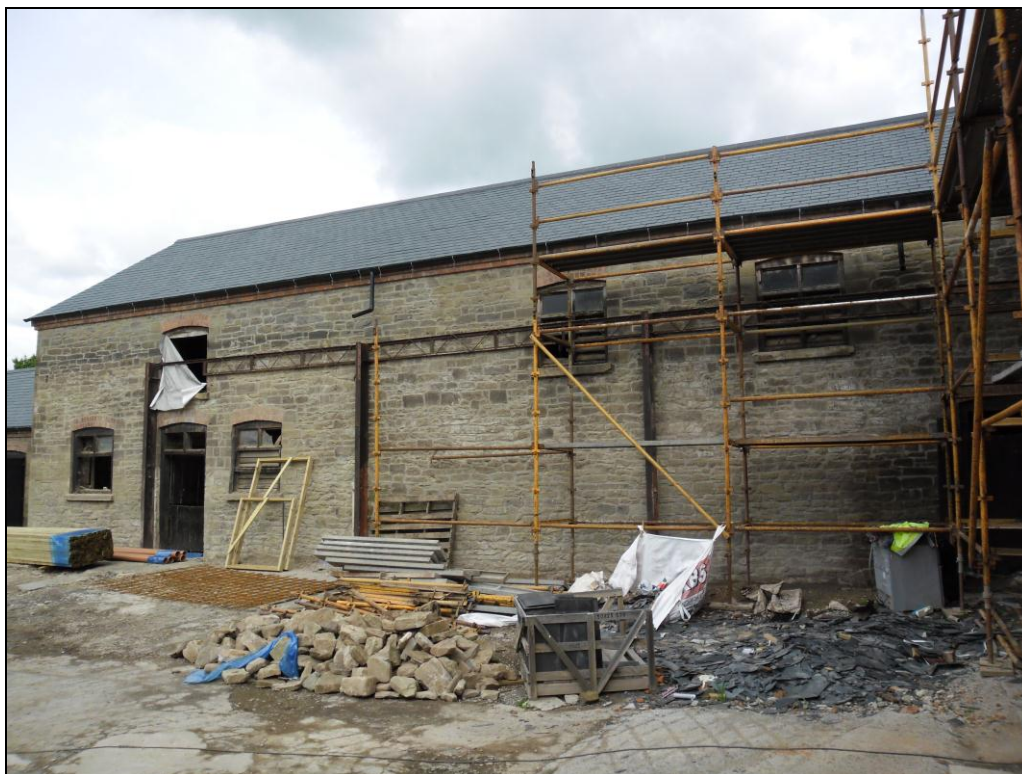
Plate 8: View looking NW showing SE-facing elevation of Building 2 with stable and hayloft to left and granary building (with segmental arched windows at first floor level) to right

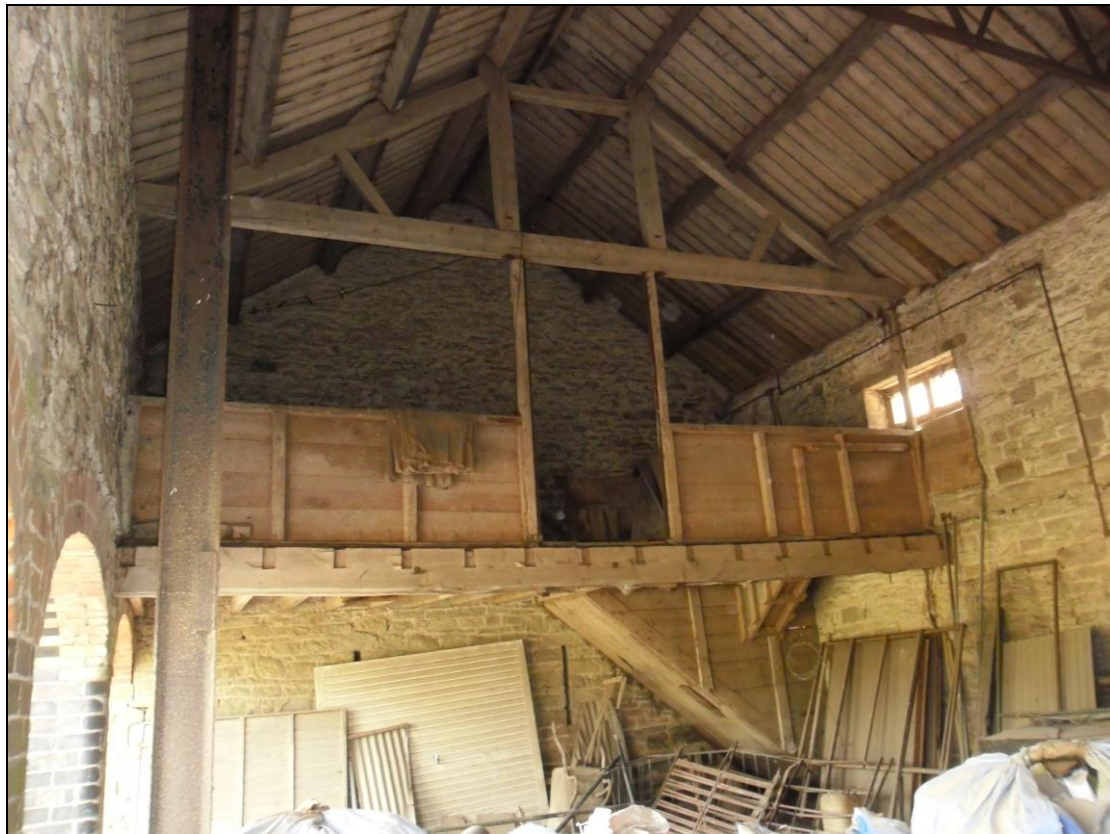
Most of the upper floor appears to have been removed with the exception of a narrow section surviving at the NE end of the block (accessed by the stairway); however the slots for rafters and wall plates set into the thickness of the wall immediately beneath the windows indicate the original extent of the granary floor. The presence of a queen-post roof truss with angled struts at the NE end of the block indicates continuity with the construction of the adjacent threshing barn; it appears that one of the trusses had been replaced by a cast iron truss at some point in the 20th century (**Plate 9**).

Plate 9: Internal view of cartshed and granary in Building 2 showing queen-post roof construction

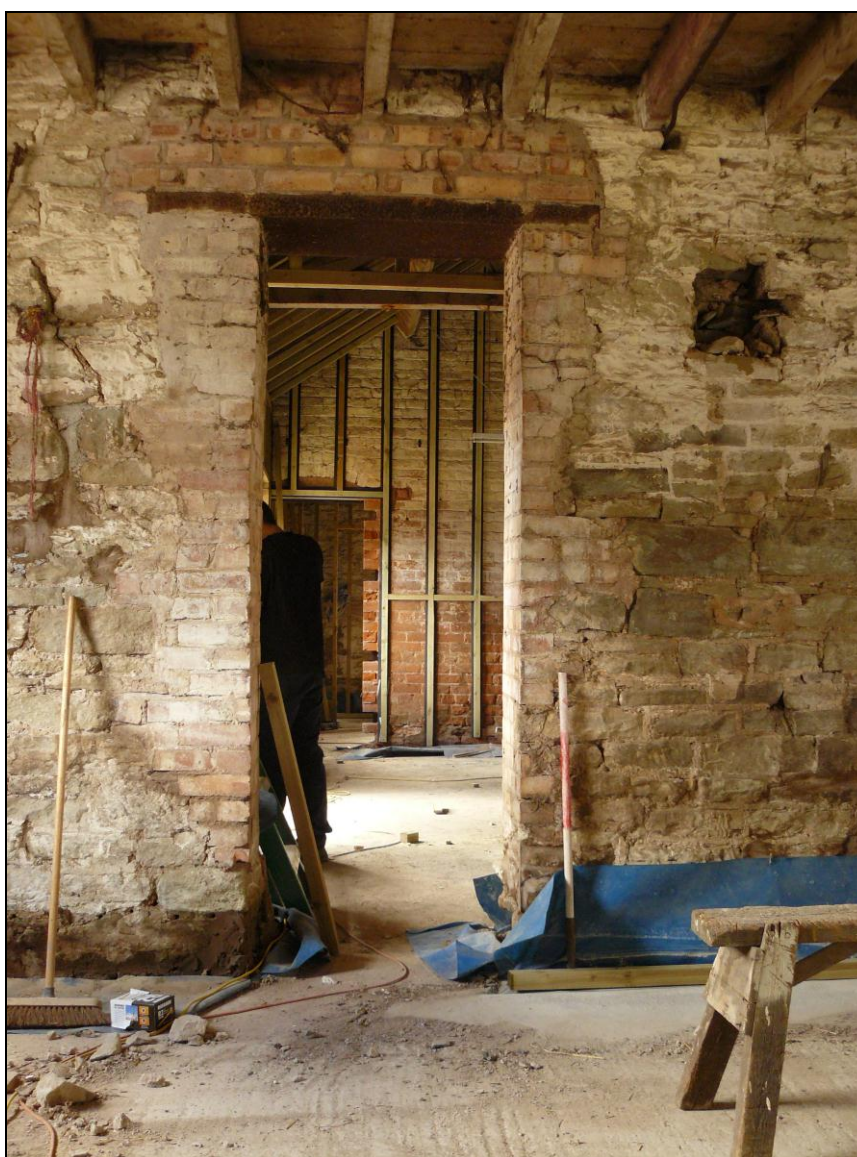
A flat headed doorway with a wooden lintel inserted into the SW gable end of the two storey hayloft and stable (which appears to be a later addition, judging from the surrounding brick infill) provides access to the single storey, five bay range, which appears to have been used as stabling (**Plate 10**).

Plate 10: Internal view of Building 2 looking SW showing modern doorway with brick surround inserted into wall of two storey stable and hayloft

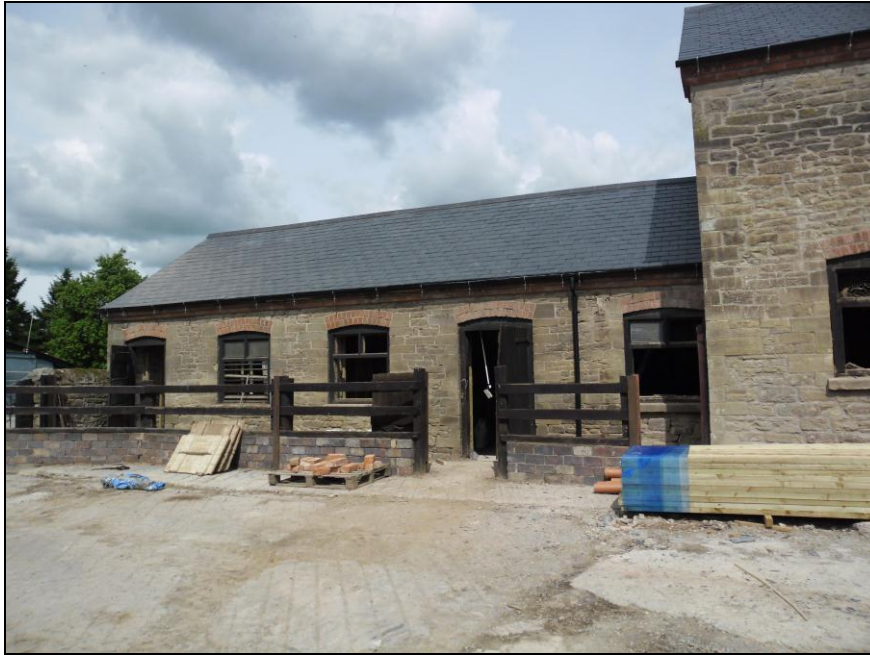
The front (SE facing) elevation of this single storey range has a segmental brick arched doorway at the SW end, to the right of which are two segmental arched casement windows, followed by another segmental arched doorway (with plank and batten stable door) with another arched casement window at the NE end (**Plate 11**). The rear (NW facing) elevation is devoid of fenestration, with two narrow ventilation slots visible just below eaves level, while a large rectangular window opening (with a wooden lintel) has been inserted in the SW gable. The stepped eaves cornice and pedimented gable indicate stylistic continuity with the two storey granary and the threshing barn.

Plate 11: View looking NW showing SE facing elevation of five bay single storey stable range at SW end of Building 2

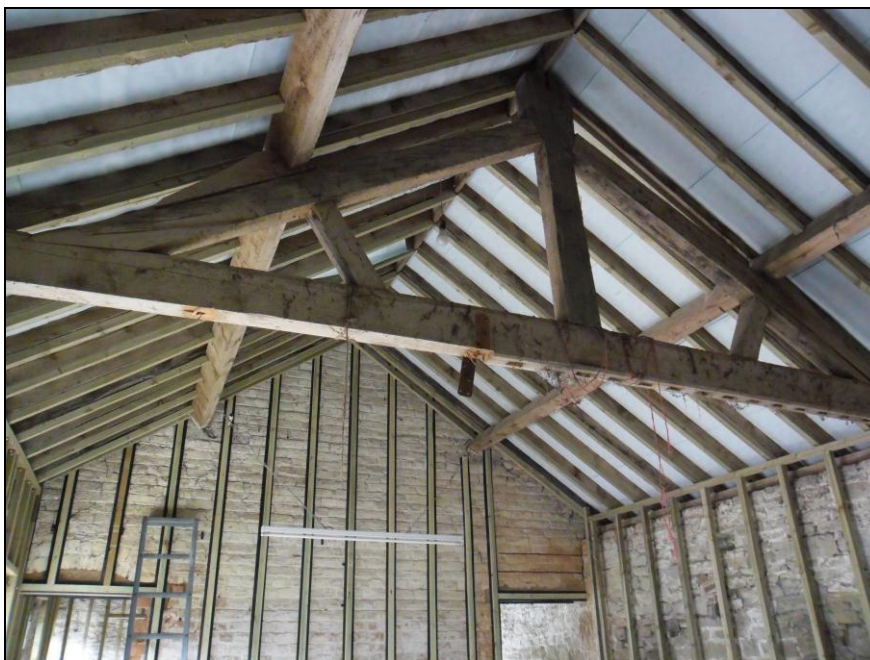
Internally, the range has been whitewashed and few original features relating to its usage were visible. The most noteworthy features consist of the roof with its kingpost trusses and a single pair of trenched purlins (**Plate 12**). A brick partition wall (laid in English Garden Bond and bonded with a cement mortar) has been inserted at a later date, separating the two southwesternmost bays from the remainder of the building. All internal fittings relating to the usage of this range as a stable (eg. hayracks, mangers etc.) appear to have been removed at a previous date.

Plate 12: Internal view looking SW showing detail of king-post roof construction and brick partition wall in single storey stable block at SW end of Building 2

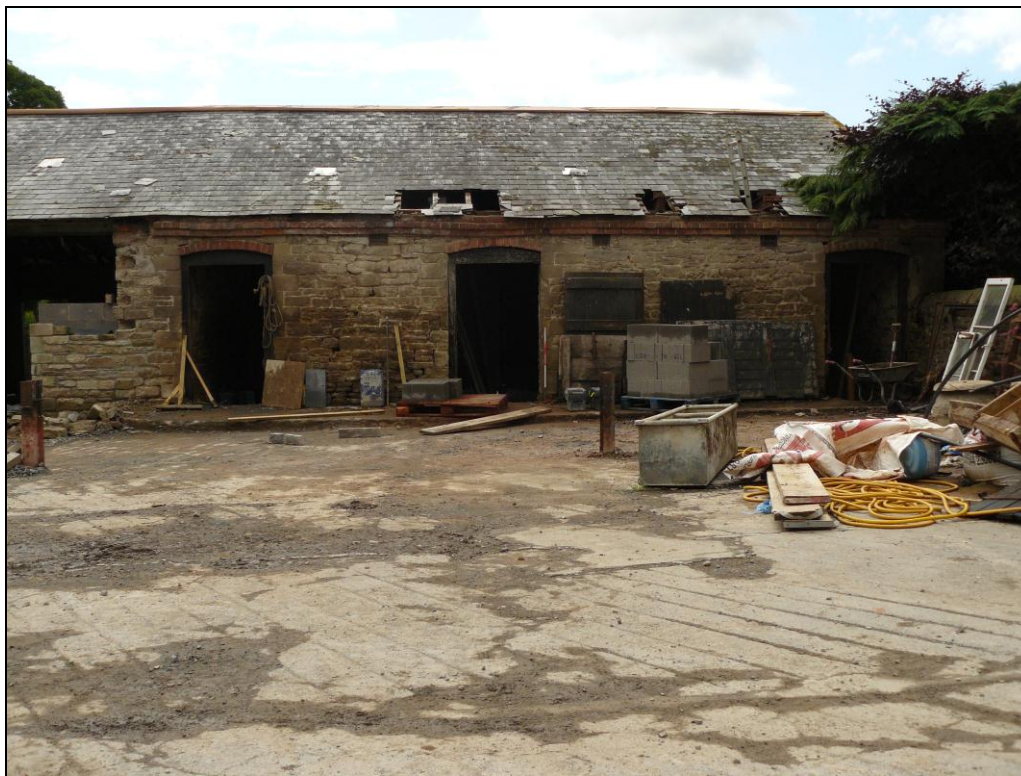
This structure, located on the SE side of the courtyard opposite Building 2, consists of a broad, single storey gabled range oriented NE-SW with a double-pitched slate roof, 9 bays long and two bays wide, projecting from the principal (SW facing) elevation of the threshing barn. This range appears to have had two distinct uses, the three southwesternmost bays appear to have been used as stabling and are separated from the remaining 6 bays (which appear to have been used as cattle sheds) by a stone partition wall. This division appears to have been part of the original internal arrangement as it is shown on the OS 1st edition map of 1887. Building 3 has been subject to considerable recent alteration, much of the upper part of the SW facing elevation (overlooking the courtyard) has been taken down with the exception of the three southwesternmost bays, which have remained largely intact with their brick stepped eaves cornice and three segmental arched doorways surviving intact (**Plate 13**)

Plate 13: View looking SE showing the three bays at the SW end of Building 3 with brick segmental arched doorways and stepped brick eaves cornice

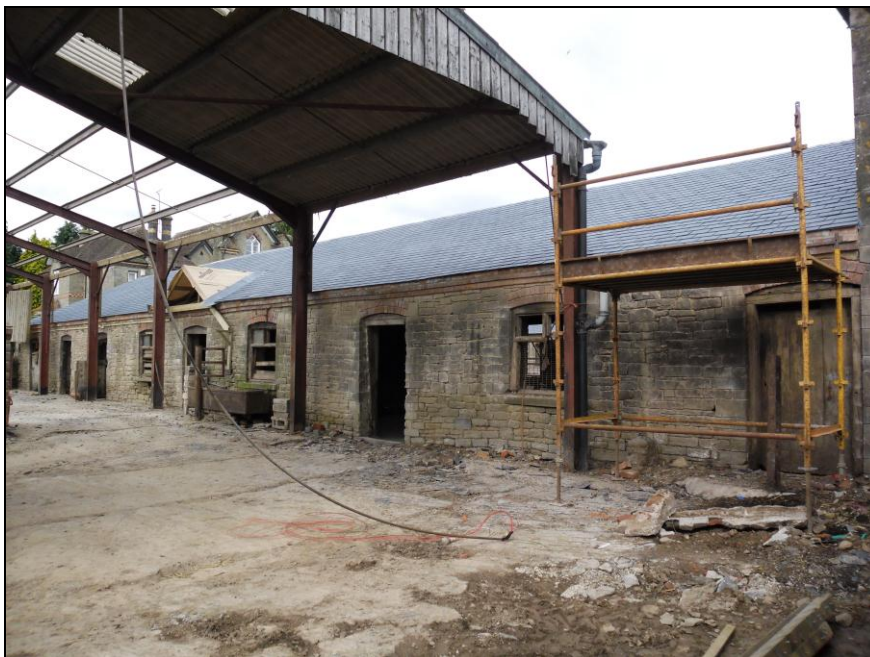
In comparison, the SE facing external elevation of Building 3 has survived largely intact although it is partially obscured by a modern four bay Dutch barn with a corrugated iron roof, the posts for which immediately abut the building itself (**Plate 14**). The three southwesternmost bays are punctuated by three brick segmental arched windows with typical plank and batten stable doors. The fenestration of the three central bays consists of a centrally placed brick segmental arched doorway surmounted by a low pitched roof and flanked by two segmental arched casement windows, while the three northeasternmost bays comprise a segmental arched casement flanked by two segmental arched doorways. The brick stepped eaves cornice and pedimented gable again indicate that this wing was almost certainly contemporary with the original construction of the barn complex c.1870.

Plate 14: View looking NW showing rear (SE facing) elevation of Building 3 with 20th century Dutch barn in foreground

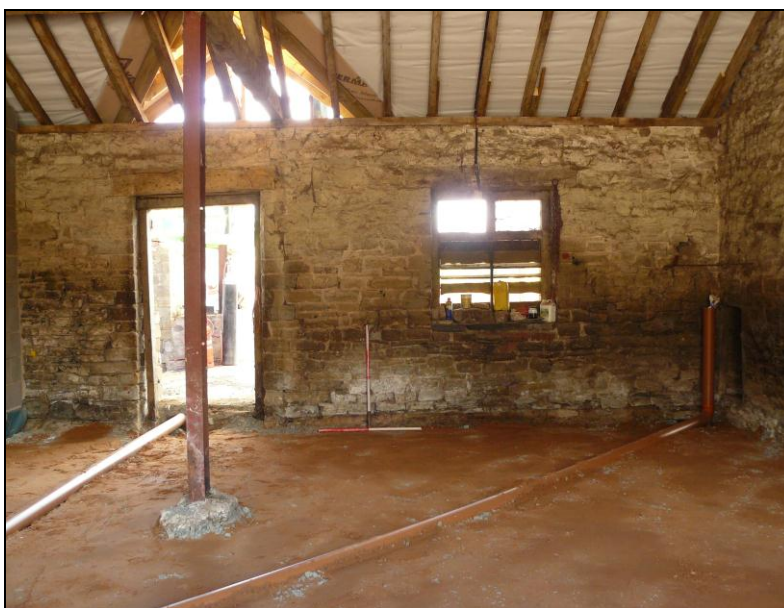
The evidence of late 19th/early 20th century Ordnance Survey mapping indicates that there was formally an internal partition extending NE-SW through the centre of the barn. Little evidence for this now survives except within the southernmost three bays of the building, where there appears to have been until recently a brick partition wall separating the NW and SE parts into distinct compartments, now replaced by a concrete breeze block wall. The interior of the building exhibits evidence of considerable recent alterations, with several concrete breezeblock partition walls having recently been erected (**Plate 15**). A single, heavily altered queen post-roof truss has survived intact, the other trusses having been replaced by steel props. Little evidence of internal fittings associated with the original usage of the barn has survived and the original flooring of the barn has also been removed.

Plate 15: Internal view looking SE showing NW facing wall of Building 3

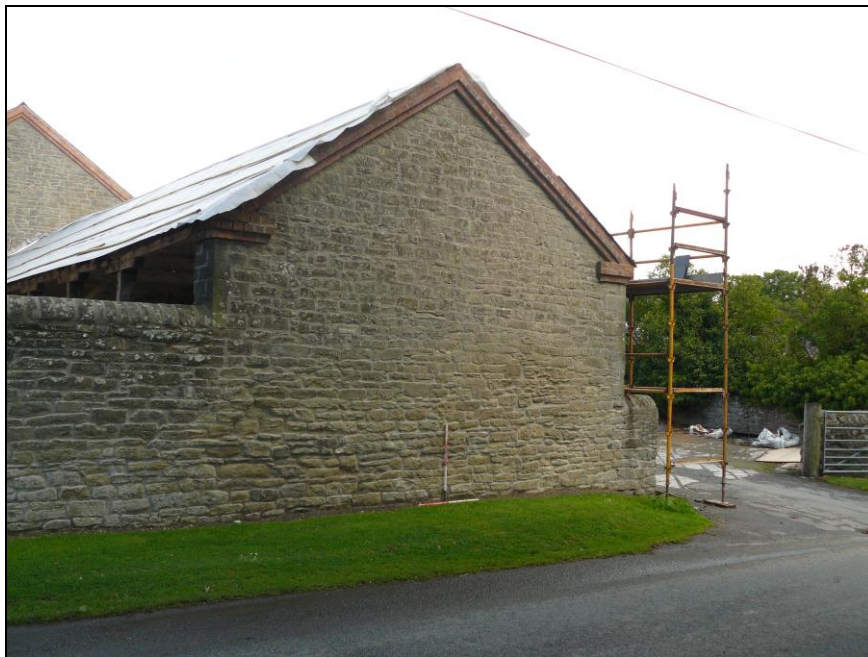
Plate 16: View looking NW showing SE end of Building 4 with pedimented gable and brick cornice

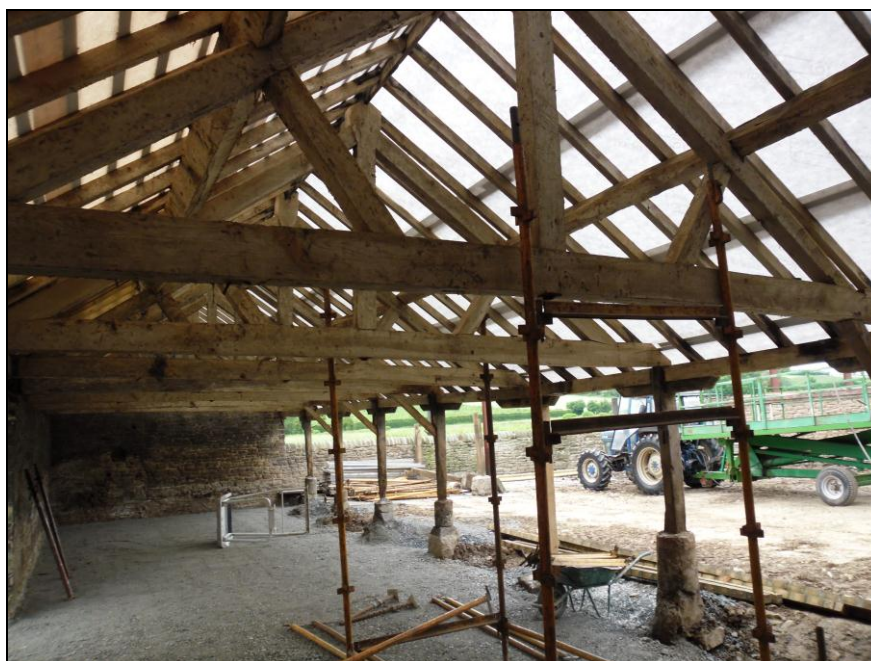
This building, attached to the SE end of the threshing barn appears to be contemporary with its construction and is shown on the OS 1st edition map of 1887. It consists of an 8 bay open shed aligned NW-SE, the NE and SE facing walls are of roughly coursed sandstone masonry with brick eaves corncicing and a pedimented gable similar to that used in the threshing barn and elsewhere within the barn complex (**Plate 16**). The roof construction consists of seven king-post roof trusses (the posts for which rest on stone pillars) with a single pair of trenched purlins (**Plate 17**).

Plate 17: View looking SE of Building 4 showing king-post roof construction
