ARCHAEOLOGICAL OBSERVATION

**FORMER VETERINARY SURGERY
CHURCH STREET
LEINTWARDINE
HEREFORDSHIRE**

**NGR: SO 40488 74040
JOB N^o: BA1120CSL**

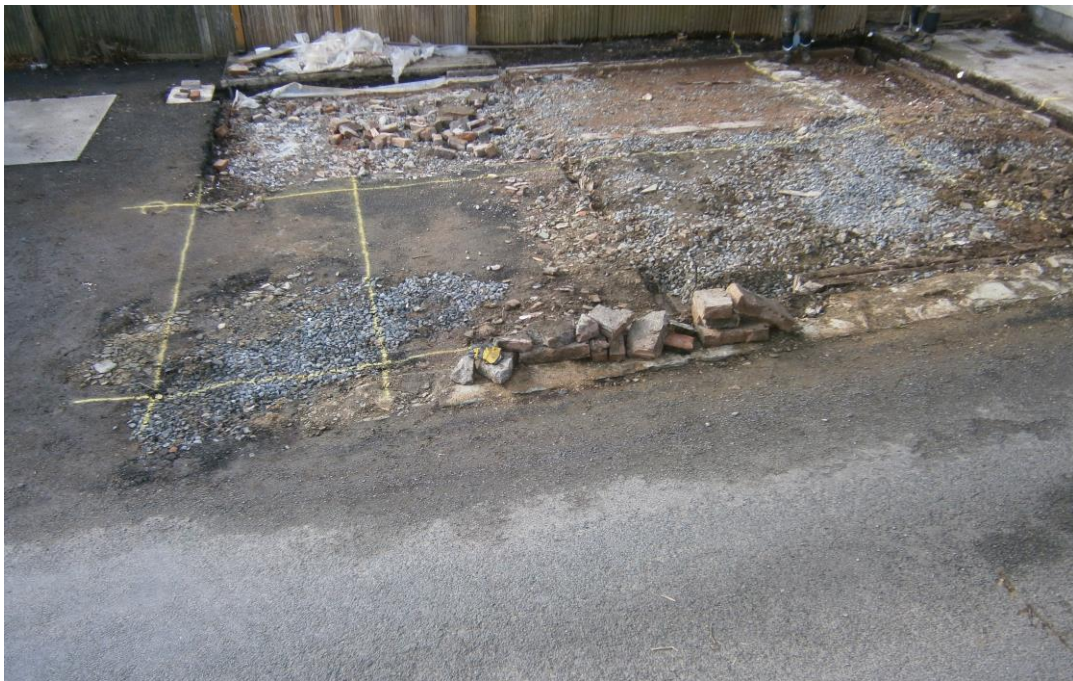
Cover: Site clearance and levelling prior to foundation excavation.

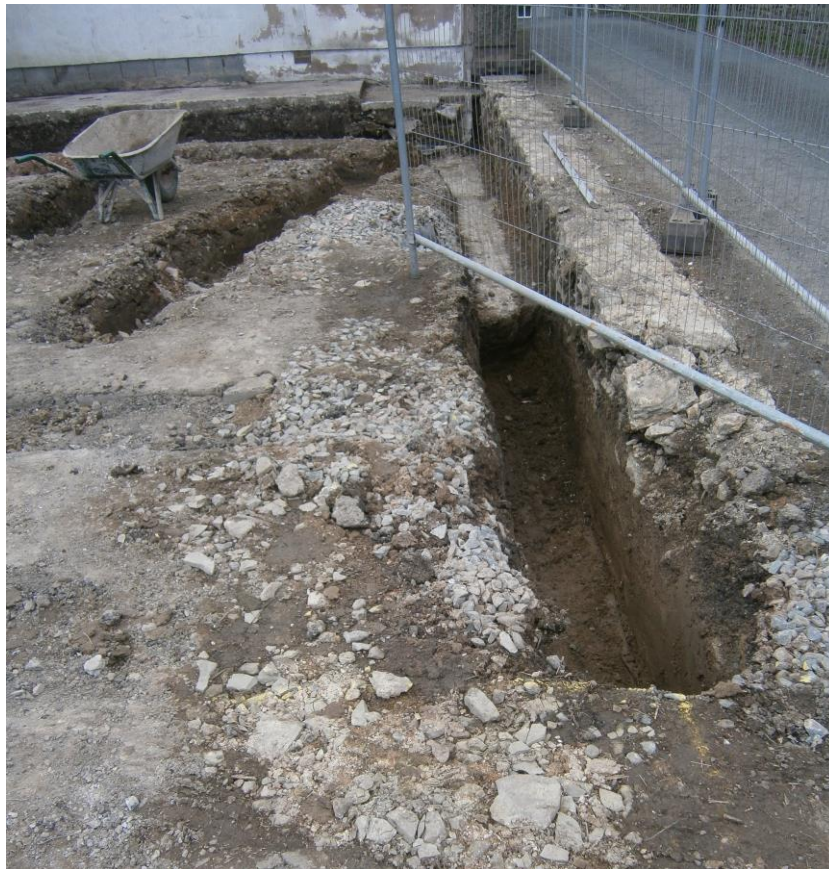
Within the NE corner of the new building plot the stratigraphy predominantly consisted of 0.15m of tarmac or disturbed tarmac overlying 0.25m of modern building make-up material and re-deposited soils. The subsoil below, a fairly loosely compacted yellow brown clay sand, with ceramic building material and charcoal was previously disturbed. In the limited areas of relatively undisturbed stratigraphy, the subsoil was of similar composition. Two probable bovine leg-bones were not retained as these were recovered from the test trench backfill. There was no natural deposits encountered at the depths observed and the W/E foundation trench did not extend below the depth of the previous evaluation trench (BA 2011a) (*Plate 1*). Where potentially undisturbed subsoil was noted, this was at least 0.5m thick.

Plate 1: View W showing the scar of the 2010 evaluation trench reflecting the position of the W/E foundation trench.

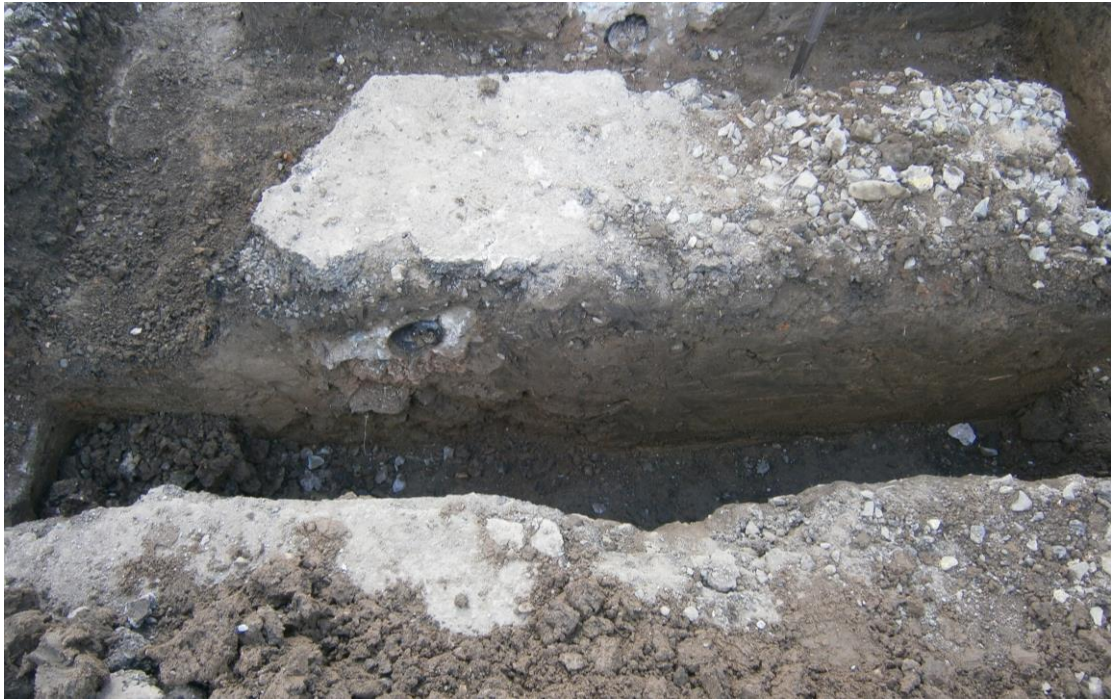
At the NE corner of the new building plot, a series of disturbances were present, including a W/E aligned water pipe running along the northern foundation and a NW/SE orientated drain encased in concrete extending across the NE corner (*Plate 2*). The northern site boundary wall had also impacted on the upper stratigraphy of the northern edge of the W/E foundation trench.

Plate 2: View W showing the N/S foundation trench with the NW/SE drain towards the S and the previous archaeological test trench to the N
