STANDING BUILDING RECORDING SURVEY

Seaford Grange Farm
Pinvin
Worcestershire
WR10 2LF

NGR: SO 95720 50767
JOB No: BA1026SGFS
HER Ref. WSM 45764

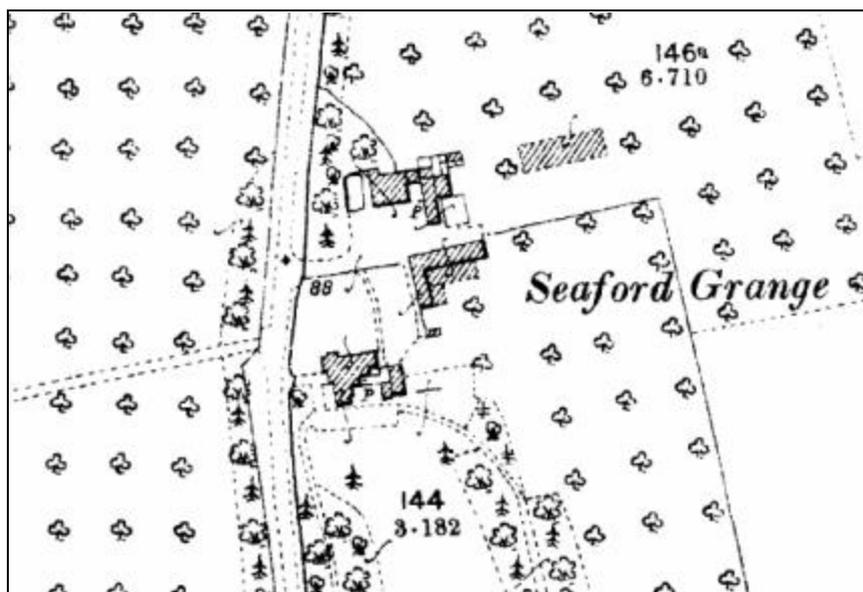
Fig. 4: Extract from the OS 2nd edition 25 inch map of 1904 showing additions to the outbuildings at Seaford Grange Farm
 (Reproduced by courtesy of the National Archives)

A further phase of building activity appears to have taken place between 1885 and 1904, as shown on the OS 2nd edition 25 inch map (Fig. 4). The most significant change was the substantial three-bay extension added to the N side of the coach house. The freestanding rectangular structure shown on the 1875 and 1885 maps immediately to the W of the coach house appears to have been in the process of demolition by the early 1900s, as it is only shown in outline on the OS 2nd edition 25 inch map of 1904.

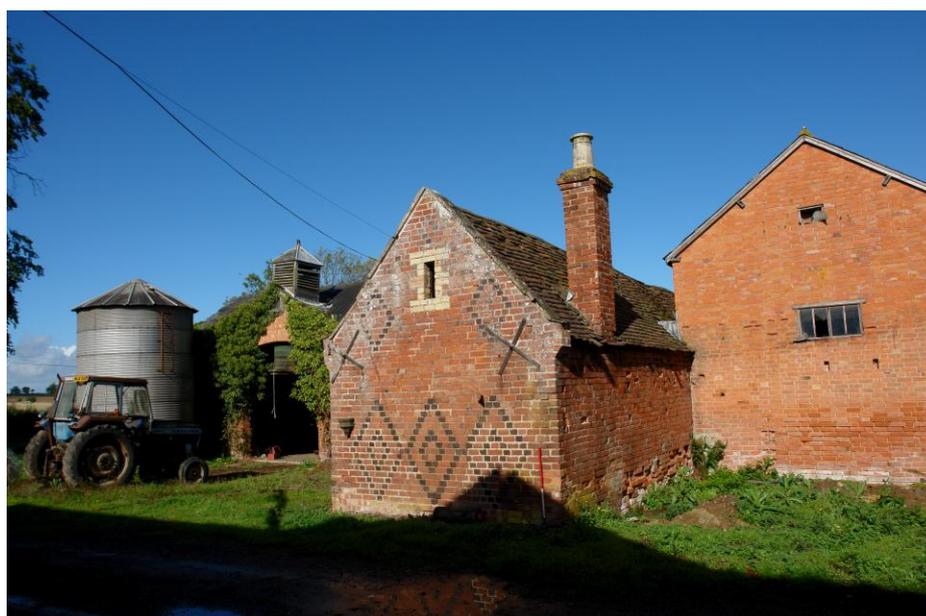
Plate 1: View looking NW showing S gable end of stable block (Building 3), with Coach House (Building 1) in background to left and two storeyed, barge-boarded stable block (Building 4) to right

The complex of buildings forming the subject of this programme of standing building recording are situated to the N of Seaford Grange, a gabled neo-Tudor Gothic house of mid-19th century date (Plate 1). The complex comprises five main components:

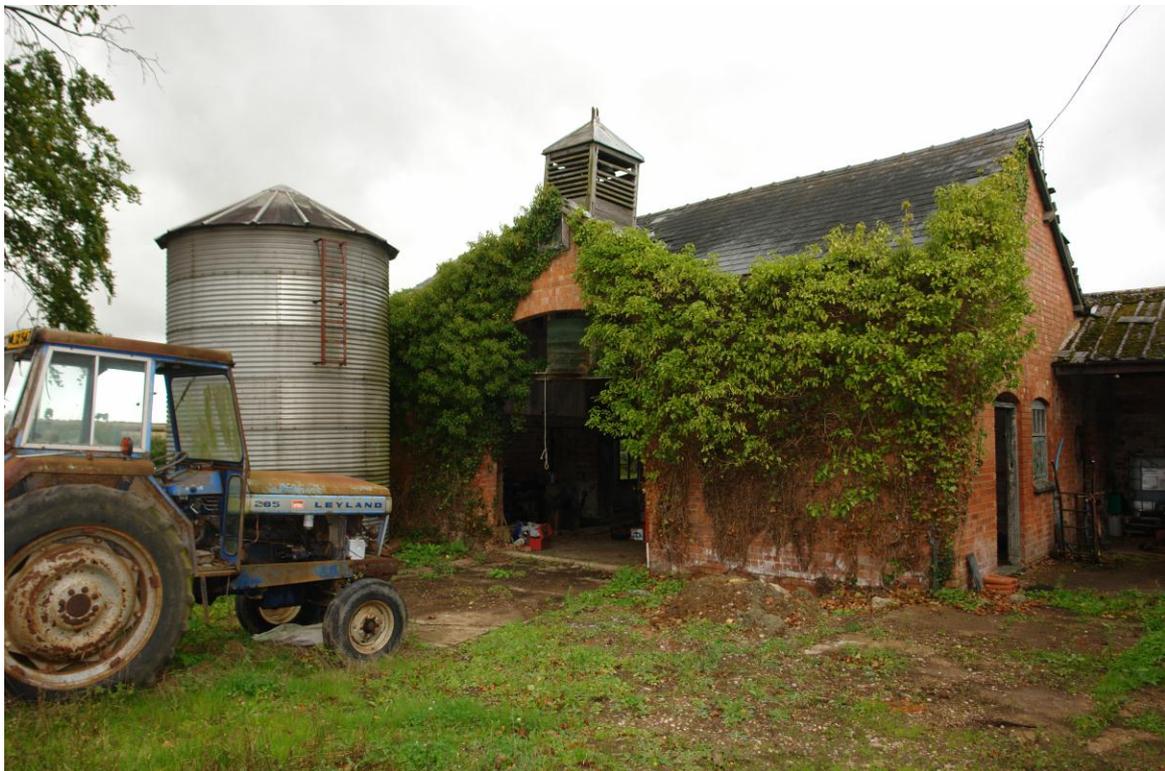
Plate 2: View NW showing the S facing elevation of Building 1 (Coach House) with central gabled entrance bay surmounted by a clock turret

Although much of the principal, S-facing elevation is obscured by vegetation and a modern corrugated iron silo tank, the dominant feature remains the gabled entrance bay (Plate 2). This consists of a wide, tall segmental brick archway, above which is a square clock face set into the apex of the gable. Despite being partially obscured by vegetation, the wooden casing of the clock and its mechanism, together with its brass dial and hands has remained intact, although the glass facing has been partially broken. Surmounting the gable is a small louvred timber bell turret with a pyramidal roof and finial; the brass bell within the turret has also survived intact. To the right of the entrance bay, partially concealed by vegetation, is a small, square single-light flat-arched window; this may represent a later insertion associated with conversion of the eastern bay of the coach house into additional stabling.

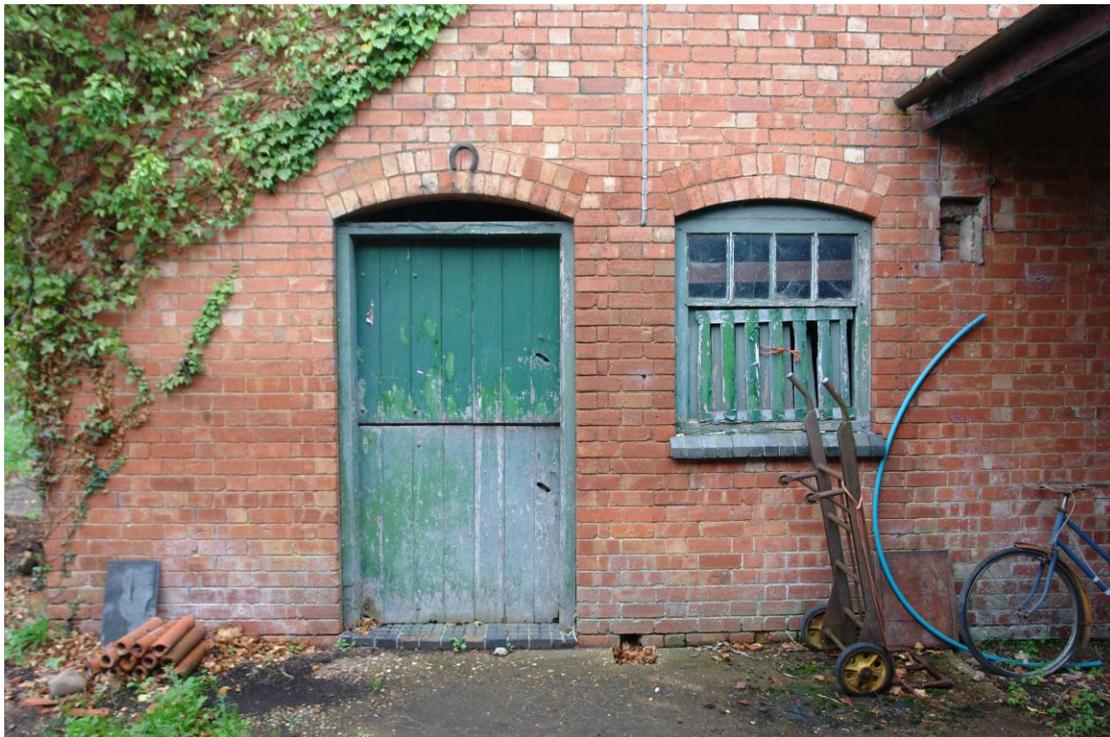
Plate 3: View looking W showing E elevation of Building 1 (Coach House) with later segmental arched doorway and window with blue brick sills

The E-facing gable elevation of Building 1 (Plate 3) exhibits evidence of extensive alterations, most notably the wooden-framed stable door with a segmental brick arch and an angled blue-brick sill and the adjoining segmental-arched window, also with an angled blue-brick sill. The upper half of the window is glazed, while in the lower half the panes appear to have been substituted with wooden mullions. The design of the window and doorway is very similar to those in the E-facing elevation of Building 4 (the two-storey block to the E of the stables) and the N-facing elevation of Building 5, both of which appear to have been constructed between 1875 and 1885. It is also noticeable that the brickwork of the E-facing gable elevation appears to be much brighter and rubbed, in contrast to the noticeably darker reddish-brown colour of the brickwork in the S- and W-facing elevations, and that the E gable is barge-boarded.

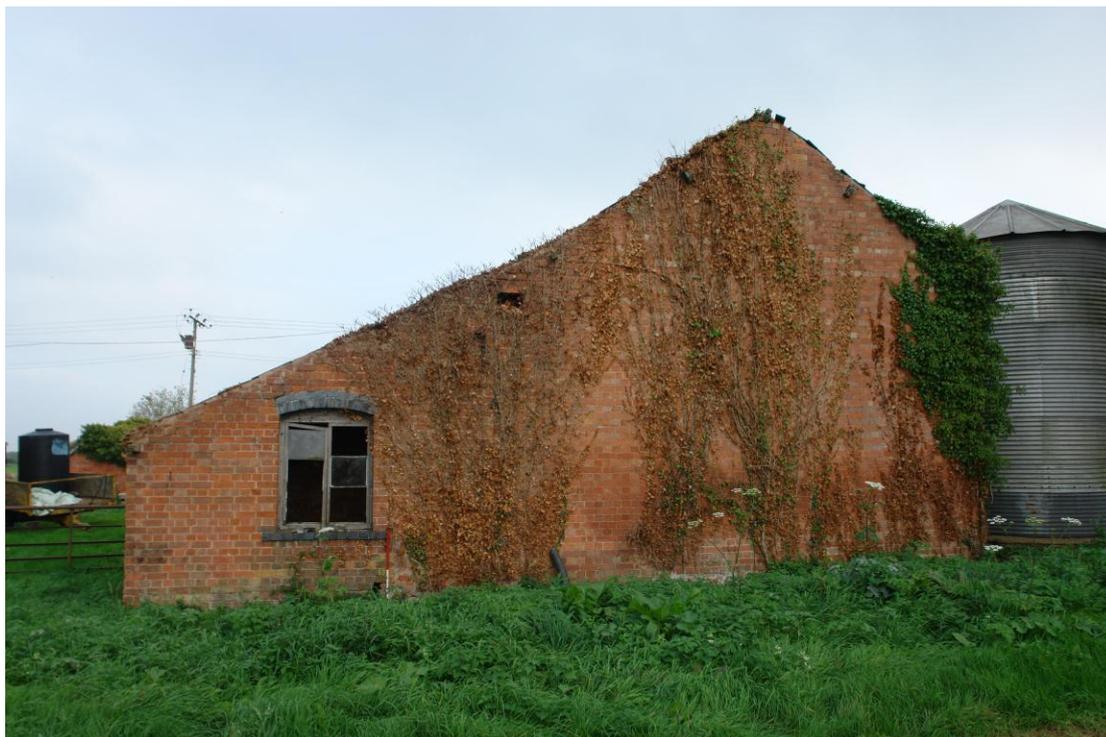
Plate 4: View looking E showing W elevation of Building 1 with construction break between the original barn and the later lean-to extension indicated by difference in brick bonding

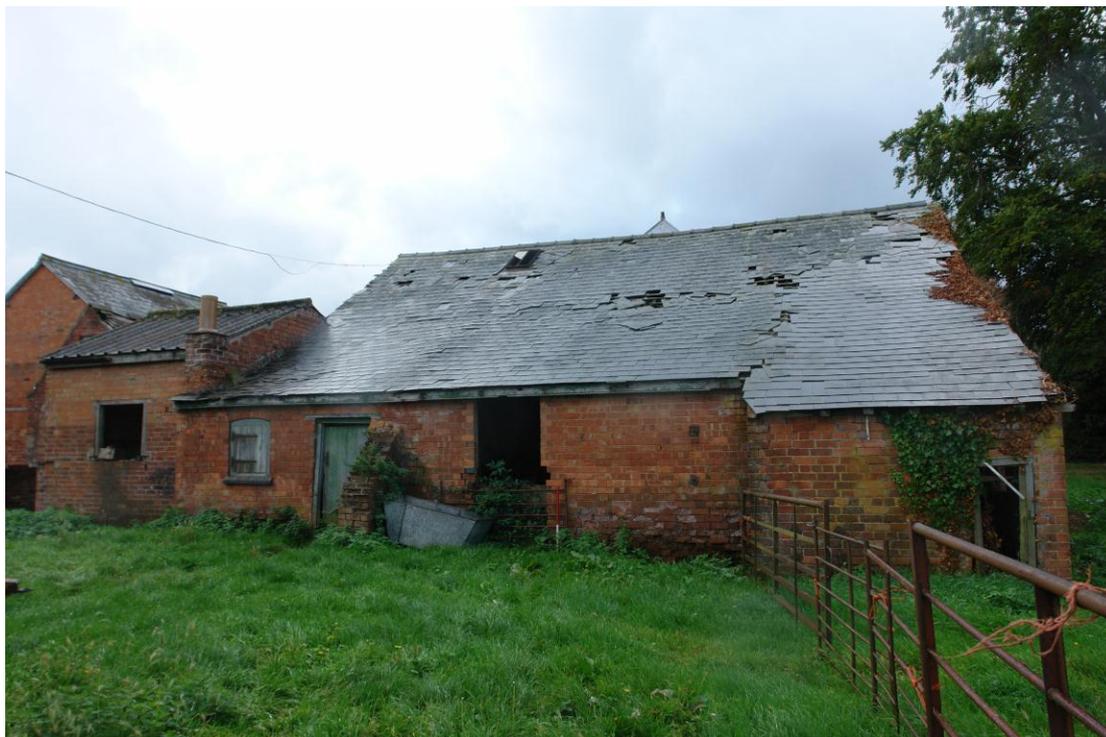
Plate 5: View looking S showing N elevation of Building 1 with three-bay lean-to extension with projecting catslide roof added between 1885 and 1904

The rear, N-facing elevation of the barn (Plate 5) consists of the single-storey lean-to extension added at some time between 1885 and 1904 to house a rolling mill associated with animal feed preparation. The presence of a chimneystack at the E end of the elevation appears to have been associated with an engine used to power the rolling mill mechanism. The projecting W bay with its catslide roof has noticeably different brickwork (consisting of rows alternate headers and stretchers) compared to the rest of the elevation (laid in stretcher bond); however, it appears to belong to the same overall phase of building activity as it is clearly shown on the OS 2nd edition 25 inch map of 1904. The flat-headed opening in the central part of the elevation appears to be a later insertion, possibly when the coach house was converted to use as a garage (by the mid 1960s).

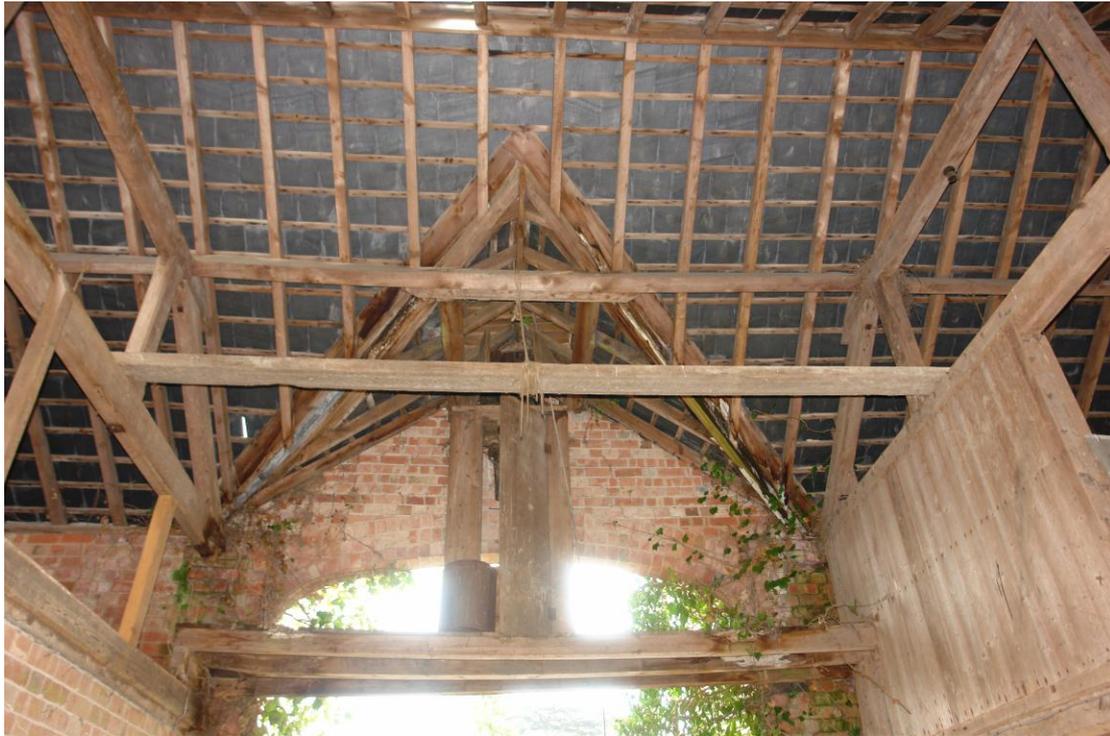
Plate 6: Internal view looking S showing louvred roof construction in central entrance bay of Building 1 with wooden case for clock mechanism supported by three transverse timbers

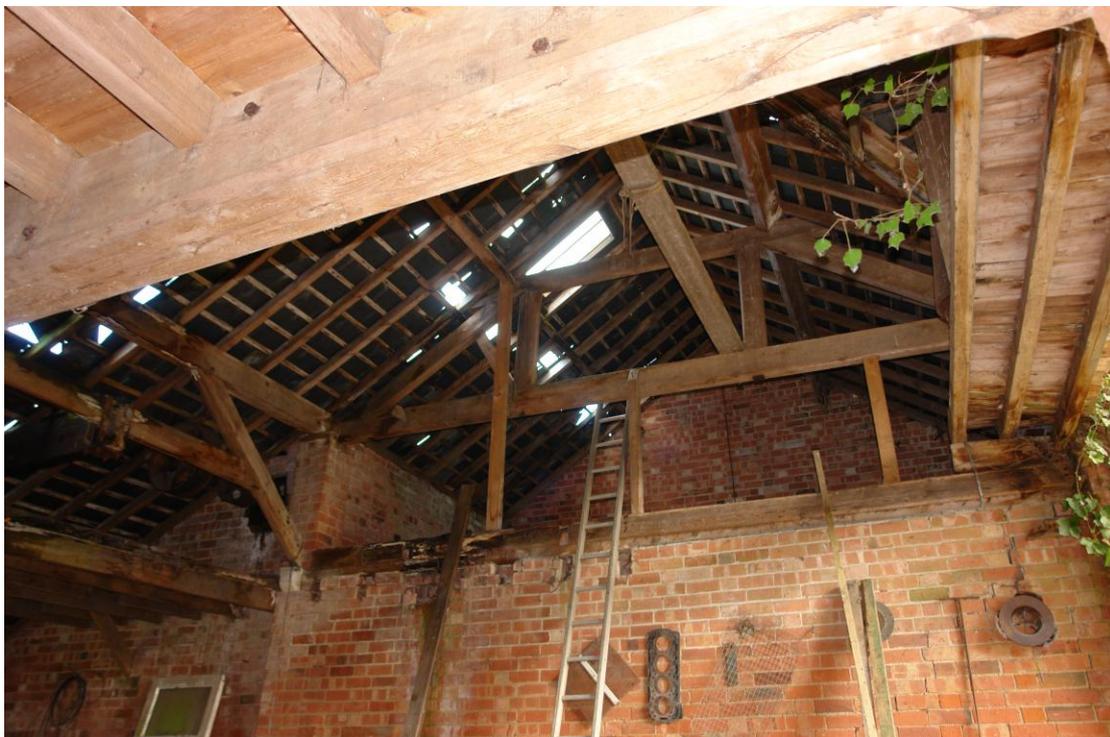
Plate 7: Internal view looking E showing the E bay of the original Coach House with its modified queen-post truss construction.

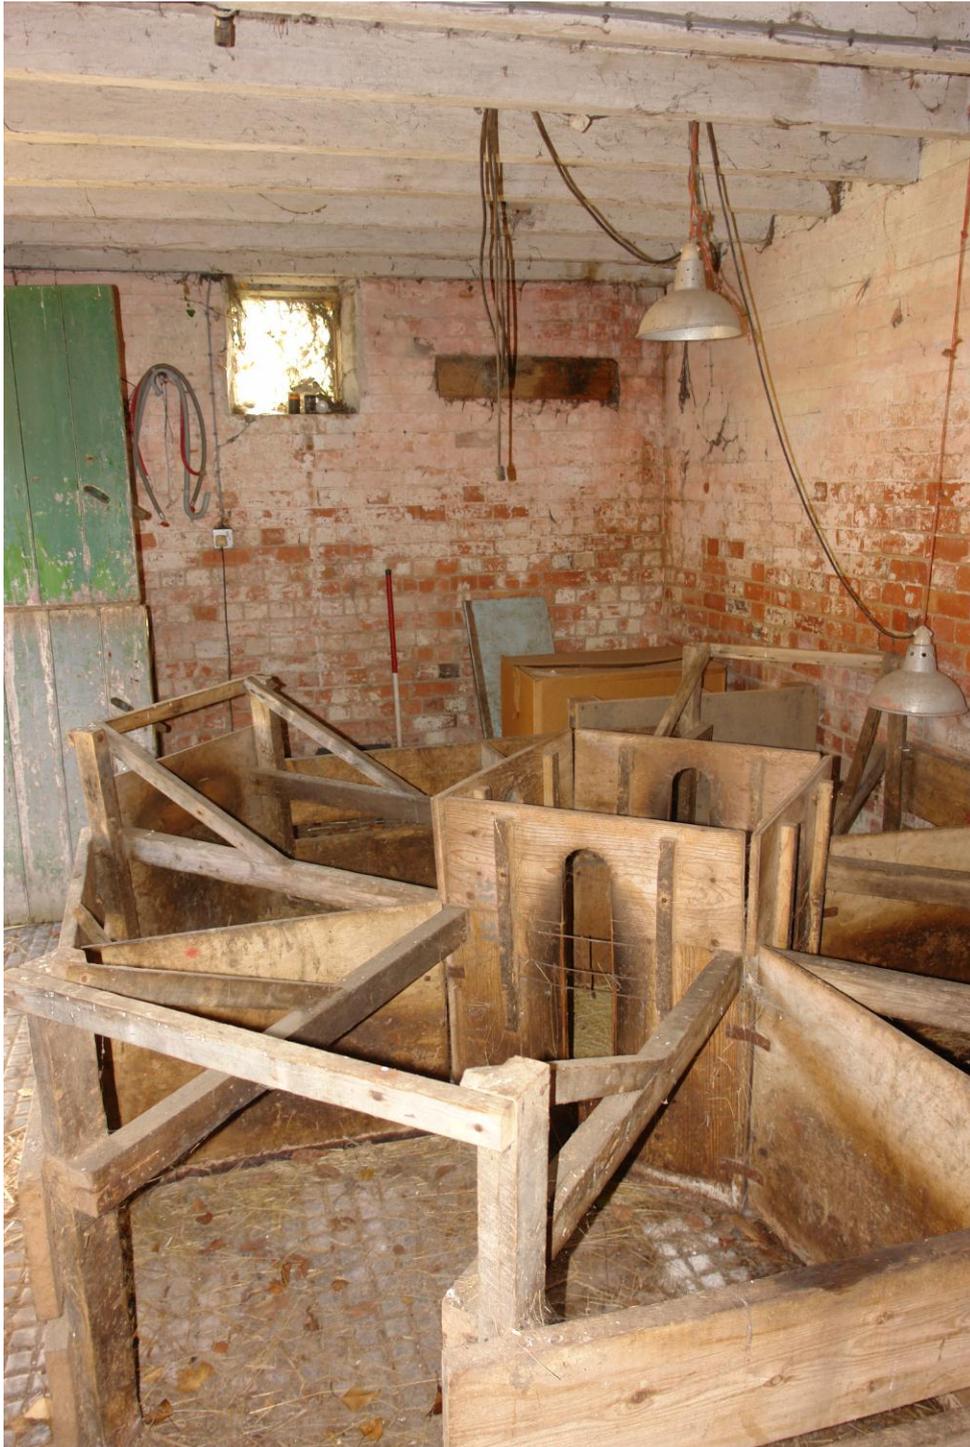
Plate 8: Internal view looking S showing interior of eastern bay of Building 1 with brick cobbled floor obscured by wooden pigpens.

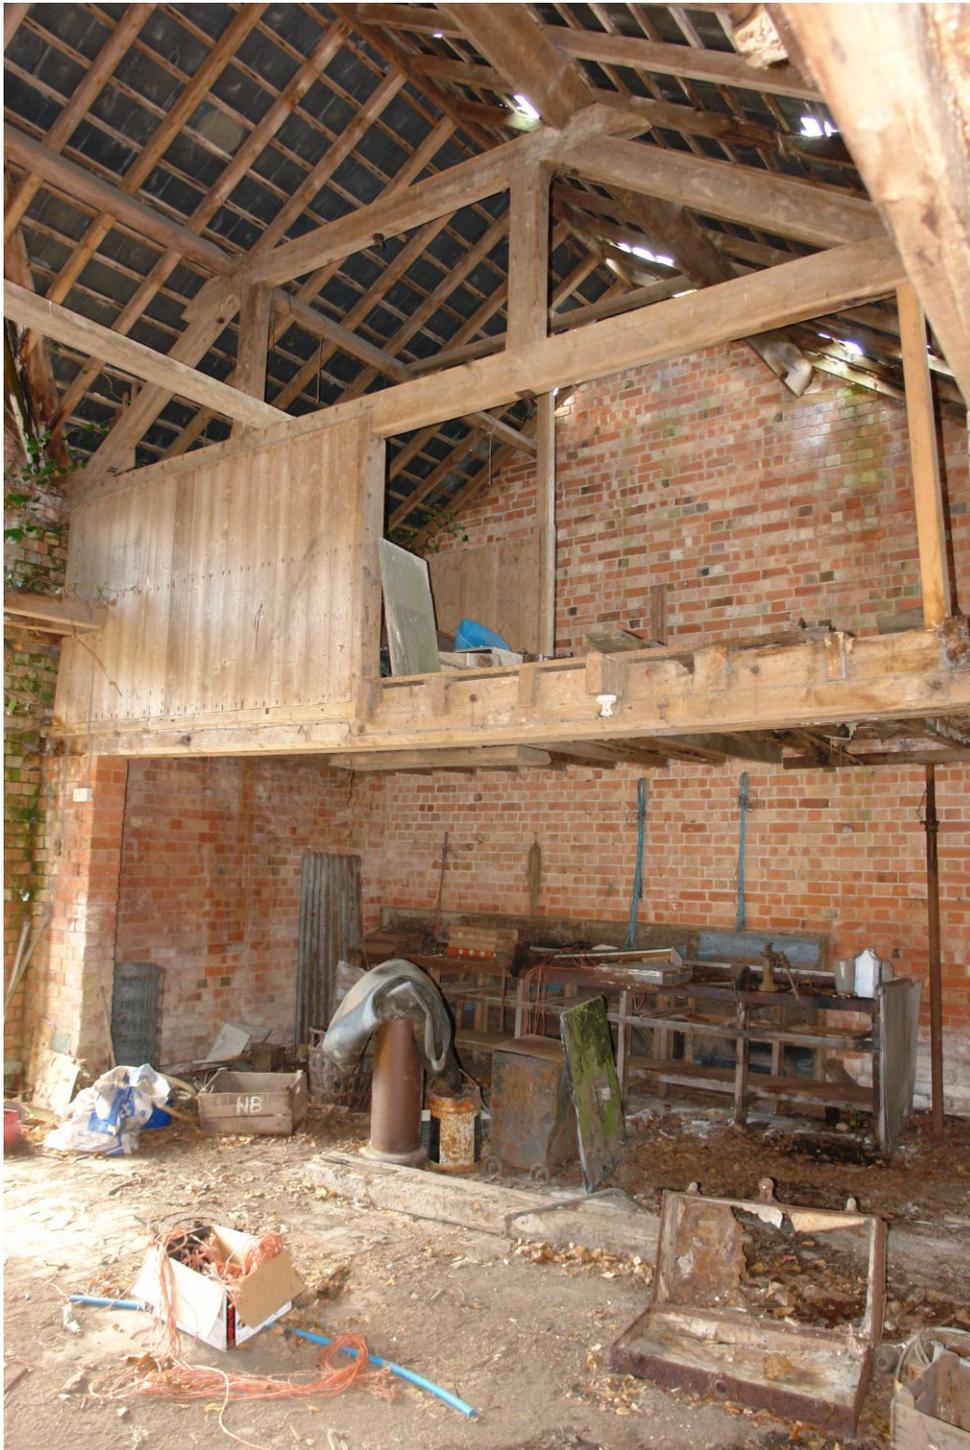
Plate 9: Internal view looking SW showing western bay of Building 1 with queen-post roof trusses

In contrast to its eastern counterpart, the western bay appears never to have been walled-off from the central entrance bay. It is currently used for storage of farm implements, vehicle parts and machinery with no obvious indication of its original usage. As with the eastern bay, there is an upper floor, presumably used for storage, which is partially concealed by planking that appears to be of relatively recent date (Plate 9).

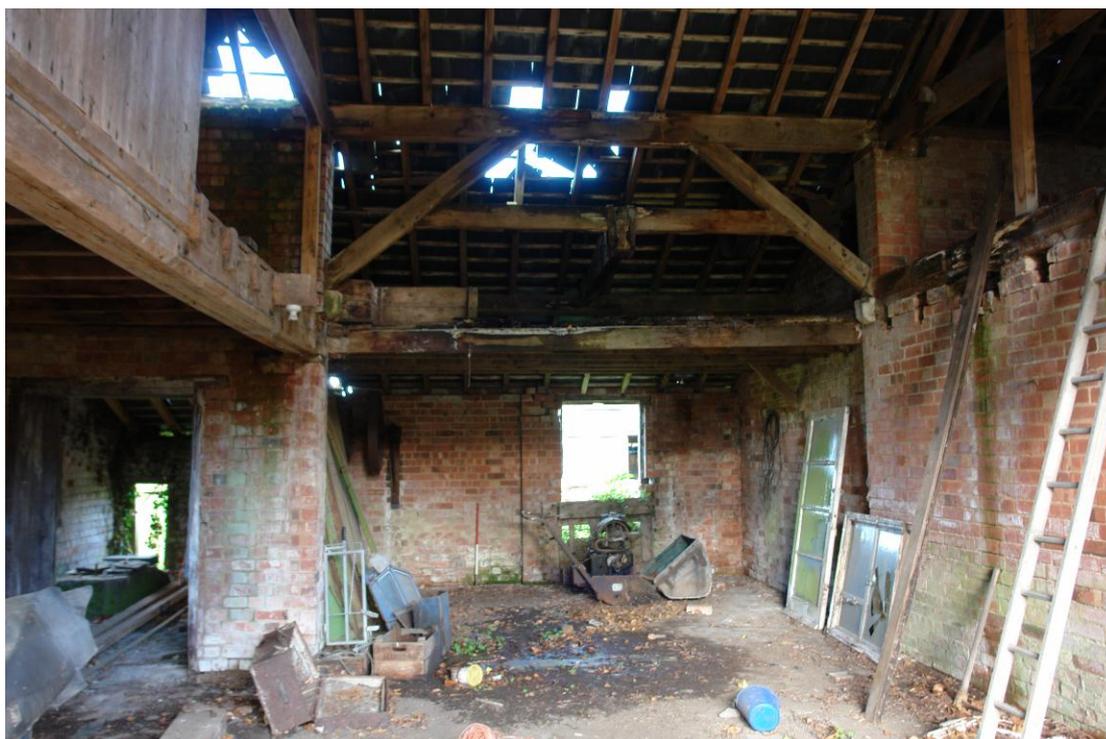
Plate 10: Internal view of Building 1 showing roof truss in central bay of lean-to extension, partially concealing the overhead shaft of the rolling mill

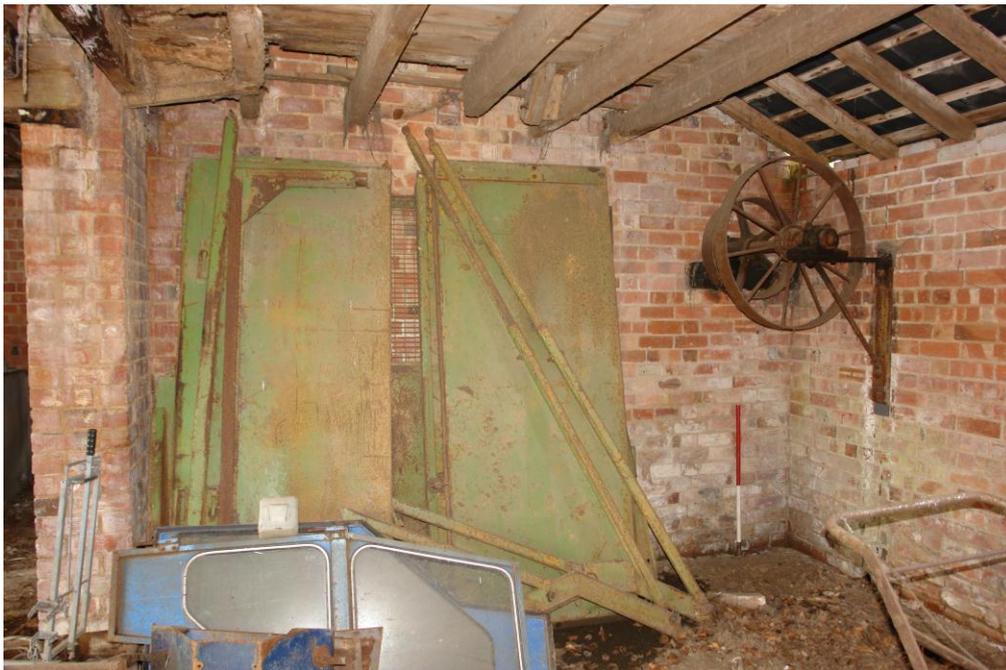
Plate 11: Internal view of Building 1 looking W showing gear wheel associated with rolling mill machinery in E-facing wall of centre bay of lean-to extension

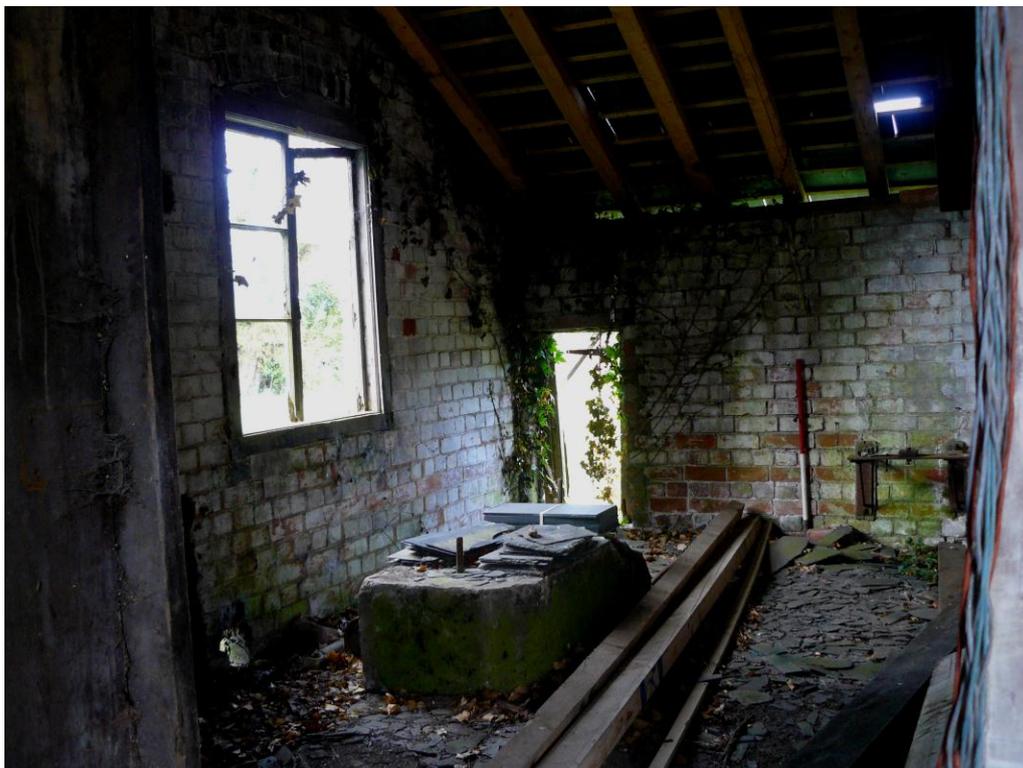
Plate 12: View looking N showing interior of compartment in NW corner of lean-to extension to Building 1, with evidence for machinery associated with rolling mill represented by stone block (in foreground) with cast iron gear wheel visible in top right hand corner

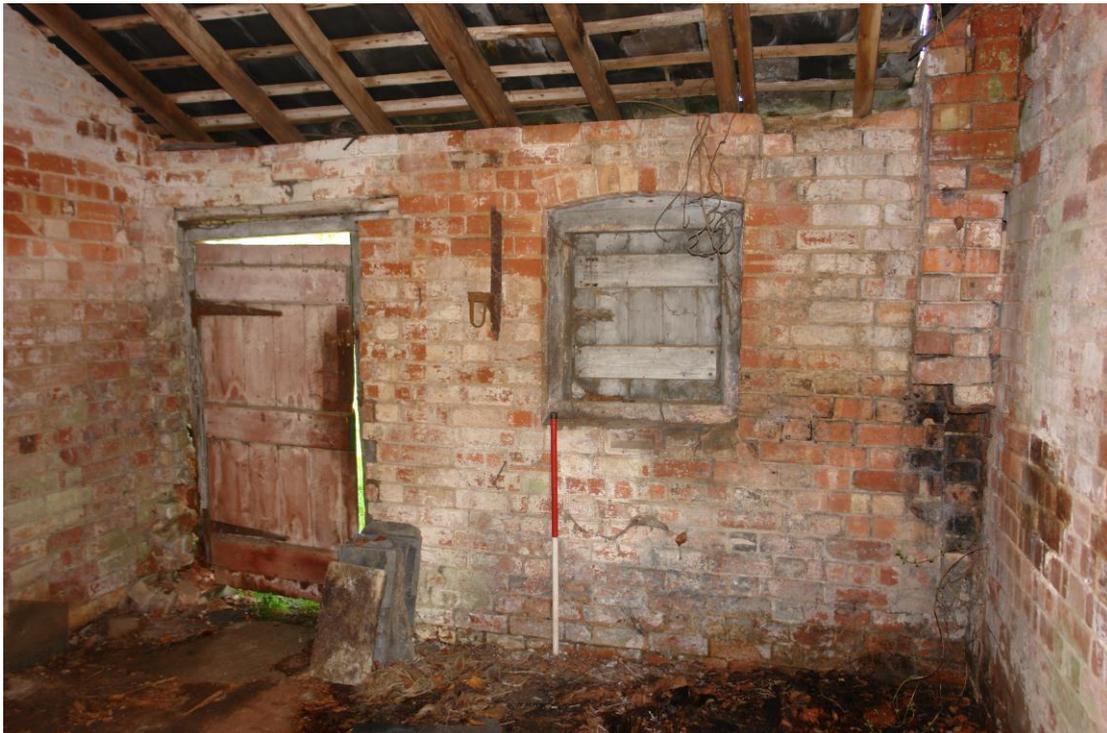
Plate 13: Internal view looking N showing S-facing wall of NE compartment with segmental brick arched window with flat-headed doorway to left, with evidence of damaged chimney flue and blackened material associated with former engine

The compartment located in the NE corner of Building 1 (Plate 13) is accessed either from a segmental gauged brick arched doorway in the E-facing elevation or from a flat-headed doorway with a wooden lintel, located in the N-facing elevation. It also appears to have housed an engine associated with the rolling mill, as evidenced externally by a small chimney in the N-facing elevation of the structure and internally by the cast-iron drive-shaft of the rolling mill, extending via a square opening into the upper part of the E-facing wall. However, in contrast to the NW compartment, most of the internal fittings associated with this engine appear to have been removed when it was converted into stabling. The engine appears to have been located in the NE corner of the compartment, indicated by the heavily blackened brickwork and flooring in this area and the partially truncated remains of the chimney flue.

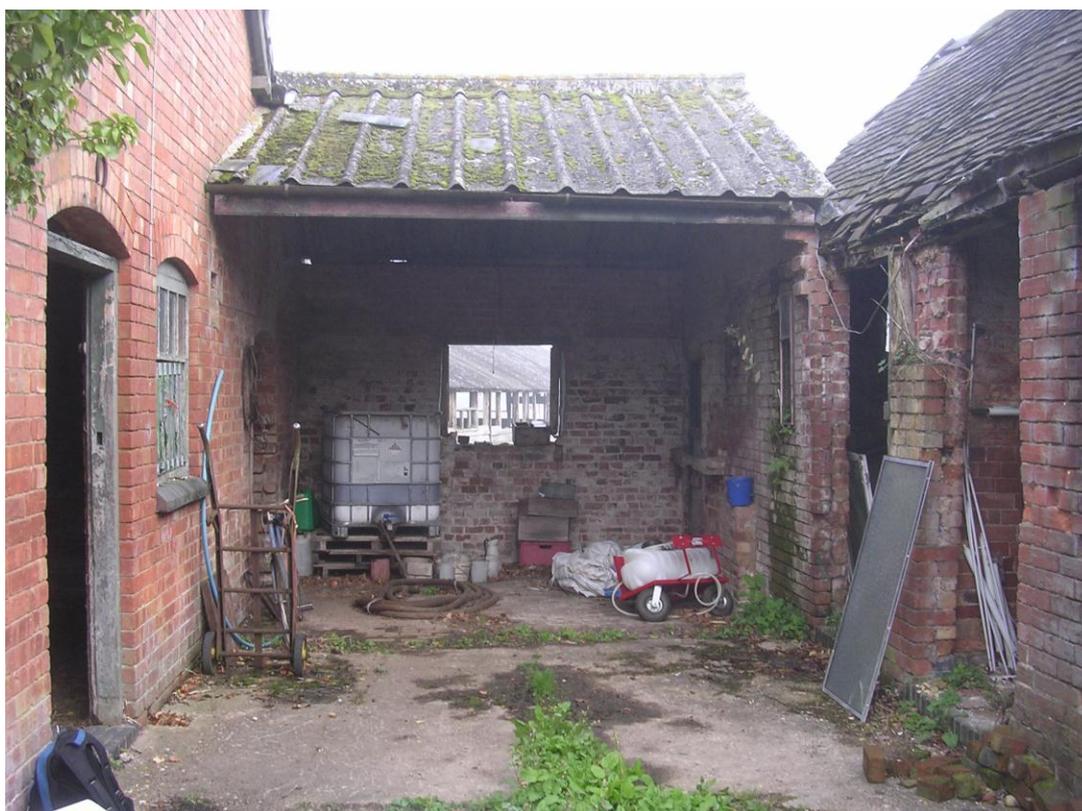
Plate 14: View looking N showing interior of fuel store (Building 2)

Building 2, which appears to have been used in recent years as a fuel store, is a single-storey, rectangular lean-to brick-built structure with a hipped, corrugated asbestos roof and brick paving, attached to the E-facing elevation of Building 1 (Plate 14). The E wall of the structure somewhat incongruously adjoins the NW corner of the stable range (Building 3). The S end of the structure is currently open; however, evidence for a demolished S-facing wall is visible and the brick paving clearly defines the interior space of the building.

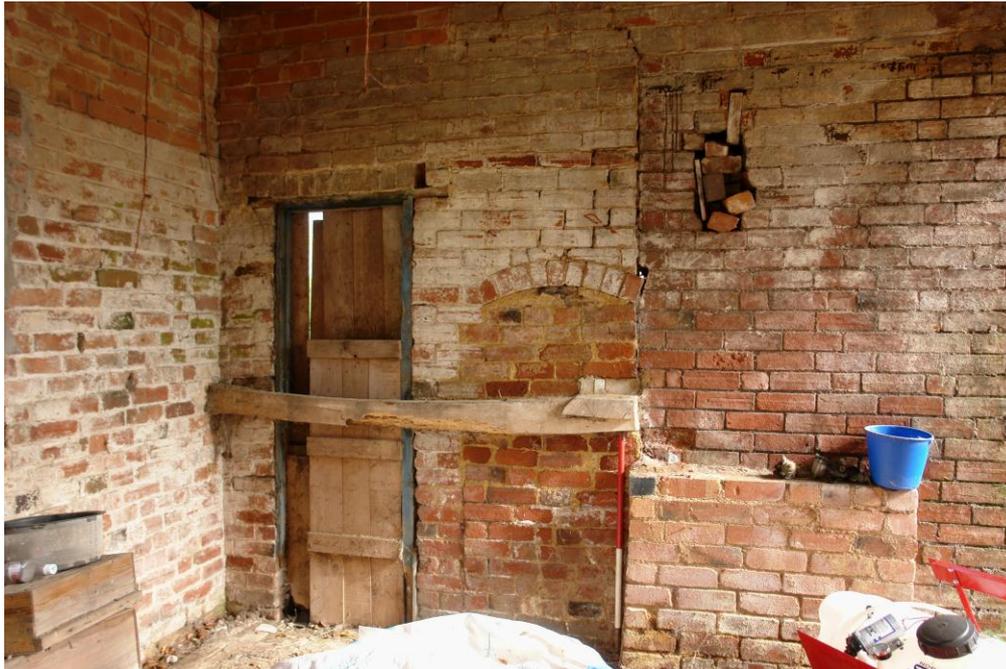
Plate 15: View looking E showing W-facing wall of fuel store (Building 2) adjoining NW corner of stable block with construction break visible, to the left of which is a blocked segmental-arched doorway with later flat-headed doorway adjacent.

The lean-to structure to the N of the stables is first shown on the OS 1st edition map of 1885; however, it appears to have been enlarged and extended to the N as shown on the OS 2nd edition map. The segmental-arched doorway appears at some point to have been blocked-up and replaced by a taller, narrow flat-headed doorway with plank-and-batten door, located immediately to the left of the earlier doorway (Plate 15).

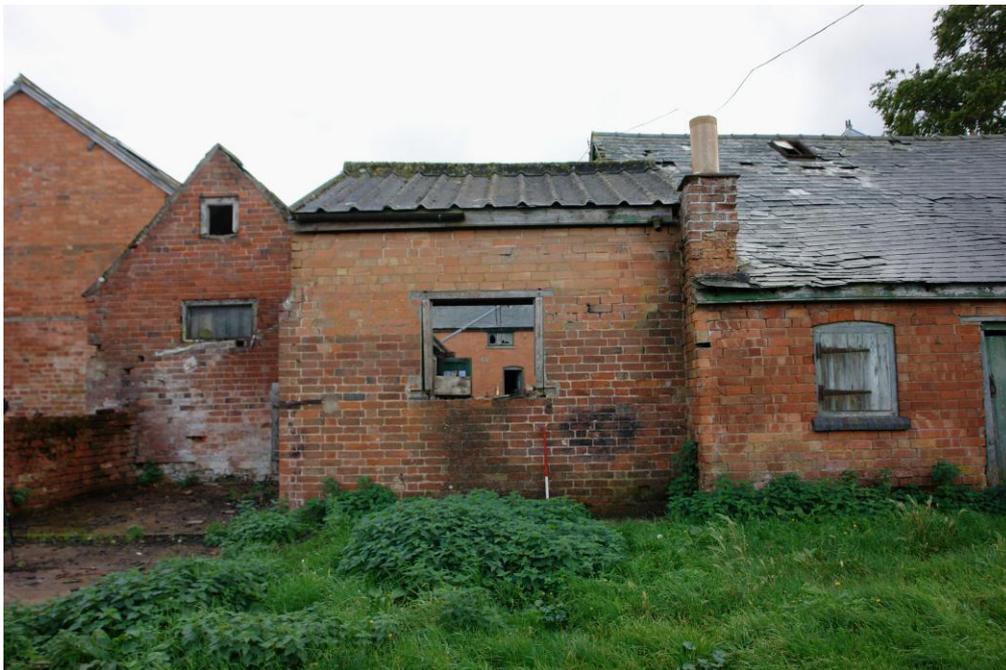
Plate 16: View looking S showing N-facing elevation of Building 2 (Fuel Store) with reconstruction of upper portion indicated by change in brickwork

At some point, the upper half of the N- and E-facing elevations of the fuel store were substantially reconstructed, which is clearly indicated by the marked difference in brickwork between the lower part of the elevations (laid in a mixed garden bond) and the upper part of the building, laid in an irregular Flemish stretcher bond (Plate 16).

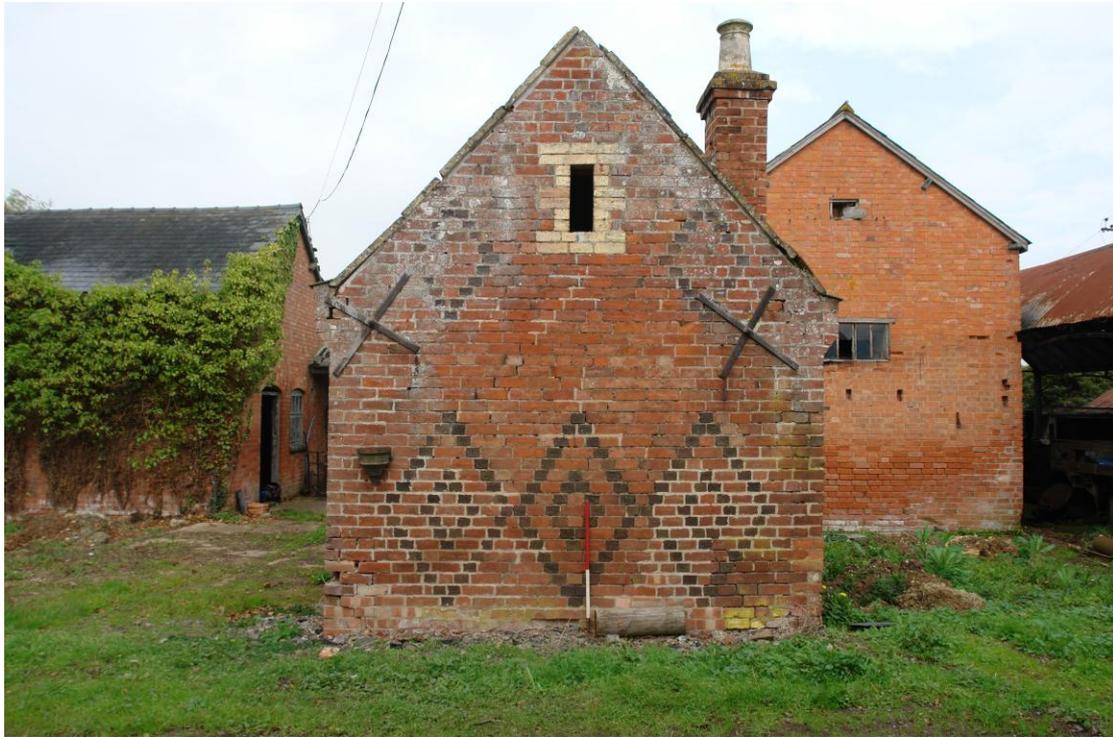
Plate 17: View looking N showing S gable elevation of stable block of c.1851-2 (Building 3) with diapered brickwork and flanking iron cross-ties at eaves level

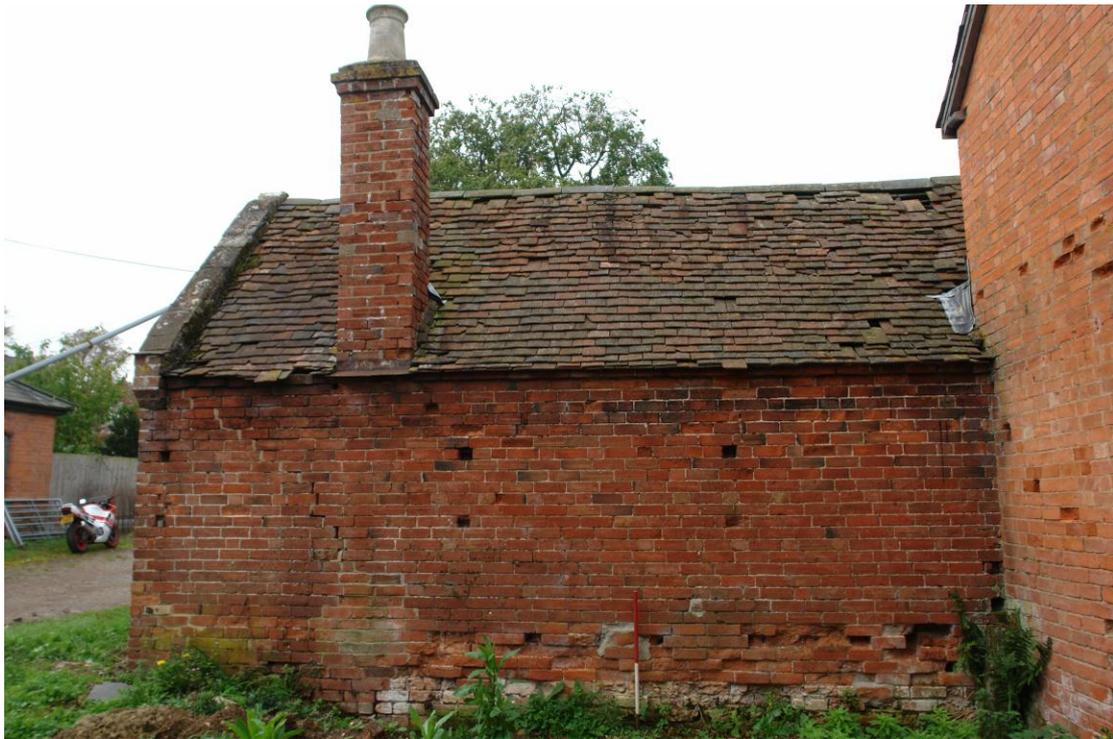
Plate 18: View looking W showing E-facing elevation of Building 3-(Stable Block) with beam slots for temporary lean-to structure

The E-facing gable elevation is devoid of architectural detailing; however, two rows of three regularly spaced square indentations, extending from left to right, were visible (**Plate 18**). The upper row of indentations was 0.35m below eaves level with the lower row 0.30m below. These indentations evidently represented beam slots for a lean-to structure, probably an open shed or shelter for livestock. In connection with this, it is worth noting that the OS 2nd edition map shows a rectangular feature immediately adjoining the E side of Building 3, possibly representing an open shed or fold for livestock.

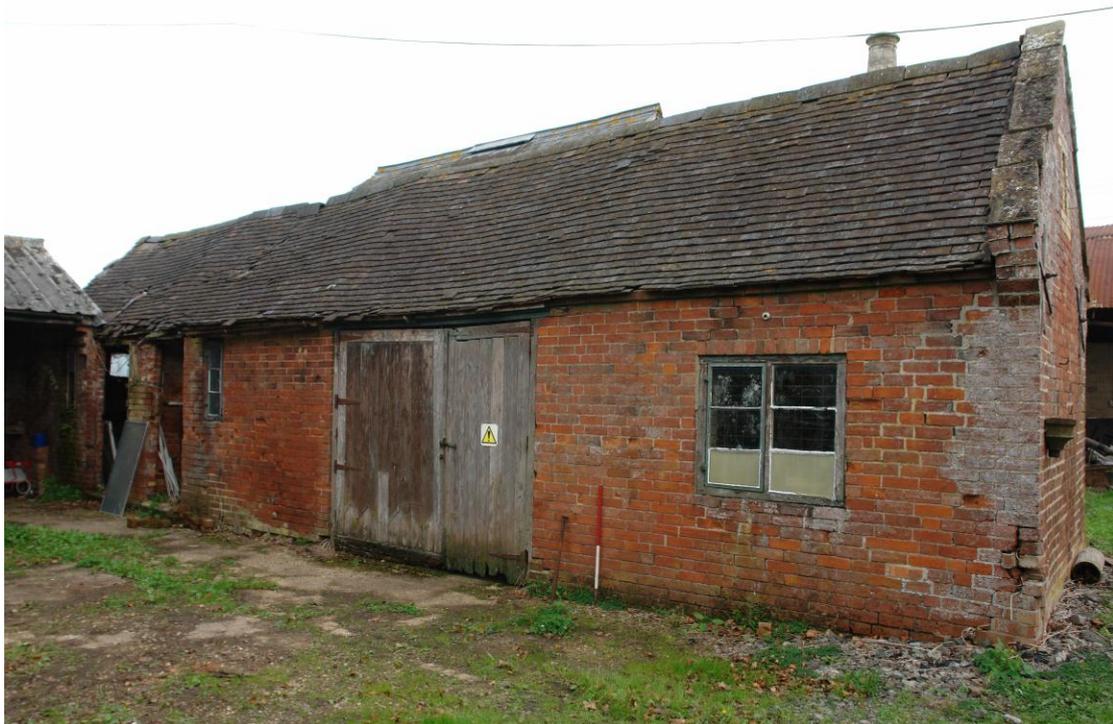
Plate 19: View looking NE showing W-facing elevation of Building 3 (Stable Block)

The W-facing external elevation (Plate 19) exhibits evidence of significant alteration, probably associated with the conversion of the barn into a garage in the mid 20th century. The flat-arched six-pane casement window in the southernmost bay appears to be a later insertion.

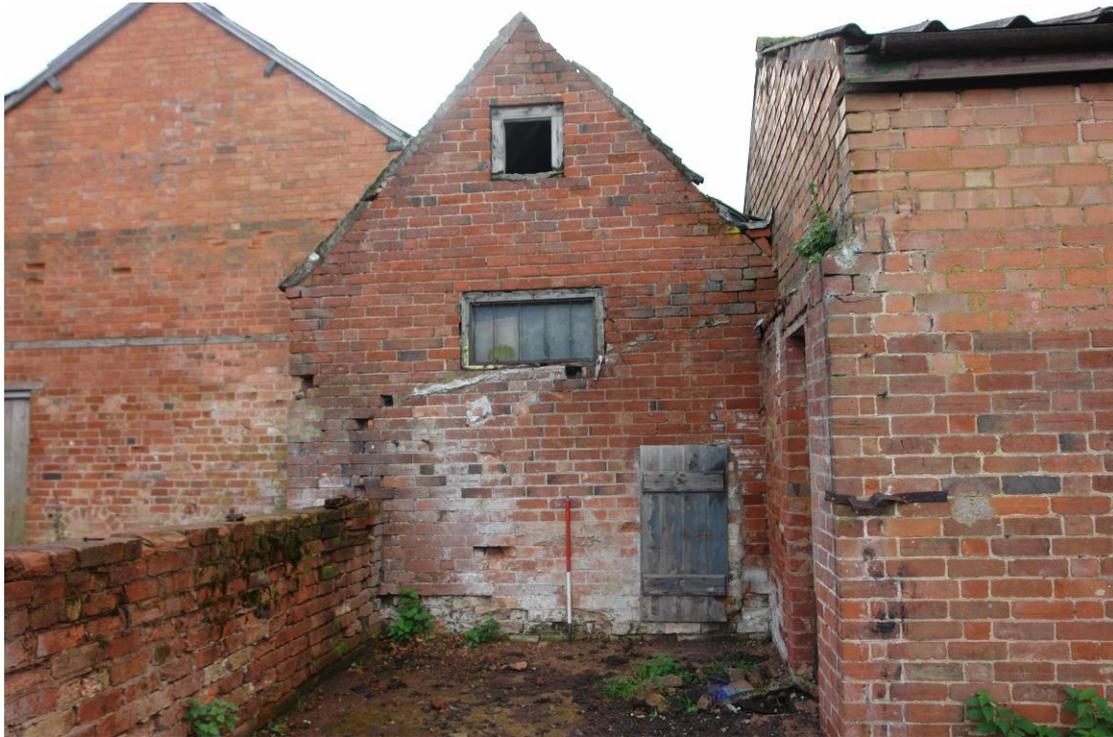
Plate 20: View looking S showing N-facing gable elevation of stable block (Building 3) with evidence of roofline of the demolished lean-to extension

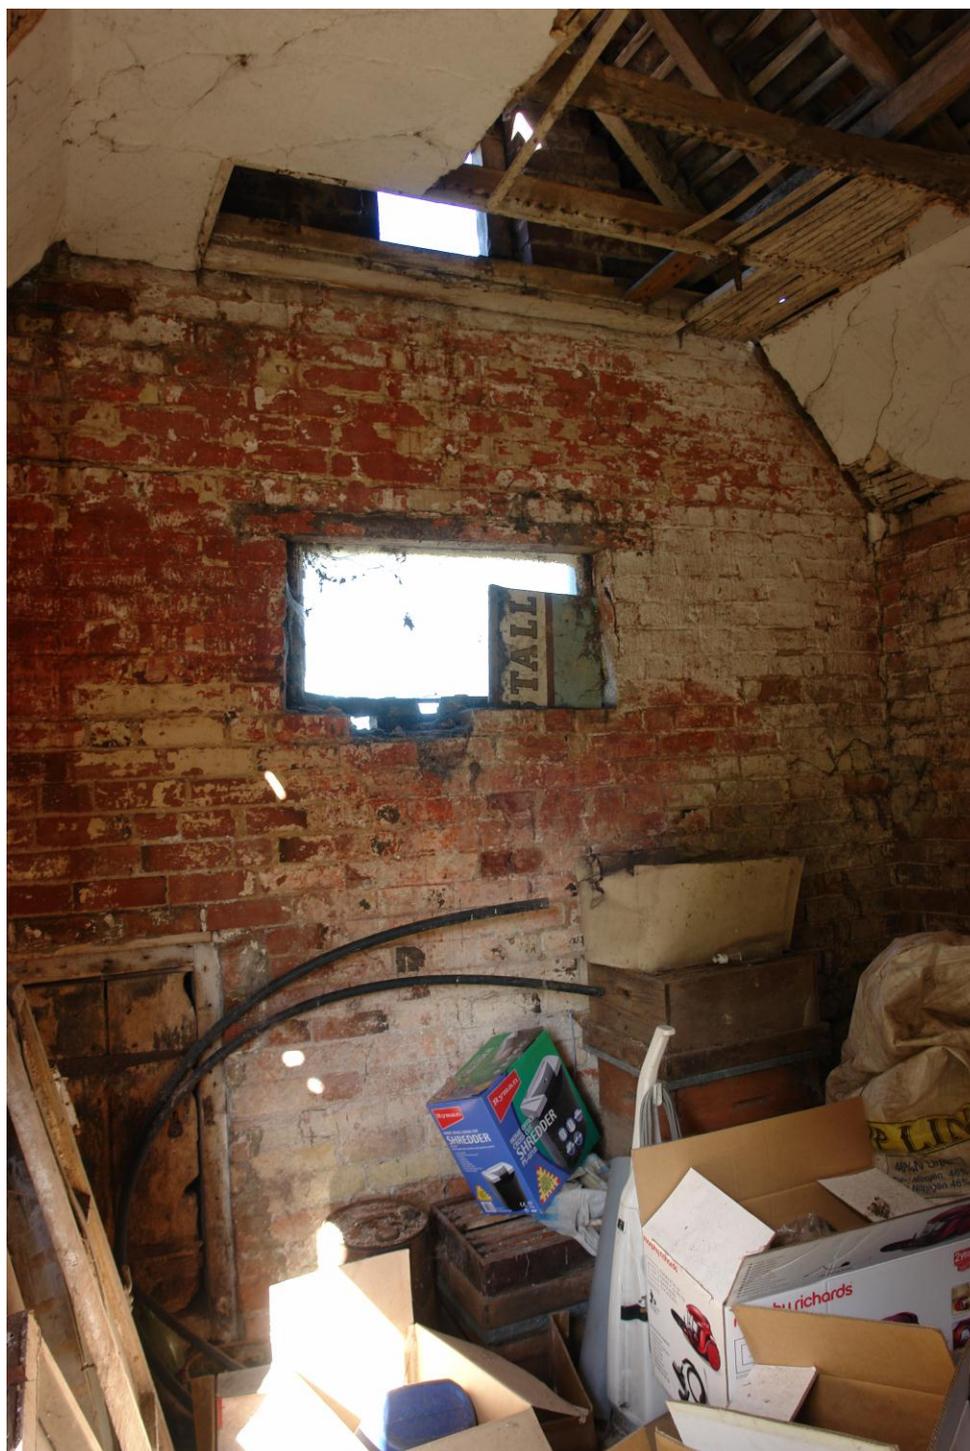
Plate 21: Internal view of Building 3 looking N showing S-facing gable wall with low doorway (to bottom left of picture) and roof trusses partially concealed by covered plasterboard ceiling

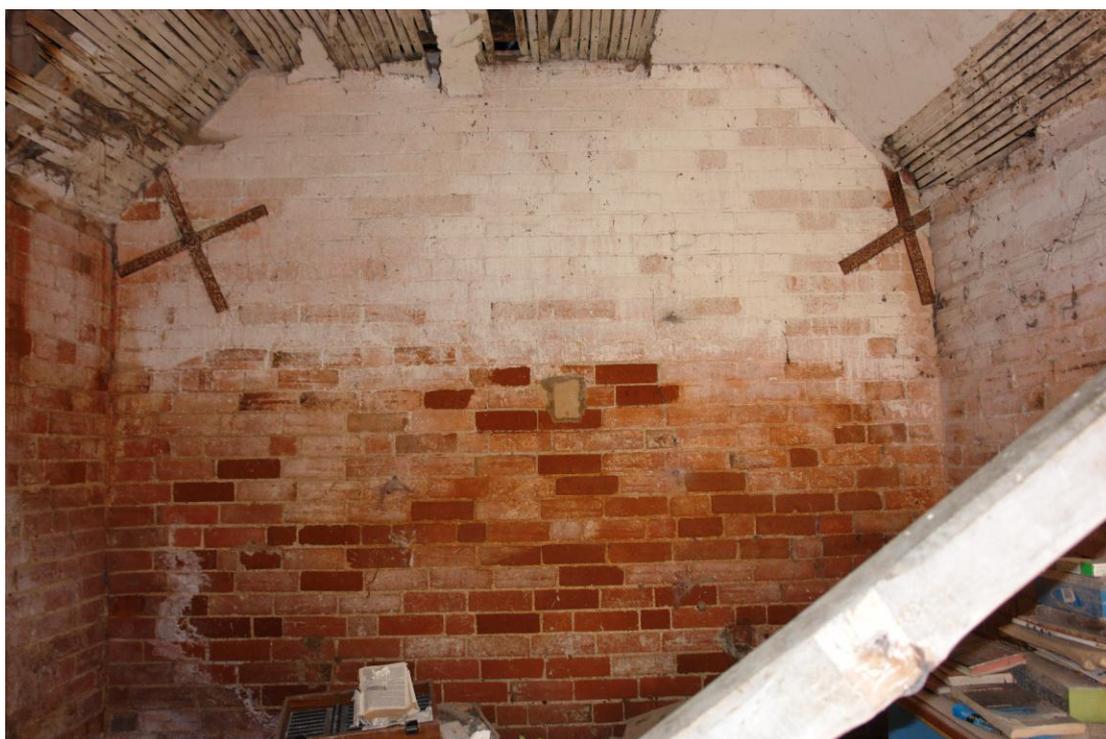
Plate 22: View looking S showing N-facing wall of compartment in stable block with flanking wrought-iron cross-ties and a single, filled-in beam slot
