STANDING BUILDING RECORDING SURVEY

Seaford Grange Farm
Pinvin
Worcestershire
WR10 2LF

NGR: SO 95720 50767
JOB No: BA1026SGFS
HER Ref. WSM 45764

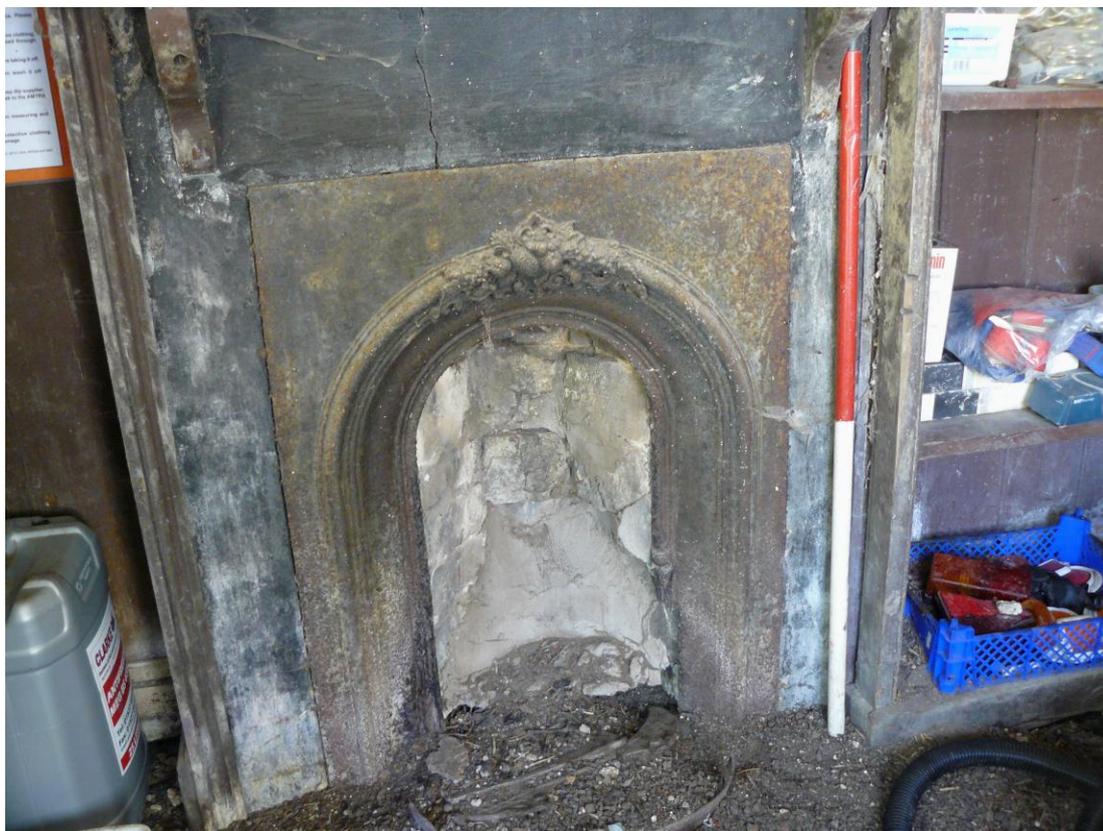
Plate 23: Internal view looking E showing detail of cast-iron fireplace in W-facing wall of panelled office at the S end of Building 3 (Stable Block)

By 1910, this room appears to have ceased to function as an office (presumably replaced by the new office in the large L-shaped block to the S) and appears to have been used as a harness room associated with the adjacent 'coach house'. This later usage is indicated by the presence of iron hooks inserted into the walls for hanging harness; the presence of a fireplace would also have been an essential requirement for drying the harness.

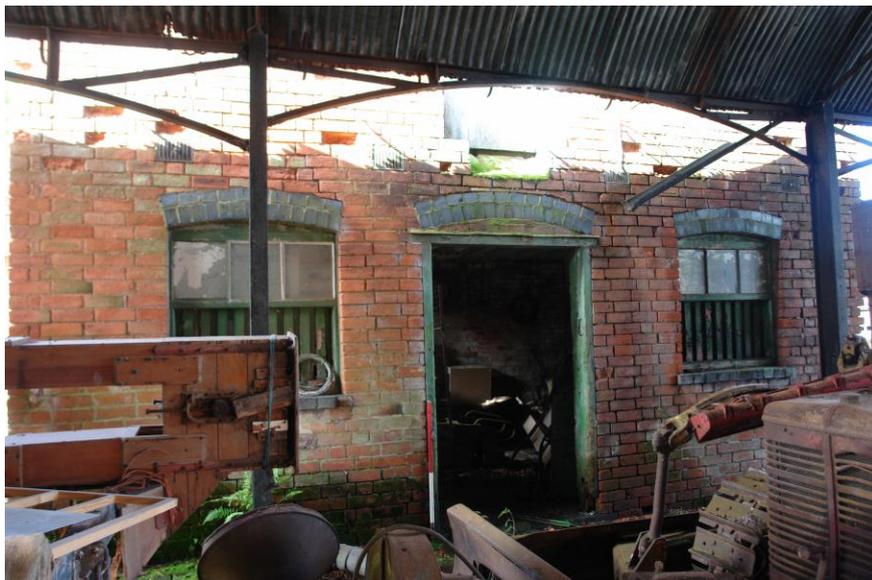
Plate 24: View looking W showing E-facing principal elevation of Building 4

The principal E-facing external elevation (Plate 24) is partially concealed by a large five-bay cast-iron Dutch barn (probably added c.1920-30). At ground level, there is a centrally placed doorway with a blue-brick segmental gauged arch, flanked by two windows with blue-brick segmental arches and sills. The window frames are similar to those in the E-facing gable elevation of Building 1, the upper half consisting of glazed lights while the lower half has wooden mullions. The fenestration of the upper storey consists of a centrally placed, flat-arched loading bay (with intact plank-and-batten door), flanked by two flat-arched, three-light windows with blue-brick sills. Four regularly spaced ventilation slots with iron grilles are visible just below ceiling level.

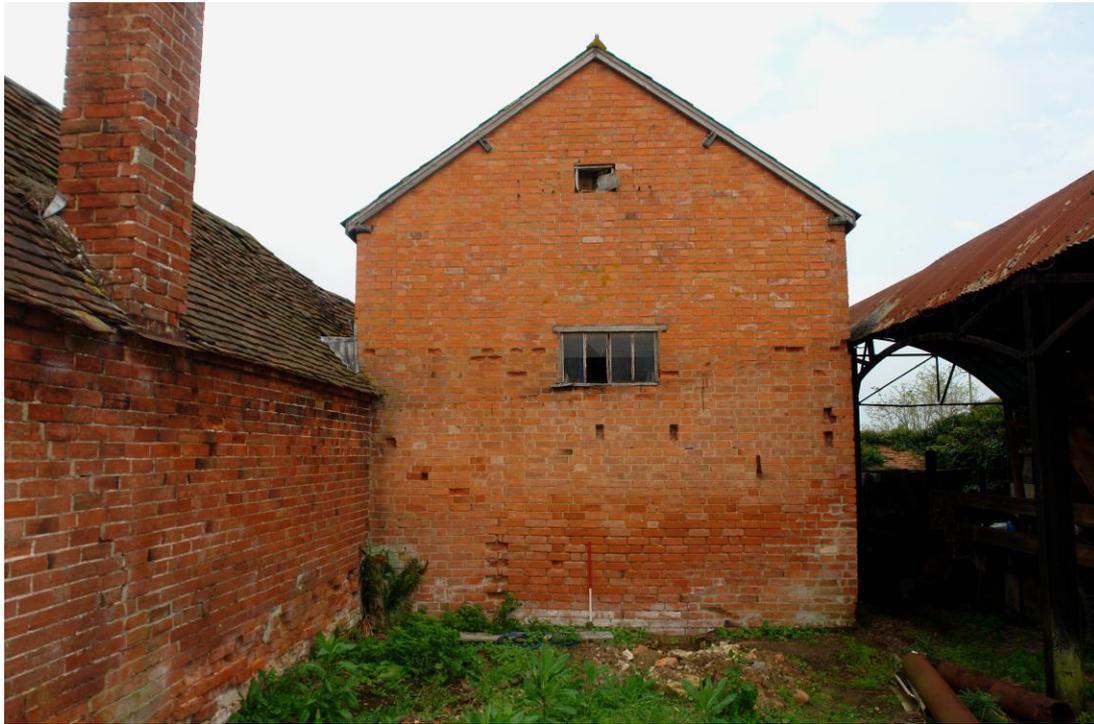
Plate 25: View looking N showing barge-boarded S-facing gable elevation of Building 4

Both the N and S gable elevations are barge-boarded; the S gable has a flat-arched, four-light window curiously placed at ceiling level, as if to provide light both for the ground floor and upper storey (Plate 25). Beneath the four-light window is a row of beam slots which may have been used for a lean-to structure, possibly an open shed or livestock shelter, which is visible in outline on the OS 2nd edition map of 1904. At the apex of the S gable is a small, rectangular single-light window, which appears to be associated with a pigeon loft or dovecote located at attic level.

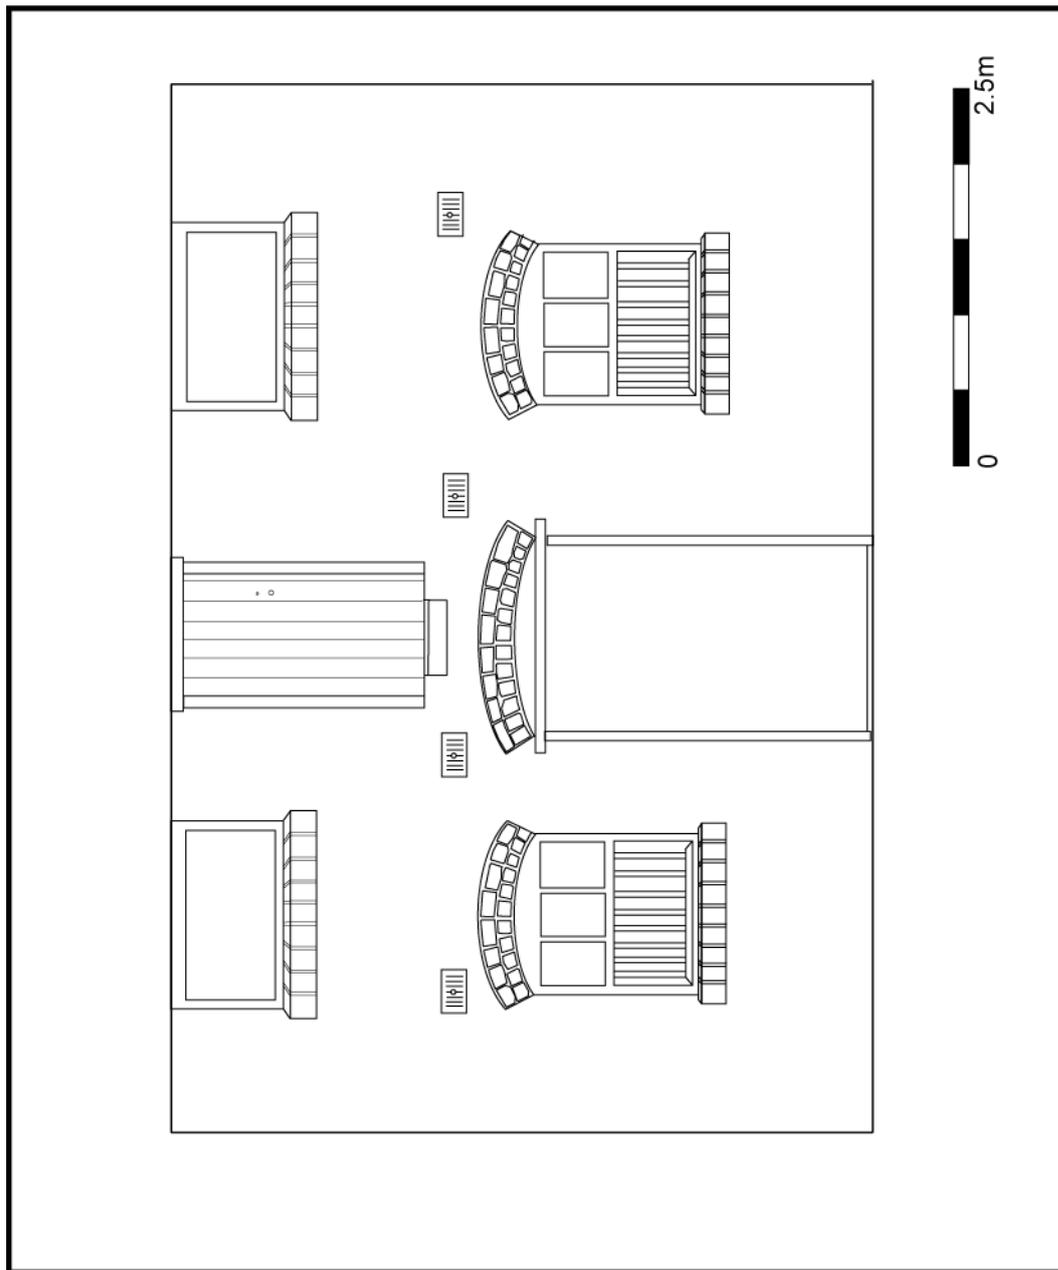
Fig. 5: Principal E-facing elevation of Building 4 (Stable, Loft and Dovecote)

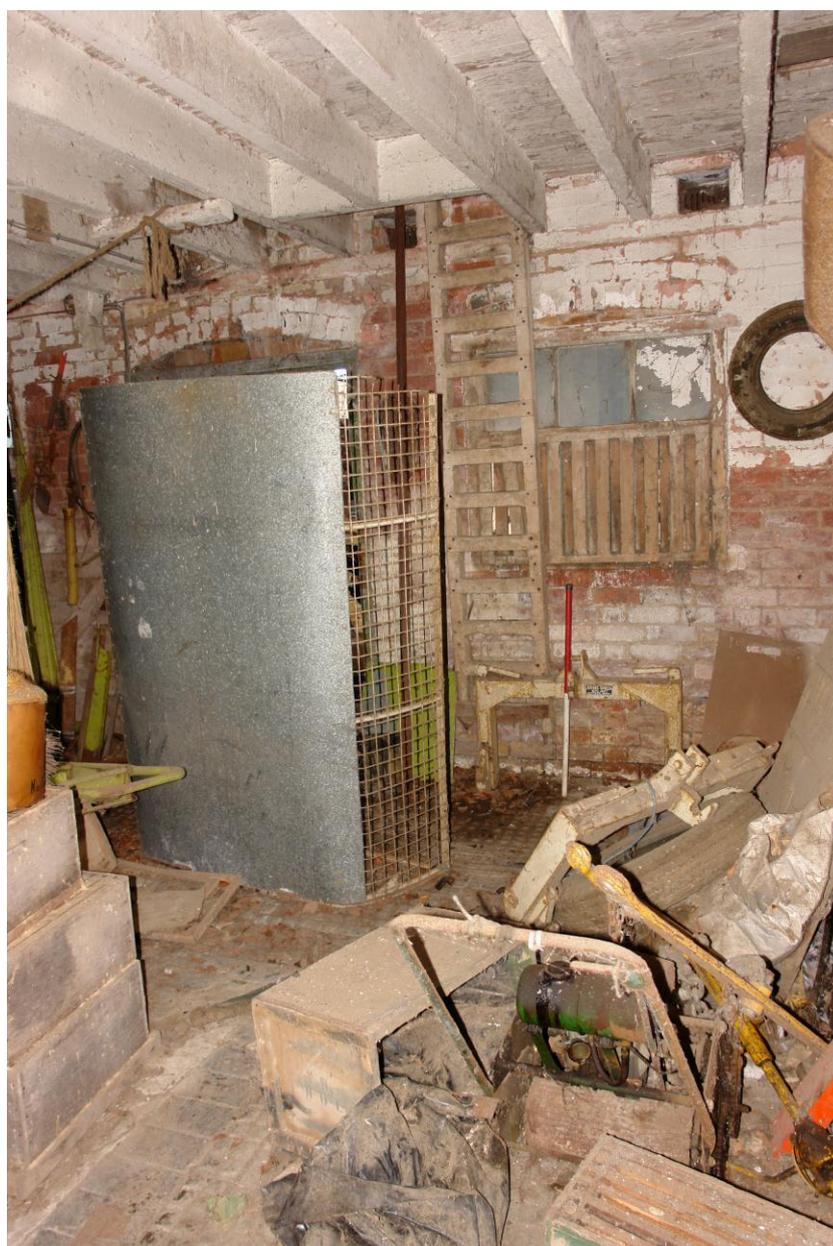
Plate 27: Internal view of Building 4 looking E showing whitewashed ceiling rafters and brick cobbled flooring, with ladder providing access to the upper storey

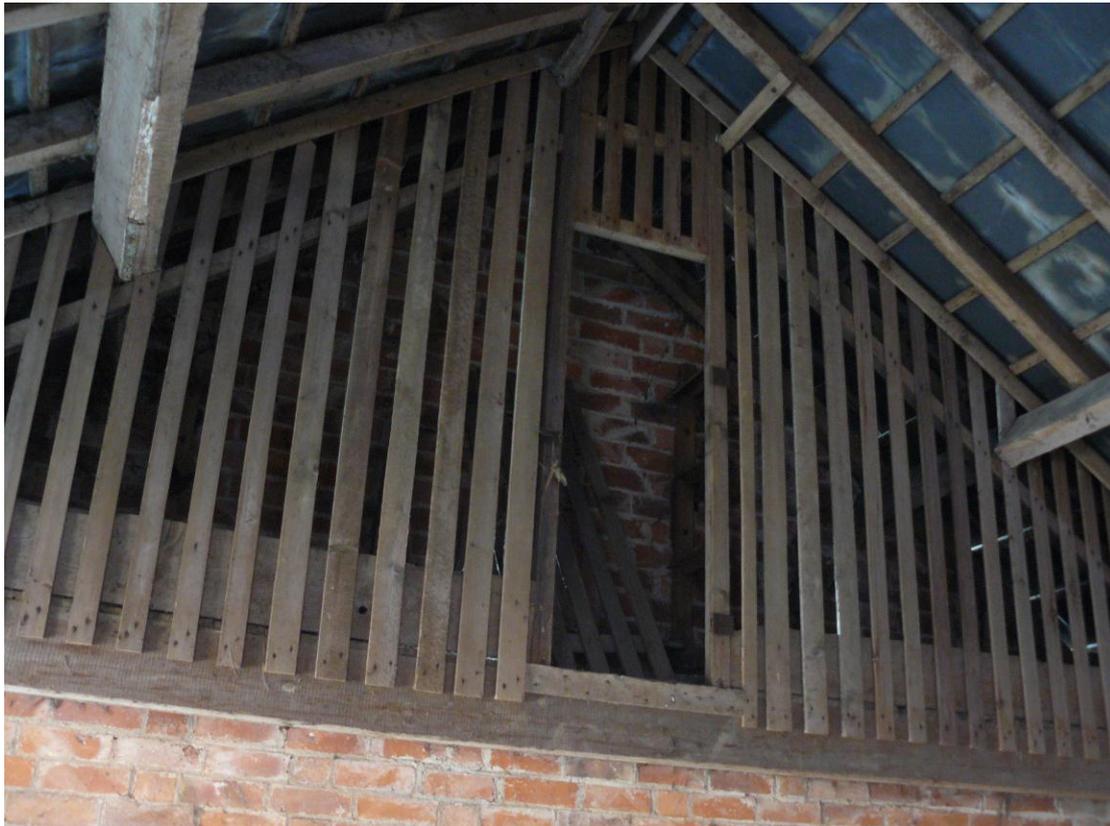
Plate 28: Building 4 upper storey - View looking S showing planked compartment and wooden nest-boxes on ledge in S gable wall

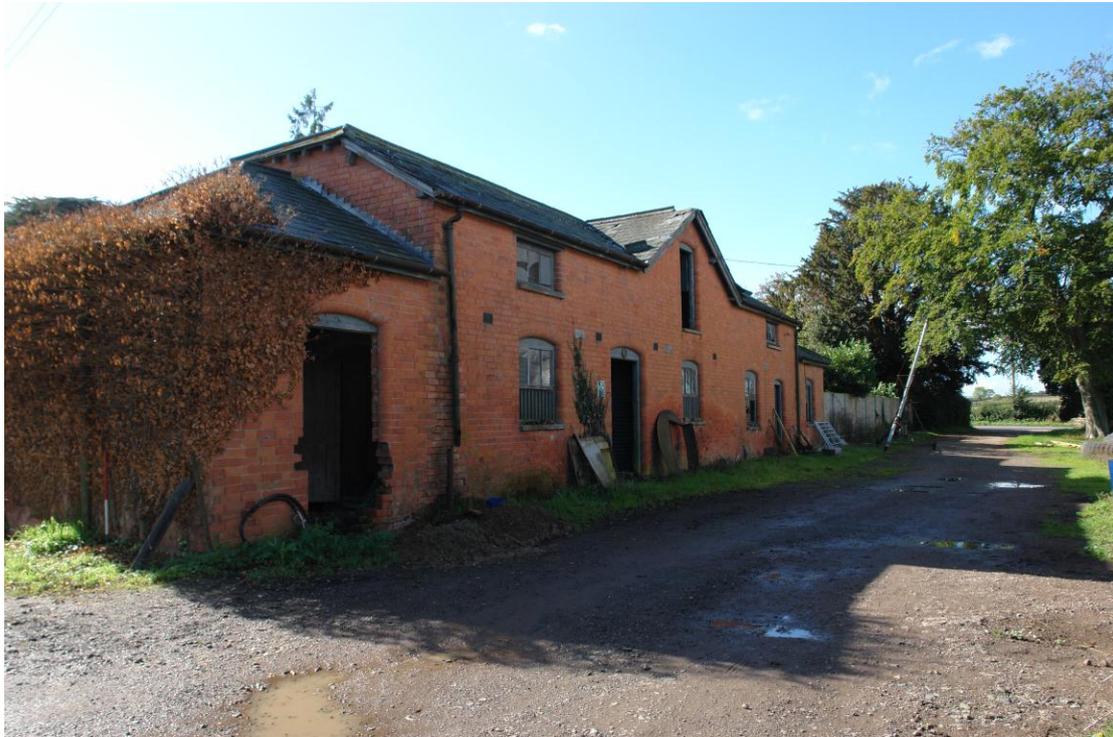
Plate 29: View looking SW showing principal N-facing elevation of Building 5

Building 5, located to the S of the coach house and stables, comprises a main block, five bays long and two storeys in height, with single-storey side-wings attached to the E and W ends (Plate 29). The building is constructed of standard-gauge, rubbed orange-red brick laid in Flemish bond and bonded with cement. The quality and finish of the brickwork is in marked contrast to that used in the construction of the earlier coach house and stables.

Externally, the principal N-facing elevation of this building comprises three components. The main, five-bay block has a central, barge-boarded gable with a loading bay at upper-storey level, flanked by two three-light windows placed at the E and W ends of the block (Plates 29 & 30). The centrally placed loading bay giving access to the upper storey loft has a segmental, rubbed-brick arch and a stone sill, while the two flanking three-light windows are

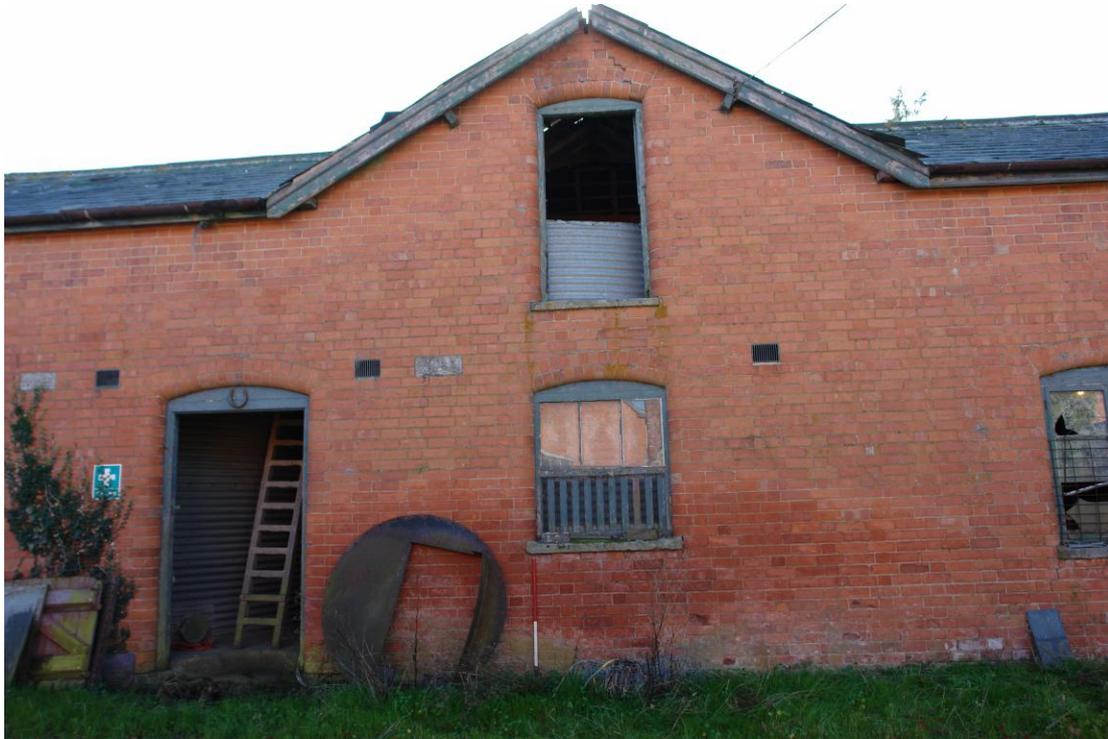
Plate 30: View looking S showing central barge-boarded gable in N-facing elevation of Building 5, with loading bay at upper-storey level

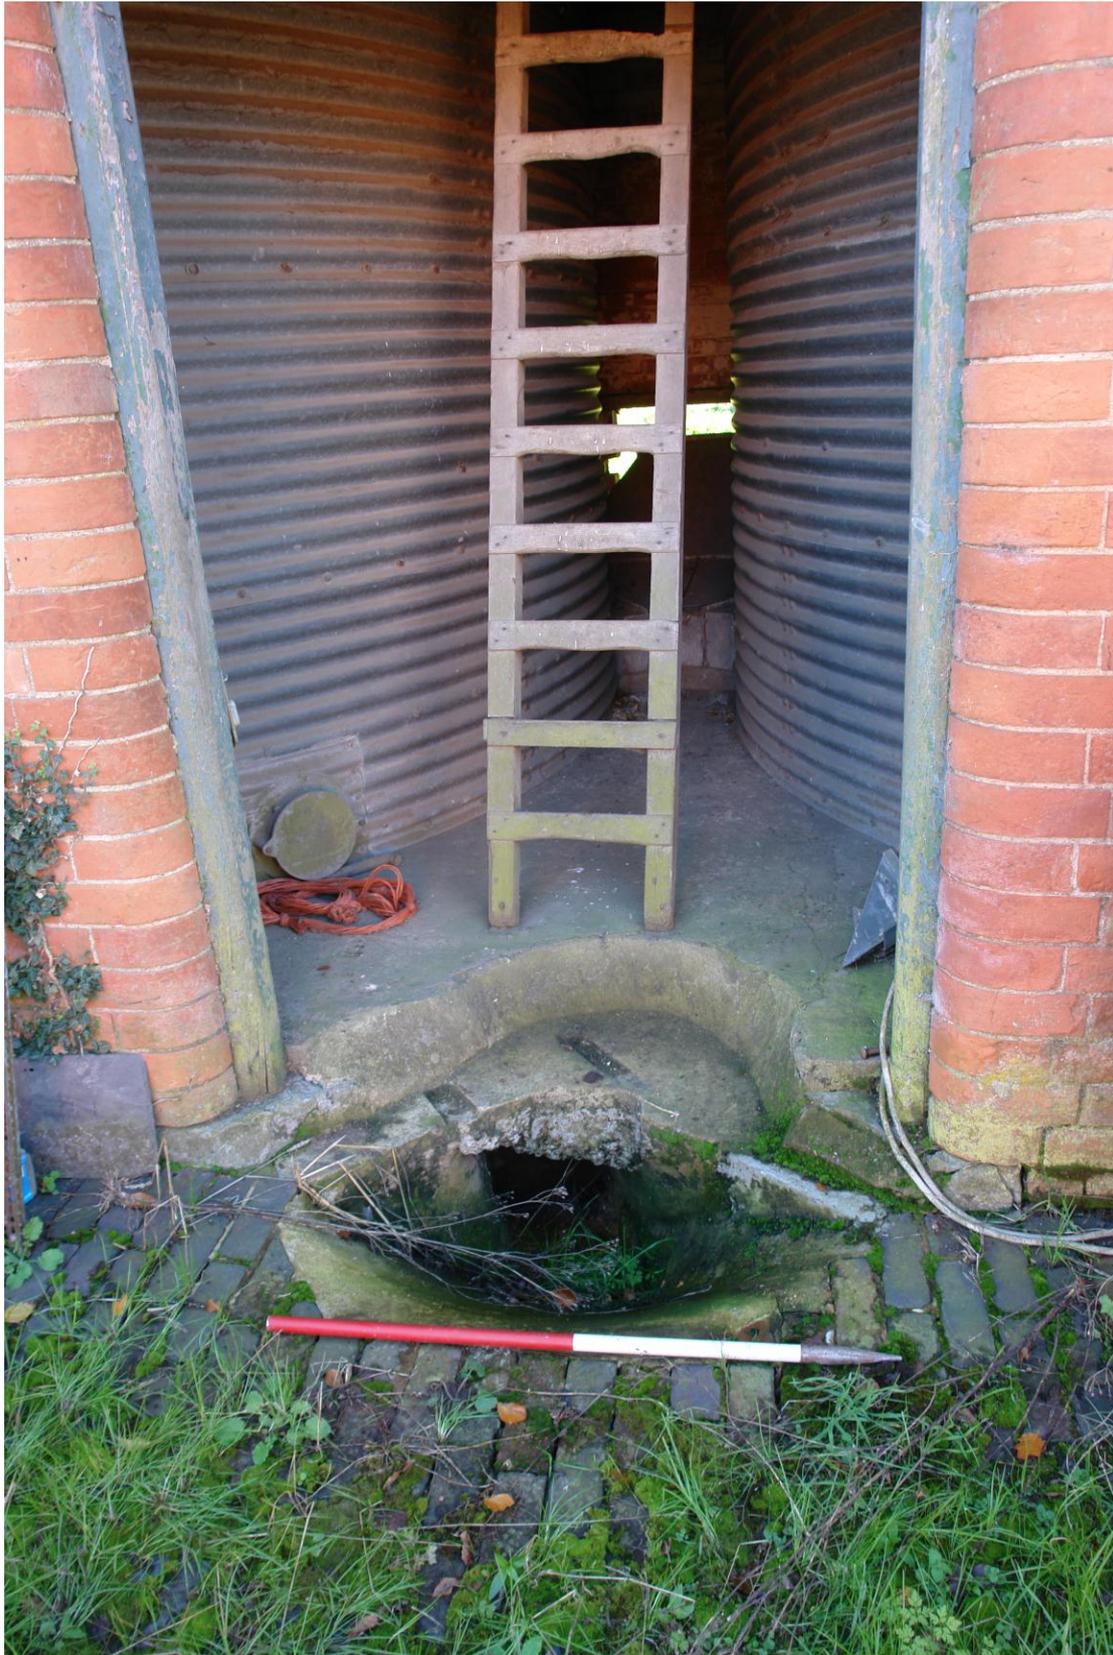
Plate 31: View looking S showing detail of culvert extending beneath doorway in N-facing elevation of Building 5

At ground level, the main block has two segmental-arched doorways, one located at the W end of the main block (providing access to the workshop and office) while the other is located to the left of the centre gabled bay (originally providing access to the stabling, which comprised two loose boxes in 1966). Beneath the sill of the latter doorway is the opening for a substantial stone culvert, which appears to have run directly N-S beneath the building (Plate 31).

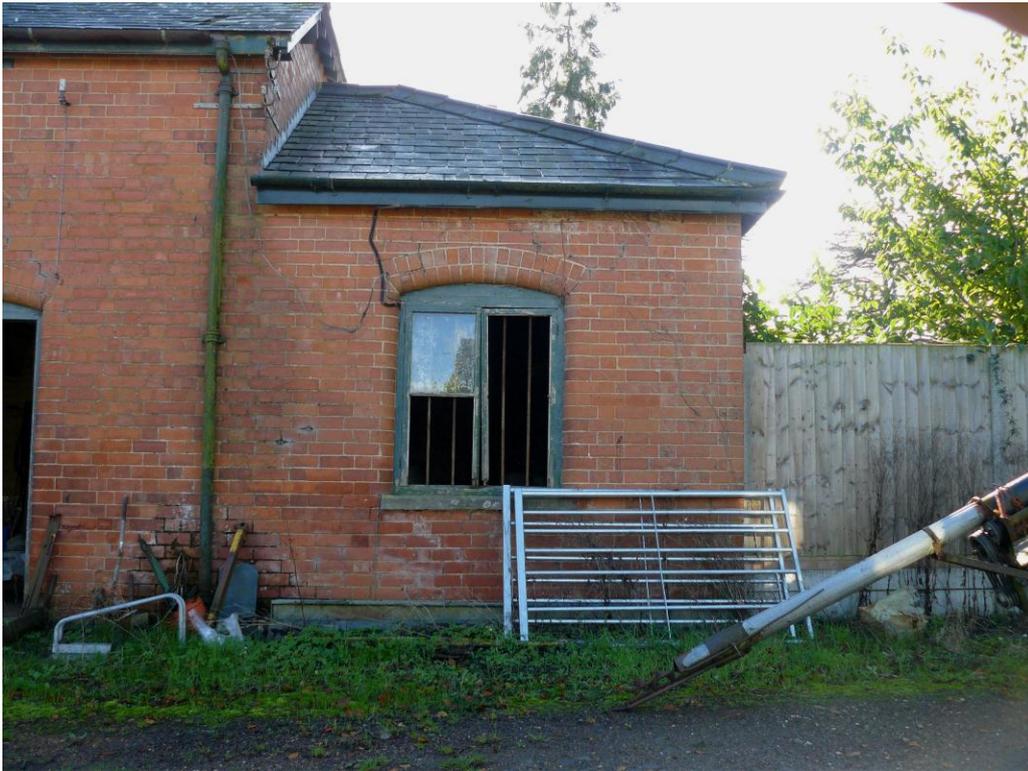
Plate 32: View looking S showing segmental-arched window with iron bars in N-facing elevation of W wing of Building 5

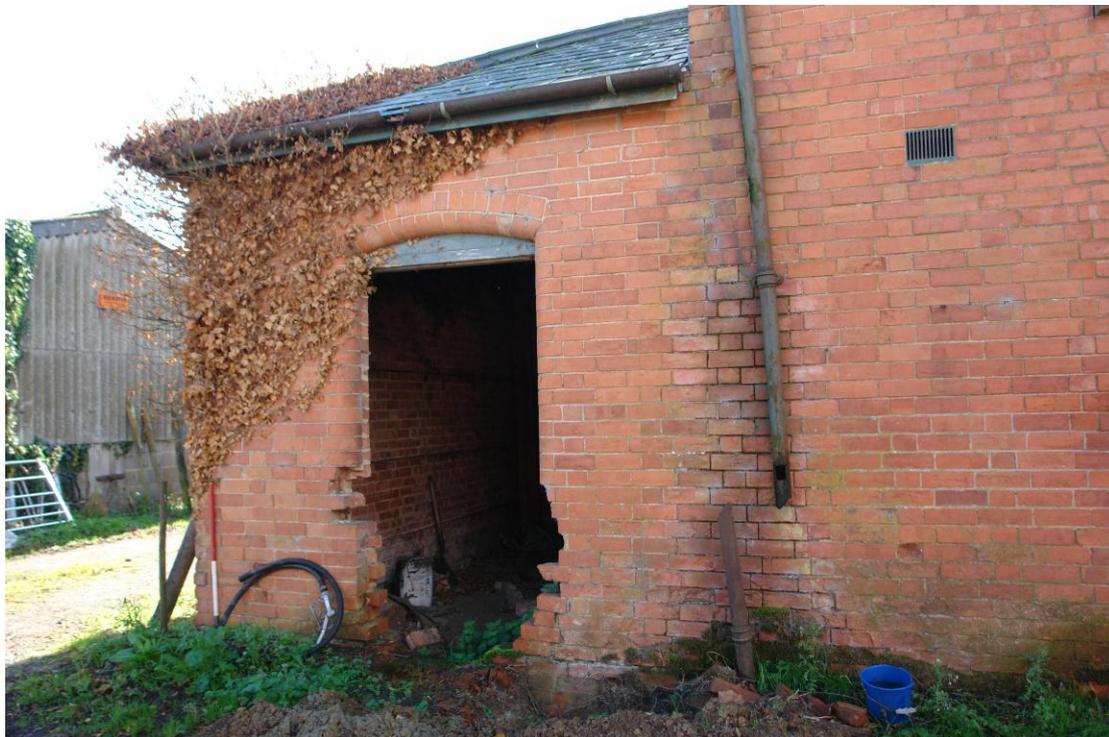
Plate 33: View looking SE showing N-facing elevation of single-storey wing at E end of Building 5 with segmental-arched window knocked out below sill level

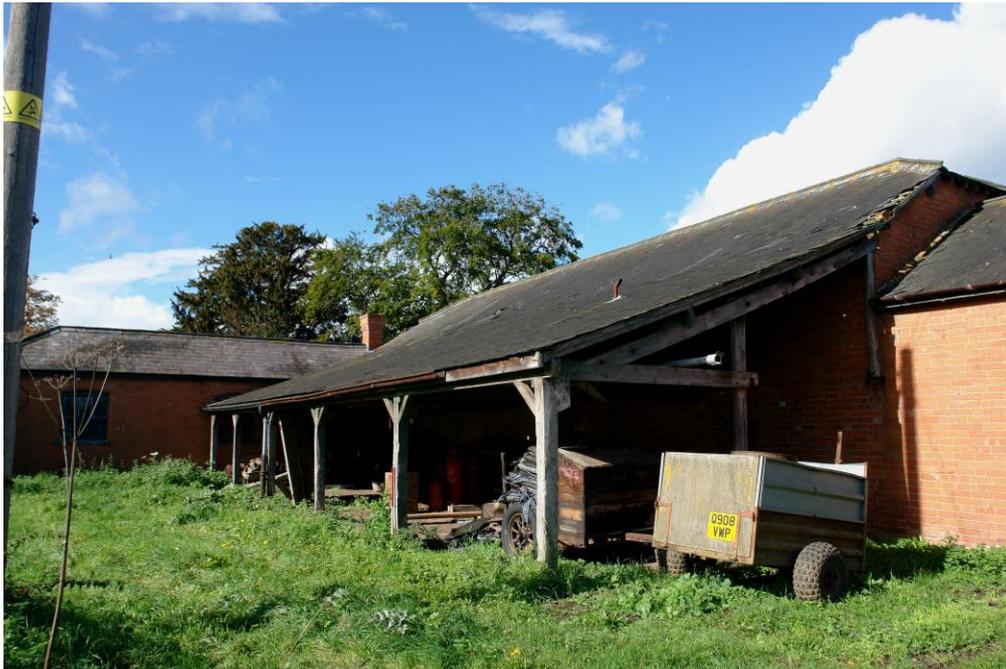
Plate 34: View looking WSW showing five-bay open shed for carts and farm implements, attached to S-facing elevation of Building 5

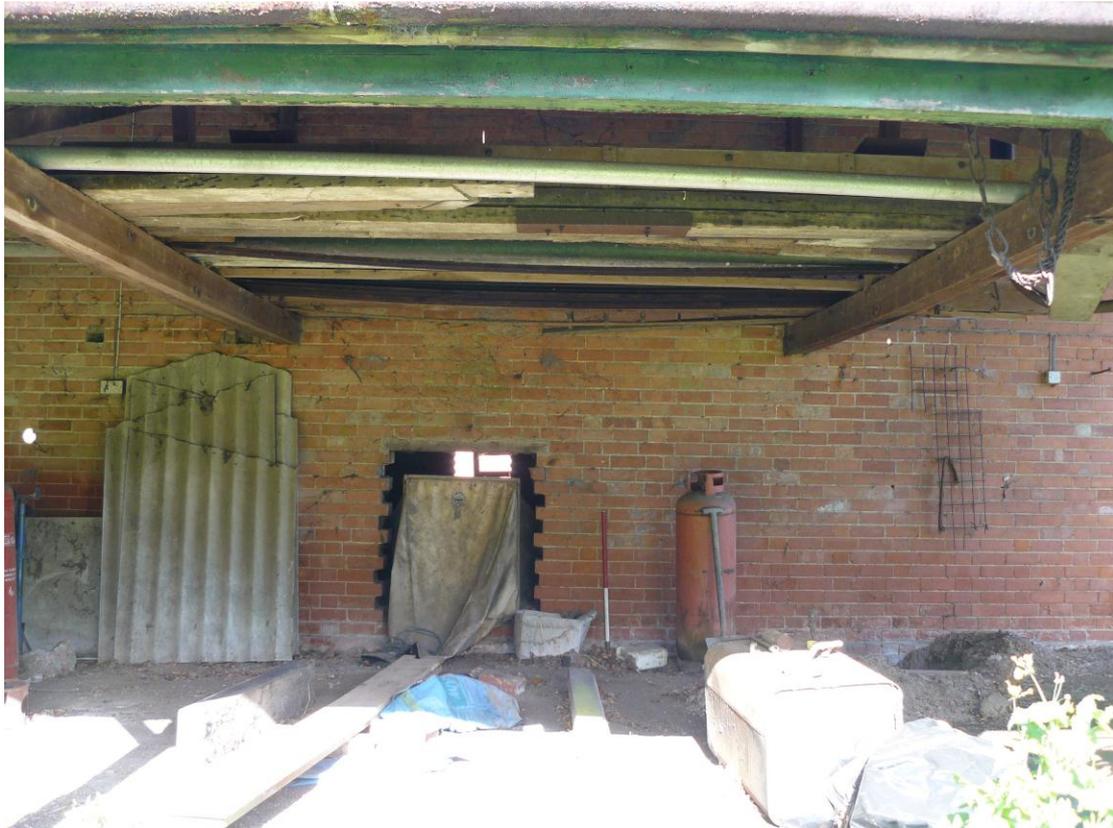
Plate 35: View looking N showing S-facing elevation of Building 5 with flat-headed door opening, contemporary with insertion of modern silo tanks

The brickwork in the S-facing elevation of Building 5 exhibits evidence of extensive repair and re-patching, possibly connected with the installing of the grain silo tanks within the central and eastern part of the main block, which had formerly been occupied by two loose-boxes as recorded in the Seaford Grange sale catalogue of 1966. A makeshift opening had been inserted through the brickwork at ground level immediately to the E of the central bay, presumably contemporary with the insertion of the silo tanks (Plate 35).

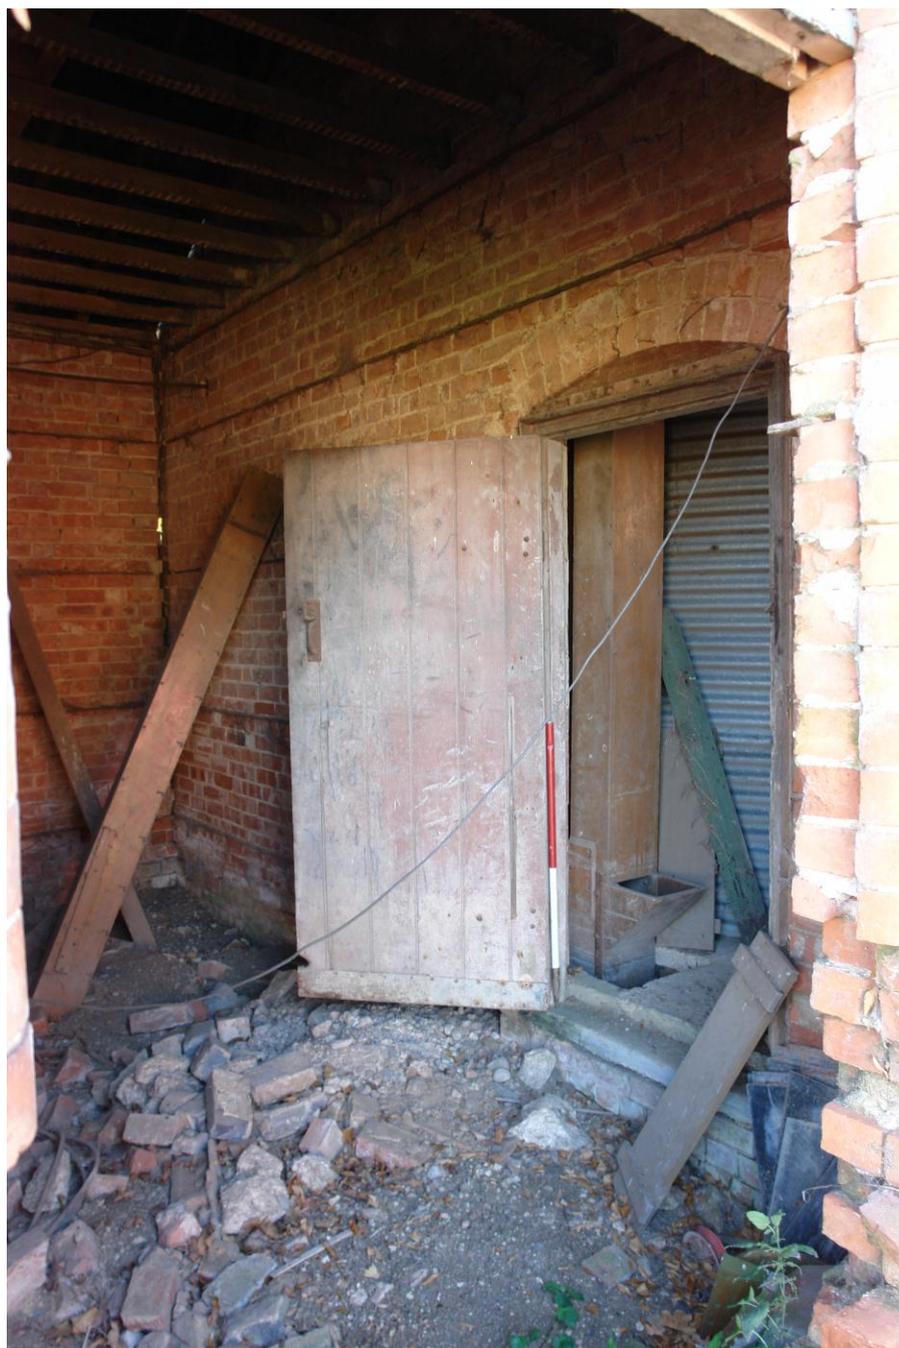
Plate 36: Internal view looking SW showing segmental-arched door leading from the stable block to the compartment at the E end of Building 5 ('Tackle Room?')

A plank-and-batten door set within a segmental gauged arch doorway in the E wall of the main block (partially obscured by the easternmost of the two silo tanks) appears originally to have provided access to the single-storey wing at the easternmost end of the main block (Plate 36).

The interior of this compartment appears to have been substantially altered (presumably when the silo tanks were installed in the early 1970s); the segmental-arched window in the N wall was knocked out below sill level to provide a makeshift doorway and any evidence of internal panelling or other fittings appears to have been thoroughly removed. However, the presence of a blocked-up chimneyflue in the rear (S) wall indicates that there was originally a fireplace in this compartment (Plate 37). It is likely that this compartment may be identified with the 'tackle room' mentioned in the Land Valuation Survey of 1910, in view of the fact that it could be directly accessed from the adjoining stables and a fireplace would have been a necessary requirement to dry the harness.

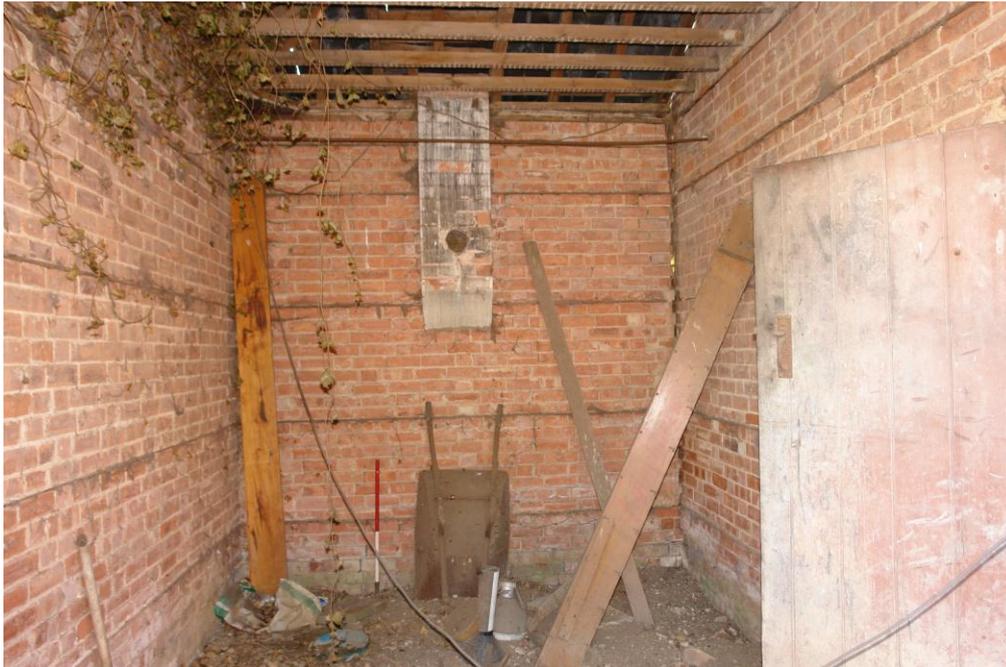
Plate 37: Internal view looking S showing interior of compartment at E end of Building 5 with remains of chimney flue

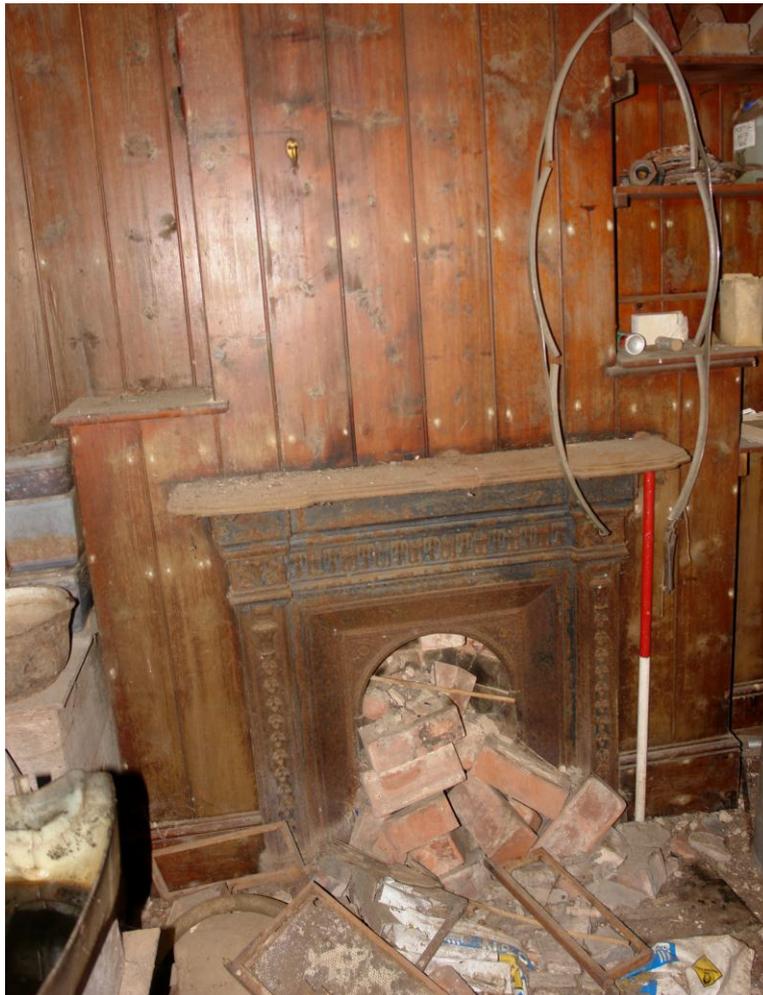
Plate 39: Building 5 -Internal view looking S showing late 19th century cast-iron fireplace (with recess containing shelving to right) and the original softwood panelling of the office

A segmental-arched doorway with original plank-and-batten door provides access from the workshop to the office, situated in the W side-wing attached to the main block. Although currently used as a storeroom and in a generally poor state of repair, the office has retained many original features, most notably its fine softwood panelling with chamfered skirting. Of particular interest is the elaborate cast-iron fireplace projecting from the S wall, comprising an arched grate (partially blocked with loose bricks) with spandrels containing foliate decoration, set within a classical surround with a dentilled frieze and fluted pilasters with finely detailed trefoil decoration in relief (Plates 39 & 40). There are recesses to the left and right of the fireplace, that on the right containing shelving, which may well represent an original feature.

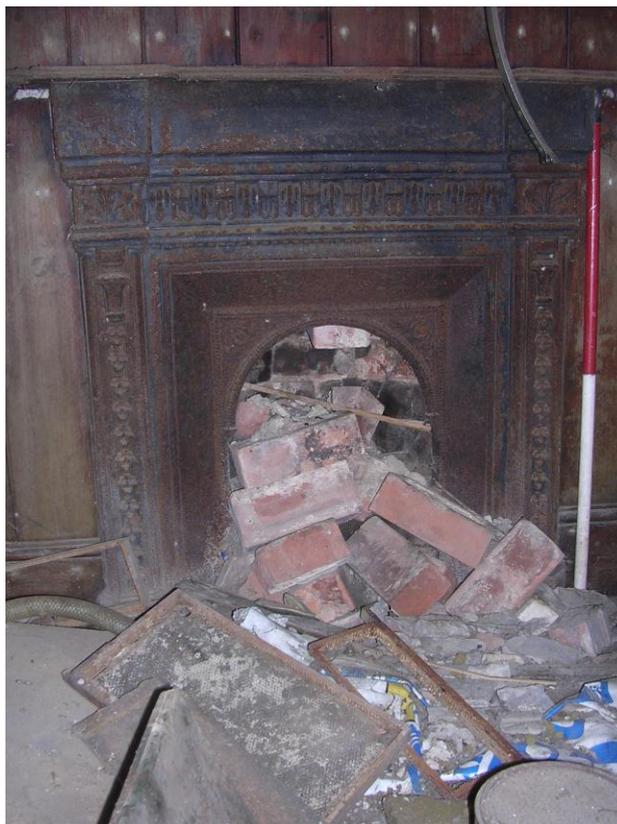
Plate 40: Building 5 - View looking S showing the detailing of the cast iron fireplace in panelled office

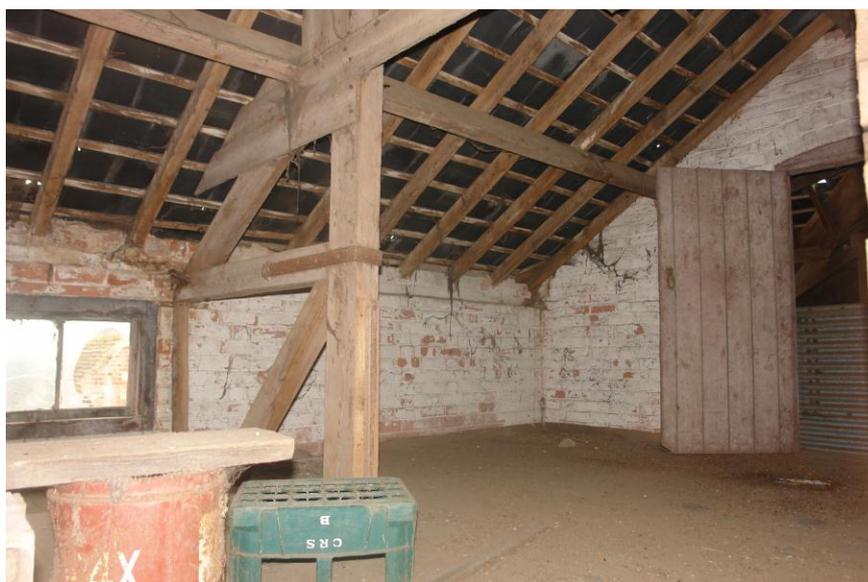
Plate 41: Building 5 Upper Storey - Internal view looking NE showing interior of loft above the workshop with segmental-arched doorway to right

The upper storey of the main block exhibits evidence of considerable alteration associated with the installation of the existing corrugated-iron grain silos. The roof construction is of a standard queen-post type with trenched purlins; many of the rafters and trusses appear to have been renewed or replaced. It appears that originally there was a floor extending across the entirety of the main block, as indicated by the loading-bay door and the slots for floor joists (partially concealed by the grain silos); however, the flooring has only survived in the room occupying the westernmost two bays above the workshop, which appears to have been used for storage (Plate 41).
