Archaeological Evaluation

Sea Road Woolston Southampton

NGR SU 43750 11240 SOU 1417

BA0536SWS February 2007

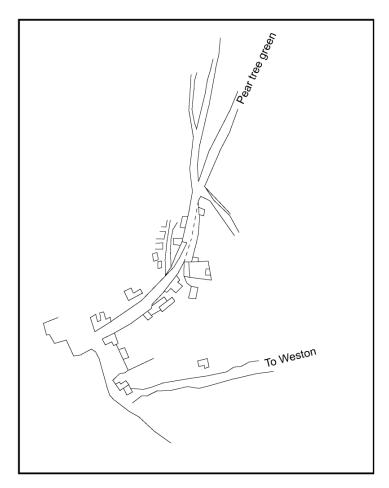
Fig. 2: Extract from 1814 Enclosure Map of the Parish of St Mary Extra, Southampton

Sea Road appears to have marked the boundary of a pre-Conquest estate at South Stoneham, which is described in two charters dating from *c*.978-1016 and 1045, respectively. The line of the road is marked on historic maps of the area dating back to the early 17th century and an enclosure map of 1814 shows a number of buildings on the site immediately S of Sea Road predating the rapid development of the area in the midlate 19th century (**Fig. 2**).

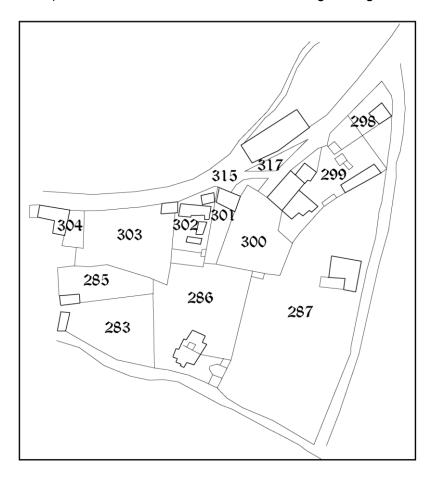
Fig. 3: Extract from 1852 Tithe Map of the Parish of St Mary Extra, Southampton

Cartographic evidence, specifically the 1852 tithe map for the parish of St Mary Extra, Southampton, indicates that the site lay within a large, triangular plot of land immediately to the S of Sea Road, subdivided into several smaller enclosures (**Fig. 3**). A large complex of buildings, consisting of an L-shaped structure with a long rectangular range immediately to the NE (marked as No. 299 on the tithe map) is described as a 'Dwelling House, Brewery & Offices' which was owned and occupied by a Mr John H. Bell. Bell occupied the brewery premises at Sea Road until as late as 1871 and by 1881 it was referred to as the Red Lion public house. To the SW of the brewery, the tithe map shows a series of buildings extending SW along the Sea Road street frontage comprising Plot Nos. 300 and 301, listed as 'a house, garden and offices' (recorded as Prospect House in the 1871 census), and Plot No. 302, described as a 'cottage and gardens'.

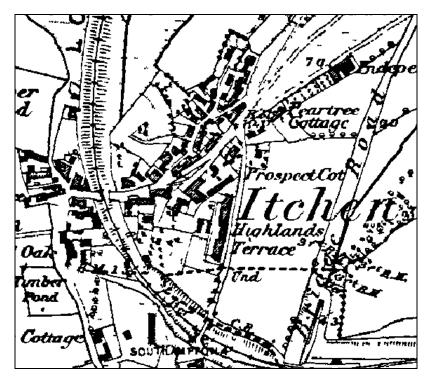
Fig. 4: Extract from OS 1st edition 6-inch map of 1871 showing Sea Road Woolston

The OS 1st edition 6-inch map of 1871 (**Fig. 4**) reveals that the area had undergone major changes since 1852, doubtless associated with the construction of the railway in the early 1860s which bisected the western half of the original triangular plot. The complex of buildings in the NE corner of the plot, denoted as 'a dwelling house, brewery and offices' in the 1852 tithe map, is shown as essentially intact and unaltered.

However, there had been a significant expansion of building activity to the SW of the brewery. The house and offices occupying Plot Nos. 300 and 301 and the cottage occupying Plot No. 302 on the 1852 tithe map appear to have been substantially rebuilt by 1871 and further to the SW along Sea Road, a row of terraced houses had been built adjacent to the railway line.

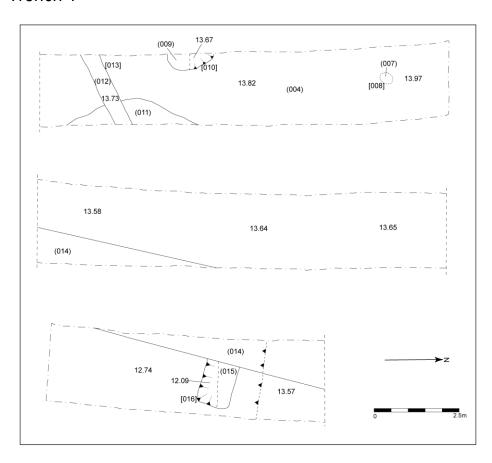
Fig. 5: Plan of Trench 1 showing location of features

Trench 1 (**Figs. 5 & 6**) was located on the western side of the site and ran approximately 32m N-S parallel to the railway line. The trench revealed 17 contexts, the uppermost of which (001) was a loose dark brown humic deposit containing building rubble and modern rubbish, with frequent modern CBM, ceramics, glass, metalwork, plastic and wood fragments, extending trench wide to a maximum depth of 0.4m.

Underlying (001) was a friable dark brown humic topsoil deposit (002), with moderate sand and gravels and incorporating frequent modern debris. This deposit extended trench-wide with an average thickness of 0.25m and overlay (003), a friable mid brown gravelly loam subsoil with frequent modern ceramic sherds, CBM fragments and metal objects. This deposit measured 0.2-0.3m in thickness.

Partially overlying (003) at the northern end of the trench was (006), a loose brick rubble deposit measuring 0.2m in thickness, which apparently represented a slightly earlier phase of demolition than (001).

Cutting (003) were a series of modern features and deposits. At the northern end of the trench, (003) was cut by [008], an irregular sub-circular cut measuring 0.4m N-S \times 0.35m E-W \times 0.24m. [008] was filled by a soft dark brown humic loam with very frequent gravel and frequent root disturbance (007). The nature of this deposit seems consistent with the fill of a tree bole.

Along the western edge of the trench, (003) was cut by a slightly irregular sub-circular cut [010] measuring 1.35m N-S x >0.5m x 0.15m. This cut exhibited a sharp break of slope at the top, concave sides and a rounded slightly concave base. Filling [010] was (009) a loose dark brown gravelly humic loam with frequent brick fragments, plastic, glass and linoleum fragments.

Bisecting the trench on an ENE-WSW alignment and cutting (003) was a rectilinear cut [013] measuring >2m ENE-WSW x 0.52m N-S x 0.66m. This comprised a sharp break of slope at the top, slightly concave sides and a regular flattish base. Filling [013] was a cohesive pale greyish-yellow clayey sand with no inclusions (012). This deposit formed the backfill of a modern trench of unknown function, which is likely to have been associated with $19^{th}/20^{th}$ century activity.

Cutting (003) at the southern end of the trench was a rectangular cut with a sharp break of slope at the top, steep slightly concave sides and a flattish base [016]. This cut measured 1.2m E-W x 0.92m N-S x 0.65m and was filled by (015), a soft dark brown / mid yellowish-brown, humic loam / sandy loam with frequent modern CBM, slate and mortar fragments. Cut [016] seemed to be associated or contemporary with structure (014).

Located along the eastern edge of the trench underlying (003) and overlying (004) was a small irregular spread of material (011) consisting of loose dark greyish-brown gravelly loam of varying thickness. This deposit seemed to comprise a mixture of material from (002) and (003) and probably indicated a natural hollow or undulation, especially as no finds were identified.

Underlying (003) were natural deposits (004) and (005). Deposit (004) consisted of a cohesive sandy gravel underlying which, at the southern end of the trench, was (005), a homogenous yellow sand.

A series of modern features were found throughout Trench 1; the finds associated with these features were of 20th century date, consisting of glass, CBM and fragments of linoleum and plastic. Also revealed were a modern service trench [013], a post-medieval pit [016] and a substantial modern concrete footing (014).

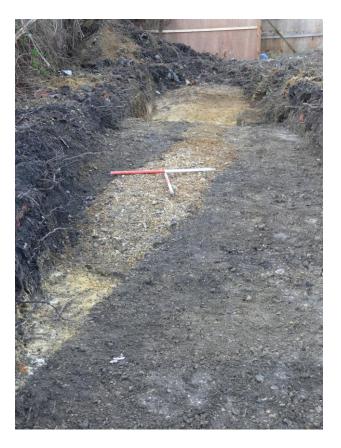
Plate 1: Structure (014) looking S

Bisecting the trench on an NNE-SSW alignment and cutting (003) was a linear concrete footing/foundation measuring >12.5m NNE-SSW x 1m E-W (014) (**Plate 1; Figs. 5 & 6**). This footing was partially overlaid by a compact mid reddish-brown sandy gravel (017). The exact nature and extent of this footing were undefined due to the limits of the evaluation but a post-1850s date seems likely.

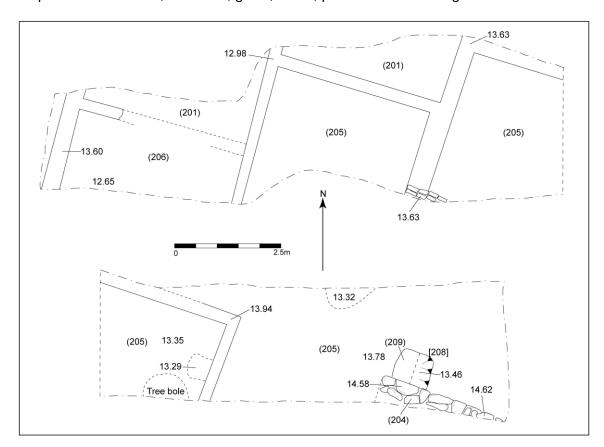
Fig 7: Plan of Trench 2a showing location of features

Trench 2a (**Figs. 7 & 8**) was located immediately W of the site entrance and ran E-W parallel to Sea Road. The trench measured 22m × 2.5m and revealed nine contexts.

The uppermost deposit was a loose dark brown humus, rubble and modern rubbish deposit (201), extending trench-wide to a maximum depth of 0.45m and containing frequent modern CBM, ceramics, glass, metal, plastic and wood fragments.

sherds (202). This deposit was 0.2-0.3m thick and extended 8.5m from E to W. Underlying upper deposits (201) and (202) was (207) a loose mixed brick rubble deposit with frequent CBM fragments and concrete and occasional Fe objects and late 19th/20th century ceramic sherds. This deposit extended trench-wide with a variable thickness up to a maximum of 1.3m.

At the E end of the trench, underlying (207), the partial remains of an E-W stone wall (204) were identified, measuring >2.8m EW \times 0.5m NS \times 0.25m and consisting of roughly dressed limestone blocks (**Plate 2**; **Fig. 8**). The average size of the blocks used was 370mm x 300mm x 250mm with an average joint width of 40mm.

Appearing on the same stratigraphic level as (204) was a series of 19th century building remains (203) consisting of concrete and brick foundations relating to a number of buildings along the frontage of Sea Road. Also appearing at this level was a rectangular cut measuring 0.8m NS x 0.85m EW x 0.22m [208], which was filled by a friable mid greyish-brown silty sand with moderate small rounded pebbles and occasional charcoal flecking (209).

Natural deposits were encountered underlying 19th century structures (203) and (204) and these consisted of two distinct deposits, (205) and (206). (205) was a loose yellowish-brown sandy gravel overlying yellow sand (206).

Trench 2a contained a series of brick walls of 19th century date (203) aligned along the street frontage and the remnant of a stone wall consisting of two masonry courses (204), again aligned parallel with the road. These walls may be associated with a rectangular building marked as a cottage on the 1852 tithe map and which appears to have been partially rebuilt before 1871. Associated with these structures were a number of utility pipes. Also identified was a single pit of unknown age and function [208].

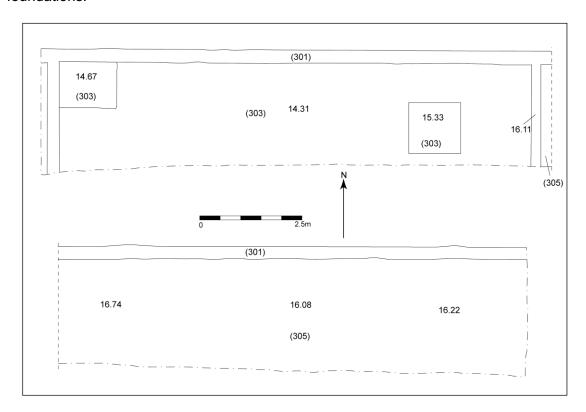
Fig 9: Post-excavation plan of Trench 2b

The trench (**Fig. 9**) revealed five contexts, the uppermost of which consisted of a loose dark brown humus, rubble and modern rubbish deposit (301) extending trench-wide to a maximum depth of 0.45m and containing frequent modern CBM, ceramics, glass, metalwork, steelwork, plastic and wood fragments.

Underlying this rubble overburden were the structural remains of a substantial 19th century building (302) (**Plate 3; Fig. 9**) and cellarage (303) (**Plate 4; Fig. 9**). Remains associated with (302) were located at the eastern end of the trench and included a

series of tiered floors (some with intact black and red tiling), two hearths and a series of wall foundations. These consisted of unfrogged brick constructed on concrete foundations.

The cellarage (303) was located immediately W of (302) and measured 11.5m E-W x > 3m N-S x > 2m, comprising the entire western end of the trench. The construction was entirely of unfrogged brick with an off-centre pier at the eastern end and a small partitioned area in the NW corner. Filling (303) was a loose brick rubble deposit (304).

Underlying structural remains (302) at the eastern end of the trench were natural deposits (305), consisting of friable yellowish-brown sandy gravel.

Trench 2b revealed evidence of substantial 19th century brick cellarage and a geometric red and black patterned tiled floor, presumably representing the remains of the Red Lion public house which occupied the premises of a former brewery marked on the tithe map of 1852.
