# Archaeological Observation

**Stableton House  
Kingsland  
Herefordshire**

NGR: SO 44965 61310  
SMR No. 48123

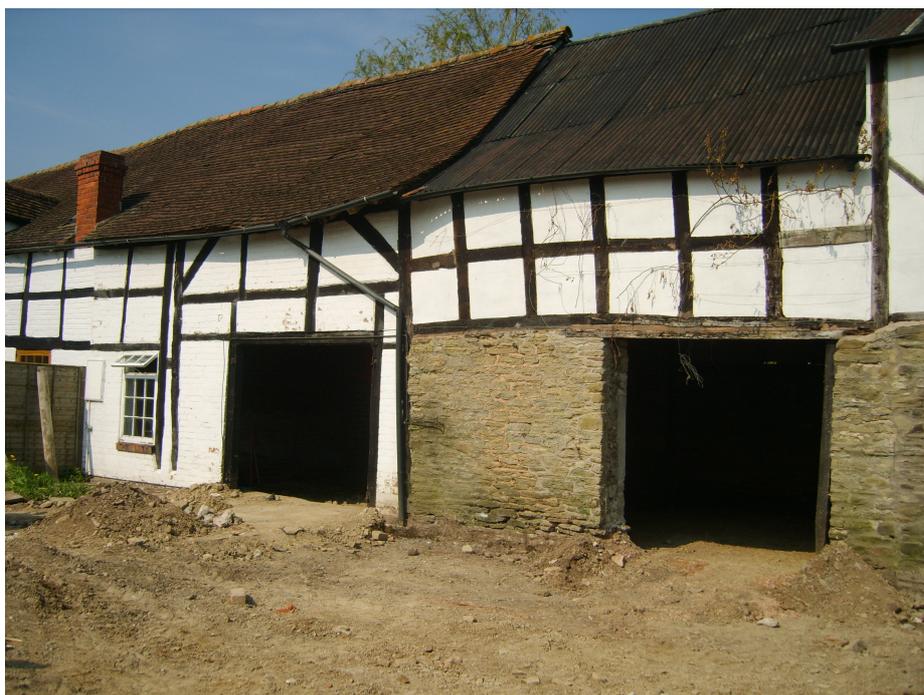
Plate 1: View looking SW of outbuilding range showing timber-framed upper storey with wagon entrances at ground floor level

The earliest fabric is represented by the middle bay of the barn (**Plate 1**), the lower storey being of regularly coursed rubble stone construction while the upper storey is timber-framed with plaster infilling. This appears to have been the southernmost bay of the original barn, indicated by the well-preserved box framing (**Plate 2**), which probably represents the original gable end. To the S of this gable end a further five bays were

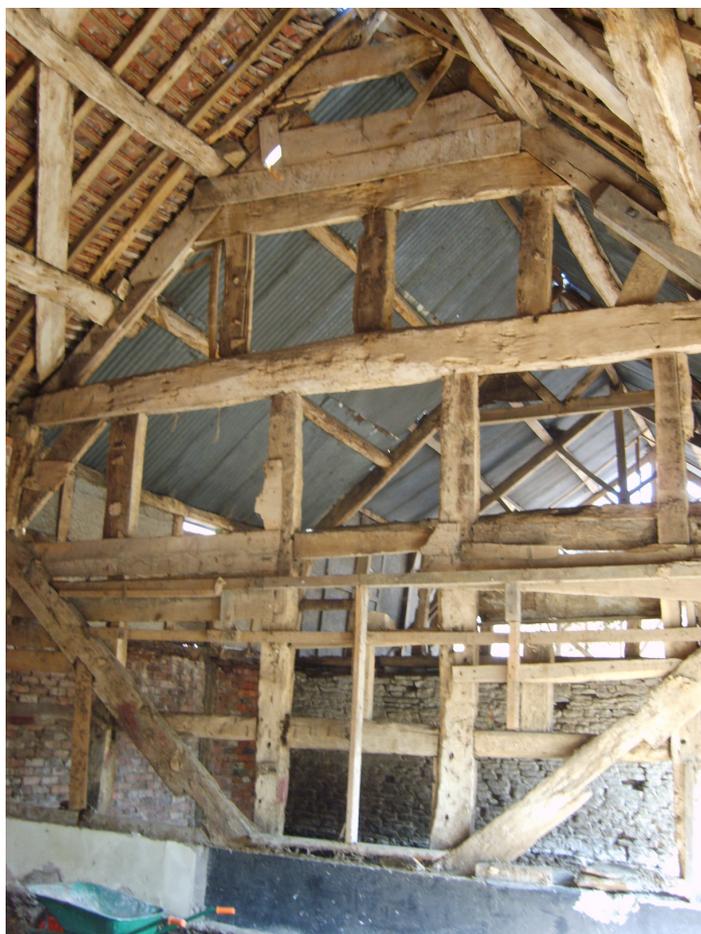
View looking N showing box framing of 18<sup>th</sup> century date, probably representing original gable end of outbuilding range

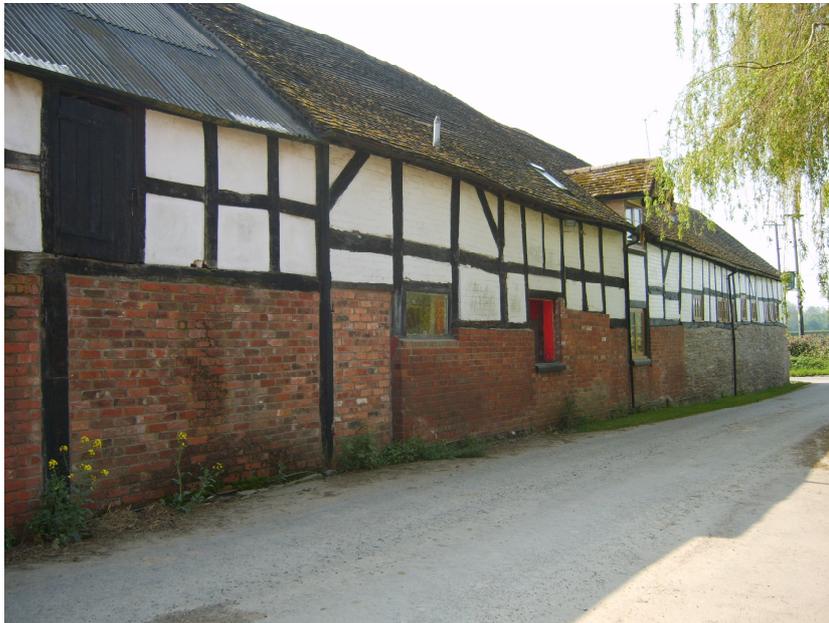
added, probably in the 19<sup>th</sup> century, the lower storey being of brick construction while the upper storey is timber-framed with brick infilling. The NW-facing elevation of the building was also extensively rebuilt in brick (**Plate 3**).

Plate 3: View looking SE showing NW-facing elevation of outbuilding range with evidence of extensive rebuilding in brick and insertion of modern windows

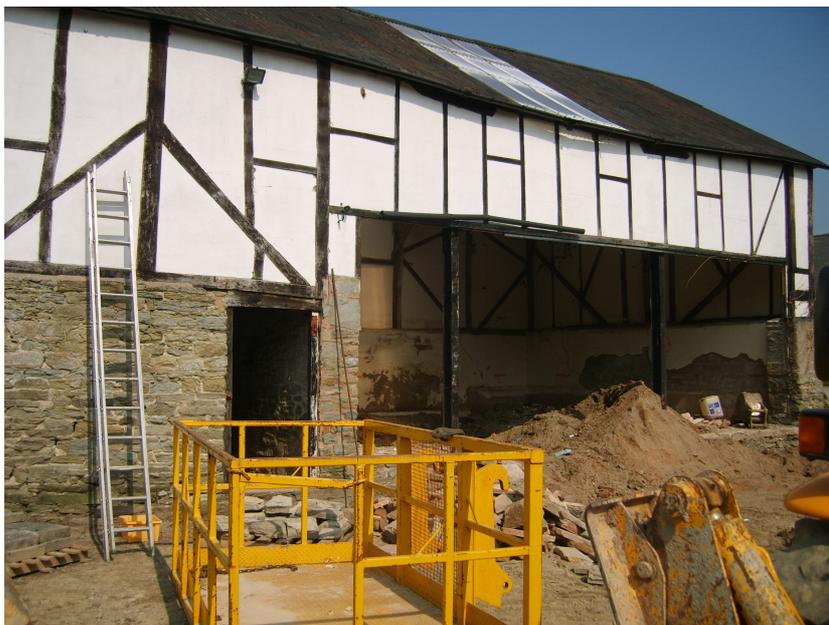
The latest phase of activity is represented by the extensive rebuilding of the northernmost two bays in the late 20<sup>th</sup> century to accommodate a swimming pool, the SE-facing elevation being largely rebuilt and heightened and the original tiled roof replaced with corrugated iron sheeting (**Plate 4**).

Plate 4: View looking NW showing SE-facing elevation of outbuilding range with modern alterations

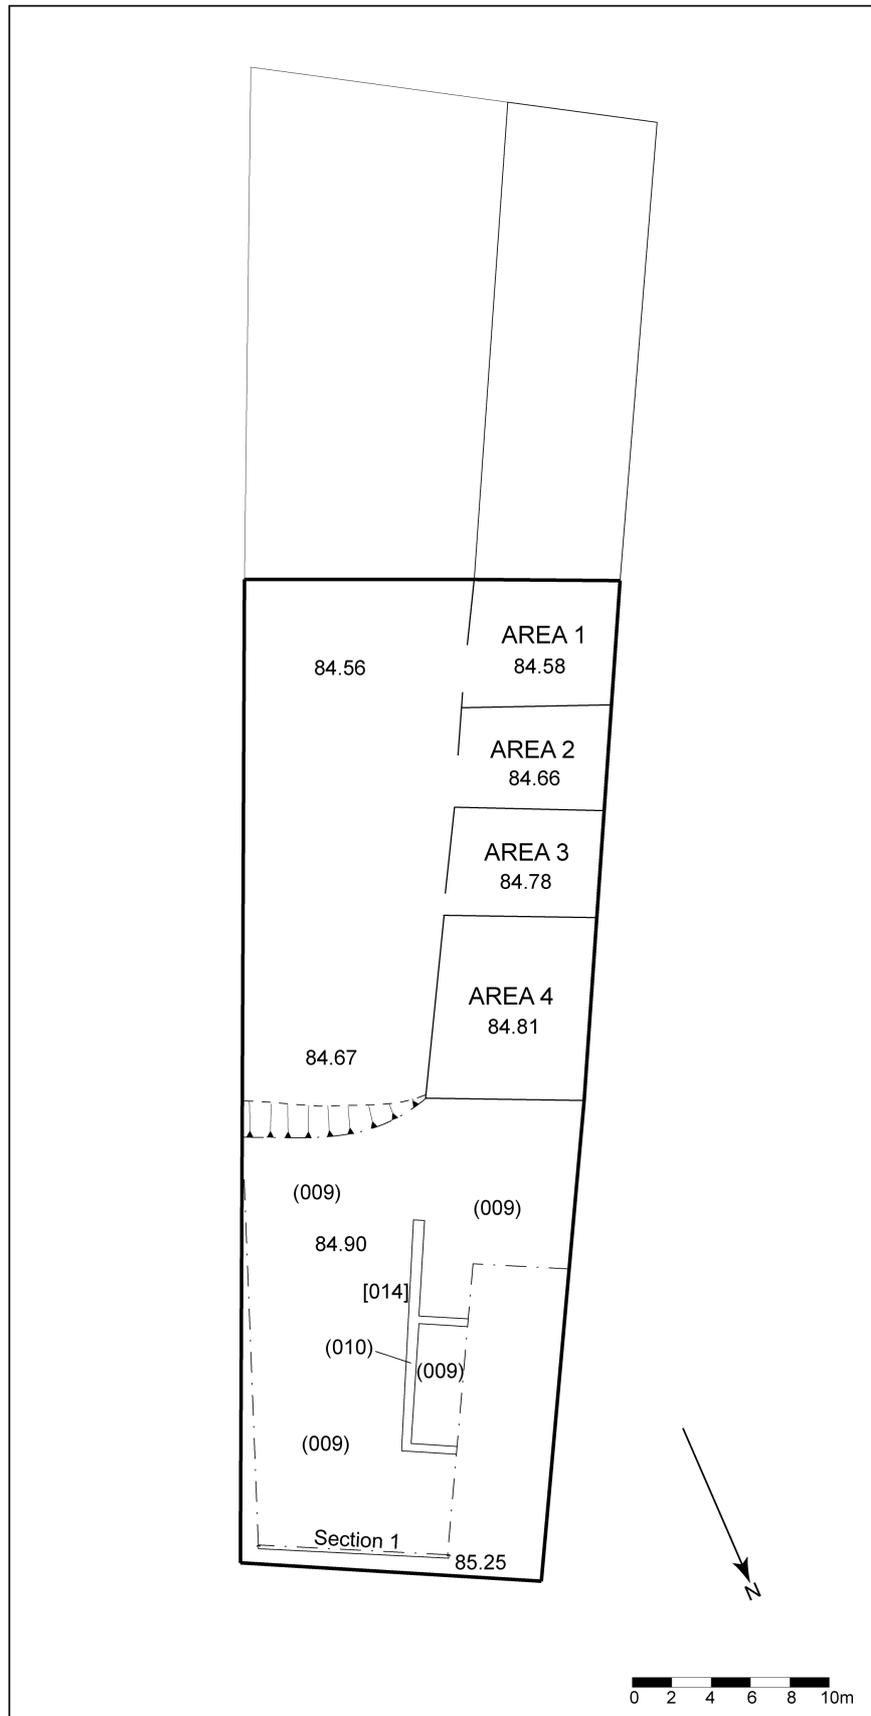
Fig. 2 Plan showing features revealed during observation of groundworks at Stableton House

The visible structural remains consisted of a brick wall (a single course in depth and two courses wide) aligned NE-SW measuring 11.8m x 0.42m x 0.07m, with a return at the NE end, extending NW-SE for a distance of 2.80m (**Plate 8; Fig. 2**). Evidence of another return was identified some 6.20m SW of the NE end of the wall, which also extended NW-SE for 2.80m; these walls appeared to frame three sides of a rectangular compartment with another smaller compartment partitioned off to the SW.

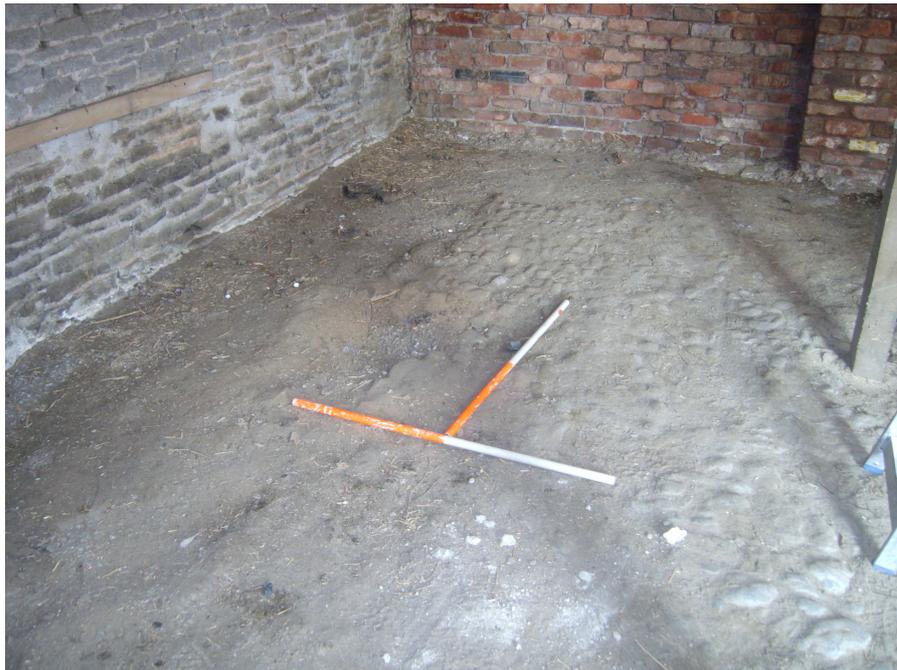
Plate 5: View looking W showing cobbled floor surface in SW corner of Area 3

Within Area 3, the bay immediately N of Area 2, the partially intact remains of a cobbled surface were identified (004), comprising irregularly laid, rounded cobbles within a hard light greyish-brown silt (**Plate 5**). The cobbled surface, which was clearly heavily worn, covered an area measuring 7.50m × 5.50m × 0.14m within the central and western parts of Area 3; part of the surface appeared to have been removed within the eastern half of the compartment. Underlying (004) was (009), a well compacted yellowish-brown silty clay, identical to that encountered in Area 2, measuring 0.30m in thickness.

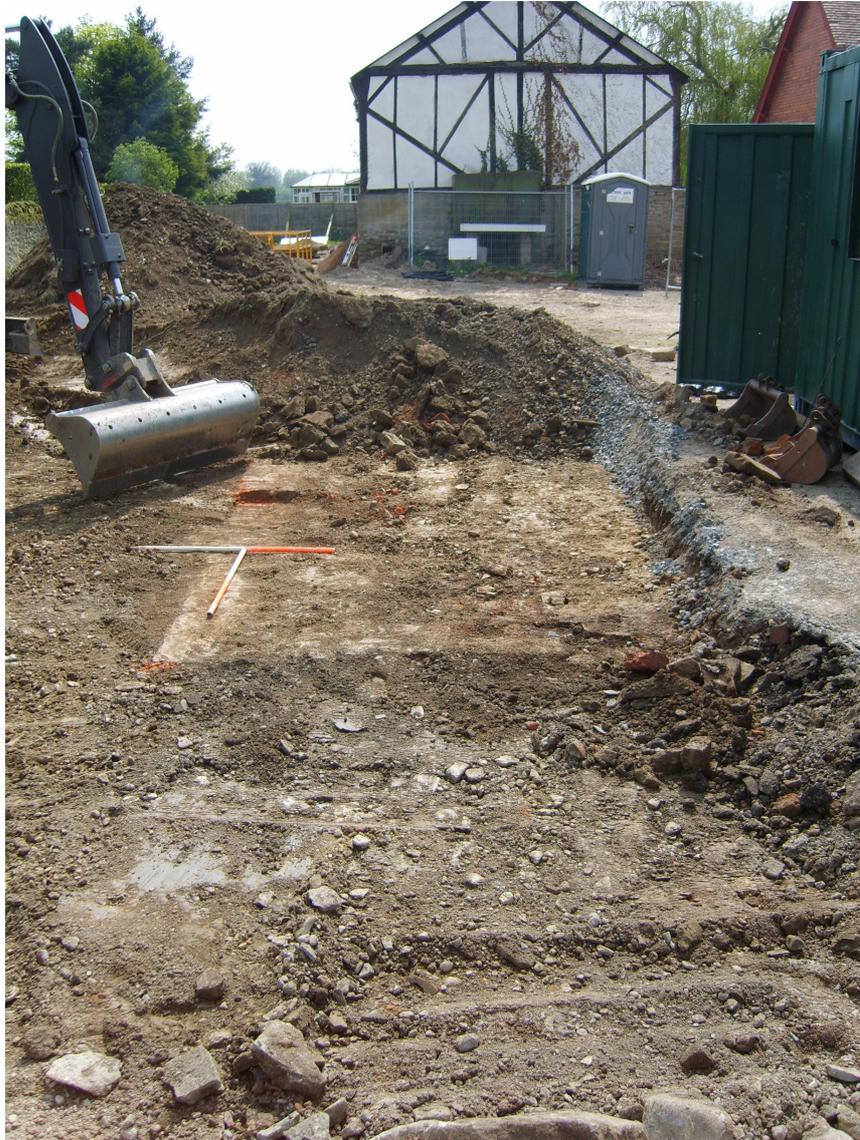
Plate 6: View looking S showing strip-back area to N of outbuilding range, with footings of demolished 19<sup>th</sup> century brick structure in foreground

This phase of the groundworks involved the reduction of ground levels to a depth of 0.60m below existing ground level within an L-shaped area (formerly used as a farmyard) immediately to the N and E of the existing outbuilding range, measuring approximately 54m (N-S) × 12m (E-W) (**Plate 6**).

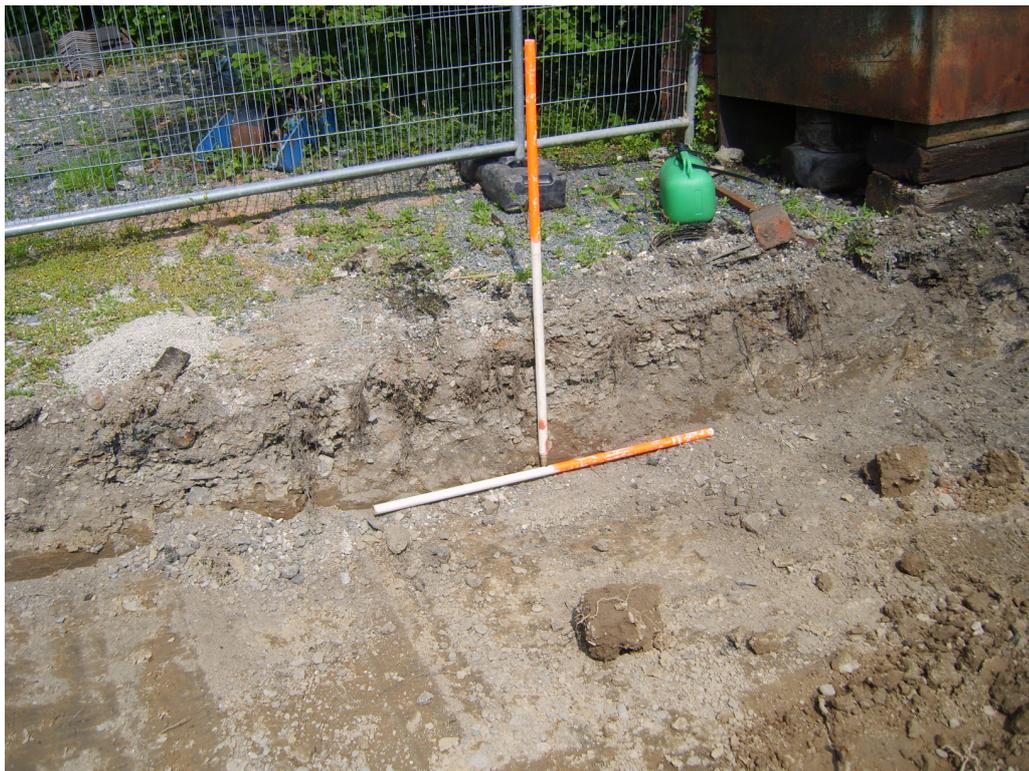
Plate 7: View N showing deposits revealed in section in NE corner of site following topsoil strip

Underlying (013) was topsoil deposit (011), a moderately compacted mid greyish-brown silty sand with occasional rounded and subangular stones, with moderate CBM and occasional pottery fragments, uniformly of late post-medieval (19<sup>th</sup> century) date, covering an area measuring 54m (N-S) × 5.5m (E-W) and gradually petering out towards the western edge of the site (**Plate 7; Fig. 3**).

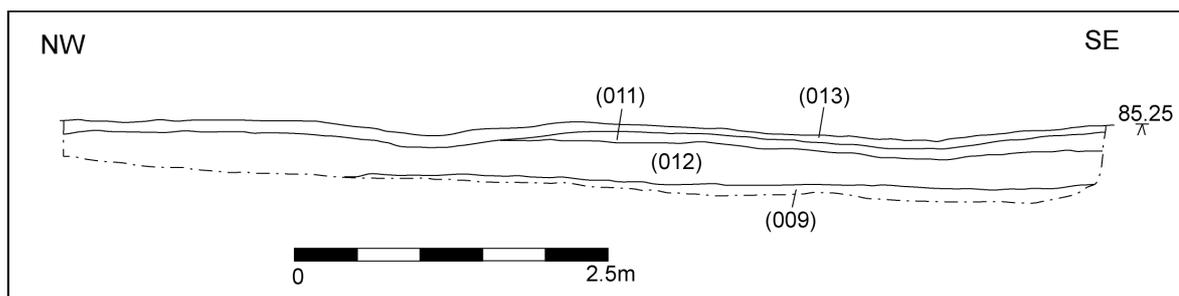
Fig. 3: SW-facing section showing deposits revealed during topsoil strip phase

(011) in turn overlaid (012), a moderate to well compacted mid brown silty sand with frequent pebbles and subangular stones with moderate CBM and occasional wood fragments and metal nails, which extended over an area measuring 54m (N-S) × 12m (E-W) to a depth of 0.22m and was interpreted as a heavily disturbed subsoil deposit. Underlying subsoil deposit (012) was (009), which covered an area measuring 8.5m × 7.5m × 0.10m and was interpreted as natural deposition.

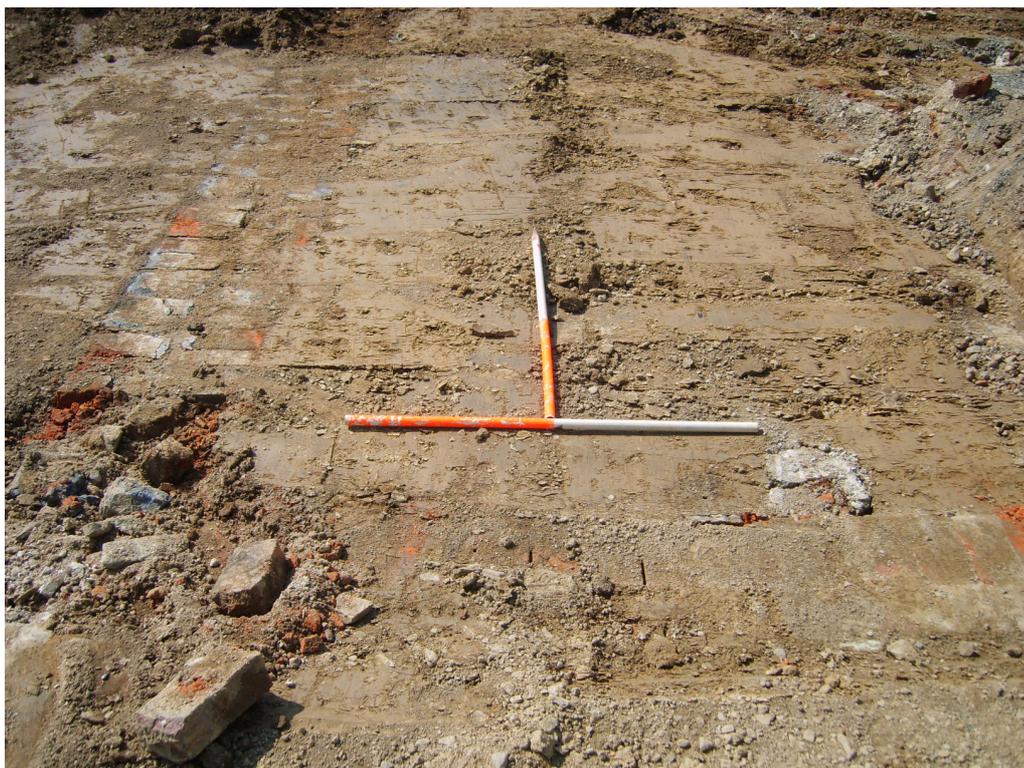
Plate 8: View S showing brick wall foundations of recently demolished rectangular structure situated to N of existing outbuilding range

The structure appeared to have been recently demolished and may be identified with a small freestanding building first shown on the Bateman estate plan of 1870, situated just to the NE of the existing outbuilding range. This building is also shown on the OS 1<sup>st</sup> edition 25 inch map of 1885; however, by that date a substantial L-shaped barn range had been constructed immediately to the NW of it, forming three sides of a large farmyard enclosure.
