Archaeological Observation

**St Leonard's Church
Yarpole
Herefordshire**

**NGR: SO 46952 64828
SMR No 4925**

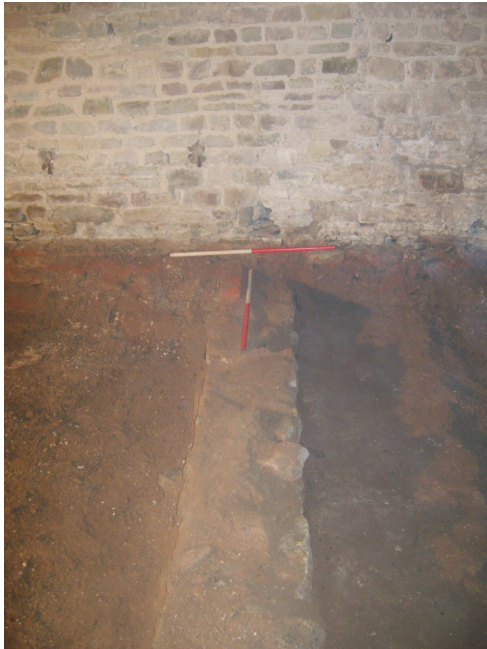
- 5.1 Two areas were excavated within the interior of the church during Phase 1 of the archaeological observation.
- 5.2 Area 1 situated at the W end of the nave extended approximately 6.5m N-S × 5.5m E-W and was excavated to a depth of approximately 0.6m. Six contexts were identified, the uppermost of which was a reddish-orange building sand extending >6.5m × >5.5m to a depth of 0.06m (1001). This overlay a reddish-brown silty sand deposit (1002) also extending >6.5m × 5.5m, to an average depth of 0.06m. Beneath this deposit, the area was divided by a dwarf support wall (1007) (**Figs. 2 & 3; Plates 1 & 2**) orientated E-W and measuring >5.6m × 0.5m × 0.4m. This was abutted on either side by levelling deposits (1004) and (1008), which appeared to be contemporary and comprised compact greyish-brown silt with an average depth of 0.38m. These deposits contained frequent stone, rubble, lime mortar and disarticulated human skeletal remains. Underlying these deposits was what appeared to be natural subsoil (1003). It was unclear without further excavation whether wall (1007) directly overlay this subsoil or cut into it.

Plate 1: View W of Area 1 showing wall (1007)

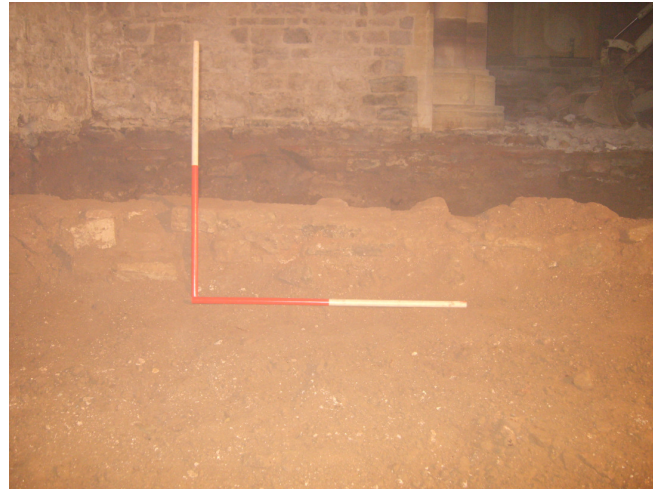
Plate 2: View N of Area 1 showing elevation of wall (1007)

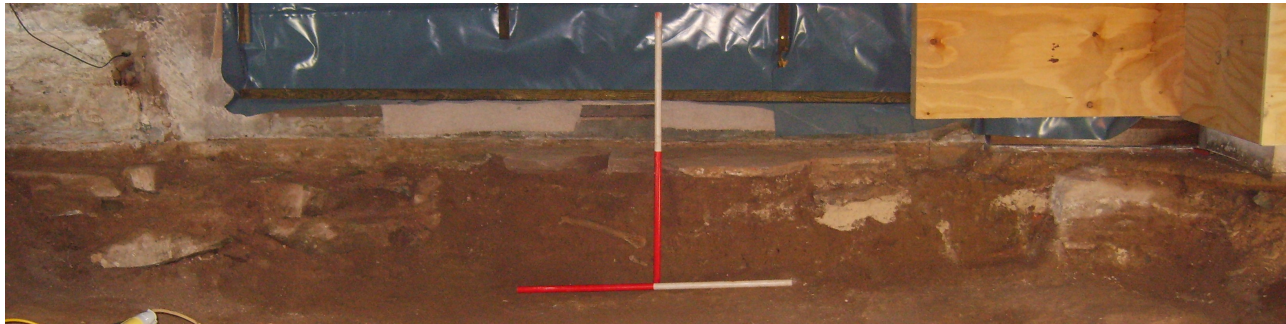
- 5.4 Beneath this current floor level (comprising of the flagstone and tiled flooring) were rubble foundation deposits (2007, 2008) (**Figs. 2 & 4; Plate 3**), supporting the chancel arch piers. The area between the two foundation deposits held a heavily disturbed mid brown clay silt deposit containing some disarticulated and partially articulated human skeletal remains, suggesting earlier burials had been disturbed during later activity (2005) (**Figs. 2 & 4; Plates 4 & 5**) presumably associated with the Victorian rebuilding of the chancel in 1863-4. The construction cuts for both rubble foundation deposits ([2009], [2010]) appeared to cut natural subsoil.

Plate 4: View E of Phase 1 Area 2 section showing disturbed deposit (2005)

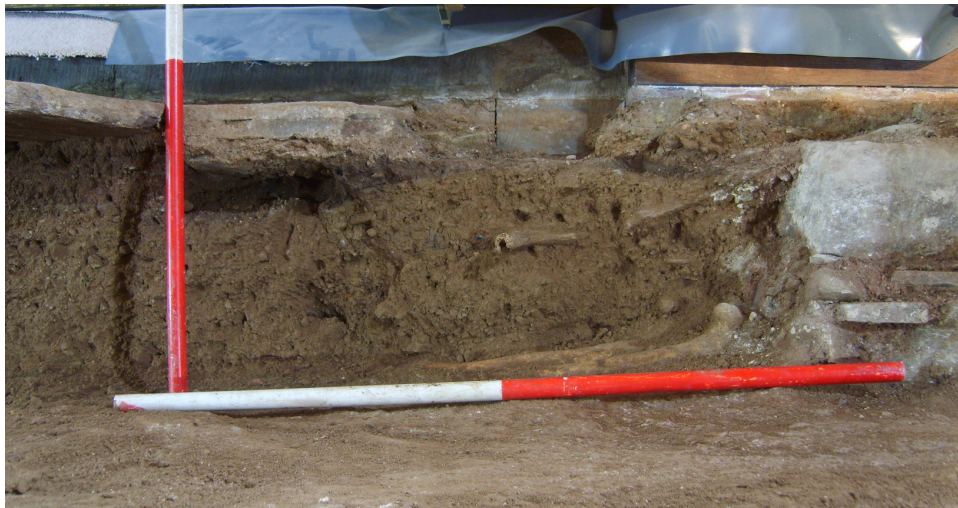
Plate 5: View E of Phase 1 Area 2 section showing partially articulated remains within (2005)

- 6.3 Deposit (2005) also contained human bone, including the partial remains of two or more individuals (mainly comprising leg bones). Some of the bones removed from beneath the centre of the section appeared to be articulated, suggesting they were early burials disturbed by later activity, probably associated with the rebuilding of the chancel in 1863-4.

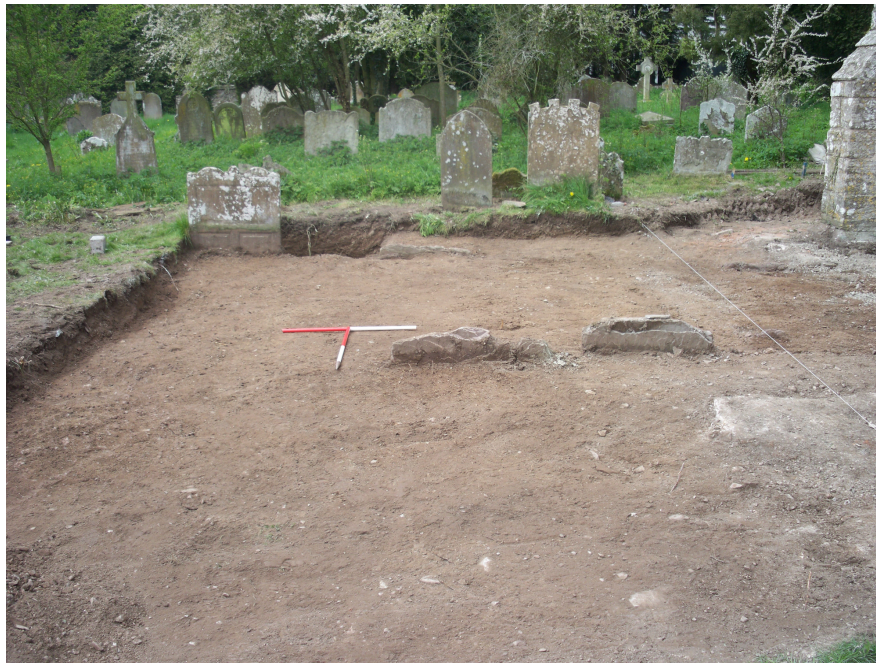
- 5.6 Six contexts were identified in this area, the uppermost of which was a friable mid greyish-brown sandy silt topsoil deposit extending across the whole area (8m × 7.5m) to an average depth of 0.24m (001). This overlay a mid yellowish-brown sandy silt (002) also extending across the entire area (8m × 7.5m) to an average depth of 0.3m (as revealed). This deposit contained a large amount of disarticulated human remains and a moderate amount of nails (presumably coffin nails), along with eight repositioned headstones. These were neither *in situ* nor related to any identified grave cut; most were damaged and incomplete. This deposit was heavily disturbed and appeared to relate to Victorian landscaping activity associated with the restoration of the church.

Plate 6: View W of Phase 2 ground reduction, showing deposit (002)

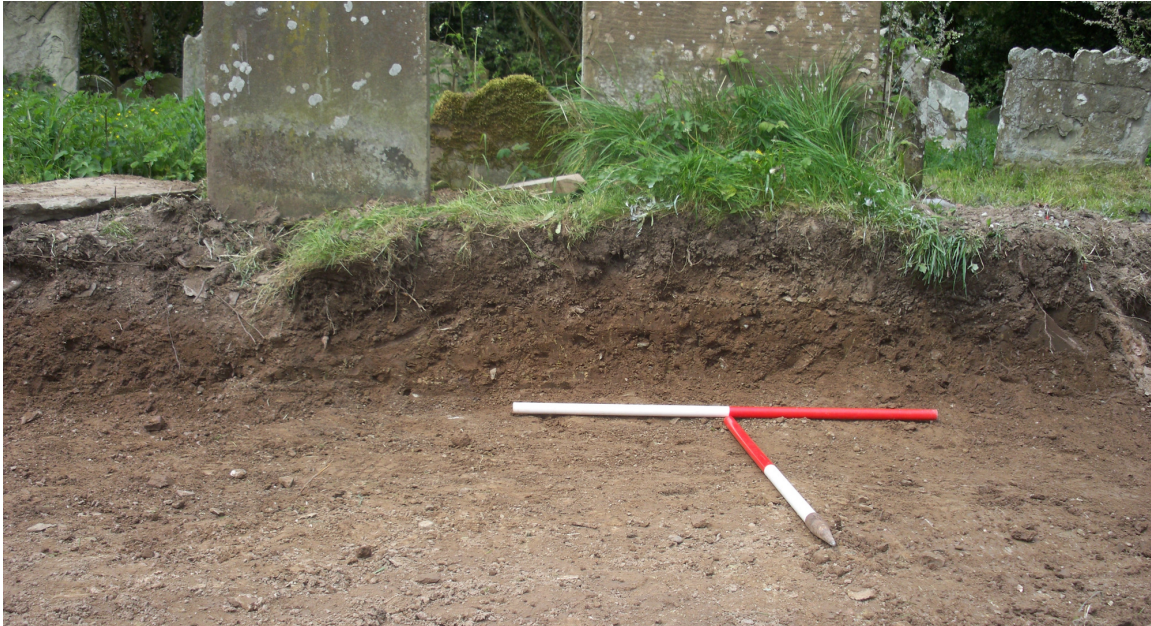
Plate 7: View W showing E-facing section of Phase 2 reduced area
