# Archaeological Observation (Watching Brief)

Phases 1 & 2  
New Manufacturing Facility  
Rolls-Royce  
Filton  
Bristol

NGR: ST 606 807

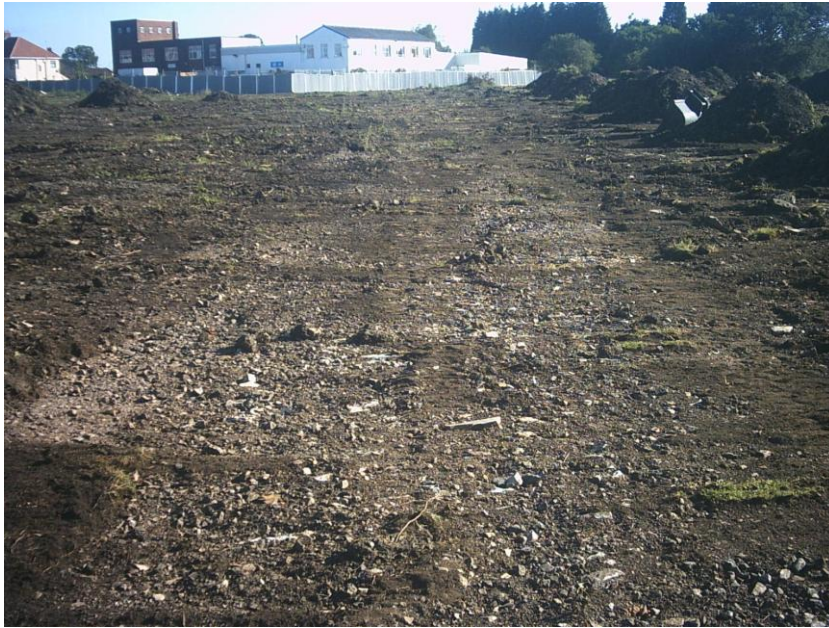
Plate 2: View N showing route of trackway, with former processing plant visible at top of photograph (003)

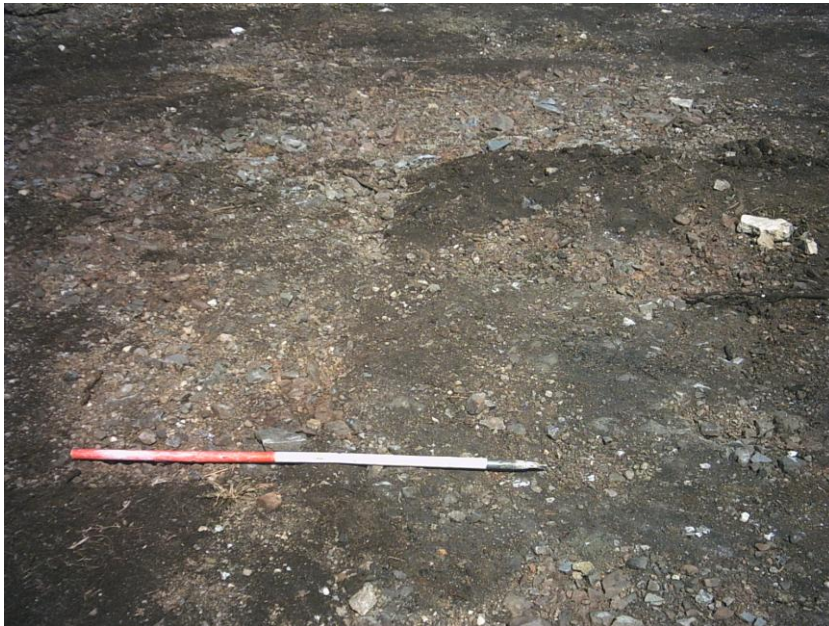
Plate 3: View N showing detail of track surface (003)

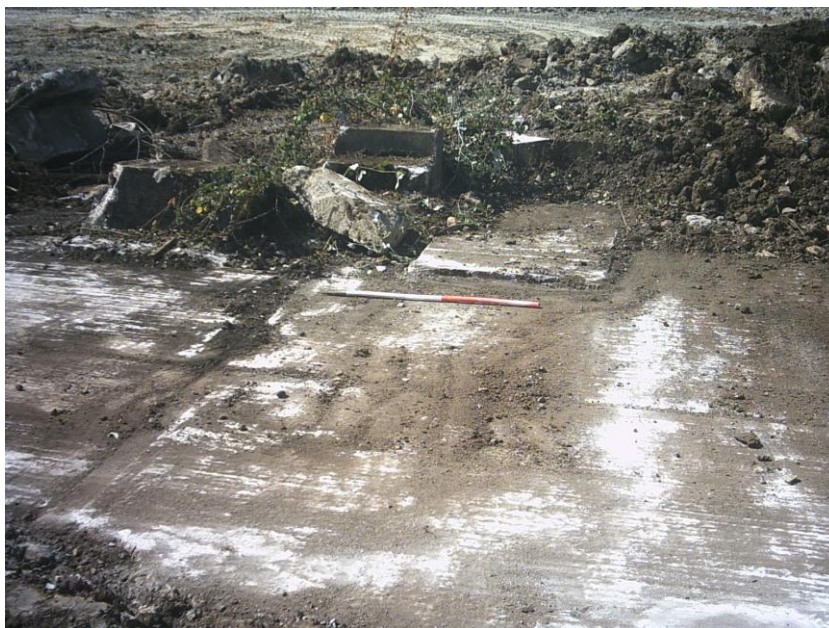
Plate 4: View W showing concrete surface (040)

Removal of the concrete surface (040) in the NE corner of the site, which was located during the topsoil strip, revealed that it was up to 0.4m thick and that it directly overlay natural soils (010).

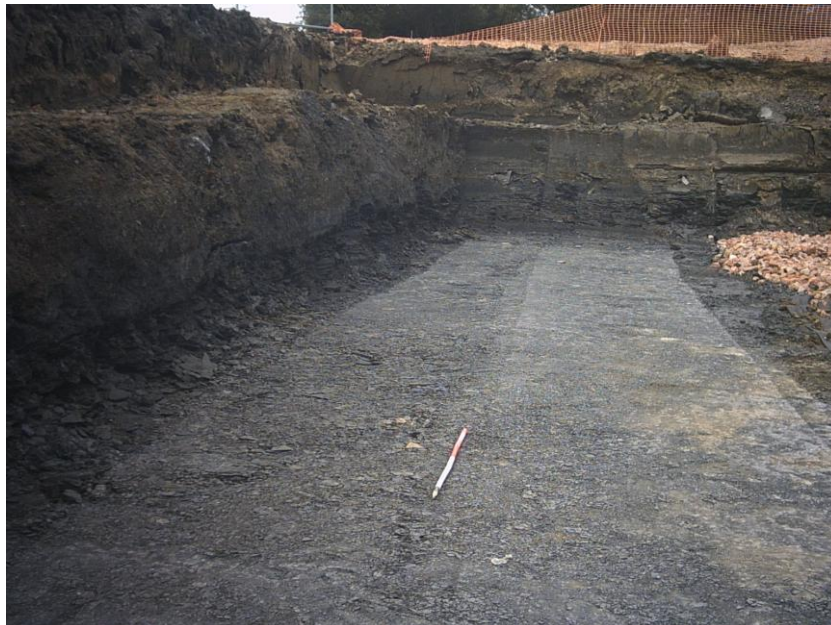
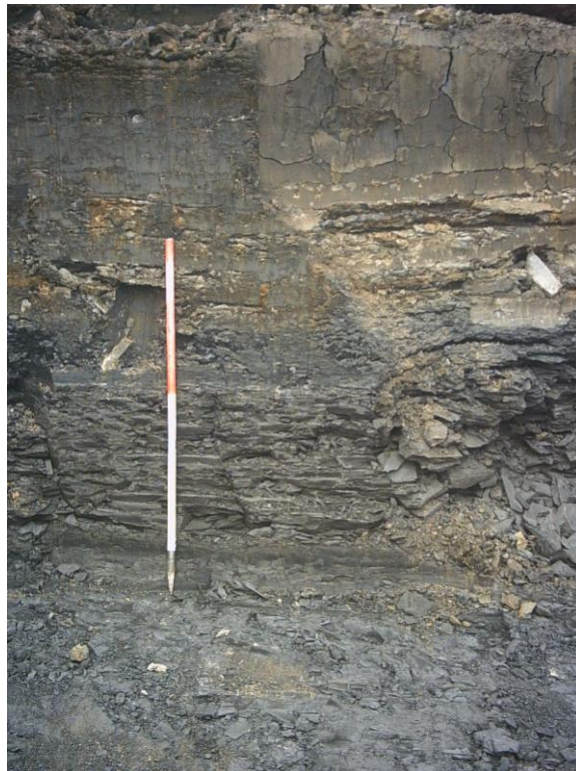
At the extreme NW and SW of the site was a localised seam of slate, (009) & (011). This occurred at around 1m below existing ground level at the NW and, due to sloping topography, at 0.6m at the SW, within the 'turning area' (**Plates 5 & 6**).

Plate 5: Extent of slate/shale in NW corner of site, looking N

Plate 6: Slate/shale in NW corner of site, looking W

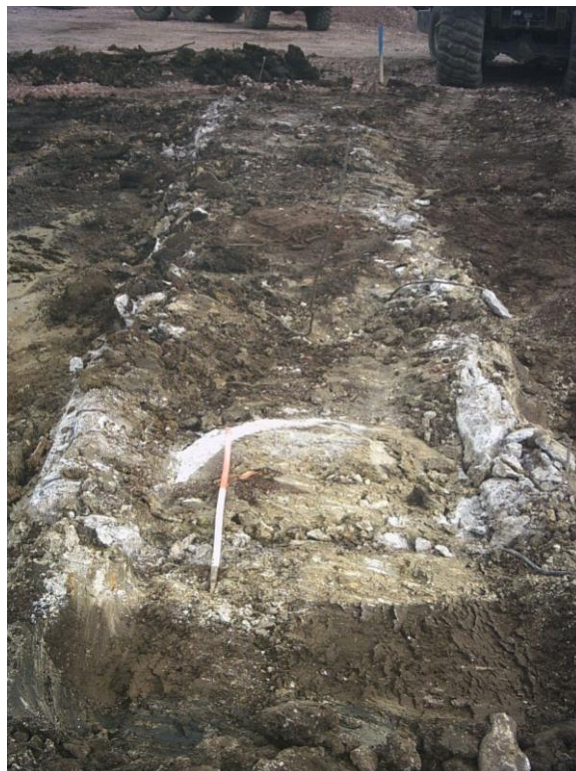
A roughly circular vehicle turning area excavated in the SW corner of the site revealed the remains of a steel reinforced concrete footing (041), probably relating to an earlier site boundary. The feature was orientated approximately NW-SE and was overlain by a post-medieval topsoil (043). The concrete was in a rectilinear cut which cut into natural deposition (010) and (011).

Plate 7: View SE showing steel reinforced base of possible boundary fence in SW 'turning' area

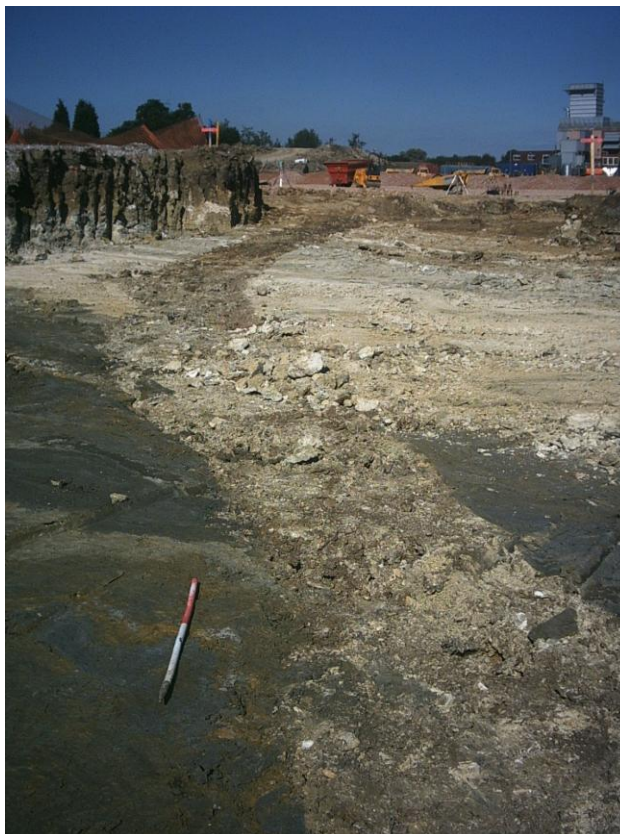
Curving through context (040) was the cut [026] and dark brown sandy clay fill of a utility trench (**Plate 8; Fig. 3**). This extended across the entire southern end of the site.

Plate 8: Utility cut [026] and fill and recurrence of slate/shale geology in SW 'turning' area, facing N

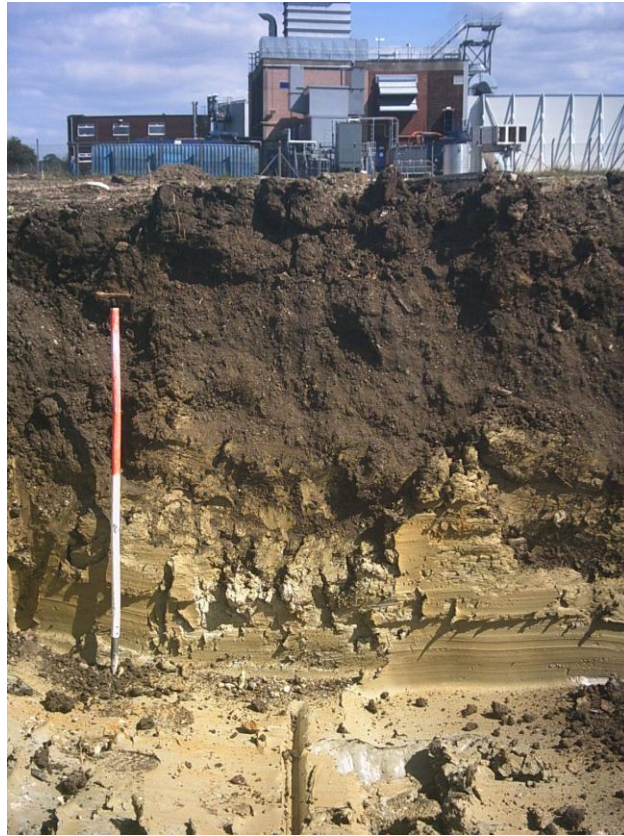
Plate 9: General view of the stratigraphy revealed over the majority of the site, facing E

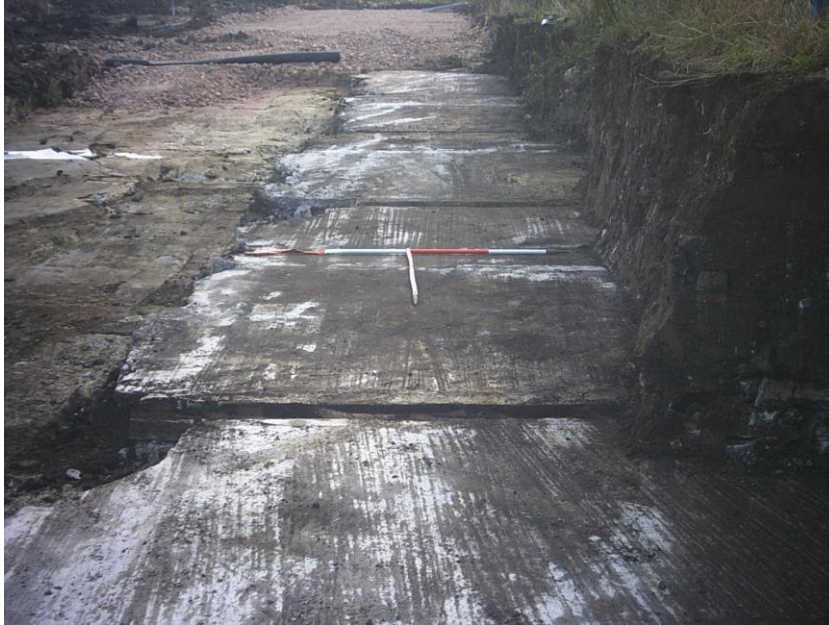
Plate 11: Concrete surface adjacent to central part of N-facing section. To left of picture the concrete has been cut to insert a utility trench. Facing E.

The surface consisted of five inclined concrete sections (**Plate 11**), the central three of which were 4m wide, while the outer two, which reduced in width towards their southern end, were 3.5m wide. Each of these sections was joined by a concrete channel containing a section of ceramic land drain (**Plate 12**). The concrete also rose gently from the channel to the highest point in the centre of each section.

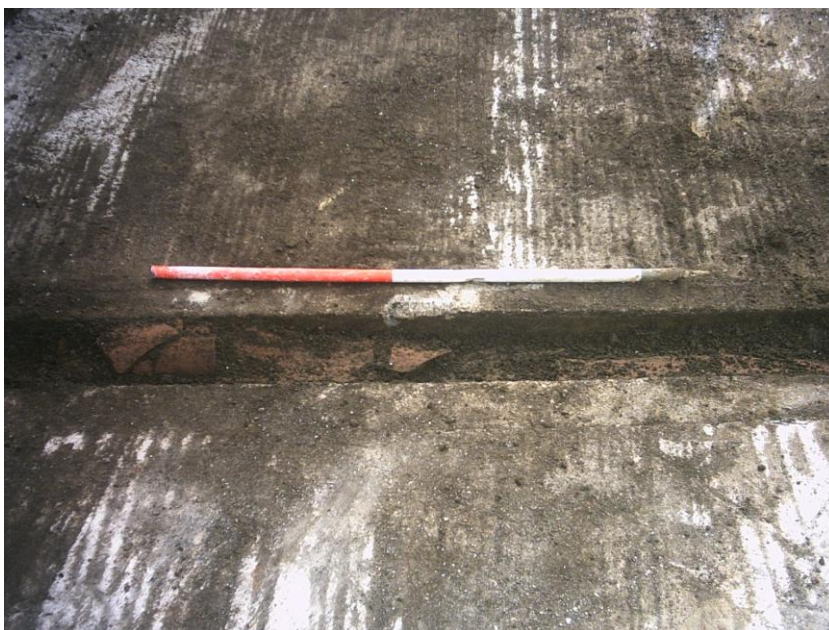
Plate 12: Detail of ceramic drain. Facing W

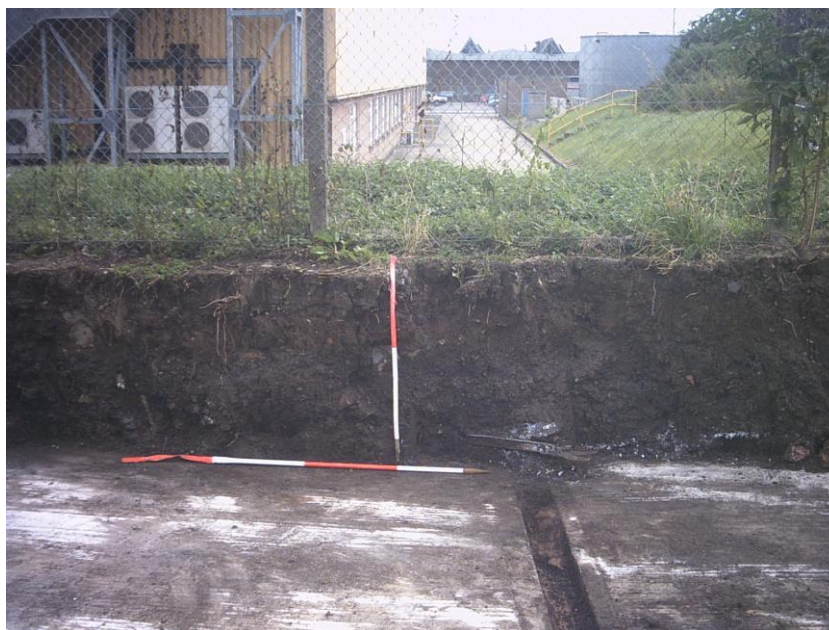
The concrete occurred at approximately 1m below the existing ground level and had been cut [030] into the natural soils (010); it was backfilled over by a series of apparent dumping deposits containing CBM, mollusc remains, concrete and charcoal flecking (031) (**Plate 14**) and which underlay topsoil (001). The concrete extended into the N-facing section of the site and for the majority of its width into what is now an overgrown coppice within the existing site boundary, although aerial photography suggests that it had previously formed part of the field within which the majority of the site lies. It should be noted that the eastern edge of the surface aligned precisely with the edge of the factory in the photograph below and the alignment of the easternmost drain was almost exactly that of a series of inspection covers visible on the road adjacent to this site. The surface continued N (039) within what appeared to be a continuation of cut [130], although, as it was badly truncated by the utility trench, it has been recorded as [128]. A similar fill to (031), consisting of dark brown silty sand with dumping materials (029), overlay this section of the concrete surface.

Plate 13: N-facing section above concrete surface (036)

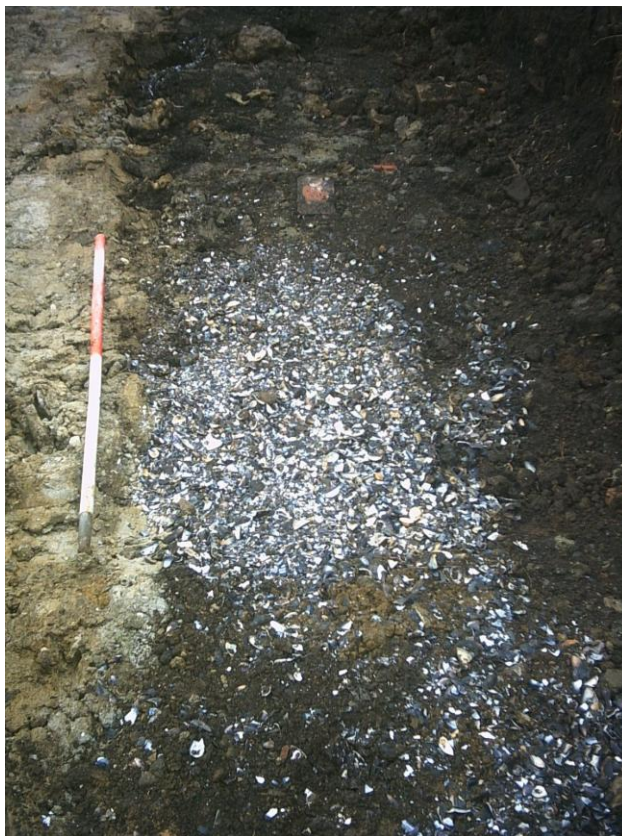
Plate 14: Shellfish deposition within context (031)

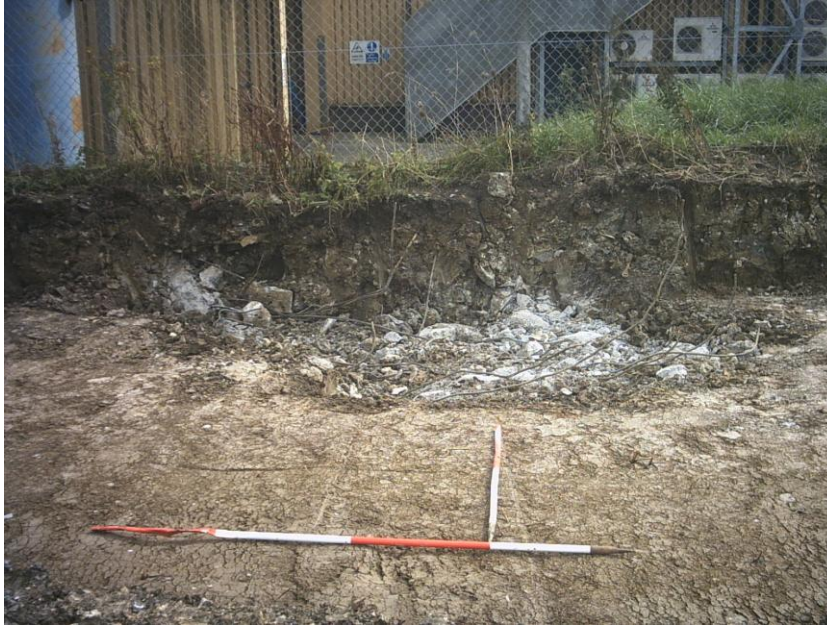
Located 7m E of this concrete surface was the terminus of a steel reinforced concrete fence base (038) similar to context (041) (**Plate 15**). The base appeared to be orientated NW–SE, underlying topsoil (014) and cutting into natural (010). On this orientation, the fence line would run directly through the nearby factory building, suggesting the fence predated the factory.

Plate 15: Concrete fence base (038). Facing S.

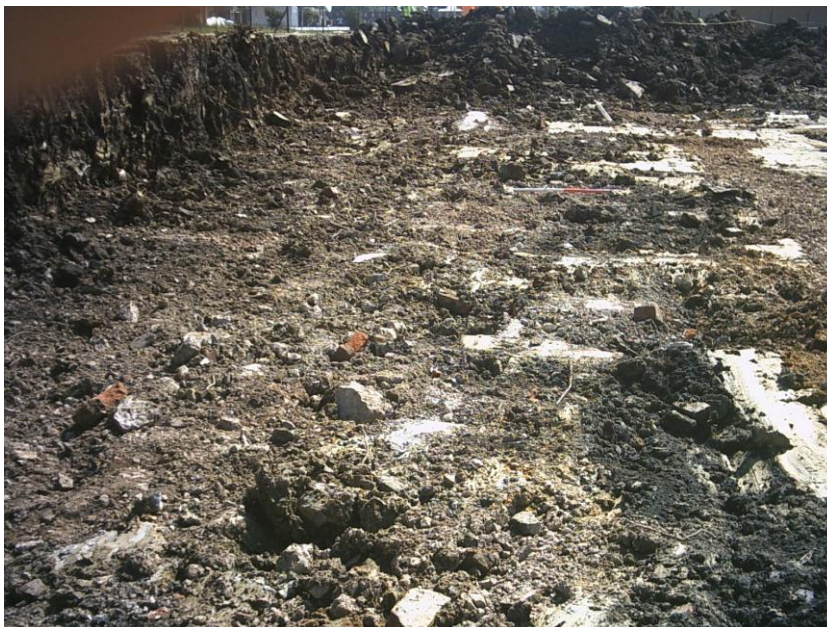
Plate 16: Demolition debris (019) overlying (026) at eastern end of site. Facing S.

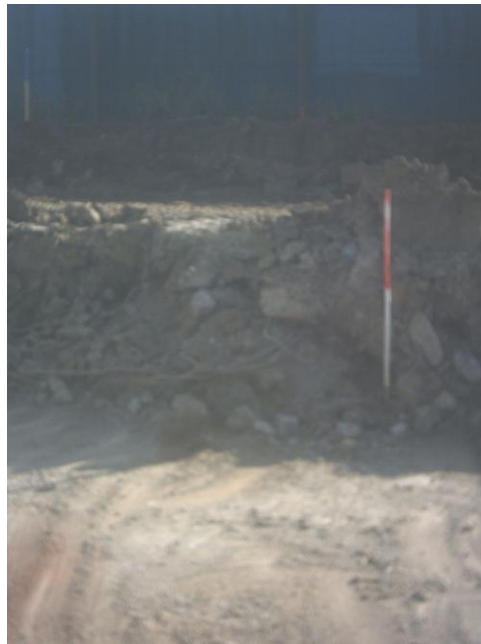
The NE end of the site contained a number of features possibly associated with a large chimneystack or vent, now demolished, that is believed to have been sited in this area and which was originally associated with an engine testing plant located to the E (approximately 20m E of the limit of excavation). The remains of this chimney/vent were represented by demolition deposits (019) and a concrete surface (046) (**Plates 16 & 17**), which was overlain by topsoil (014) at depth of 0.4m. The deposits filled a large roughly rectangular cut measuring 11m in length and which was cut into natural soils (010). Underlying context (019), 1.2m below the existing ground level, was a large steel reinforced concrete platform measuring >20m x 20m x 0.4m (046), which may well have been the foundation for the chimney/vent, although it was fully exposed and removed

Plate 17: Concrete surface (046) and overlying demolition material (019). Facing E

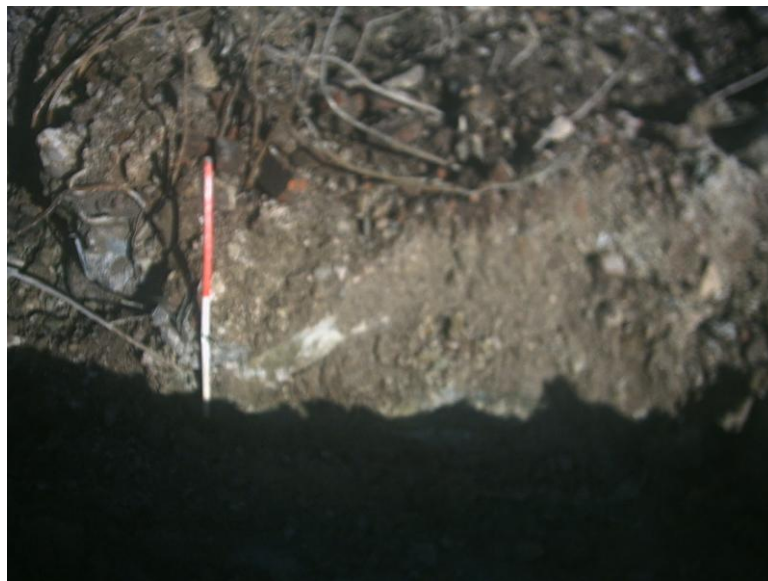
Plate 18: Edge of concrete surface (046). Facing E.

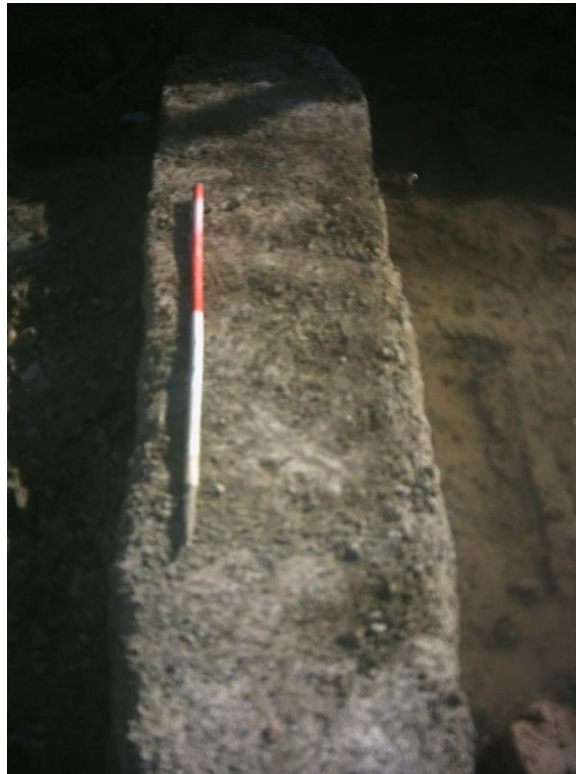
Also associated with feature (046) was brick foundation wall (017) orientated N-S and running from these features to the N of the excavation. The wall overlay a concrete foundation (047) that cut [048] into natural soils (010). This foundation ran N-S and at each end turned to E and ran into the W-facing section.

Plate 19: Concrete foundation (047). Facing E.

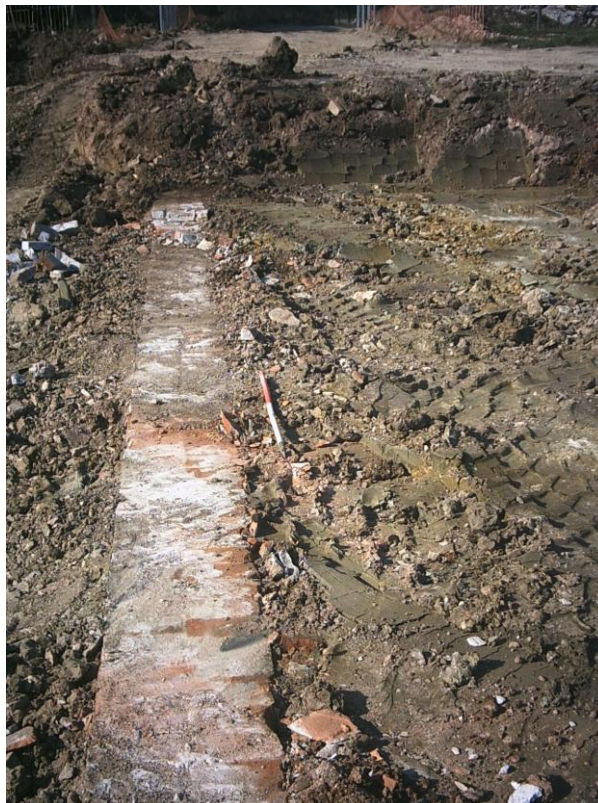
Plate 20: Brick Wall (017). Facing N.

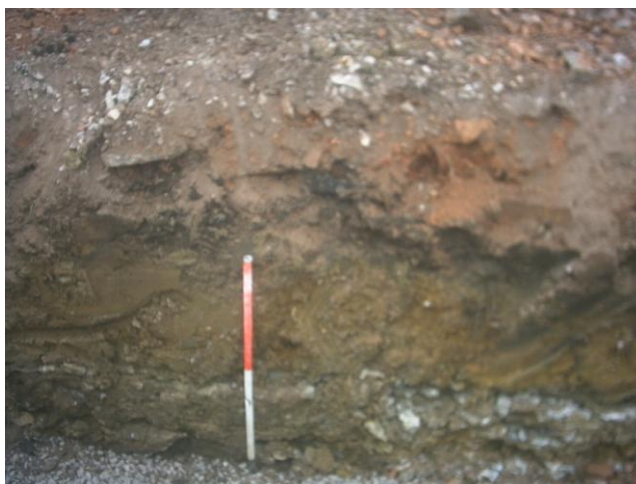
The first section excavated comprised a trench 1m wide located to the S of the Plant Engineering Transport Services building at the southernmost end of the Rolls-Royce car park between ST 60627 80665 and ST 60611 80677. The stratigraphy in this area was fairly consistent, comprising tarmac (1001) overlying a gravel sub-base (1002), which overlay a dark brown loosely compacted silty sand with moderate amounts of brick (1003). Underlying this was a moderately compacted light orangey-brown sand (1004), which overlay a layer of naturally occurring mudstone (1005). Underlying (1005) was a loosely compacted blue gley (1006). The stratigraphy was occasionally cut by service trenches, the deepest of which extended to 1m below the existing ground level. The trench was up to 1.8m in depth at this point. No finds of archaeological significance were located within this section of trench.

Plate 21: Stratigraphy in Section 1 between ST 60627 80665 and ST 60611 80677. Facing W.

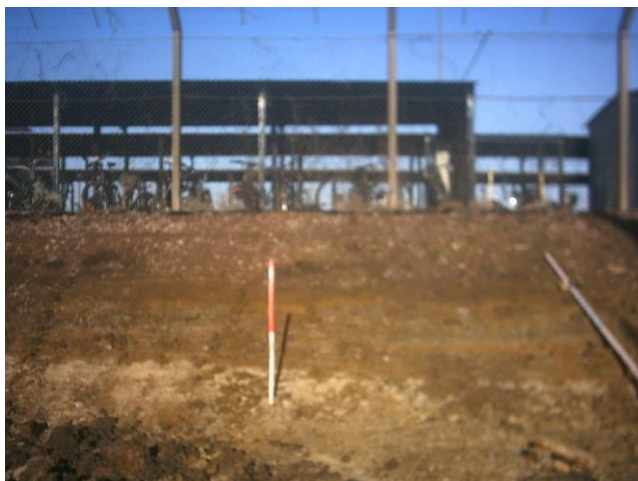
Both spur trenches terminated in a 25m<sup>2</sup> 'pond' that was excavated to a depth of 1.3m with gently sloping sides and a flat base. No change in stratigraphy was observed in this area (**Plate 22**).

Plate 22: Picture of pond, facing N

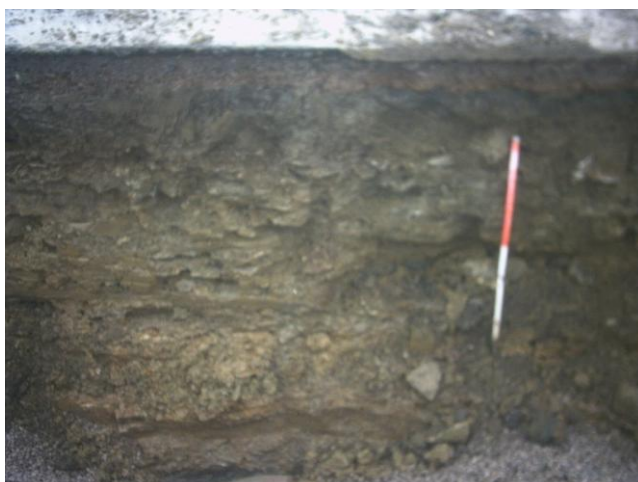
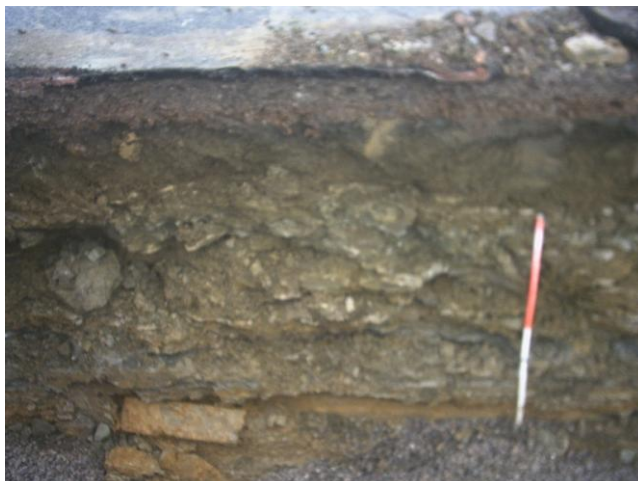
The main trench continued N, leaving the Plant Engineering Transport Services compound at ST 60591 80716, from which point it ran through the Rolls-Royce plant car park to ST 60591 80716 (**Plates 23 & 24**). The depth of the trench increased as it continued N due to rising topography; however, only minor stratigraphic changes were noted, with the layer of mudstone (1005) increasing to a maximum of 0.6m in thickness while the underlying blue gley (1006) continued beyond the trench base, which reached a maximum depth of 4m.

Plate 23: General view of stratigraphy within trenching

Plate 24: General view of stratigraphy within trenching
