## Archaeological Observation

Weobley-Dilwyn Phase 2 Mains  
Refurbishment Scheme

### Weobley Village

Laing O'Rourke / Dŵr Cymru  
Welsh Water

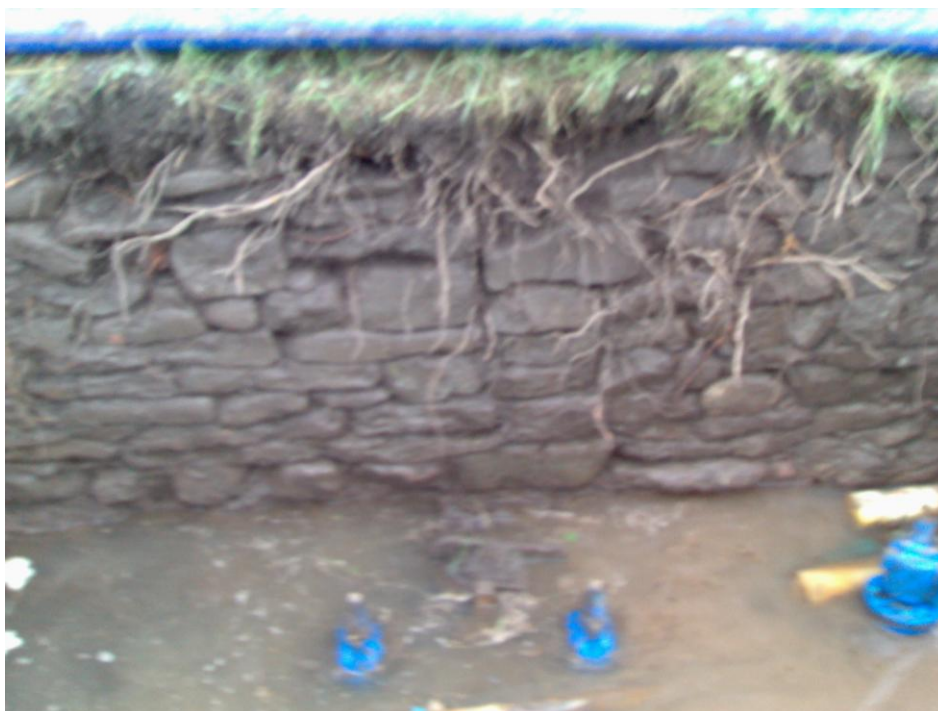
During the excavation of a pit on the S verge of Kington Road, opposite Park View (dimensions measuring 3.4m × 1.2m × 1.4m), the remains of a substantial masonry wall were identified in the N-facing section (**Plate 1**). The visible remains of the wall (102), which underlay a loose greyish-brown silty clay topsoil (101) with evidence of frequent root disturbance (0-0.1m), measured 3.4m long and 1.2m deep and comprised seven courses of roughly worked, irregular sandstone slabs bonded with reddish earth and exhibiting evidence of brick infill in the uppermost courses. The wall in turn overlay a firm reddish-brown clay (104) extending to the base of the pit.

Plate 1: View showing remains of substantial masonry wall identified in N-facing section of pit on S verge of Kington Road at NGR SO 39625 51904

The wall appears to represent the lower courses of the external wall of a small cottage that occupied a narrow strip of land immediately fronting onto the S side of Kington Road and is marked on the Weobley tithe map of 1838, the OS 1<sup>st</sup> edition 6-inch map of 1888 and subsequent OS maps until the early 1950s. The OS 2<sup>nd</sup> edition 6-inch map of 1904 also shows a well located to the rear of the building, which is still marked on modern maps of the area. Although no finds were recovered from the cut of the wall that might have provided a firm date for its construction, the irregular coursing of the wall and the substantial nature of the masonry suggest that it was probably built during the early post-medieval period and subsequently repaired at some point in the 19<sup>th</sup> century.

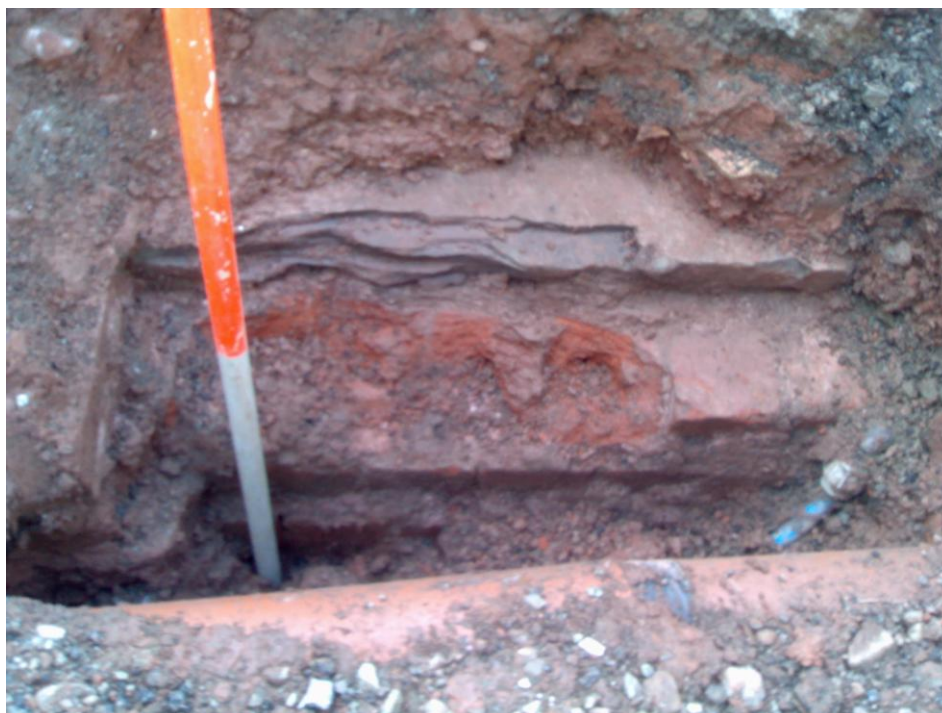
Pit WL25: Underlying the modern tarmac road surface (201) and sub-base (202) was a firm mid reddish clay with frequent medium angular stones (203) and at the base of the pit a firm mid red sandy clay with frequent stone inclusions (206). Cutting (206) was [205], the cut for wall (204), which comprised large roughly hewn sandstone blocks bonded with a mid brown sandy clay.

Plate 2: Remains of post-medieval masonry walling located in Bell Square opposite 'Brook Cottage' at NGR SO40185 51727

The masonry remains found in these two locations appear to be associated with a wall or culvert which ran E-W along the N side of Bell Square, immediately to the W of the Red Lion Hotel, a Grade II\* Listed building of 14<sup>th</sup> century date. The 1838 tithe map of Weobley shows that the street frontage of the Red Lion originally extended much further

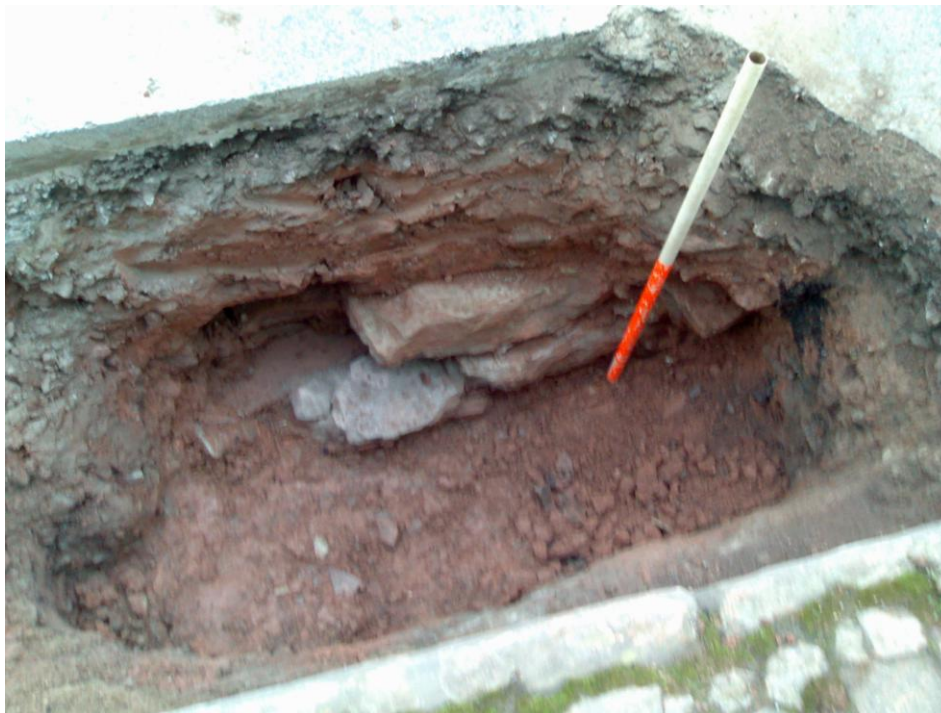
Pit WL24: These remains were located c. 10m E of Pit WL25 during the excavation of a pit measuring 1.9m (E-W) and 0.8m (N-S). Underlying the modern tarmac road surface (301) and sub-base (302) was a firm mid red silty clay with occasional rubble inclusions and deposits of mid brown clay (303). This material overlay the remains of a sandstone masonry wall (304) at a depth of approximately 0.5m below the existing ground level comprising roughly hewn blocks bonded with a plastic clay. These extended to the base of the pit at a depth of roughly 1m.

Plate 3: Remains of post-medieval masonry walling located in Bell Square at NGR SO40194 51725

to the W than at present, with a long range of outbuildings fronting onto Bell Square. By 1887, however, the OS 1<sup>st</sup> edition 25-inch map shows that this range of outbuildings had been partially demolished and a garden plot laid out to the W of the Red Lion. It would seem likely that these masonry remains were related to these demolished outbuildings to the W of the Red Lion, which may have been of late medieval or early post-medieval date and were taken down at some point between 1838 and 1887.

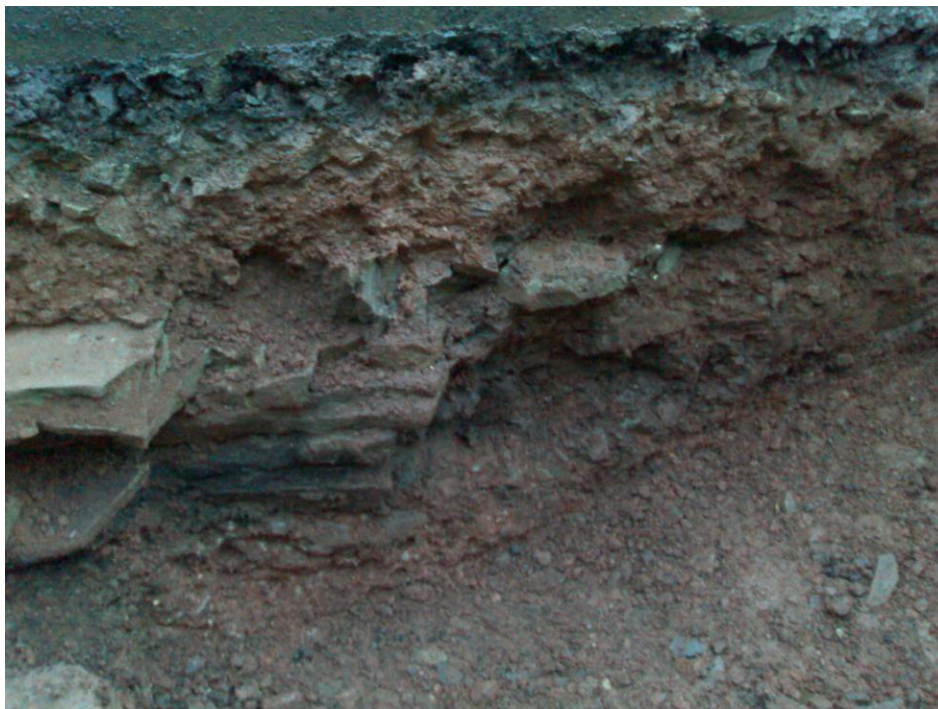
Plate 4: View showing remains of heavily truncated masonry wall revealed in pit excavated at Bell Square opposite Bellbrook Cottage at NGR SO 40133 51671

The wall may be associated with a series of four small properties shown on the Weobley tithe map of 1838, which occupied a small rectangular enclosure at the SW corner of Bell Square, immediately fronting onto the street. These properties marked as Nos. 714, 715, 716 and 718 on the tithe map, were 'vote houses' belonging to the Marquis of Bath

and appear to have been largely demolished in 1844-45. The OS 1<sup>st</sup> edition map of 1888 shows that, out of the four houses shown on the 1838 tithe map, only the easternmost two buildings appear to have survived, the rest of the plot having been cleared and converted to orcharding. No finds were recovered from the foundation cut of the wall that might indicate the date of its construction but an early post-medieval date seems likely.

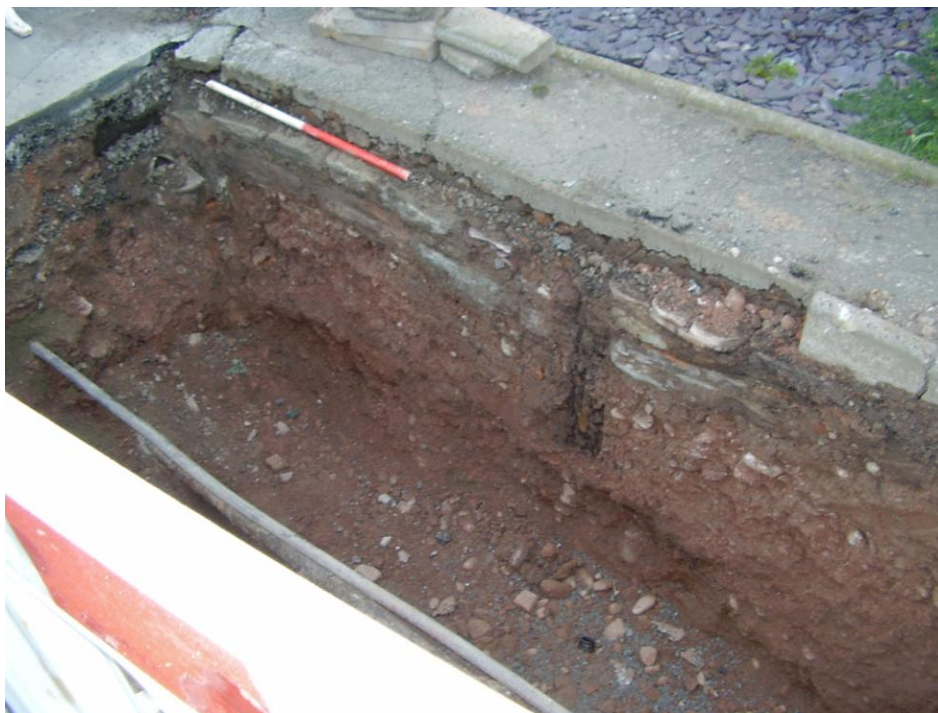
Plate 5: View NE showing remains of stone boundary wall and associated wooden post in SW facing section of pit at NGR SO 40163 51589

The masonry remains appear to represent the foundations of a stone boundary wall running along the E side of Back Lane and marking the W end of a rectangular enclosure shown on the Weobley tithe map of 1838 and the OS 1<sup>st</sup> edition 6-inch map of

1888. No finds were recovered in association with the wall, although the irregular coursing of the masonry suggests an early post-medieval date.
