ARCHAEOLOGICAL OBSERVATION

**Symonds Yat Rapids
Symonds Yat East
Herefordshire**

NGR SO 5610 1560

SMR No: 48815

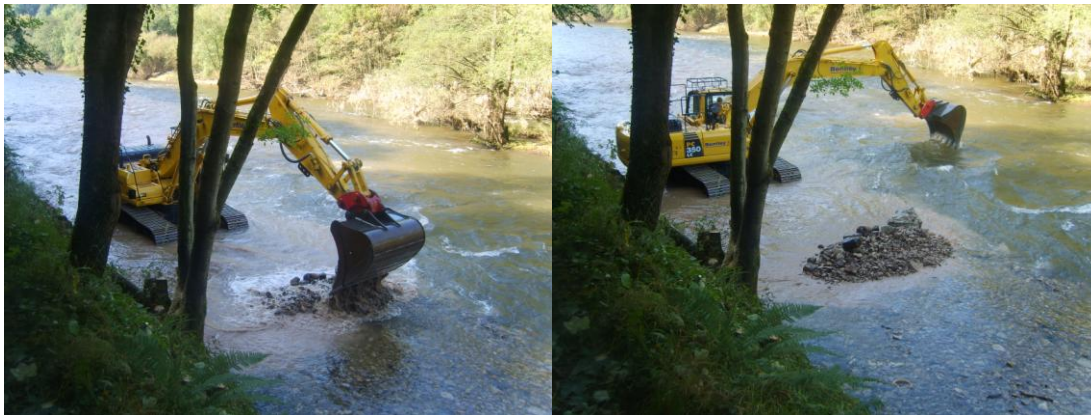
Plates 1 & 2: Removal of material from the river channel for access platform

Considerable quantities of ironstone and slag were identified in the excavated spoil, which was, presumably, waste material associated with the ironworks located on the W bank. Unworked, unabraded stone rubble was also observed, which may have originally formed part of the weir.

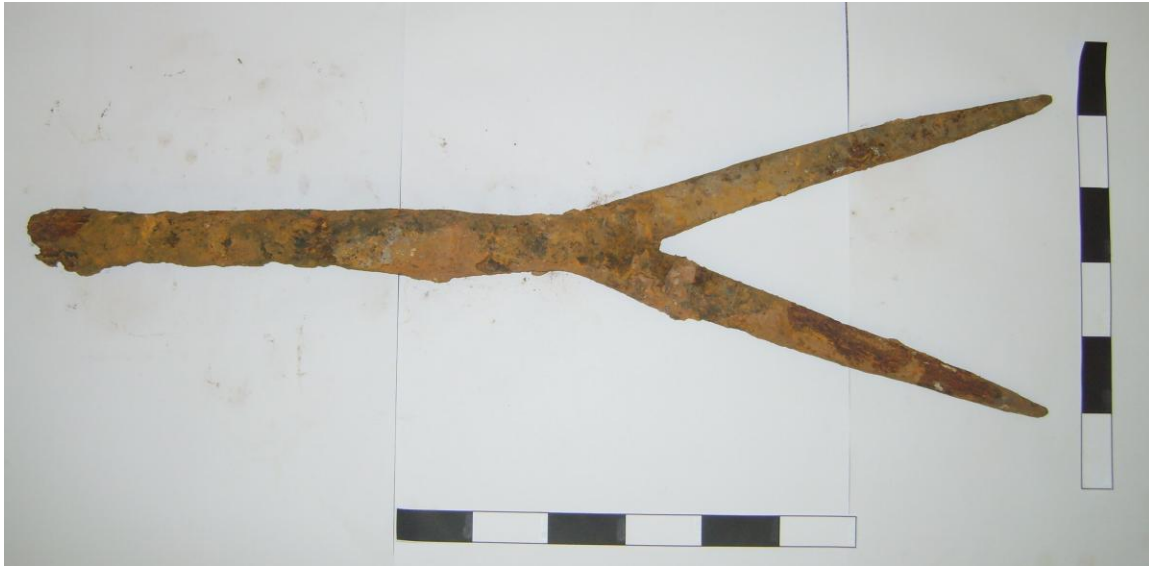
Plate 3: Quant pole pronged end

A number of iron artefacts were found, including pronged 'quant pole' ends associated with commercial river traffic. A barge pole fixture was also recovered and several items associated with the railway immediately to the E of the site.

A large number of double pronged 'quant pole' heads, of varying size and form, and part of a large boat hook were removed from the navigable channel. These implements were attached to wooden poles and used to propel and steer vessels through fast flowing sections of river or upstream; evidently, these examples had broken off during use. The largest were probably used for barges, with smaller versions used for correspondingly smaller craft. Such implements remained in use well into the 20th century, although the use of heavier deeper draft barges, carrying coal and other bulk cargos, would probably have declined sharply with the expansion of the rail network in the mid 19th century.

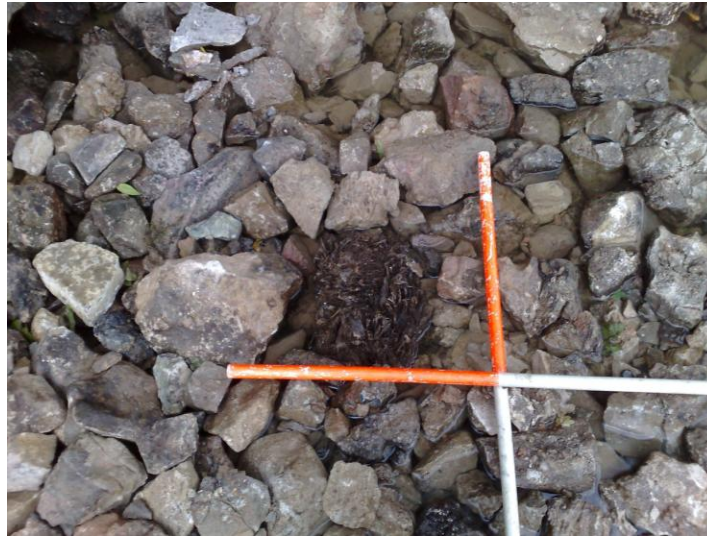
Plate 5: Timber post (102)

An in situ timber post measuring 0.38m x 0.30m (102) was found close to the east bank opposite the southernmost extent of the island. This could represent the remains of a mooring point.

The remains of a hardwood post, which was located approximately 3m from the E bank and slightly to the S of the rapids, may represent a mooring point for river traffic waiting to move upstream. Barges and other larger vessels probably worked close to the E bank, which was formerly the channel for the flash lock (prior to 1826) and adjacent to the towing path (established after 1809). It seems probable that some kind of mooring to the S of the rapids would have been necessary, especially if two or more boats were attempting to pass through the rapids simultaneously or if a vessel required towing or winching from the bank side in order to make headway upstream.

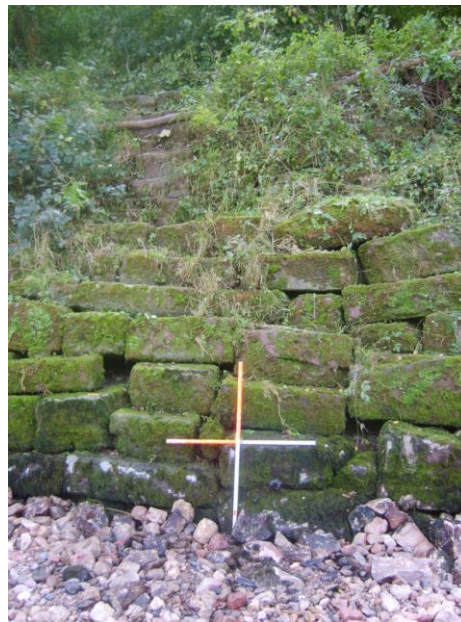
Plate 6: Revetted embankment on the E side of the river

The observation of groundworks at Symonds Yat Rapids identified considerable evidence for use of the river and the immediate environment. The eastern riverside appears to have been built up in the 1870s with the construction of a revetted embankment associated with the railway. This may have significantly impacted upon the river channel in the vicinity of the flash lock which was located at the E end of the weir.
