Photographic Recording & Archaeological Observation

**Castle Farm Moat Wall
Cheney Longville
Shropshire**

NGR SO 4174 8479

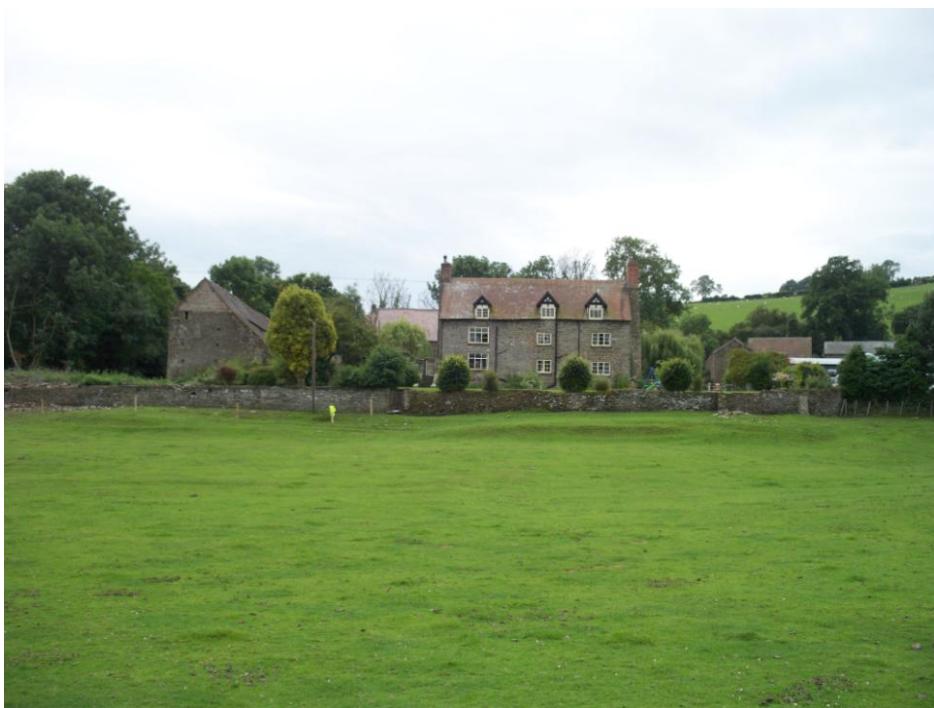
Plate 1: General view looking SW of Castle Farm showing the farmhouse and outbuildings occupying the raised platform of the original medieval moated site, below which is the NE arm of the Moat Wall with evidence of earthwork banks in foreground

Castle Farm (**Plate 1**), in its present form, comprises a 17th century farmhouse and associated outbuildings, ranging in date from the 14th-19th centuries, built around a central courtyard and accessed from the NW by an arched gateway. The farmhouse and outbuildings occupy the raised platform of a 14th century moated manor house, of which considerable earthworks survive, together with associated water management features and a number of post-medieval tanning pits. The site is designated as a Scheduled Ancient Monument (SMR No. 00162; SAM Ref. 13679).

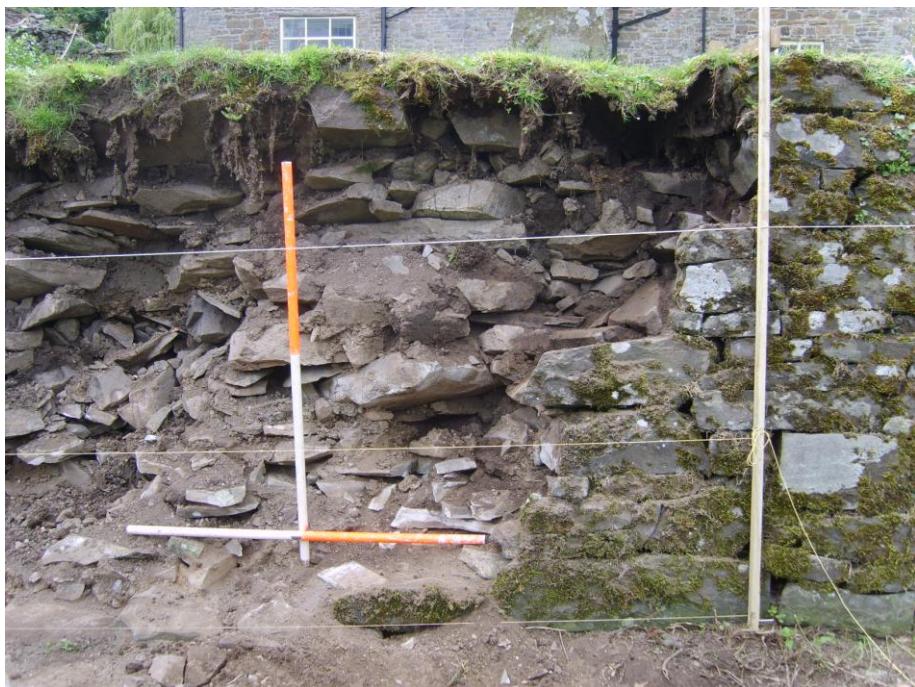
Plate 2: View SW showing rubble core (003) and external masonry facing (004)

Removal of the facing masonry on either side of the gateway revealed a drystone rubble wall core (003) containing sherds of late post-medieval pottery (chiefly china and Midlands redware of early to mid 19th century date), fragmentary animal bone and CBM (**Plates 2 & 3; Fig. 6**).

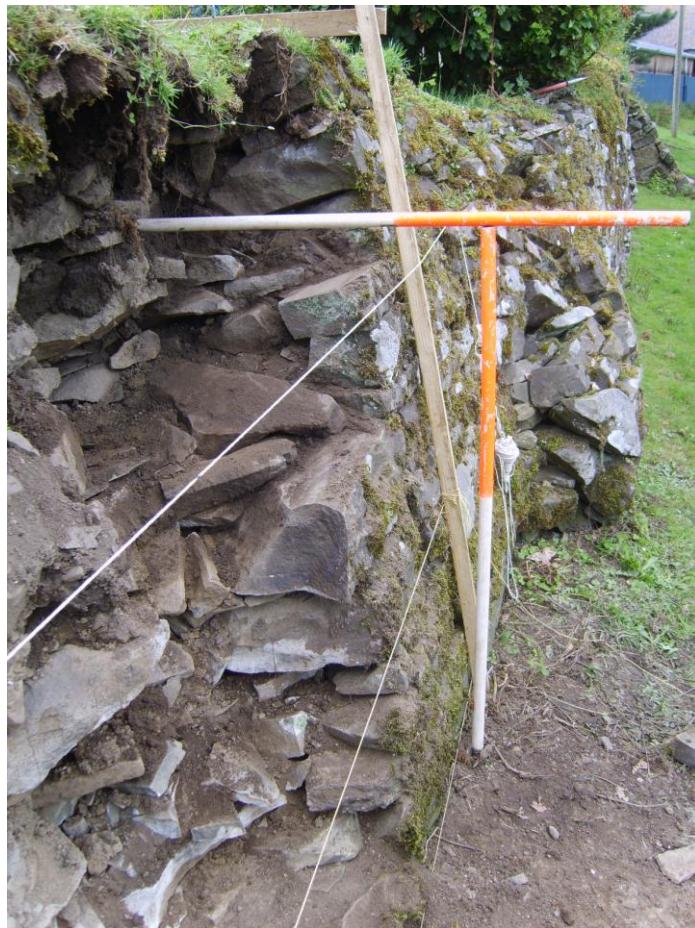
Plate 3: Cross-section through external masonry facing and rubble core to NW of gateway

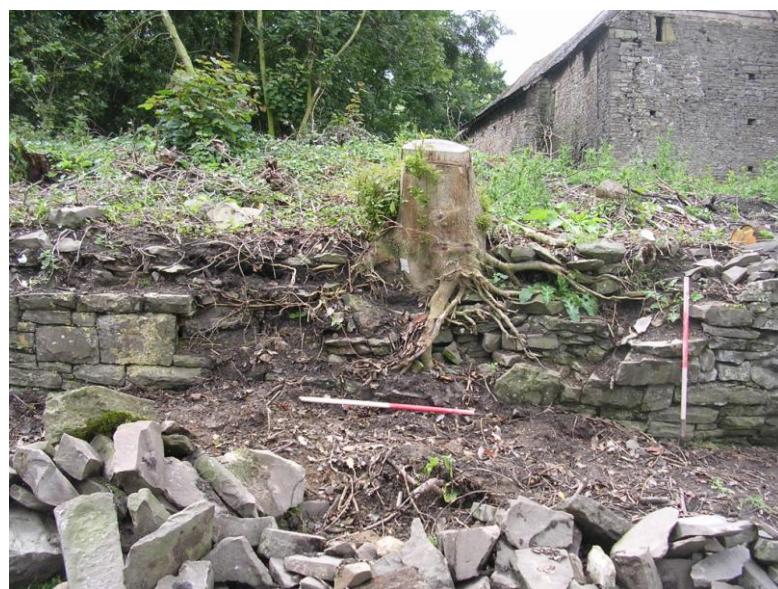
Plate 4: View S showing extent of root disturbance to SE of gateway

The external masonry facing of the longer section (006) running SE from the gateway (approximately 55m in length) consisted of large, dressed sandstone blocks, randomly coursed and largely drystone bonded. The quality of the dressed masonry suggested that it could have been re-used from earlier buildings, although no obvious evidence of diagnostic features such as mouldings or masons' marks was noted. Evidence of stone coping was visible in several places and the masonry was built upright with no discernible batter. Parts of the wall had collapsed due to tree root disturbance (**Plate 4**).

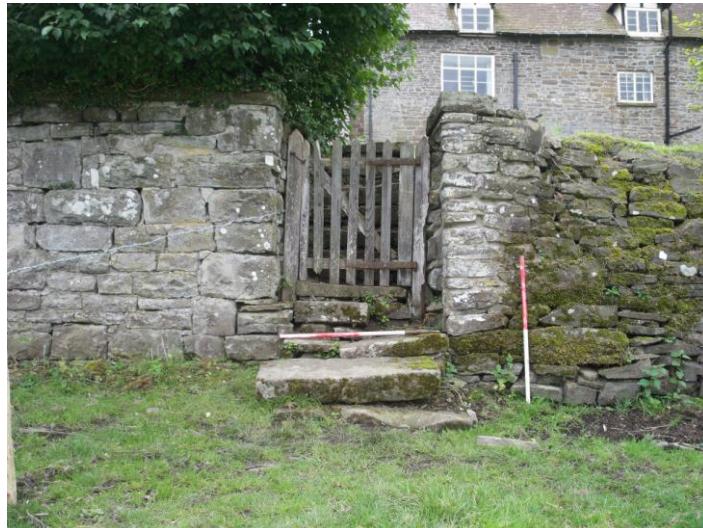
The coursing of the external facing masonry on either side of the gateway exhibited two markedly different methods of construction (**Plate 5**). The section extending NW of the gateway (approximately 30m in length) was characterised by a facing constructed primarily of randomly coursed, roughly worked and elongated sandstone slabs (004), largely drystone bonded, with a batter of approximately 80 degrees (**Fig. 6**). ‘Blowing’ and ‘bowing’ had occurred in several places due to the weight of material behind the section; two stone buttresses, bonded with cement, had been added to support this part of the wall, in addition to other minor repairs, which were evidenced by the use of cement bonding particularly in the immediate vicinity of the gateway.

Plate 5: View SW showing marked differences in masonry coursing on either side of the gateway

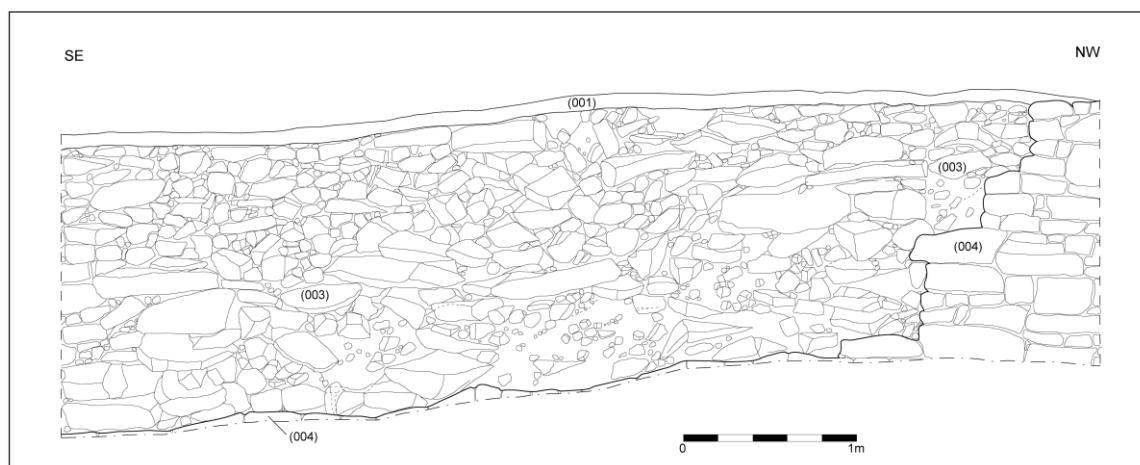
Fig. 6: NE facing elevation of section of Moat Wall to NW of gateway, showing drystone rubble core (003) and later masonry facing (004)
