Programme of Archaeological Work

Fownhope Trunk Main Herefordshire

Laing O'Rourke for Dŵr Cymru Welsh Water

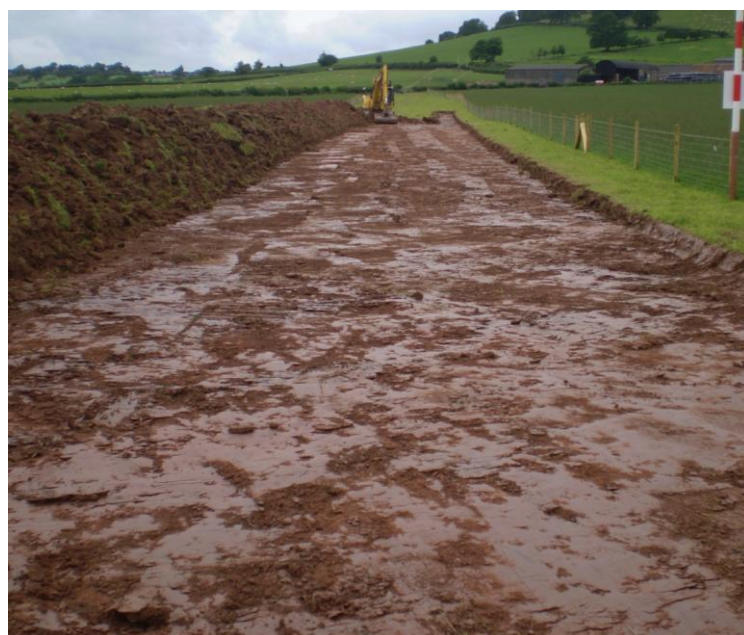
This section of pipeline corridor was machined to an average depth of 0.3m (**Plate 1; Fig 1**). Three contexts were revealed, the uppermost being a friable mid brown silty sand topsoil (001), with very occasional small rounded stones, extending >280m × >8m to an average depth of 0.1m. This overlay a firm, slightly reddish-brown silty sand ploughsoil (002) incorporating abundant decomposing litter (straw), with occasional post-medieval pottery and CBM evident, extending >280m × >8m to a maximum depth of 0.19m. Underlying this was a moderately compact to firm reddish-brown sandy silt colluvial deposit (003) extending >50m × > 8m to a depth of >0.05m, which was cut by a series of NE-SW post-medieval land drains. These cuts measured 0.1m wide and were largely filled by medium angular sandstone fragments and post-medieval CBM

No archaeologically significant finds or features were identified within the area of topsoil removal in this location

Plate 1: View SW of topsoil removal at Location 1

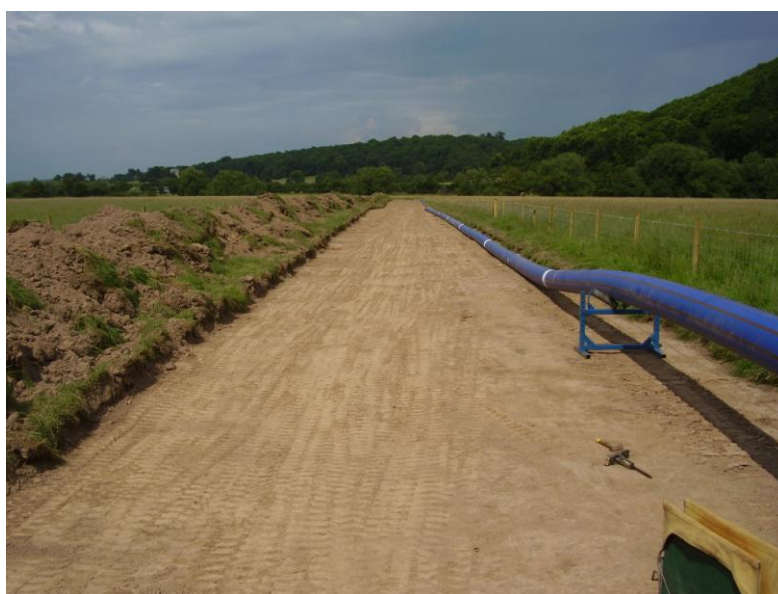
This section of pipeline corridor was machined to an average depth of 0.3m (**Plate 2; Fig. 1**) revealing two contexts, the uppermost of which (401) was a friable mid brown clayey silt topsoil containing occasional small sub-rounded stones and extending >400m × >15m to a maximum depth of 0.25m. This overlay a friable light yellowish-brown, slightly sandy silt subsoil (402) containing moderate amounts of charcoal flecking and small sub-rounded stones, extending >400m × >15m × > 0.05m.

No archaeologically significant finds or features were identified within the area of topsoil removal in this location.

Plate 2: View SW of Location 2

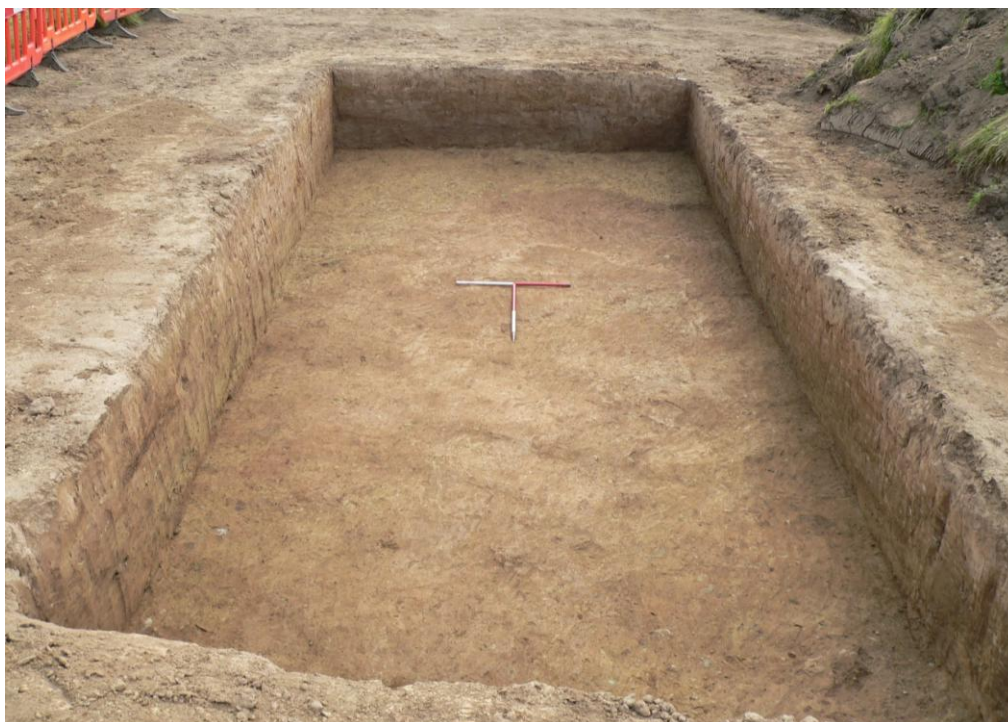
Trench 1 was located approximately 50m from the SW field boundary of the wayleave corridor (**Plate 3; Figs. 1-3**). The trench was orientated NE-SW and measured 11m × 4m. Three contexts were revealed beneath the largely removed topsoil deposit (101). The first of these was a friable light yellowish-brown, slightly sandy silt subsoil deposit (102) containing moderate charcoal flecking and small sub-rounded stones, together with occasional ceramic sherds, CBM and glass, which extended >11m (NE-SW) × >4m (NW-SE) × 0.14m (average depth). Underlying (102) was a firm mid yellowish-brown clay-silt-sand colluvium (103), containing occasional charcoal flecking and very occasional ceramic sherds, extending > 11m × >4m × 0.3m (average depth). This overlay a firm reddish-/greyish-brown clayey sand colluvium containing frequent degraded sandstone and extending >11m × >4m × >0.65m (104).

Plate 3: View SW of Trench 1 post-excitation

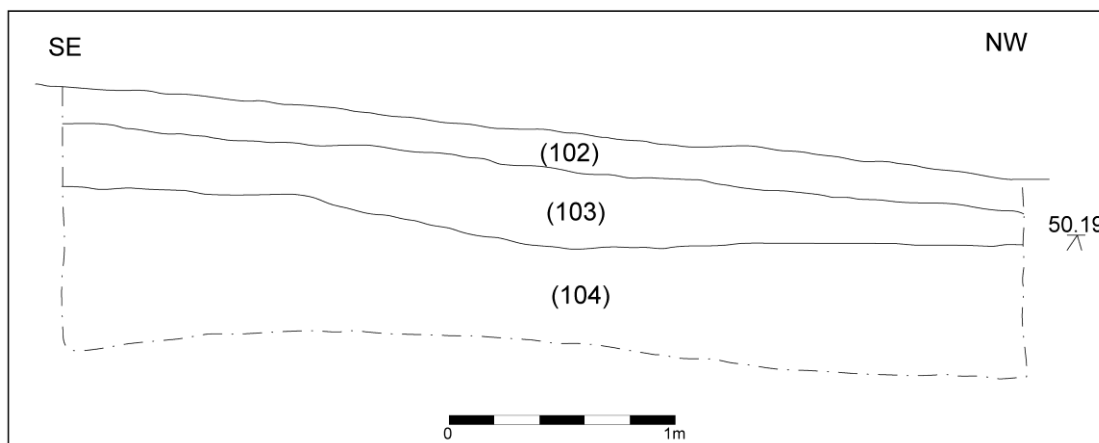
Fig 2: NE-facing sample section (Trench 1)

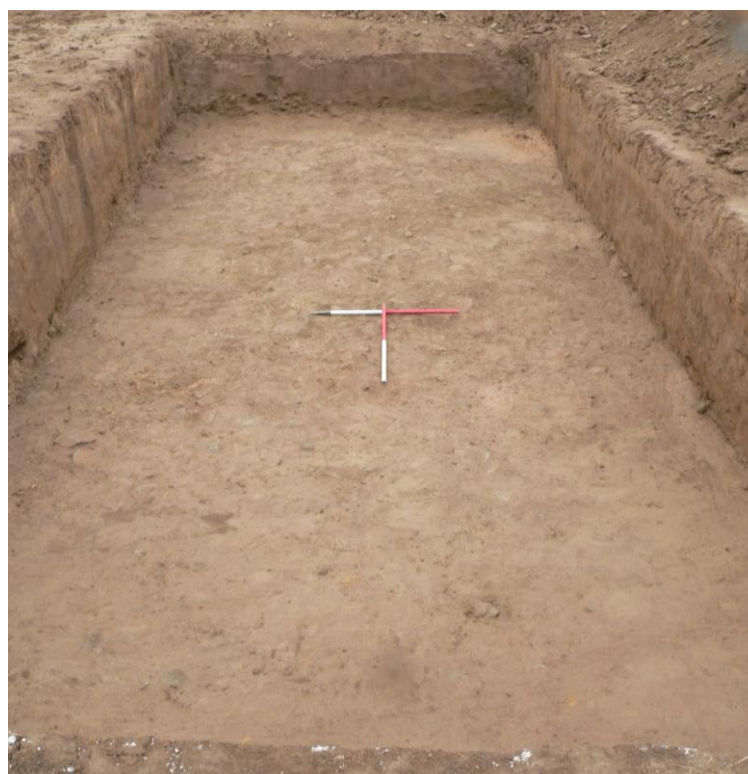
Trench 2 was orientated NE-SW and measured 11m × 4m and was located 50m NE of Trench 1 (**Plate 4; Fig. 1 & 3**). Four contexts were revealed beneath the previously stripped topsoil, the three uppermost deposits - (202), (203), (204) - being identical in colour, texture and compaction to (102), (103) and (104). However, beneath (204) was revealed compact degraded sandstone forming a natural deposit extending >11m × >4m × > 0.05m (205).

Plate 4: View SW showing Trench 2 post excavation

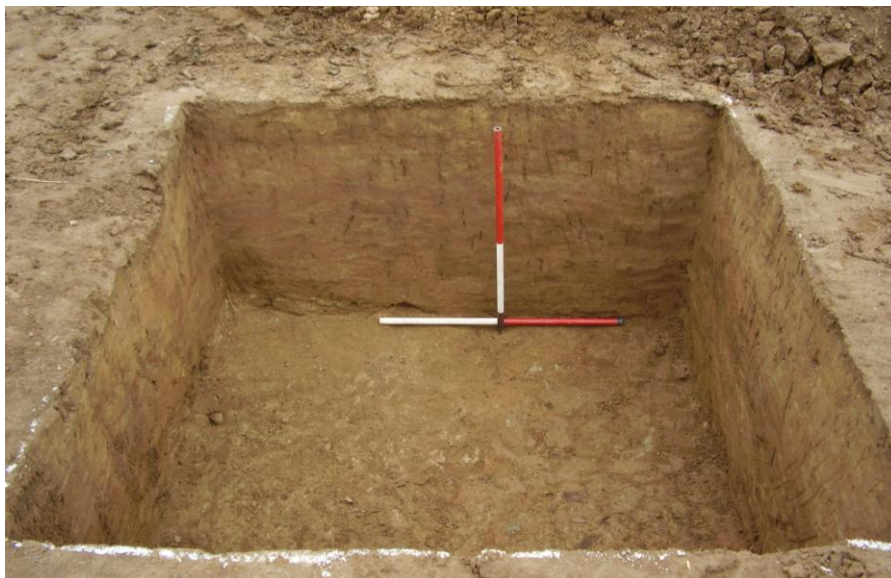
Trench 3 measured 2 × 2m, and was located approximately 80m from the SW field boundary of the wayleave corridor between Trench 1 and Trench 2 (**Plate 5; Figs. 1 & 3**). Three contexts were revealed, in addition to the previously largely removed topsoil deposit (301). This sequence of deposits - (302), (303), (304) - were essentially the same in terms of colour, texture and compaction as contexts (102), (103) and (104), as revealed in Trench 1, and (202), (203) and (204) in Trench 2.

Plate 5: Post-excavation view NW of Trench 3
