Archaeological Programme of Works

**Space Architects UK Ltd on behalf
of Mrs L. Vaughan**

13 High Street Budleigh Salterton
Devon EX9 6LD

June 2014

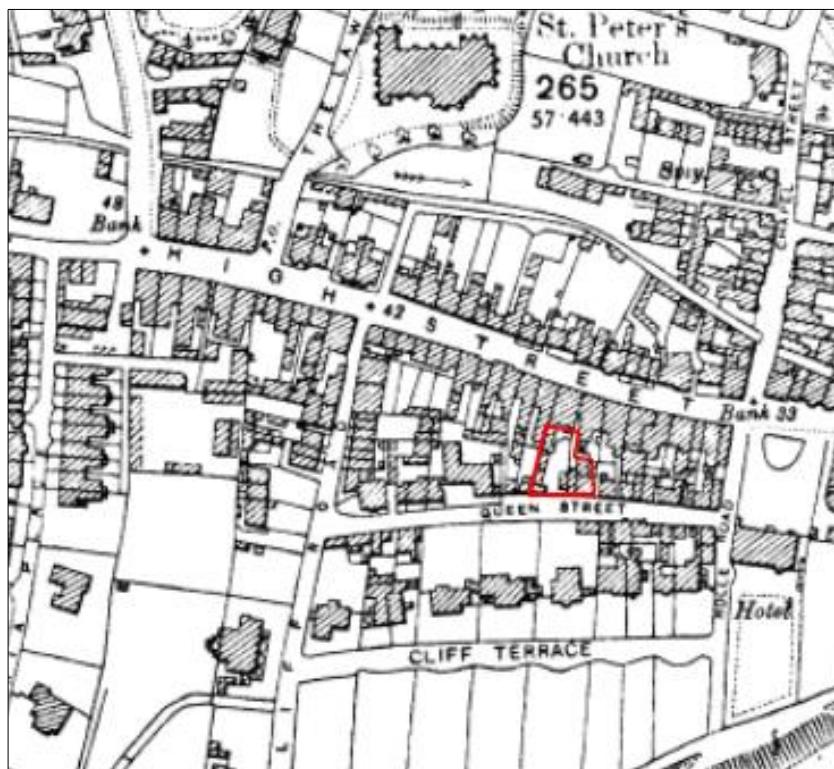
*Fig. 4: Extract from the OS 2nd-edition 25-inch map of 1905
(Reproduced by courtesy of Devon Record Office)*

Examination of the OS 2nd-edition map dated 1905 (*fig. 4*) shows that the western outbuilding (Building A) had remained largely unchanged since 1889. However, the eastern outbuilding had undergone some alterations; the larger of the two structures abutting it on its western side had been removed. The L-shaped building to the rear of the adjoining property (No. 12) had also remained essentially unaltered.

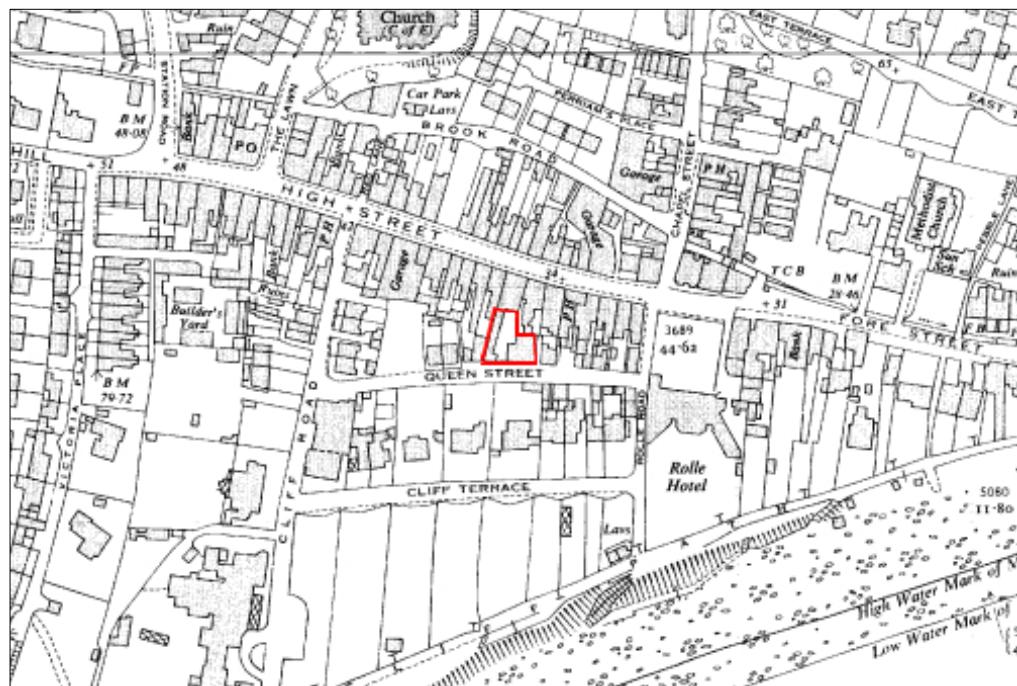
Fig. 6: Extract from the OS 1:2500 map of 1955
(Reproduced by courtesy of Devon Record Office)

The OS 3rd-edition map of 1933 (*fig. 5*) indicates that the layout of the outbuildings to the rear of No. 13 had remained essentially unchanged from that shown on the earlier 2nd-edition map. However, by 1955, significant changes appear to have occurred, as shown on an OS 1:2500 map of that date (*fig. 6*). The outbuilding on the E side of the yard to the rear of No. 13 High Street appears to have vanished; the site of this outbuilding, together with the L-shaped building to the rear of No. 12, appears to have been superseded by a large rectangular structure occupying the site of both buildings, which almost certainly corresponds to the existing two-storey structure occupying the E side of the yard (Building B).

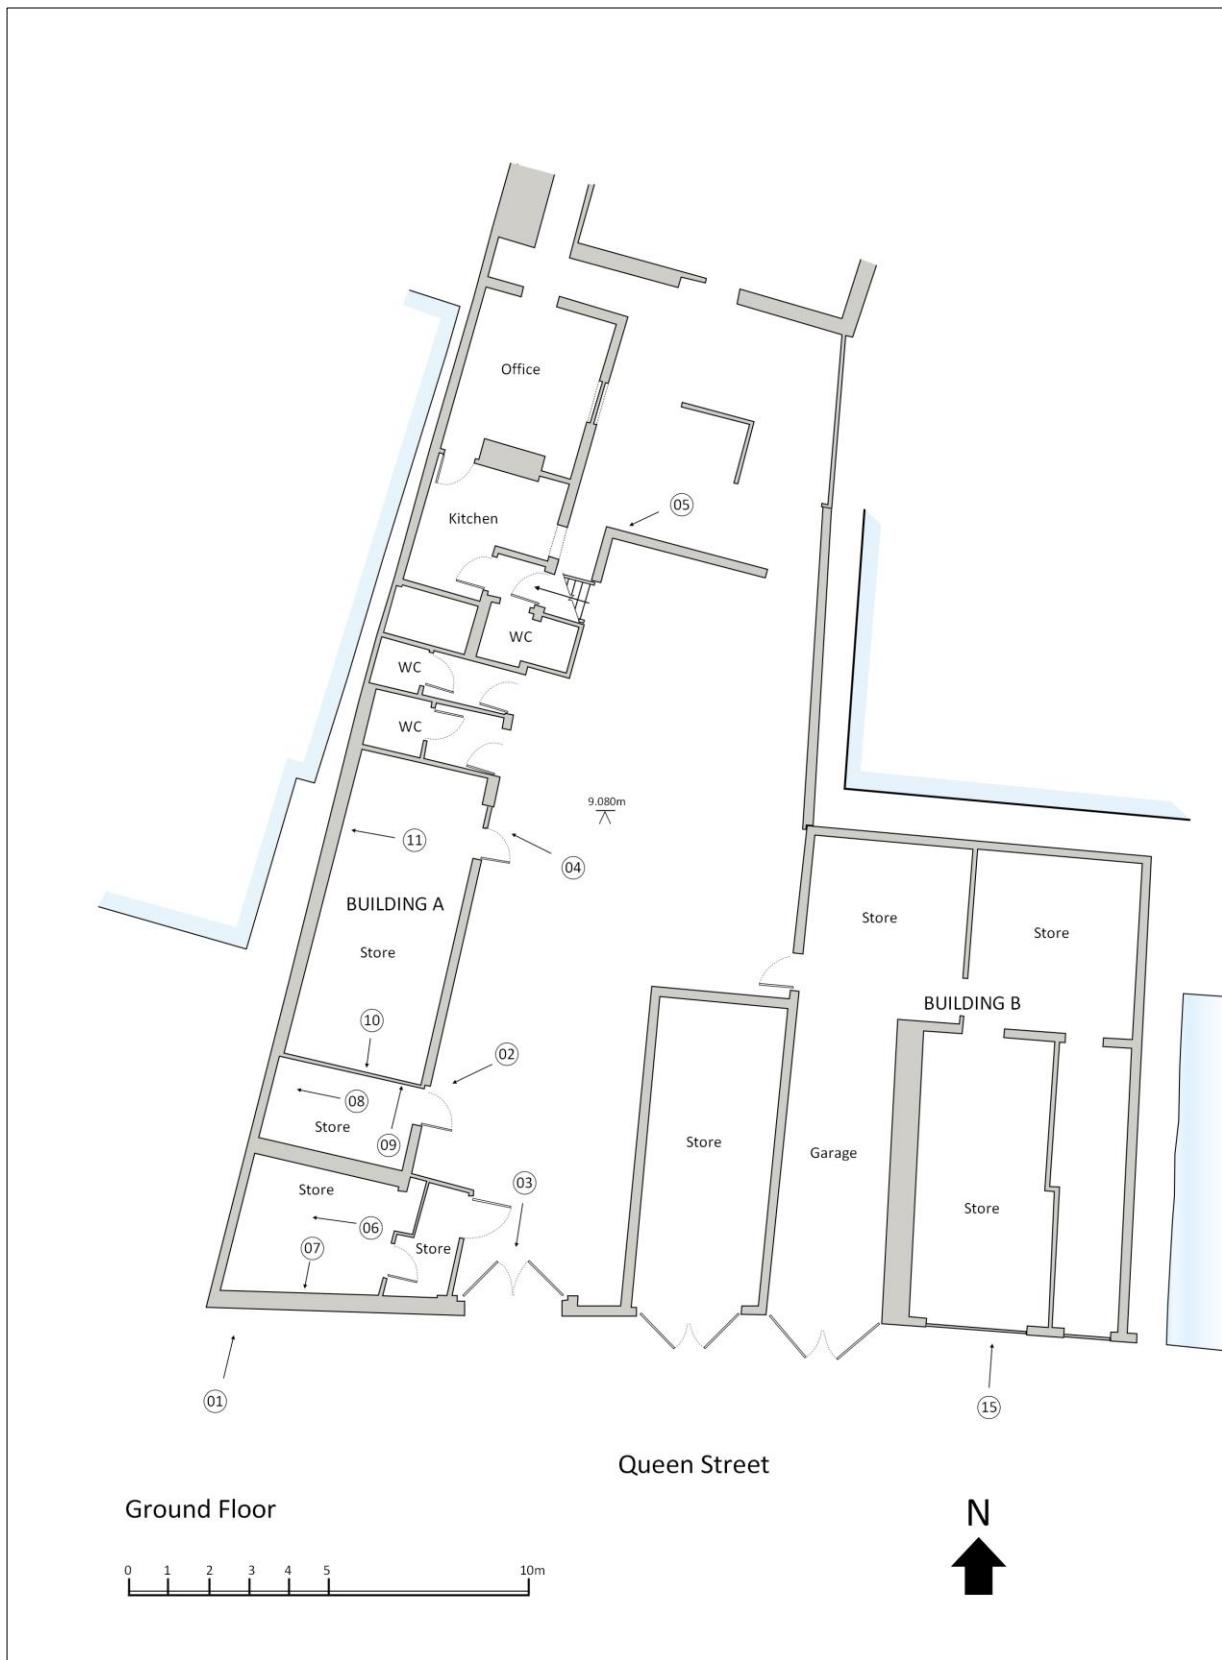
Fig. 7: Ground-floor plan of outbuildings to the rear of No. 13 High Street Budleigh Salterton

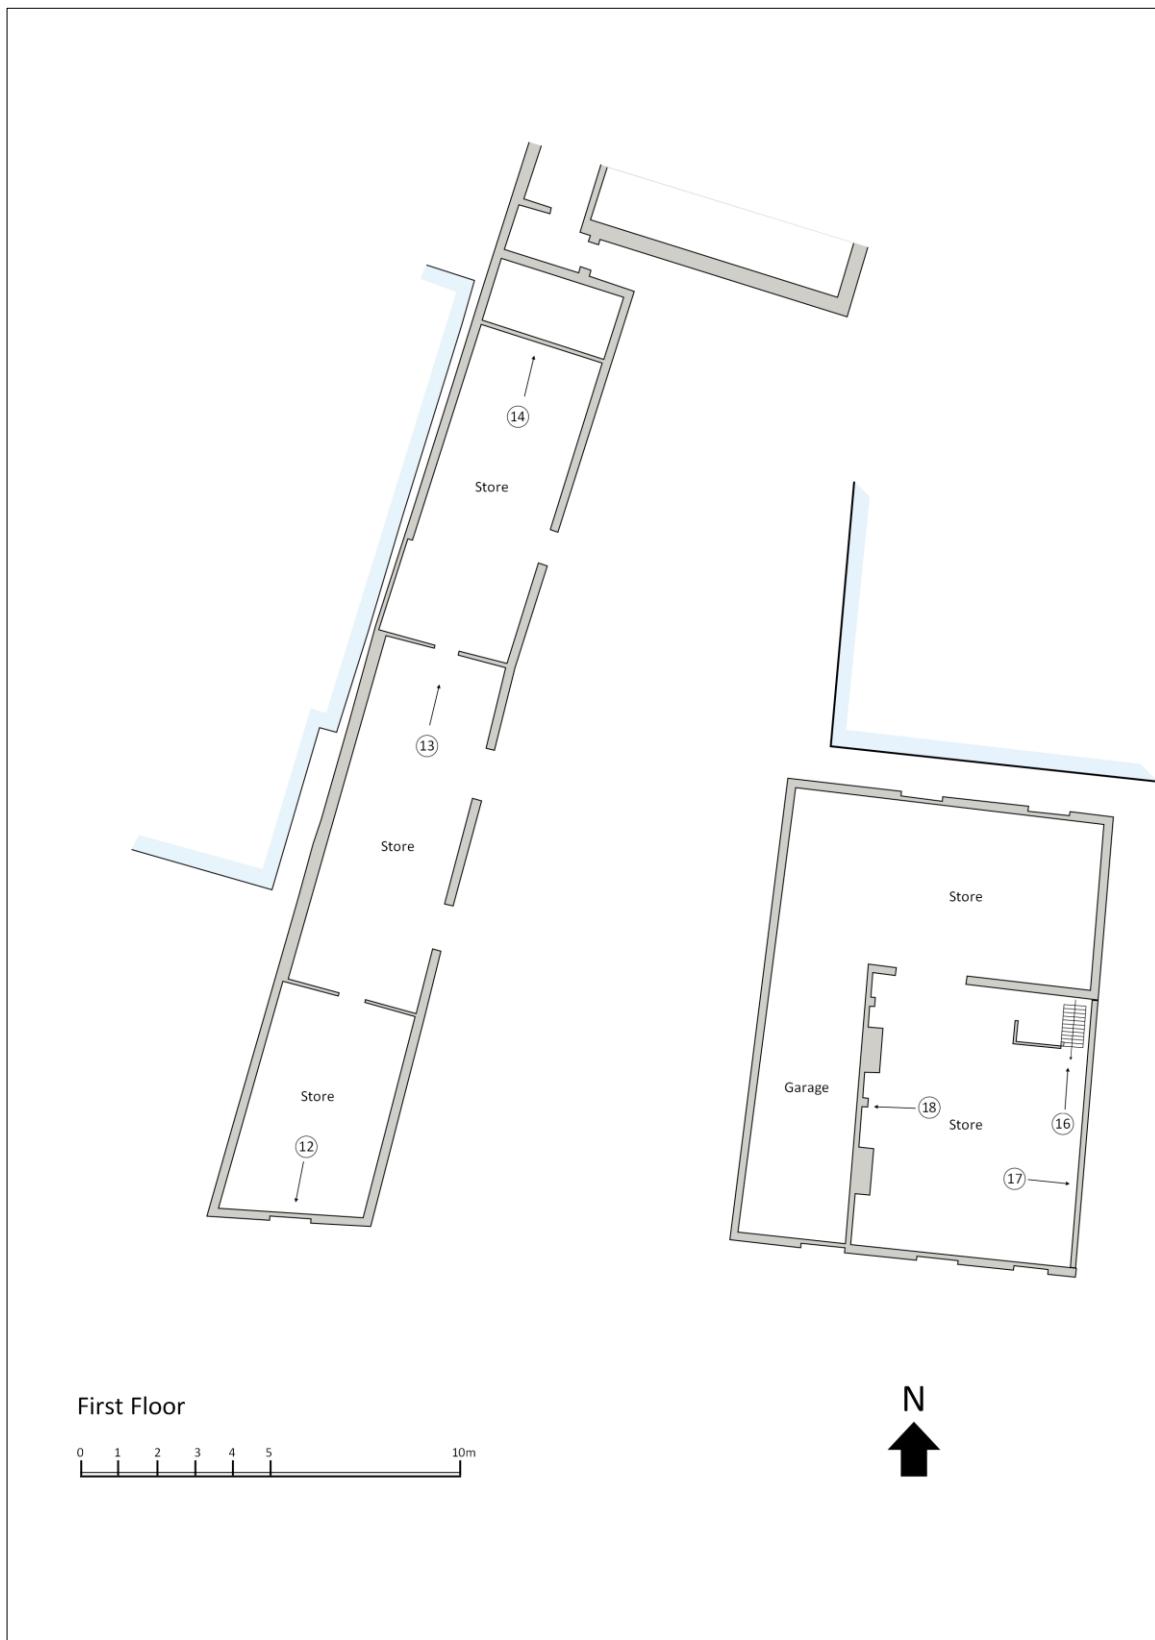
Fig. 8: First-floor plan of outbuildings to the rear of No. 13 High Street Budleigh Salterton

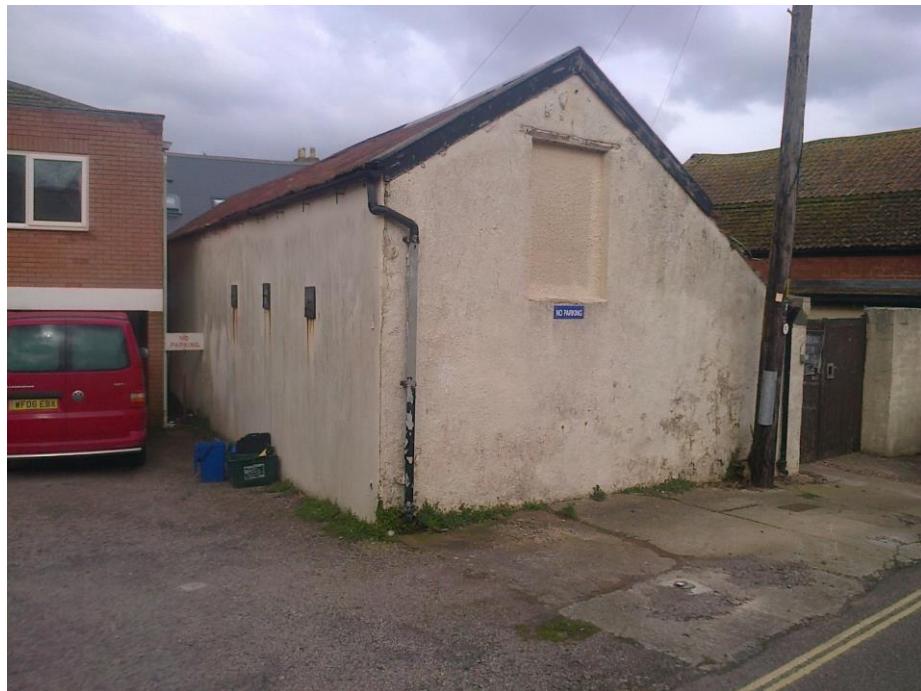
Plate 1: View looking NE showing S and W elevations of the southern range of Building A, externally roughcast, with a blocked up window or loading bay with wooden lintel at first-floor level

Building A, situated on the W side of the yard, consists of two contiguous gabled ranges, both one-and-a-half storeys high and six bays in length, the roofline of the southern range being slightly higher than its northern counterpart. It should be noted that it was not possible to gain access to the ground floor of the northern range, used as a kitchen and offices. Both ranges are entirely roughcast externally with pitched roofs, the original roofing (probably tile) appears to have been replaced in both cases with corrugated metal sheeting (*Plate 1*). The southernmost bay of the southern range appears to have projected slightly to the E with a catslide roof; this appears to have been demolished recently, although the footings and the roofline of the projecting bay are still clearly visible (*Plate 2*).

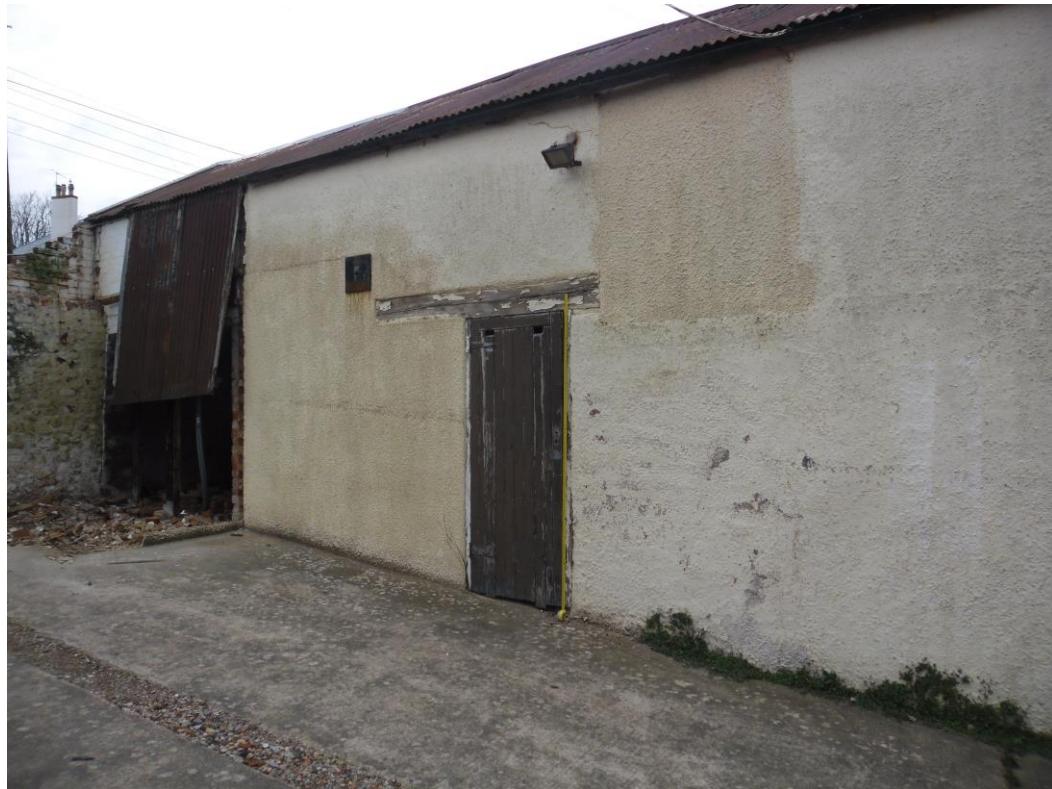
Plate 2: View looking SW showing E-facing elevation of southern range of Building A, with demolished footings of projecting bay

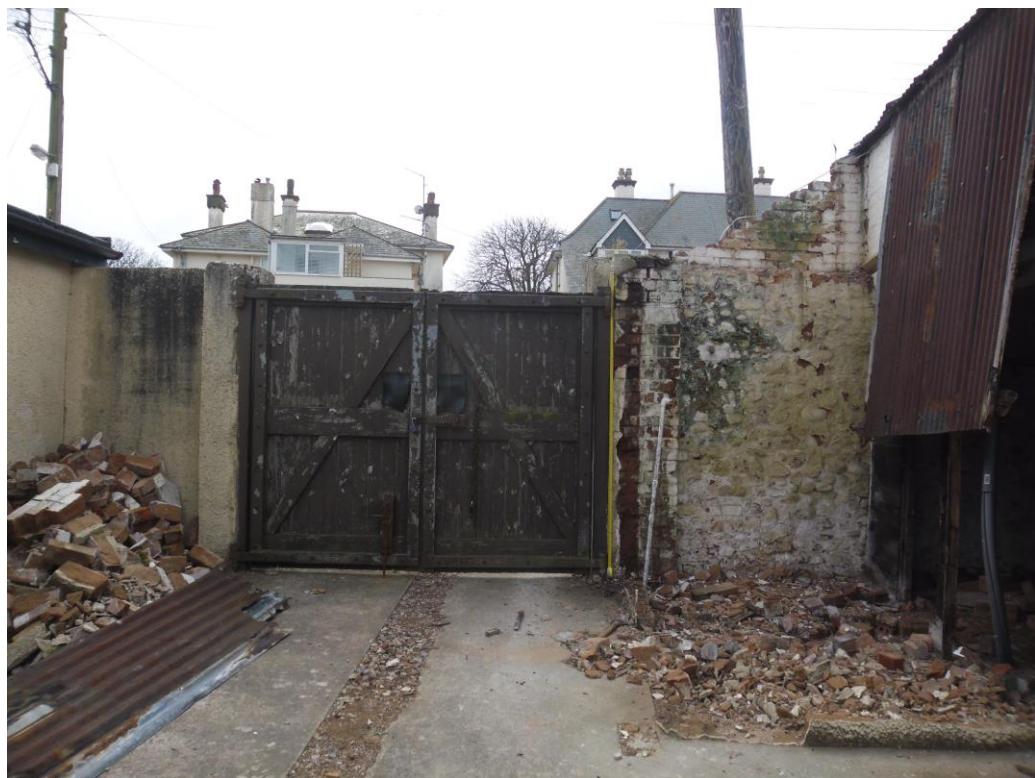
Plate 3: View looking S showing internal face of S gable wall (to right of gateway) and roofline & footings of projecting bay

The lower stages of the S gable wall of the southern range are constructed of roughly-coursed rubble masonry (*Plate 3*); it is difficult to assign a date to this masonry (which is roughcast externally and whitewashed internally), although it does appear to be of an earlier date than the rest of the building (which is chiefly of brick construction), excepting the lower stages of a section of the W wall of the southern range, which it appears to resemble quite closely. Inserted in the upper stage of the S gable end is a flat-headed window or loading bay with a thin wooden lintel, subsequently blocked up with concrete breeze blocks.

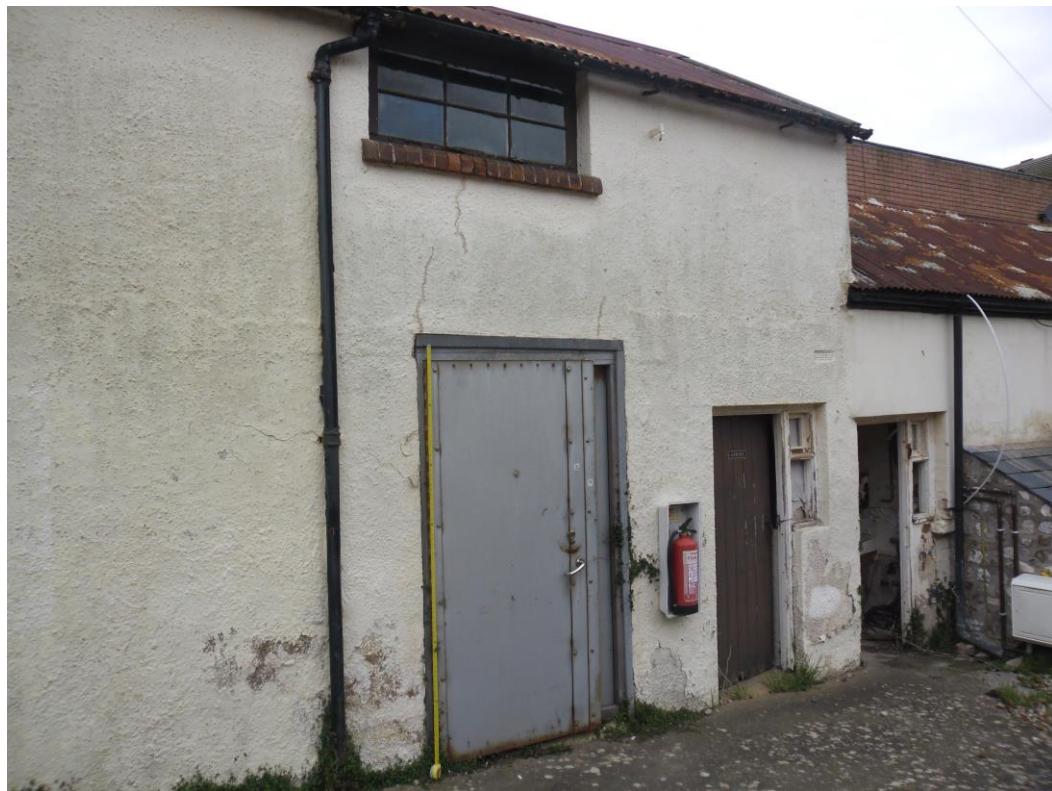
Plate 4: View looking NW showing N end of southern range of Building A with modern doorways and six-paned window above

Above the larger of the two doorways is a rectangular six-paned window, extending up to eaves level, with a single-course brick sill (*Plate 4*). Internal evidence indicates that substantial sections of the E wall of the southern range were heavily reconstructed in the mid-late 20th century and it thus appears likely that the existing doorways and the 6 -paned window are contemporary with this rebuilding.

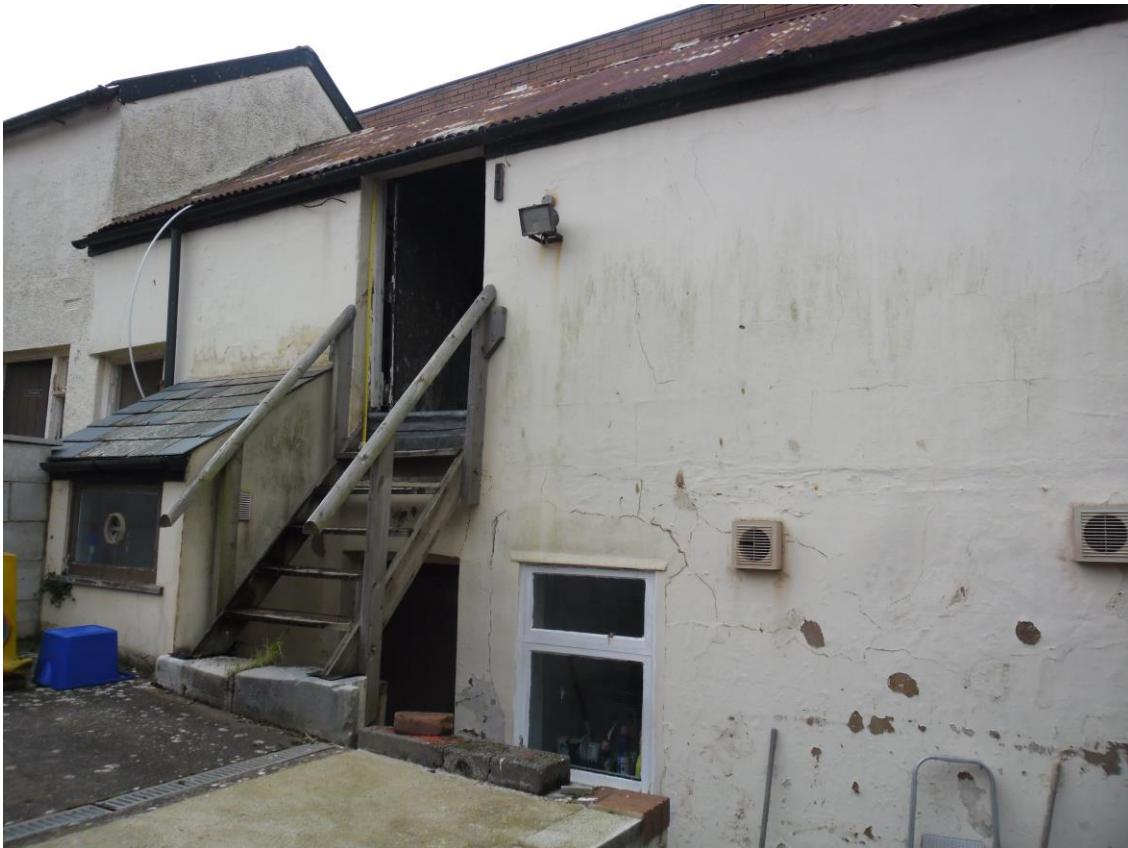
Plate 5: View looking SW showing E-facing external elevation of northern range of Building A, with flight of wooden stairs leading to upper storey, with a low segmental-arched doorway beneath

The northern range of Building A (*Plate 5*) is set slightly below its southern counterpart, reflecting the topography of the site, which slopes gently downhill from Queen Street to High Street. It is six bays long and externally roughcast with a corrugated metal roof. A wooden stairway at the southern end of the range leads to a doorway providing access to the upper storey, beneath which is a low segmental arched doorway leading to the ground floor of the building (which could not be accessed at the time of recording). To the right of this doorway is a flat-headed window with PVC frame which is evidently a modern insertion.

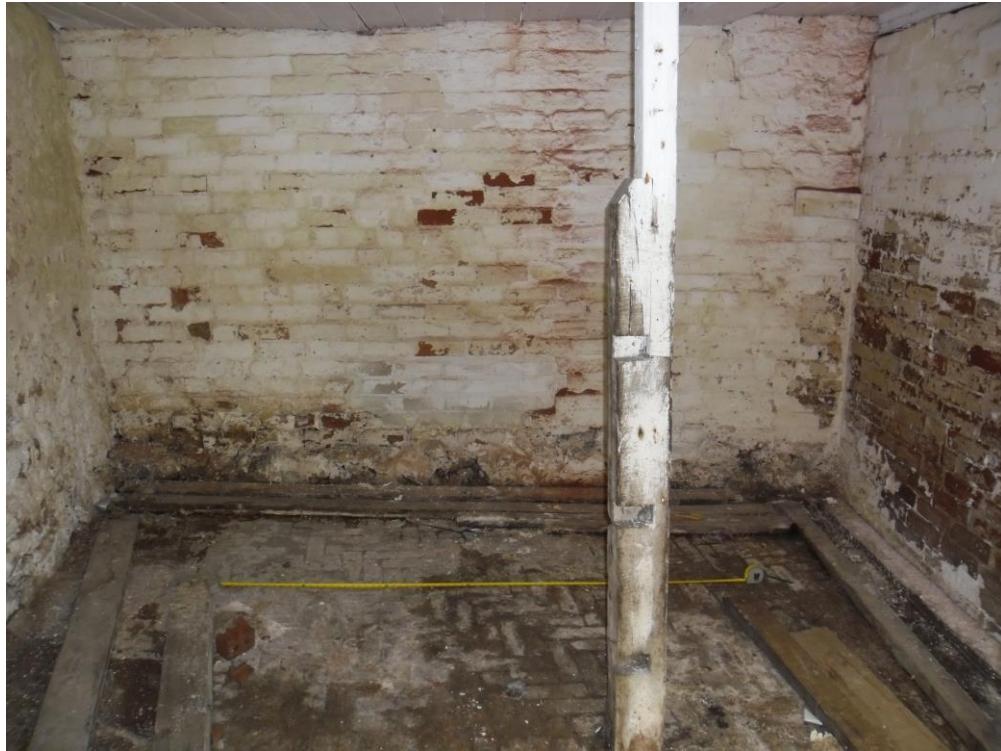
Plate 6: View looking W showing interior of southernmost compartment in southern range of Building A with brick cobbled floor

The ground floor of the southern range is subdivided into three separate compartments, all being used for storage purposes. The southernmost compartment is largely of red-brick construction, with a flat wooden planked ceiling and a brick cobbled floor (*Plate 6*). The brickwork of the walls are laid in stretcher bond (*Plate 6*), however, the W wall appears to rest upon the foundations of a heavily truncated masonry wall (which may represent the line of a boundary wall visible on the 1842 tithe map), while the S wall appears largely to be of un-coursed rubble masonry. Remains of timber shelves attached to the S wall may represent an original fitting (*Plate 7*).

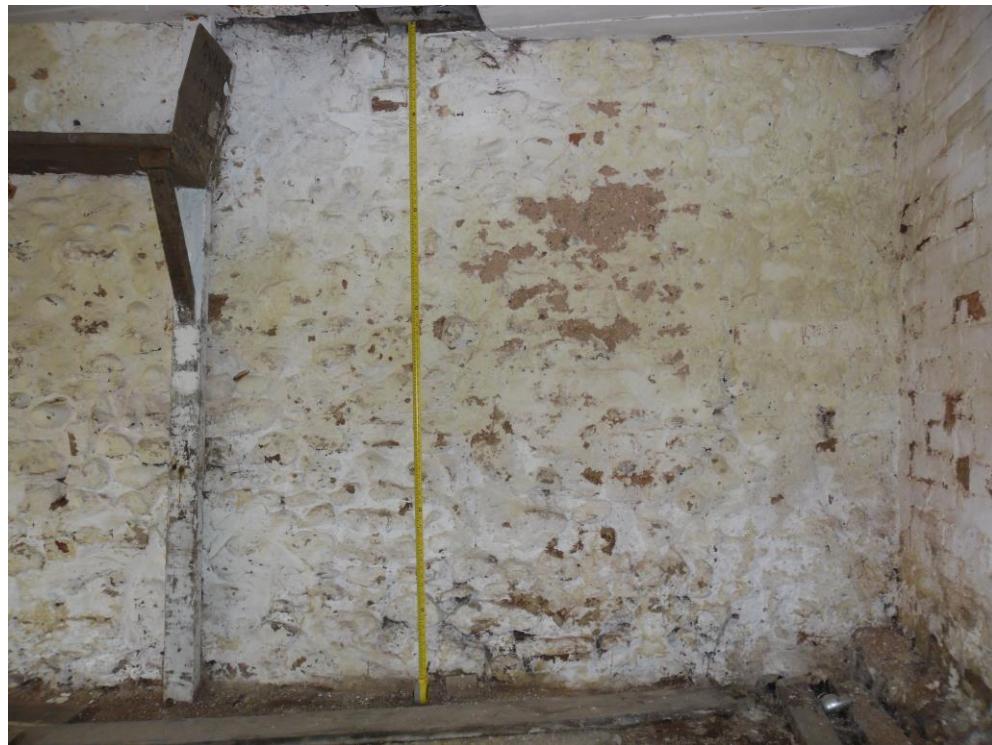
Plate 7: View looking S showing roughly coursed rubble masonry wall in southernmost compartment in southern range of Building A with timber shelving to left of picture

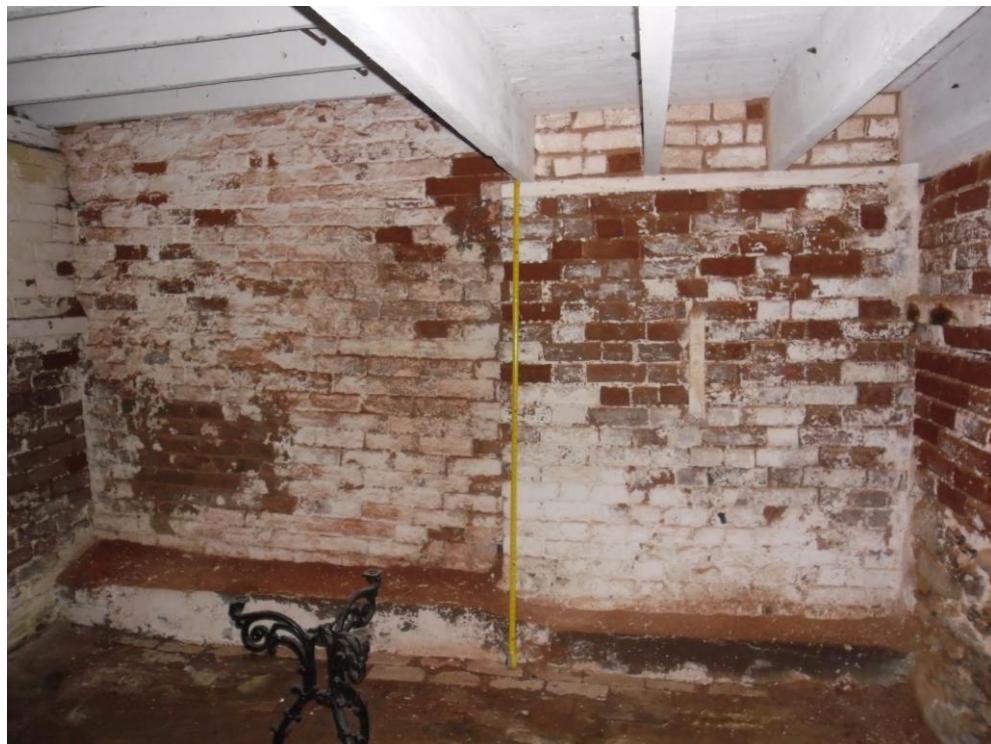
Plate 8: Internal view looking W showing second compartment in southern range of Building A with evidence of construction break in central part of elevation

Immediately to the N is another narrow compartment, largely of brick construction with a brick cobbled floor. Evidence for a probable construction break was noted in the middle of the W wall of this compartment, distinguished by a marked difference in bonding between the stretcher bond to the left and a more irregular bond consisting of rows of stretchers and intervening rows of headers. This reconstruction of the W wall appears to have been connected with a lowering of the ceiling in this part of the building (*Plate 8*). The E wall of this compartment appears to have been substantially reconstructed with concrete breeze blocks.

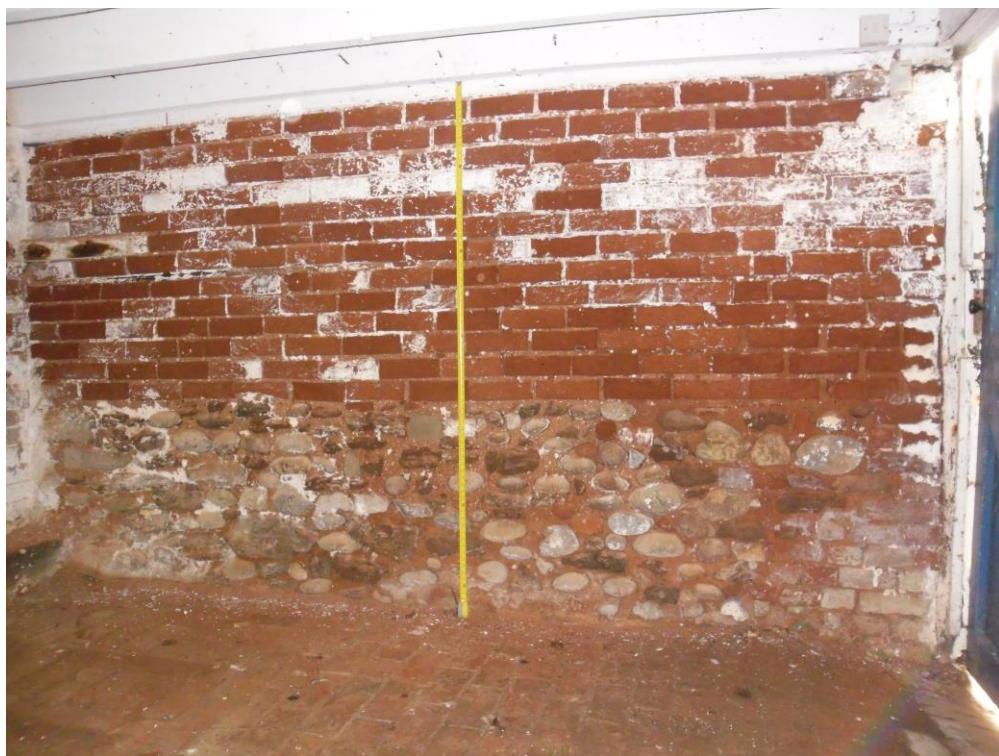
Plate 9: Internal view looking N showing S-facing wall of second compartment, the lower stages of brick and rubble masonry construction surmounted by brickwork laid in stretcher bond

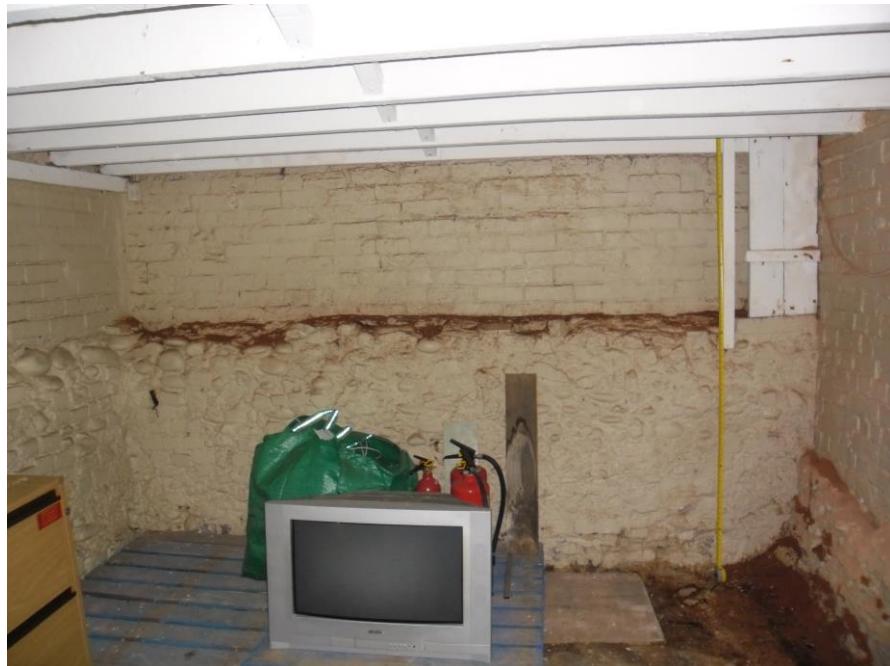
Plate 10: View looking S showing N-facing wall of long compartment within southern range of Building A

Immediately N of this is the largest compartment within the southern range of Building A, three bays in length. The construction of this part of the building differs markedly from the other compartments; the lower stages of the E-, W- and S-facing walls are of irregularly-coursed rubble masonry construction surmounted by a later brick wall laid in stretcher bond, all of which are coated in whitewash (*Plate 10*). The flooring appears to have been partially removed but evidence for rough stone cobbling was noted. Two low flat-arched window openings, subsequently blocked, are visible within the E wall of this compartment, one of which appears to have a wooden lintel (*Plate 11*).

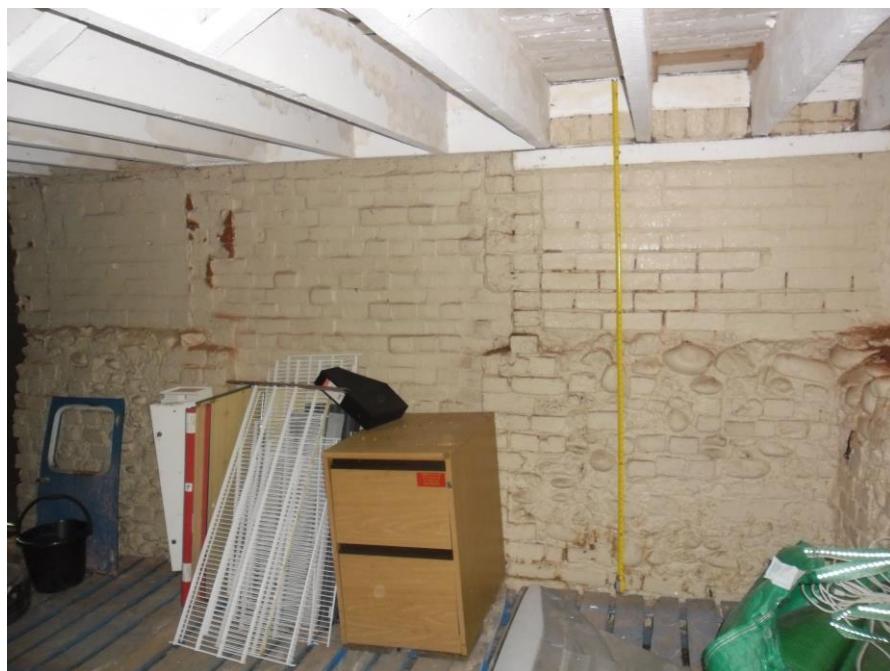
Plate 11: Internal view showing blocked-up window openings in W wall of long compartment in S range of Building A

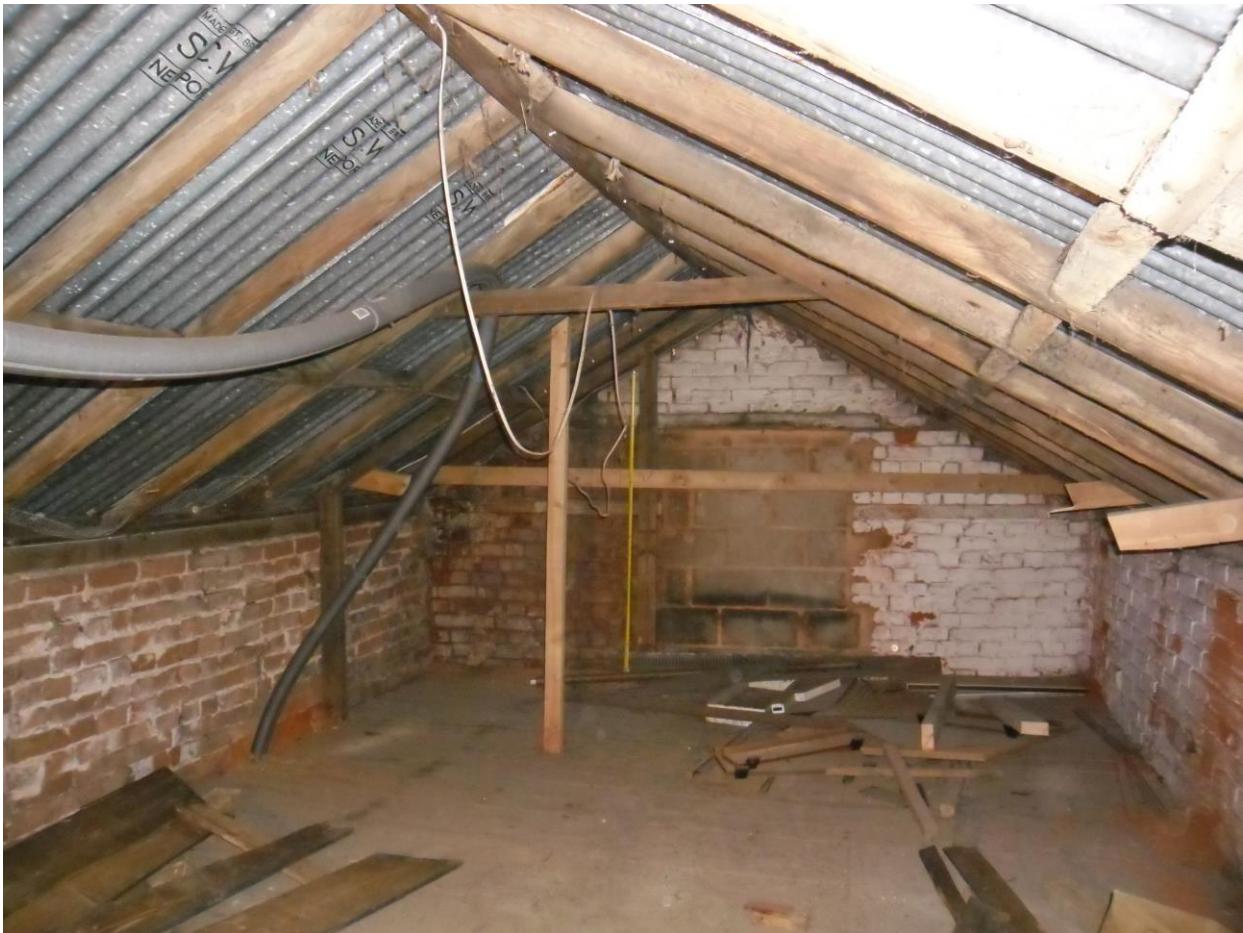
Plate 12: Internal view looking S showing upper storey of compartment at southernmost end of southern range of Building A, with evidence for open truss roof construction and blocked-up window or loading bay in S gable end

The upper storey of Building A is entirely of brick construction and arranged into three split-level compartments descending from S to N, each accessed by a flight of wooden stairs. The southern range of Building A comprises two compartments; the floor of the southern compartment is set slightly above its northern counterpart. The southernmost compartment (*Plate 12*) has a roof of open-truss construction with trenched purlins. The brickwork of the E and W walls are laid in stretcher bond; however, the brick bonding of the S gable wall is much more irregular and appears to indicate a phase of rebuilding. Inserted in the S gable wall is a flat-headed opening with a wooden lintel, which could be either a window or loading bay.

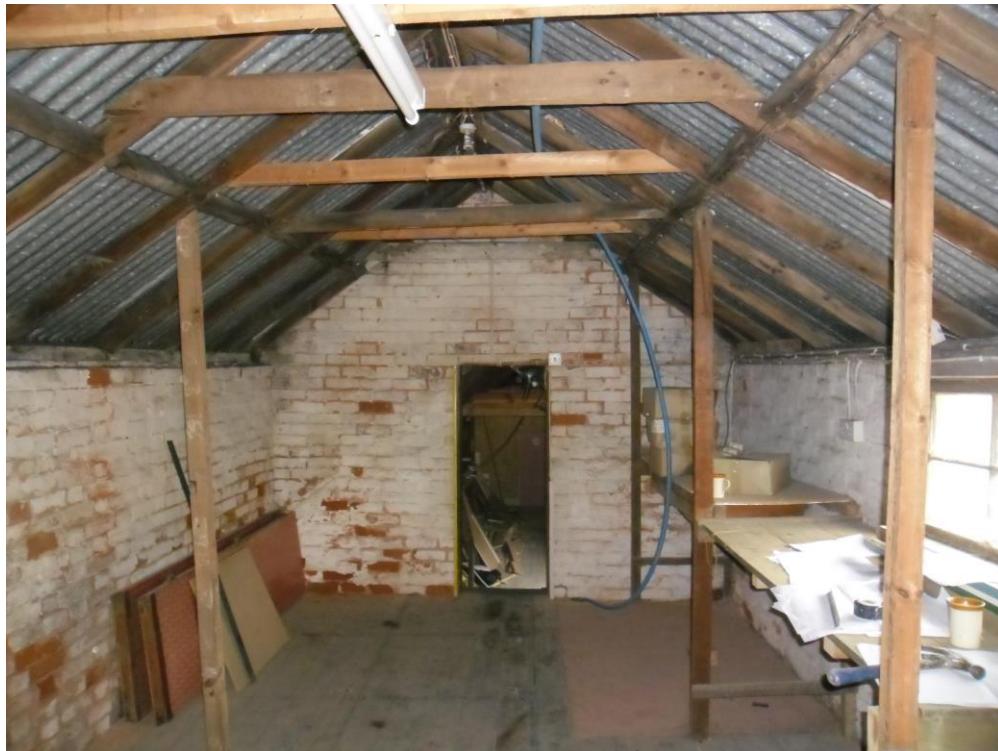
Plate 13: Internal view looking N within upper-storey compartment in northern half of southern range of Building A showing open-truss roof construction with vertical struts linked to the principal rafters

A flight of wooden stairs leads down from this compartment to another room within the southern range of Building A (*Plate 13*), which appears to have been used until fairly recently as workshops (indicated by the benches flanking either side of the room). This room is lit by a single six-paned casement window (presumably of modern date); the roof construction is open truss with trenched purlins but has vertical struts linked to the principal rafters. The flanking walls are of brick construction, laid in stretcher bond and coated in whitewash.

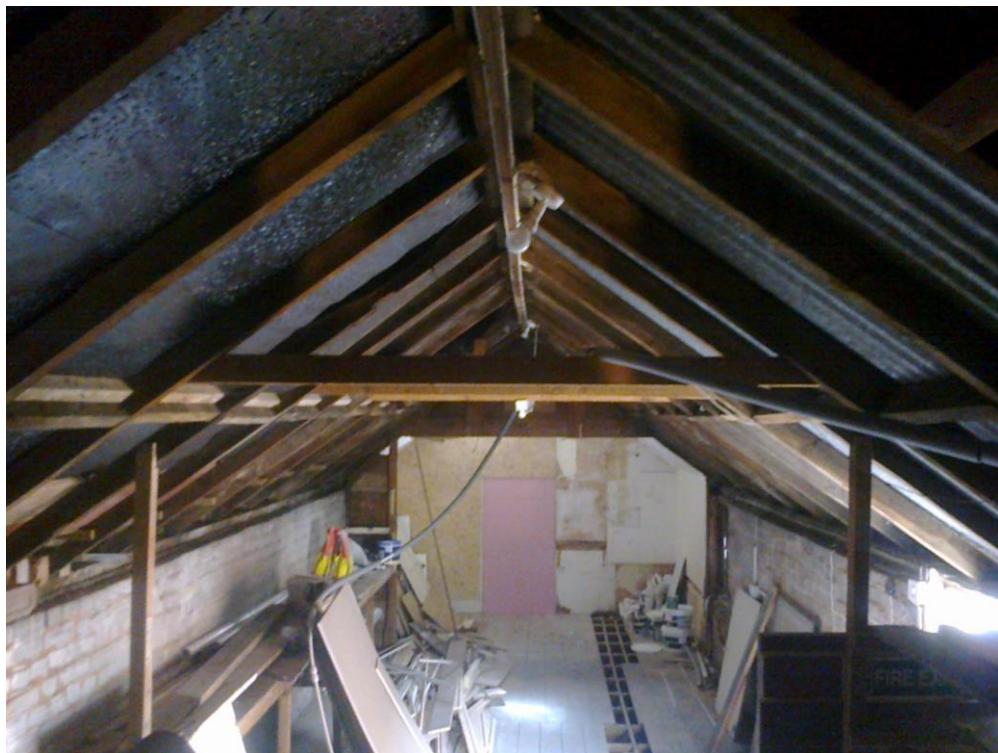
Plate 14: Internal view looking S within upper storey of northern range of Building A showing open-truss roof construction with vertical struts supporting the principal rafters

To the N of this room, a flight of stairs leads down to the upper-storey compartment within the northern range of Building A, which is separated from the southern range by a brick partition wall (laid in stretcher bond). This compartment is lit by a 16-paned casement window (which has been boarded-up). The flanking walls are of stretcher bond and partially whitewashed, while the N gable end has been completely clad in plasterboard and wallpaper (*Plate 14*). A blocked doorway in the centre of the N gable wall presumably led to the main building, above which is a partially blocked triangular window inserted in the apex of the gable, which appears to be a modern addition.

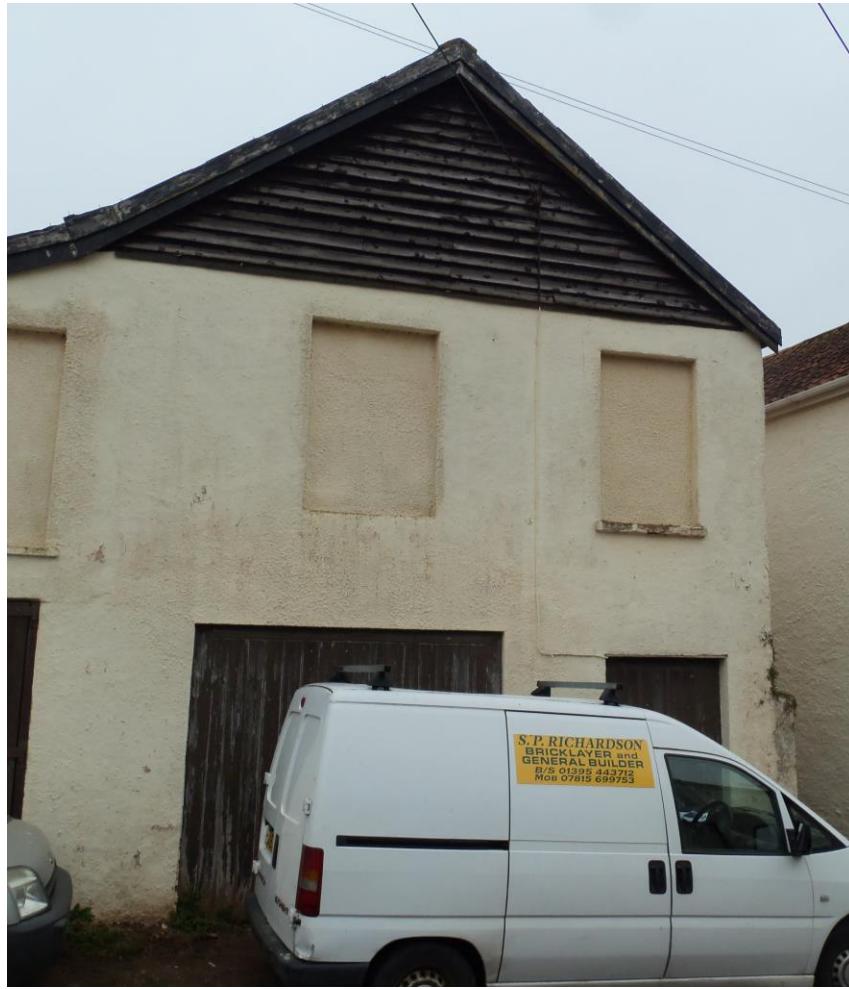
Plate 15: View looking N showing S-facing elevation of Building B, externally roughcast with blocked-up windows at upper storey level

Building B, located directly opposite Building A on the E side of the yard, consists of a rectangular two-storey block of brick construction, three bays wide (E-W), externally roughcast with a weather-boarded gable and pitched-tiled roof (*Plate 15*). The westernmost bay with its catslide roof appears to be a later addition. Three blocked-up, flat-headed windows with brick sills are visible at upper-storey level. Attached to the W side of the building, projecting into the yard, is a modern single-storey structure, also of brick construction, with a flat concrete roof. The ground floor of the building was, at time of writing, in use as a garage and storeroom and was largely coated in whitewash; no features of interest were visible within this area

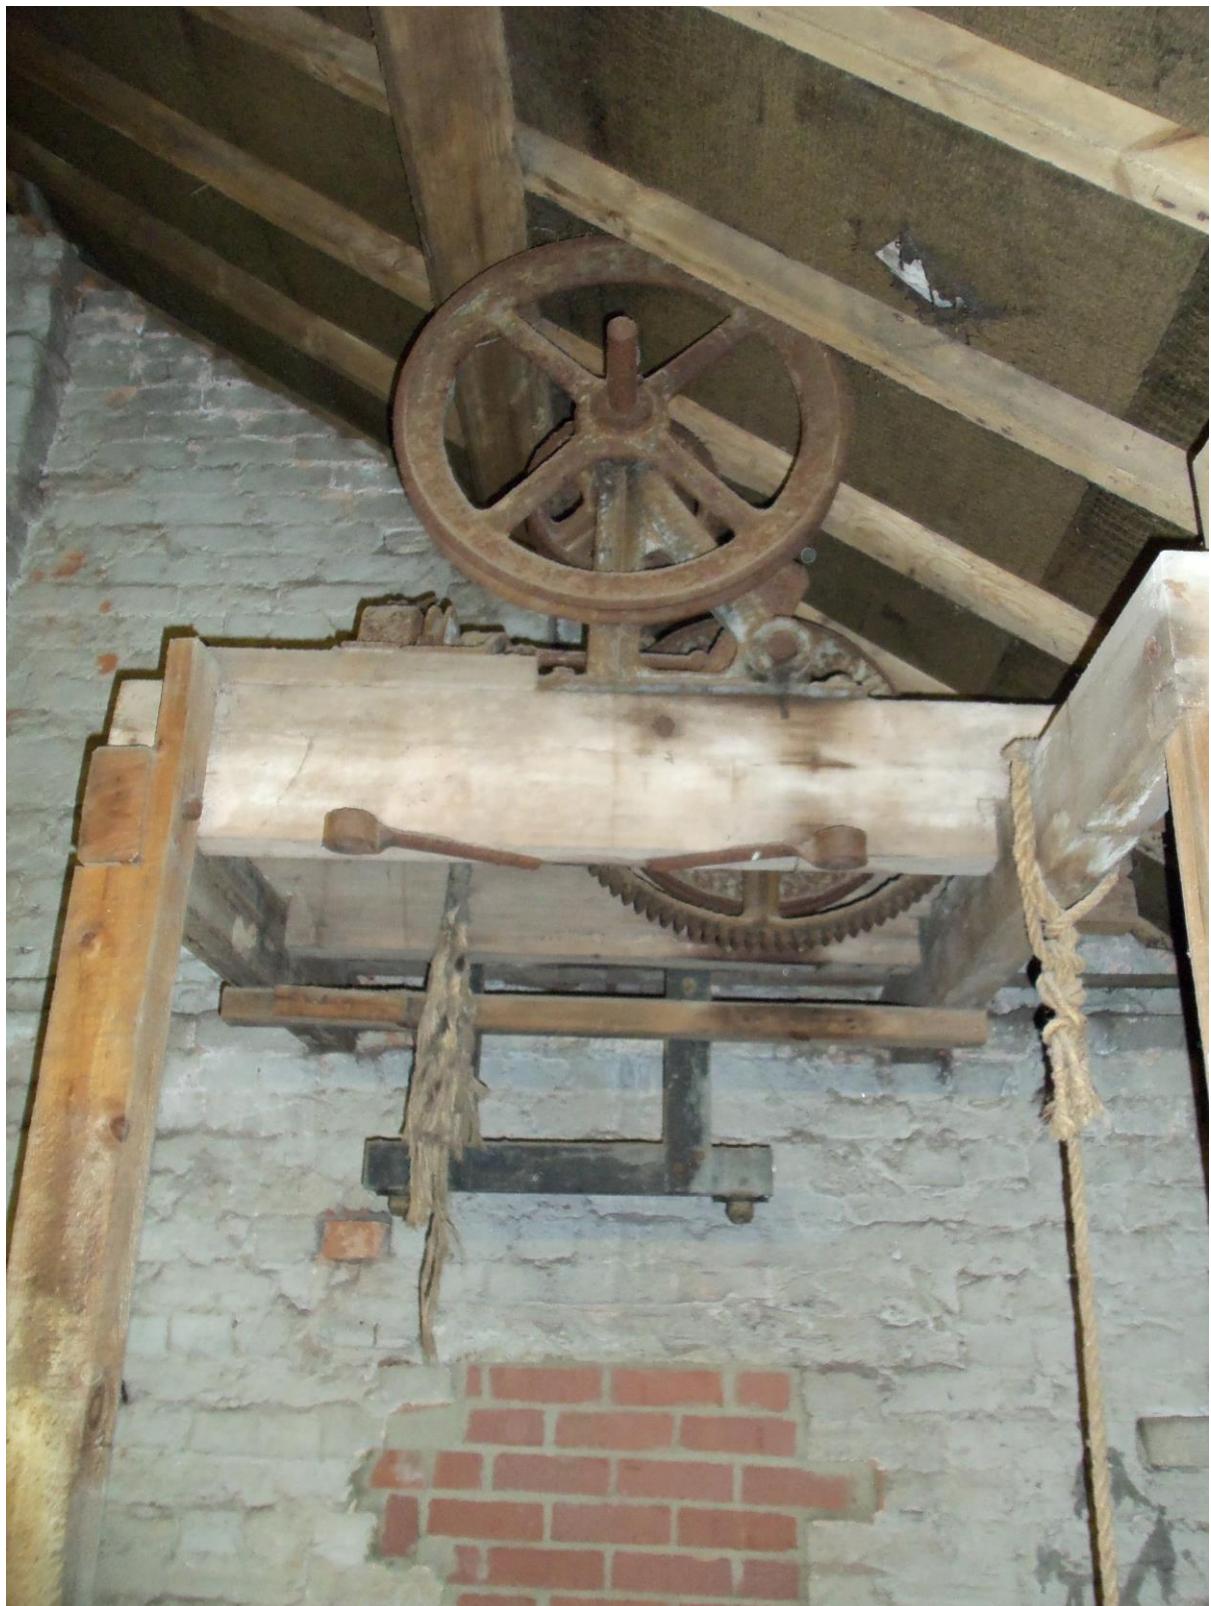
Plate 16: Internal view looking N showing hoist mechanism above stairs in upper storey of Building B

At first floor level, the building is arranged into two separate compartments, accessed by a narrow flight of stairs in the NE corner. Above the stairs was a hoist and pulley mechanism of uncertain date, possibly late 19th or early 20th century (*Plate 16*). The roof is of simple post-and-truss construction, while the E wall has been exposed to reveal timber-framing with evidence of lath-and-plaster infill (*Plate 17*). Two fireplaces with segmental brick-arched openings have been inserted into the thickness of the W wall, flanked by projecting brick buttresses, giving the impression that this wall may originally have been an external wall (*Plate 18*). The exposed timber-framing of the E wall and the brickwork of the W wall (laid in an irregular English Garden Bond) appear to represent evidence of earlier fabric, probably associated with the L-shaped building first marked in this location on the OS 1st-edition map of 1889.
