Archaeological Programme of Works

**Space Architects UK Ltd on behalf
of Mrs L. Vaughan**

13 High Street Budleigh Salterton
Devon EX9 6LD

June 2014

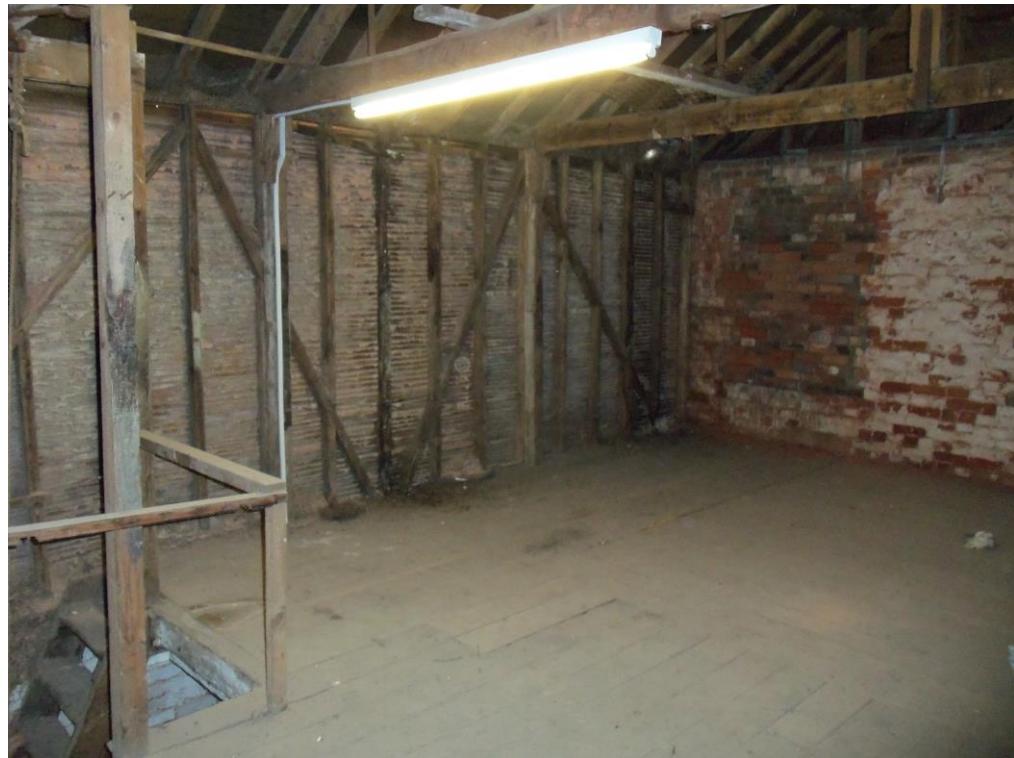
Plate 17: Internal view of upper storey of Building B looking ESE showing exposed timber-framed walling and lath-and-plaster infill

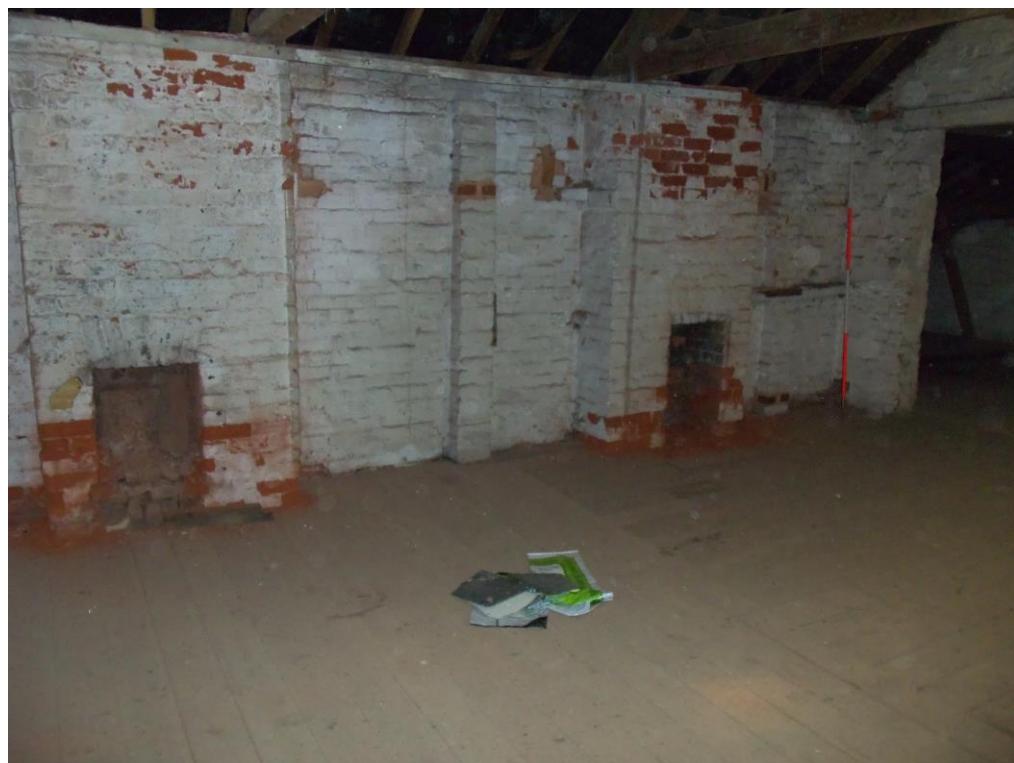
Plate 18: Internal view looking W showing brick walling and fireplaces in upper storey of Building B

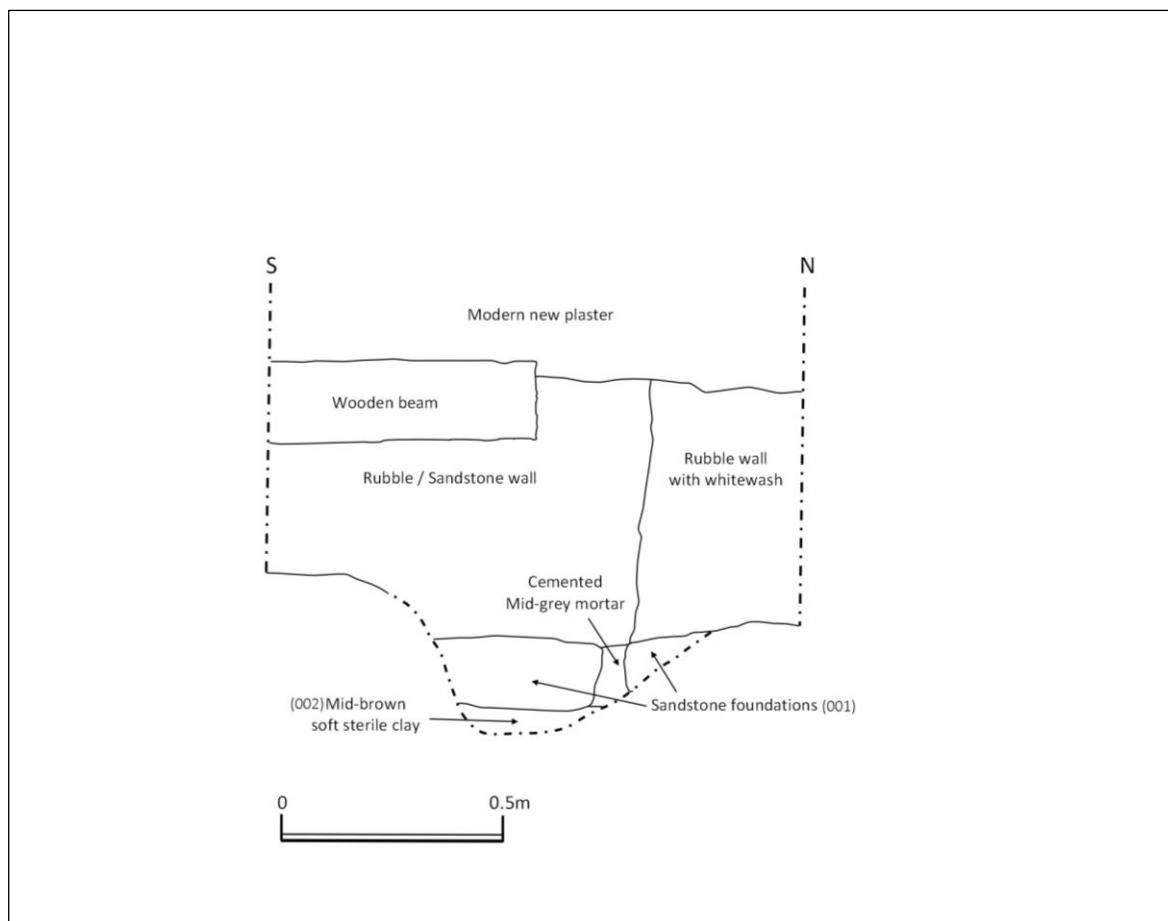
Fig. 9: E-facing section within Building A showing foundations of W wall

Reduction of ground levels within the southern range of Building A, immediately beneath the W wall, constructed of roughly-coursed rubble masonry (the lower stages of which appear to incorporate the remains of an earlier wall defining the W edge of the boundary plot), revealed evidence of a foundation course of large reddish sandstone slabs (001), 0.18m thick and bonded with a well-cemented mid-grey mortar, which, in turn, overlaid a sterile, soft mid-reddish brown sandy clay (002) measuring between 0.07-0.12m thick, devoid of finds and interpreted as probable natural deposition (*Plate 19; Fig. 9*).

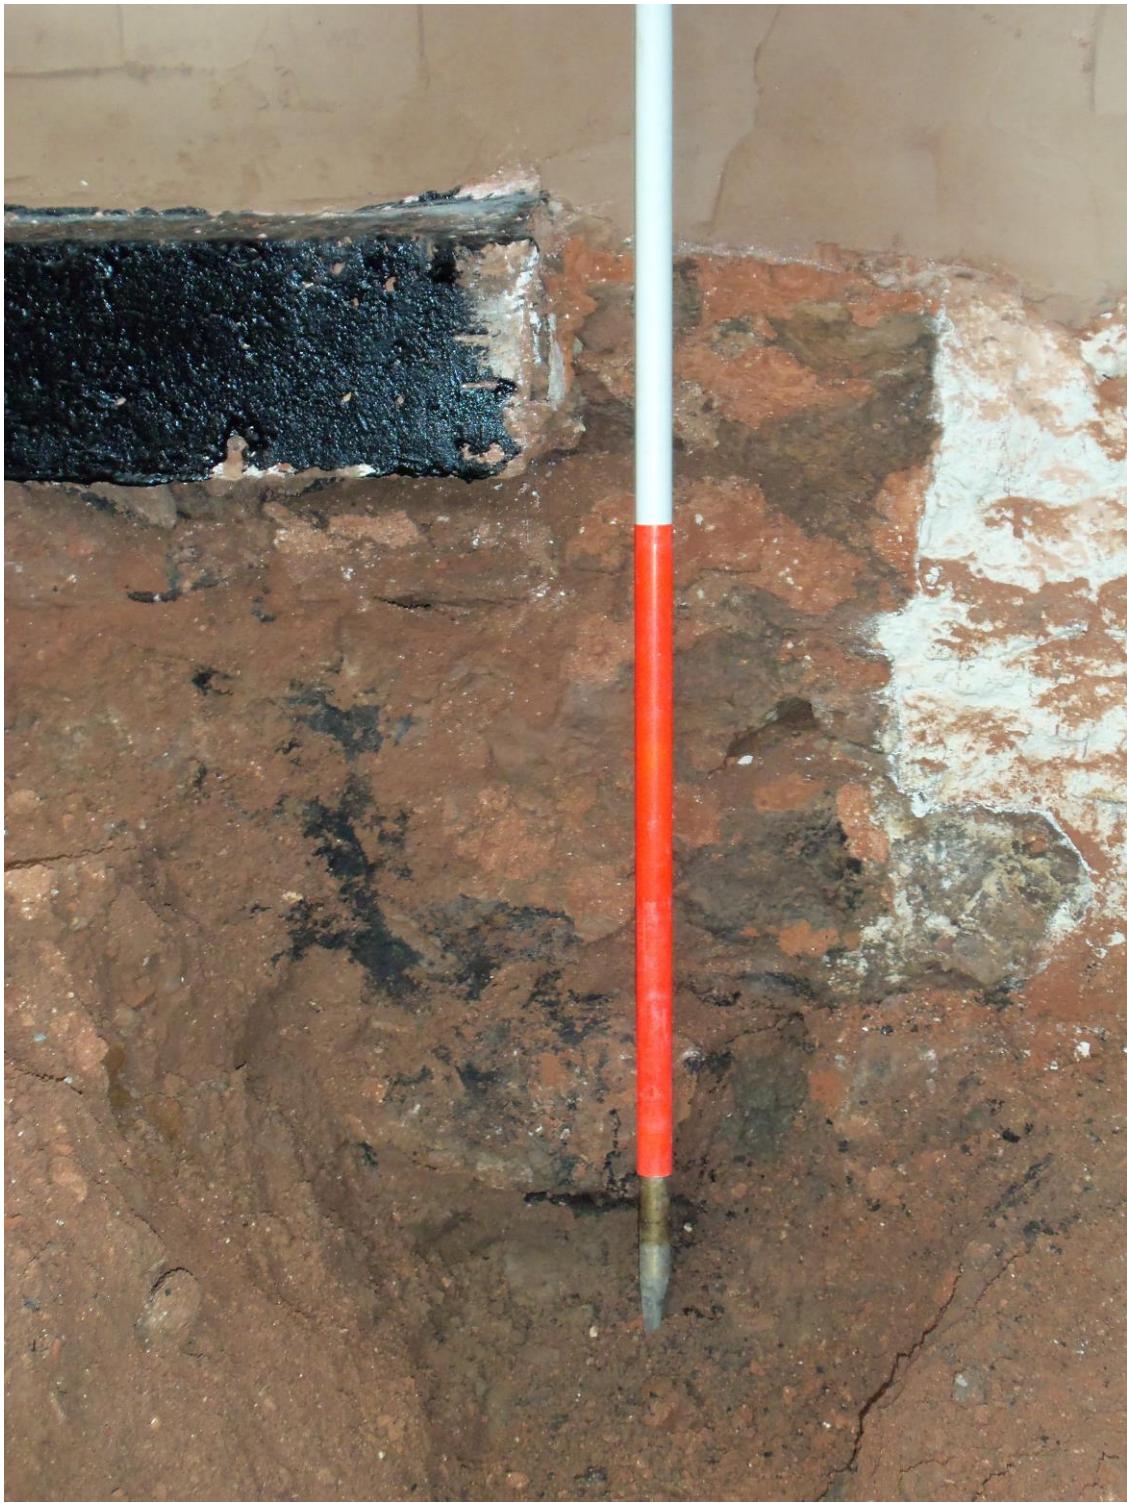
Plate 19: View looking W showing E-facing section within Building A, with evidence for sandstone rubble foundations
