Archaeological Observation

Nos. 144 – 152 York Road

Bristol BS3 4AJ

February 2015

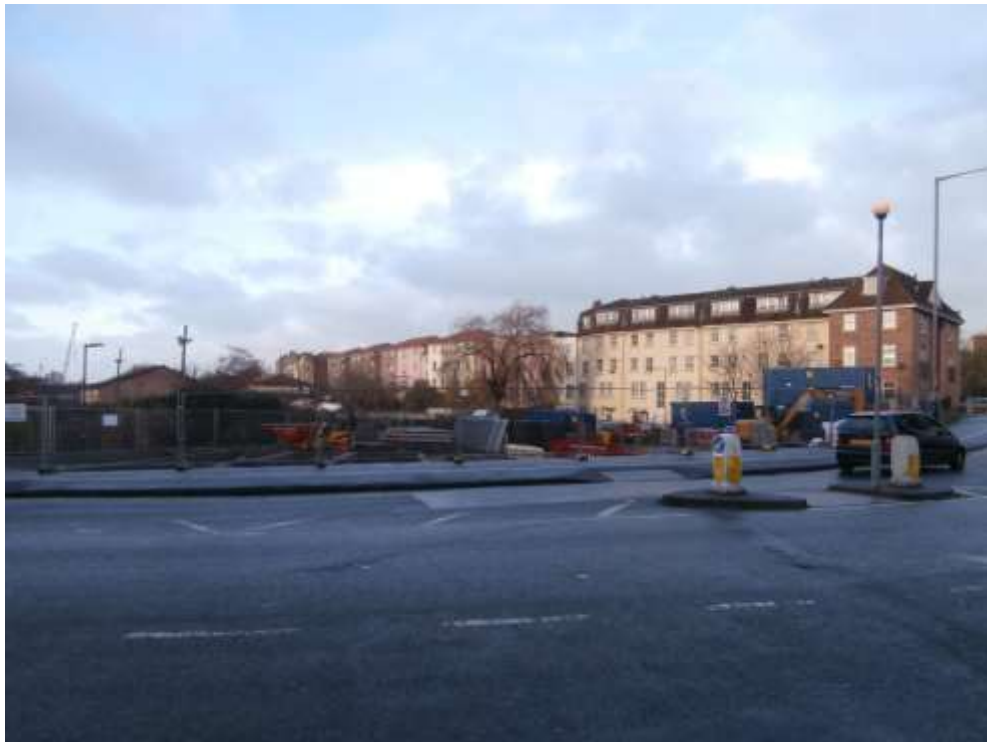
The site was located at the corner of York Road and St. Luke's Road and was previously in use as a car park (*Plate 1*).

Plate 1: View to the NW of the site from St. Luke's Road

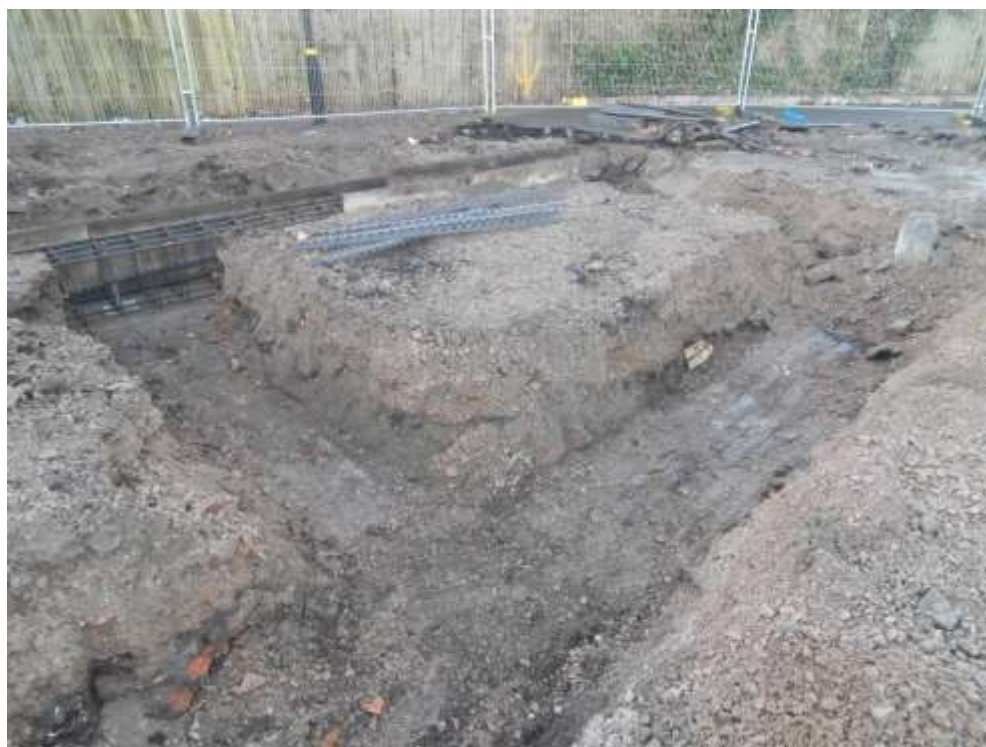
Plate 2: View to the SW depicting the modern made ground and levelling layers present across the site

The uppermost stratigraphy encountered across the site comprised a modern car-park surface (1001) and associated bedding layer (1002) and a demolition layer (1003) relating to former early 20th -century terraced housing (*Plate 2*).

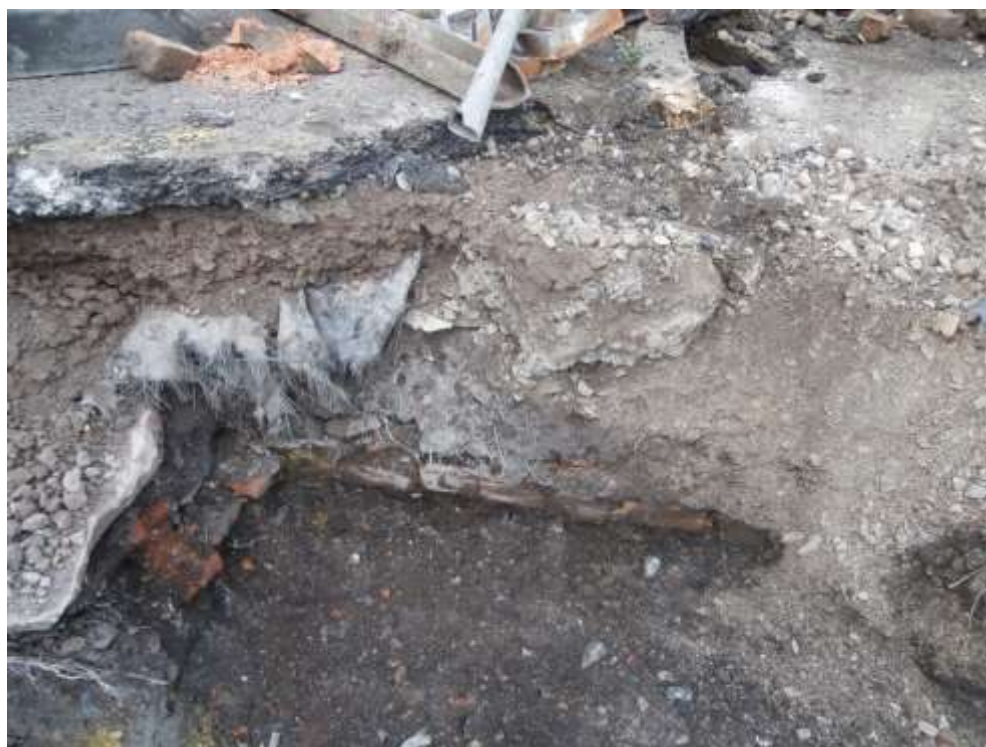
Plate 3: View to the W of wall (1007)

Wall (1007) was encountered at the SE limit of excavation and was visible only in the trench section (*Plate 3, fig. 2*). Of standard-gauge brick construction, the wall remains comprised a single course of brick foundation above demolition layer (1008). The foundation wall would thus appear likely to represent the remains of early 20th -century terraced housing.

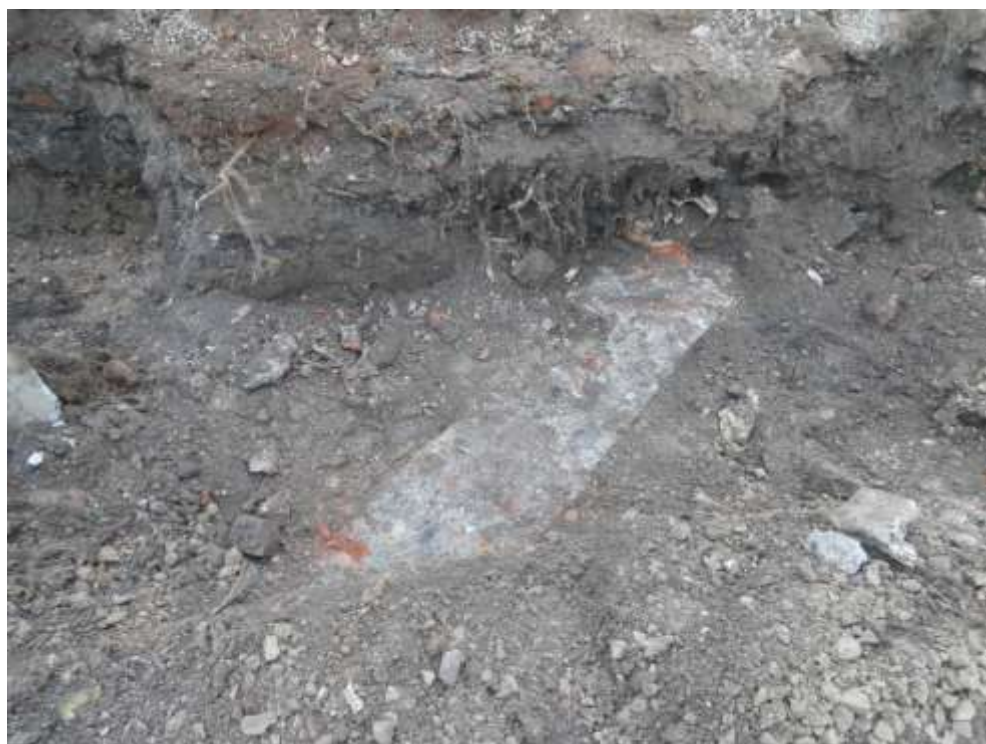
Plate 4: View to the NE of wall (1004)

Wall (1004) was located at the eastern extent of the excavation and was encountered at the very limit of the impact depth (*Plate 4, fig. 2*). The wall foundation, aligned NE-SW, was constructed from standard-gauge bricks with cement bonding.

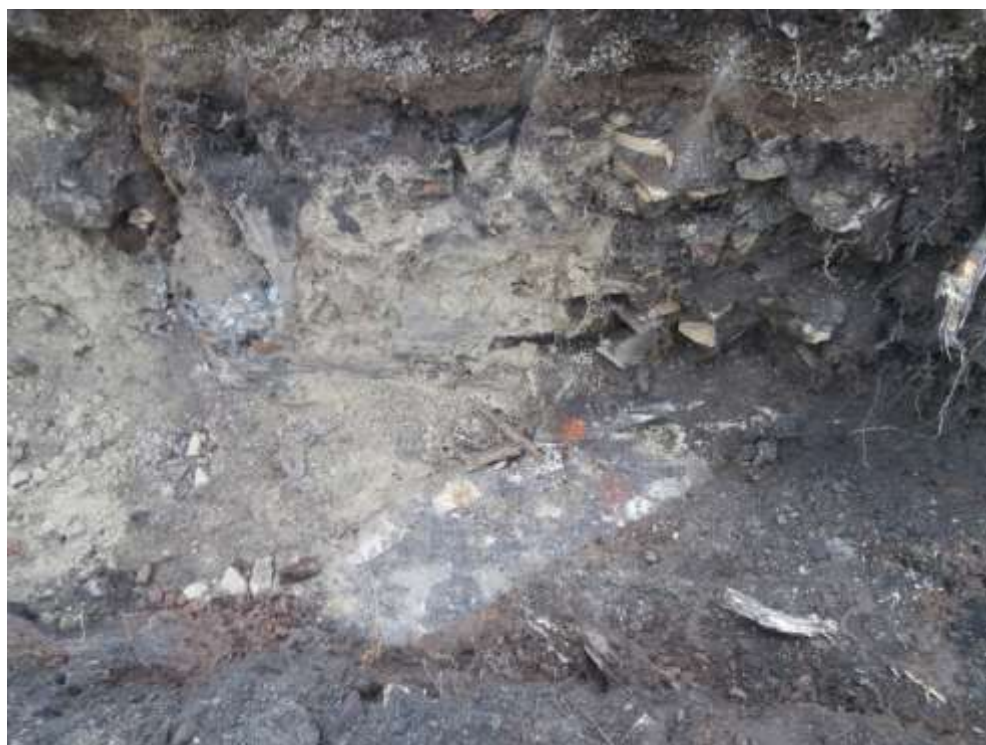
Plate 5: View to the NE of wall (1005)

Wall foundation (1005) was also located at the SE extent of the site and was aligned NW-SE parallel to St. Luke's Road. The wall lay directly beneath the hard-core levelling layer (1003) and was of cement-bonded red-brick construction. The position and construction methodology of walls (1004) and (1005) would suggest they related to early 20th –century terraced housing development.

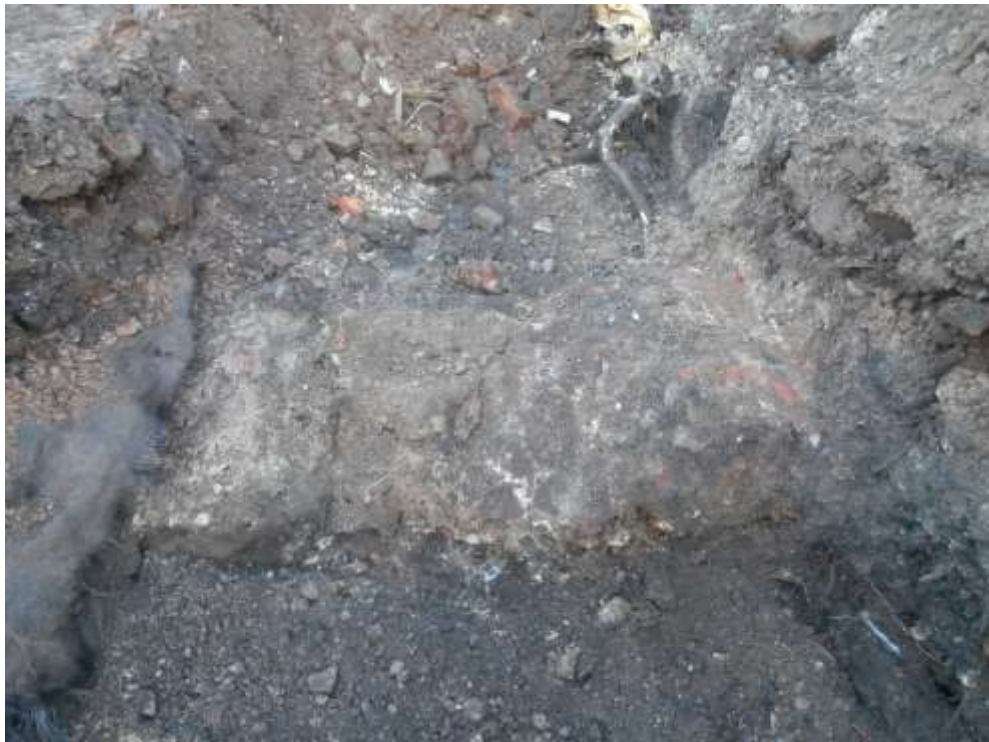
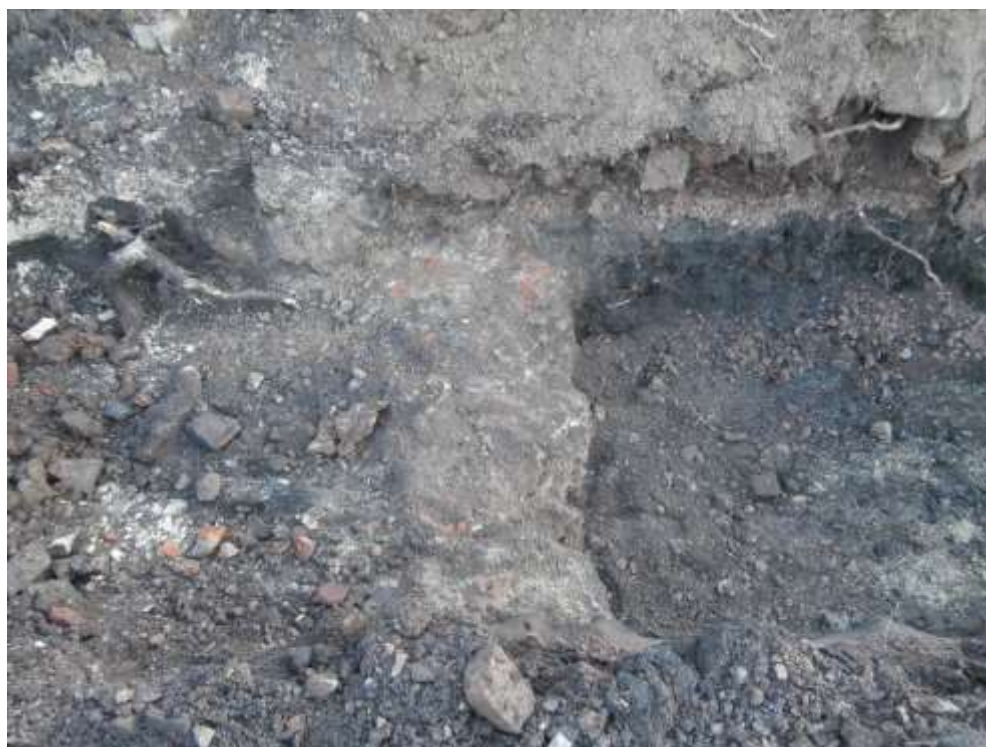
Structures (1015) and (1016) were wall foundations, both constructed of cement-bonded standard-gauge brick (*Plates 6-7, fig. 2*). Both sections of masonry were encountered at the limit of excavation and only a single course survived in each case; it was thus not possible to identify the type of bond. The width of both walls suggests they may relate to the external walls of the early 20th –century dwellings.

Plate 6: View to the S of wall (1015)

Plate 7: View to the E of wall (1016)

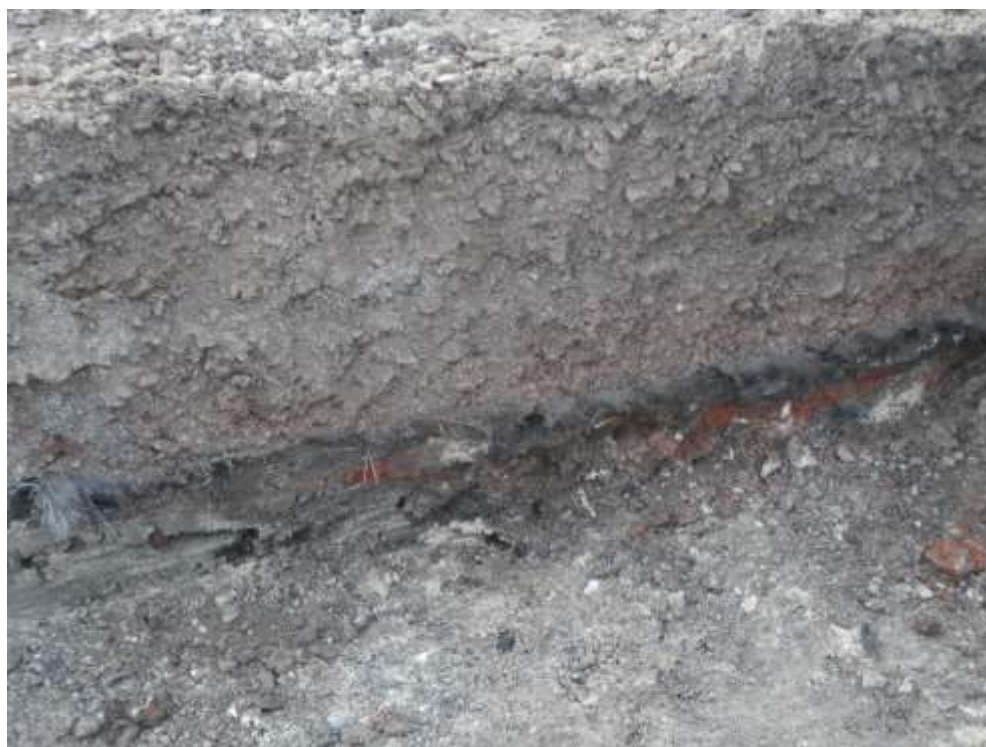
Plate 8: View to the SE of walls (1017) and (1018)

Structures (1017) and (1018) were very heavily truncated and were only partially visible at the limit of excavation (*Plate 8, fig. 2*). Both were constructed from cement-bonded standard-gauge brick; (1017) was visible only in plan whilst (1018) was visible only in the N-facing section.

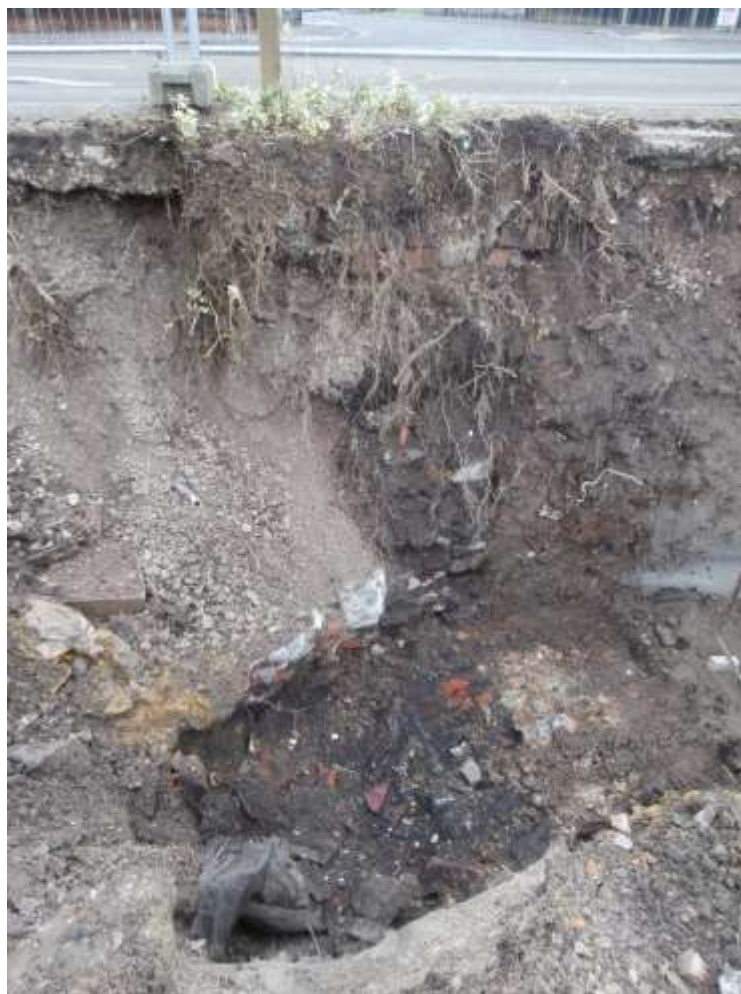
Plate 9: View to the NE of wall (1019)

Wall foundation (1019) stood at the eastern extent of the site (*Plate 9, fig. 2*). For safety reasons, the wall was not fully excavated and recording was possible only from the top of the trench. It appears possible that the foundation represents either a wall return (based on a change of alignment from E-W to NE-SW) or from two separate construction phases. However, their similarities in terms construction materials suggested they were contemporary.

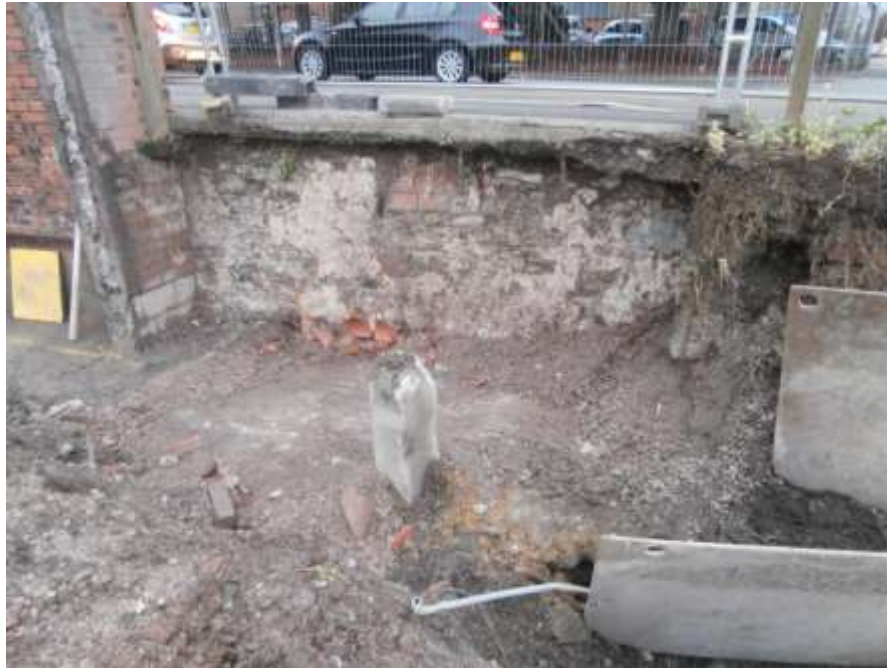
Plate 10: View to the NW of wall (1020)

Wall (1020) was a NW-SE -aligned section of masonry encountered 0.21m below ground level at the NE edge of the site, directly beneath the hard-core bedding layer (1011) (*Plate 10, fig. 2*). The wall remains extended 3.36m (NW-SE) with a maximum thickness of 1.42m. The wall was of cement-bonded standard-gauge brick construction with traces of possible whitewash, although this material had degraded and was very friable.

Towards the centre of the wall was a small recessed area which may have represented a window opening or coal chute. This section of wall was situated on the very outer limit of site and will be preserved *in-situ*. The wall is considered to represent a good example of an internal cellar wall relating to one of the early 20 –century terraced properties.

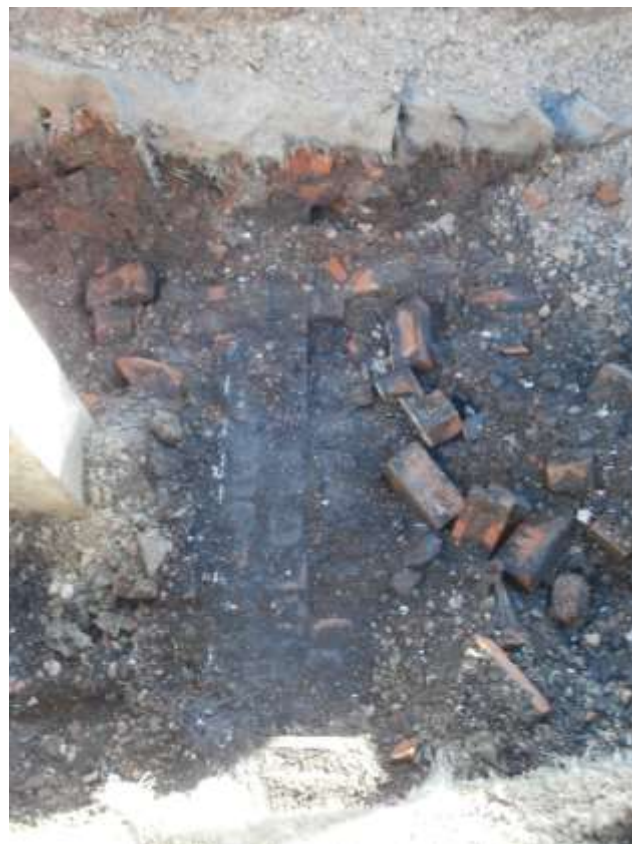
Plate 11: View to the N of wall (1021)

Masonry (1021) represented a small and heavily truncated section of brick foundation wall aligned NW-SE across the width of the trench, which possibly represented an internal foundation (*Plate 11, fig. 2*).
