**Standing Building Recording
Survey**

The Royal George Inn

Lyonshall

BA1501RGIL

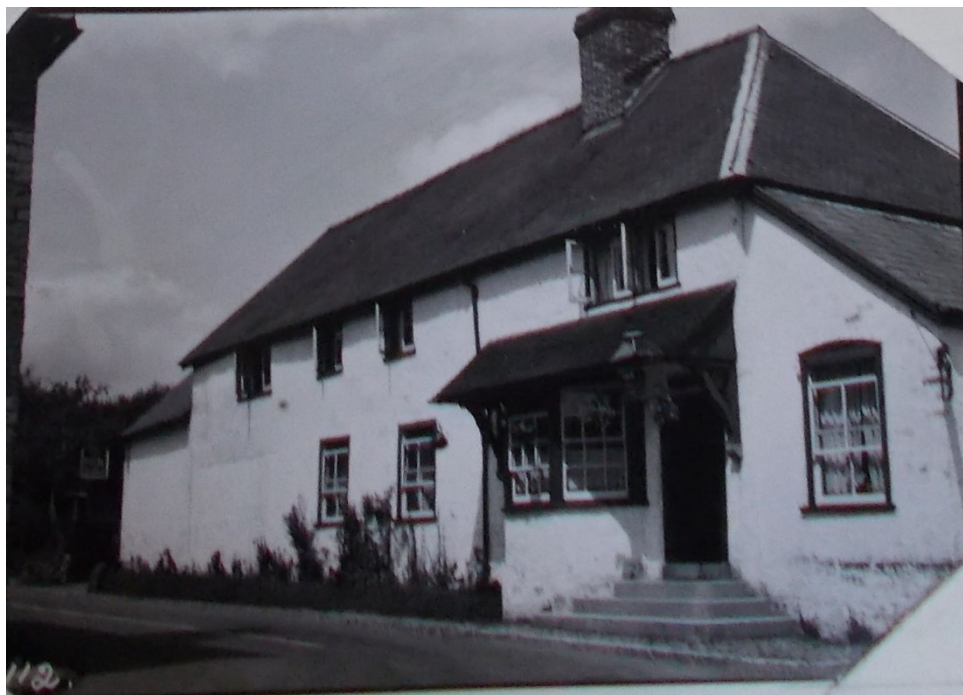
*Fig. 4: Photograph of the Royal George Inn taken in 1933
(Reproduced by courtesy of the National Monuments Record)*

To the right of the easternmost sash window is a canted bay window flanked by two partially glazed doors, each with four stone steps leading to pavement level, all under a penticed, tiled roof supported by plain scrolled timber brackets (*Plate 3*). Comparison between photos of the SW-facing frontage of the Inn taken in 1933 and 1965 (*Figs. 4 & 5*) indicate that only the door to the right of the canted bay window was in existence in 1933 and

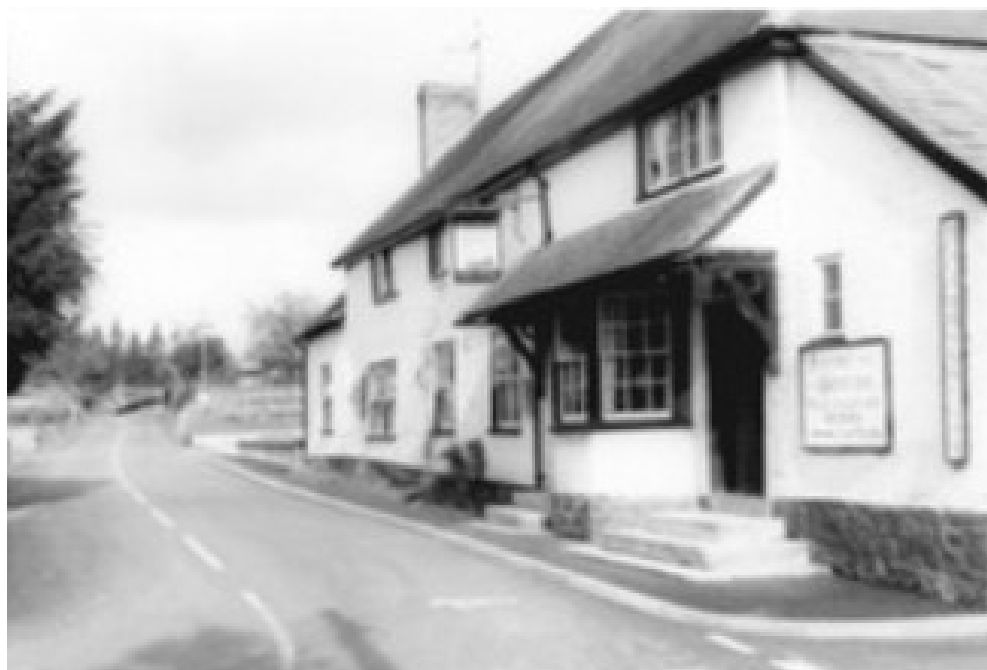
*Fig. 5: Photograph of the Royal George Inn taken in 1965 showing alterations
(Reproduced by courtesy of Hereford Central Library)*

that its counterpart to the left was inserted (and the penticed roof extended over it) by no later than 1965. The fenestration of the canted bay window consists of three 12-paned sash windows, the upper sash of the central window has been replaced (at some time before c.1965) with frosted glass and a circular ventilation slot inserted. Inserted in the wall between the easternmost sash window and the glazed door to the left of the canted bay window is a glazed plaque bearing the inscription 'West Country Ales – 1760'; this plaque was added between 1958 and c.1967 and indicates that the Royal George had been purchased by West Country Breweries.

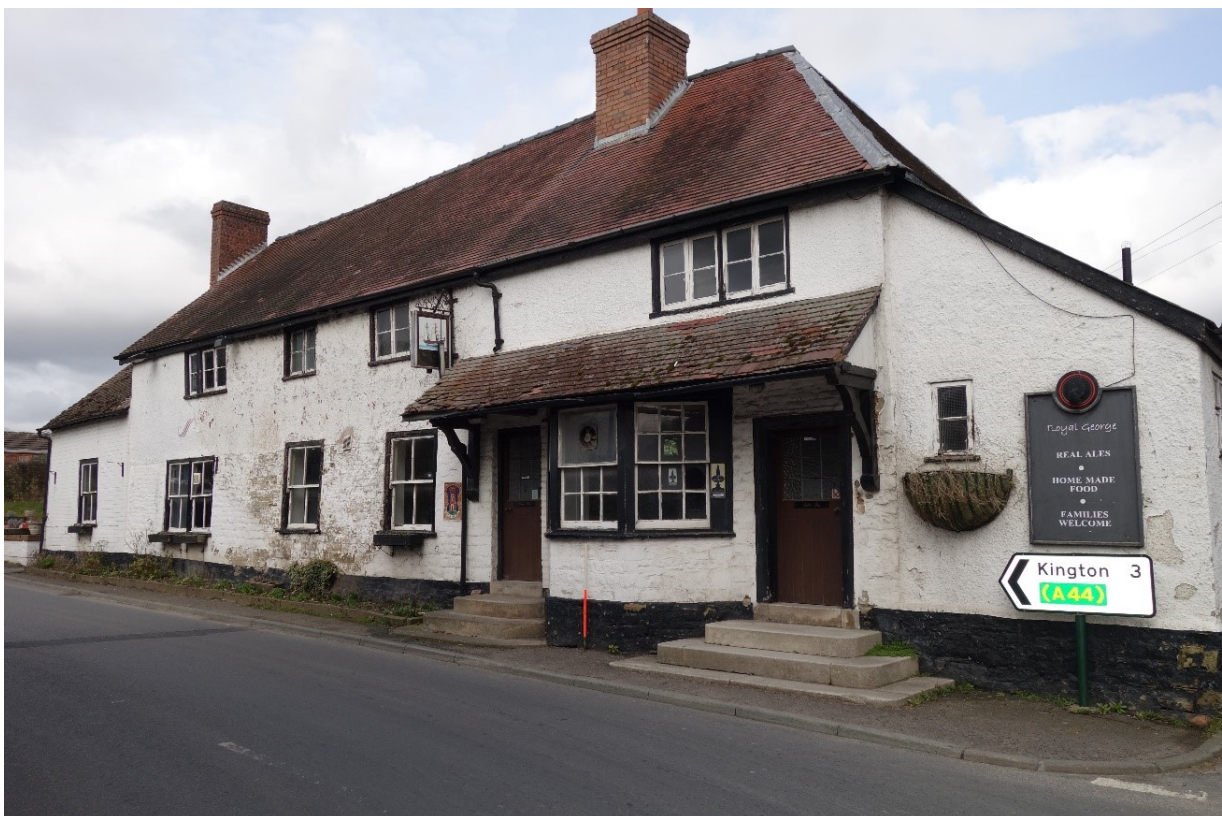
Plate 1: View looking N showing principal SW-facing external elevation of the Royal George Inn

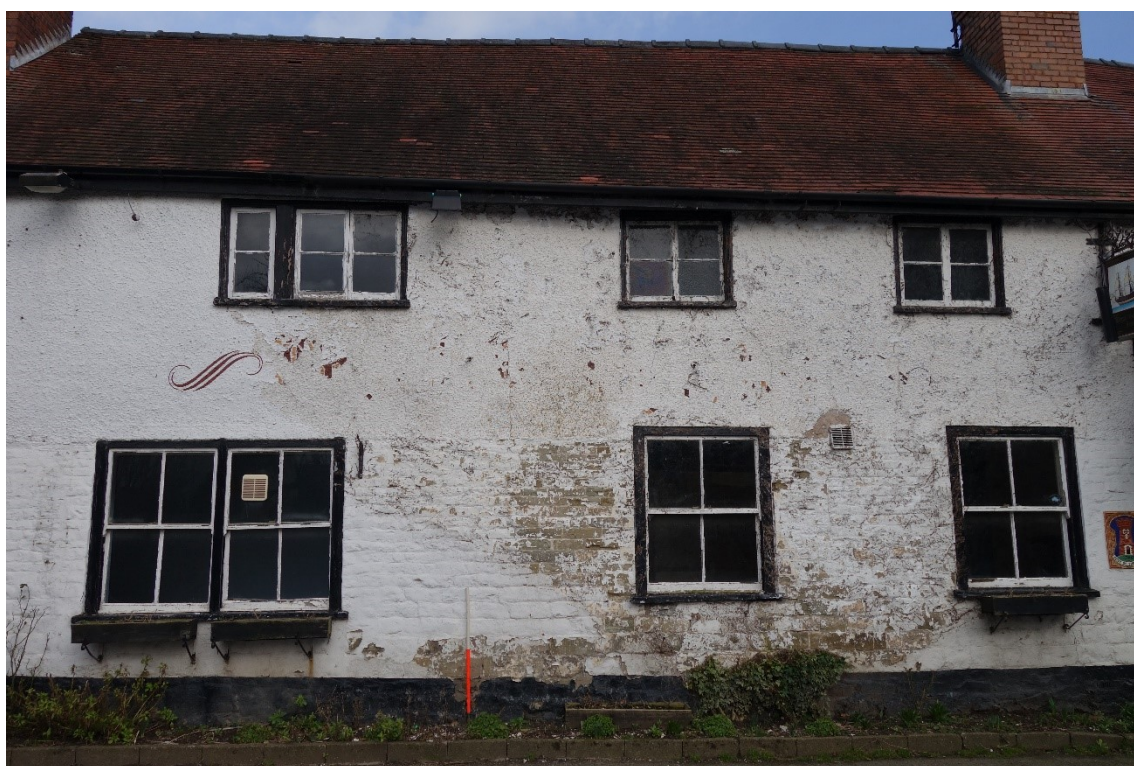
The main block is four bays long and two storeys high; the lower storey of the principal, SW-facing elevation is of coursed sandstone masonry construction, whitewashed and resting on a sandstone rubble plinth. The upper storey is clad in roughcast, concealing evidence of its original construction, but internal evidence indicates that it is timber-framed with square panels infilled with lath-and-plaster and more recent brick nogging. The description of the building in the RCHME survey (compiled in 1933) refers to the frontage as originally being of jettied construction (i.e. with an overhanging upper storey), which was subsequently underbuilt at a later date.

Plate 2: View looking NE showing the SW-facing elevation of the central three bays of the main block, the fenestration comprising sash windows at ground level and casement windows at upper-storey level

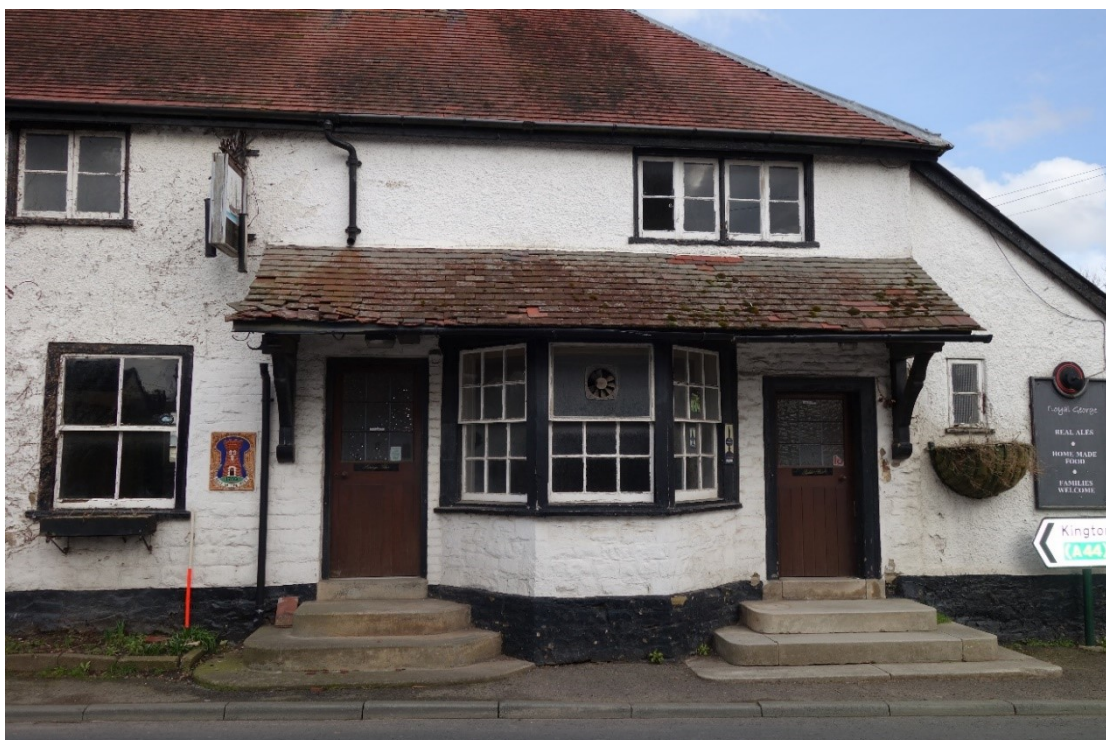
Plate 3: View NE showing the SW-facing elevation at the SE end of the main block, with a canted bay window of late 19th - century date flanked by two doorways, the one to the left being a 20th -century insertion

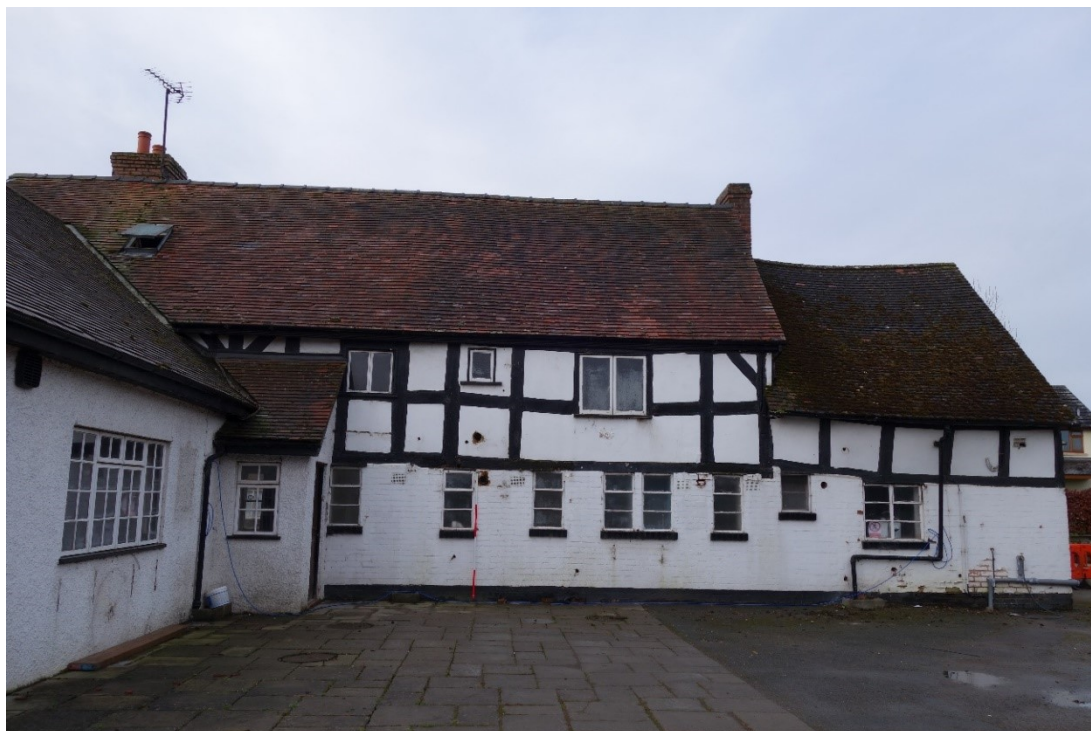
A substantial portion of the rear (NE-facing elevation) of the main block, extending SE from the kitchen to the public bar, appears to have been wholly rebuilt in brick at ground level during the mid-20th century, when the pantry and new toilet block were inserted (*Plate 4*). Some evidence of exposed square-panelled timber-framing is visible at upper-storey level, although the fenestration, consisting of two two-paned casement windows flanking a small single light window, appears to be of modern date.

Plate 4: View looking SW showing the rear (NE-facing) elevation heavily reconstructed in brick during the mid-late 20th century, with exposed timber framing at upper-storey level

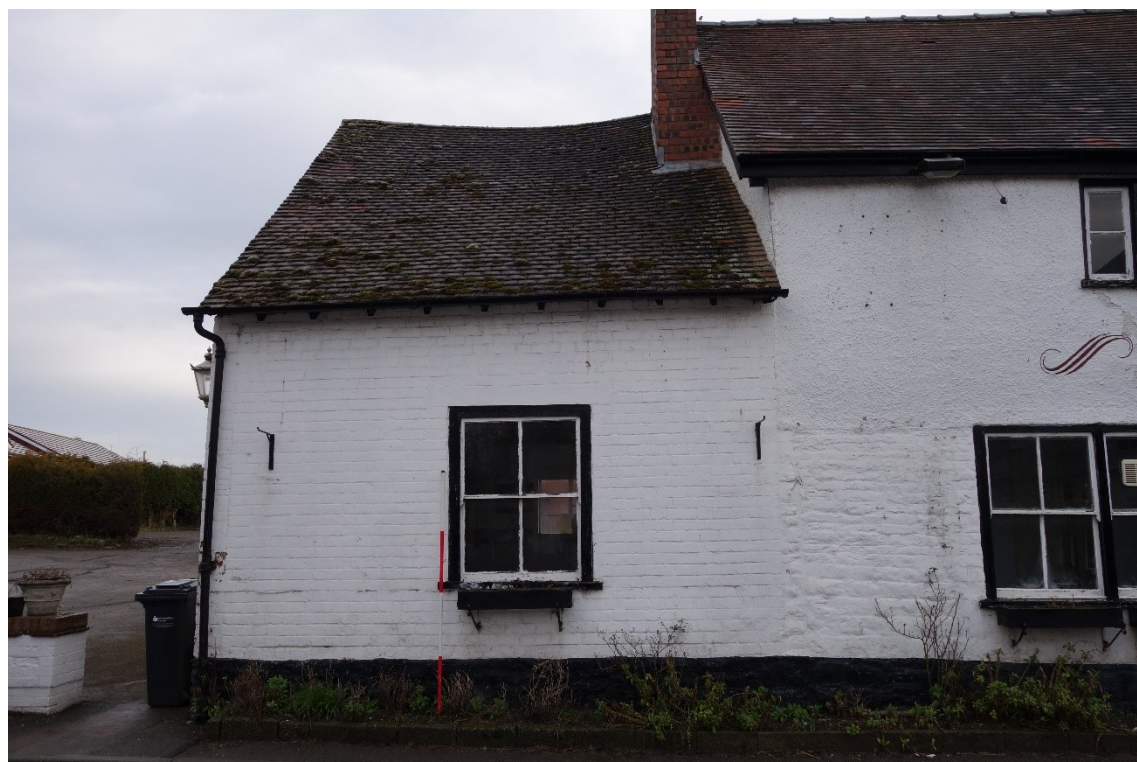
Plate 5: View NE showing the SW-facing elevation of the single-storey gabled block at the NW end of the Inn, rebuilt in brick with a modern sash window inserted

The SW-facing elevation of the single-storey structure is of brick construction (laid in a regular stretcher bond) resting on a low sandstone plinth (*Plate 5*). Set within the centre of the elevation is a single four-pane sash window in a flat-headed wooden architrave surmounted by a brick lintel. The lower portion of the NW-facing gable wall (including the plinth) and the NE-facing elevation also appear to have been rebuilt in brick. At ground level, a partially glazed doorway is set off-centre within the NW gable elevation, to the left of which is a bricked-up single-light window with a brick sill and lintel. The fenestration of the rear NE-facing elevation consists of a six-paned casement window with a brick sill, above and to the left of which is a single-light glazed window.

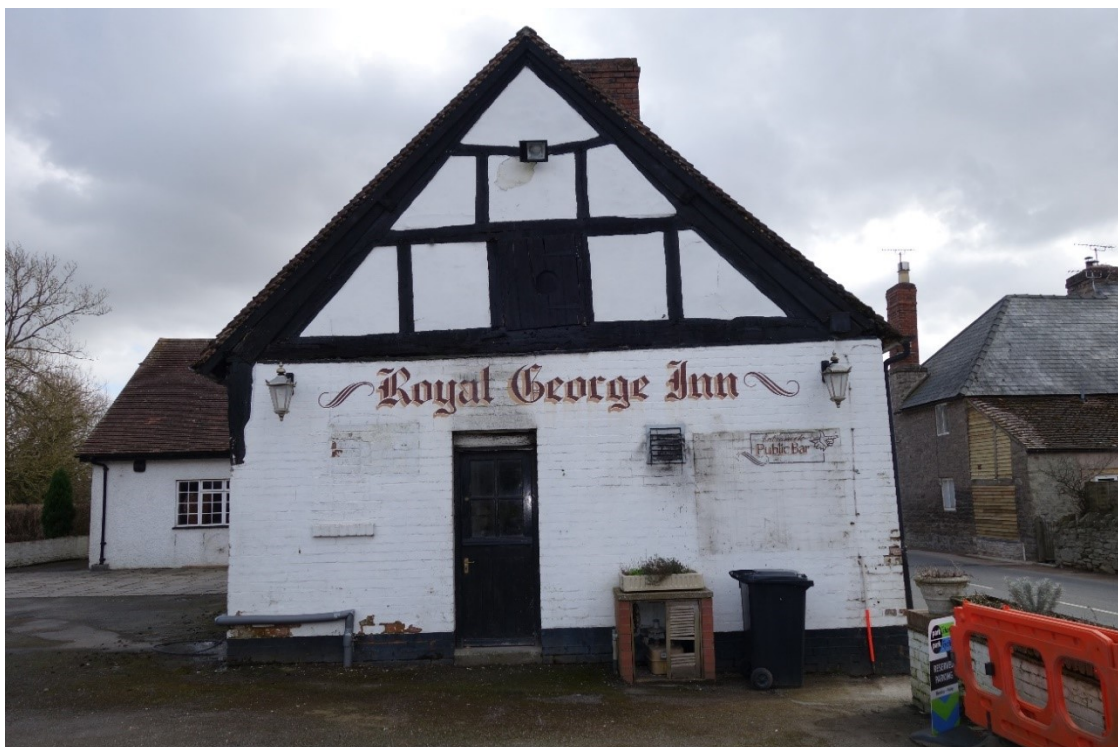
Plate 6: View looking SE showing the NW-facing elevation of the gabled block (cider house) rebuilt in brick at ground level with exposed timber framing and loft door at upper-storey level

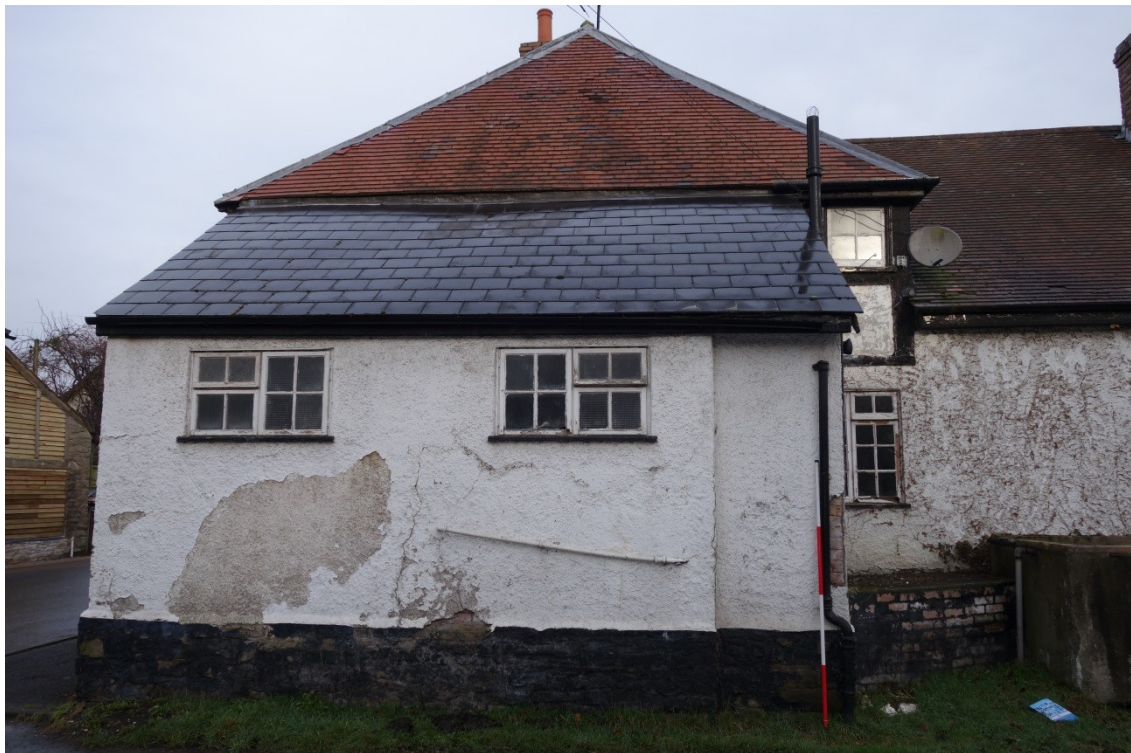
Attached to the SE end of the main block is a single-bay lean-to structure (formerly used as a toilet block) of brick construction, externally roughcast, with a steeply pitched catslide roof of grey Welsh slate (*Plate 7*). The fenestration consists of a single light two-paned window in the SW-facing elevation (which appears to have replaced an earlier sash window shown on photographs of c.1910 and 1933), two rectangular four-paned windows in the SE-facing elevation and another single-light window in the NE-facing elevation. There already appears to have been a lean-to structure in this location as early as 1840; however, in its present form, it appears largely to have been constructed in the mid-20th century.

Plate 7: View looking NW showing lean-to toilet block with catslide roof, of brick construction, externally roughcast, reconstructed in the mid-20th century

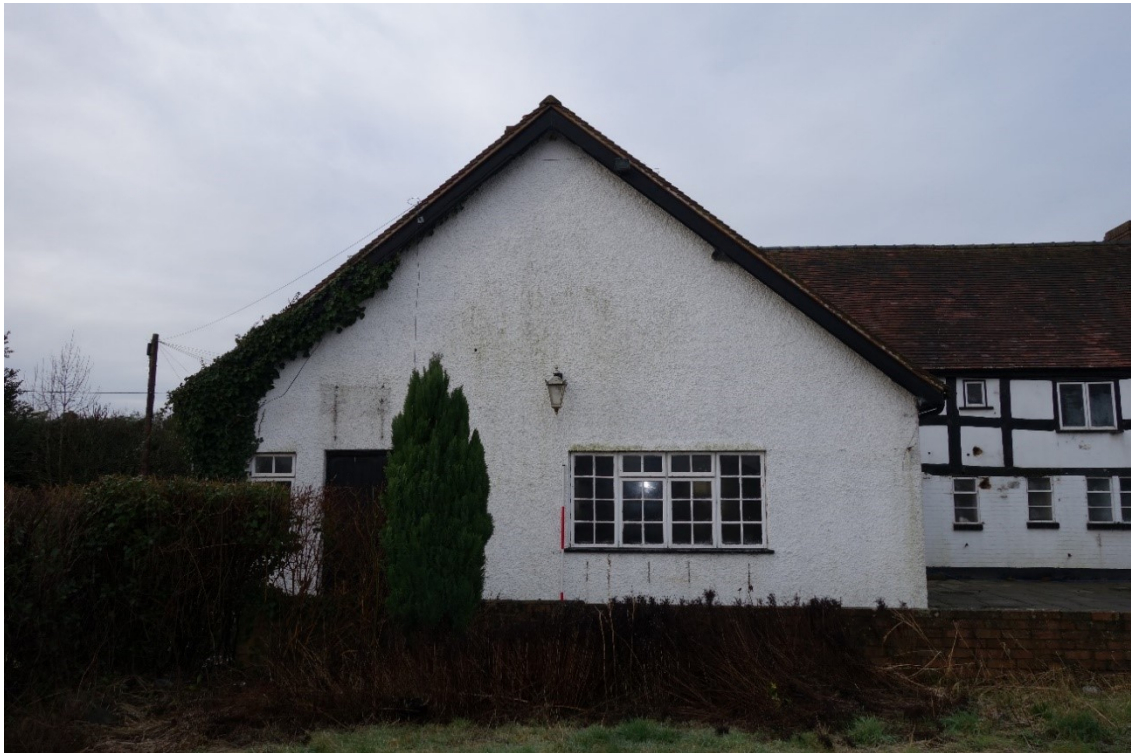
Projecting from the SE end of the rear elevation of the main block is a broad single-storey gabled structure of brick construction, externally roughcast, with a pitched tiled roof surmounted by a brick chimneystack (*Plate 8*). The NE-facing gable elevation has a doorway inserted to left of centre, flanked by a single-light, eight-paned window to the left and a broad, flat-headed four-light, 32-paned window to the right. The SE-facing elevation is devoid of fenestration, while the NW elevation has another four light, 32-paned window. To the left of this window, located in the angle between this gabled structure and the main block, is a gabled entrance porch which also appears to be a modern insertion.

Plate 8: View SW showing NE gable elevation of the modern NE extension added in the mid-20th century

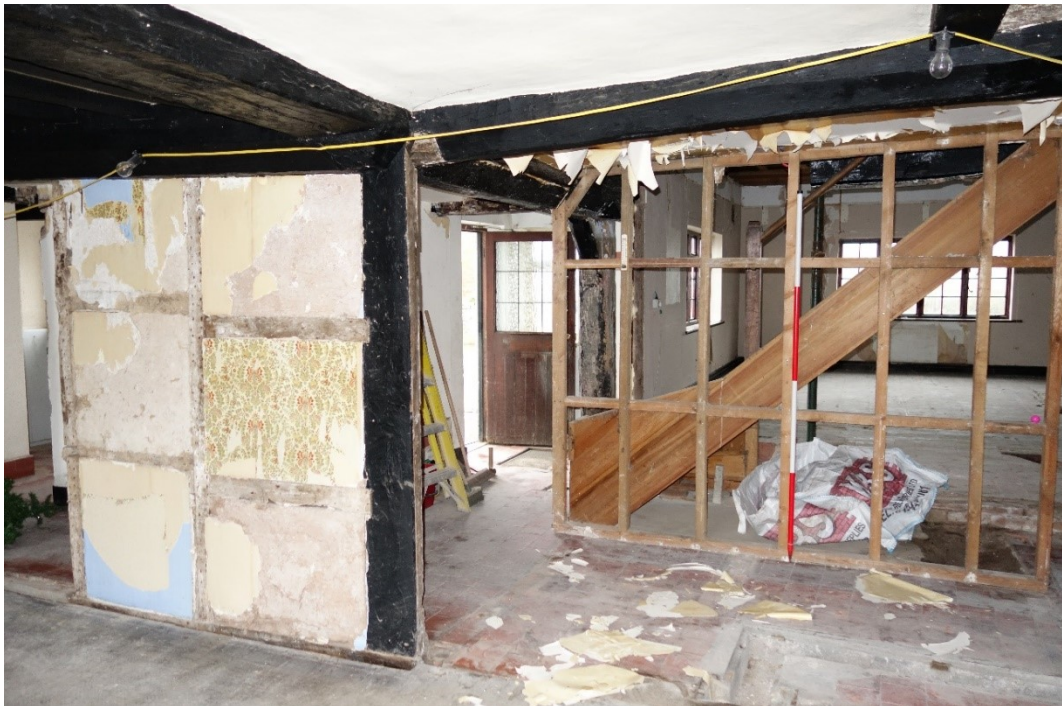
Plate 9: Internal view showing chamfered NE-SW aligned cross-beam in the central bay of the main block at ground-floor level, with later partition wall beneath cross-beam to left of picture

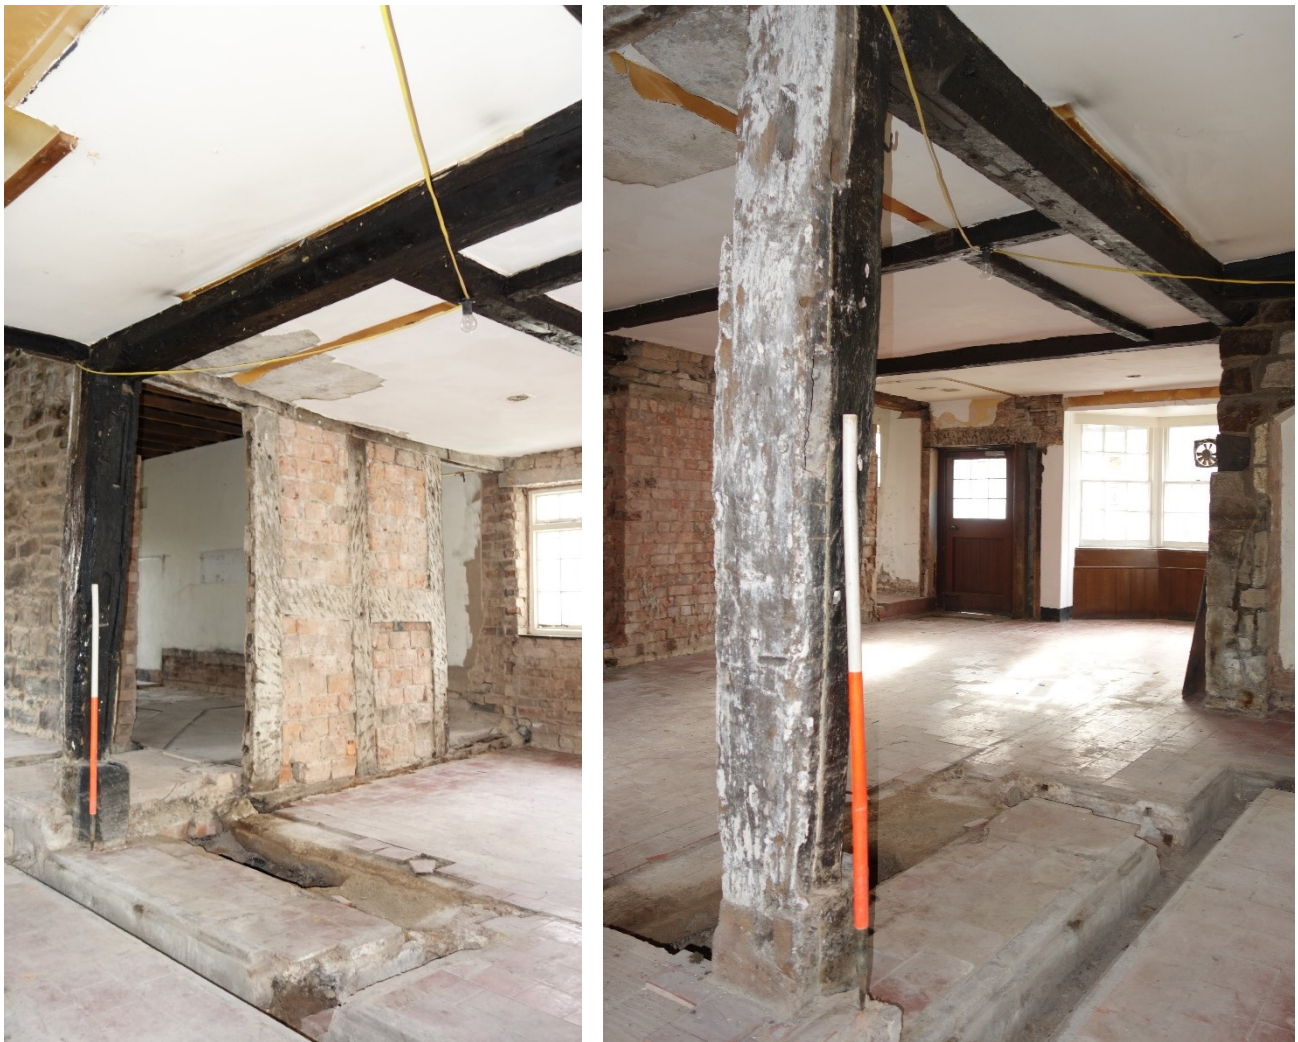
Evidence for the original gable-end framing at the SE end of the building is represented by the substantial vertical corner-post, tapering towards its chamfered base, and the stop-chamfered beam which it supports (*Plate 10*). The vertical corner-post and chamfered beam display evidence of slots for horizontal and vertical members and of circular holes for wooden staves, which would have supported timber laths or withies attached to them (*Plate 11*). At the SW end of the chamfered beam is a large mortise hole, which may have been intended to carry a bracket for a jetty bressummer beam supporting the original overhanging upper storey (*Plate 12*).

Plate 10 & 11: Internal views looking E and S respectively showing tapering vertical corner-post supporting a cross-beam with evidence of slots for horizontal and vertical members, possibly representing the original SE gable end frame

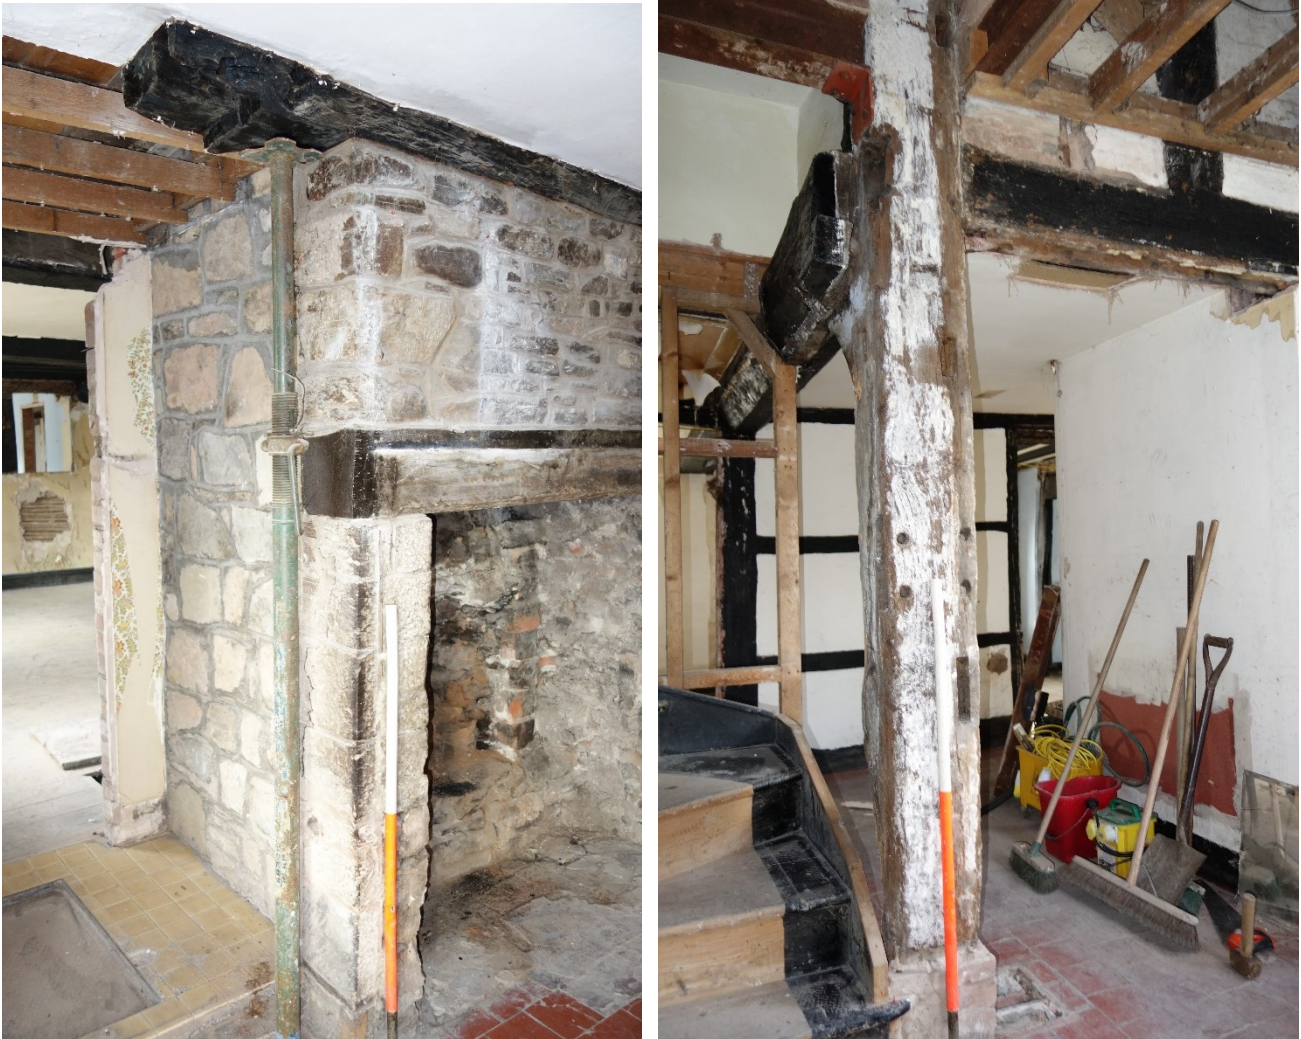
The original framing of the rear (NE-facing) elevation of the building can be clearly discerned within the former lounge bar, consisting of square panels which have survived at upper-storey level but which have been removed at ground-floor level, although slots for the horizontal and vertical members have survived. The surviving panels have brick nogging up to eaves level (which appears to be of late 19th -or 20th -century date), although some isolated evidence of lath and plaster infill appears to have survived within the panel above the stairway leading to the first floor (*Plate 13*).

Plate 12: Internal view looking NW showing large cross-beam with mortise hole over chimneybreast between lounge and public bar; Plate 13: Internal view looking SW showing timber-framing with lath-and-plaster infill above stairway to first floor

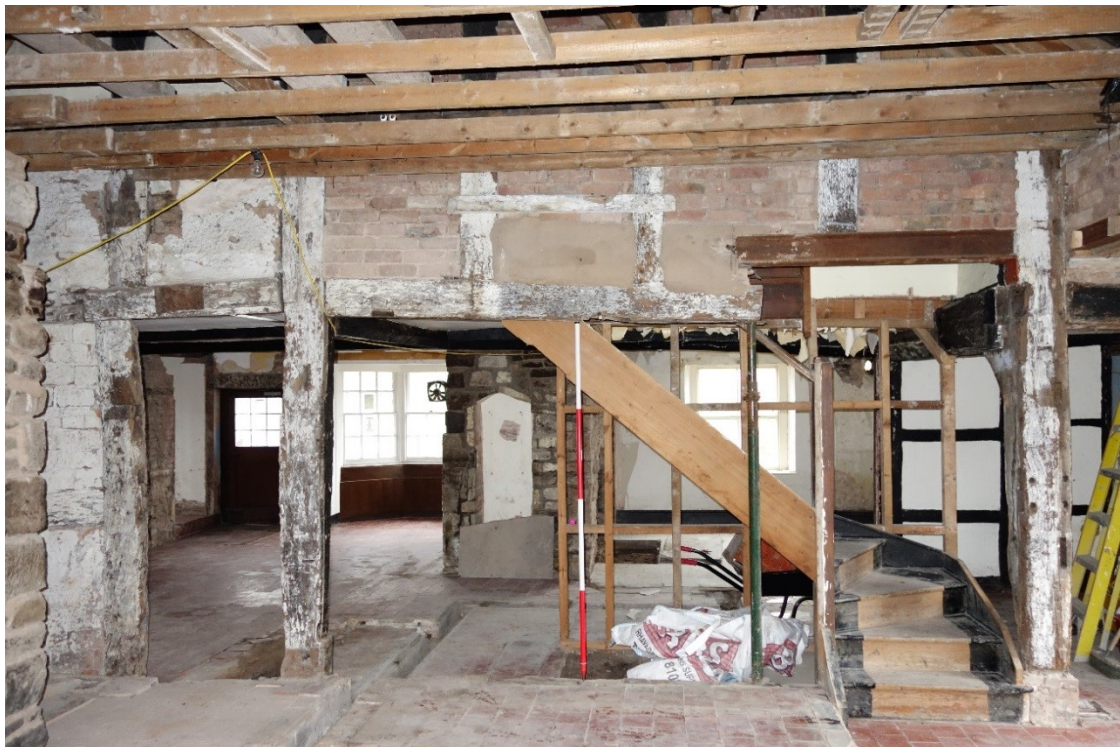
Plate 14: Internal view looking SW showing timber-framing forming part of original NE-facing external elevation, with later addition visible to left of picture

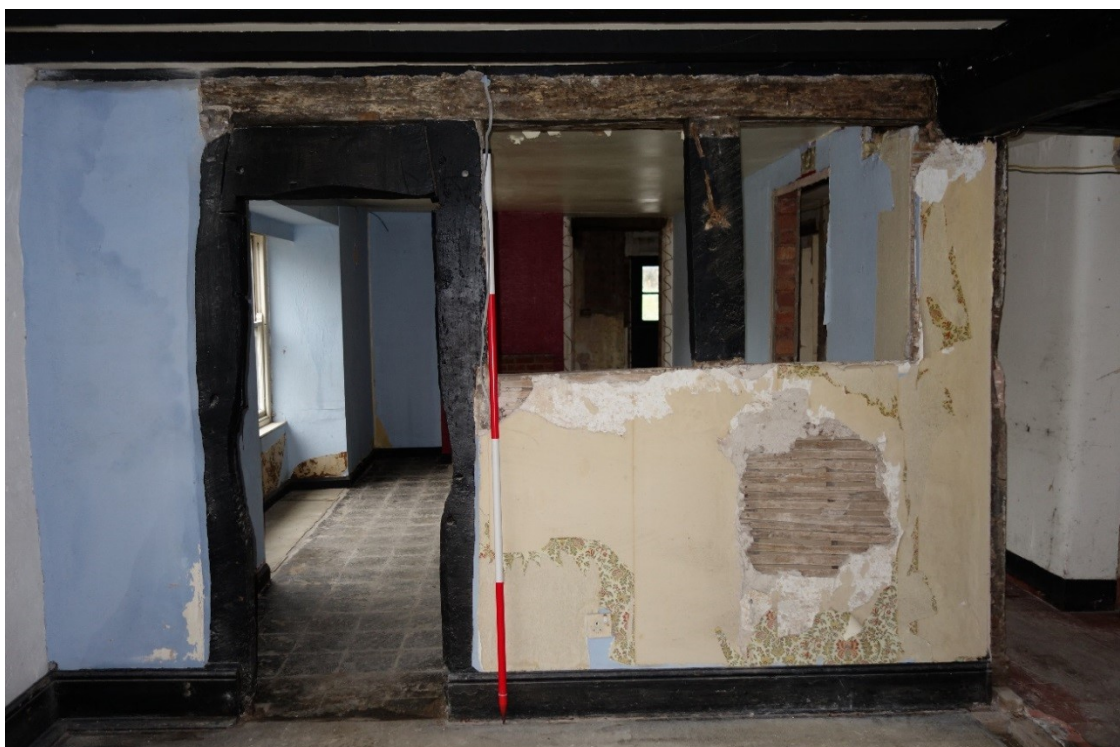
Plate 15: Internal view looking NW showing partition wall between the lounge bar and kitchen with lath and plaster infill

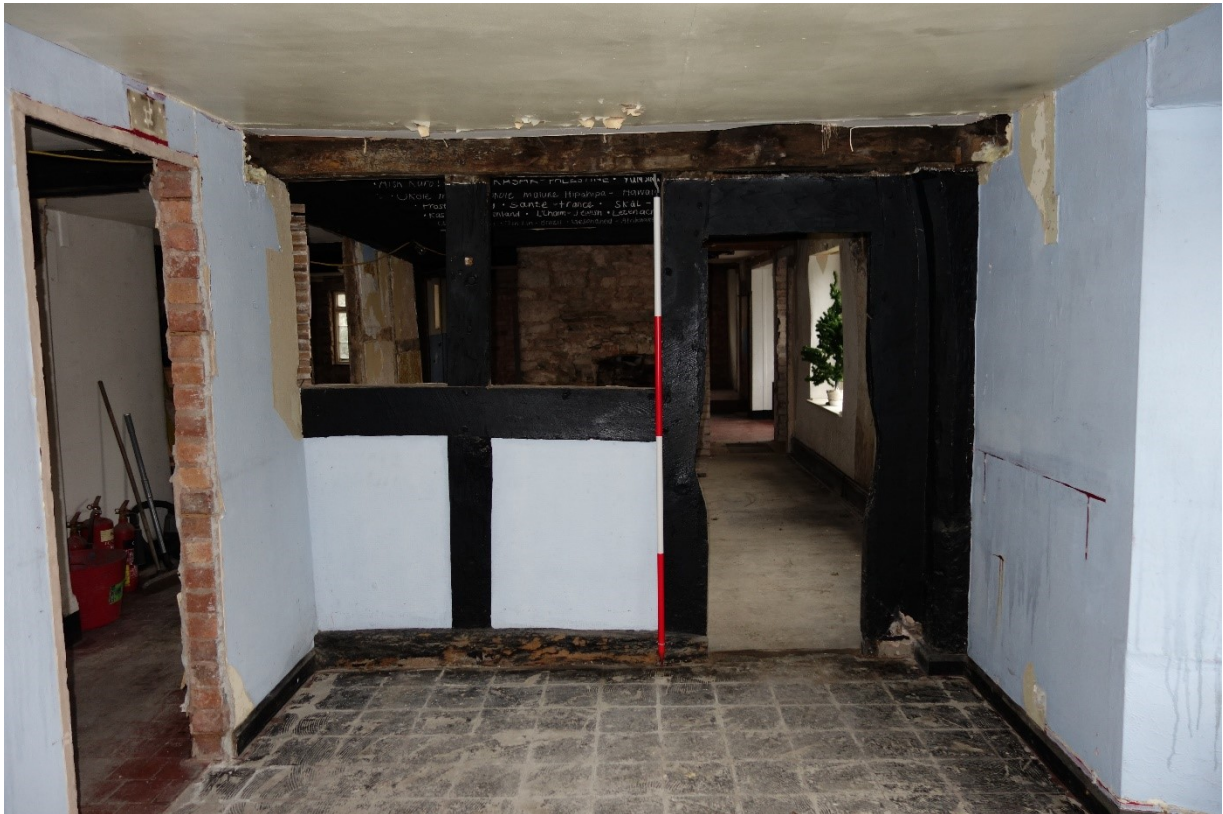
Plate 16: Internal view looking SE showing square-framed partition wall between lounge and kitchen

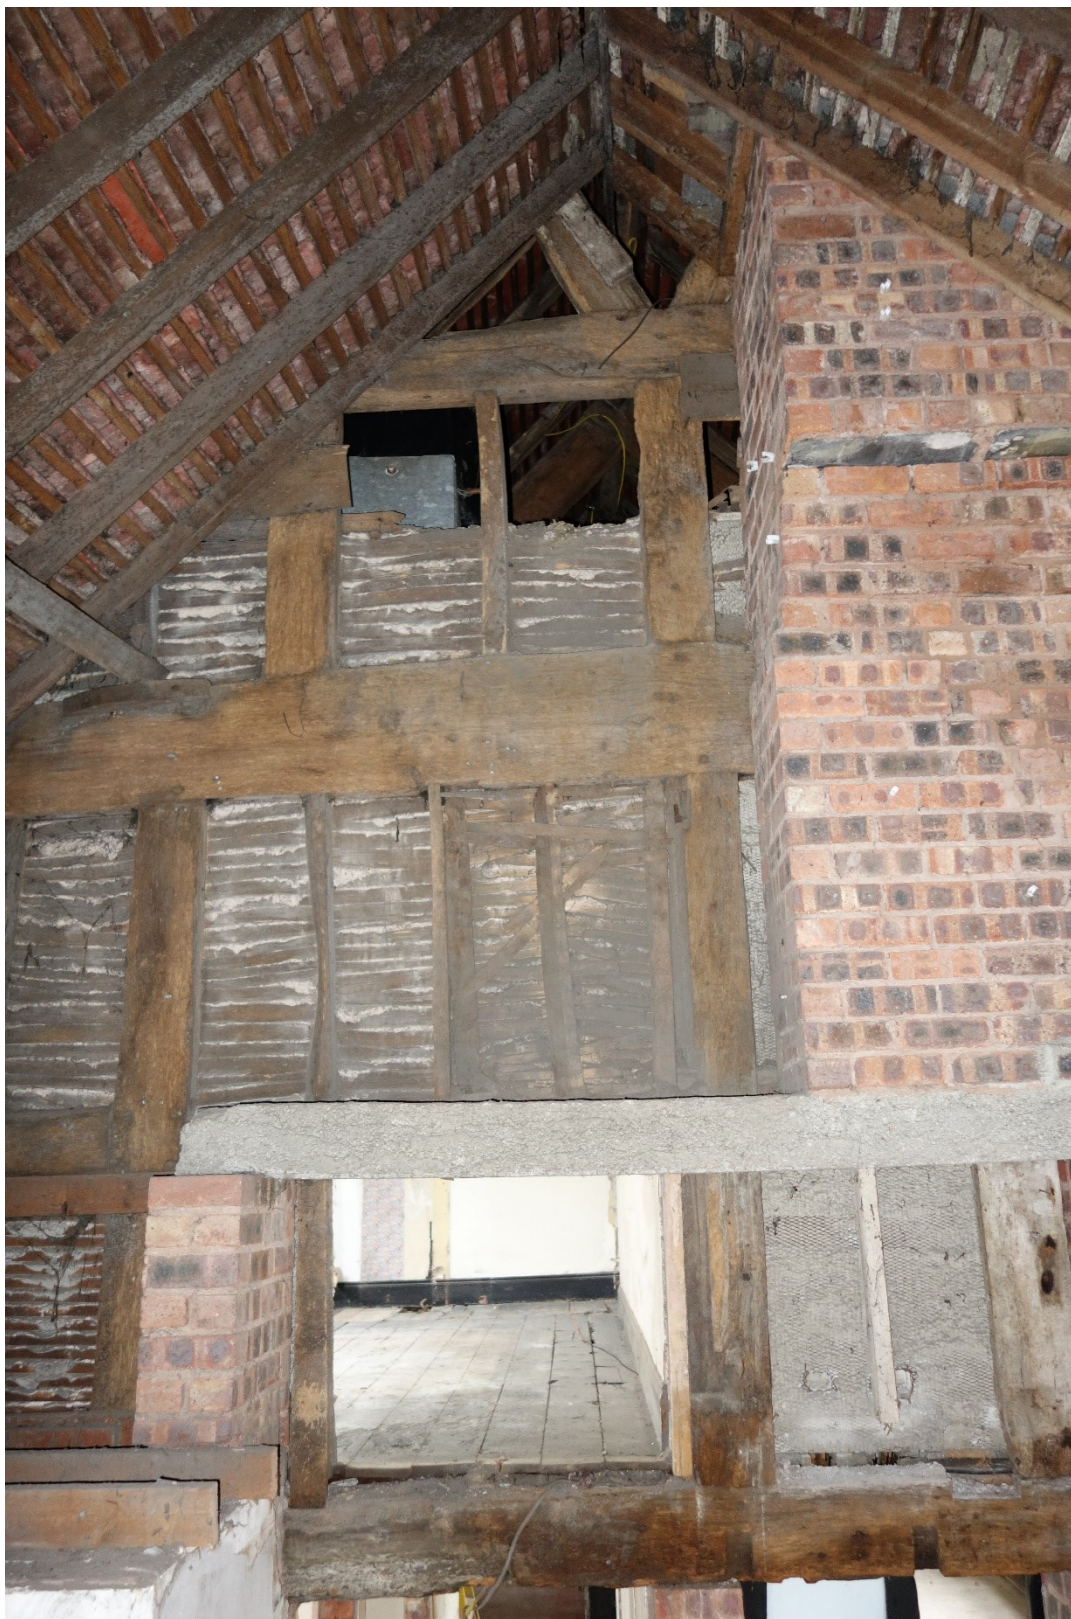
Partially exposed within the interior of the kitchen block at the NW end of the building is the timber-framing of the NW gable end of the original building, of box-framed construction with squared panels infilled with lath-and-plaster carried on vertical oak staves, with angled struts at the apex of the gable connecting the collar to the principal rafters (*Plate 17*). This gable end form is commonly found in 17th-century timber-framed houses in Herefordshire and elsewhere in the West Midlands. The NW gable end is partially obscured by a substantial brick chimneystack which appears to be a modern addition, constructed at some point between 1933 and 1965, when it appears that the lower storey walls of the kitchen block, originally of masonry and timber-frame construction, were entirely rebuilt in brick.

Plate 17: Internal view looking SE showing timber-framing of original NW gable end, obscured by modern brick chimneystack (to right of picture)

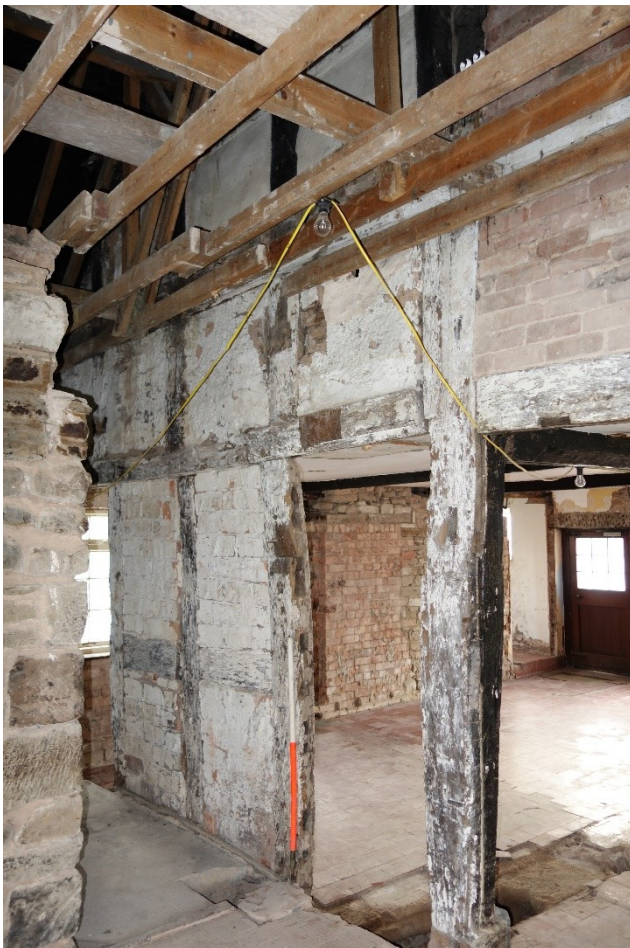
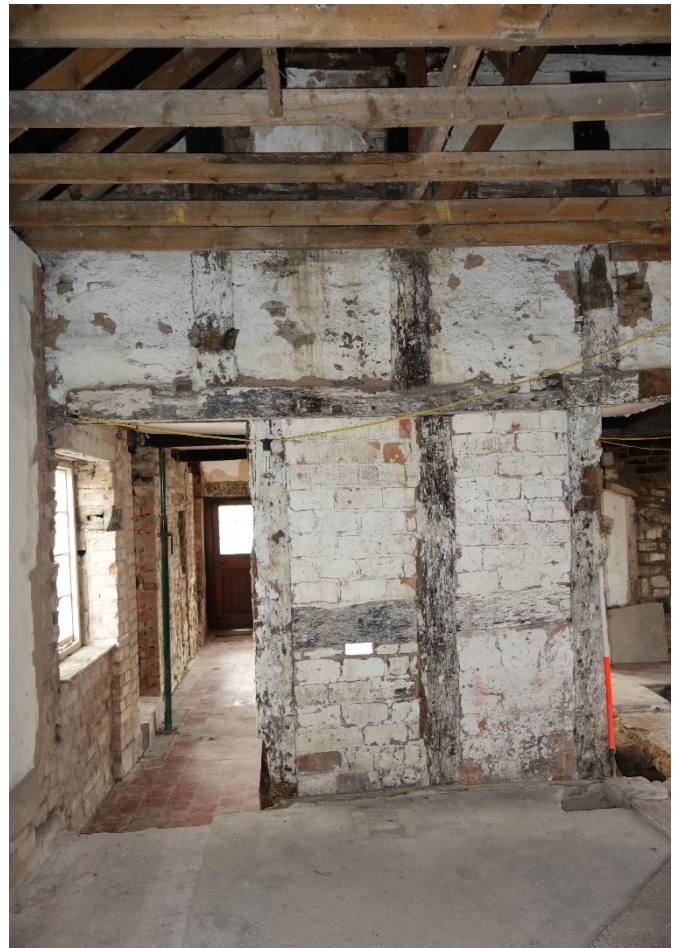
Plates 18 & 19: Internal view looking S and SW respectively showing exposed timber-framing of SE extension to main block, of late 17th-early 18th-century date

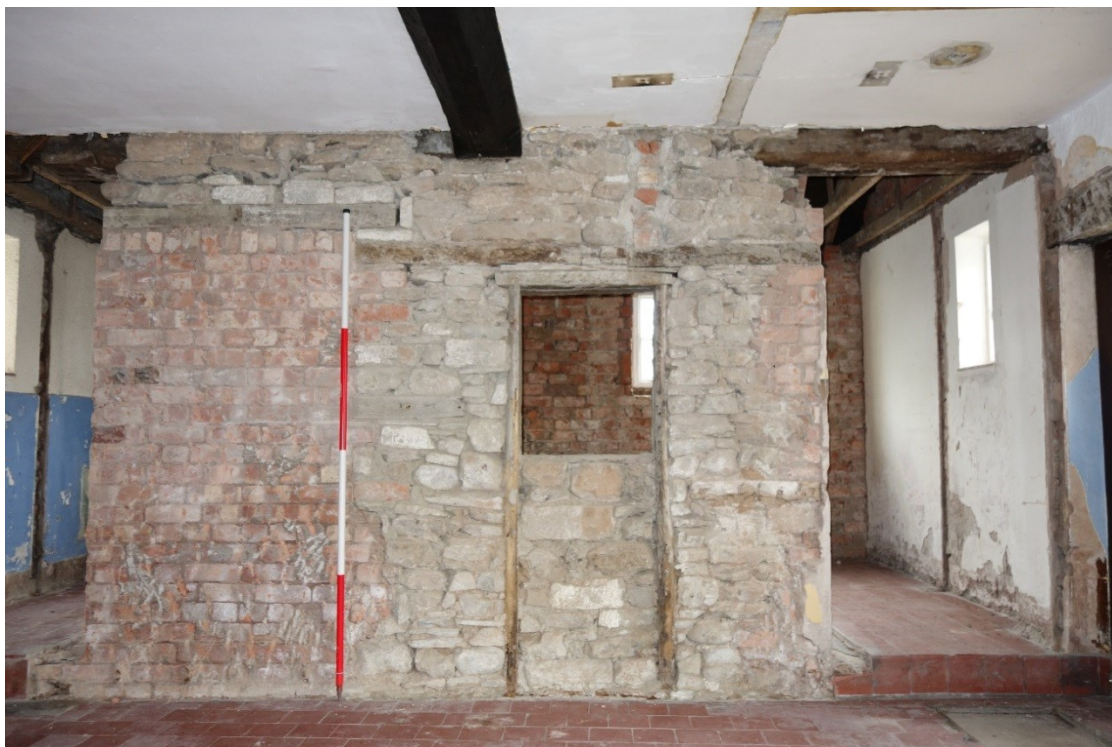
Plate 20: Internal view looking SE showing masonry wall forming part of SE extension to main block, partially rebuilt in brick, with evidence for a partially blocked-up doorway

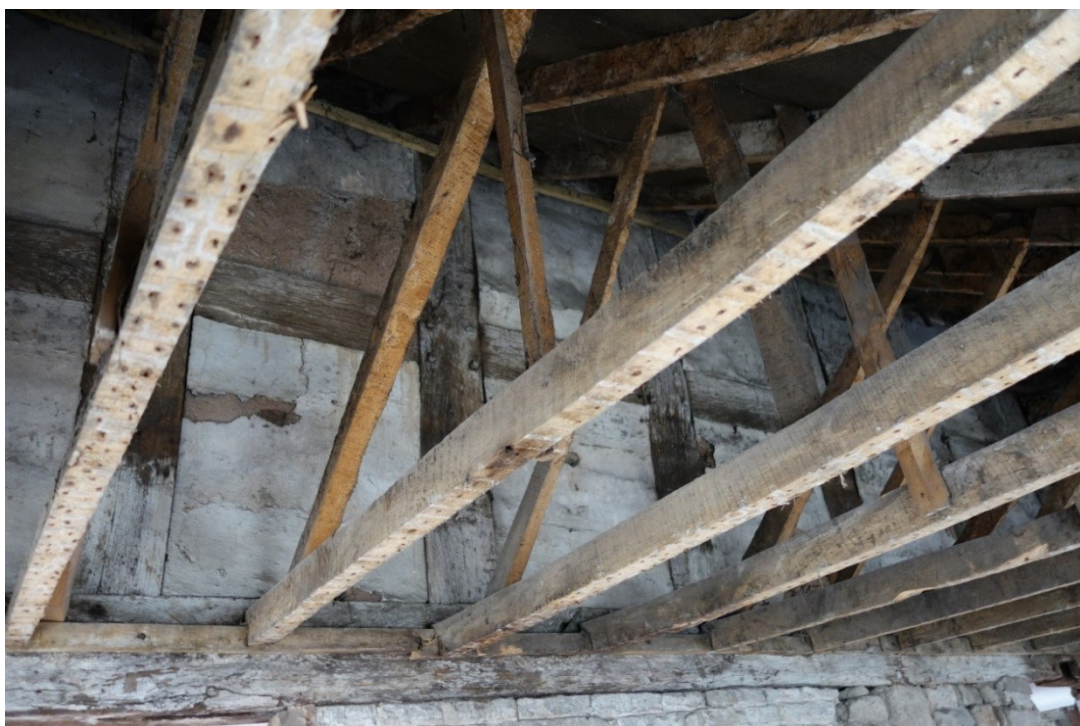
Plate 21: View looking NNW showing timber-framing of upper storey of SE extension, obscured by modern roof of later toilet block of post-and-truss construction.

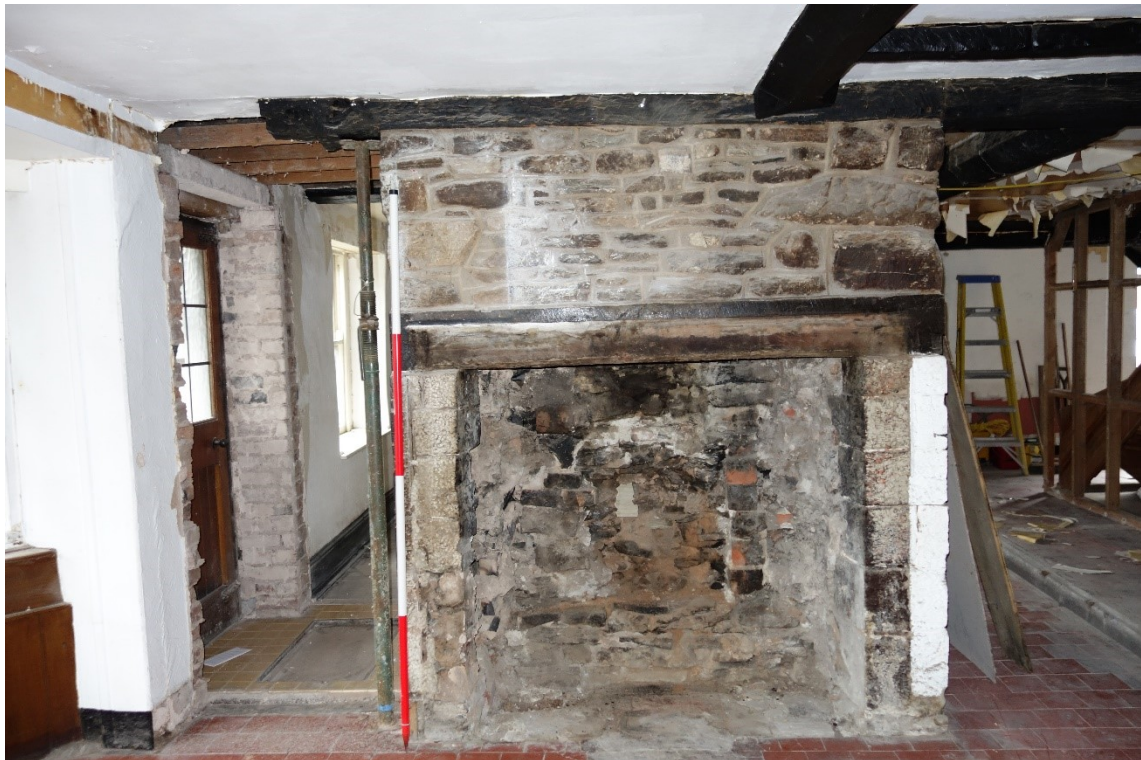
Plate 22: Internal view looking NW showing large stone fireplace in public bar

It is likely that the stone chimneybreast, in its existing form, belongs to this secondary phase of construction, with a large fireplace with inglenook and a substantial timber bressummer on its SE face (*Plate 22*), indicating that this new extension almost certainly housed the kitchen and living room at ground -floor level (indicated by the large fireplace), with a parlour located on the opposite site of the chimneybreast (as evidenced by the smaller fireplace) (*Plate 23*).
