**Standing Building Recording
Survey**

The Royal George Inn

Lyonshall

BA1501RGIL

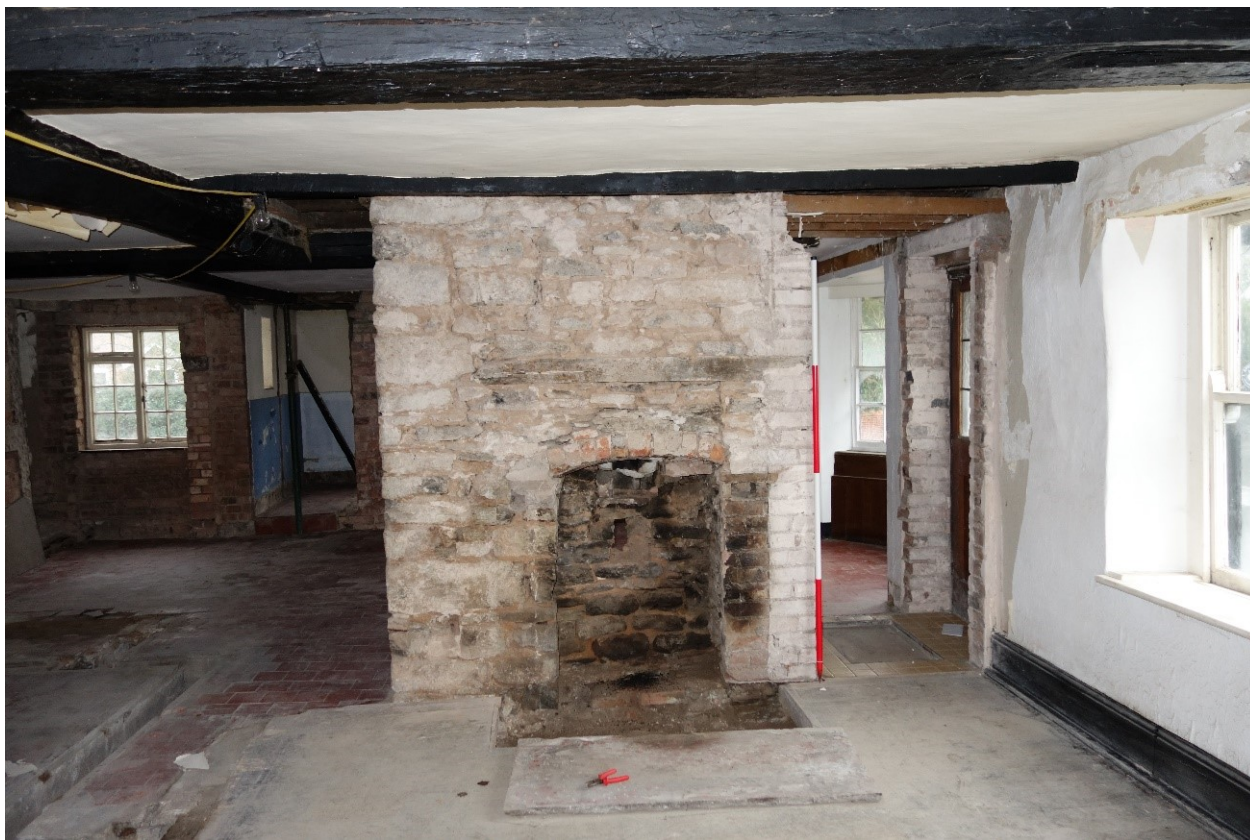
It is likely that the stone chimneybreast, in its existing form, belongs to this secondary phase of construction, with a large fireplace with inglenook and a substantial timber bressummer on its SE face (*Plate 22*), indicating that this new extension almost certainly housed the kitchen and living room at ground -floor level (indicated by the large fireplace), with a parlour located on the opposite site of the chimneybreast (as evidenced by the smaller fireplace) (*Plate 23*).

Plate 23: Internal view looking SE showing smaller fireplace in chimneybreast in lounge bar

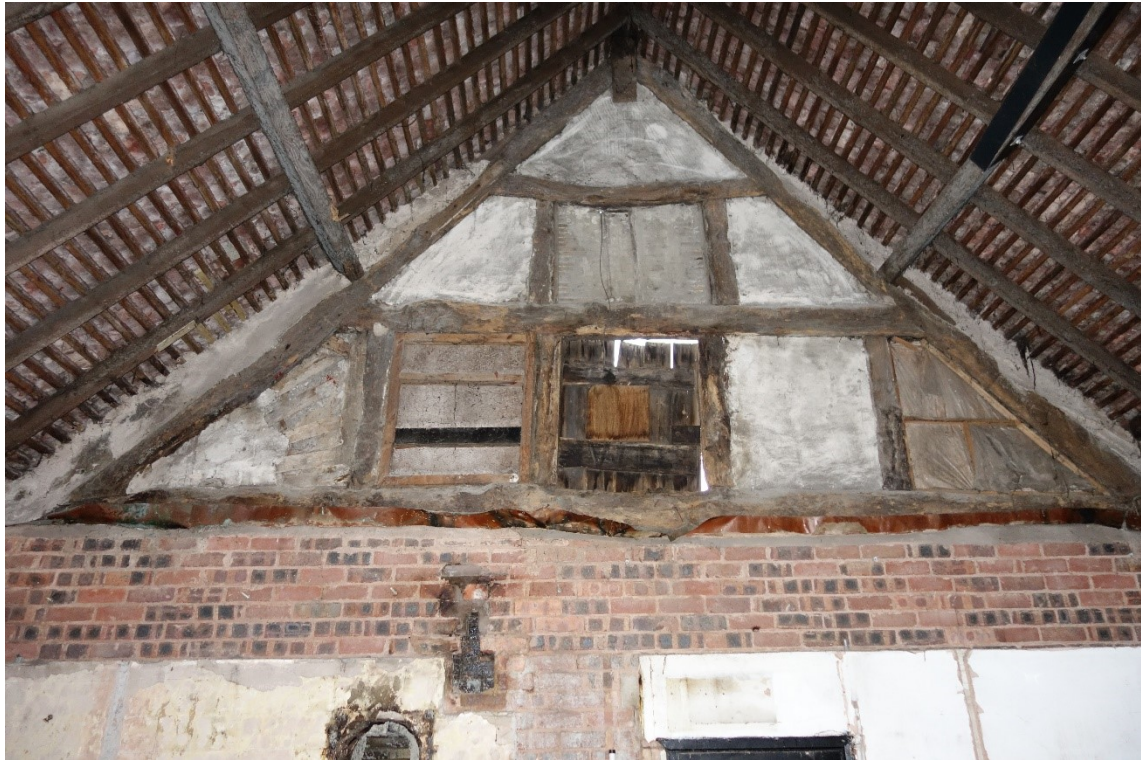
Plate 24: Internal view looking NW showing surviving box-framing in upper portion of NW gable, with central loft door inscribed with the initials 'W.T.'

The only surviving portion of the original fabric of the cider house is the NW gable end, of box-framed construction, the panels infilled with lath and plaster and rendered internally, with a centrally placed hayloft door of plank-and-batten construction inserted immediately above the wall-plate (*Plate 24*). The hayloft door appears to be inscribed with the initials 'W.T.'; the identification remains uncertain although one possibility might be William Tranter, who is documented as selling the property to Richard Clarke in 1795.

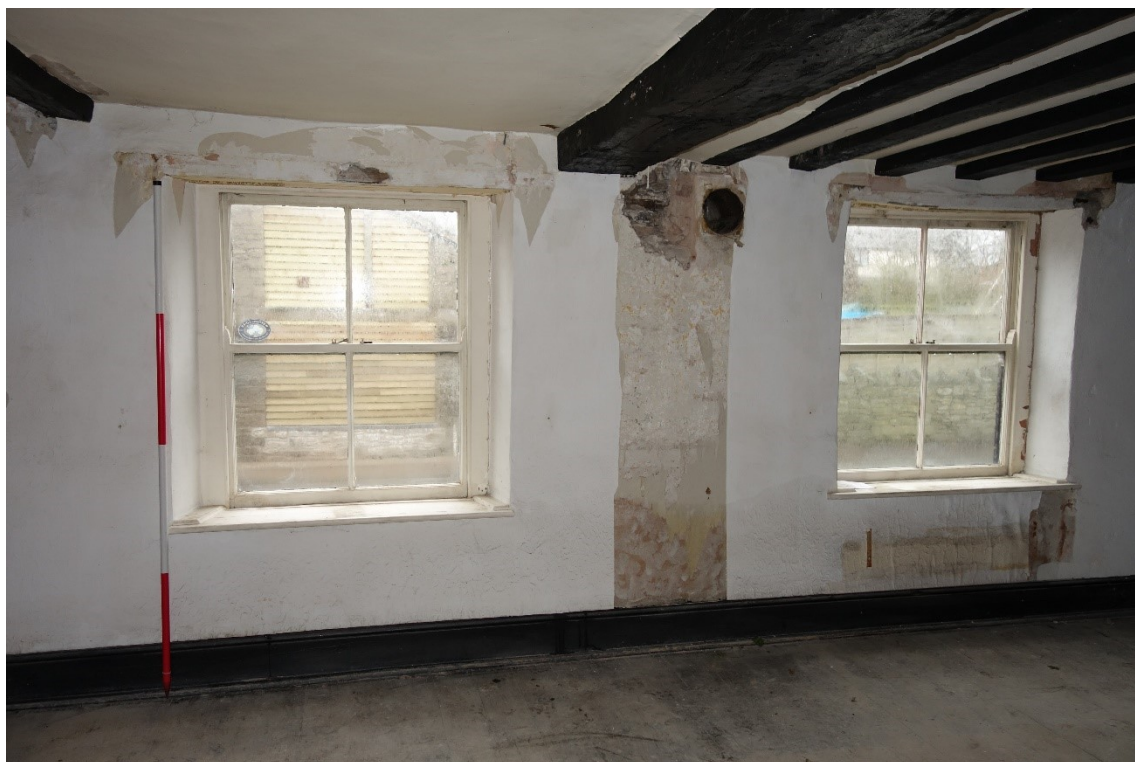
This phase of building activity, which may be assigned to the late 18th -early 19th century, is primarily represented at ground-floor level by the construction of the existing SW-facing wall in roughly coursed rubble masonry beneath the overhanging upper storey. The two four-paned sash windows with narrow vertical glazing bars within the lounge bar probably date to this phase of activity, together with the majority of the narrow ceiling joists visible in the lounge and public bar (*Plate 25*). The doorway to the right of the canted bay window (which is a later addition) with its substantial timber lintel can also be dated to the late 18th -early 19th century. The 1840 tithe map shows an extension to the SE end of the main block, which appears to correspond to the site of the present lean-to brick toilet block with catslide roof; however, the existing structure appears essentially to be a later 20th -century rebuilding.

Plate 25: Internal view looking SW showing sash windows with narrow vertical glazing bars in lounge

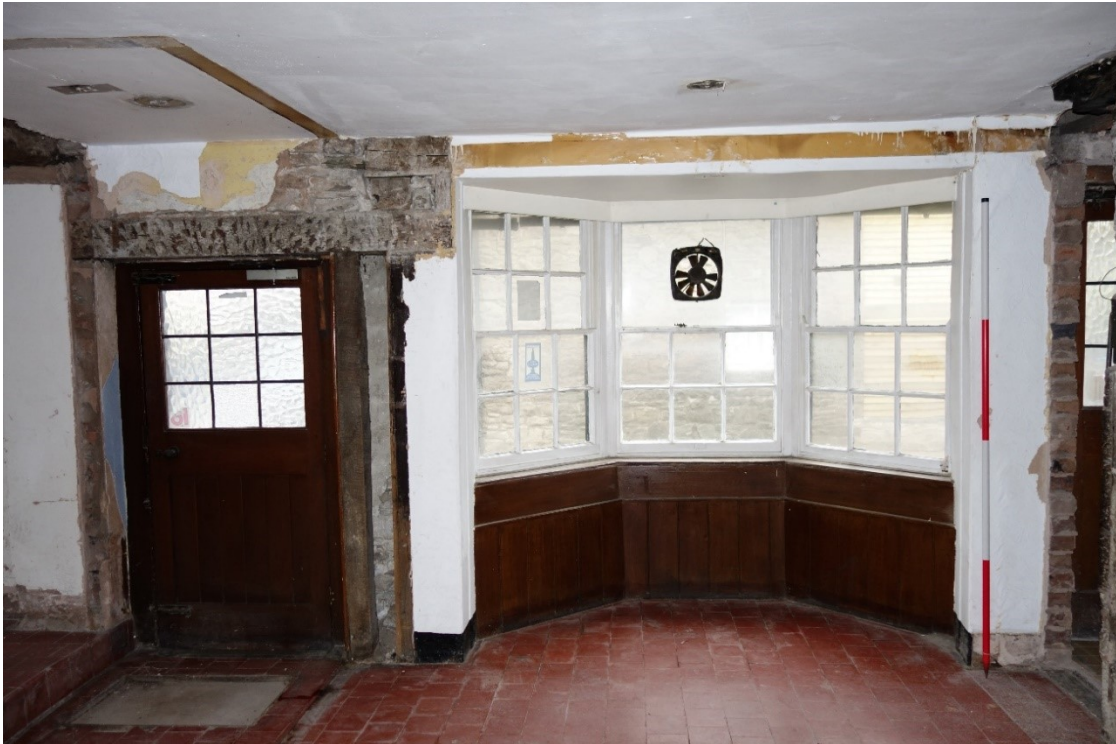
A subsequent phase of activity, datable to the second half of the 19th century, is represented by the construction of the canted bay window in the public bar (*Plate 26*). The bay window is not shown on the tithe map of 1840 but is depicted on the OS 1st edition map of 1887.

Plate 26: Internal view looking SW showing late 19th -century canted bay window with earlier doorway with wooden lintel to left of picture

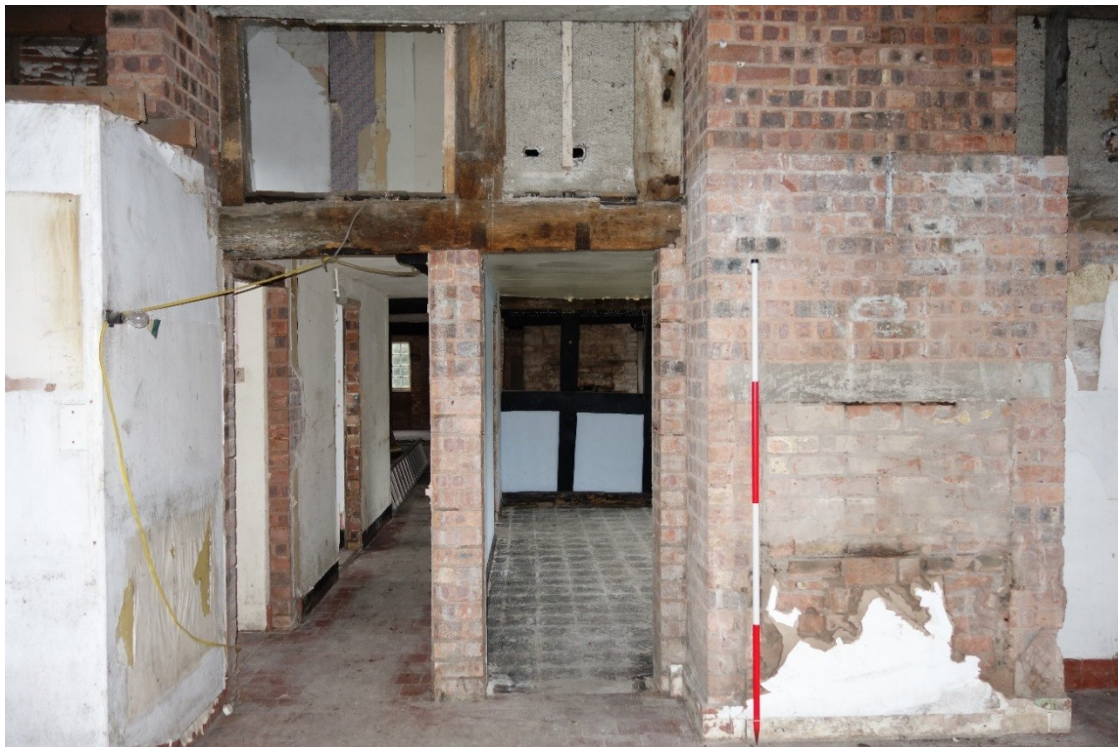
Plate 27: Internal view of kitchen block looking SE with modern fireplace and brick chimneystack to right of picture and passageway leading to pantry and toilet block to left

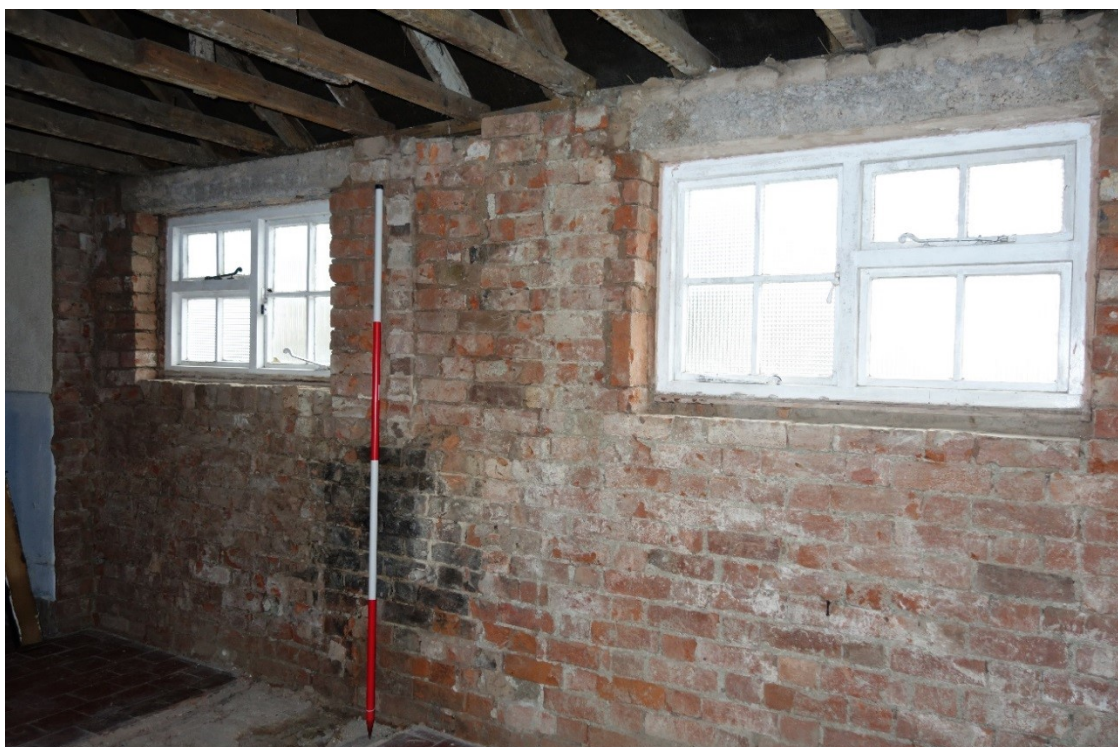
Plate 28: Internal view looking E showing interior of toilet block at SE end of Inn, originally built in early 19th century and completely reconstructed, with modern eight-pane casements inserted, in the mid-20th century

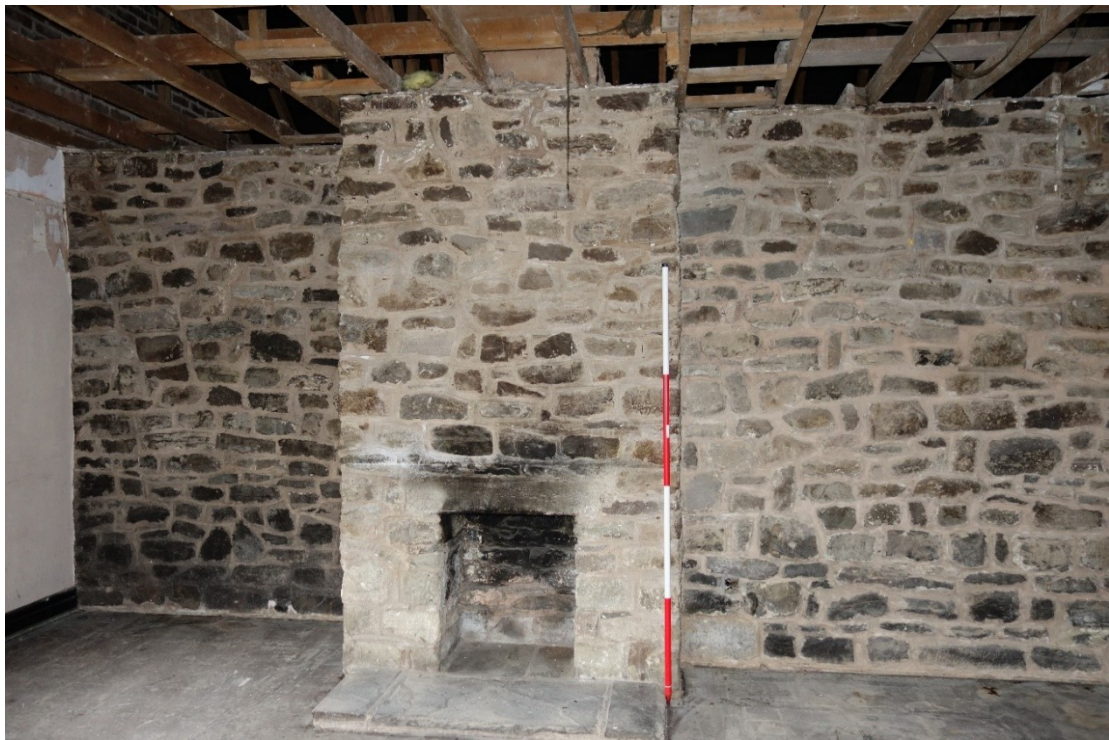
The most significant modern alterations visible at ground-floor level comprise the addition of the four-bay toilet block and pantry along the rear (NE-facing) elevation of the main block, which necessitated the entire reconstruction of the rear wall of the building at ground-floor level and the insertion of six new windows (*Plate 30*). Contemporary with this work was the complete reconstruction of the walls of the former cider house at the NW end of the building and the addition of a brick chimneystack (*Plate 27*) (not shown on a photograph of 1933 but visible on a later photograph of the inn taken in 1965), the rebuilding of the lean-to toilet block with its simple post-and-truss roof at the SE end of the Inn (*Plate 28*) and the construction of the large single-storey gabled building (formerly a restaurant and cellar) attached to the rear wall the building, which is first shown in its present form on an OS 1:2500 plan of 1974 (*Plate 29*).

Plate 29: Internal view looking SE showing masonry fireplace and chimneybreast in mid-20th -century extension to NE of the main block

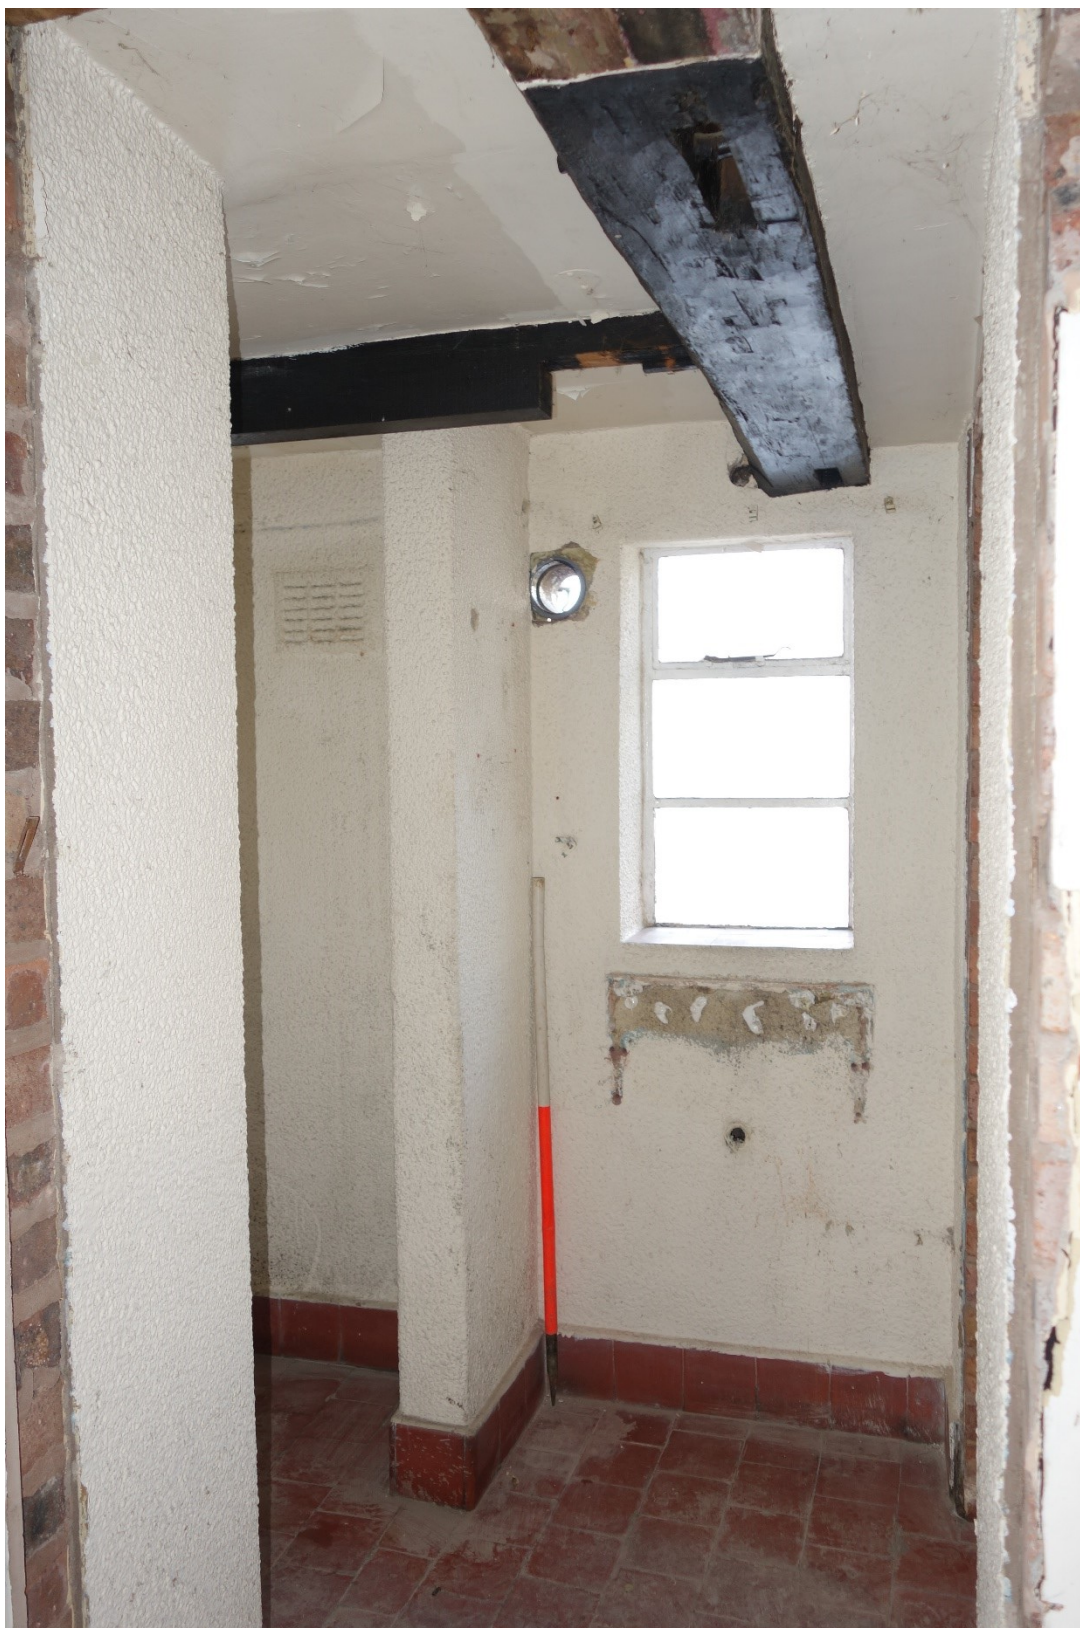
Plate 30: Internal view looking NE showing modern toilet block with earlier crossbeam at ceiling level with slots for vertical posts

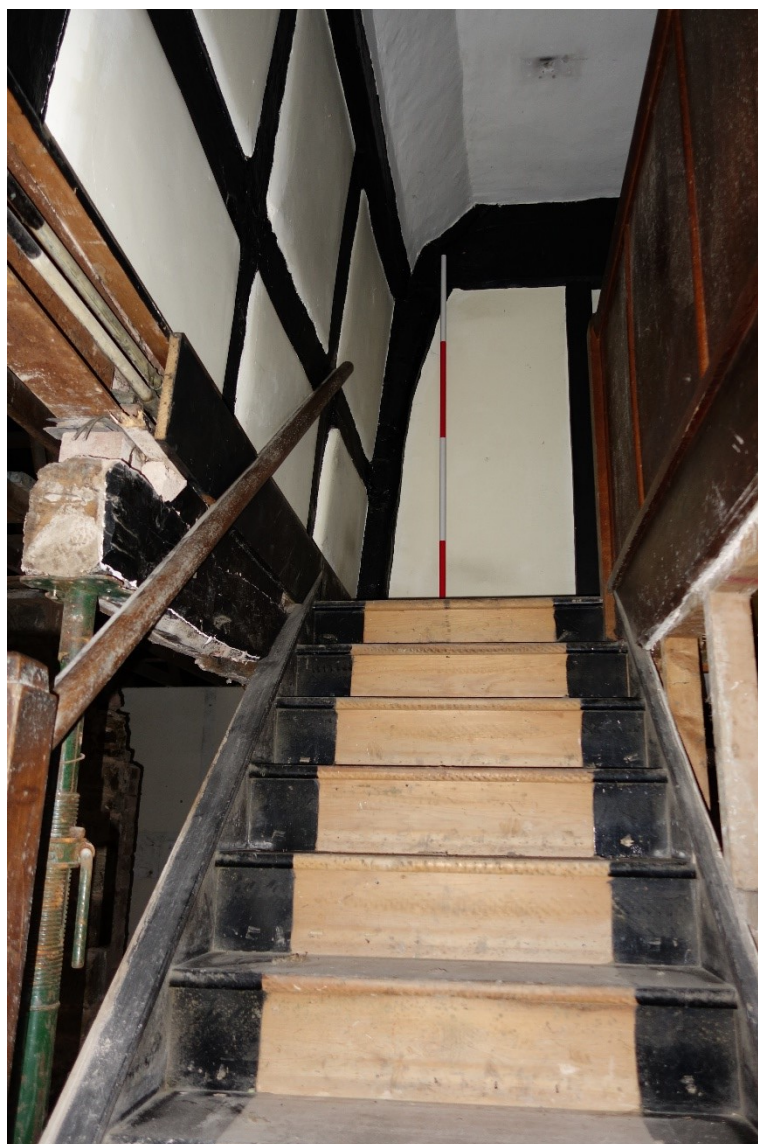
Access to the first floor is gained via a dog-leg staircase located immediately opposite the rear entrance to the Inn. The existing staircase (*Plate 31*) is modern in date, although it occupies the location of an earlier straight flight of stairs leading to the first floor shown on the RCHME survey plan of 1933. The internal partitions at first-floor level have remained largely intact, although a significant proportion of fixtures and fittings have been removed.

Plate 31: Internal view showing staircase leading to first-floor landing with timber framing visible above and to left of picture

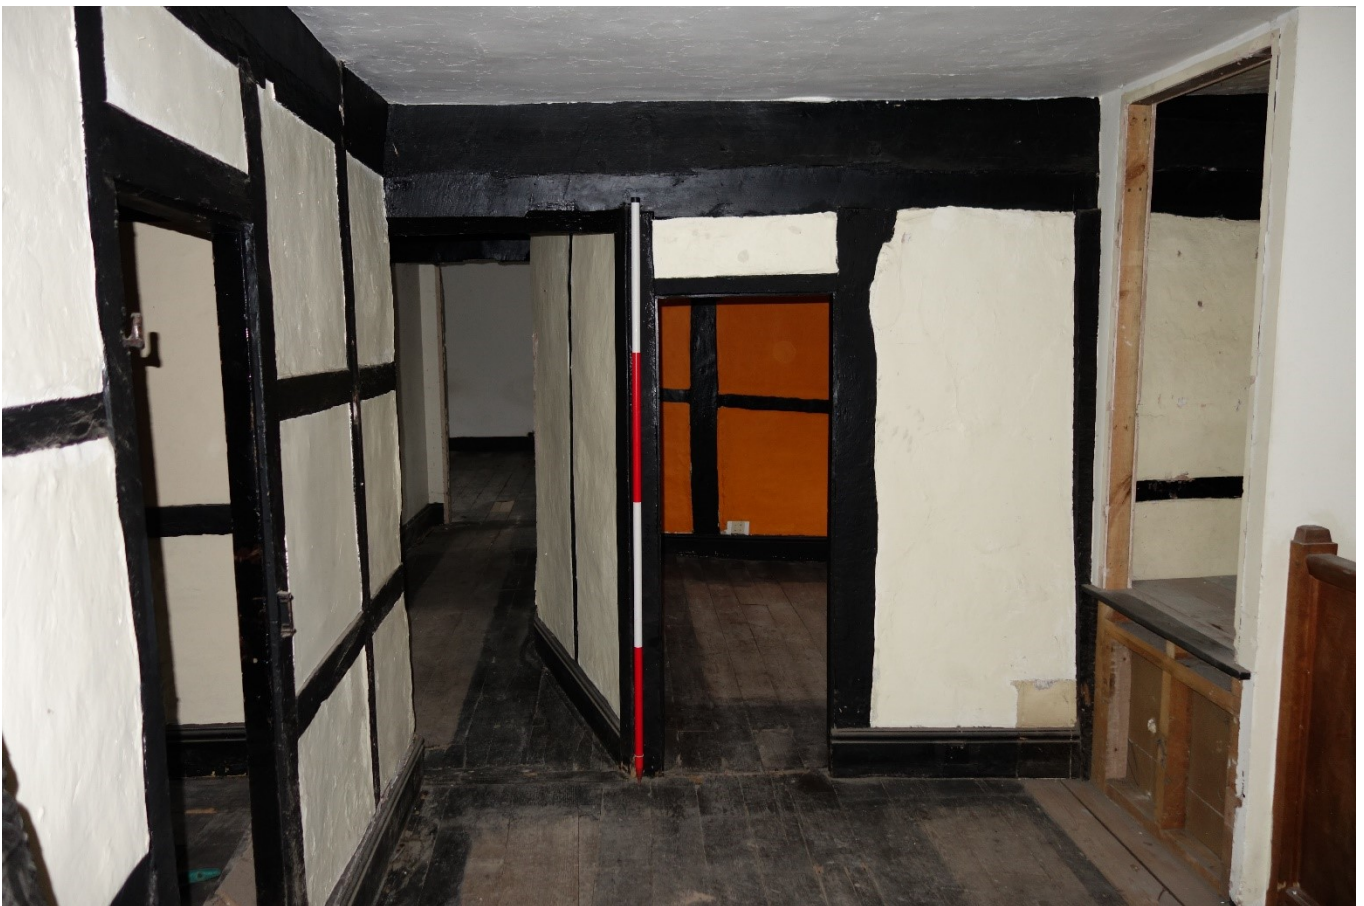
Plate 32: Internal view looking NW showing first-floor landing and passageway with substantial NE-SW aligned cross-beams and later 18th-19th -century square-framed partitions with regular, thin scantling

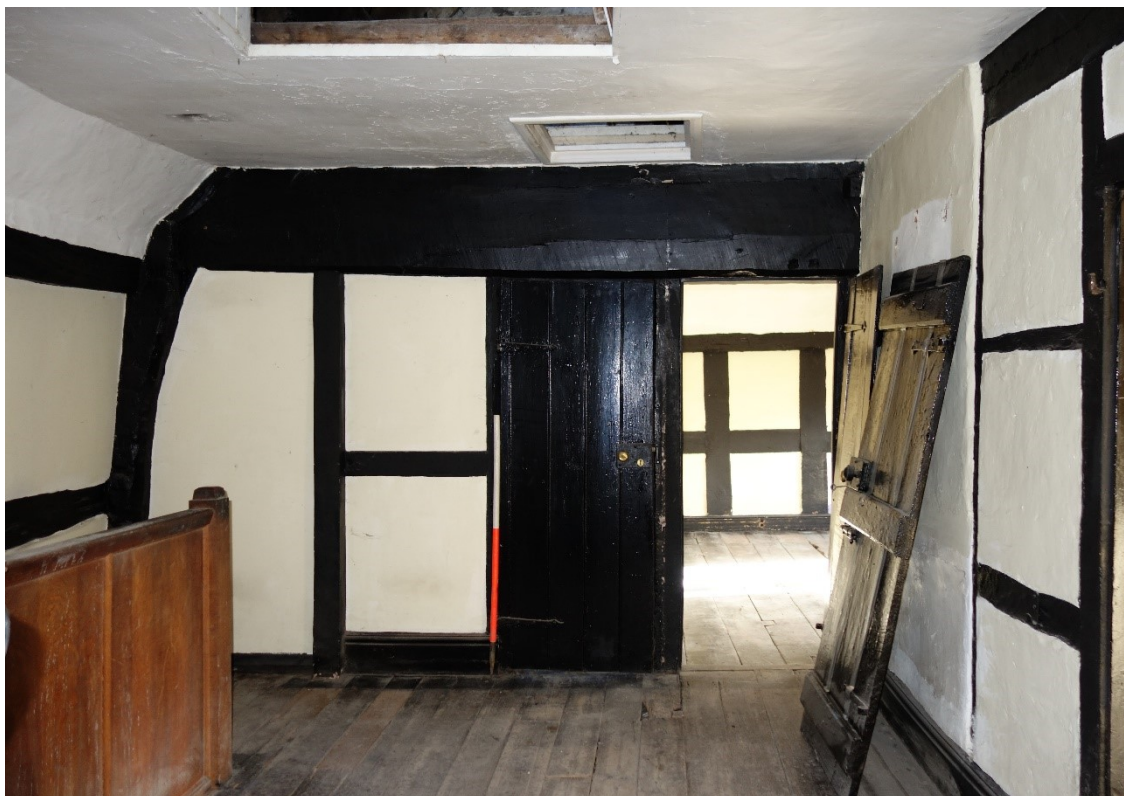
Plate 33: View looking SE from first-floor landing showing cross-beam with jowelled corner-post (to left of picture) and timber framed partition wall with doorways leading to living room and bedroom

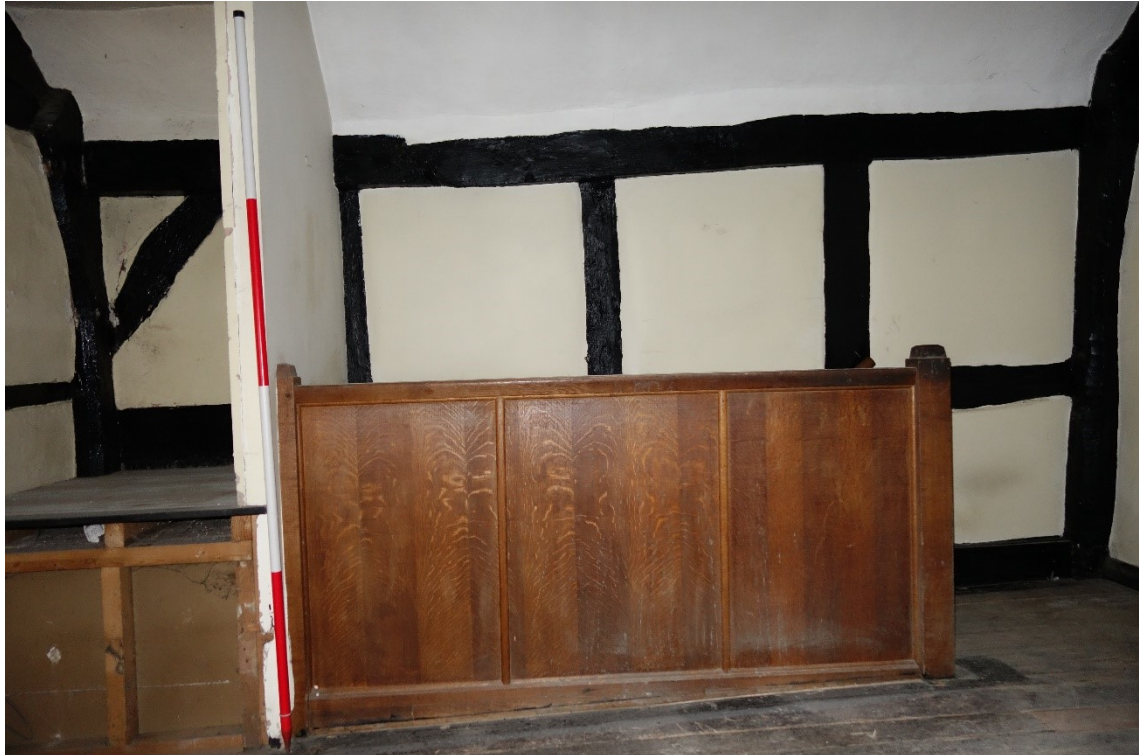
Plate 35: Internal view looking NE showing roughly square panelled timber-framing in NE wall of first-floor landing above staircase, with diagonal brace and jowelled corner-post visible to left of picture

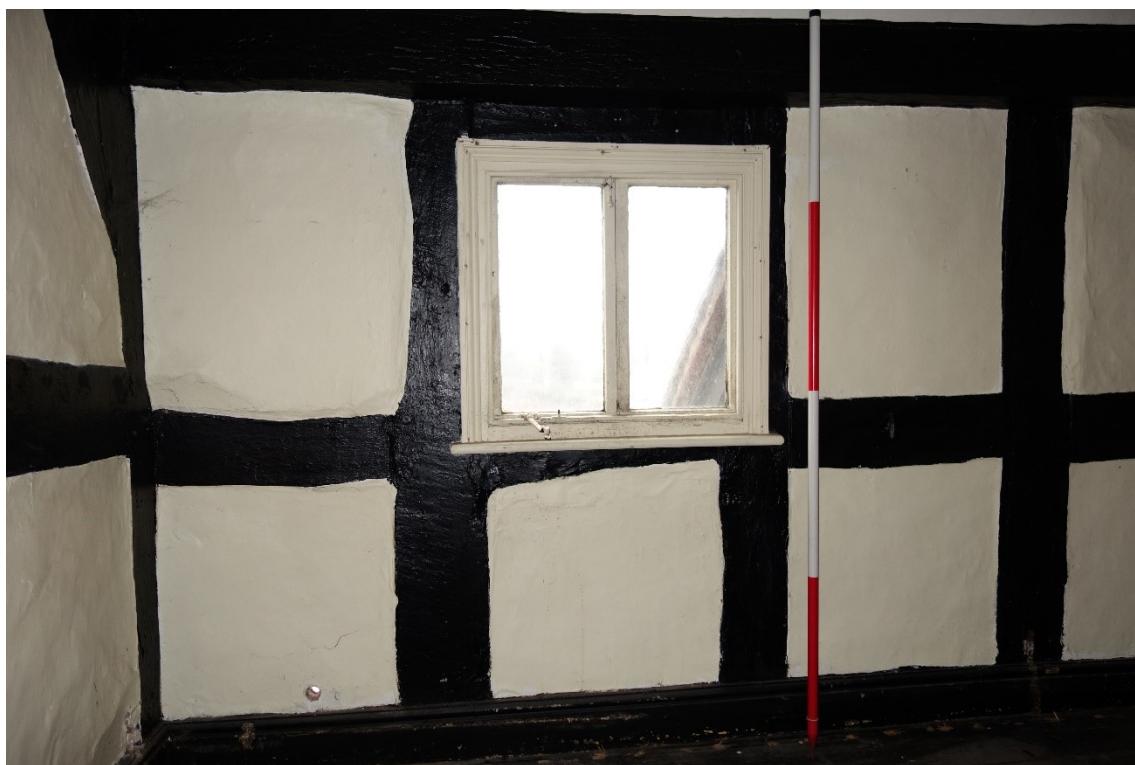
Plate 36: Internal view looking NE showing exposed square-panelled timber-framing with irregular thick scantling in NE wall of bedroom to NW of first-floor landing

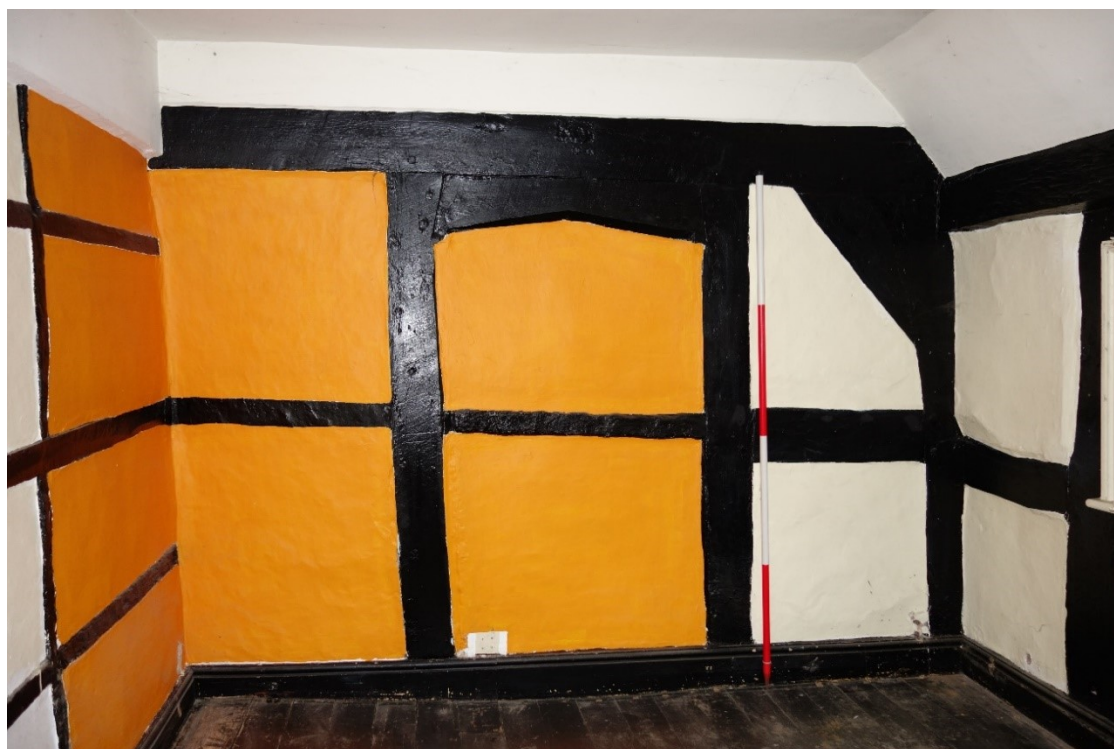
Plate 37: Internal view looking NW showing section of cross-framing in NW wall of bedroom to NW of first-floor landing, with centrally placed low-arched frame

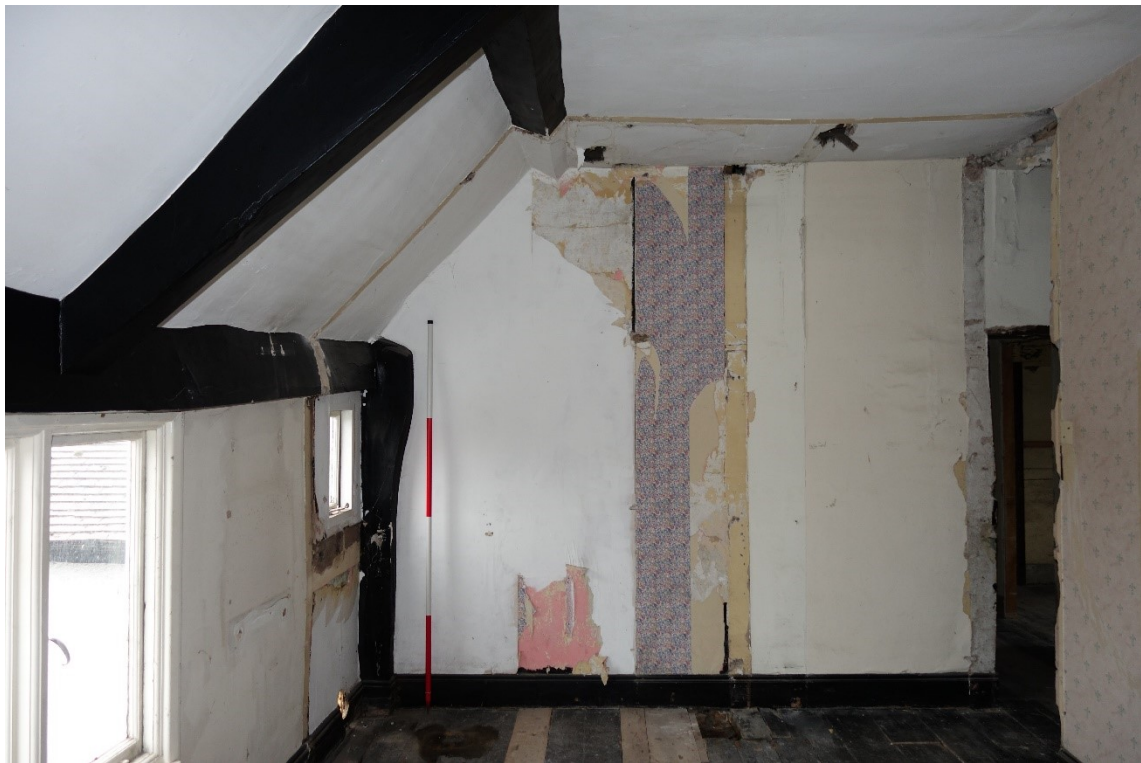
Plate 38: Internal view looking SE showing exposed timber wall-plate and jowelled vertical corner-post in bedroom in NE corner of the first floor

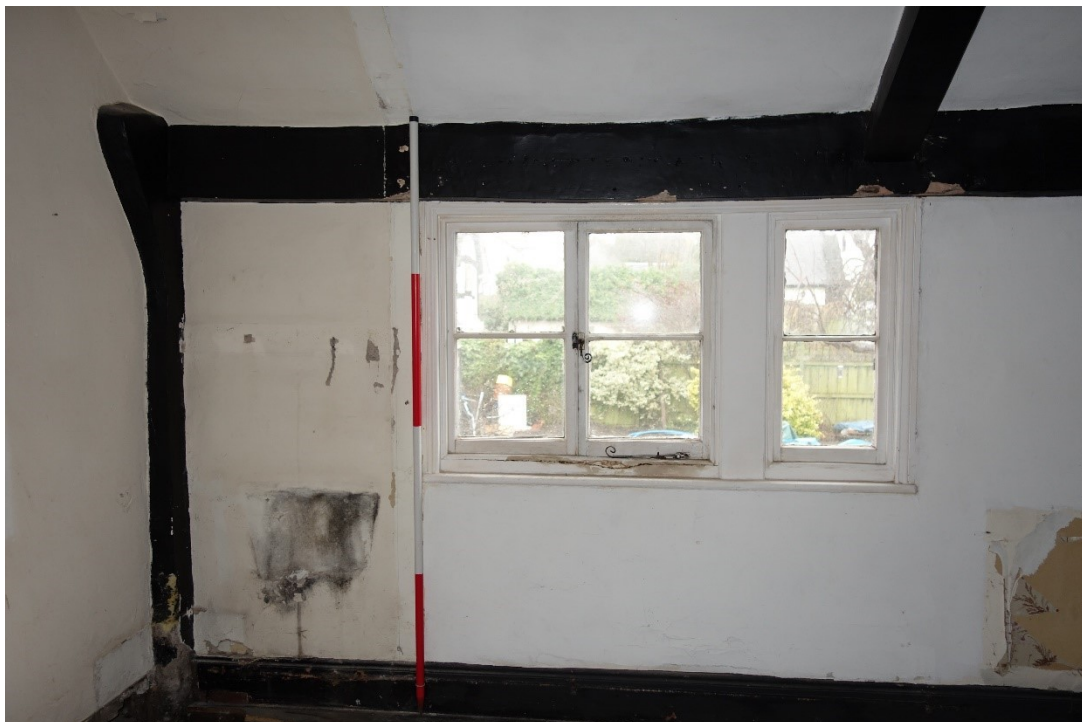
Plate 39: Internal view looking SW showing exposed wall-plate and jowelled vertical corner-post in bedroom in NW corner of the first floor. The casement window appears, in its present form, to be of late 18th- or 19th-century date

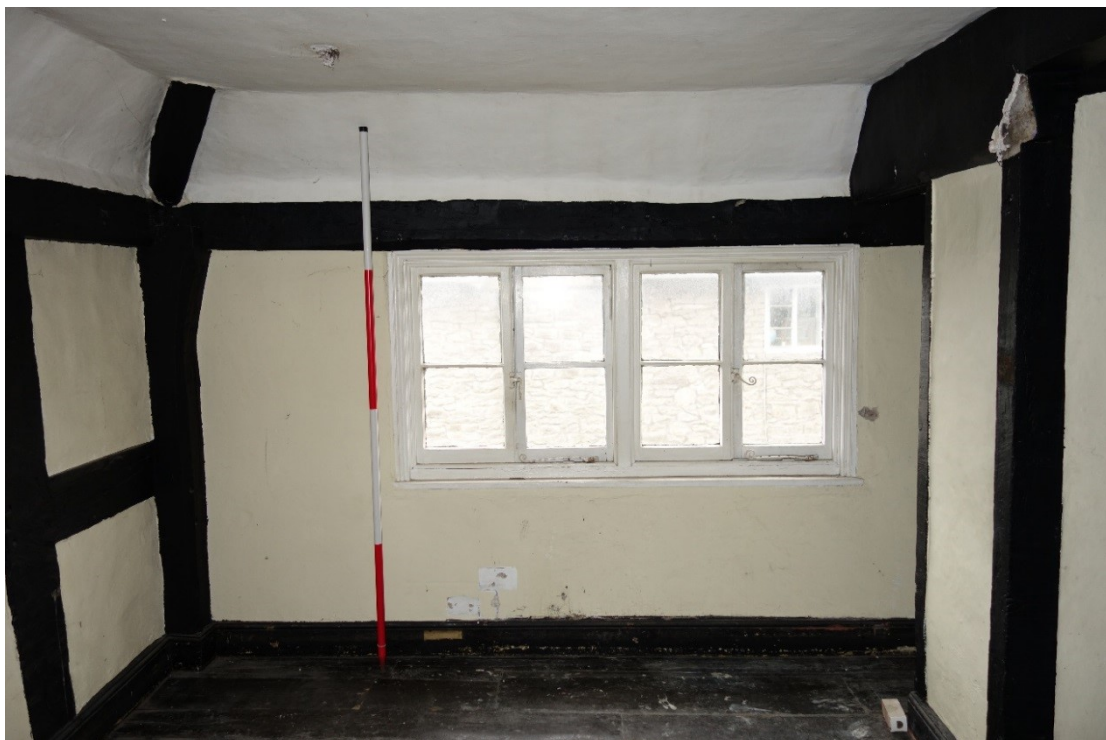
Plate 40: Internal view of living room at SE end of first floor showing coved ceiling and casement windows

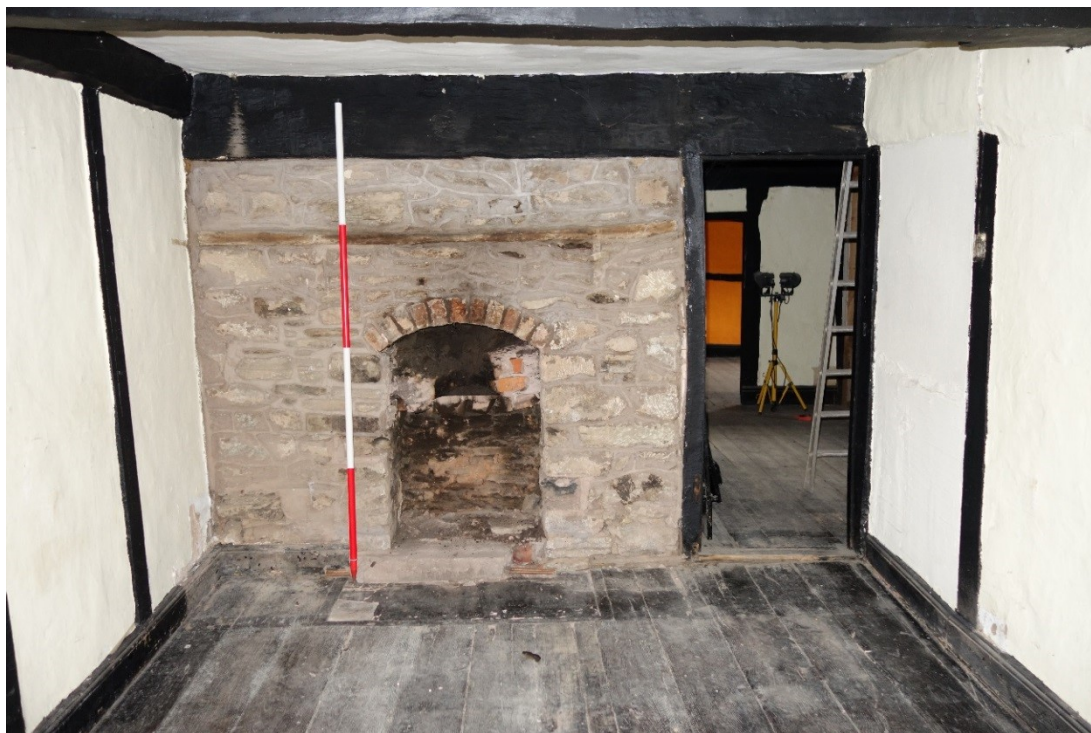
Set within the NW wall of the living room is a large fireplace with a brick segmental arch set within the upper portion of the masonry chimneystack extending upwards from the lounge/public bar at ground-floor level. Inserted in the thickness of the chimneybreast above the fireplace is a horizontal timber (*Plate 41*). Within the SE wall of the room is a section of exposed square-panelled timber-framing, the regular form of the panels and the thickness of the scantling contrasts markedly with the thinner scantling of the partitions on the opposite side of the room flanking the fireplace (*Plate 42*). Extending NE-SW across the ceiling of this room and the adjacent bedroom is a large chamfered cross-beam with slots for vertical timbers; it is difficult to determine whether this cross-beam was associated with a partition wall or (as seems more likely) these represent re-used timbers inserted to provide additional support for the roof above (*Plate 44*). The adjoining bedroom has a coved roof and is lit by a single four-pane casement window in the SE-facing elevation. There is exposed square-panelled timber-framing with thick scantling in the SE and NE walls, identical to that visible in the living room (*Plate 43*).

Plate 41: Internal view looking NW showing fireplace in living room at SE end of first floor, with substantial cross-beam above

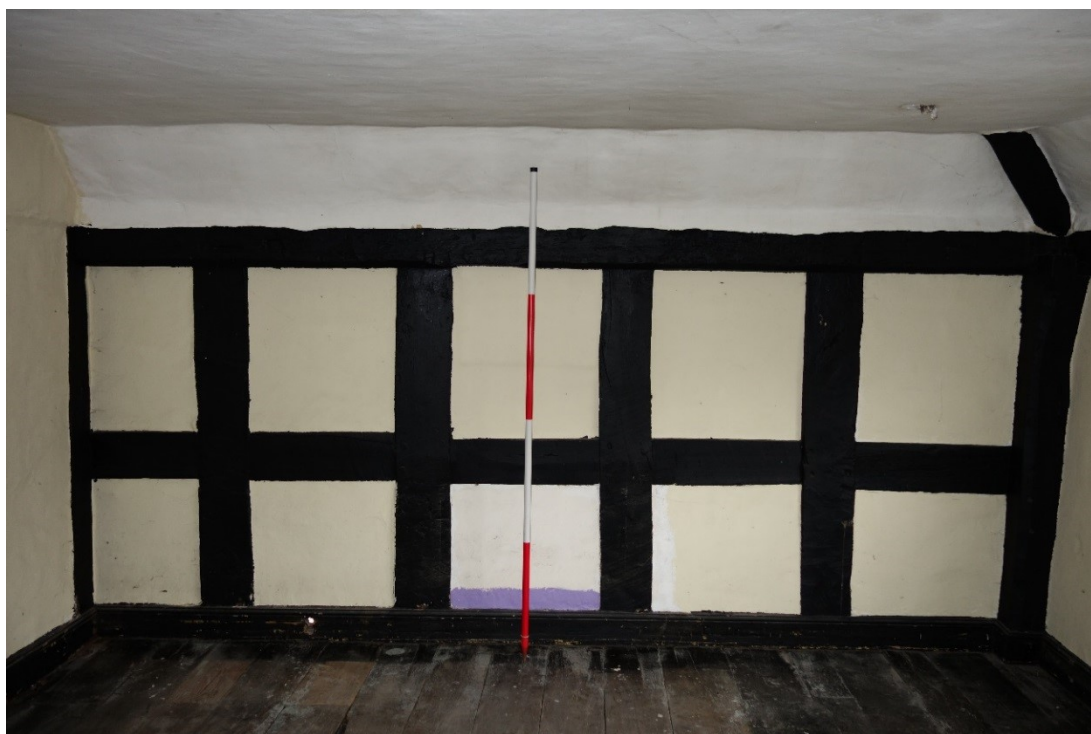
Plate 42: Internal view looking SE showing regular, square-panelled timber-framing with thick scantling in SE wall of living room at first-floor level

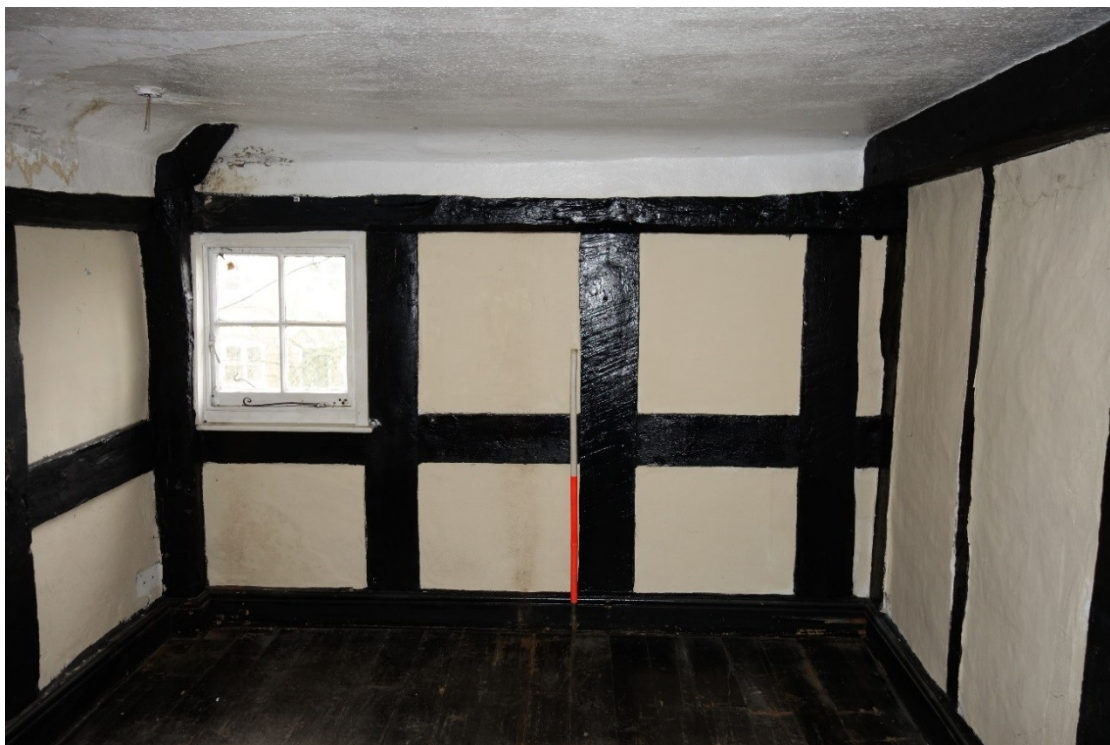
Plate 43: Internal view looking SE showing square-panelled timber framing and casement window in SE wall of bedroom at the SE end of the first floor

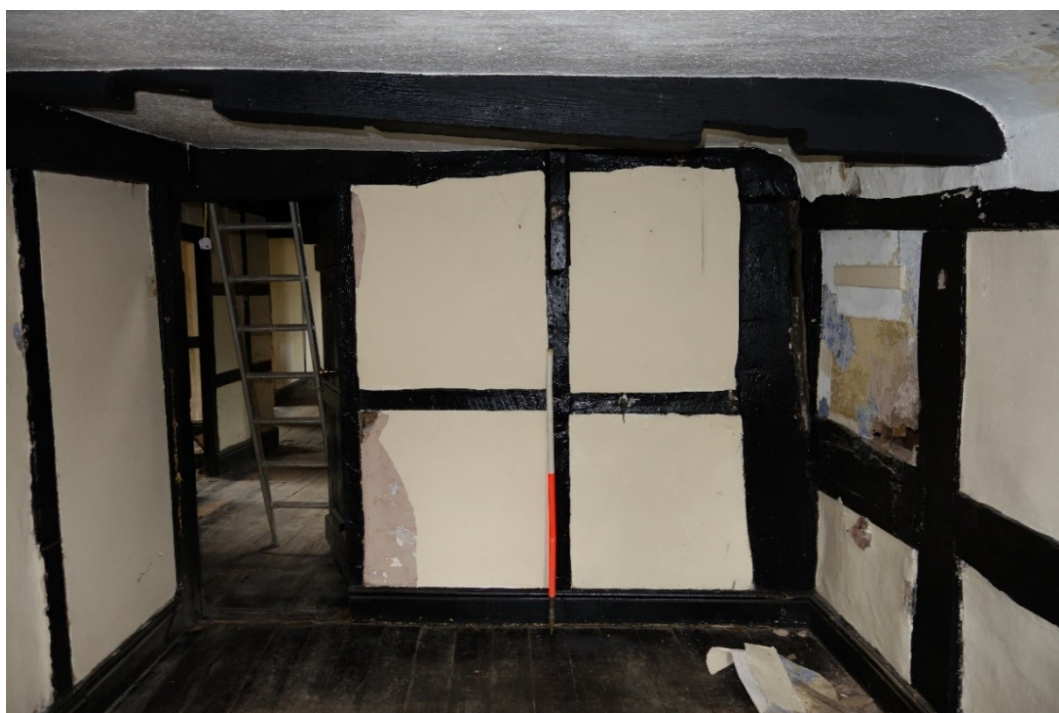
Plate 44: Internal view looking NW showing bedroom to SE of first-floor landing showing square-panelled framing and cross-beam with slots for vertical posts (in foreground of picture)

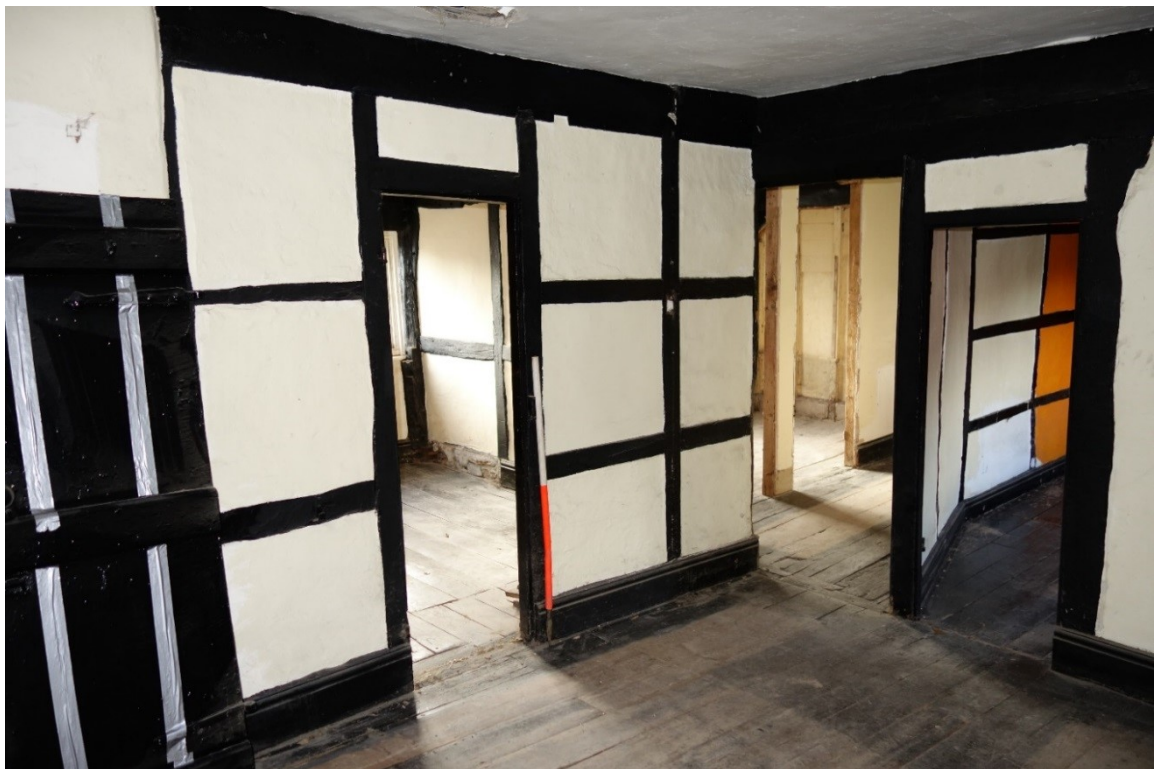
Plate 45: View looking N showing first-floor landing and passageway with square-framed partition walls

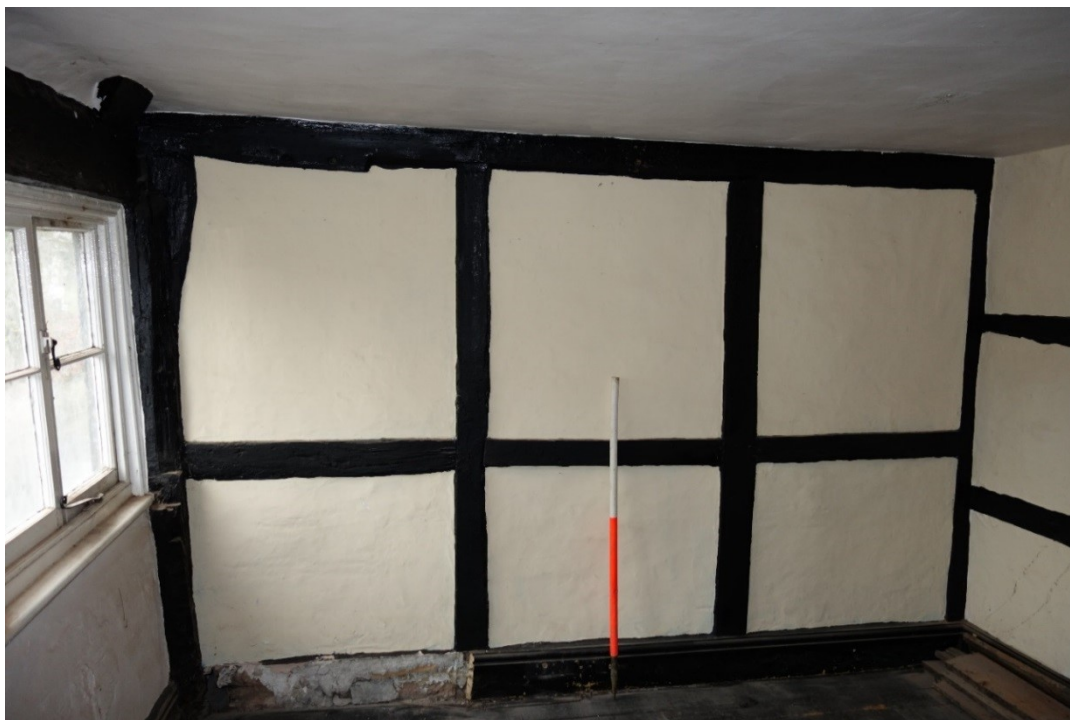
Plate 46: Internal view looking NW showing thin scantling of partition wall of bedroom to SW of first-floor landing with earlier jowelled corner-post and wall-plate to left of picture
