**Standing Building Recording
Survey**

The Royal George Inn

Lyonshall

BA1501RGIL

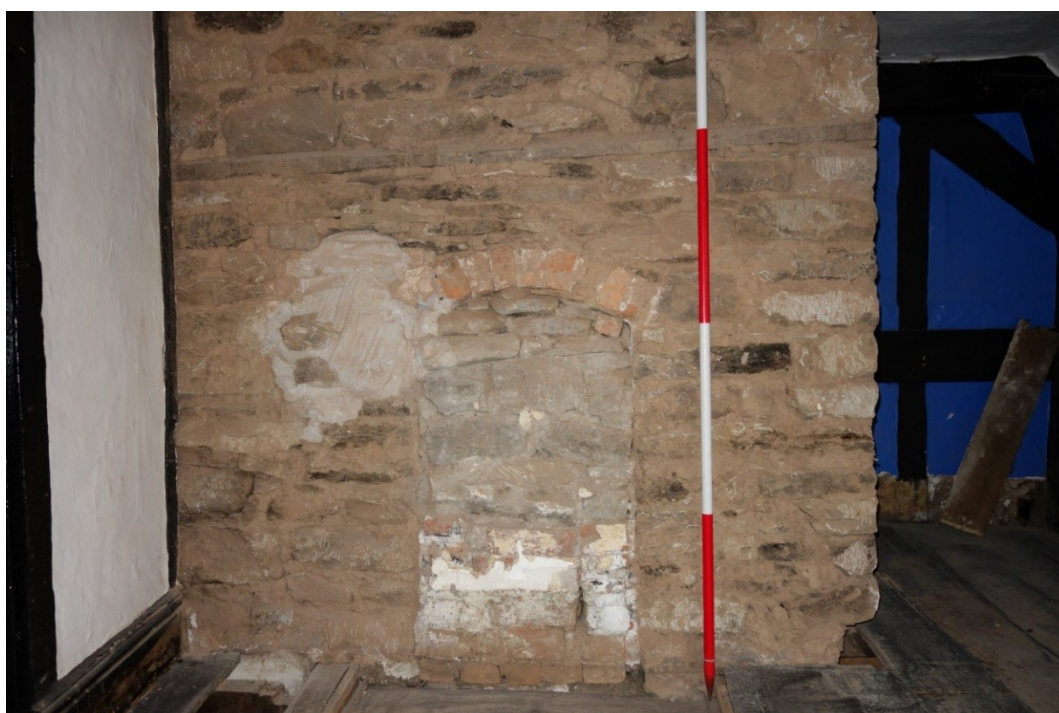
The bedroom to the SW of the landing is lit by a single four-light casement window set within a flat-headed architrave of probable 19th-century date. The walls of the room are of square-panelled construction (the panels infilled with lath-and-plaster as elsewhere) with jowelled corner-posts visible in the SW and SE corners and ogee-moulded skirting (*Plate 46*). The post in the SE corner is connected to the wall-plate by a cast-iron tie. Located at the SE end of the room is the upper stage of the masonry chimneystack visible at ground level. A brick

segmental-arched fireplace (since blocked-up) is visible within the chimneystack, above which is a horizontal timber inserted into the thickness of the stack (*Plate 47*).

Plate 47: View looking SE showing blocked fireplace and chimneybreast in bedroom to SE of first-floor landing

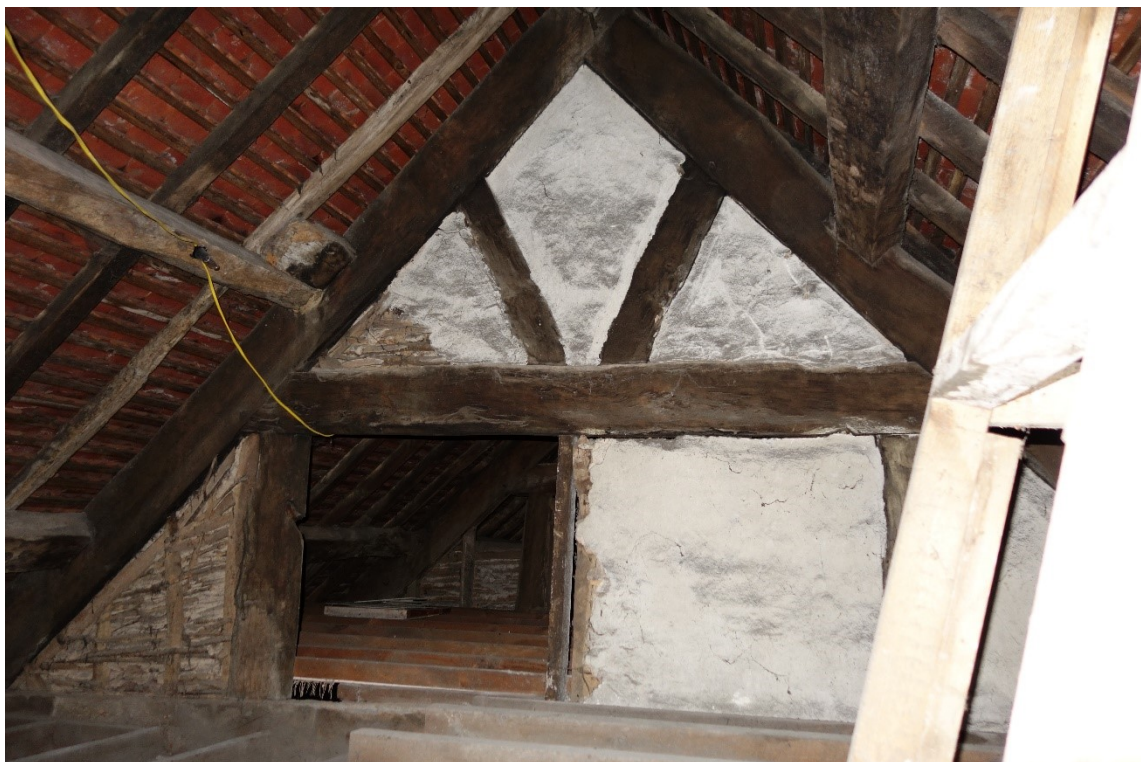
Plate 48: Internal view NW showing roof truss of probable late 16th -early 17th century date, with trenched purlins and angled struts connecting the collar to the principal rafters, the panels infilled with wattle and daub and lath-and-plaster

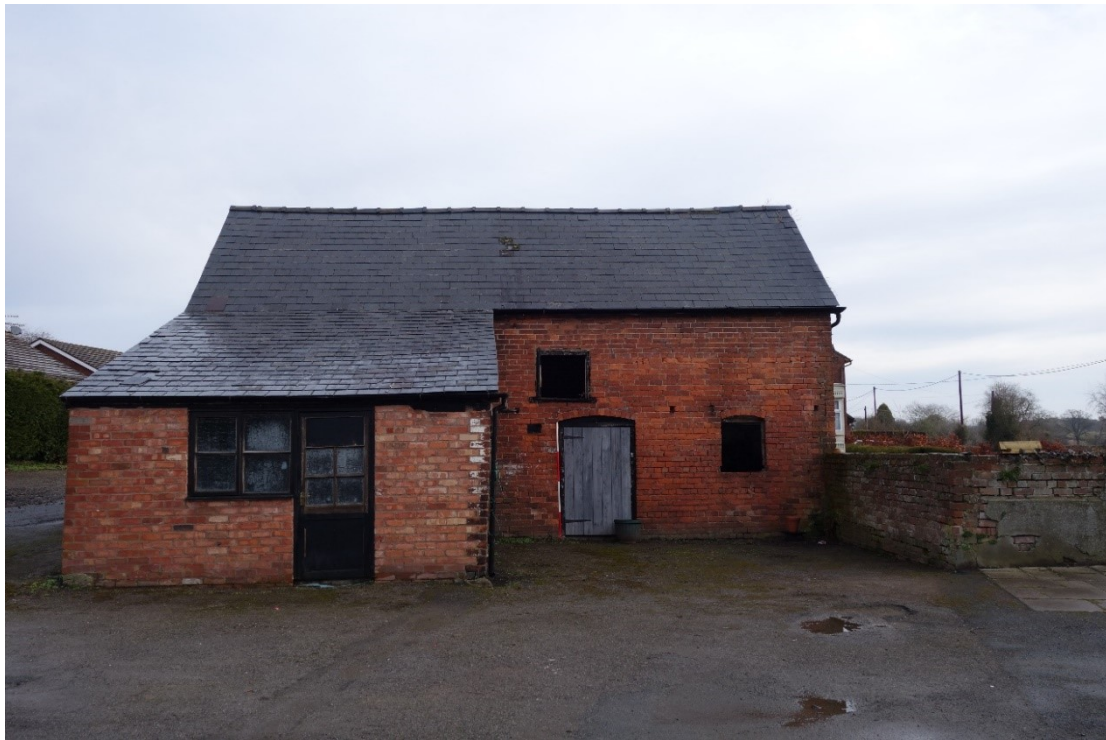
Plate 49: View looking NE showing the principal SW-facing elevation of the brick outbuilding with projecting extension with catslide roof

The SW-facing elevation of the main gabled block (*Plate 49*) has a segmental-arched doorway at ground-floor level with a segmental-arched window to the right of the doorway and flat-headed window with a wooden sill above it. The NW-facing gable elevation has a centrally-placed segmental-arched window at ground-floor level with a stable doorway immediately to the right of it and a segmental-arched hayloft door above (*Plate 50*). The SE gable is devoid of fenestration, although there is a small rectangular area of whitewashed brickwork in the bottom left-hand corner of the elevation which indicates the position of a wooden lean-to shed against this wall.

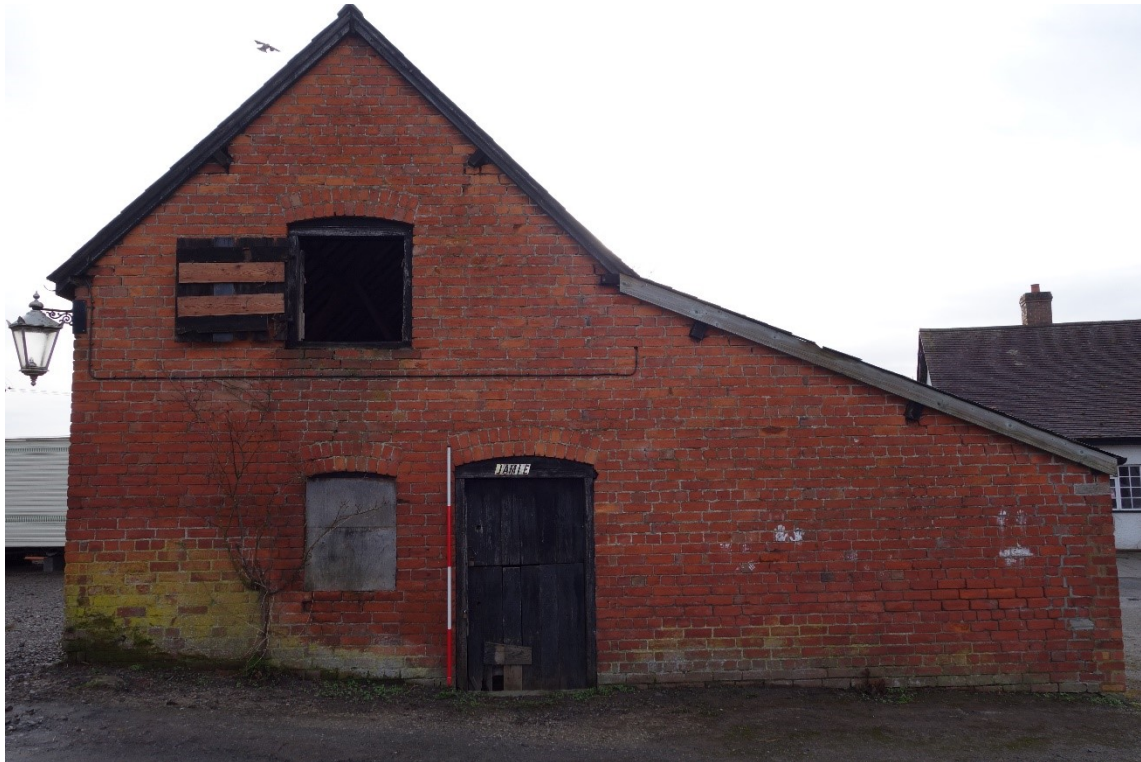
Plate 50: View looking SE showing the NW-facing gable elevation of the brick outbuilding

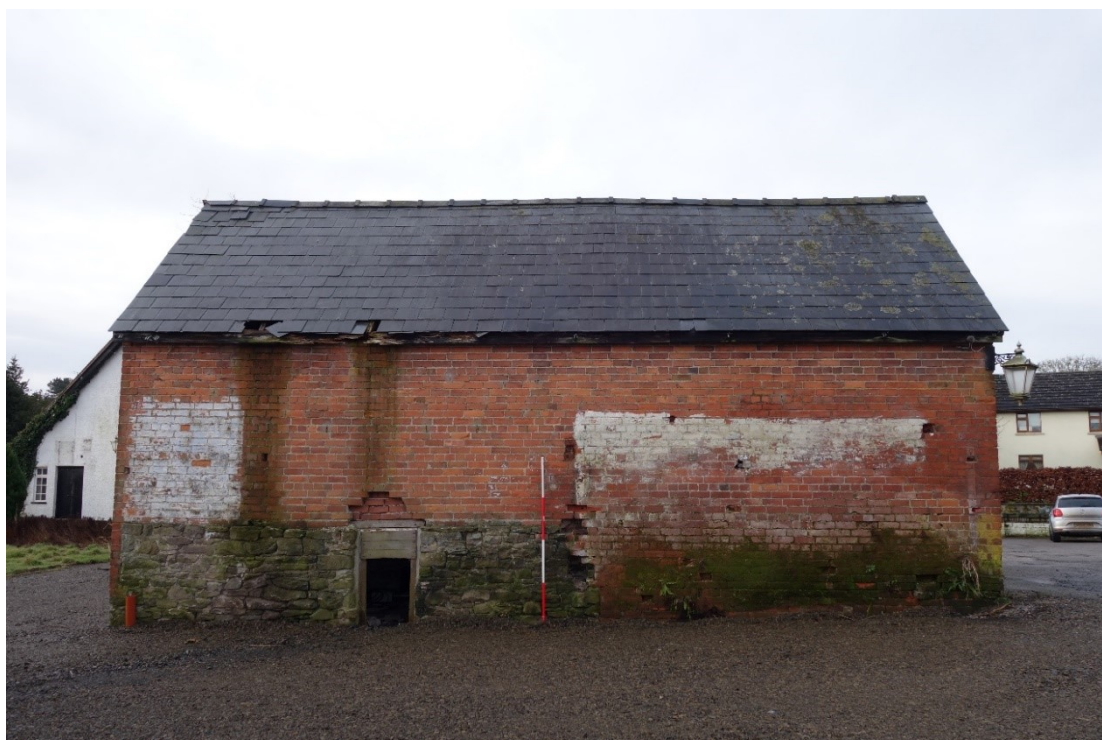
Plate 51: View looking SW showing the NE-facing rear elevation of the brick outbuilding, partially reconstructed in roughly coursed masonry with evidence for lean-to structure (now demolished)

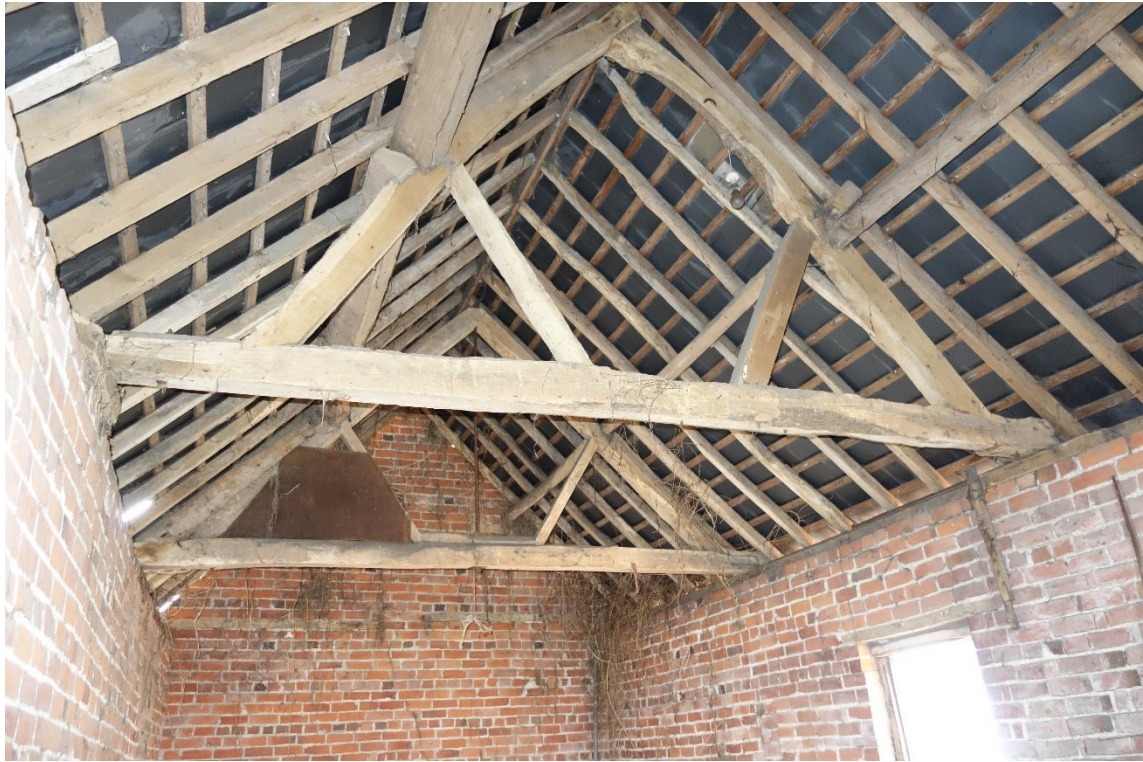
Plate 52: Internal view looking SE of main compartment of outbuilding showing roof construction, of typical 19th -century open-truss type

Few features of interest were noted within the larger of the two compartments. The lower stages of the NE wall of the larger compartment appear to have been reconstructed with roughly coursed rubble masonry (tapering outwards towards the base), possibly in connection with the insertion of the low doorway leading outside to the sheds for chickens or pigs. A timber wall-plate has been inserted in the wall between the masonry and the brickwork above (*Plate 54*). No evidence for stalls or fittings, such as racks or mangers for horses or livestock, was noted, although these may have been removed previously. Within the smaller compartment, wooden hay racks and a concrete feeding trough attached to the NE wall were identified, all of which appear to be of relatively modern date. Patches of cobbled flooring were noted in both compartments.

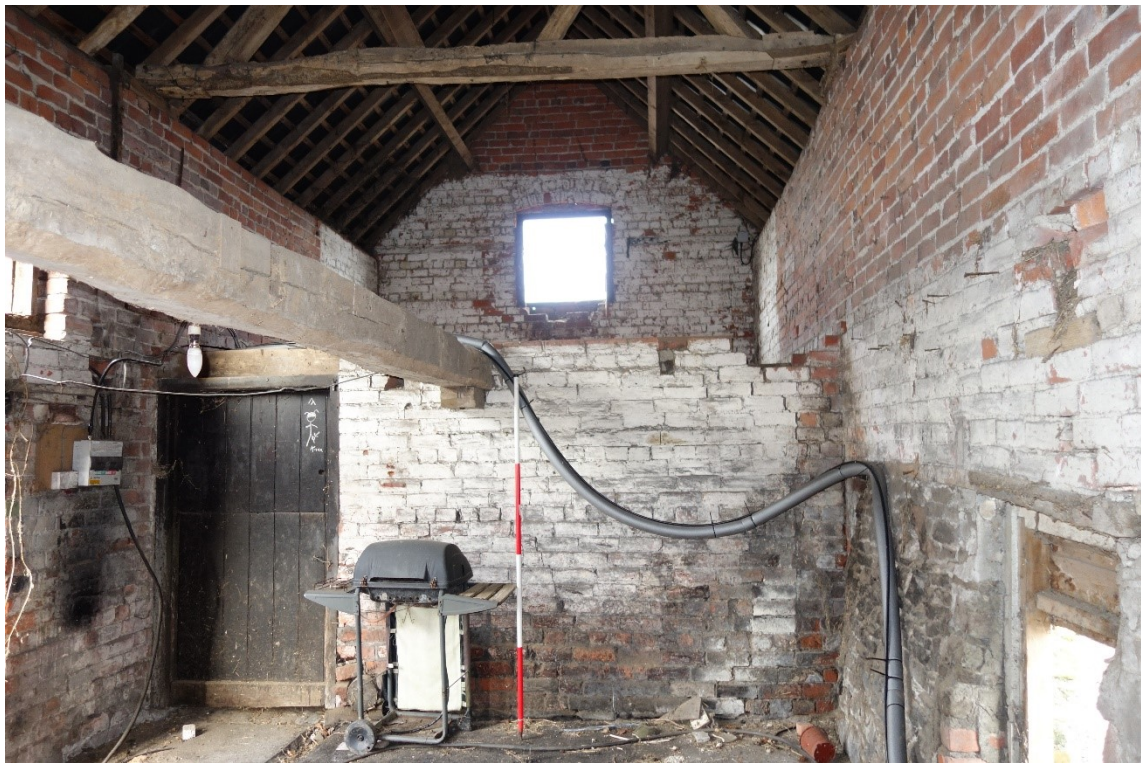
Internally, the main gabled block has an open truss roof with trenched purlins and angled struts connecting the tie beam to the principal rafters (*Plate 52*). It comprises two separate compartments, both of which are whitewashed at ground-floor level, sub-divided by a brick partition wall, 2m in height (laid in English Garden Bond). Extending through the centre of both compartments is a substantial, low cross-beam supporting joists for a hayloft above (*Plate 53*). Within the larger of the two compartments the joists for the hayloft have been removed, although the mortise slots for these joists are visible in the cross-beam and beam slots within the flanking walls. Within the smaller of the two compartments, the joists for the hayloft have remained intact.

Plate 53: Internal view looking NW showing brick partition wall separating the two compartments, with horizontal cross-beam to left of picture

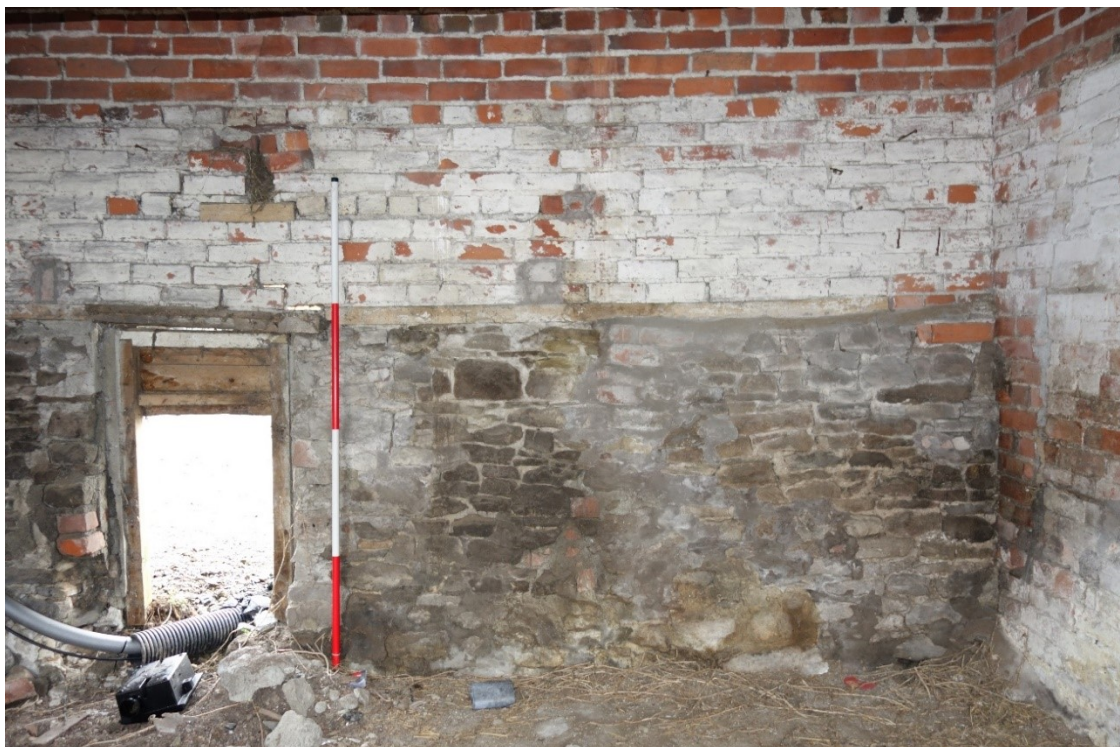
Plate 54: Internal view looking NE showing rear wall of main compartment of outbuilding, the lower portion partially reconstructed and a low doorway inserted
