BA1421MKUWRS

The programme of building recording to RCHME Level 2 undertaken by Border Archaeology on a complex of buildings within a field on the E side of Calverton Lane has produced the following results, which are summarized below:

Report title:		Report Ref:	
Standing Building Recording Station at Upper Weald Cal Milton Keynes		BA1421MKUWRS	
Report written by	Stephen Priestley MA & And	drew Tizzard BA PhD MlfA	
Reported edited by	Reported edited by George Children MA MIfA		
Issue No.	Status	Date	Approved for issue
1	Final	June 2014	Neil Shurety Dip.M G M Inst M

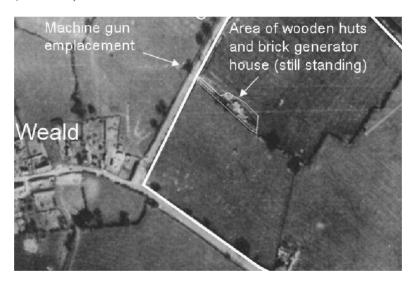
Plate A: Extract from aerial photograph taken on April 9th 1946 showing Upper Weald radio station

The radio station at Upper Weald consisted of two prefabricated huts, probably constructed of wood (of which only the foundation plinths survive), which appear to have served as the wireless station and a recreation room/accommodation for the wireless operators and a brick-built single-storey structure (still extant) which appears to have been used as a generator/battery room and offices. Located immediately opposite the brick-built structure is the plinth for a third hut that also appears to have been used as a generator room, to the SE of which are the foundations for another block, probably used for toilets or a washhouse. A metalled driveway ran NW from the radio station to Calverton Lane, with evidence for a possible sentry post at the field entrance. These buildings are all visible on a RAF vertical photograph of the area dated April 9th 1946 (Calverton Records Society). The station at Upper Weald was apparently dismantled shortly after the Second World War, between April and October 1946; the 1946 aerial photograph still shows that the buildings were extant at that time; however, an OS 6-inch map of 1953 only shows the brick structure housing the generator/battery room and offices and the driveway providing access to Calverton Lane.

The layout of the radio station complex at Upper Weald is clearly shown on an aerial photograph taken in April 1946, shortly before its demolition and the programme of building recording undertaken by Border Archaeology has essentially confirmed the accuracy of this photograph.

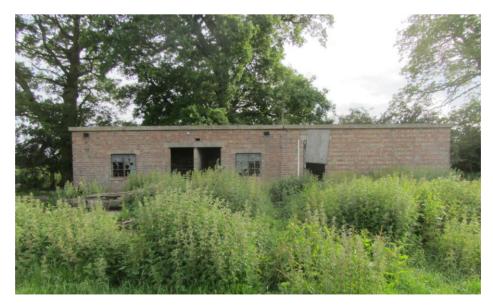
Buildings A, B and C have been considered together, as they form part of a single unit. Buildings A & B have been identified as a generator building (Pidgeon 2008, 83) and certainly appear to be utilitarian in character, although the presence of windows in the compartment at the SE end might suggest that this room may have also been used as an office/storeroom. Building A (*Plate 1*) is a single-storey structure of brick construction (laid in English Bond) measuring 8m long (NW-SE) × 4m wide (NE-SW) × 2.64m high with a concrete roof sloping to the rear. The principal NE-facing elevation of Building A is punctuated by a pair of doorways with concrete lintels set slightly off-centre and flanked by two 12-paned casement windows with concrete lintels; the casements are glazed with reinforced, frosted glass (*Plate 2*). At the upper left -and right-hand corners of the elevation are two ventilation slots with iron grilles, with another slot and a fitting, possibly for a light, above the pair of doorways. Inserted in the centre of the SE-facing elevation of the building is a single 12-paned casement window with a concrete lintel and a brick sill (*Plate 3*).

Plate 1: View looking SW showing principal NE-facing elevation of Buildings A & B

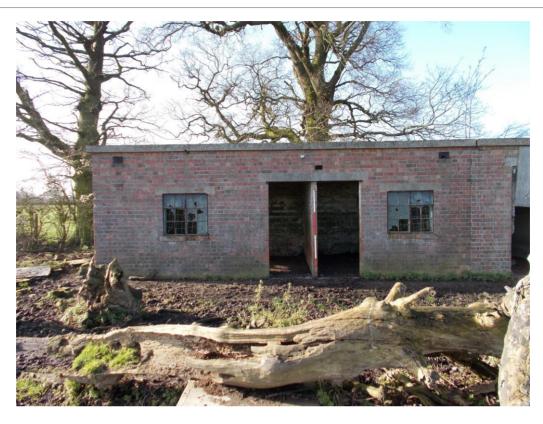
Plate 2: View looking SW showing detail of NE-facing elevation of Building A

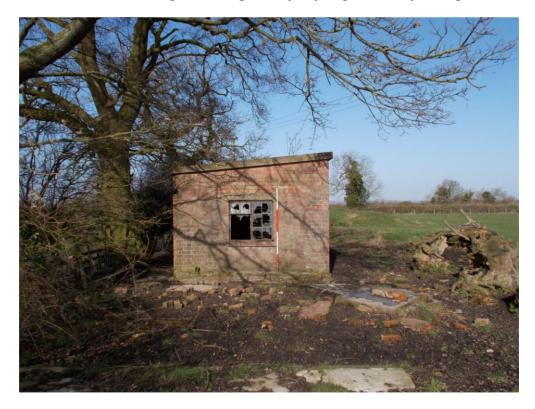
Plate 3: View looking NW showing SE-facing elevation of Building A

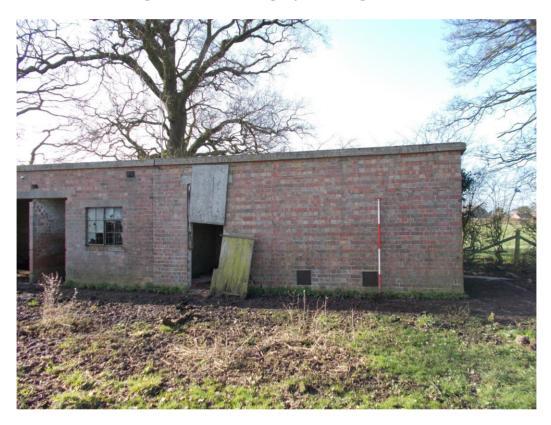
Attached to the NW end of Building A is another single-storey structure (Building B), of similar brick construction with a sloping concrete roof (*Plate 4*), measuring 6.5m long × 3m wide × 2.64m high. It would appear from the evidence for a construction break and a slightly offset roof slab that Building B post-dates Building A, although the similarity in construction method suggests it cannot be very much later in date. In contrast to the adjacent structure, Building B is devoid of fenestration, with a single narrow doorway with concrete lintel giving access to a small compartment at the SE end of the building and a broad doorway inserted at the NW end, leading into a much larger compartment (*Plate 5*). Building B appears to be much more utilitarian in character than the adjacent building and has been interpreted as a generator room. Two square ventilation slots with metal grilles have been inserted in the NE-facing elevation of Building B, just above ground level.

Plate 4: View looking S showing NE-facing elevation of Building B

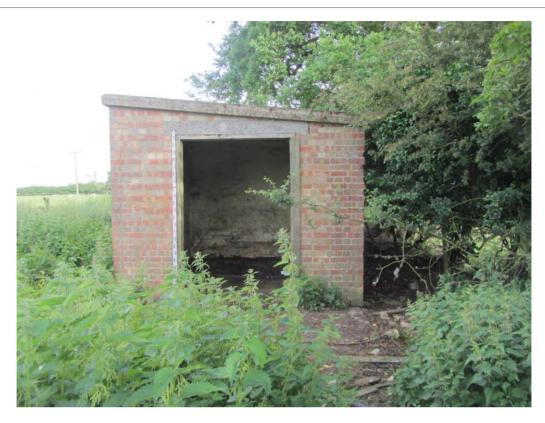
Plate 5: View looking SE showing NW-facing elevation of Building B with broad doorway

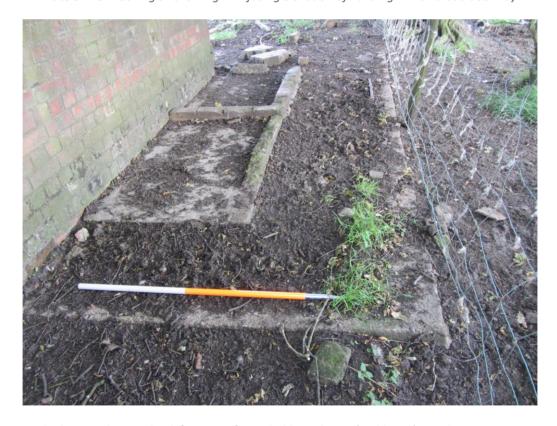
Attached to the rear of Building A are the footings of a small, narrow brick structure (Building C) measuring 4.30m (NW-SE) \times 1.80m (NE-SW) comprising two compartments standing on a concrete plinth (*Plate 6*), which may be identified as a toilet block that was still extant in 2012 but appears to have been demolished shortly after that date. A photograph taken in 2012, shortly before its demolition, reveals that the toilet block had a concrete slab roof.

Plate 6: View looking SE showing brick footings of a probable outhouse (Building C) standing upon a concrete plinth

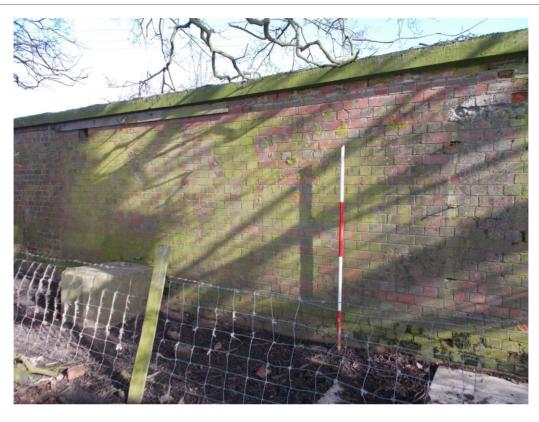
To the NW of the toilet block, attached to the rear (SW-facing) elevation of Building A, is a hexagonal concrete plinth measuring 0.90m long (NE-SW) \times 0.40m wide \times 0.30m high (*Plate 7*). The function of the plinth is unclear; it presumably was intended as a base for a machine or possibly a boiler. Evidence was noted for a circular hole inserted in the wall directly above the plinth (*Plates 7 & 8*).

Plate 7: View looking N showing SW-facing rear elevation of Building A with footings of Building C visible to right of picture

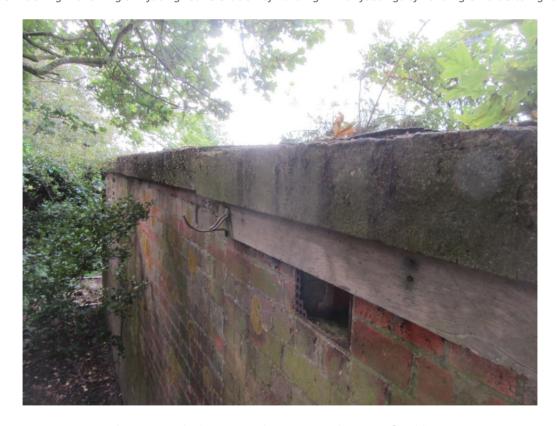
Plate 8: View looking NNW showing rear elevation of Building B

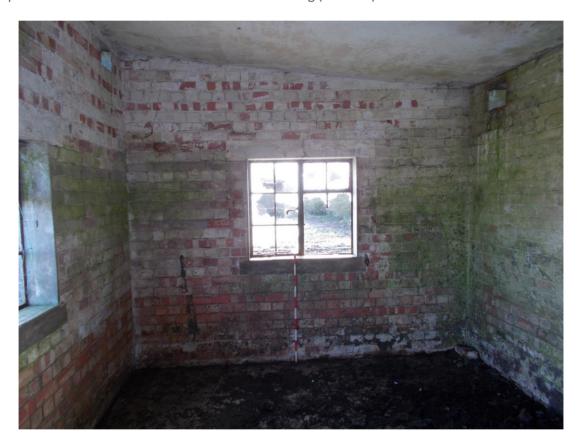
Internally, Buildings A and B are both divided into two compartments, all of which are heavily coated in whitewash. The larger of the two compartments within Building A (at its SE end) is four bays long and lit by two 12-paned casement windows with reinforced frosted glass in the NE and SE walls (*Plates 9-11*). Ventilation slots with grilles were noted in the NE and SW walls. Indentations for shelving and cupboards were visible on all the internal wall surfaces.

Plate 9: Internal view looking SE within compartment at SE end of Building A

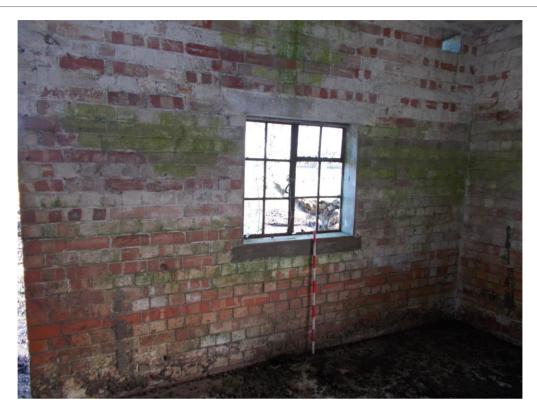
Plate 10: Internal view looking NE within compartment at SE end of Building A

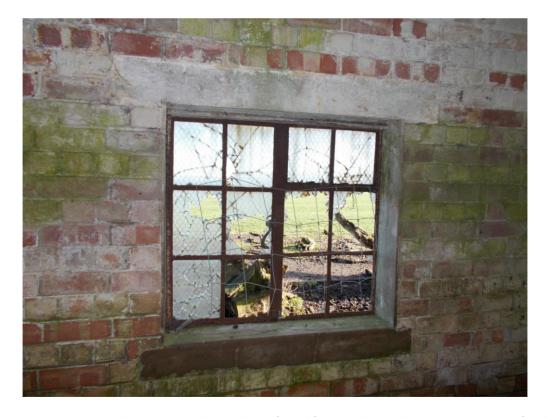
Plate 11: Detail showing 12-paned casement window with reinforced frosted glass within SE compartment of Building A

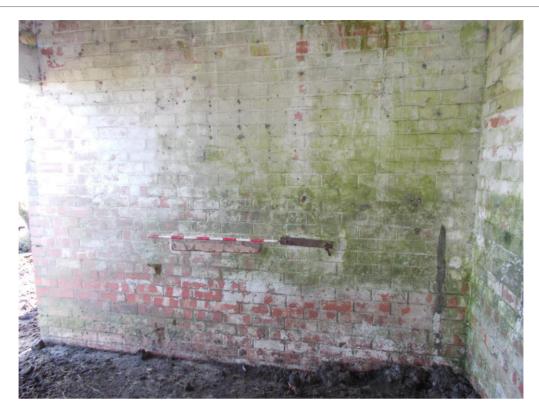
Plate 12: Internal view looking SE showing whitewashed wall with iron wall tie within NW compartment of Building A

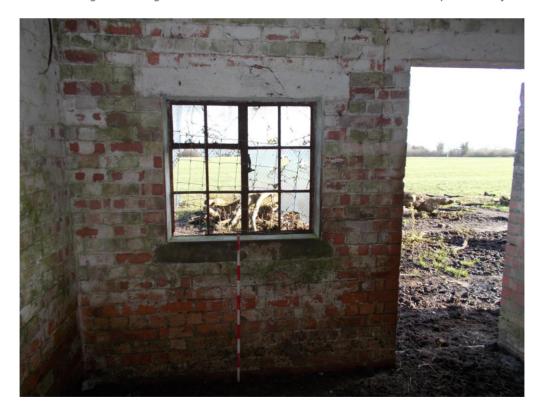
The smaller compartment within Building A is lit by a single 12-paned window in the NE wall (*Plate 13*); again, evidence of indentations for shelving and cupboards was noted on all internal wall surfaces, as well as an iron fitting with a handle attached to the SE wall, of unknown function. A circular hole was also noted in the centre of the SW wall, which appears to have been associated with machinery (or possibly a boiler) located on a hexagonal concrete plinth attached to the rear elevation of the building (*Plate 14*).

Plate 13: Internal view looking NE showing 12-paned casement window in NW compartment of Building A

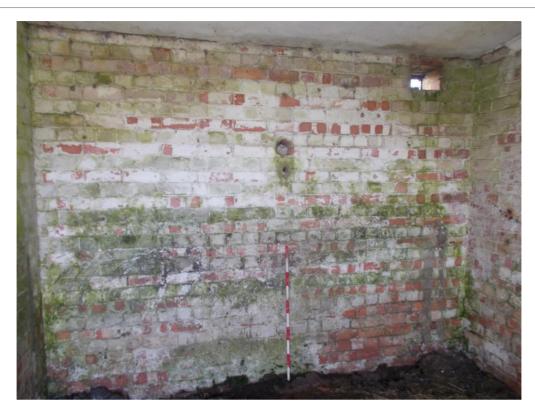
Plate 14: Internal view looking SW showing circular hole in centre of NE-facing wall of NW compartment of Building A

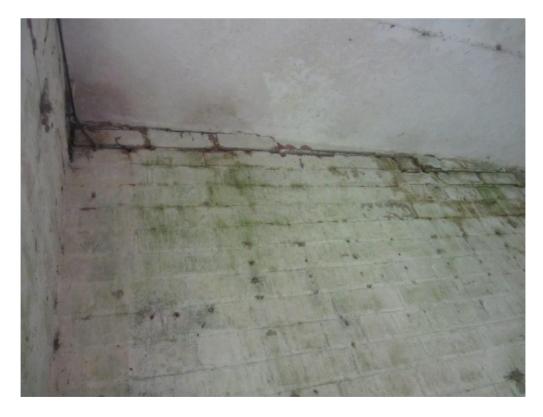
Plate 15: Detail showing indentations for shelving in SE compartment of Building B

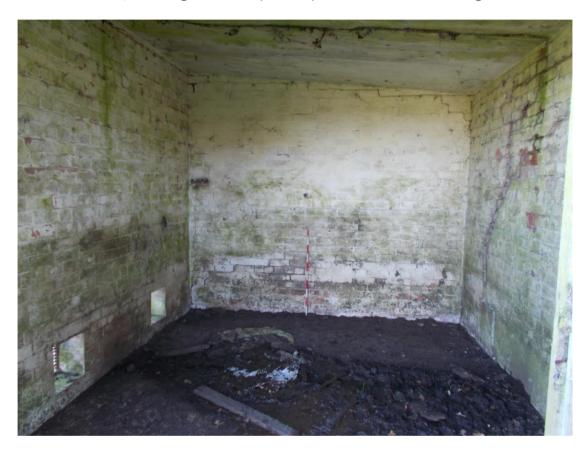
Building B is similarly divided into two compartments of unequal size; the smaller of the two compartments was entirely coated in whitewash with evidence for numerous indentations for shelving on all internal wall surfaces, extending to ceiling height (*Plate 15*). The larger compartment, at the NW end of the building, may have been used to house the generator; again, the room is entirely whitewashed, although there is considerably less evidence of indentations for cupboards and shelving compared to the other rooms. Two ventilations slots have been inserted in the NE wall, close to ground level (*Plate 16*). No other fixtures of fittings of interest were noted.

Plate 16: View looking SE showing whitewashed interior of large compartment at NW end of Building B with ventilation slots visible to left of picture

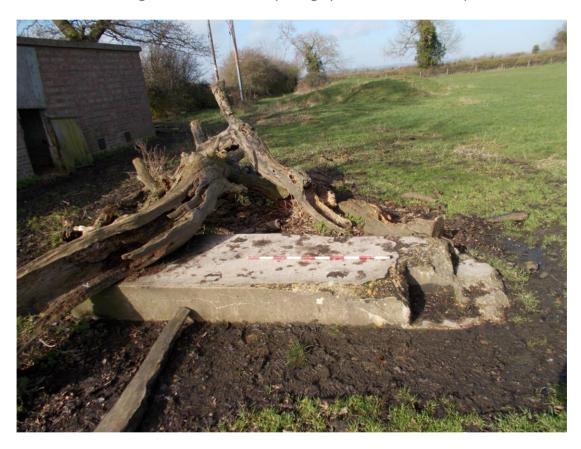
Located immediately opposite Buildings A & B is a rectangular, chamfered concrete foundation plinth measuring 9.80m long (NW-SE) \times 6.10m wide (NE-SW) \times 0.05m high (*Plates 17-19*). The plinth is evidently the foundation for a prefabricated structure, probably of wooden construction, which appears to have housed machinery, most likely a generator. Located roughly at the centre of the structure is a rectangular concrete machine base measuring 3.00 long \times 1.30m wide \times 0.29m high with evidence for a series of metal pins set into the top of the base, which is likely to have supported substantial machinery, almost certainly a generator. This likelihood is further reinforced by evidence for heavy copper cabling noted projecting from the foundation plinth just beneath the SW end of the machine base (*Plate 20*). It is unclear whether this represents the original generator for the radio station or whether it could represent a back-up generator that was added when the radio station was expanded in 1944. This building is visible on an aerial photograph of the area dated April 1946.

Plate 17: View looking NW showing concrete machine base, probably for a generator, standing upon a rectangular foundation plinth for a prefabricated structure (Building D)

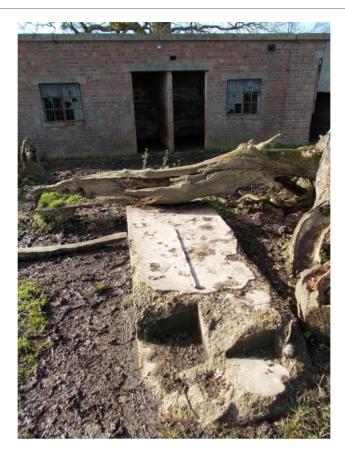
Plate 18: View looking SW showing detail of concrete machine base in Building D

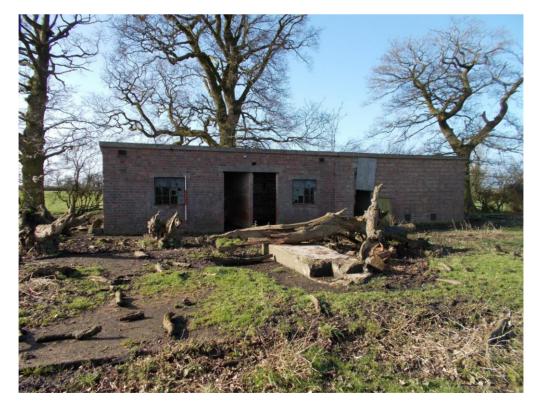
Plate 19: View SW showing foundation plinth for Building D in foreground with concrete base visible to right of picture

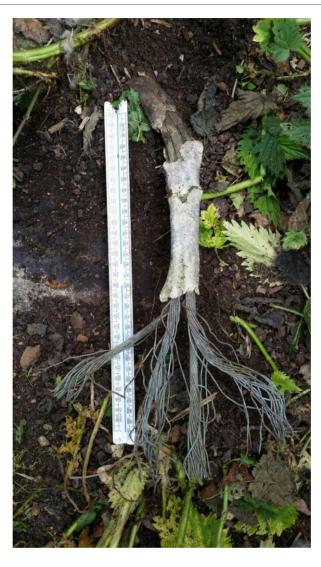
Plate 20: Detail showing heavy copper cabling projecting from plinth of Building D

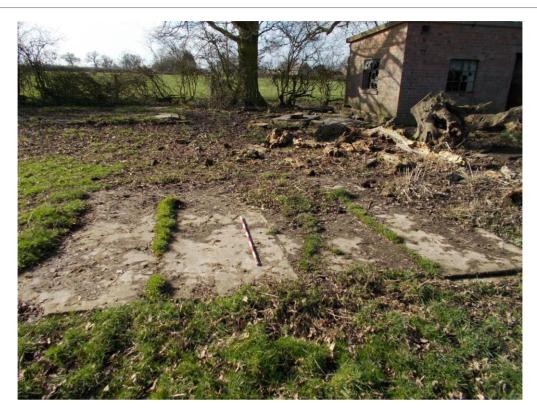
Located approximately 3m SE of Building D is another rectangular concrete foundation plinth, measuring 3.80m long \times 2.80m wide (*Plate 21*). This foundation was probably intended to house a toilet block or washhouse, indicated by the evidence for the division of the structure into four regularly spaced cubicles (*Plate 22*). No other fixtures or fittings of interest were noted.

Plate 21: View SW showing concrete foundations of probable toilet or washhouse block (Building E)

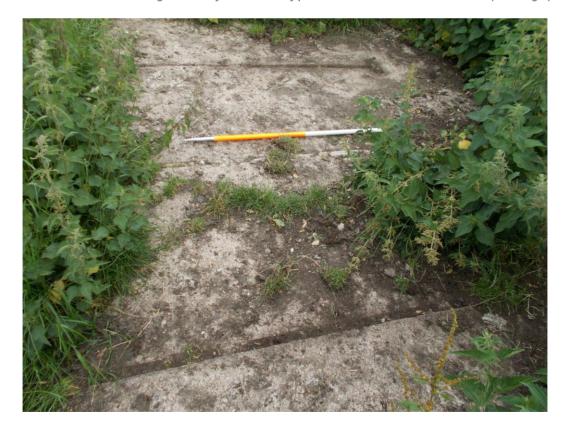
Plate 22: Detail showing divisions for cubicles within the toilet or washhouse block (Building E)

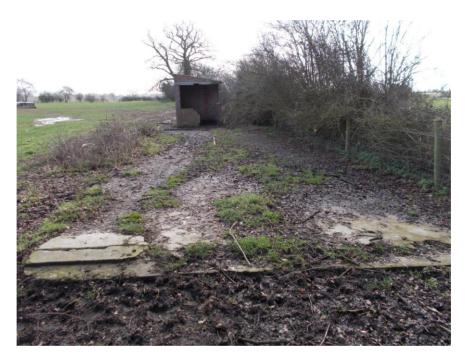
Located approximately 6m SE of Building A are the partially denuded footings of a rectangular, raised concrete plinth (designated as Building F) measuring approximately 11.80m long (NW-SE) \times 5.30m wide (NE-SW) \times 0.05m high (*Plate 23*). This appears to represent the plinth for one of the prefabricated huts recorded as forming part of the radio station complex at Upper Weald; the structure is visible on an aerial photograph dated April 1946. It is unclear whether this represented the hut actually housing the wireless station or an accommodation/recreation room for the wireless operators. The truncated remains of a cast-iron pipe were noted, projecting roughly from the central part of the plinth, which may have been inserted to provide a water supply to the hut.

Plate 23: View SE showing rectangular concrete plinth for prefabricated hut (Building F), with Building G in background

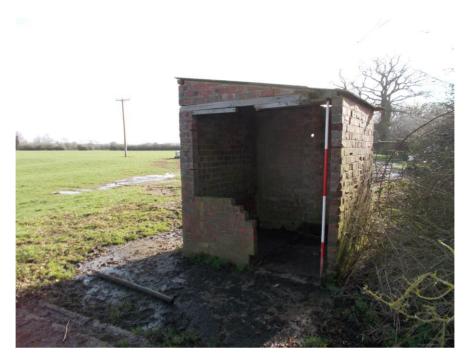
Located approximately 3m SE of Building F is a small square brick structure (laid in stretcher bond) with a sloping corrugated asbestos roof (Building G) measuring $1.95m \times 1.95m \times 2.37m$ high (*Plate 24*). A door originally appears to have been inserted on the right-hand side of the NW-facing elevation; however, most of the surround appears to have been removed together, with a section of the wall to the left of the doorway and a wooden lintel inserted at a later date, presumably when the building was converted to agricultural usage. Within the interior of the structure (which is not whitewashed) are the footings of a brick partition (*Plate 25*).

Plate 24: View NE showing NW-facing elevation of Building G, with concrete plinth for prefabricated hut in background to rear

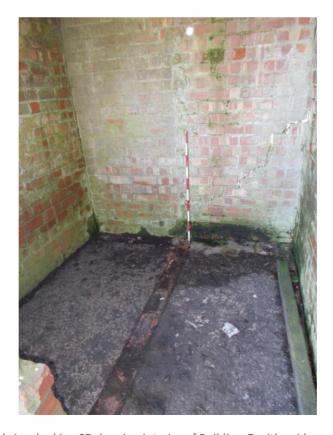
Plate 25: Internal view looking SE showing interior of Building G with evidence of brick partition

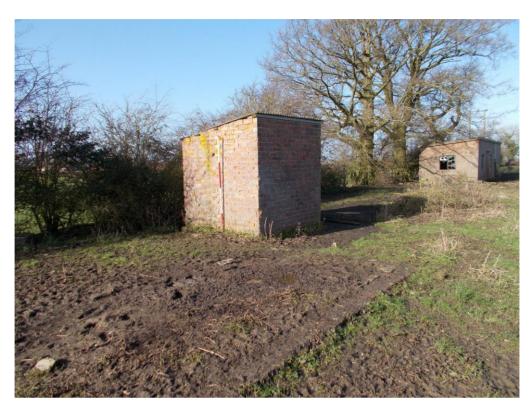
The function of this building is uncertain; however, it is evidently associated with another rectangular chamfered concrete plinth located immediately SE of it, which appears to have been the foundation for another prefabricated hut (Building H) visible on an aerial photograph dated April 1946. (*Plates 26 & 27*) This foundation plinth appears to have been slightly larger in size compared to its counterpart to the NW, measuring 16.5m long (NW-SE) × 6m wide (NE-SW) × 0.05m high. A narrow concrete drainage gully runs along the NE side of the plinth. It is unclear whether this hut housed the wireless operating room or was used as an accommodation/recreation room. It is possible that Building G may have housed batteries associated with the wireless operating room; a

supposition enhanced by the presence of a circular hole (possibly for cabling) in the SE wall abutting the site of Building H.

Plate 26: View WSW showing SE-facing elevation of Building G and a concrete foundation plinth for a prefabricated hut to the SE

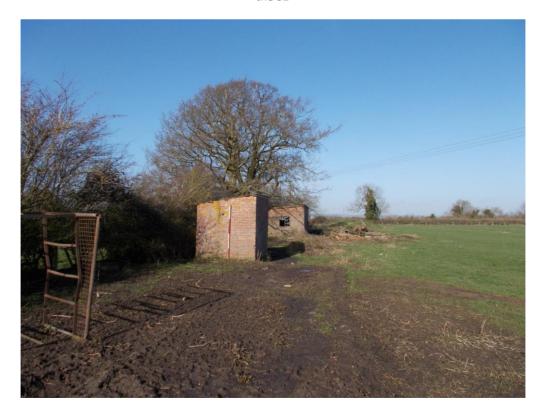
Plate 27: View W showing full extent of concrete plinth for hut to SE of Building G

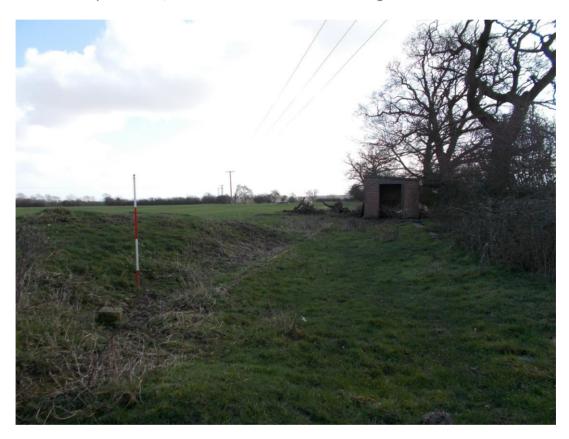
Extending NW from the generator/battery room and offices (Buildings A & B) is a concrete driveway, approximately 55m in length, which leads to a gateway giving access to Calverton Lane. The driveway is largely obscured by undergrowth, although sections of kerbing defining the edges of the driveway are still discernible (*Plate 28*). Running immediately SW of and parallel to the driveway is a metalled footpath, approximately 1.5m wide and again heavily overgrown. Inserted in the S field boundary fence adjoining the footpath, towards its NW extremity, is a gateway now disused and covered with barbed wire (*Plate 29*), which formerly provided access into the field immediately to the SW, which was one of the fields housing the radio transmitter masts.

Plate 28: View looking SE along driveway leading to the radio station complex, with evidence of kerbing and spoil-heap to left of picture

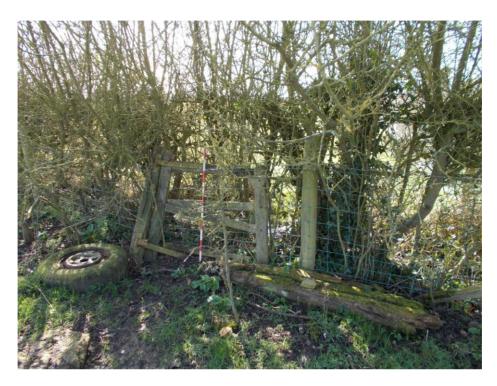
Plate 29: View looking SW showing disused gateway leading to field immediately SW of radio station

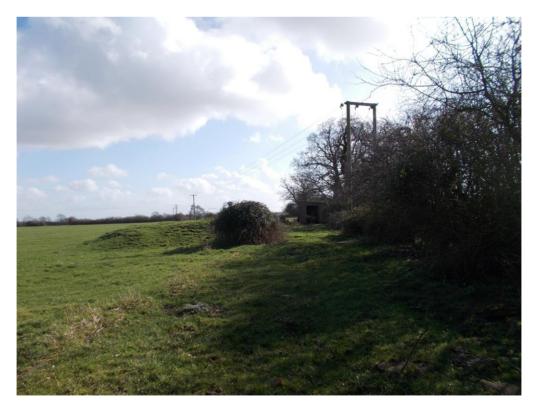
Adjoining the NE side of the driveway is a substantial grassy mound, measuring 27m long (NW-SE) \times 14m wide (NE-SW) and standing to a height of roughly 1.8m, upon which a significant scatter of brick and concrete building debris is visible. It was originally hypothesized that this might represent the remains of a blast shelter; however, it is not visible on an RAF aerial photograph of the site taken in April 1946 and a more likely explanation is that this represents a spoil-heap of building debris deposited after the majority of the buildings associated with the radio station were demolished (*Plate 30*).

Plate 30: View looking SE showing spoil-heap to left of driveway and remains of metalled footpath to right of picture

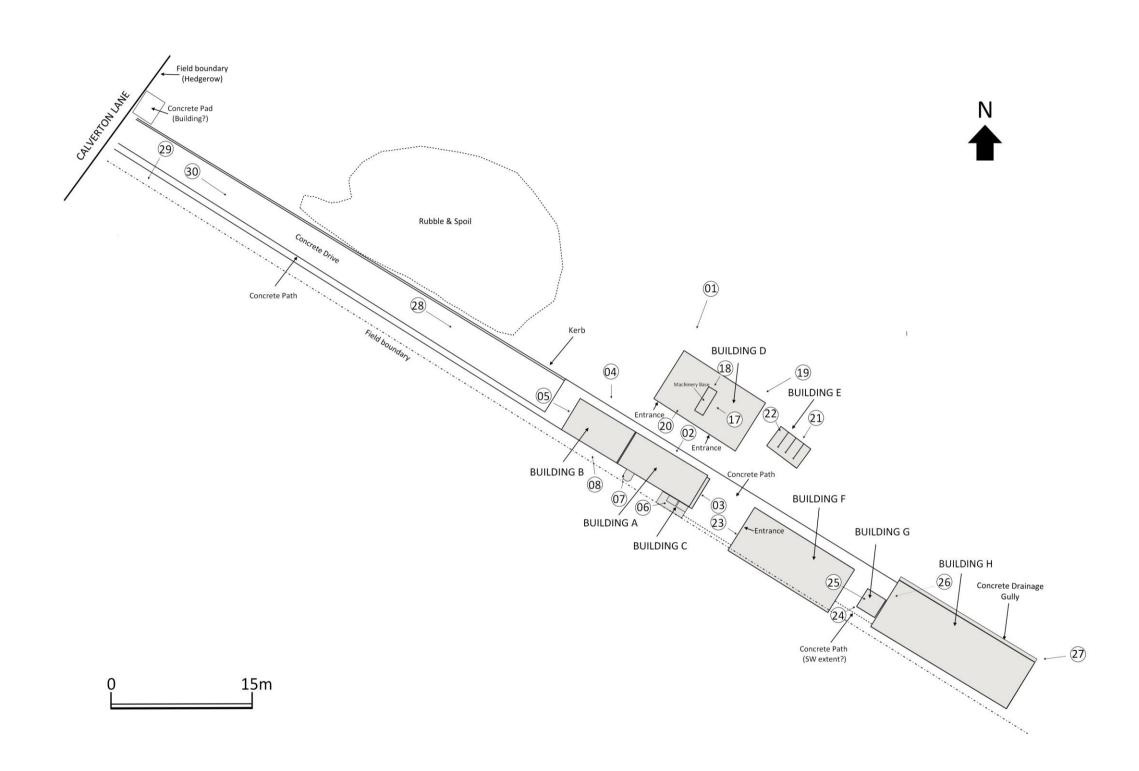
Fig. 2: Plan showing layout of former complex of buildings at Upper Weald Radio Station

The complex of buildings recorded at Upper Weald comprises eight separate components. Lying parallel to the S boundary of the field is a single storey brick structure oriented NW-SE comprising two separate components (Buildings A & B) with a toilet block attached to the rear (Building C). Immediately to the NE of Buildings A & B is the foundation plinth for a prefabricated hut (Building D) with another foundation pad for a freestanding toilet/wash-room block (Building E) lying to the E of that building. Lying to the SE of Buildings A & B are two further rectangular foundation plinths for prefabricated buildings (Buildings F and H) together with the extant remains of a small brick built shed associated with one of the huts (Building G).
