Historic Building Recording

Peter Hunt Architects

Nafford Bank Farm Barns
Eckington Pershore Worcestershire
WR10 3DH

May 2014

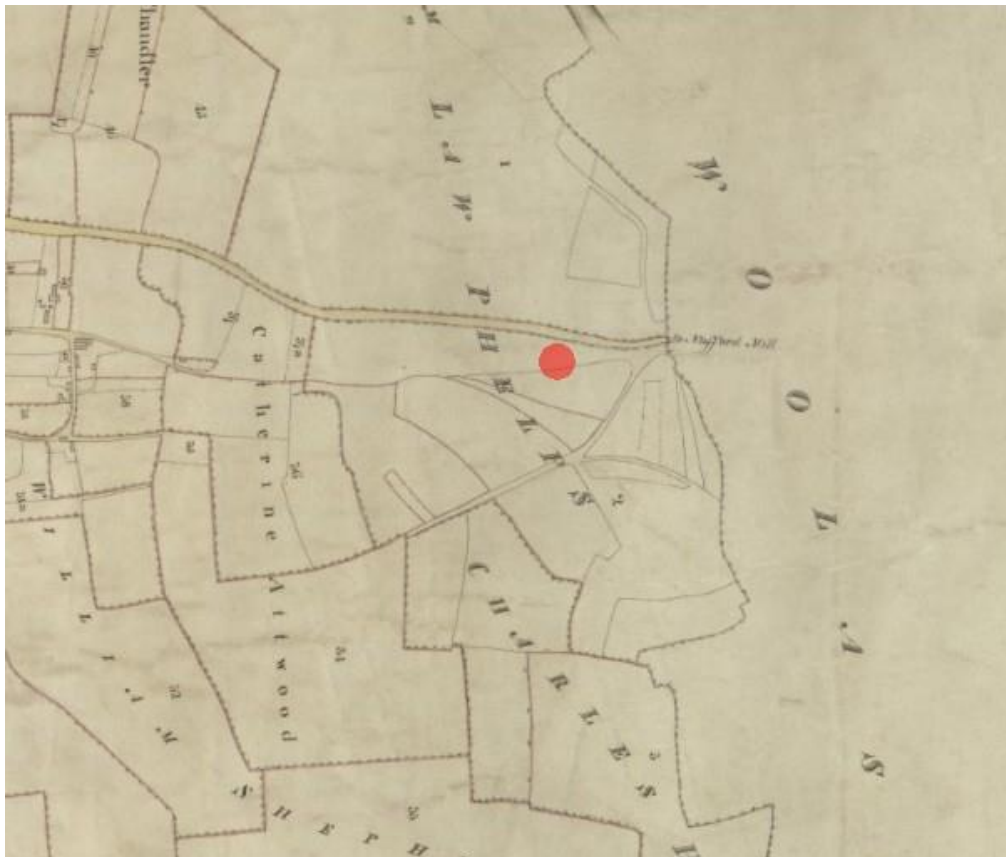
*Fig. 2: Extract from the inclosure map for the parish of Eckington surveyed by Nathan Izod (1813)
 (Reproduced by courtesy of Worcestershire Record Office)*

The inclosure award plan for 1813 (*fig. 2*) shows that the study area was then located at the eastern end of a roughly triangular shaped plot to the south of the road from Eckington towards Nafford Mill, forming part of a series of irregularly shaped field enclosures on the south side of the road, suggestive of piecemeal enclosure of previously unenclosed common land. To the north of the road lay an extensive swathe of largely unenclosed common land on the eastern edge of Eckington Parish. The land on both sides of the Nafford road is marked on the inclosure map as being in the possession of William Phelps Esq of Tynning, who appears to have retained possession of the estate until his death in 1834.

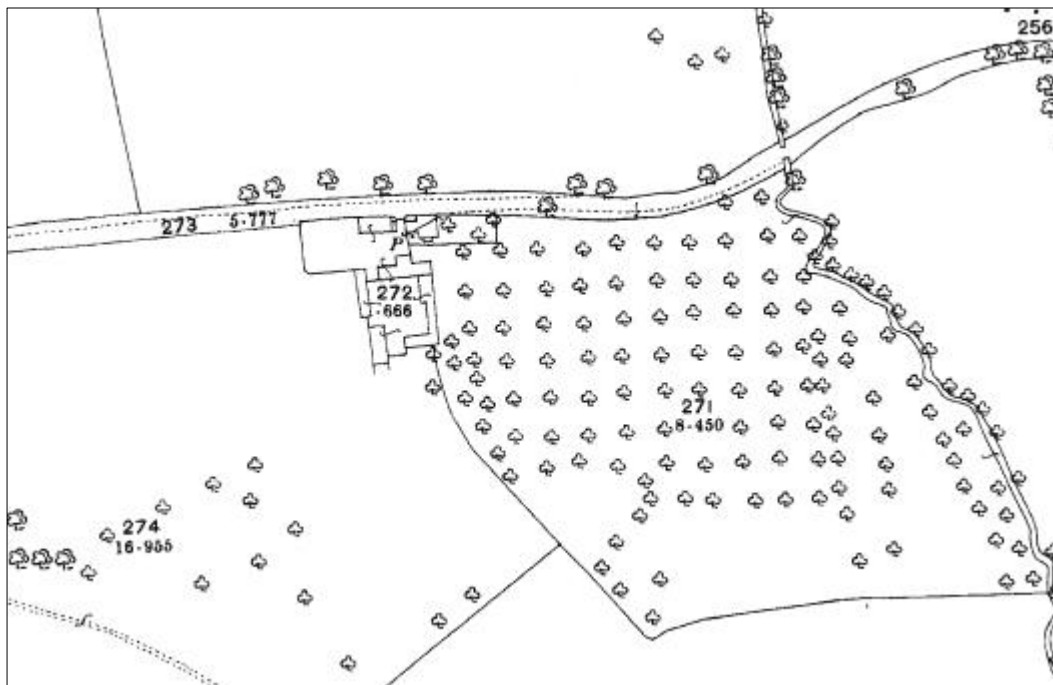
*Fig. 3: Extract from the OS 1st edition 25 inch map of 1886
 (Reproduced by courtesy of Worcestershire Record Office)*

Cartographic evidence for the site, prior to the late 19th century, is extremely limited. In the absence of a tithe map for Eckington parish, the earliest detailed plan showing the farmhouse and outbuildings is the OS 1st edition 25 inch map of 1886 (*fig. 3*). This shows four separate buildings ranged around a roughly quadrangular yard, located to the south of the farmhouse. The existing rectangular block and L-shaped range on the east side of the yard is shown (corresponding to Building A); while in the southwest corner of the yard is another oblong structure aligned north-south (which partially survives as Building B). To the north of this structure is another oblong range (identifiable with Building C). On the north side of the yard, a long rectangular range oriented east-west is shown, attached to the north gable end of Building A, with a water pump marked immediately north of it.

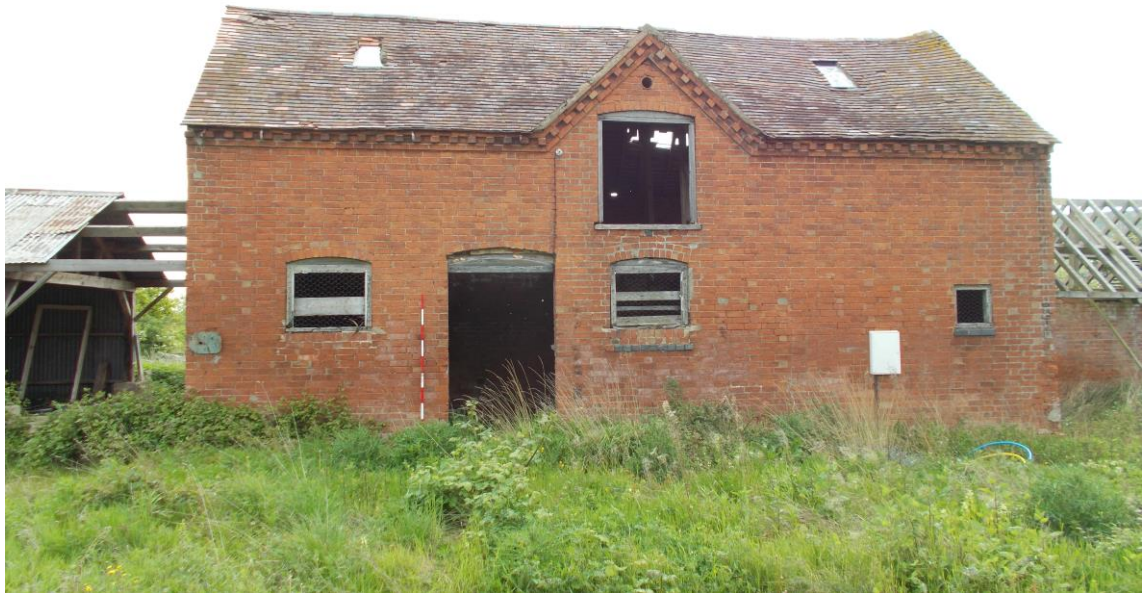
The principal west-facing elevation has a dentilled eaves cornice and a centrally placed gable with a loading bay leading to a hayloft at first floor level, consisting of a wooden frame and sill set within a segmental gauged brick arched opening, with a small circular opening (presumably a ventilation slot) immediately above. At ground level is a large segmental arched doorway providing access to the main part of the building, inserted to the left of the central gabled bay and flanked on either side by two small wooden framed windows with brick sills set within segmental-arched openings; no clear evidence of window bars or shutters was noted. At the south end of the elevation is a small flat-arched window, possibly later in date than the other two windows.

Plate 1: View looking east showing west-facing elevation of two storey gabled main block (Building A), with central loading bay and dentilled eaves cornice

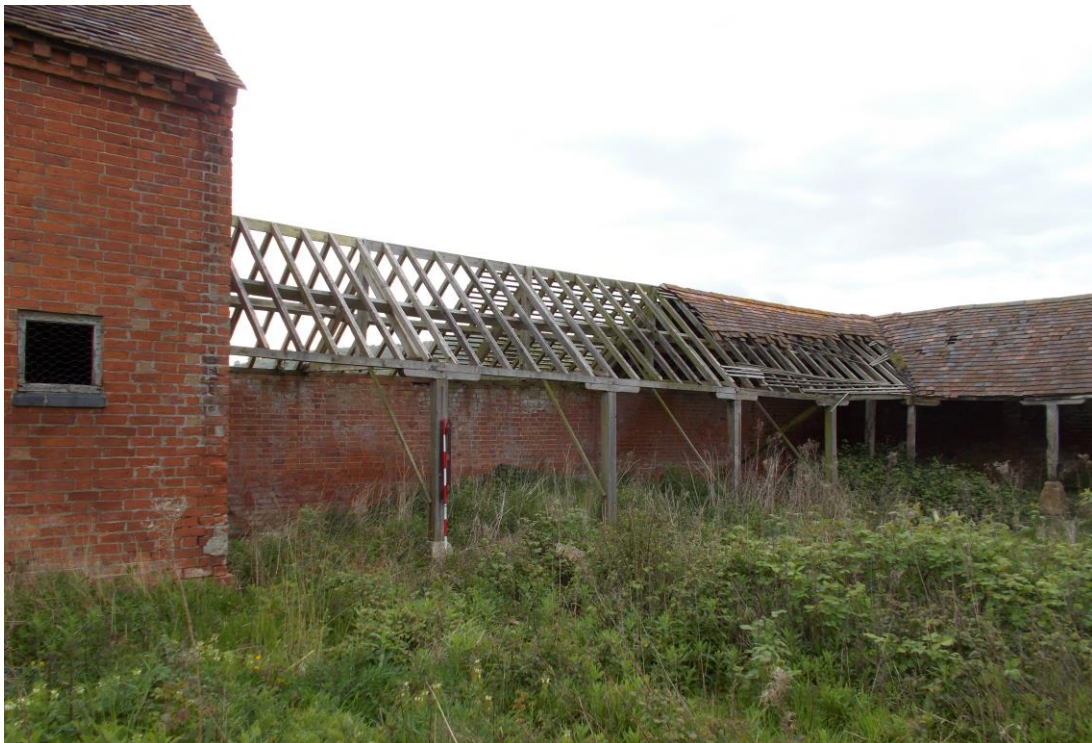
Plate 2: View looking southeast showing L-shaped open fronted range of livestock shelters to south of two storey main block (Building A)

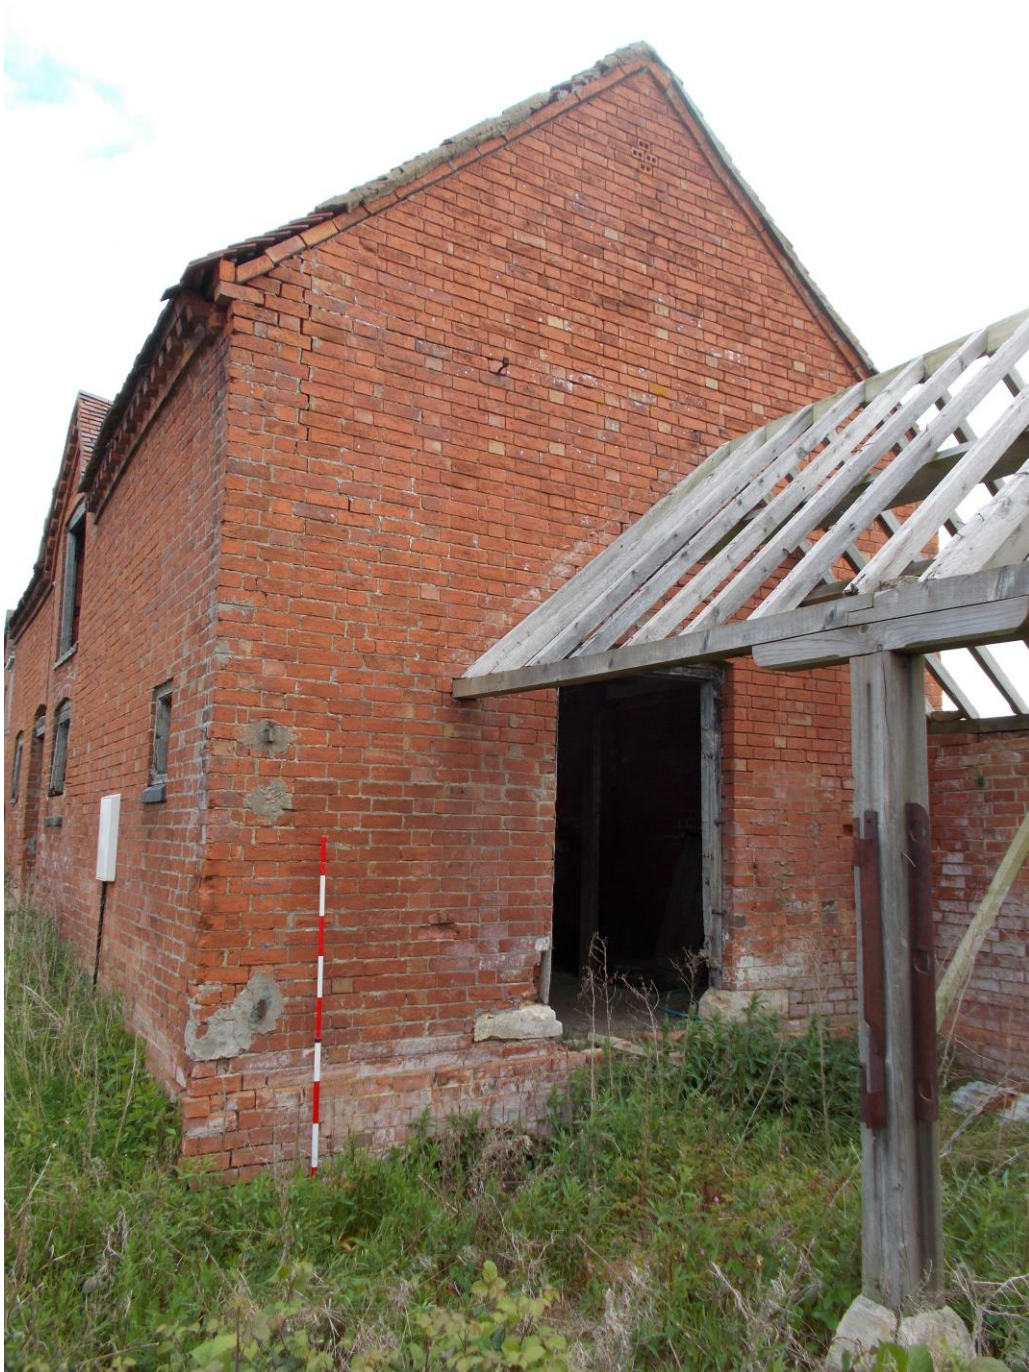
The south gable end of the two-storey block has a centrally placed segmental arched doorway providing access to the L-shaped range of shelters (*Plate 3*). Just below and to the left of the doorway, the upper part of a broad segmental brick arch is visible, probably relating to a culvert or drain which appears to have extended on a roughly north-south alignment beneath the two storey block (*Plate 4*).

Plate 3: View looking north northeast showing south-gable range of main block (Building A)

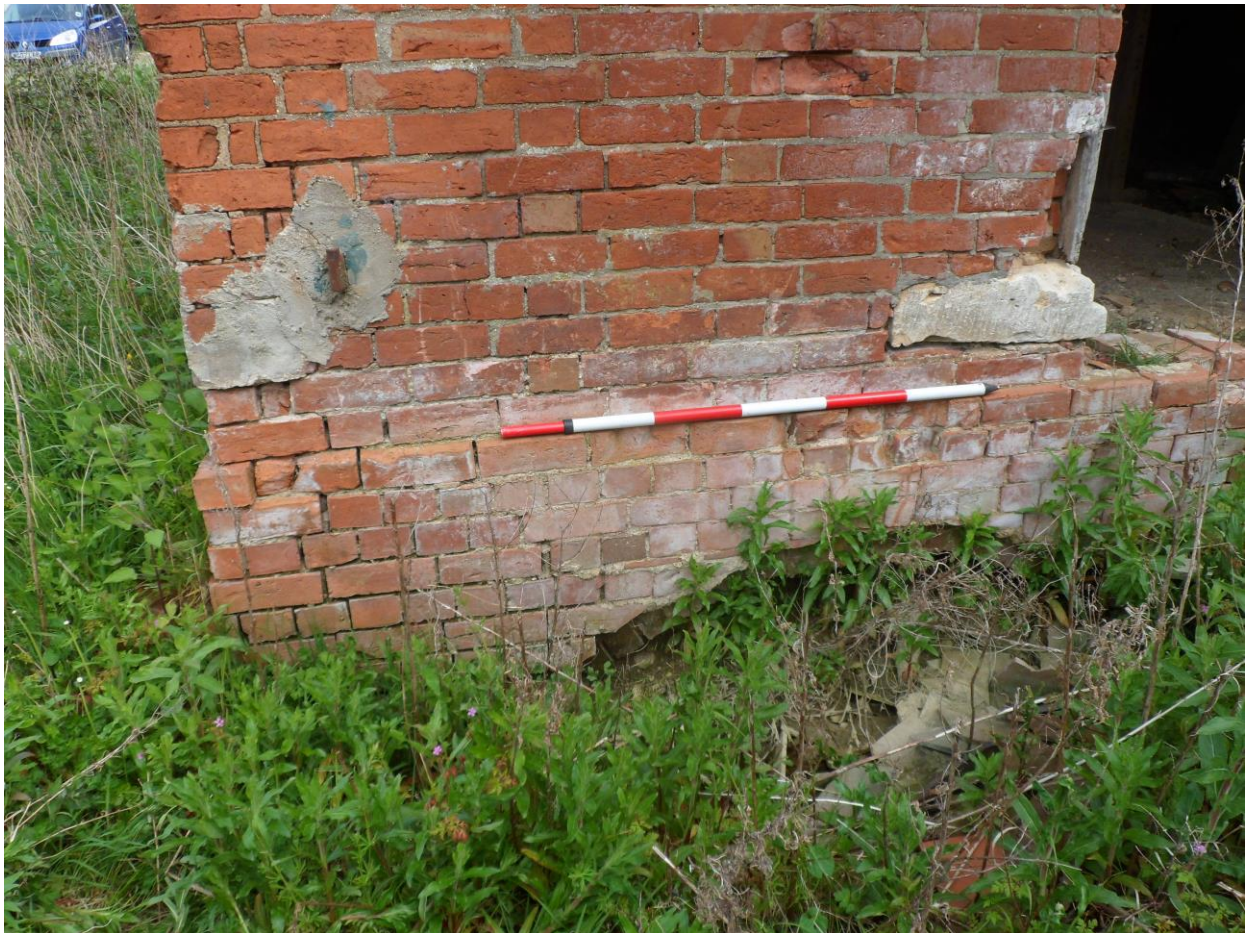
Plate 4: Detail showing arched culvert beneath doorway in south gable end of Building A

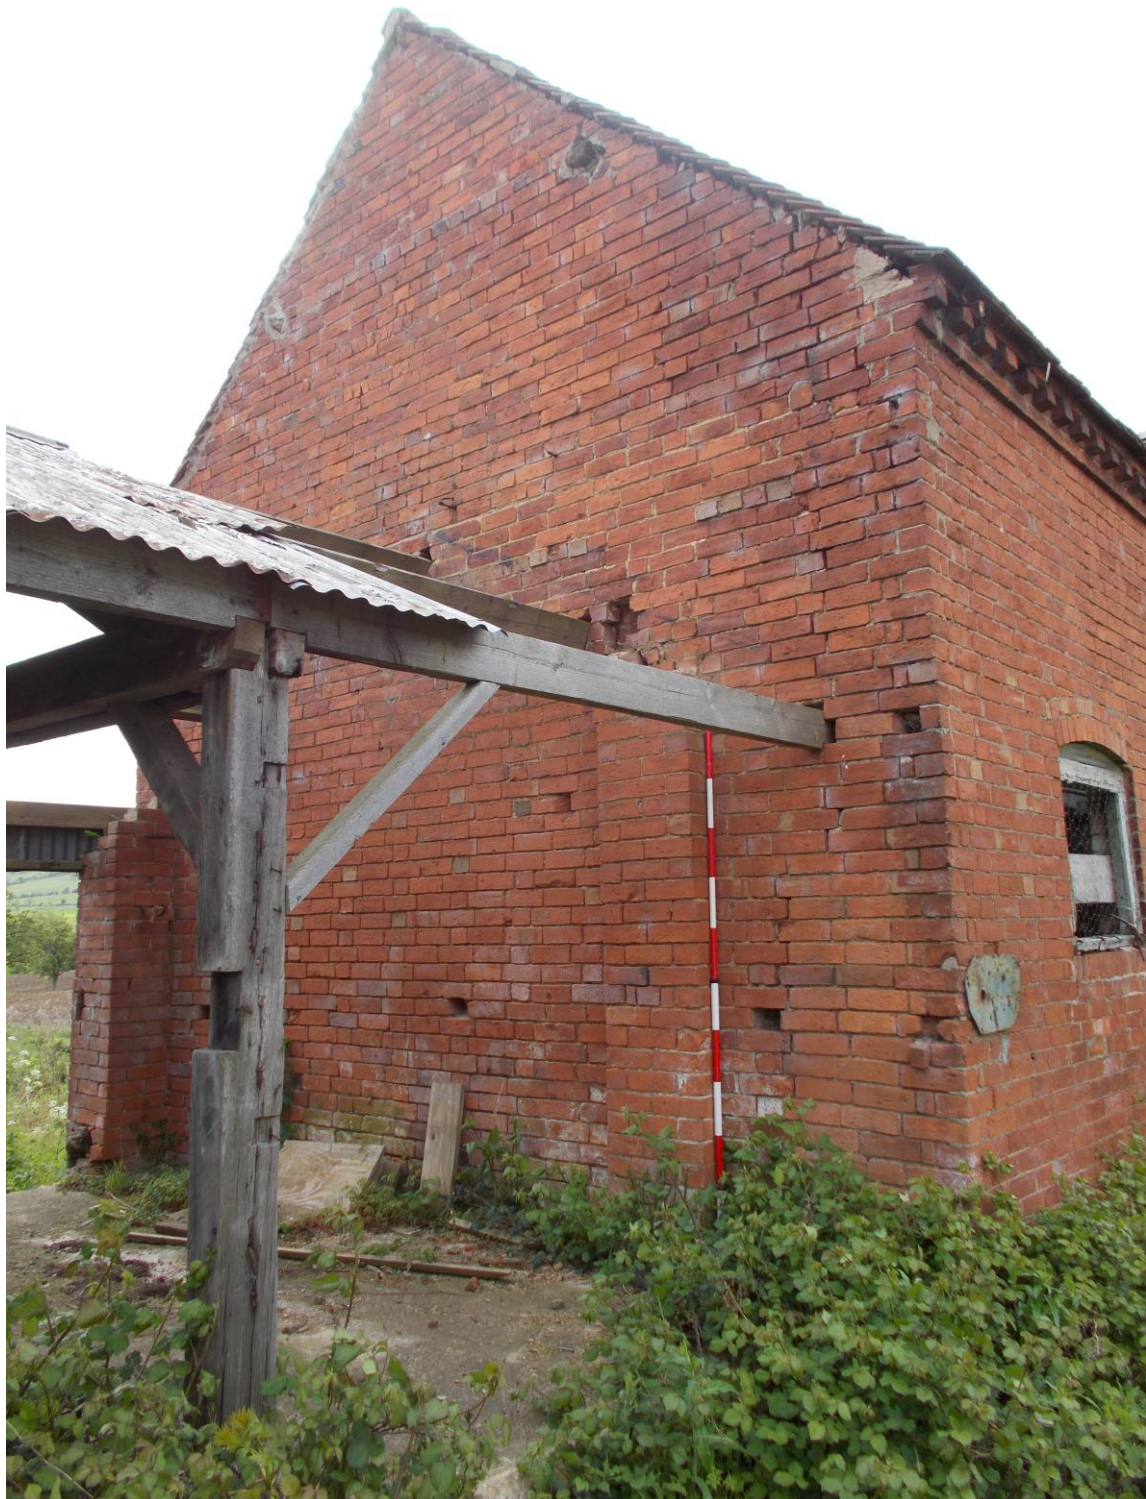
The north gable end of the building is devoid of fenestration (*Plate 5*). Attached to the gable end is a small two-bay timber lean-to structure, probably of fairly recent date, with a timber framed roof covered with corrugated metal sheeting set upon an area of concrete hard-standing. Two sets of four horizontal beam slots set into the thickness of the wall at ground level would appear to relate to an earlier structure formerly attached to the north end of the building, which may be further evidenced by a partially truncated brick wall stub at the east end of the gable wall. The gable end appears to have required support following the removal of the structure adjoining it, as evidenced by the addition of a thin brick buttress. It is also noticeable that the brickwork of the upper stage of the north gable wall is much more irregular compared to the more regularly coursed Flemish Garden Bond visible at ground level, suggesting that it may have been partially rebuilt.

Plate 5: View looking southeast showing north-facing gable end of Building A with adjoining modern lean-to structure with corrugated metal roof

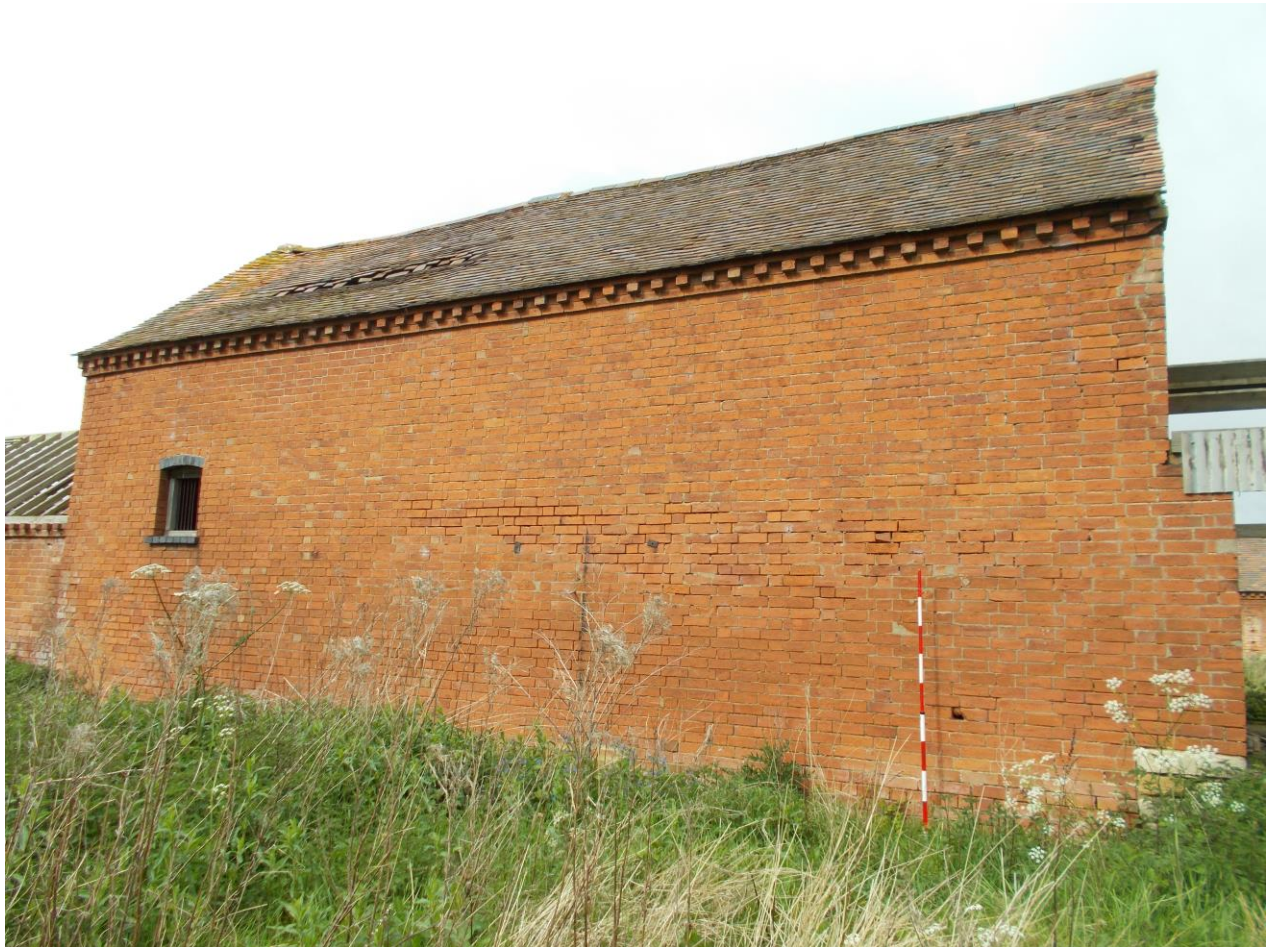
The rear, east-facing elevation of the two storey block has dentilled eaves corncicing similar to that visible in the principal elevation (*Plate 6*). It is largely devoid of fenestration apart from a single light window consisting of a wooden frame and iron grille set within a segmental arched opening and brick sill; the use of Staffordshire blue bricks for the arch and sill suggests that it probably represents a later 20th-century insertion.

Plate 6: View looking west showing rear (east-facing) elevation of Building A with dentilled cornice at eaves level

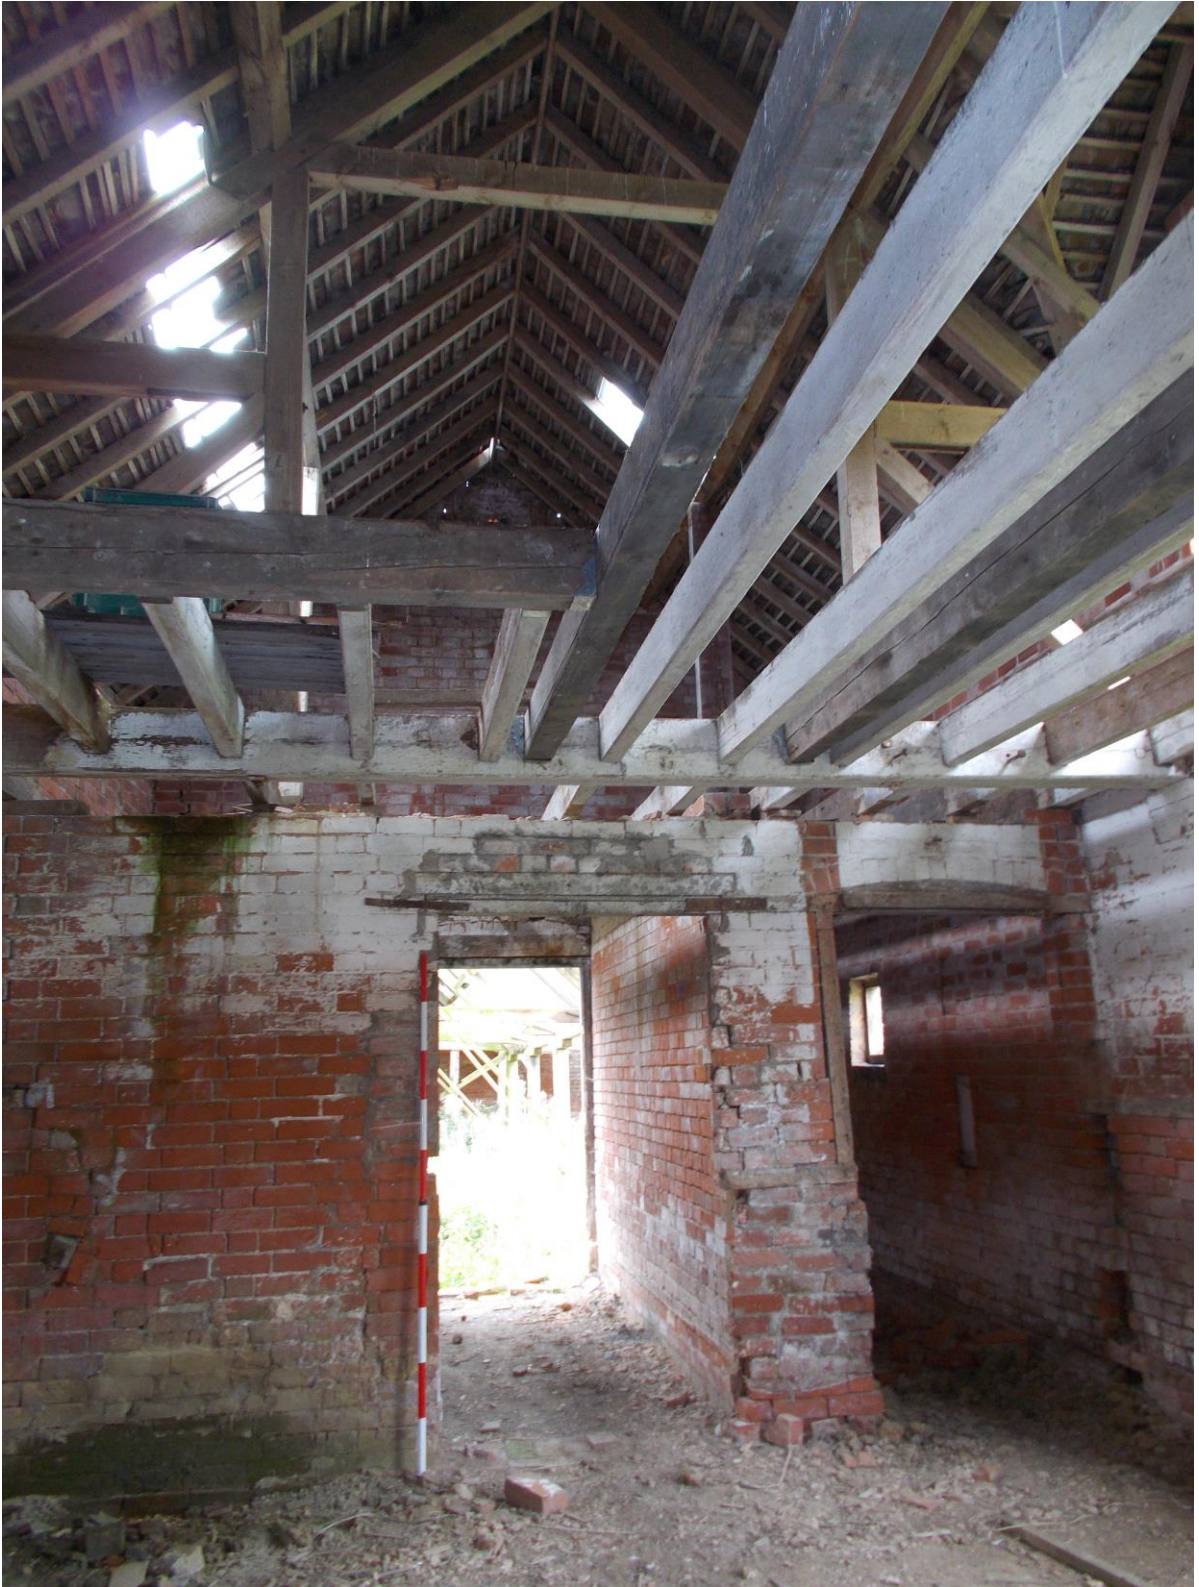
Internally, the two -storey block is arranged into three compartments separated by brick partition walls, with a hayloft at first floor level. The roof is of open truss construction with a series of interrupted tie beams at eaves level connected by vertical struts to the collars above (*Plate 7*). The largest compartment (three bays long) occupies the central and northern parts of the building and may have been used as a cow-house or for stabling, suggested by the presence of two rows of beam slots probably for racks or mangers set into the thickness of the east wall (*Plate 8*). The upper row of slots contained evidence of timber stubs protruding from the slots which were almost certainly associated with racks or mangers (since removed). Evidence of whitewashing on the walls was noted but no evidence for cobbled or flagstone flooring or any other internal features of interest was identified in this area. The joists for the hayloft floor are intact however the planking has been removed.

Plate 7: Interior view of Building A looking south showing detail of open truss roof structure and internal partition walls

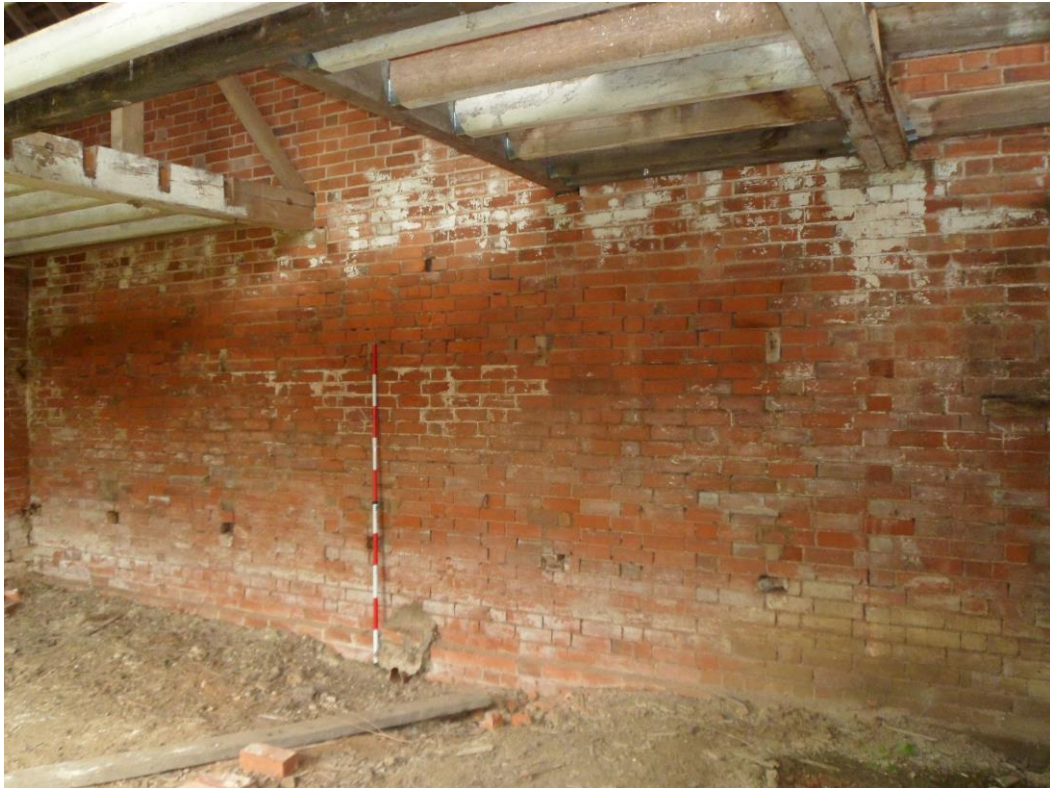
Plate 8: Interior view looking northeast showing west-facing internal elevation of barn with two horizontal rows of slots (some with timber stubs) for wooden racks or mangers

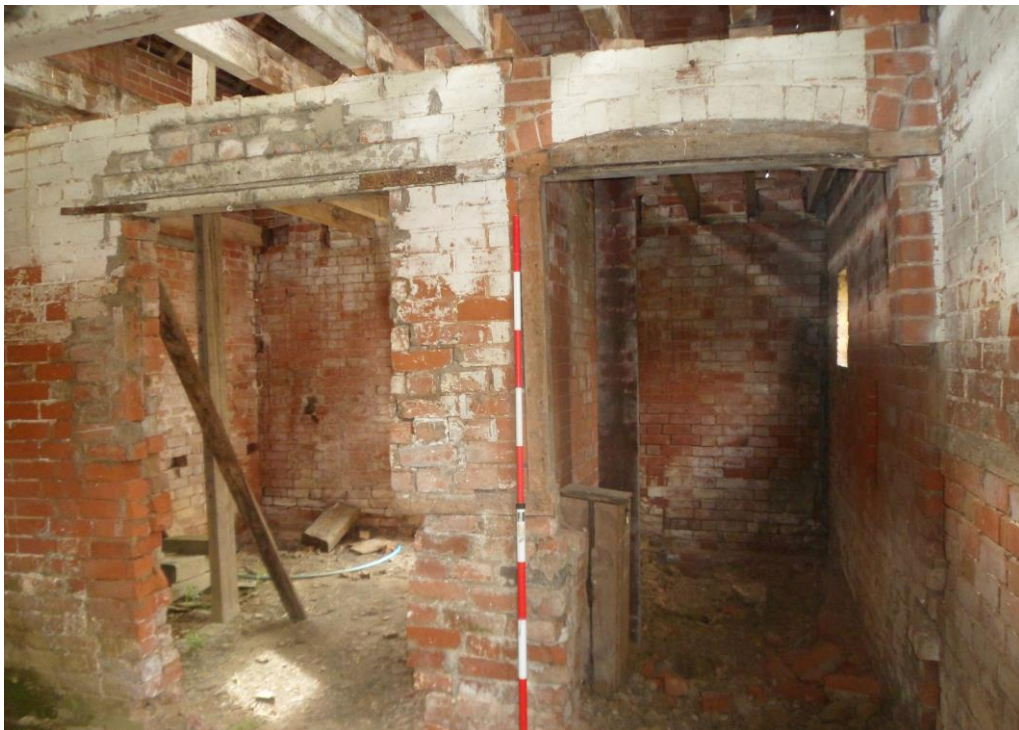
Separated from the main compartment by a thin brick partition wall (two courses thick) are the southernmost two bays of the barn, which, in turn, are sub-divided into two unequal sized compartments, each light by single light windows (*Plate 9*). The uppermost part of the partition wall appears to have been rebuilt (the coursing in stretcher bond differs from the Flemish Garden Bond used for the lower courses) and the two single light window openings appear to be later insertions. The entrance to the larger compartment is via a flat -arched doorway while a narrow segmental arched doorway provides access to the smaller compartment. Both rooms appear at some point to have been whitewashed; however, both were almost entirely devoid of features that might give an indication of their former function and no cobbled or flagstone flooring was noted. Two rows of slots set into the thickness of the east wall in the larger compartment might indicate that there were racks or mangers in this part of the barn (*Plate 10*).

Plate 9: Interior view looking south showing partition wall and compartments in south part of Building A

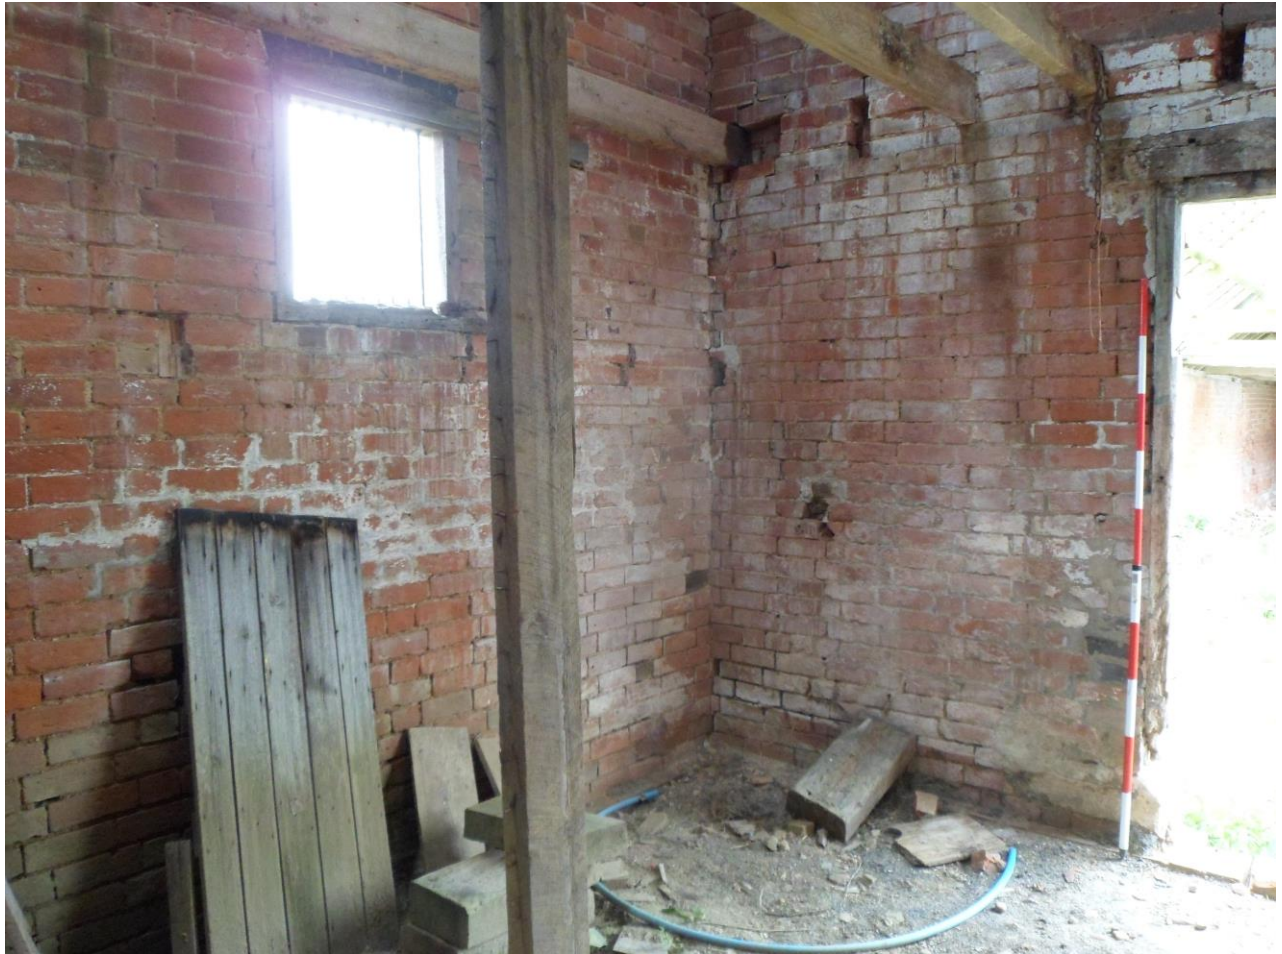
Plate 10: Interior view looking southwest showing the larger of the two compartments in the southern part of Building A

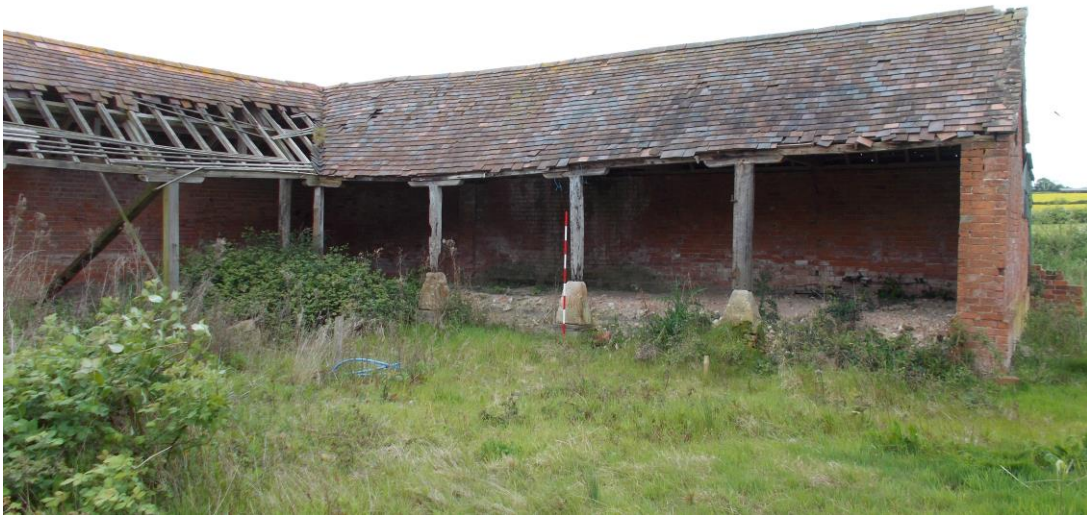
Attached to the south gable end of the two storey block is a single -storey open fronted range of sheds or shelters for livestock, (*Plate 11*). The range, which is L-shaped in plan, consists of two arms, both five bays long and oriented north-south and east-west respectively. The eastern and southern exterior walls are of brick construction laid in Flemish Garden Bond and have dentilled eaves cornices identical to those in the adjoining two -storey block, indicating that they almost certainly form part of the same phase of construction. Set within the upper storey of the west-facing gable end of the L-shaped range is a wooden slatted window in a broad segmental arched opening. Two regularly spaced rows of square slots inserted in the west gable wall at ground level may represent a lean-to structure adjoining the animal shelters.

Plate 11: View looking southeast showing L-shaped range of animal shelters with partially denuded tiled roof to south of Building A

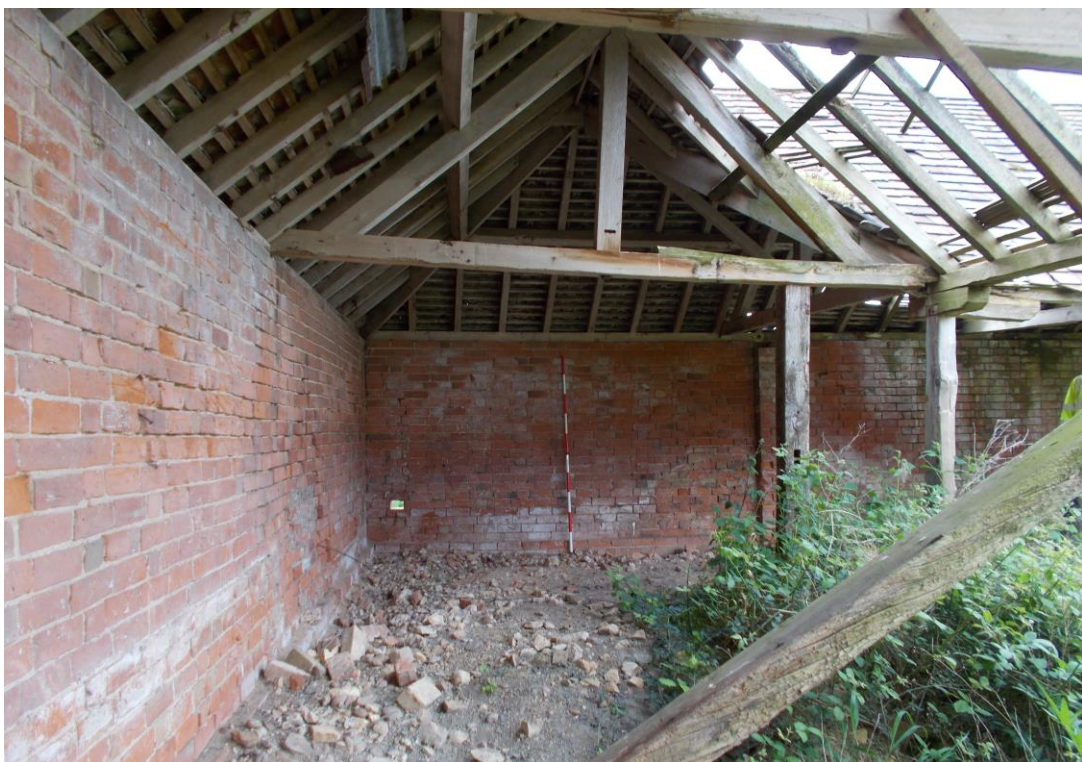
The roof of the L-shaped range of shelters is of simple post-and-truss construction with the principal rafters linked by a single set of trenched purlins, the wallplate is supported on its west and north facing sides by a series of roughly-hewn timber posts carried on stone pillars (*Plate 12*). No evidence of internal fittings (e.g. slots for racks) was noted and any flooring appears to have been removed. Attached to the south-facing wall of the L-shaped range are two brick pigstys with a flat corrugated iron roof which may be identified with buildings in this location first depicted on the OS 3rd -edition map of 1923 (*Plate 13*).

Plate 12: View looking south along southern arm of open fronted animal shelter adjoining Building A showing post and truss roof construction

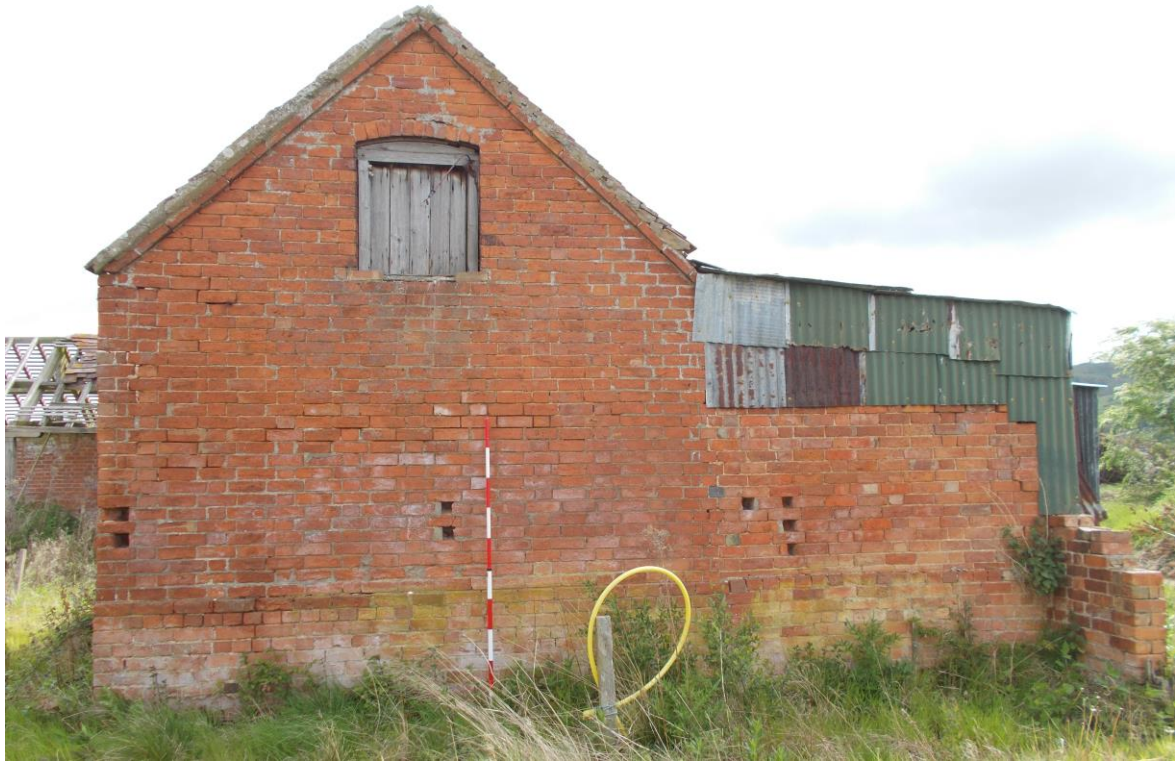
Plate 13: View looking east showing west-facing gable end of L-shaped range (Building A) with segmental arched window opening in upper storey and later brick pigstys to right of picture

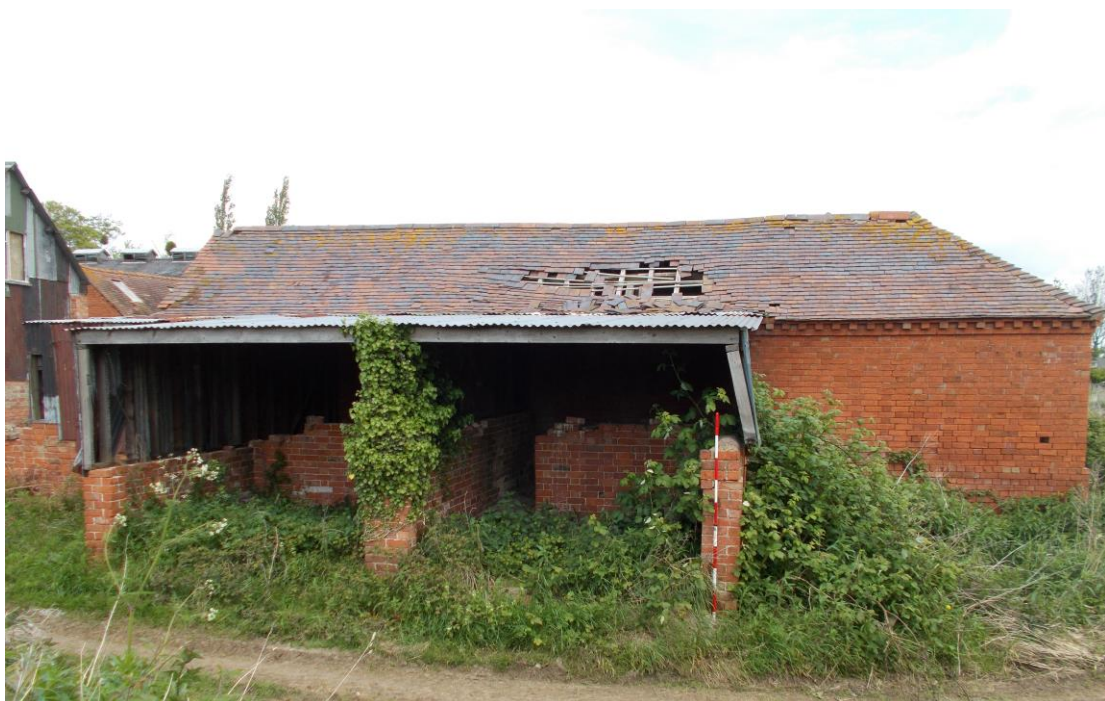
Plate 14: View looking north showing brick pigstys attached to south elevation of L-shaped range (Building A)

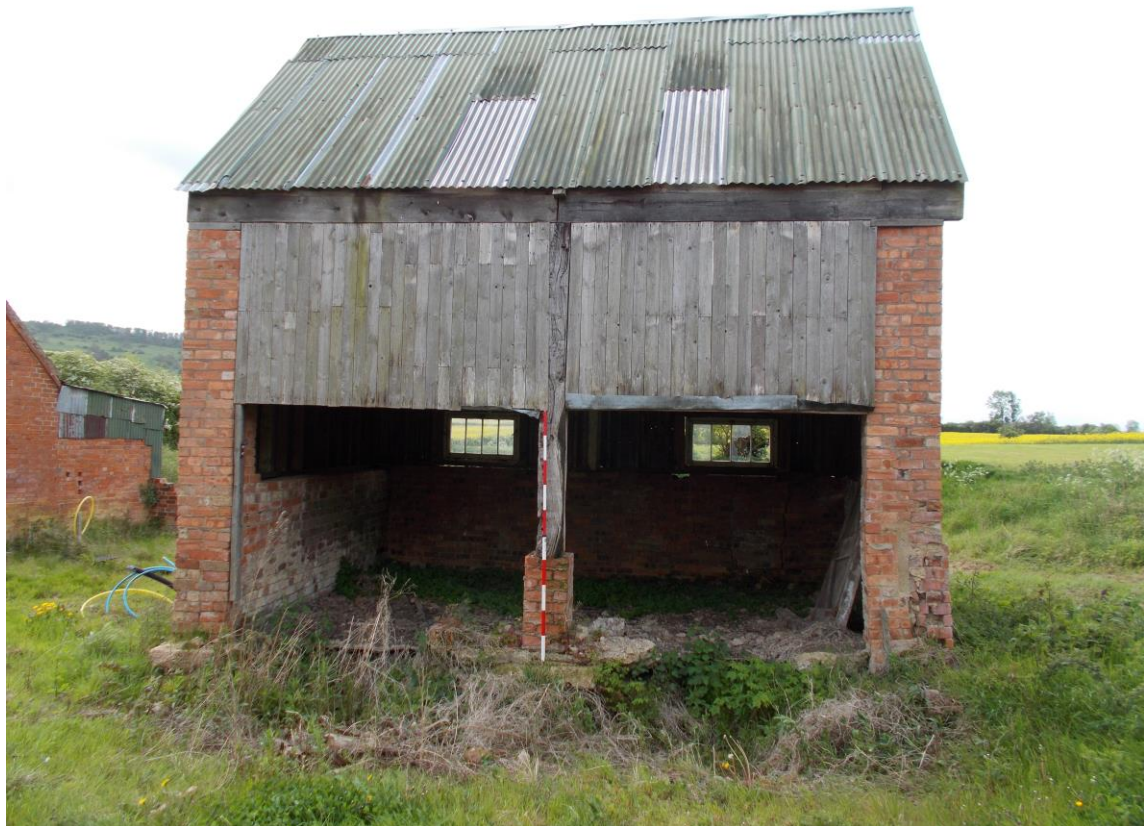
The north-facing elevation is open-fronted at ground level with a weatherboarded upper storey with no fenestration (*Plate 15*), while the west facing elevation comprises a low brick wall, 15 courses in height, laid in Flemish Garden Bond and surmounted by corrugated metal cladding, with a centrally placed loading bay door and a modern three -paned window inserted at first -floor level (*Plate 16*). The east-facing elevation is of similar construction with a large modern two paned window at first -floor level.

Plate 15: View looking south showing north-facing elevation of Building B with weatherboarded upper storey

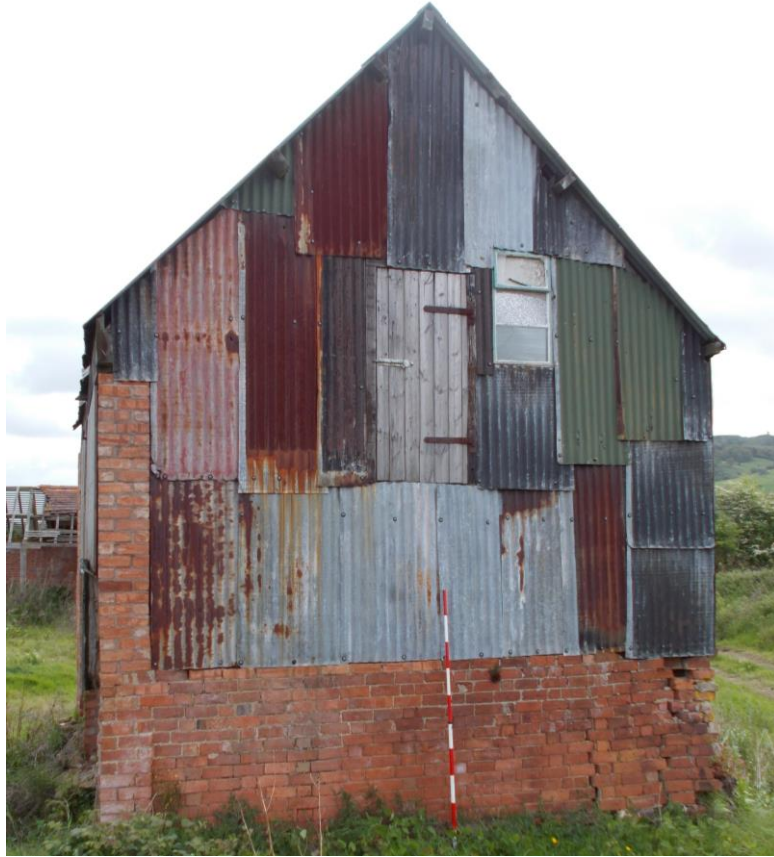
Plate 16: View looking east showing west-facing elevation of Building B with corrugated metal cladding upon a brick wall

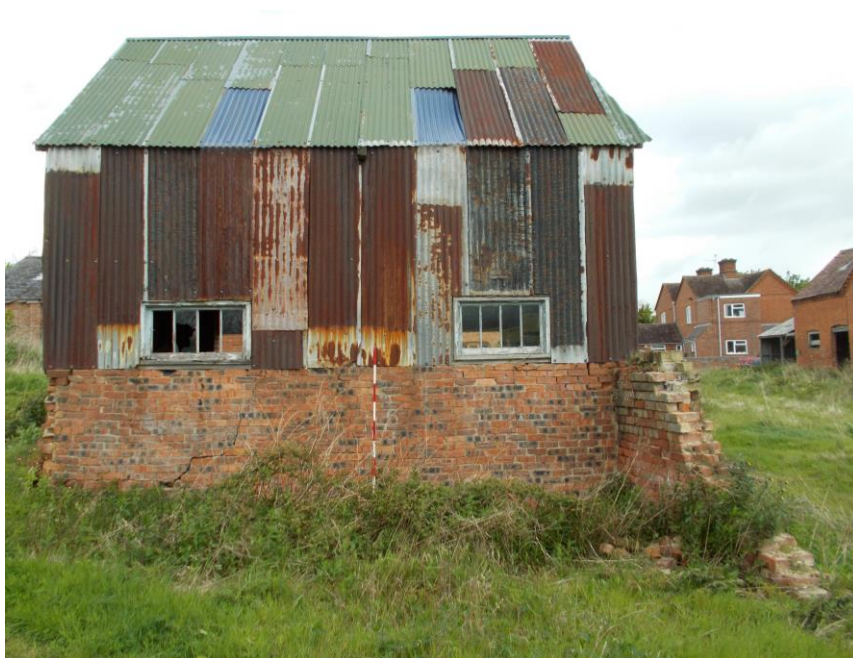
The south-facing elevation appears to have been heavily rebuilt with a modern brick wall laid in stretcher bond and bonded with a greyish white cement, again surmounted by corrugated metal cladding to eaves level, with two modern flat arched four paned windows inserted at ground level immediately above the brickwork (*Plate 17*). At the east corner of this elevation, a heavily truncated brick wall stub extending southwards represents the original east wall of the barn, which appears to have been largely removed at some point between 1947 and 1970. Internally, the ground floor of the building, which appears to have been used in recent years as a stable, exhibited no features or fittings of interest, apart from a plank and batten stable door of probable modern date. Health and safety concerns with regard to access to the upper floor of the building meant that it was not possible to investigate this area in greater detail.

Plate 17: View looking north showing south-facing elevation of Building B showing wall stub representing remains of barn wall
