Historic Building Recording

Peter Hunt Architects

Nafford Bank Farm Barns
Eckington Pershore Worcestershire
WR10 3DH

May 2014

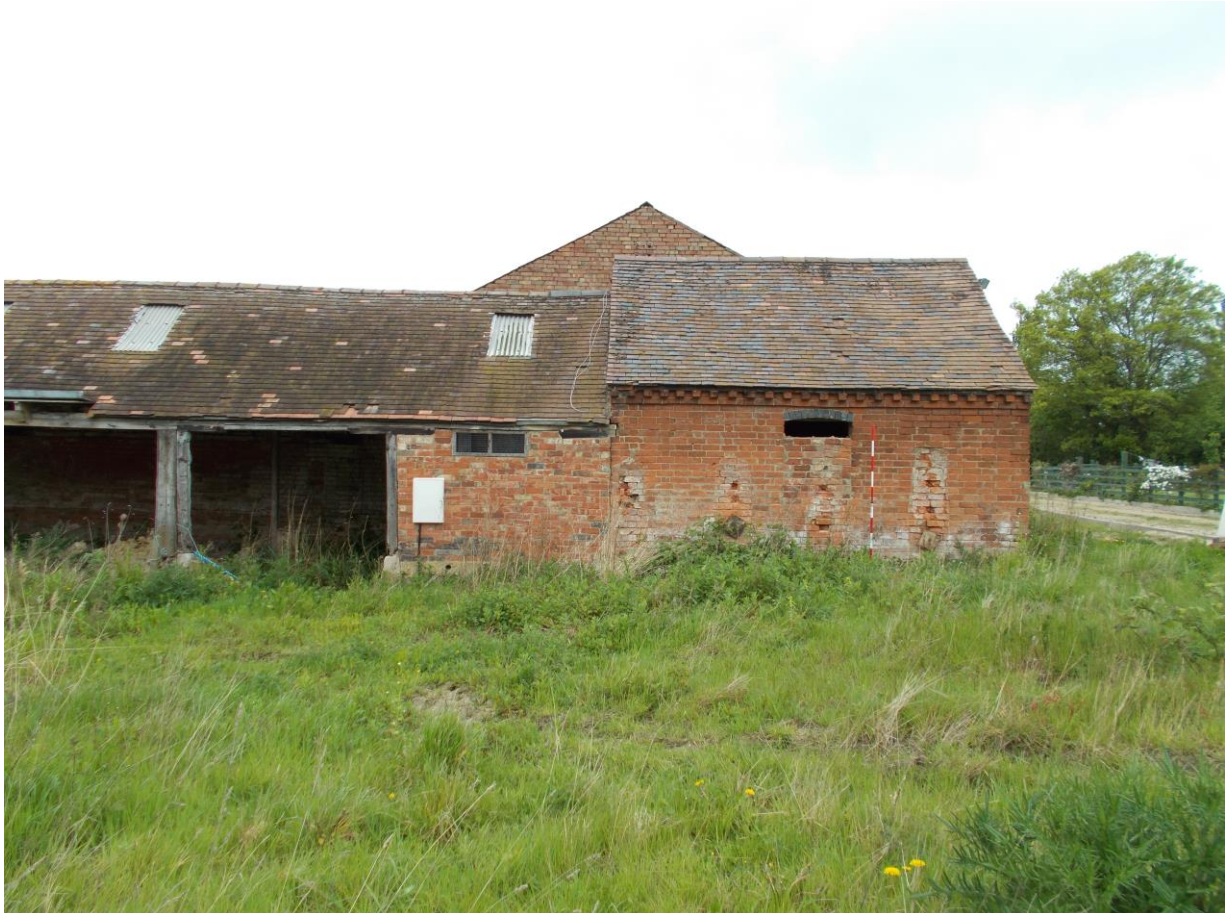
Building C, located on the west side of the farmyard opposite Building A, consists of a single storey gabled brick structure oriented north-south, two bays in length, with an open -fronted range of sheds or animal shelters four bays long (originally five) extending to the south. This building, which has a hipped, tiled roof, appears to correspond to a structure marked in this location on the OS 1st edition map of 1886 although there is some evidence of alterations.

Plate 18: View looking west showing east-facing elevation of Building C with blocked up door opening in centre of elevation with an open fronted animal shelter to south (the northernmost bay having been blocked in at a later date)

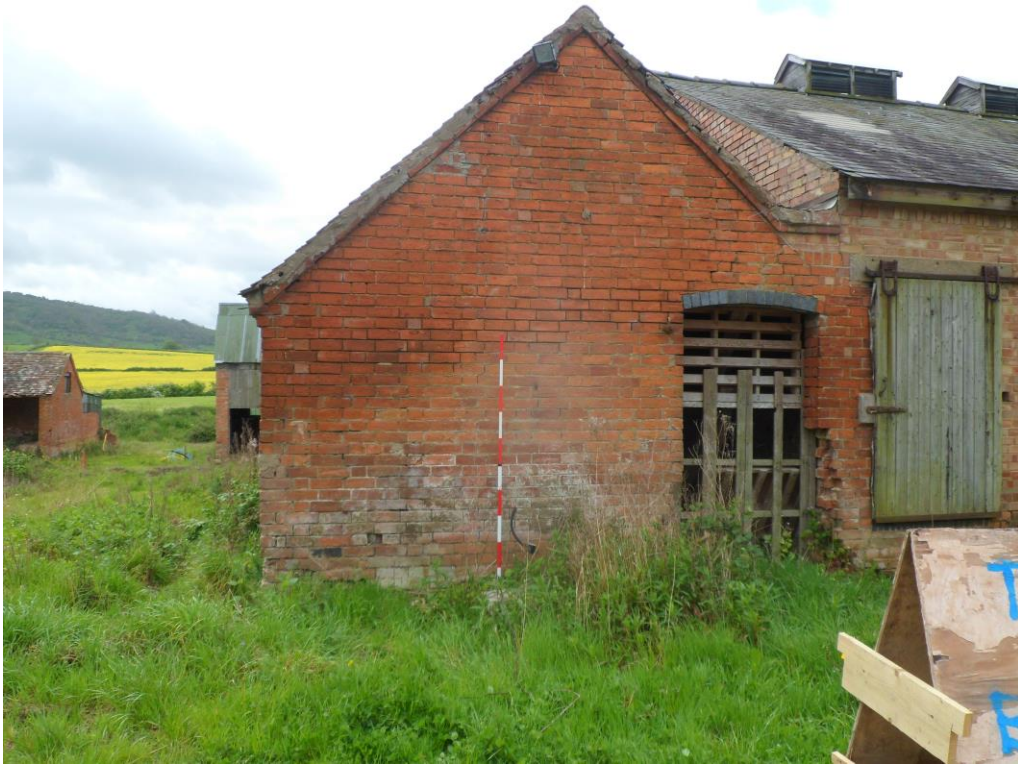
The gabled brick structure at the north end of Building C is two bays long, of orange-red brick construction (laid in Flemish Garden Bond) with a dentilled eaves cornice in the east-facing and west-facing elevations identical to that found in Buildings A & B (Plate 18). Evidence was noted for a partially blocked up doorway, in the centre of the east-facing elevation, which appears to have been converted into a narrow window slot, as evidenced by a segmental arch of Staffordshire blue bricks which probably represents a modern insertion. A similar segmental -arched doorway of probable modern date has been also inserted in the north-facing gable (Plate 19).

Plate 19: View looking south showing north-facing gable end of Building C with later doorway inserted (to right of picture)

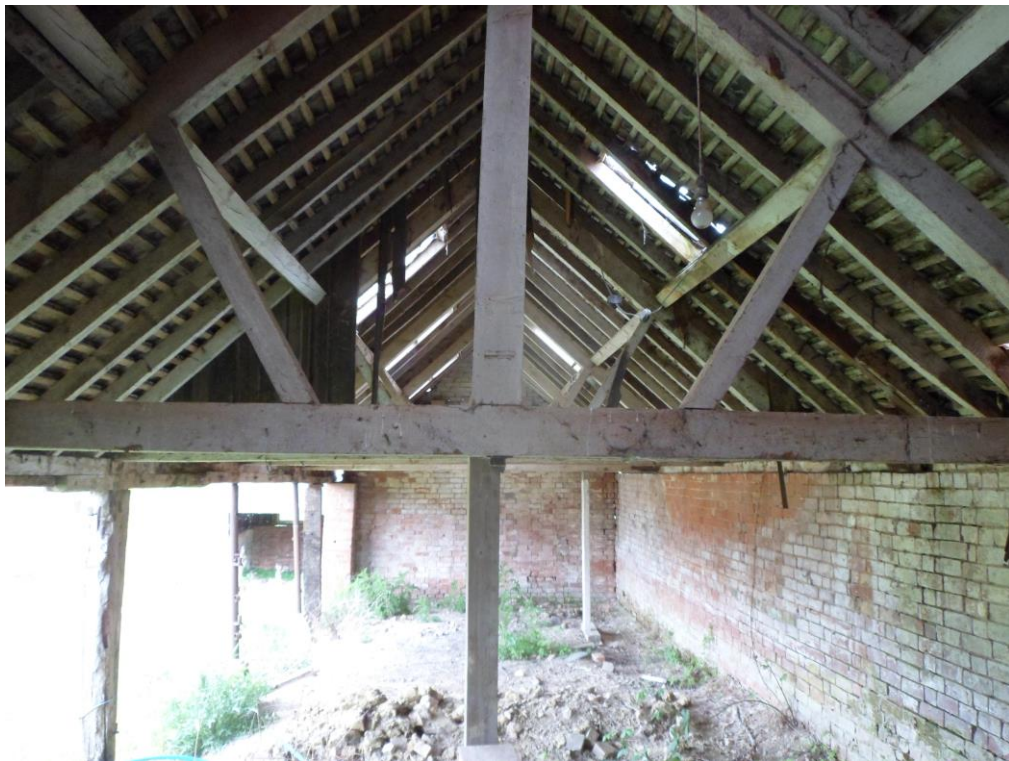
Extending to the south of this building is a range of open-fronted sheds or shelters for livestock, originally five bays in length with a roof of kingpost construction with angled struts connecting the tiebeams to the principal rafters and a single set of trencled purlins (Plate 20); the wallplate being supported by roughly hewn posts carried upon stone pillars identical to those in the L-shaped range of sheds attached to Building A.

Plate 20: View looking south showing kingpost roof construction of animal shelter attached to Building C

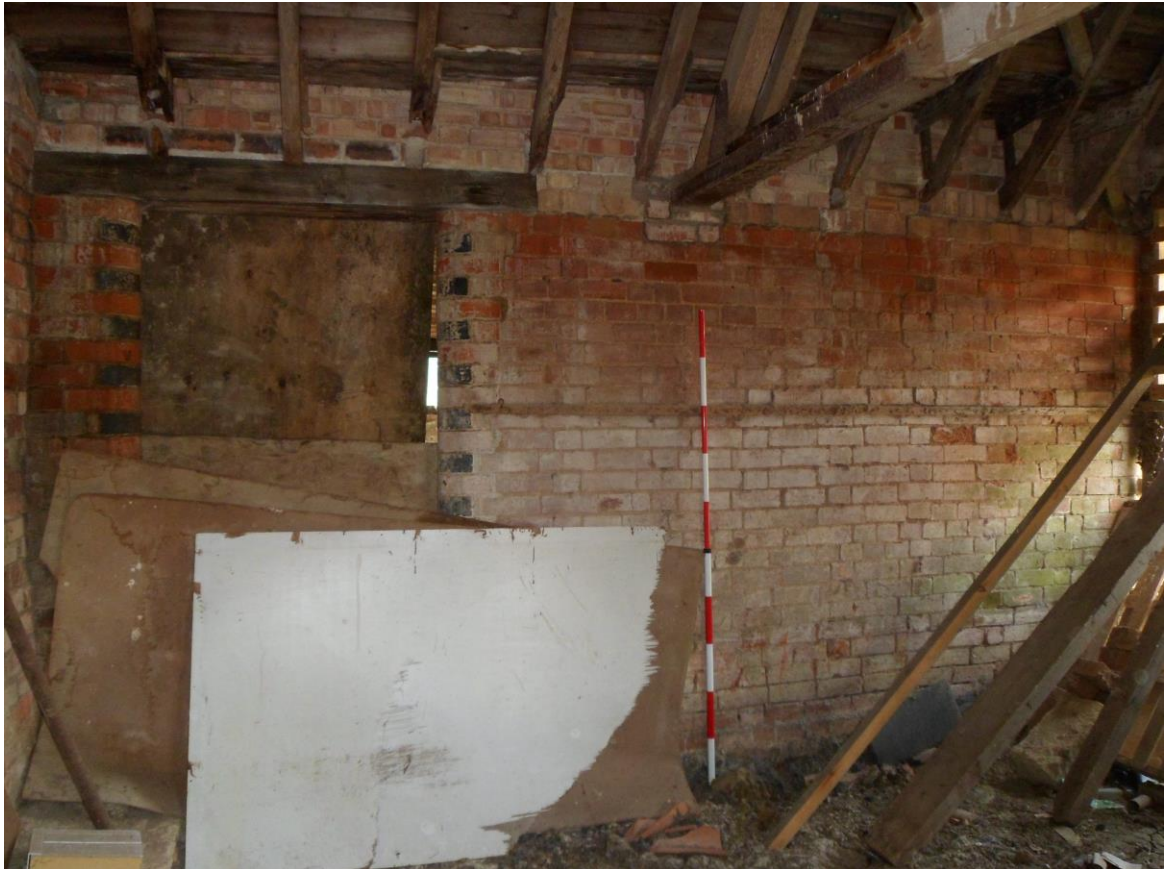
The northernmost bay was subsequently blocked by the insertion of a thin brick wall (laid in stretcher bond and bonded with greyish white cement) incorporating the original timber wallplate at eaves level, with a flat arched two light window of probable modern date. No features or fittings of interest were noted within Building C apart from a modern flat -arched doorway with a wooden lintel inserted to provide access to the adjoining early 20th -century building to the west (Building D) (*Plate 21*)

Plate 21: Interior view of Building C looking west showing modern flat arched door opening leading to Building D

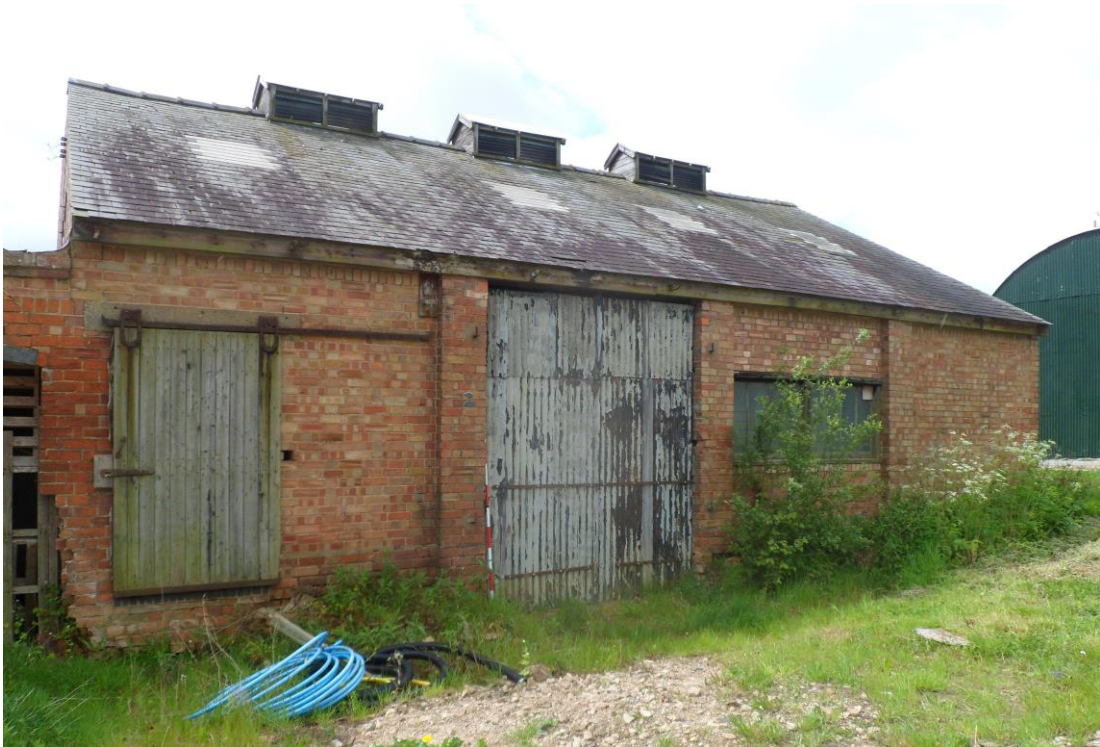
The north-facing external elevation is four bays long, punctuated at regular intervals by three brick buttresses, with a large doorway, blocked up by corrugated iron sheeting located just to left of the central part of the elevation, to the right of which is a flat -arched eight -paned glazed window with an iron grille (*Plate 22*). The west-facing gable end comprises a centrally placed flat -arched doorway surmounted by an eight -paned glazed casement window with a large wooden lintel, flanked by two flat arched four -paned windows with wooden lintels and sills (*Plate 23*).

Plate 22: View looking south southwest showing north-facing elevation of Building D, built between c.1904 and 1923

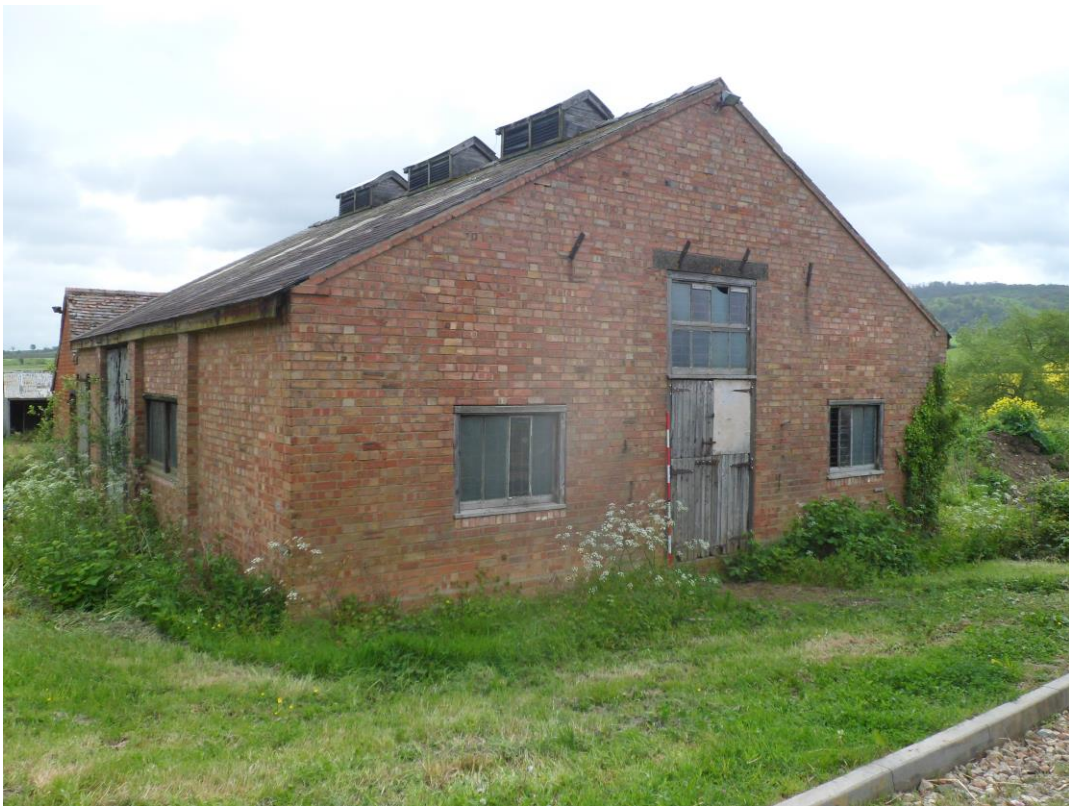
Plate 23: View looking east southeast showing west-facing gable elevation of Building D

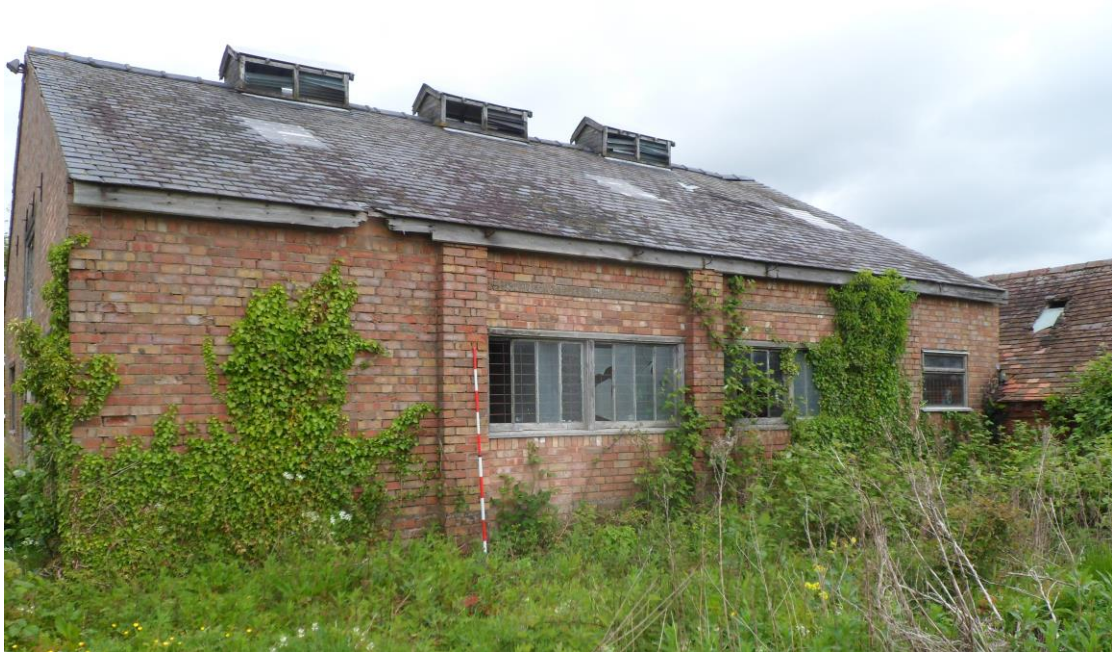
The south-facing elevation is punctuated with three regularly spaced buttresses in similar form to its northern counterpart; the fenestration consisting of two flat -arched eight -paned glass windows in the central two bays, with a single flat arched two -light glazed window in the northernmost bay (*Plate 24*).

Plate 24: View looking north showing south-facing elevation of Building D

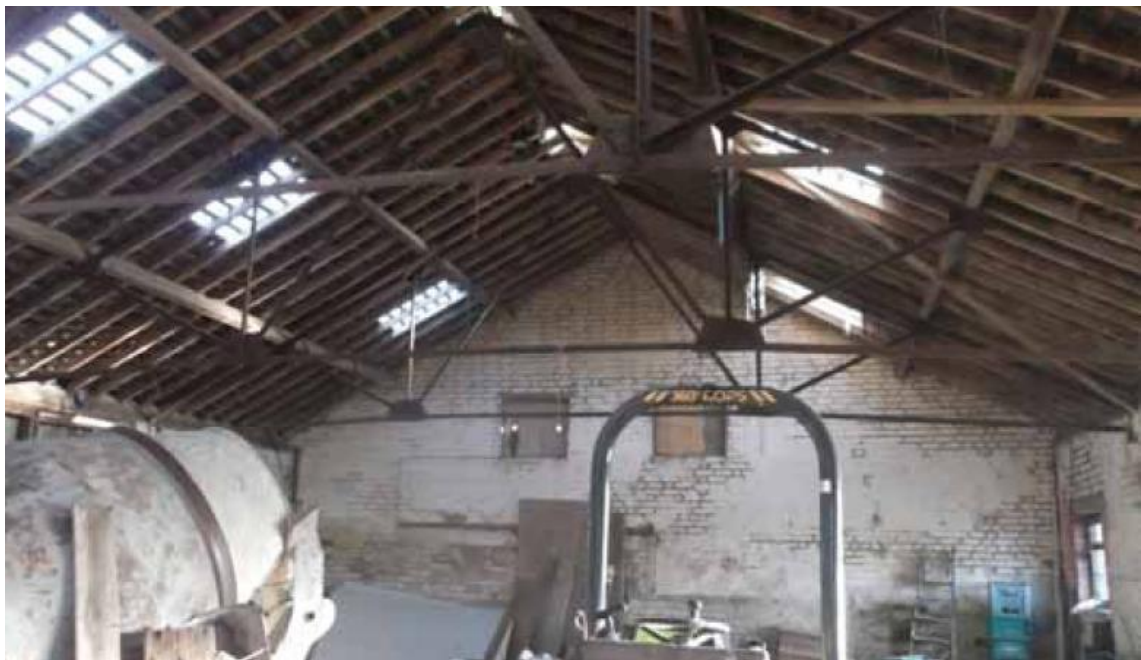
Due to access restrictions, it was not possible to inspect the interior closely, which is currently used for equipment storage. The roof construction consisted of an open truss timber roof with a single set of trenched purlins, with a series of steel roof trusses (carried on brick supports) comprising ties and angled struts inserted to provide additional support, presumably at some point after its original construction (*Plate 25*). No other fixtures or fittings of interest were noted.

Plate 25: Interior view of Building D showing details of roof construction with timber roof supported by steel trusses
