Historic Building Recording

Blakeshall Farm

Wolverley

May 2015

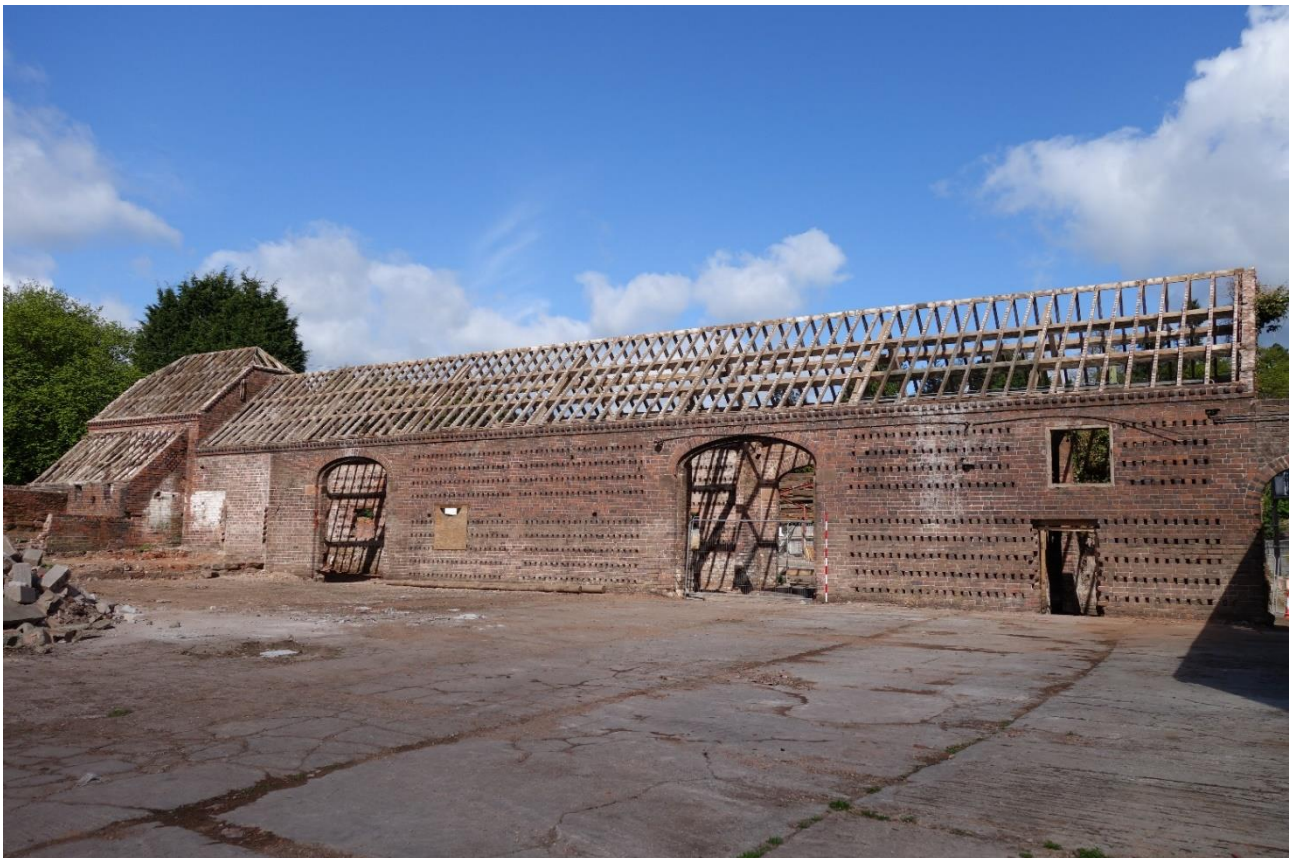
The NW- and SE -facing elevations are both pierced by two tall depressed archways extending up to eaves level (evidently intended for wagons) with gauged brick *voussoirs* and ashlar stone imposts. The barn doors have been removed, although the iron hinges are still visible. Within the north-easternmost bay of the SE -facing elevation, a plain flat-arched doorway with wooden lintel has been inserted at ground level, above which is a rectangular opening interpreted as a loading bay associated with a hayloft at first-floor level (*Plate 1*).

Plate 1: View WNW showing the SE -facing elevation of the threshing barn overlooking the courtyard, with the granary and cartshed situated at the SW end of the barn

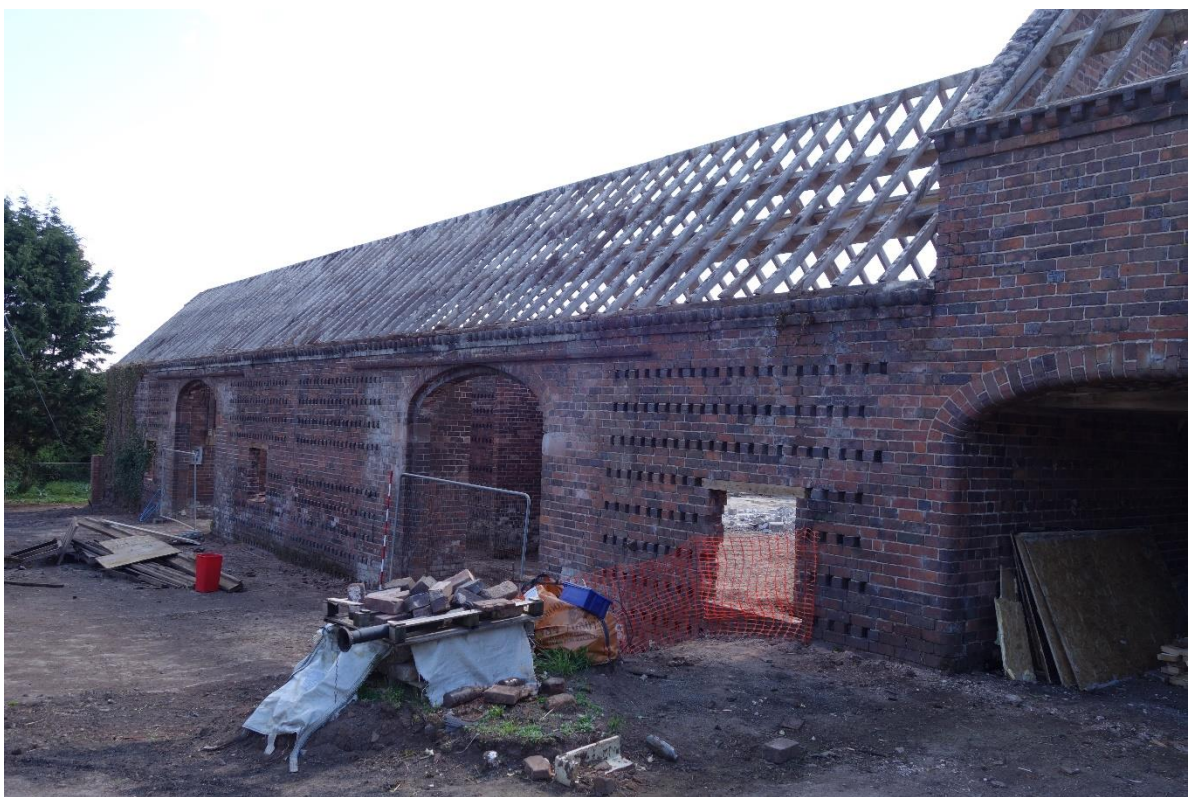
The archway at the SW end of the SE -facing elevation is flanked to the right by a square opening at ground-floor level (now boarded up) while to the left of the archway are the brick footings and projecting wall stubs of a lean-to brick structure (internally whitewashed), which has recently been demolished. In the NW -facing elevation, the archway towards the NE end is flanked by two flat-arched window openings at ground level, while another flat-arched opening with intact wooden lintel is located to the right of the archway, towards the SW end of the elevation (*Plate 2*).

Plate 2: View looking ENE showing NW-facing elevation of Building A, with the granary and cartshed to right of picture

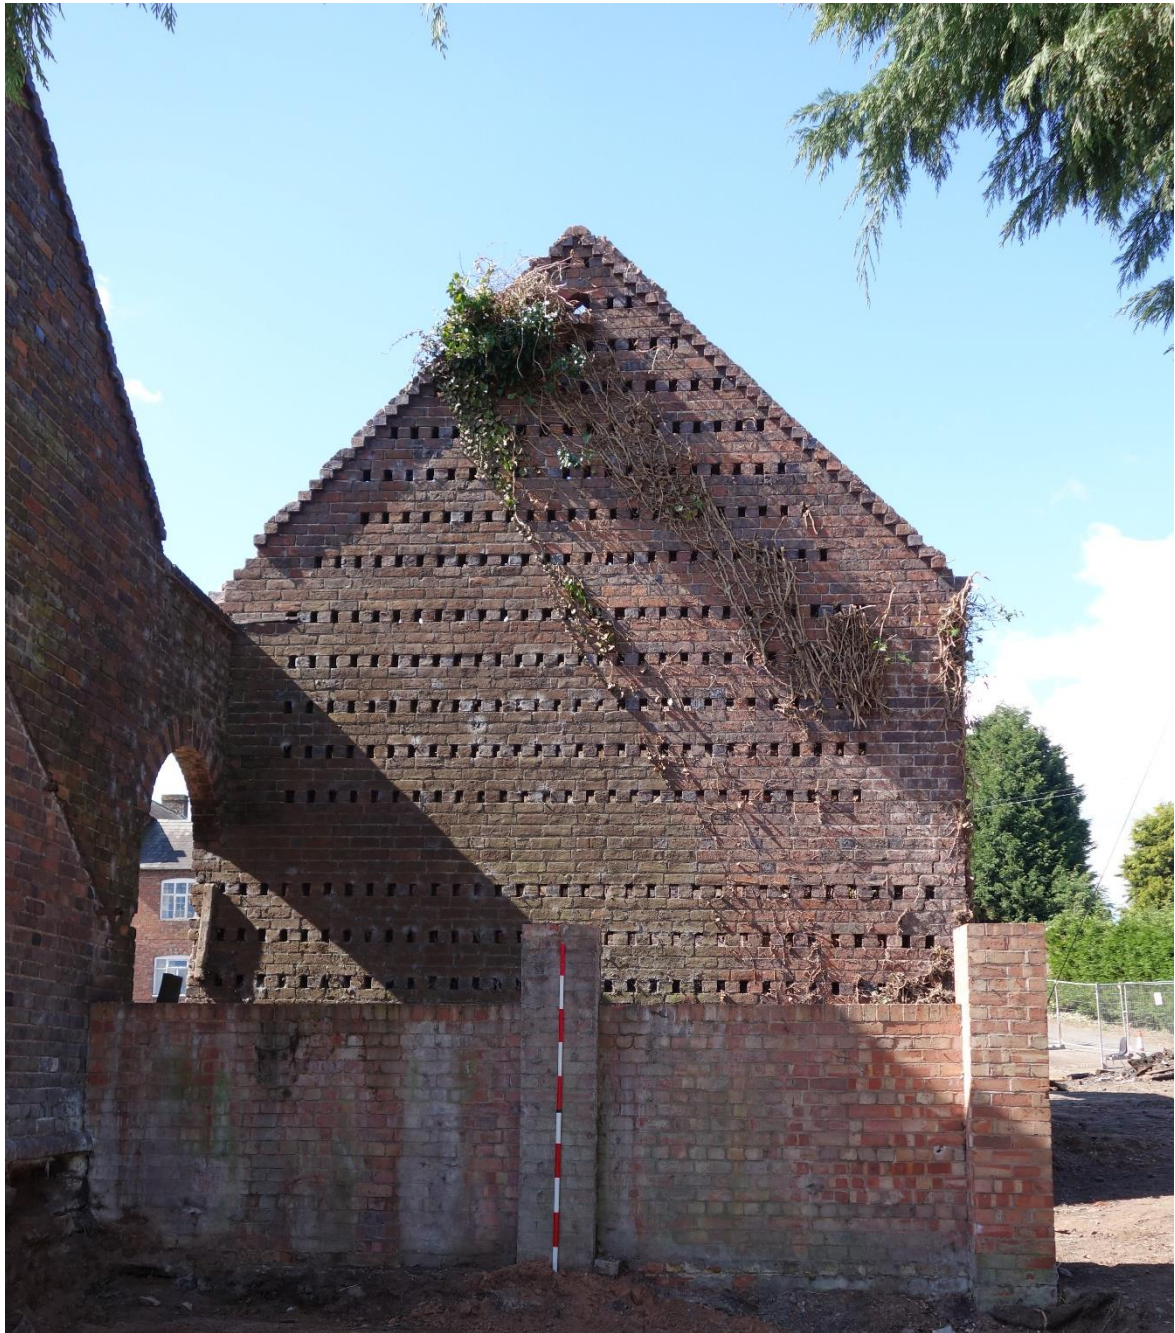
Building A was evidently used as a threshing barn (for the storing and processing of grain crops) as indicated by the nine rows of small rectangular ventilation slots extending up to eaves level across the NW- and SE -facing elevation (*Plates 1 & 2*); the NE gable elevation has a similar series of ventilation slots; however, in this case they extend up to the apex of the gable (*Plate 3*).

Plate 3: View showing the NE gable end of the threshing barn (Building A) with ventilation slots extending up to the apex of the gable, to the left of which is a section of wall with a round-headed door opening connecting Buildings A & B

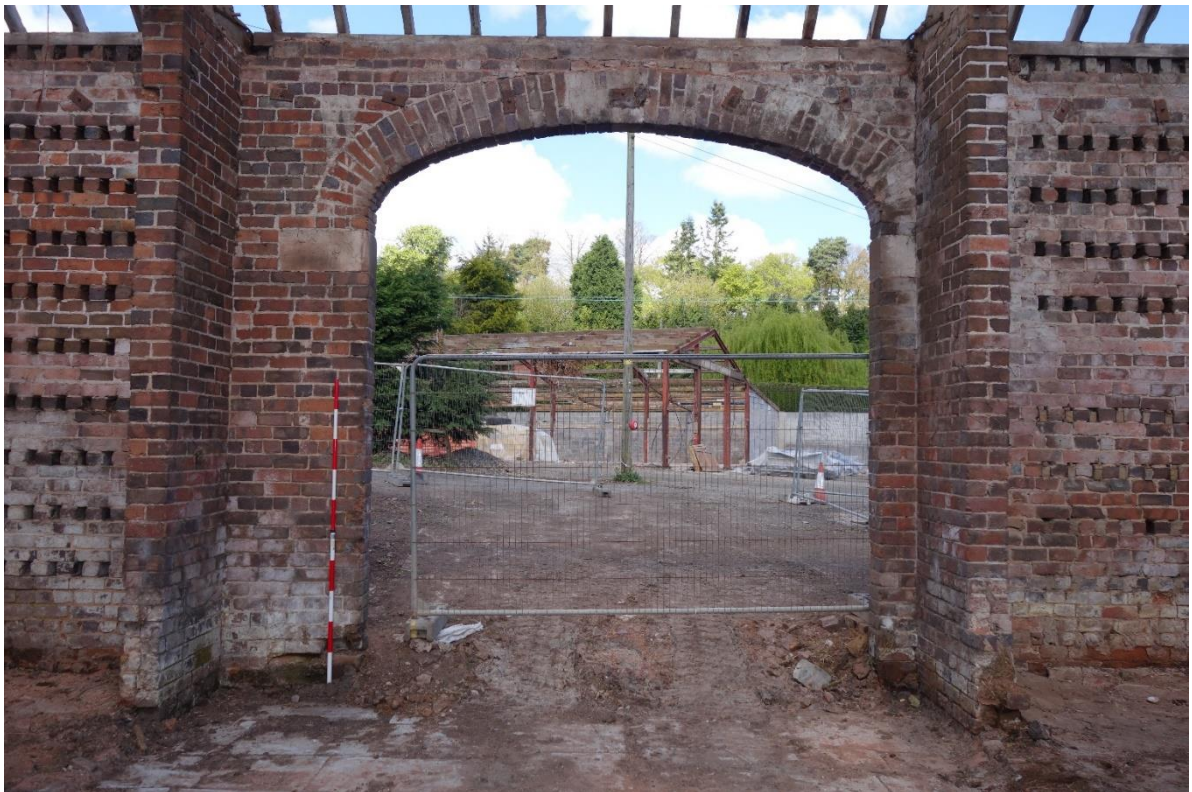
Plate 4: Internal view looking NW showing the wagon arch towards the NE end of Building A, with the threshing floor in background, partially truncated by a modern concrete ramp

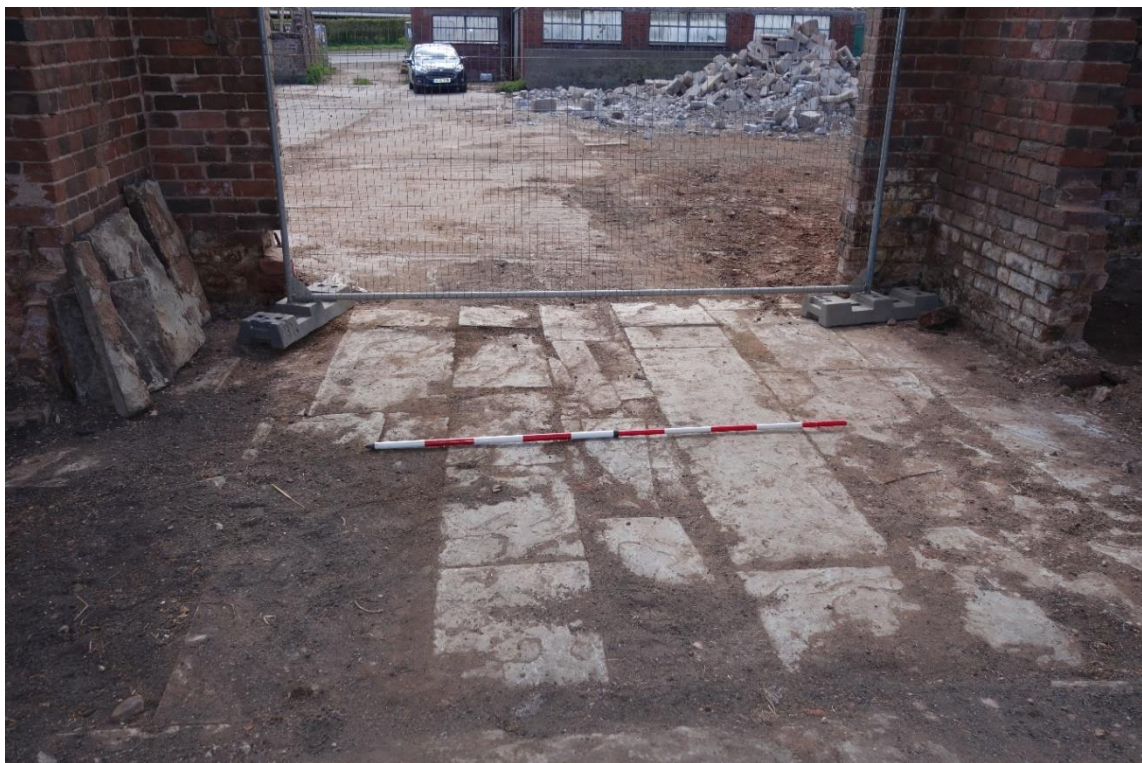
Plate 5: Internal view looking SE showing the partially intact stone flagged threshing floor at the NE end of Building A

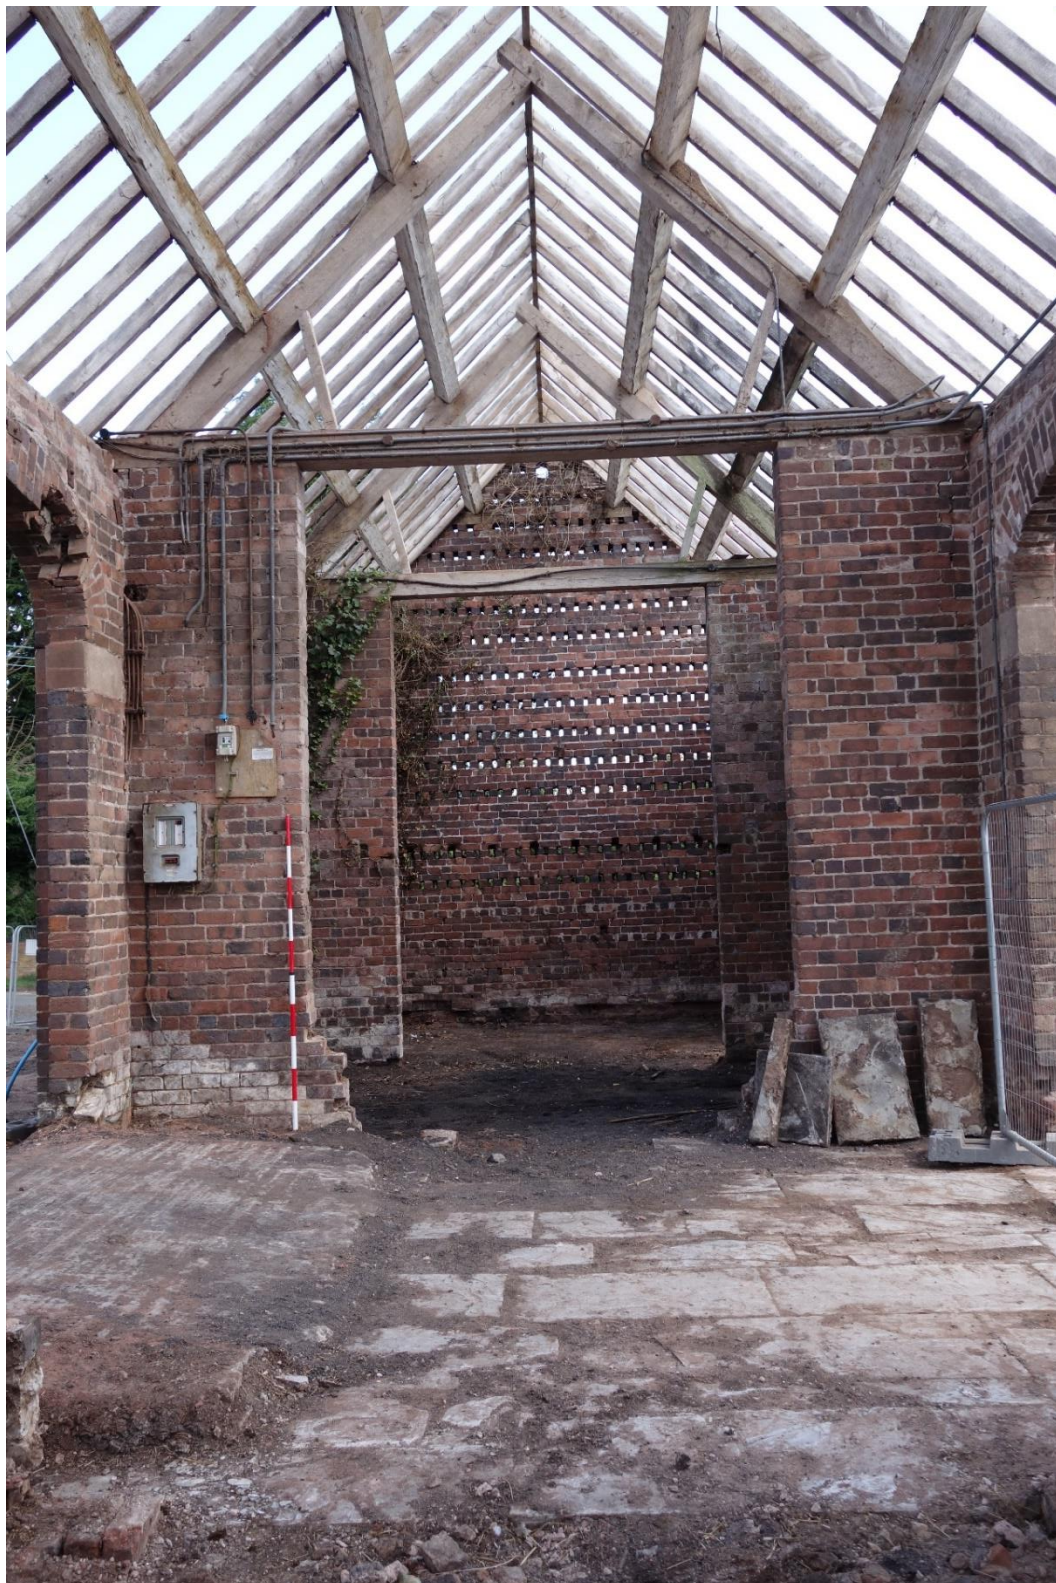
Plate 6: Internal view looking NE showing NE part of Building A with open-truss roof structure, the stone-flagged threshing floor in the foreground and beam slots for loft in NE gable wall

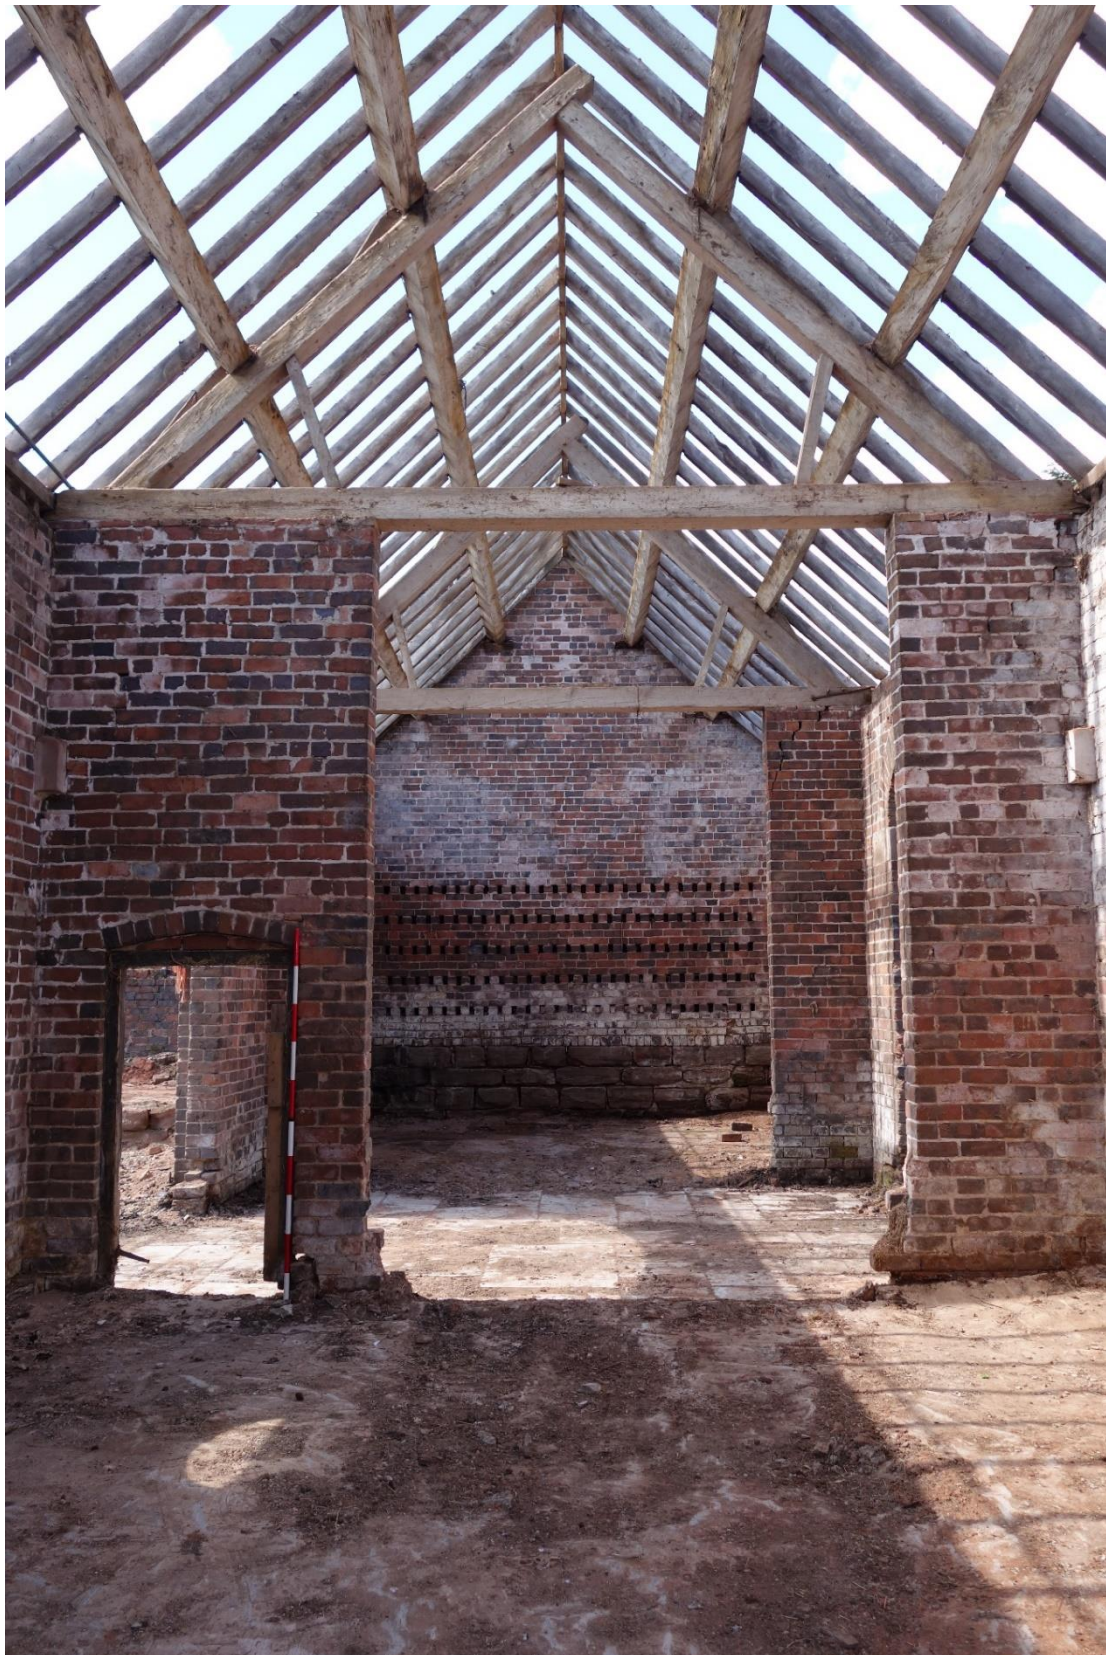
Plate 7: View looking SW showing SW end of threshing barn (Building A) with segmental-arched doorway inserted in buttress to left of picture, with evidence for a low brick partition wall indicated by heavily truncated wall stubs.

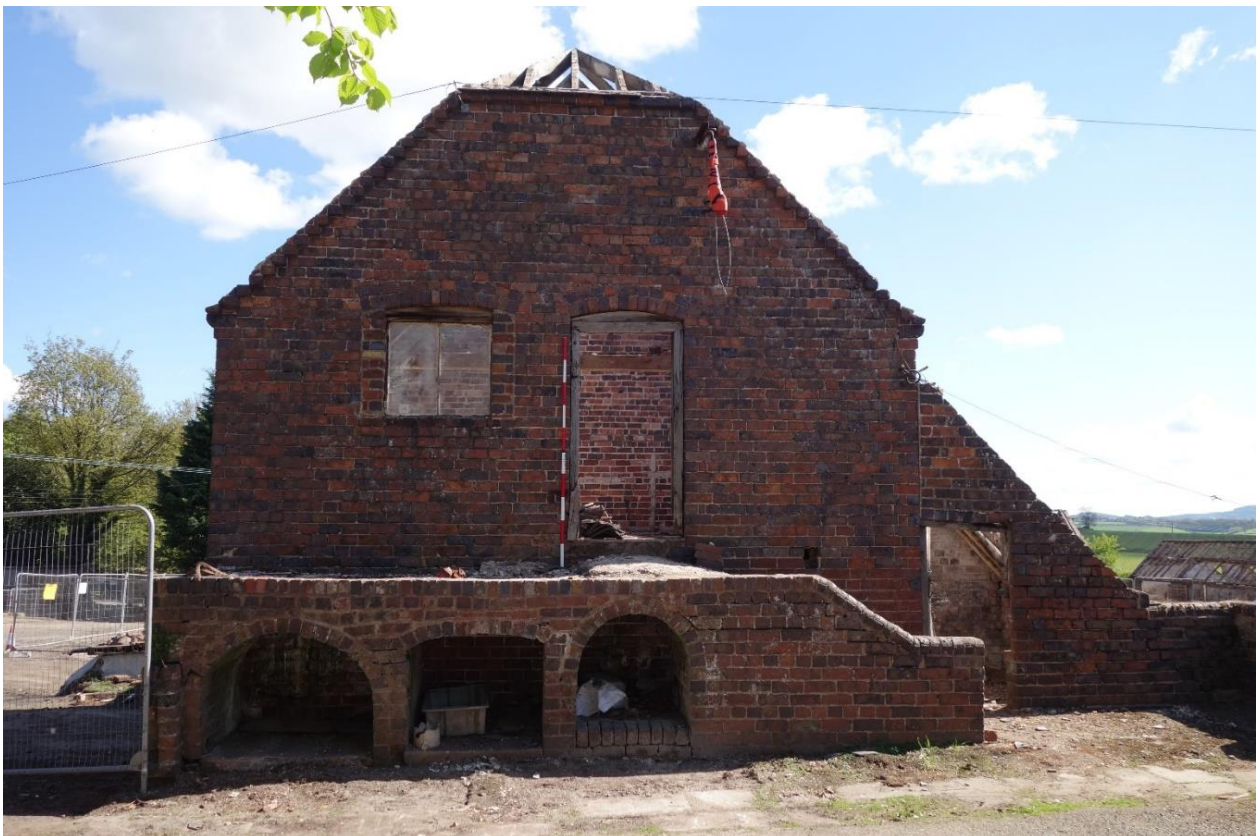
Plate 8: View looking NE showing SW-facing elevation of granary with arched recesses in stairs and lean-to piggery building to right of picture

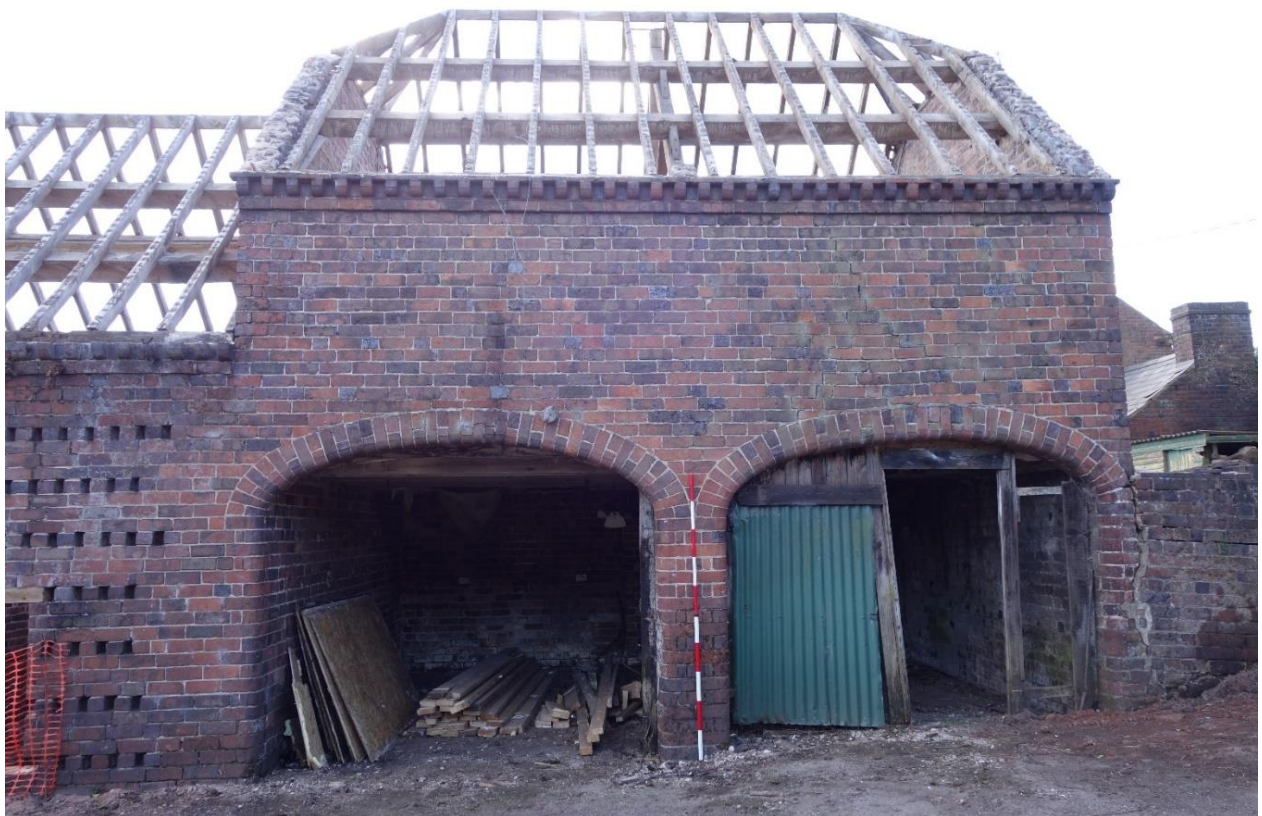
Plate 9: View looking SE showing NW-facing elevation of granary and cartshed, showing two depressed arched openings with brick voussoirs at ground level

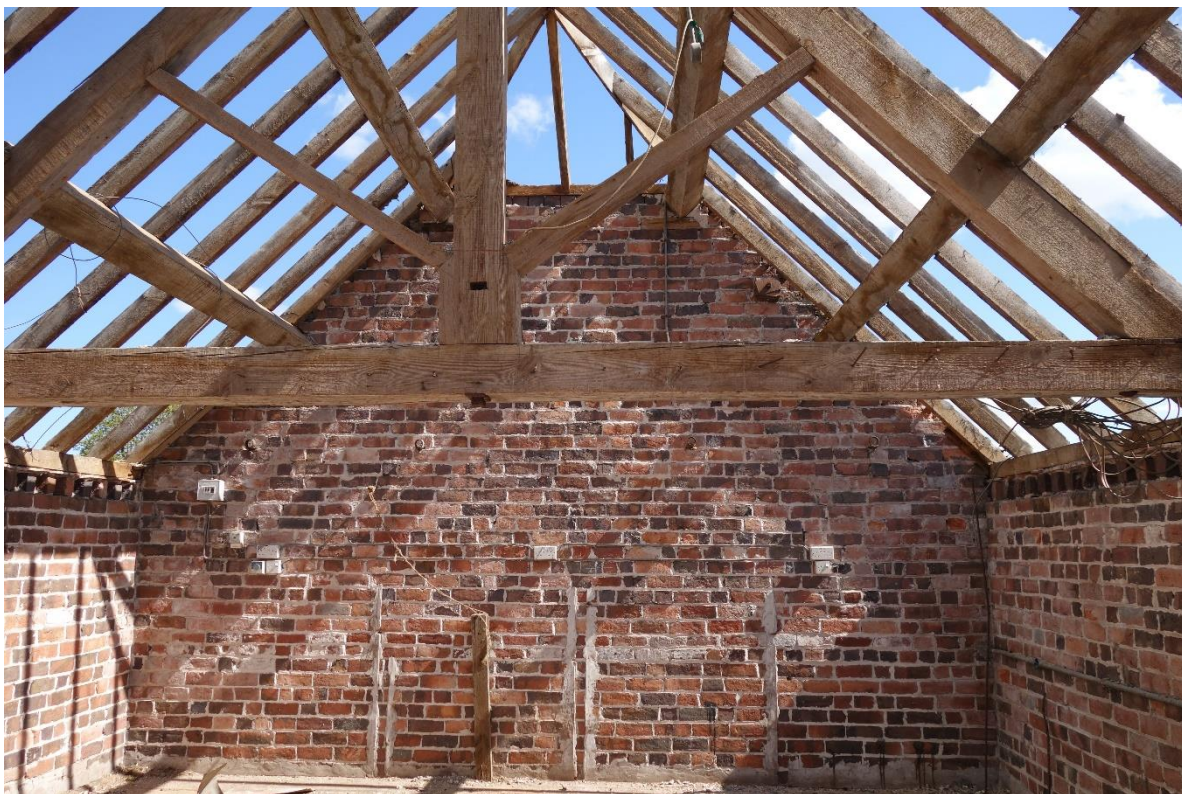
Within the interior of the granary, the most notable surviving features are the kingpost roof structure, with angled struts connecting the kingpost to the principal rafters, and the intact timber planked floor of the granary, with two hatches leading down to the cartshed at ground floor level (*Plate 10*).

Plate 10: Internal view looking NE showing interior of granary with kingpost roof structure

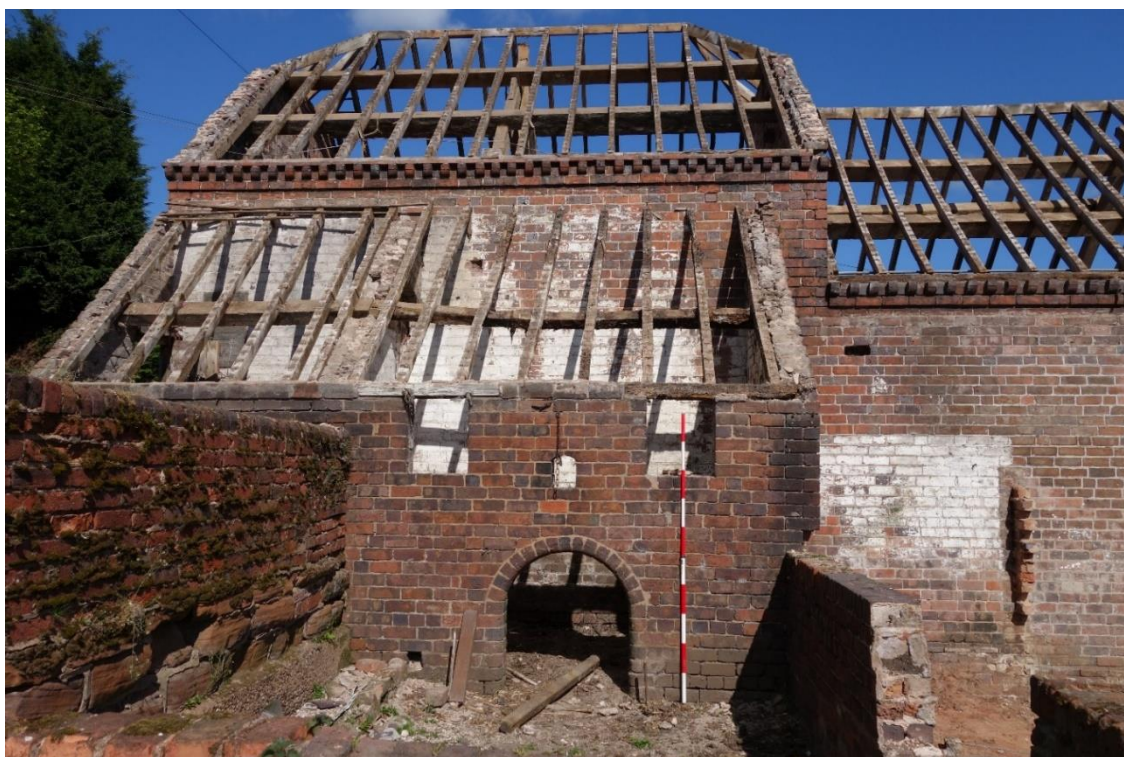
Plate 11: View looking NW showing SE -facing elevation of lean-to piggy structure with wall stub of demolished lean-to building visible to right of picture

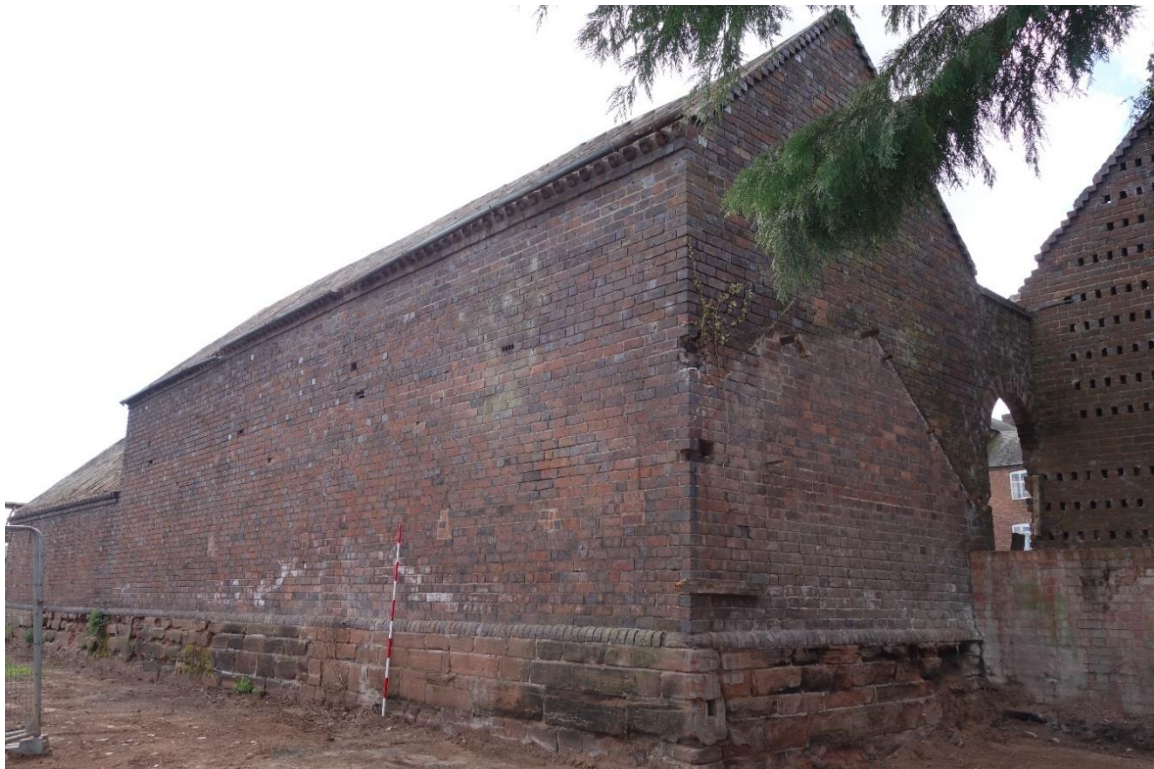
Plate 12: View looking S showing the NE walls and NW-facing gable end of stable block (Building B) resting on a roughly coursed masonry plinth, with evidence for demolished structures adjoining both elevations

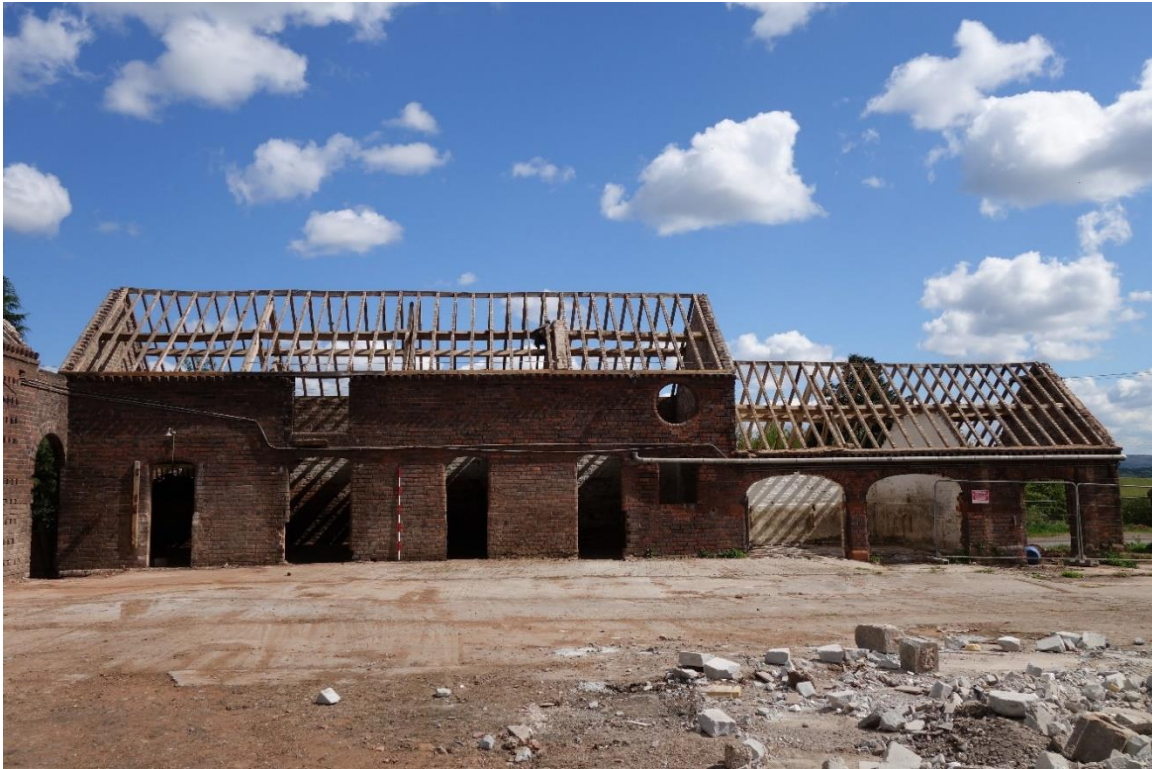
The principal, SW-facing elevation of the four-bay structure is pierced by four segmental-arched doorways (the wooden doors have since been removed) with a segmental-arched window to the right of the south-easternmost bay. Above this window at the SE end of the elevation is a circular gauged brick pitch-hole for delivering hay to the loft above. Inserted at upper-storey level, above the doorway located to left of centre within the SW-facing elevation, is a flat-arched loading bay door leading to the hayloft (*Plate 13*)

Plate 13: View looking NE showing the principal SW -facing elevation of Building B, showing the four-bay stable block with adjoining three-bay annexe, probably used as a cartshed

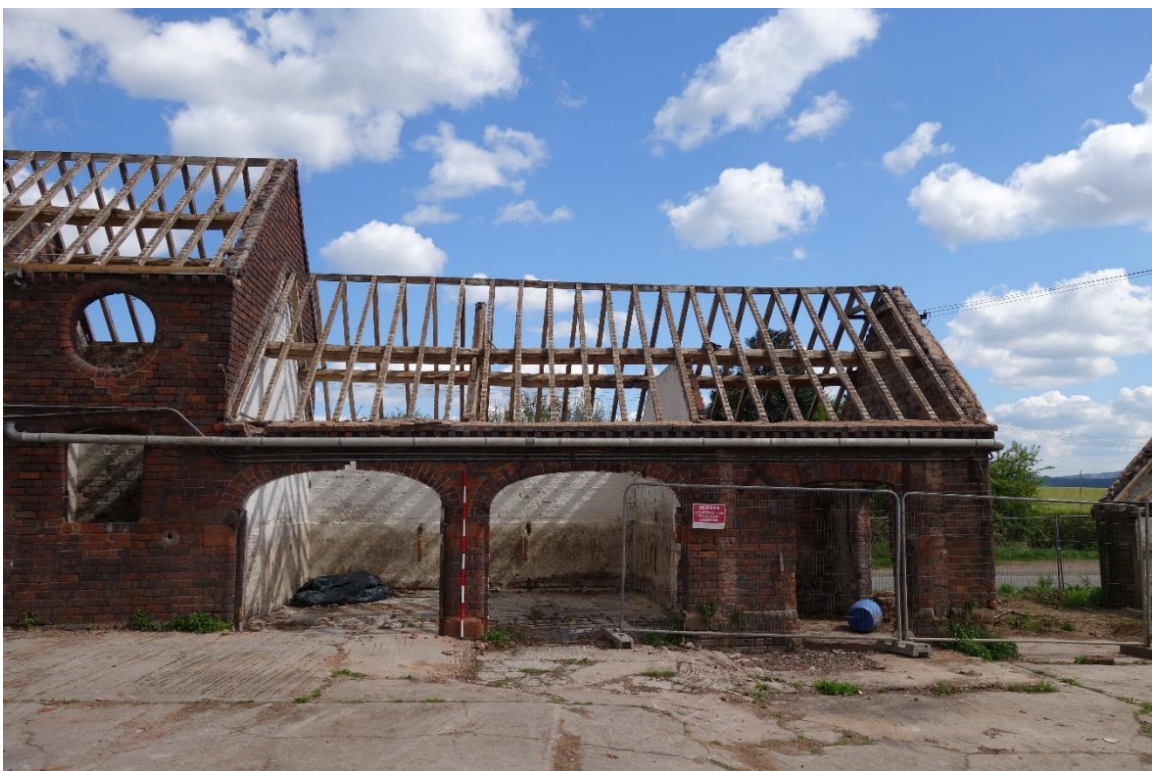
The four-bay structure appears to have functioned as a stable with hayloft above while the attached single-storey structure appears to have functioned as a cartshed, judging by the extremely broad depressed archways inserted in the SW-facing elevation (*Plate 14*).

Plate 14: View looking NE showing SW -facing elevation of single-storey, three-bay annexe at SE end of Building B

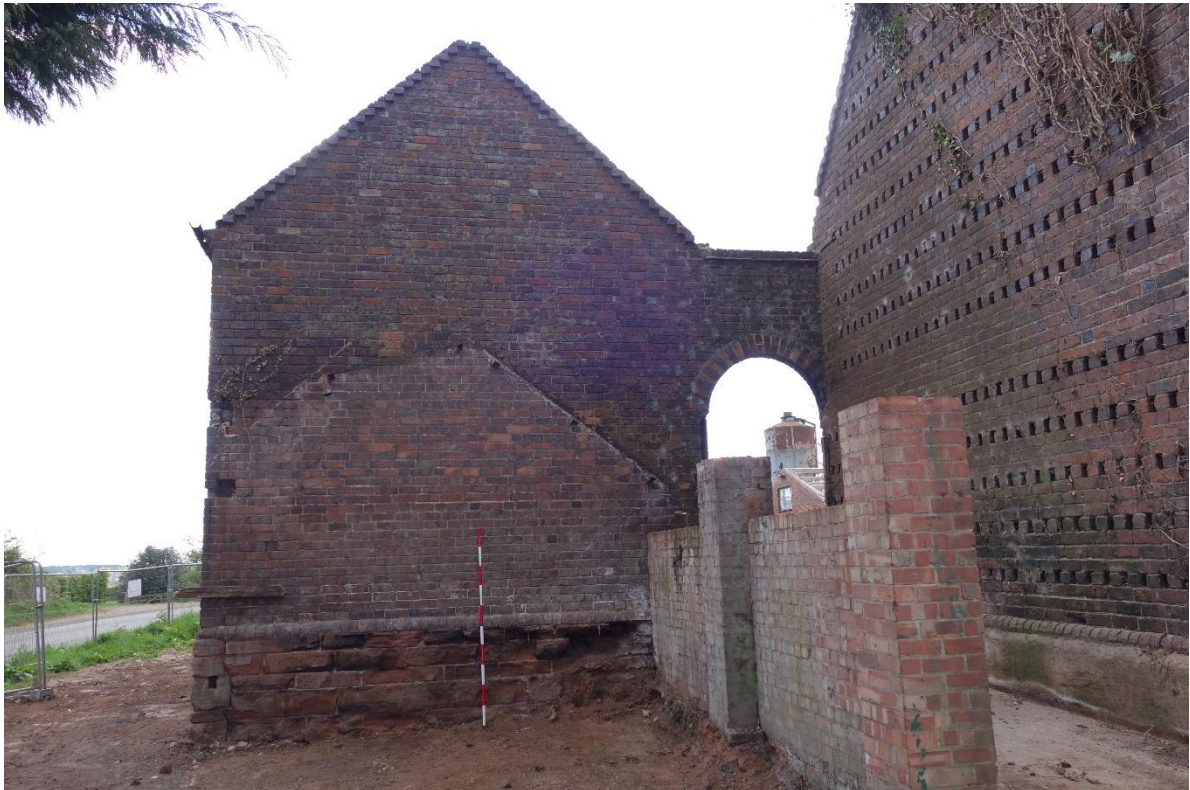
The NE -facing elevation is devoid of fenestration (*Plates 12 & 15*); however, a row of beam slots inserted in the wall below eaves level appear to relate to a four-bay lean-to range (most likely a cow stall), which is marked in this location on the OS 1st edition map of 1883. A gabled roofline and projecting brick wall stub is visible on the NW gable end of Building B; this appears to represent the remains of a single-storey rectangular structure oriented NW-SE (since demolished), which is marked on the OS 1st edition map and subsequent OS mapping until recently (*Plate 15*).

Plate 15: View looking SE showing NW gable end of stable block (Building B), with evidence of a gabled extension indicated by a pitched roofline and projecting brick wall stub

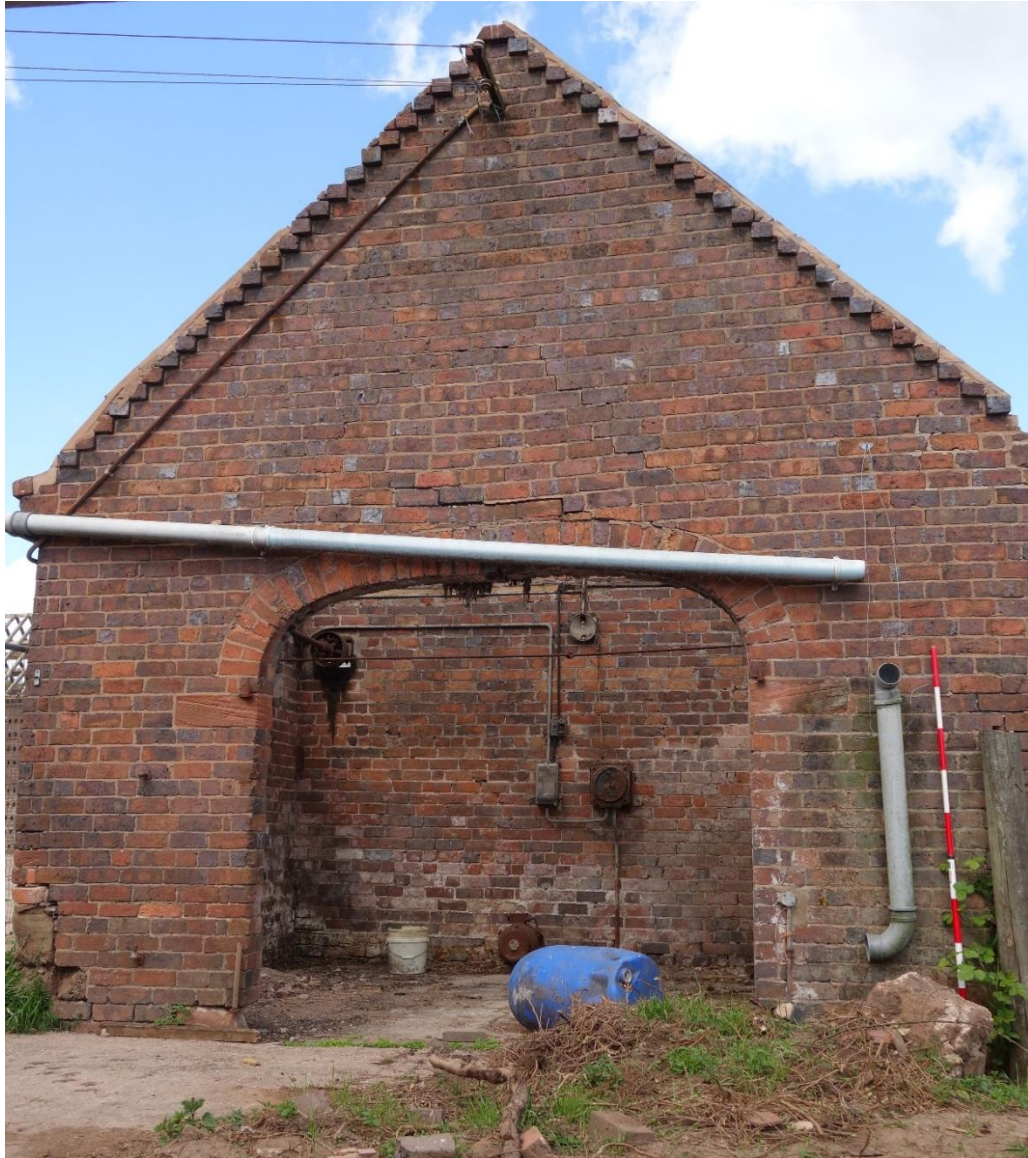
Plate 16: View looking NW showing SE gable end of Building B with a centrally placed, depressed arched opening with brick voussoirs and imposts and dentilled decoration along the roofline of the gable

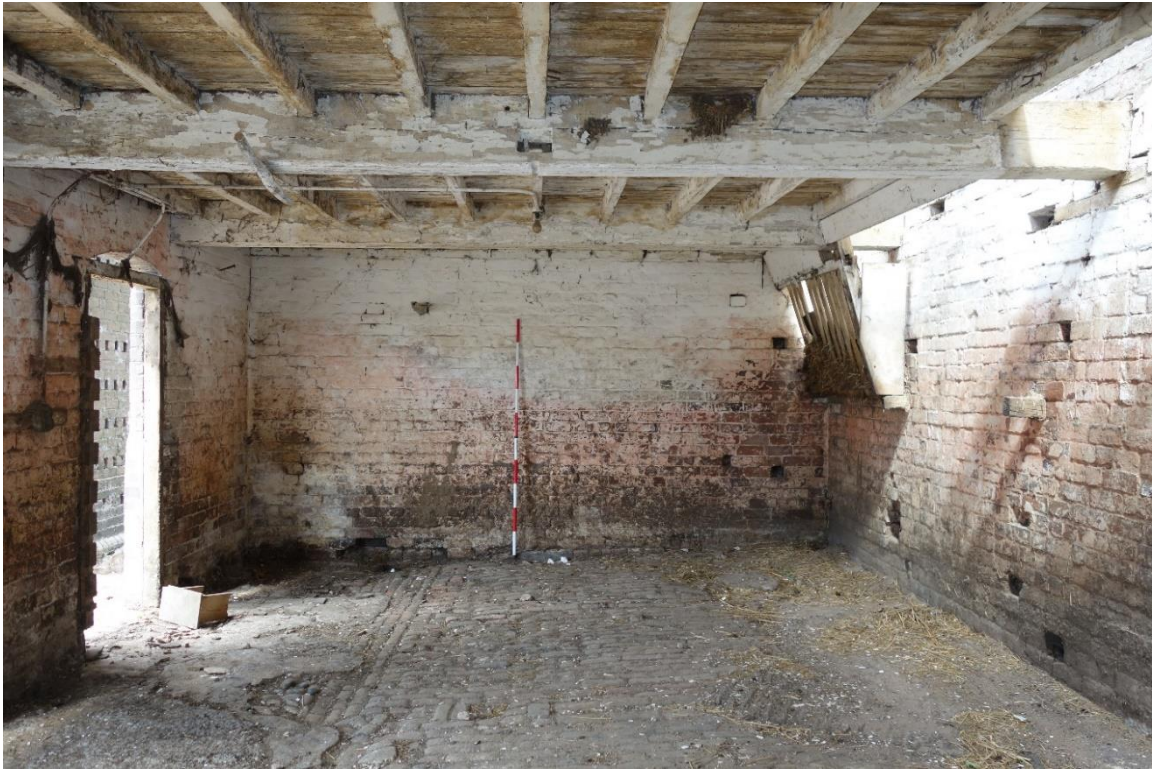
internal fittings appear to have survived, although evidence of a hayrack was noted within the far NE corner of the compartment, as well as horizontal wooden posts inserted in the NW wall, which were probably used for hanging harnesses (*Plate 17*).

Plate 17: Internal view looking NW showing interior of four-bay stable block (Building B) with cobbled flooring and intact hayrack in NE corner

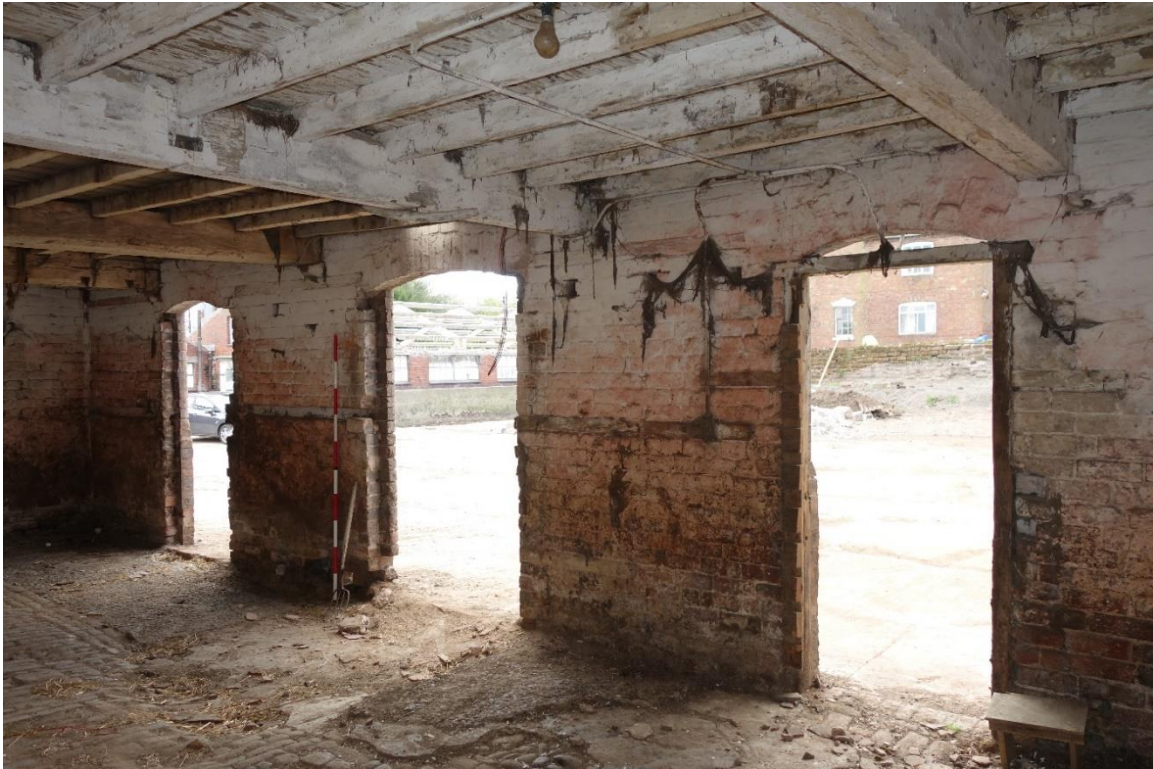
Horizontal wooden timbers and beam-slots inserted in the thickness of the wall were presumably associated with hayracks or mangers, which have since been removed (*Plate 18*). Slots inserted in the beams may be associated with partitions for stalls; however, little visible evidence for internal sub-divisions has survived. The flooring of the compartment, consisting of stone cobbles, has remained largely intact. Within the 'loose box' at the SE end of the four-bay structure, little evidence of internal fixtures or fittings has survived (although beam slots for a hayrack were visible in the NE wall) and no evidence for cobbling was noted. Due to access and safety considerations, it was not possible to investigate the upper storey of Building B more closely. The roofing, which

Plate 18: Internal view looking S showing interior of four-bay stable block with segmental-arched doorways

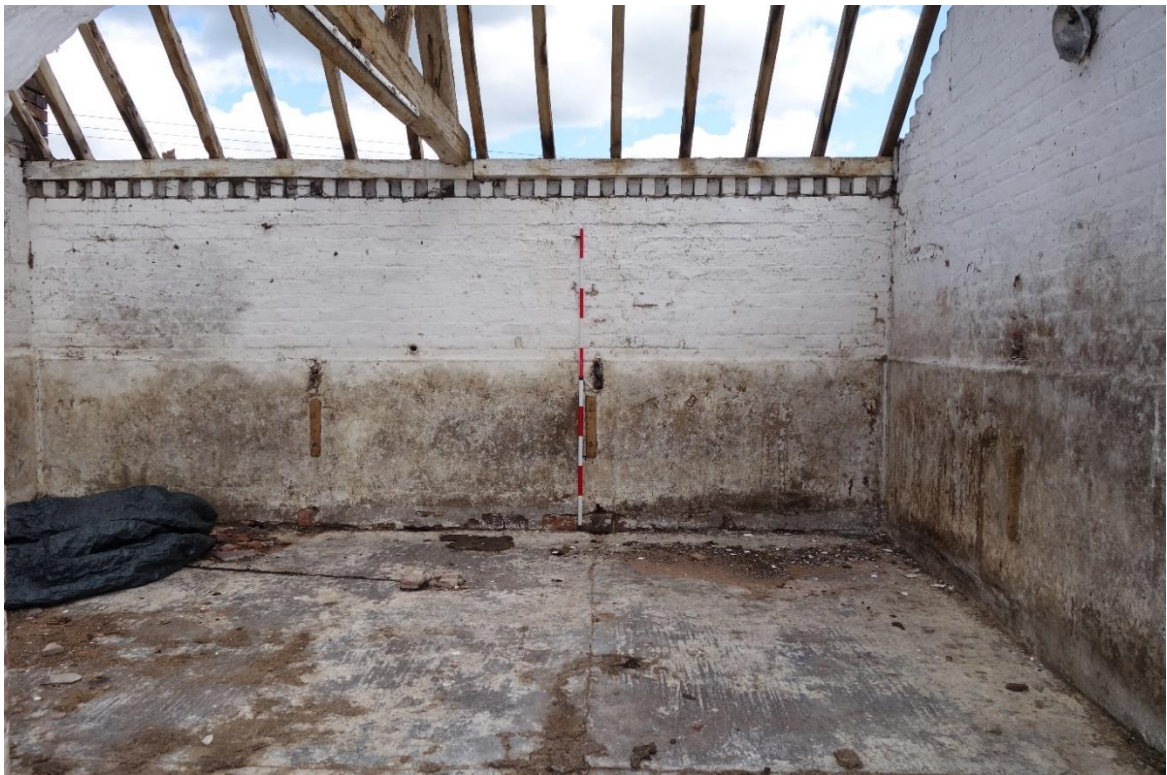
Plate 19: Internal view looking NE showing interior of two-bay compartment (Building B) with later concrete flooring
