Historic Building Recording

Blakeshall Farm

Wolverley

May 2015

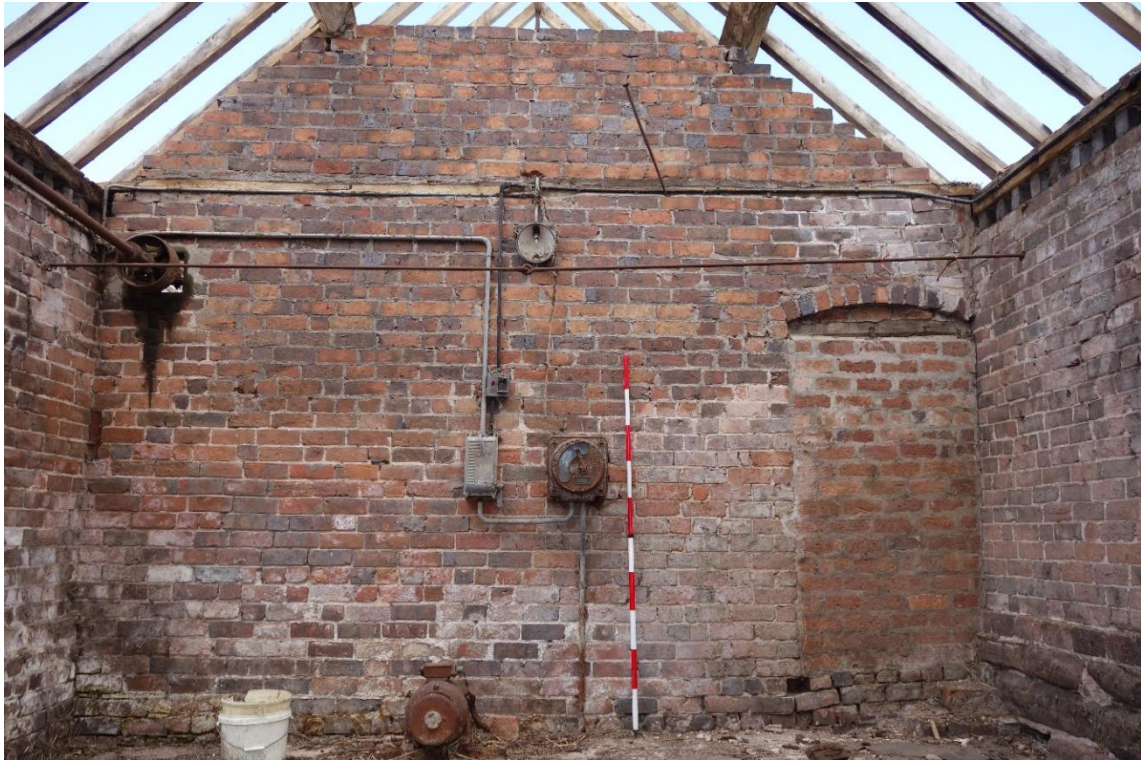
Plate 20: Internal view looking NW showing partition wall in smaller compartment at SE end of Building B, with blocked doorway to right of picture and generator in centre of picture

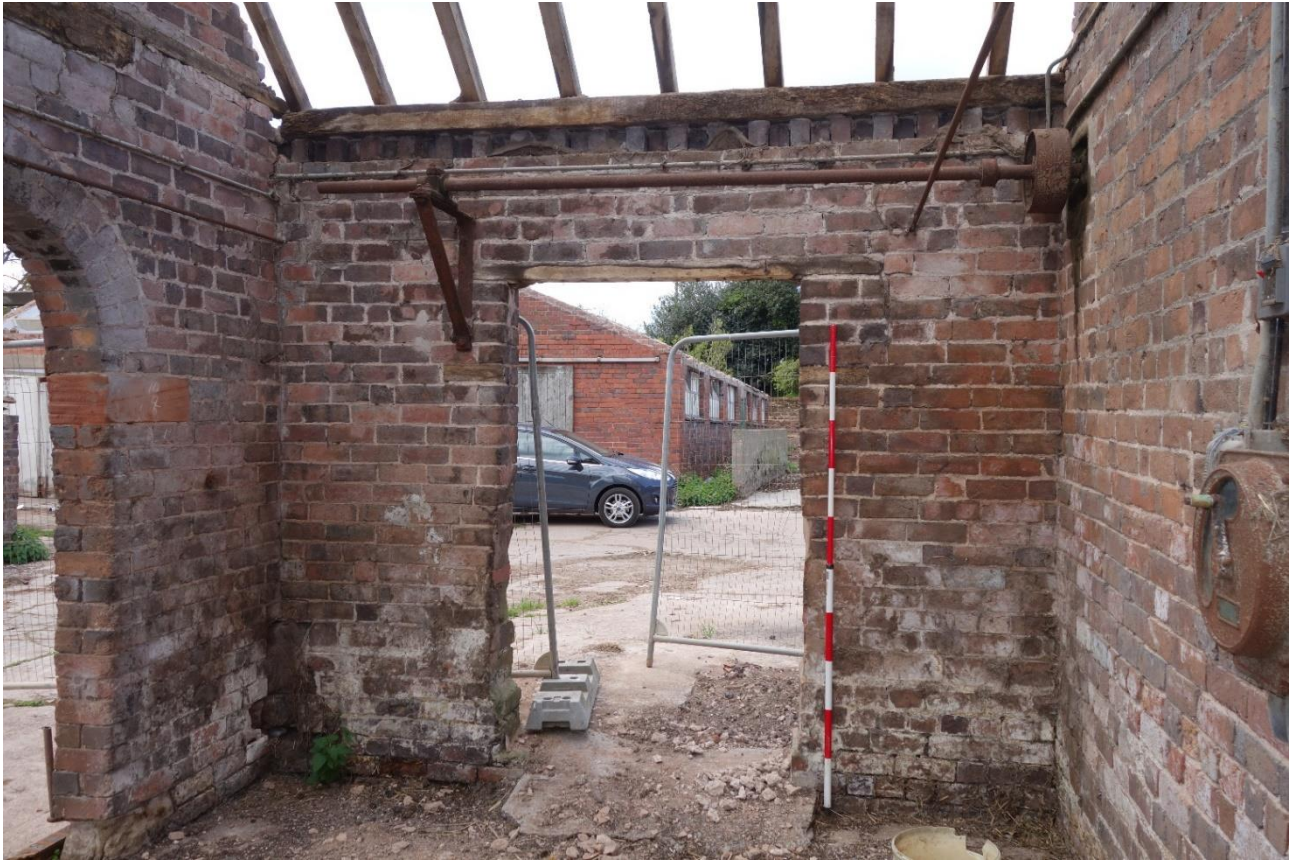
Plate 21: View looking SW showing cast iron overhead drive shaft and gear wheel above doorway in smaller compartment of Building B

It is likely that this shaft and gearing mechanism was associated with a rolling mill for processing animal feed, which was probably housed in the larger two-bay compartment. In connection with this, it is worth noting that an oat-kibbling mill is mentioned in the 1904 sale catalogue for Blakeshall Farm. It appears that a generator was subsequently installed in this room to power the internal and external lighting within the complex of farm buildings. The heavily truncated remains of a generator and switch mechanism are attached to the partition wall and may predate the Second World War.

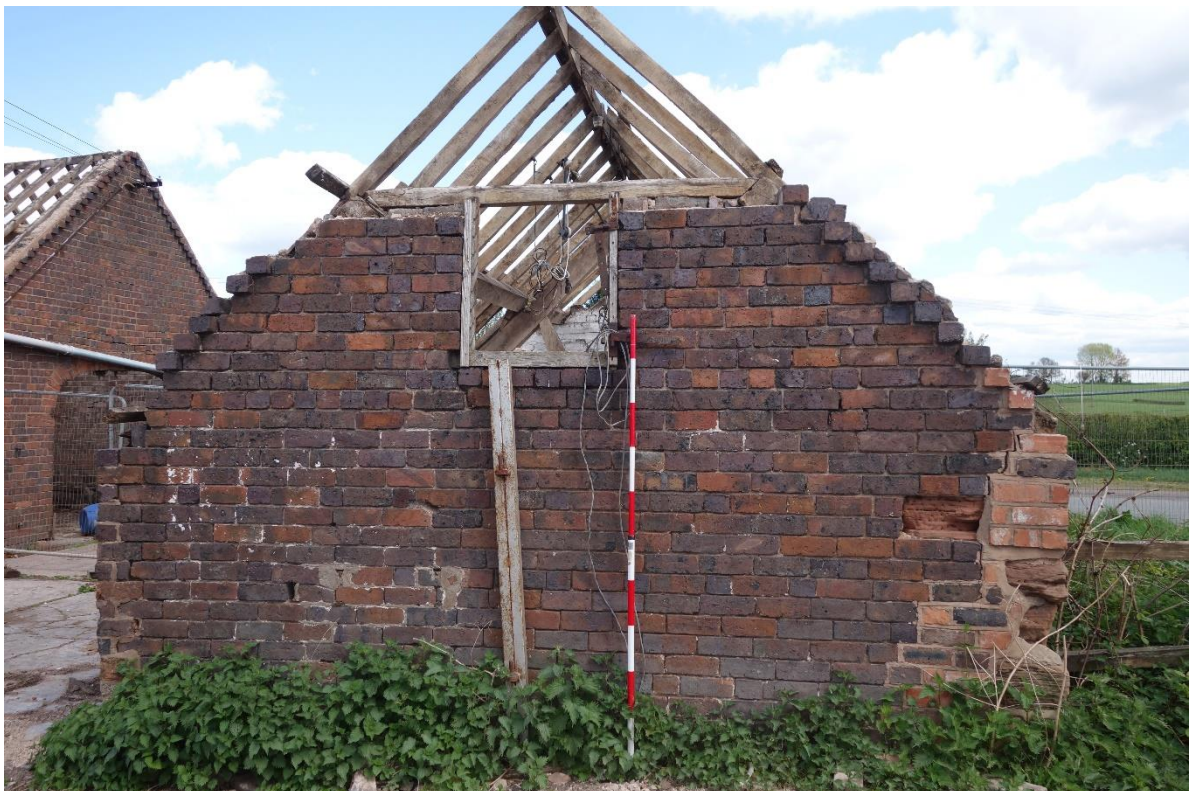
Plate 22: View looking NE showing SW gable end of Building C

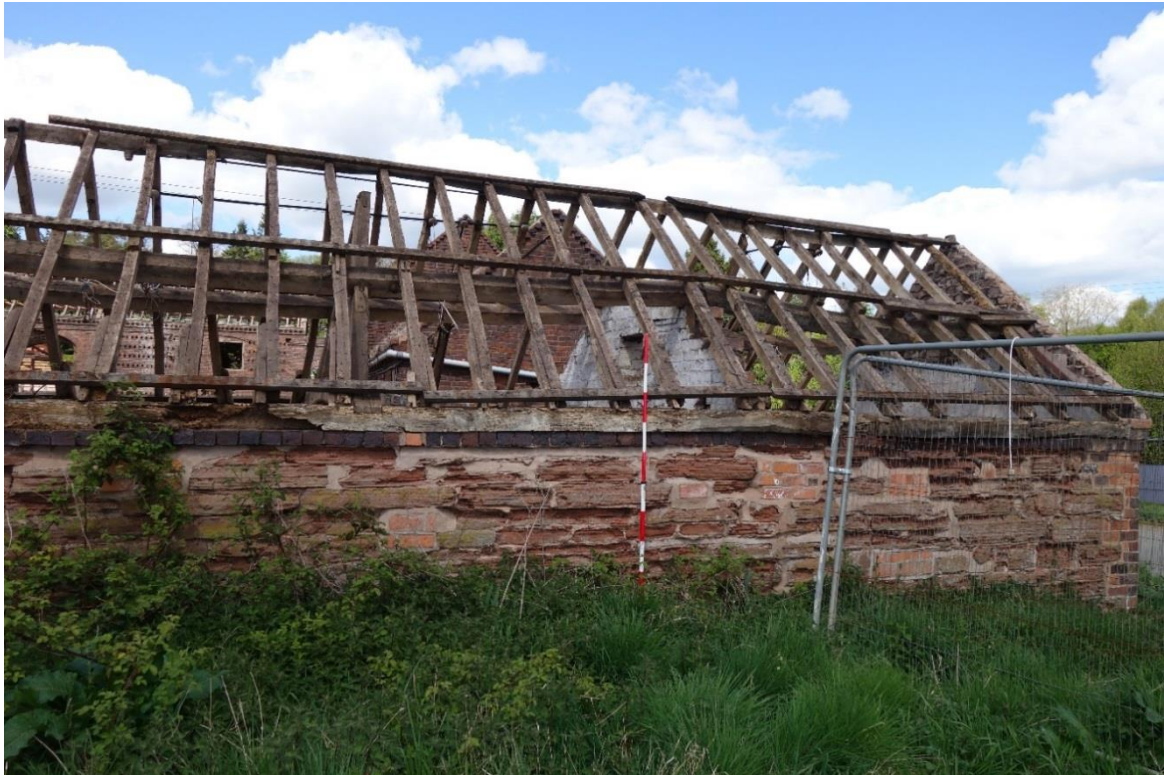
Plate 23: View looking NW showing SE-facing elevation of Building C

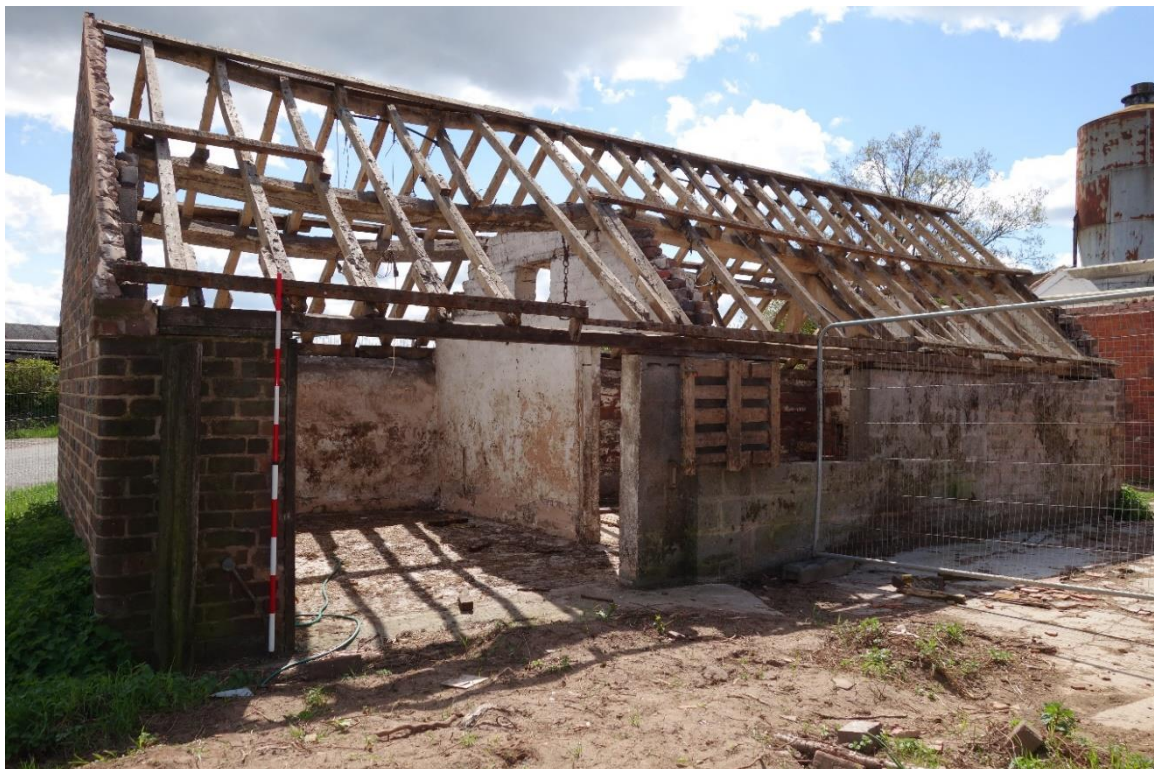
The other walls of the barn appear to have been substantially reconstructed in two phases. The SE -facing elevation is of roughly-coursed rubble masonry construction bonded with greyish-white cement (with a single brick stringcourse at eaves level) and has been roughly keyed into the brickwork of the SW gable end (*Plate 23*). A later, modern phase of alteration is represented by the NE gable end, which has been reconstructed in dark reddish-brown brick laid in stretcher bond, and the NW -facing elevation which has been entirely rebuilt with concrete breeze blocks, with a broad rectangular door-opening inserted in the north-easternmost bay (*Plate 24*).

Plate 24: View looking S showing NW-facing elevation of Building C, heavily rebuilt with concrete breezeblocks, and the NE-facing elevation rebuilt in brick

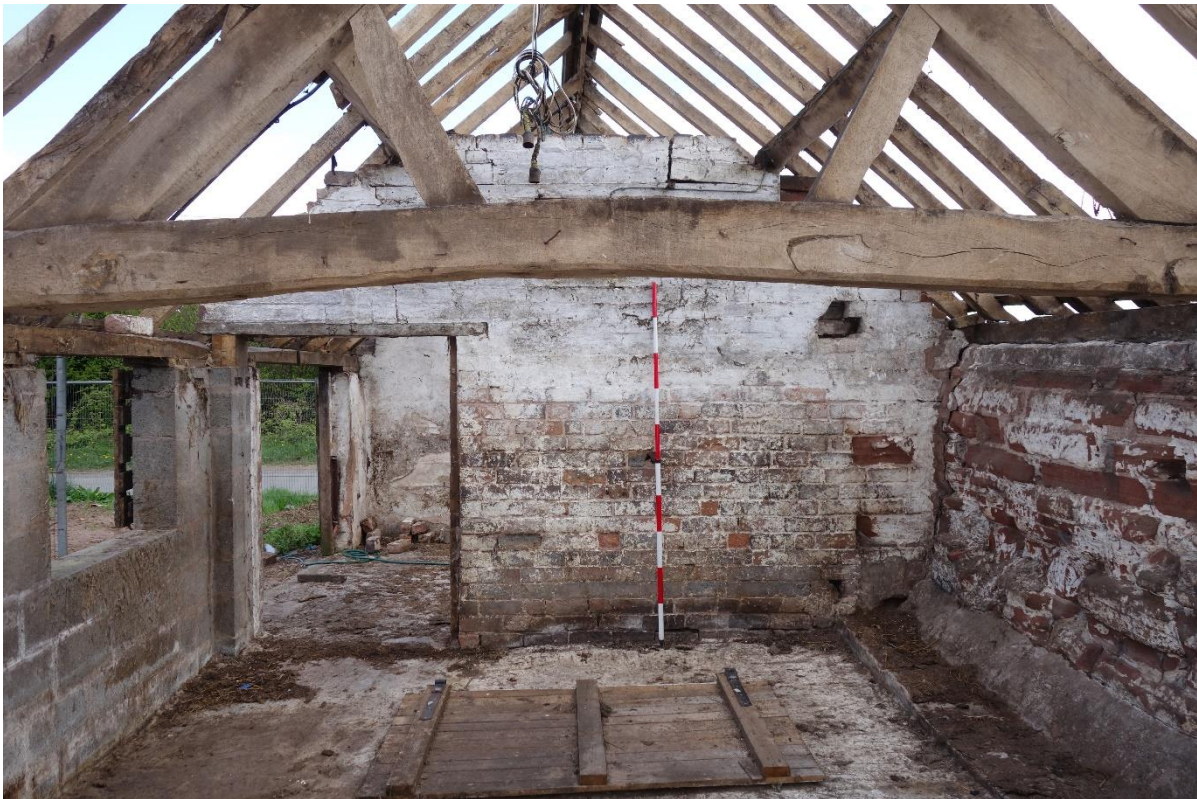
Plate 25: Internal view looking SE showing interior of compartment within Building C showing open-truss roof structure with angled struts connecting the tie-beam to the principal rafters

Internally, the barn is separated into two compartments, the NE bay being separated from the remaining two bays by a brick partition wall (Plate 25). The interior of the both compartments has been whitewashed; no fixtures or fittings of interest were noted. The roof structure is of open-truss construction, with the tie-beam connected by angled struts to the principal rafters and a single set of trenched purlins.

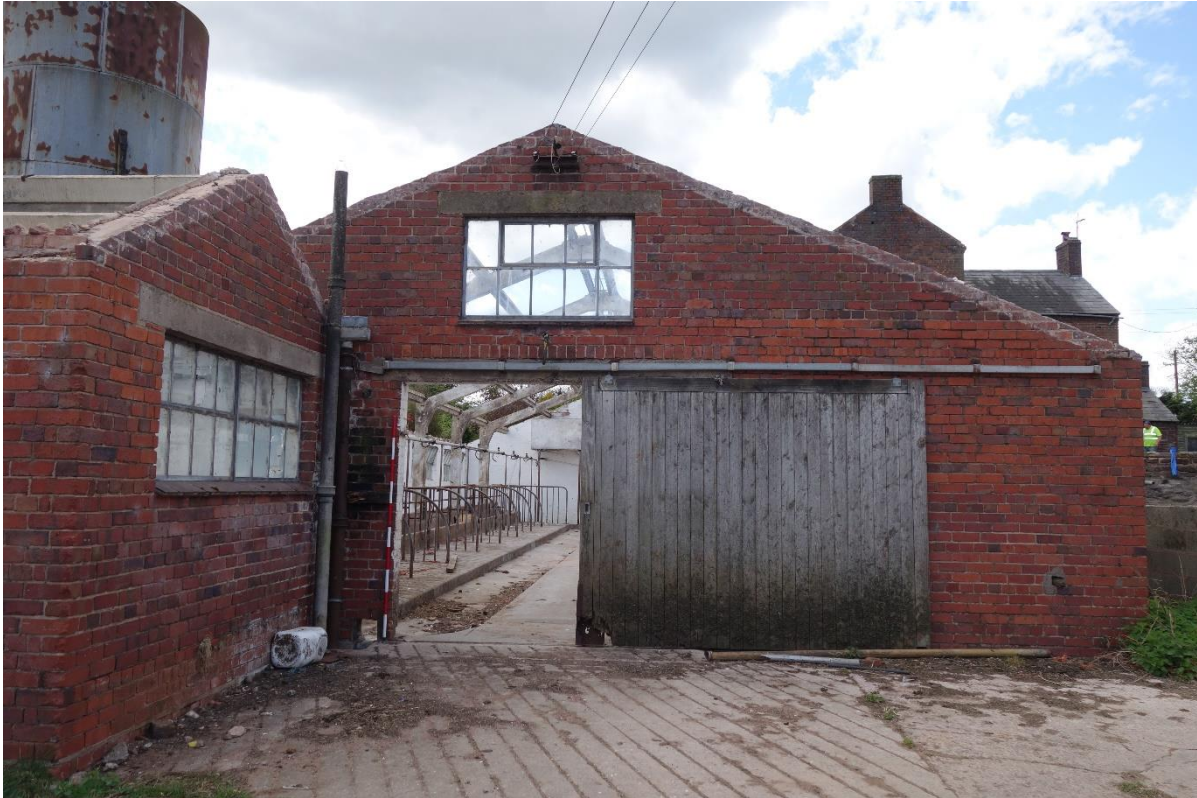
Plate 26: View looking SW showing NE -facing elevation of milking parlour (Building D), with adjoining block to left of picture

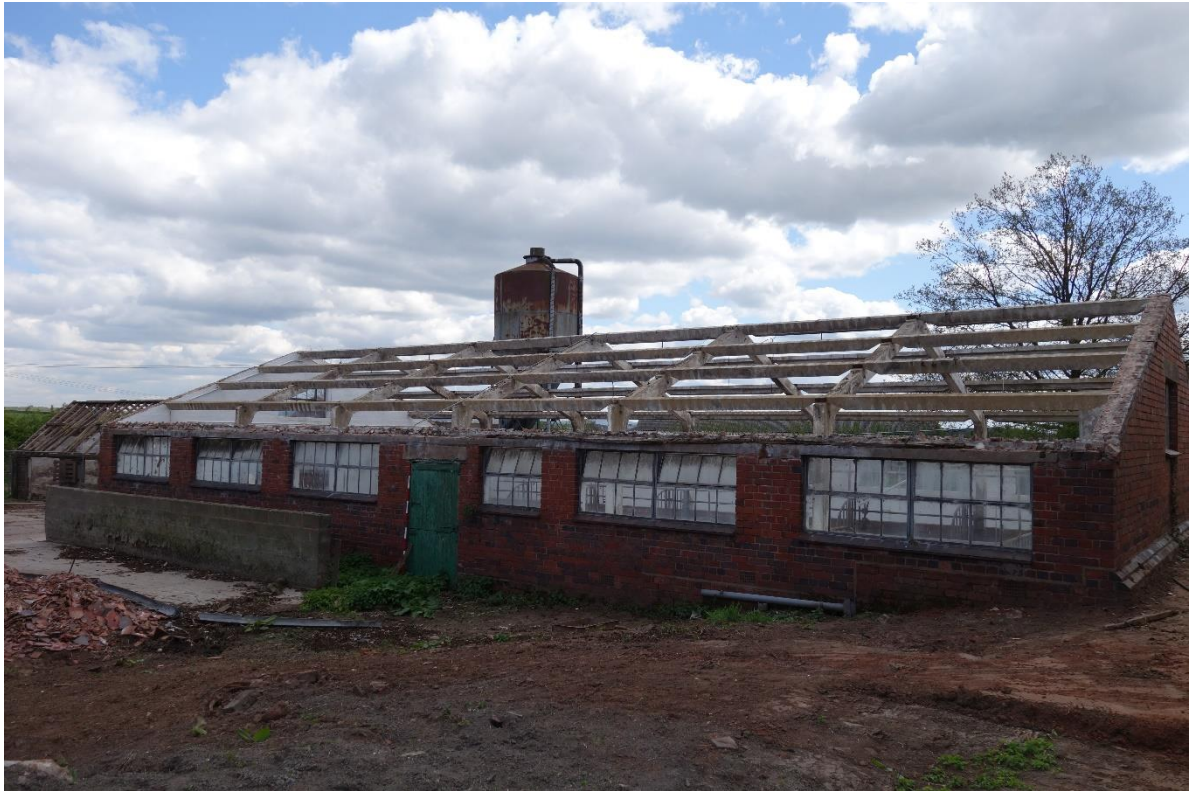
Plate 27: View looking ESE showing NW-facing elevation of milking parlour, with cylindrical tank to rear of building

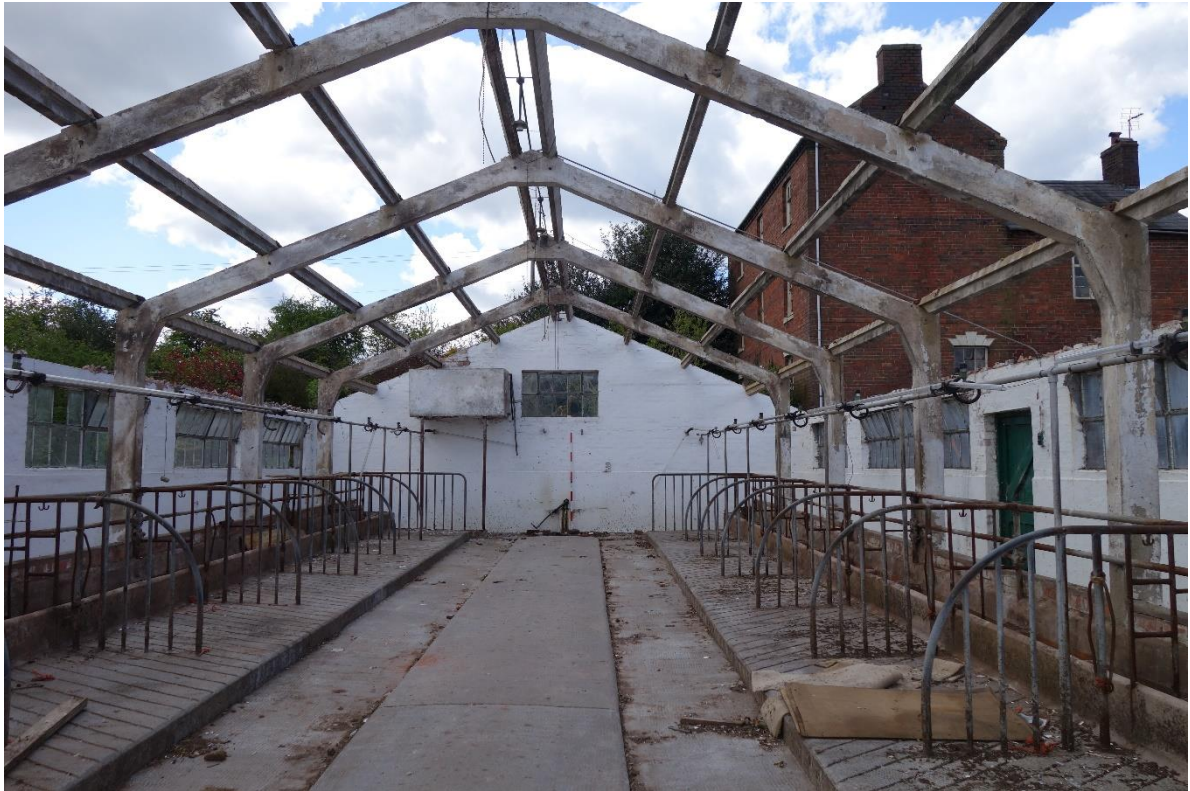
Plate 28: View looking SW showing interior of milking parlour (Building D) with steel roof trusses

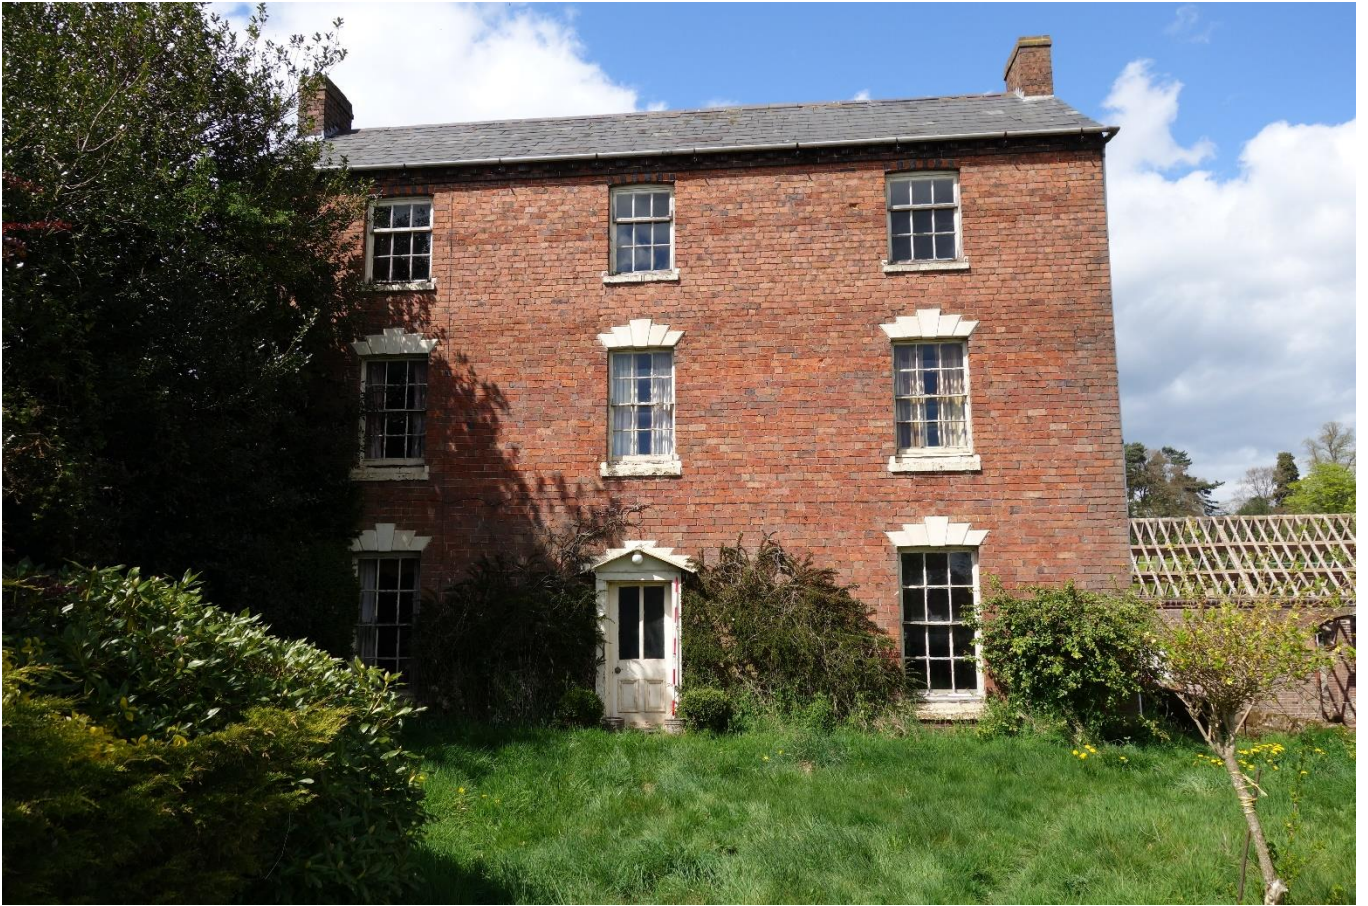
Plate 29: View looking NW showing the principal SE-facing elevation of the farmhouse at Blakeshall Farm

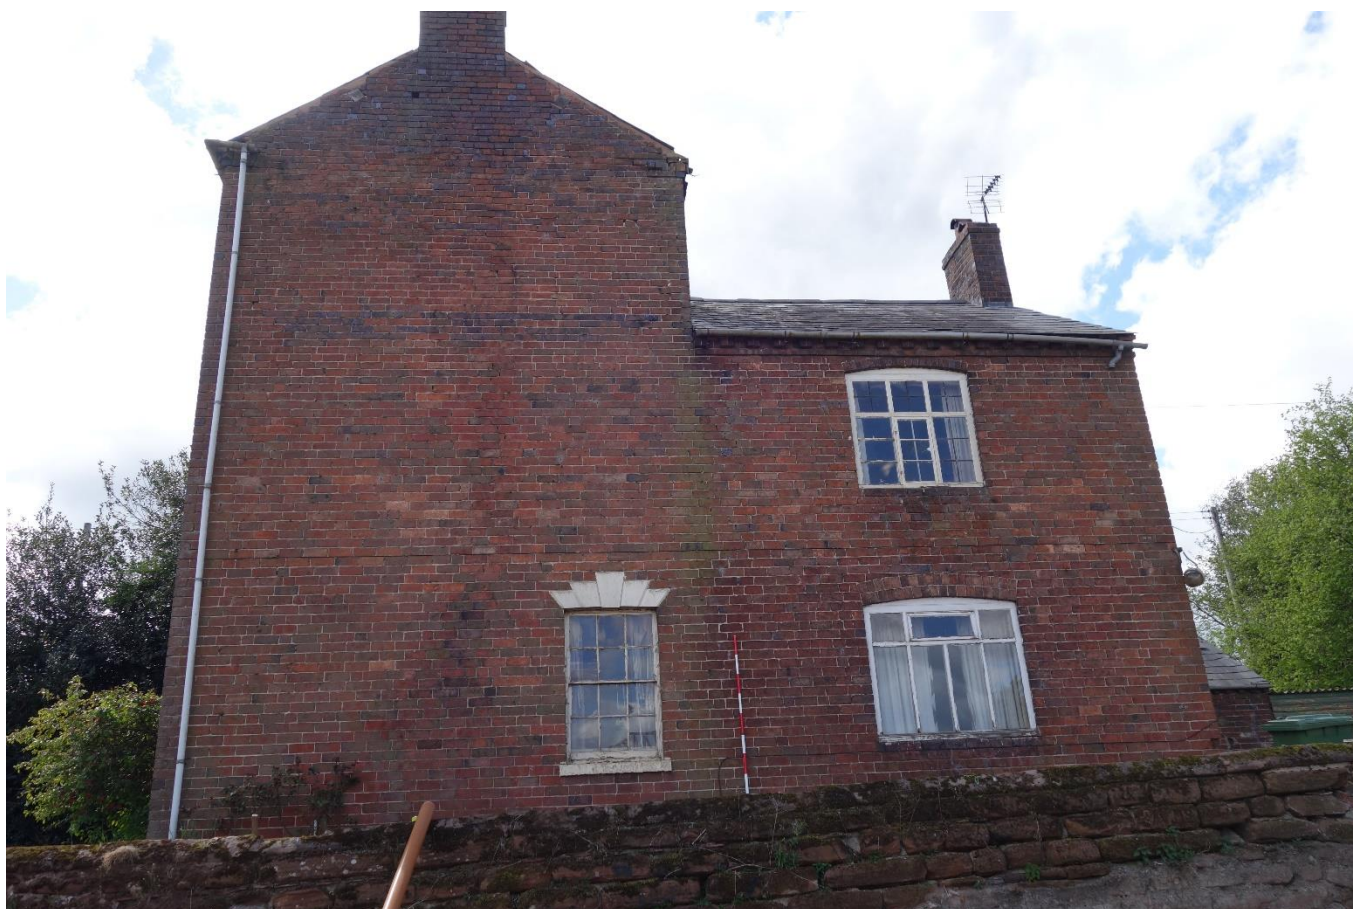
Plate 30: View looking SW showing the NE -facing elevation of the farmhouse with double-pile gabled block to rear
